IRISH SPRING APPLN.

File: 3004857  
FNR-2013-0023  
1

Inspected Nov 21, 2008 by M. Edward

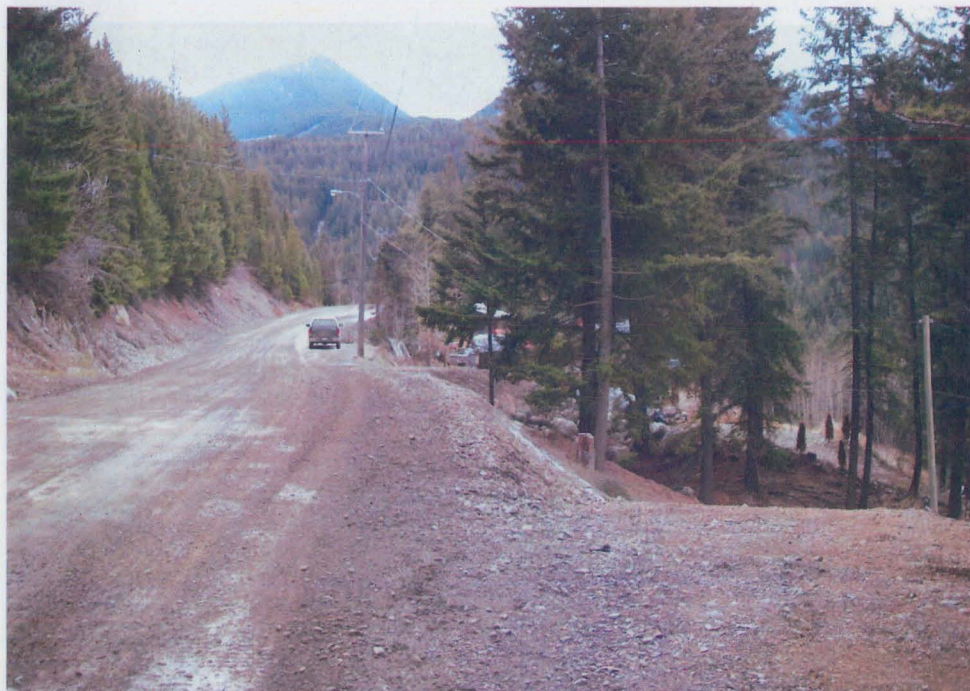
Looking towards Lawrence house along Balorne Rd

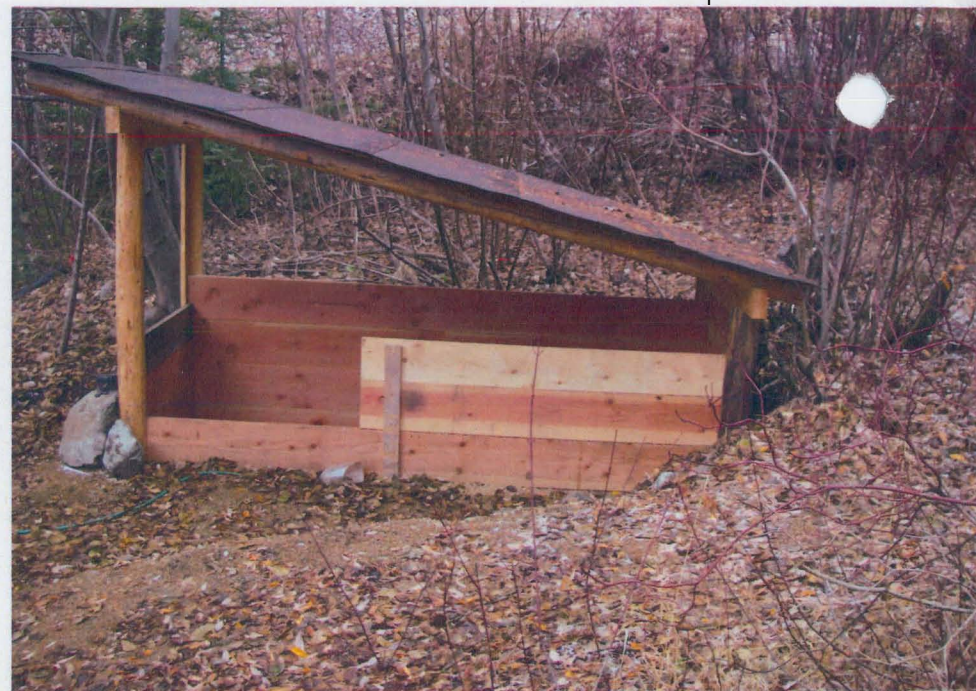
Collection box for Irish Spring on Lot 12, Plan 5847

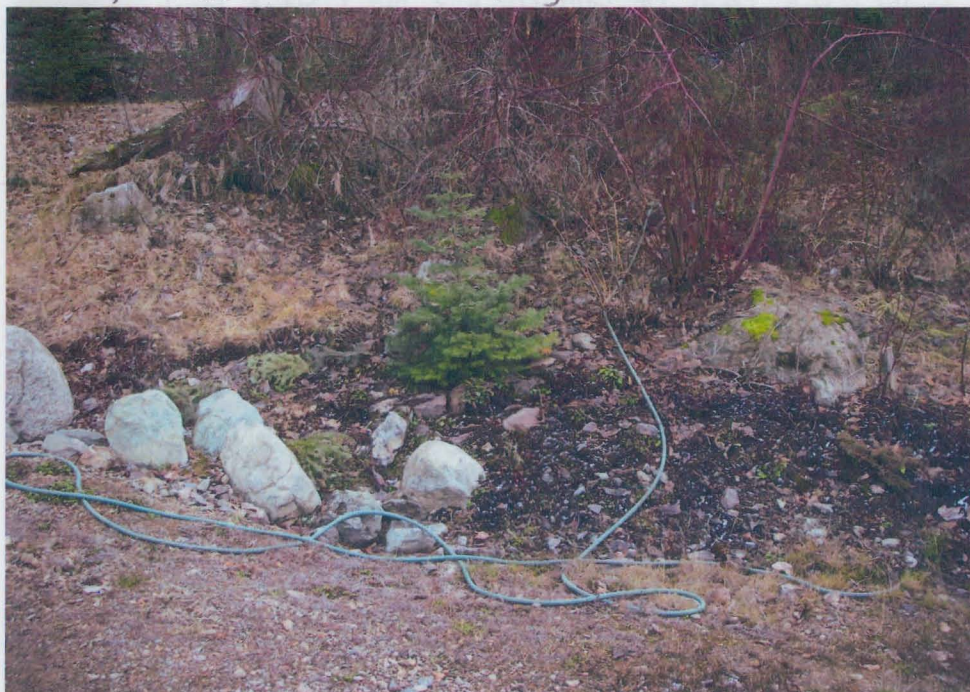
Garden hoses on Lot 12 probably used to water shrubs/trees/plants from Irish Spring by syphon.

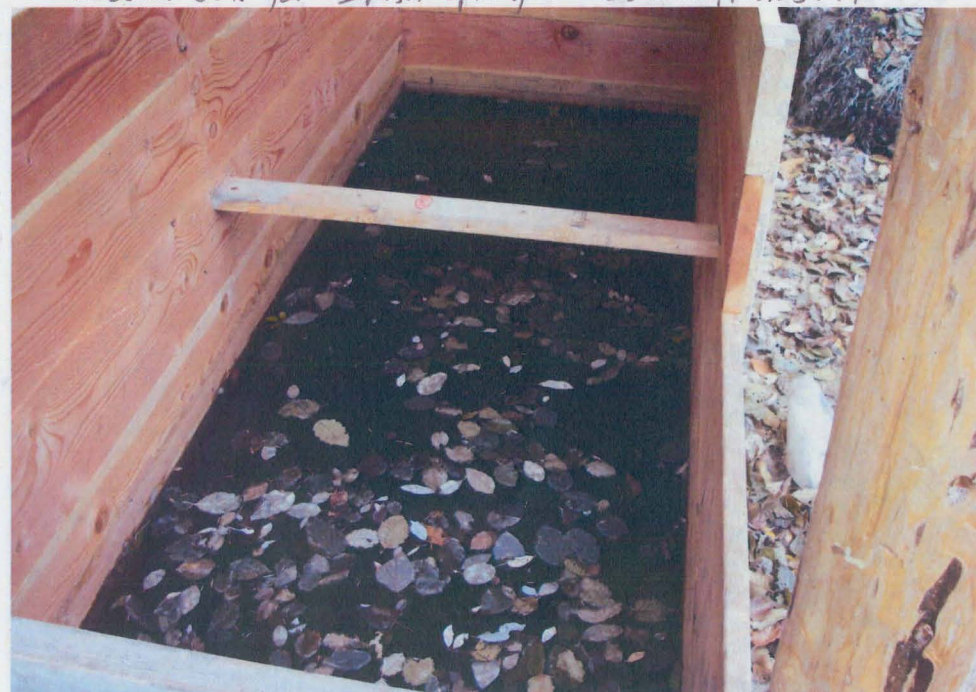
Collection box for Irish Spring. No observed outlet pipe.

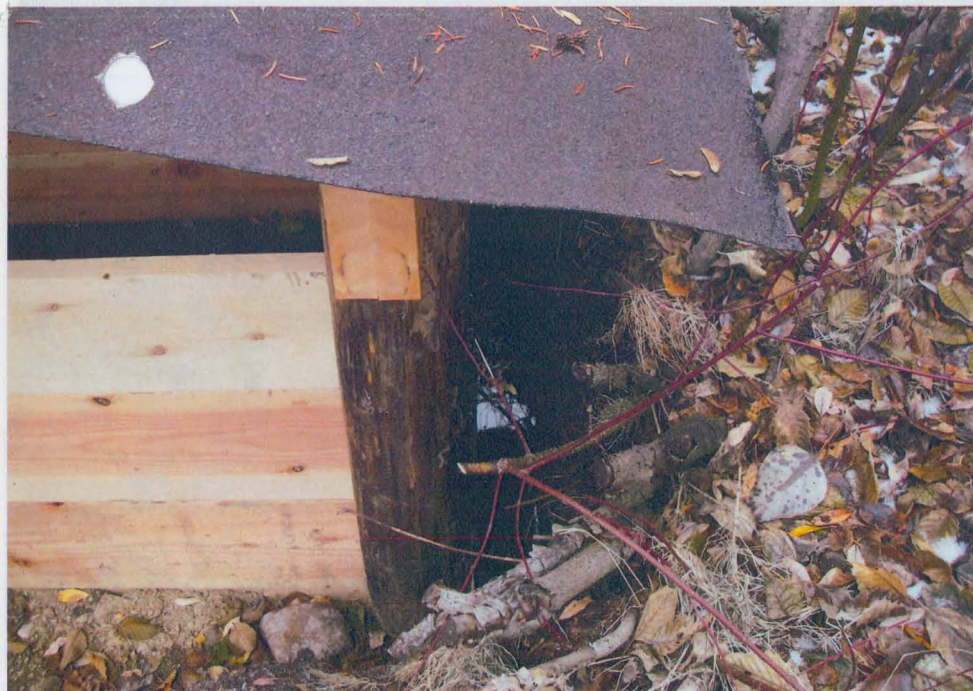
Inlet end of collection box dug into gully.

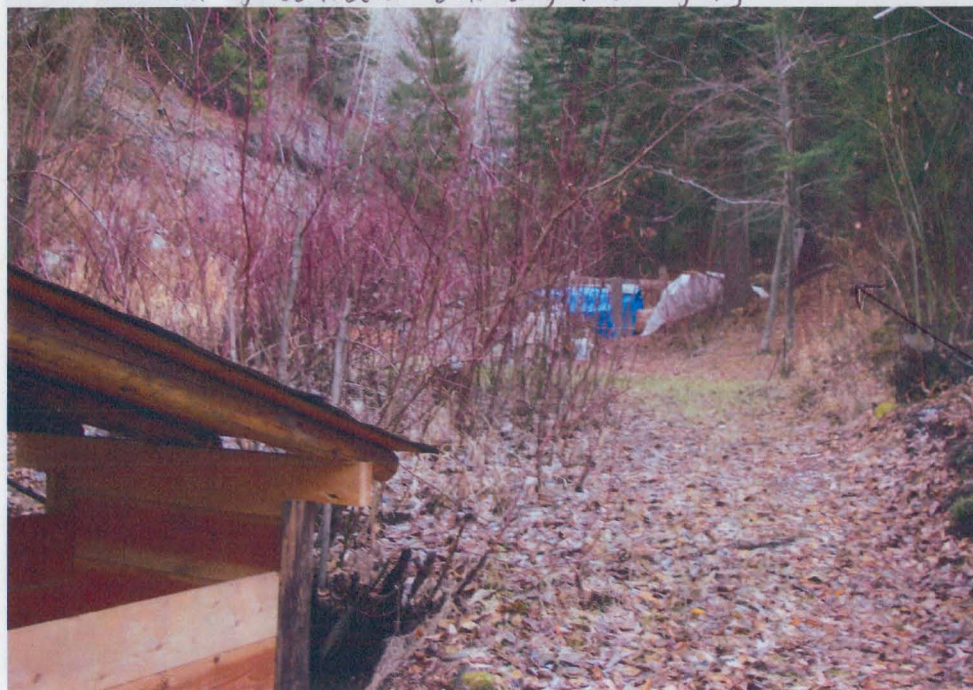
Gully with willows leading up to collection box for Irish Spring.

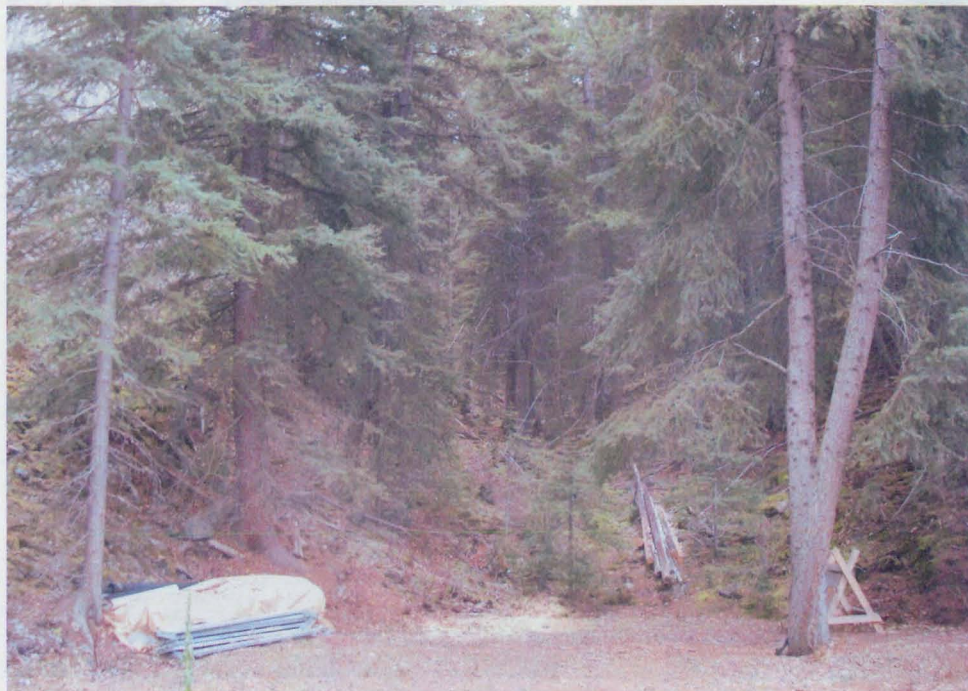
Gully which leads to collection box. No surface flow.

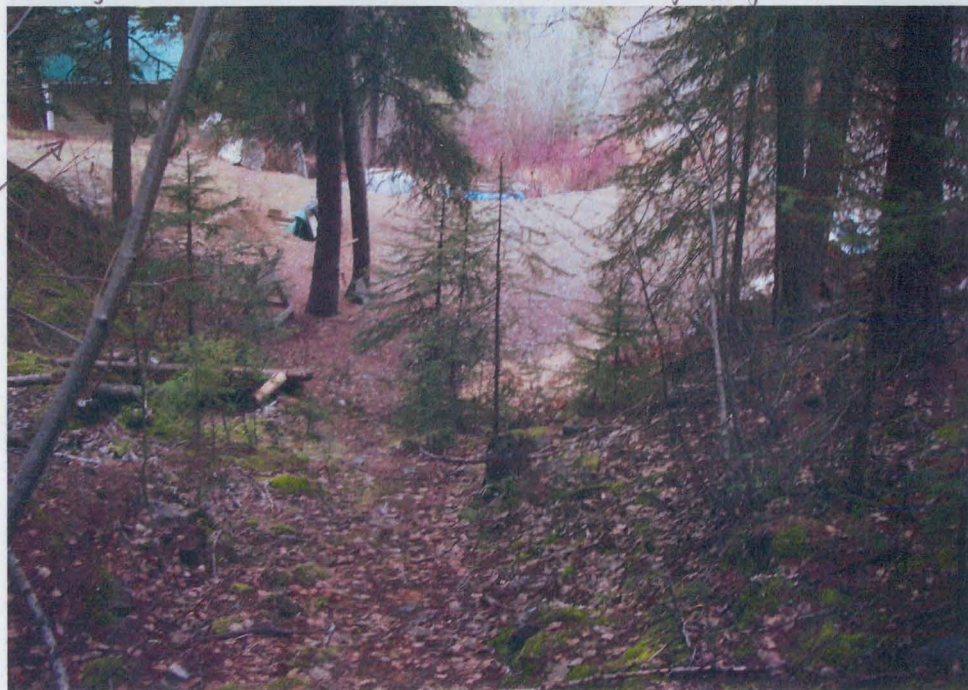
Looking downslope along gully which leads to collection box. No surface flow. There is a cabin on lot 12 but it is ~~also~~ higher than the collection box.

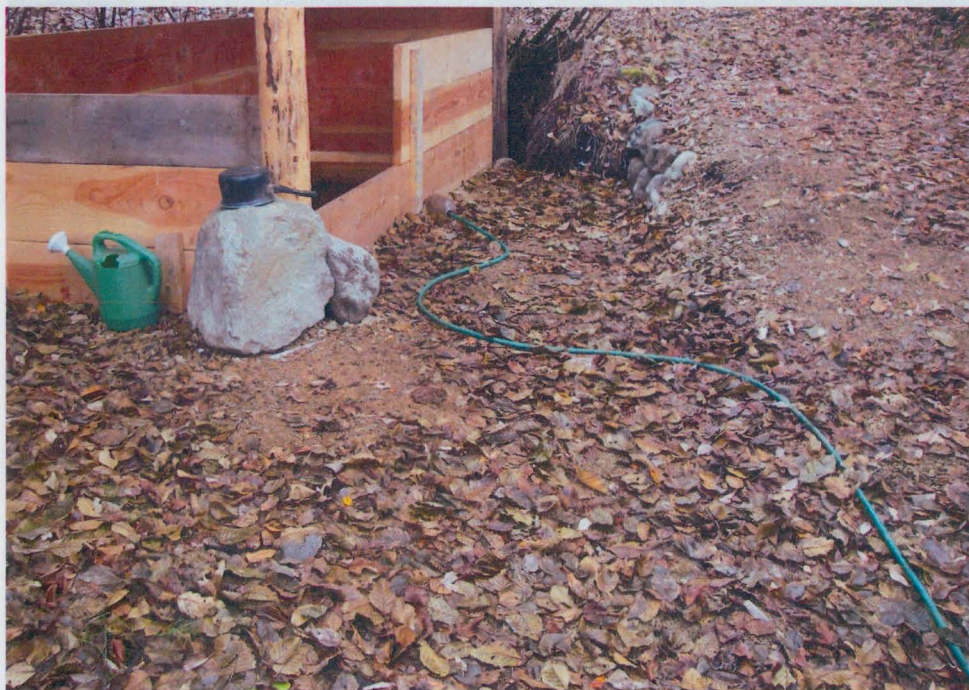
Garden hose with pop bottle probably used as a syphon from collection box.

Note also watering can and pot.

No sign of any pipeline from the collection box.

There was no dwelling on Lot 12, Plan 5847 which could be served with water from Irish Spring by gravity.

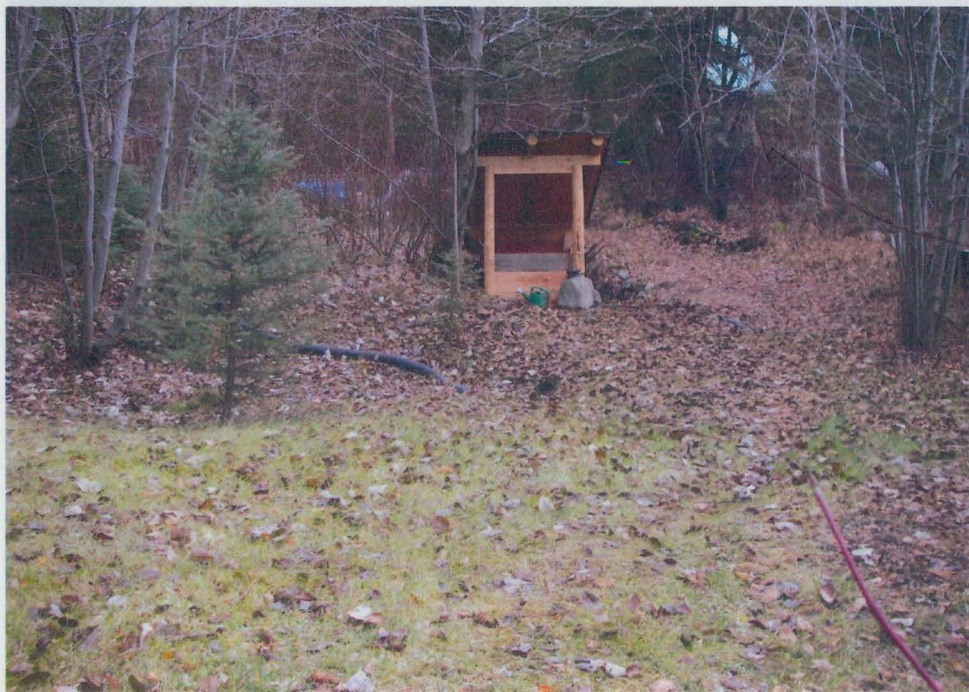
Looking upslope towards collection box

Small cabin on property but no sign of any ~~water~~ works serving water to the cabin from Irish Spring. Cabin is upslope from the collection box and there is no power to the spring or cabin.

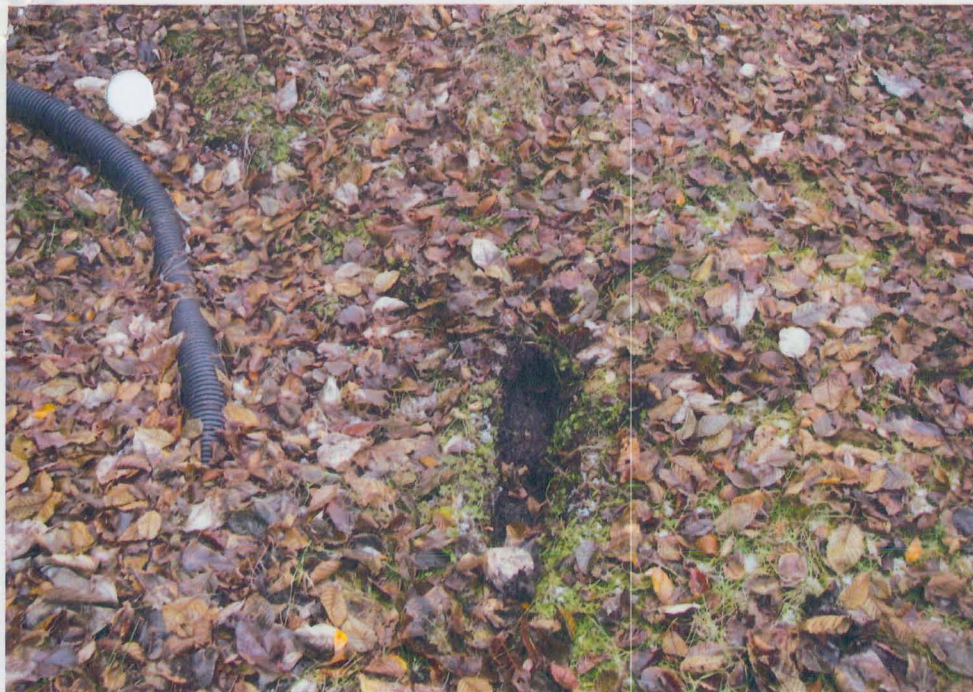
Small <sup>outflow</sup> ~~below~~ collection box

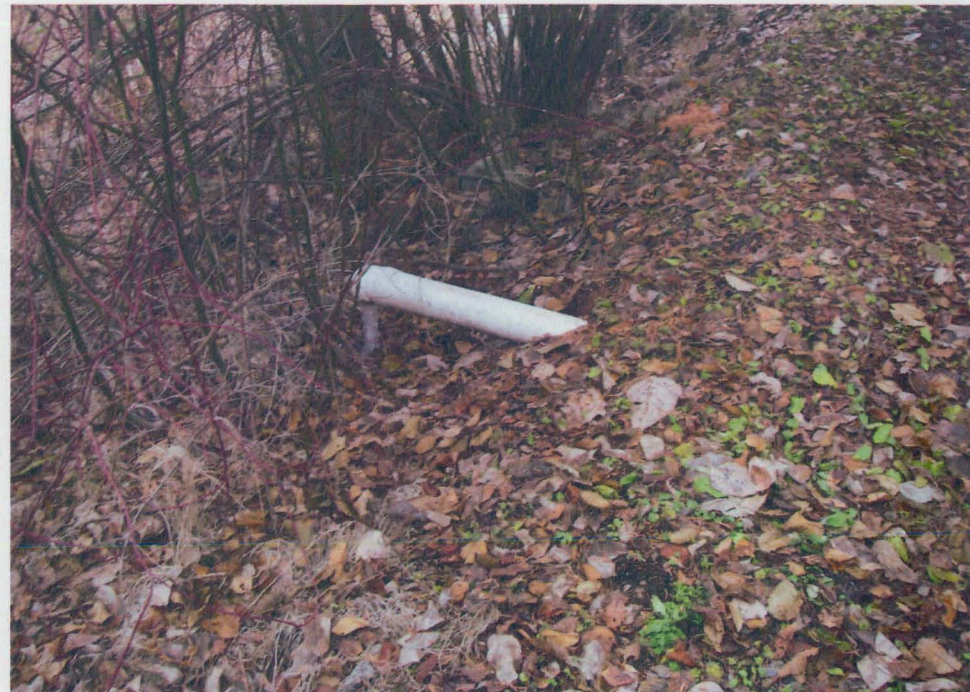
Small outflow ~~below~~ collection box

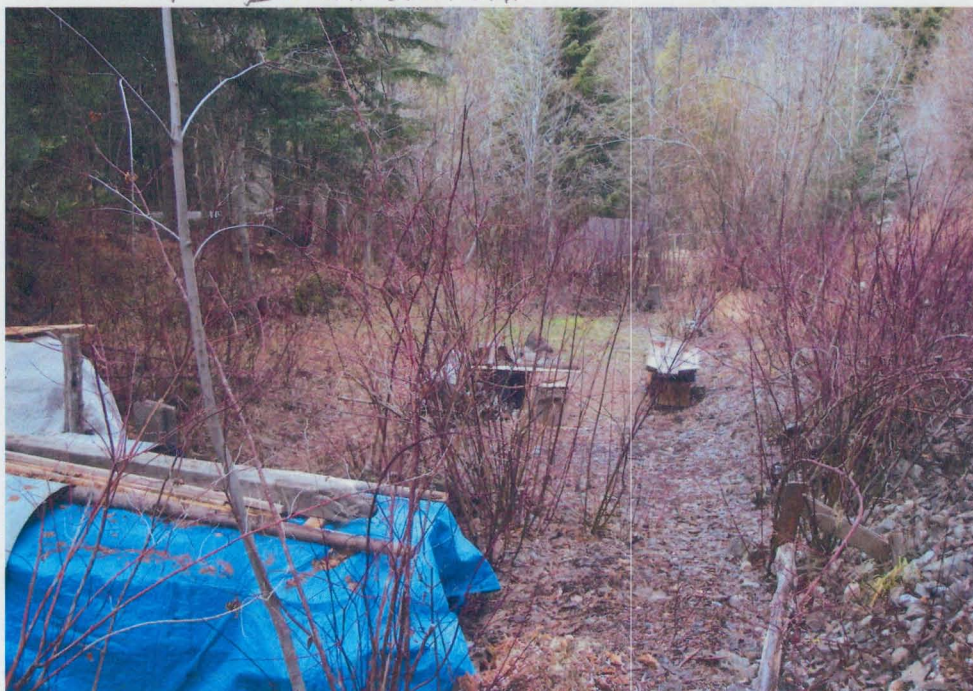
Looking downslope along gully leading to collection box

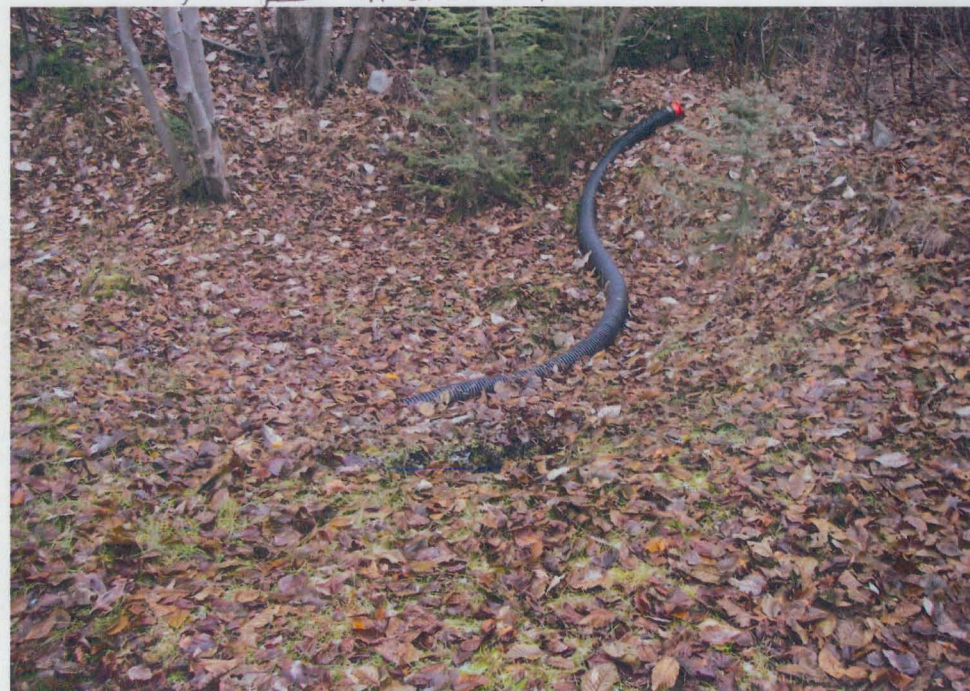
Uncertain what drain tile is used for.

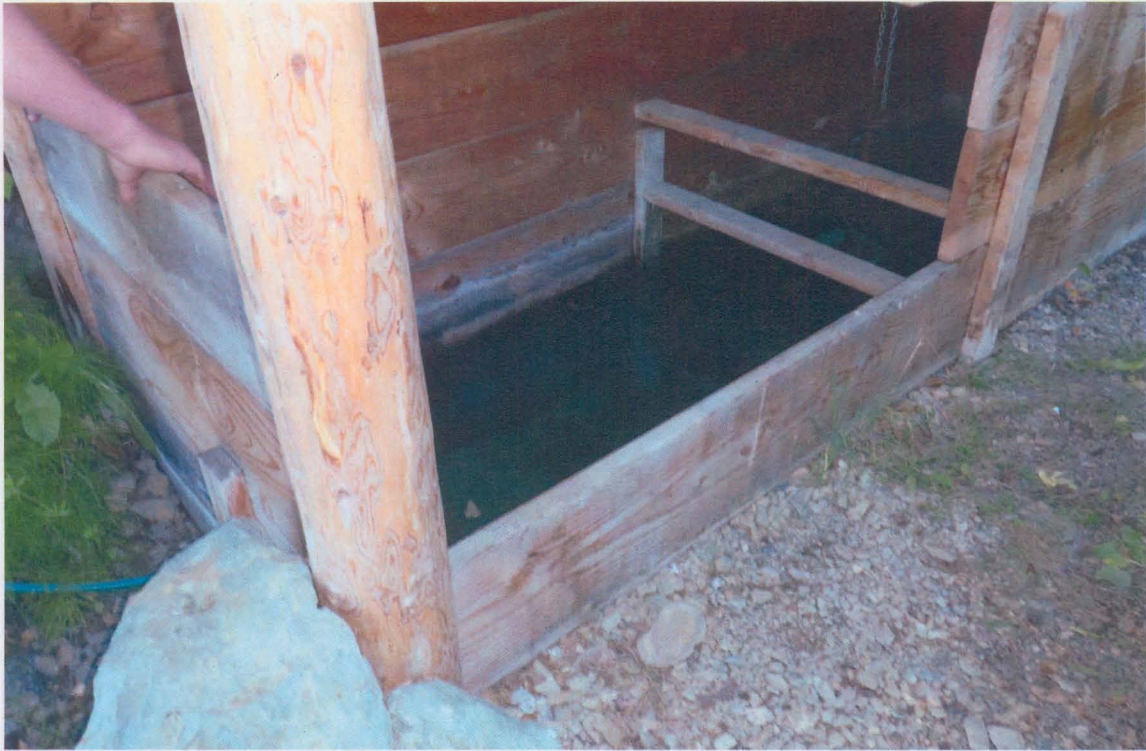
Drawdown measurement completed. Collection box is 334.5 cm long by 114.5 cm wide. Box recovered 1 cm in 2 hrs = 0.4596 m<sup>3</sup>/d.

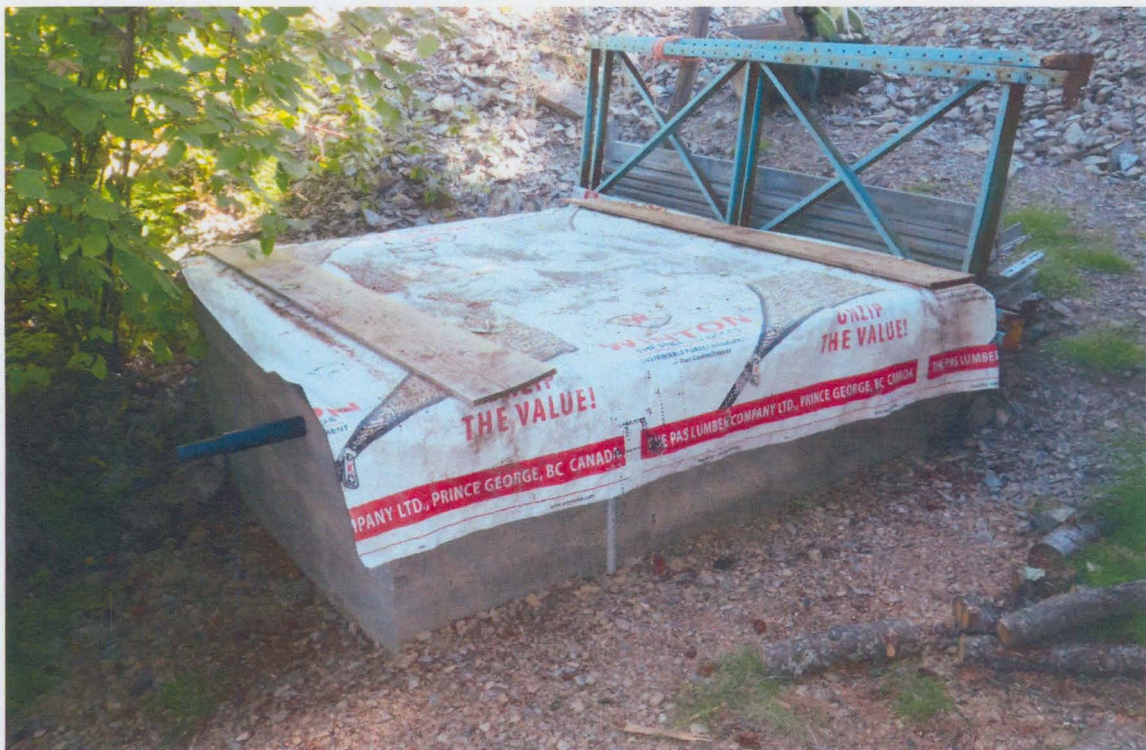
Uphill from above box, Jim & Nada installed this collection box - locked.

\*located on Parcel A (consolidation of lots 11, 12 & 13) lot 2372  
plan 5847

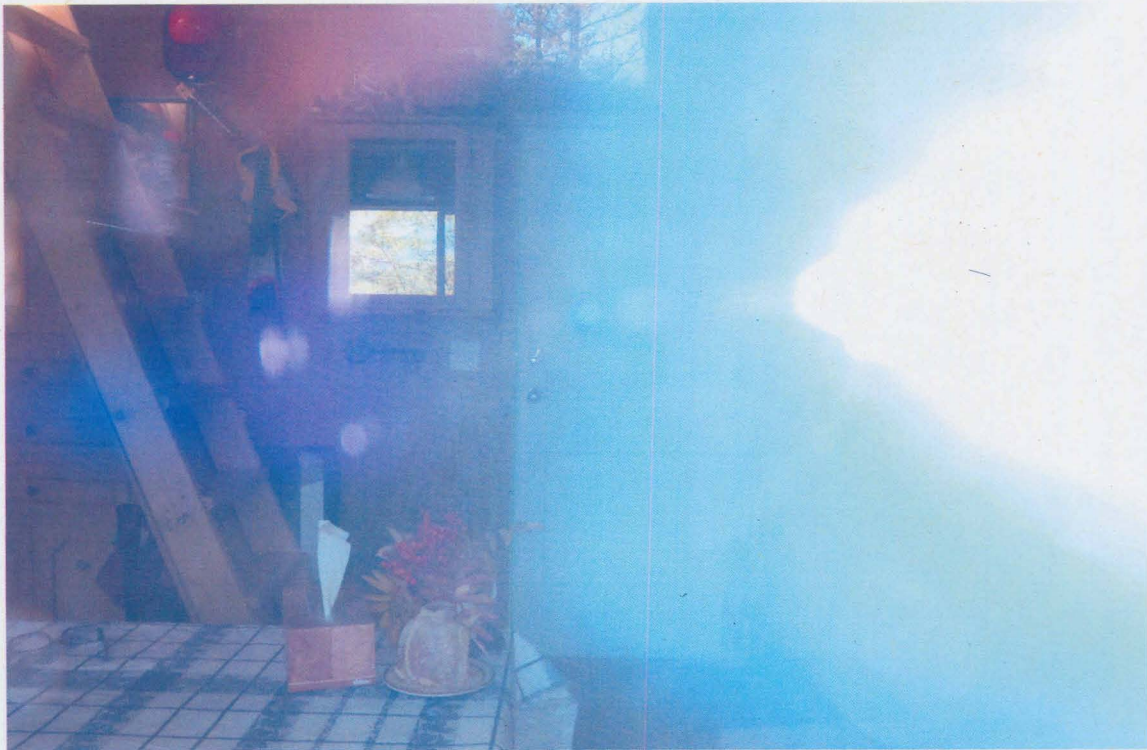
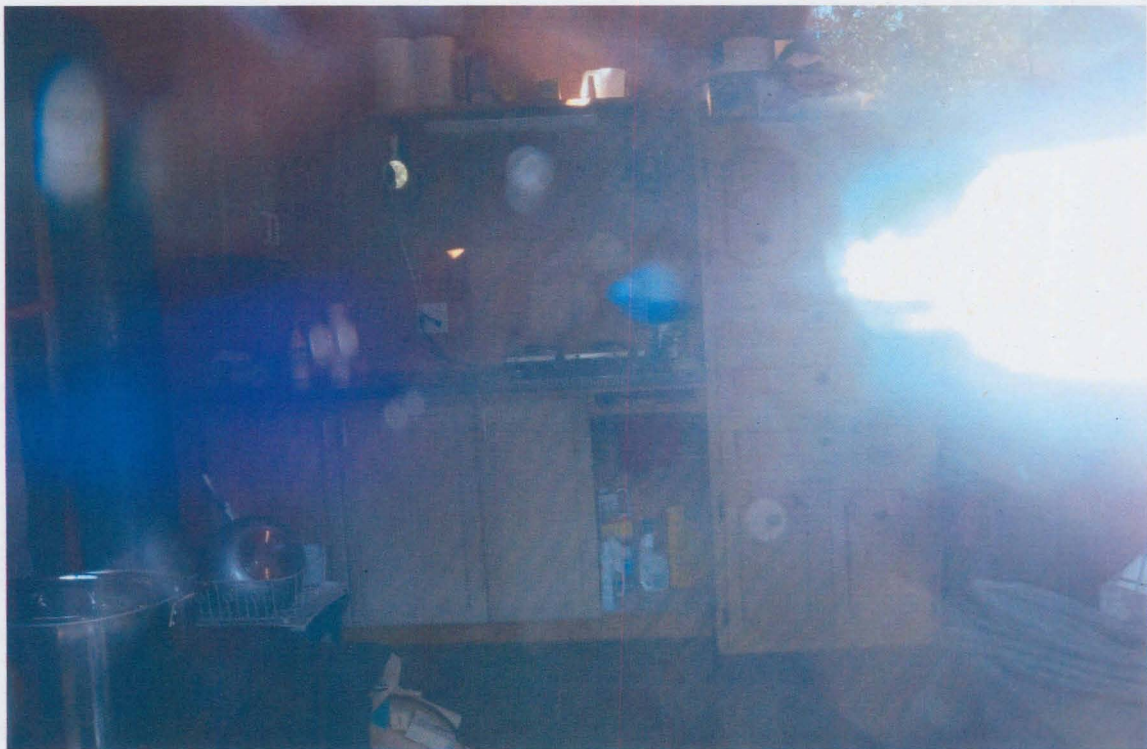
Inside dwelling on Noda + Jiri's property, no sink / bathroom.

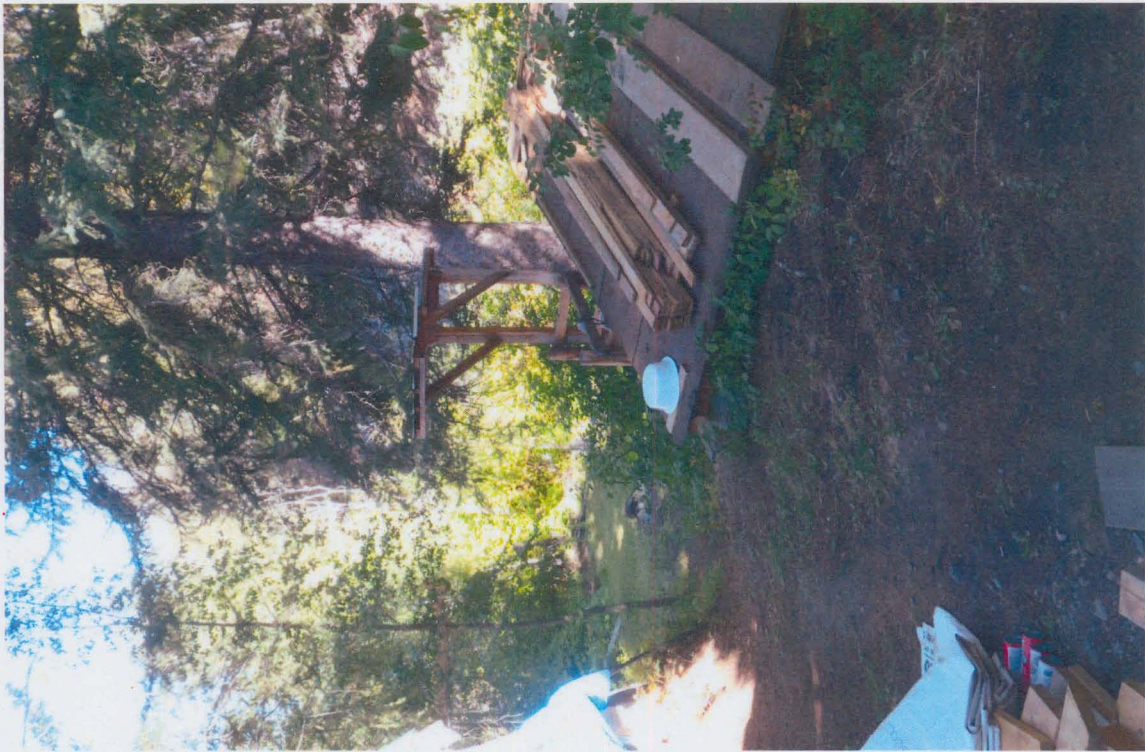
outdoor shower on Jini + Noda's property

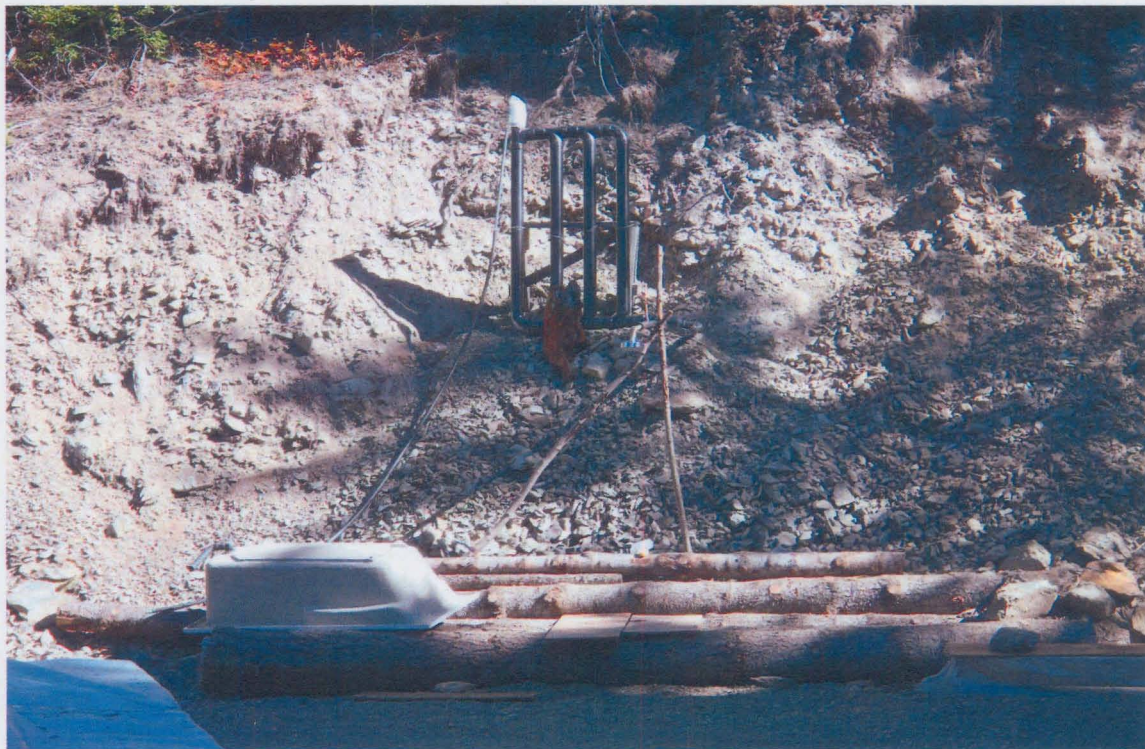
construction site/pipes - Jini + Noda's

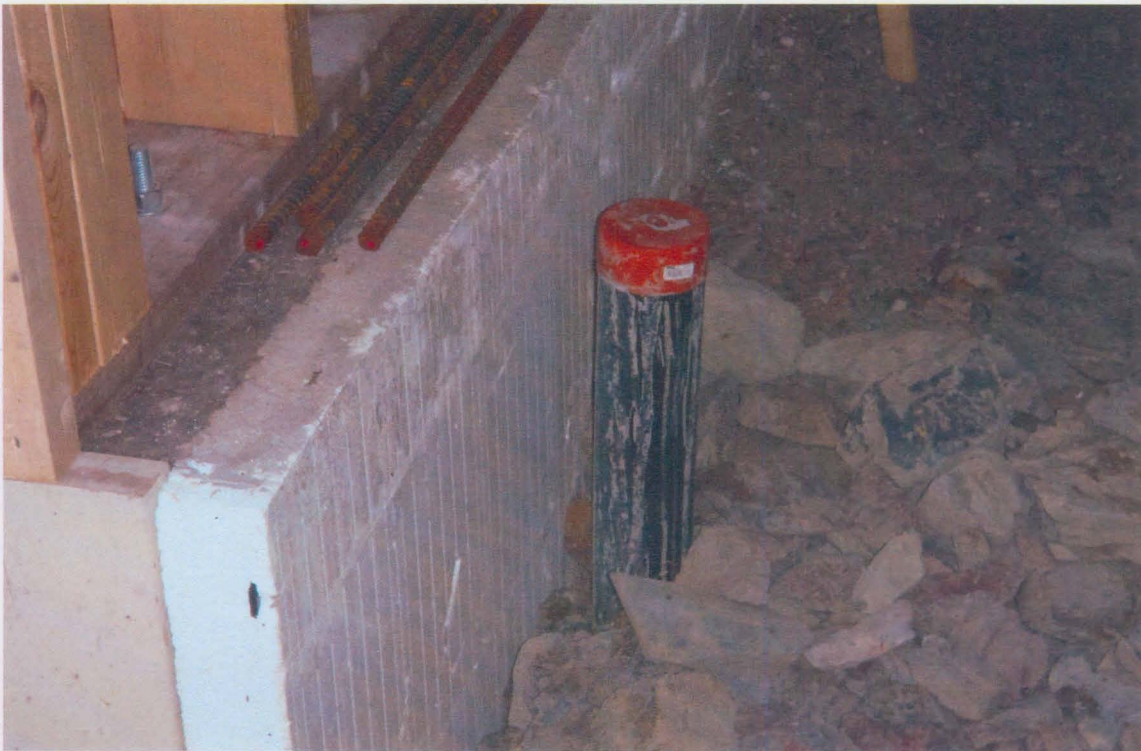
Pipe located inside Jiri+Nada's new dwelling (under construction)

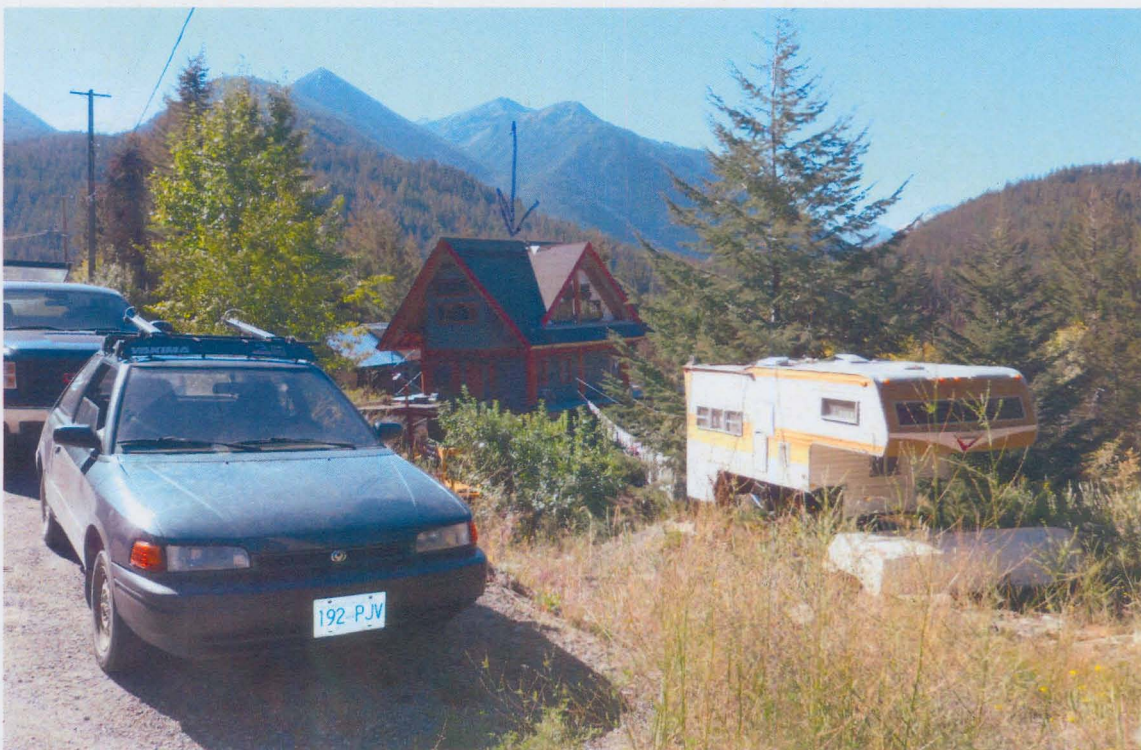
Carolyn Lawrence's dwelling - lot 9 DL2372  
plan 5847

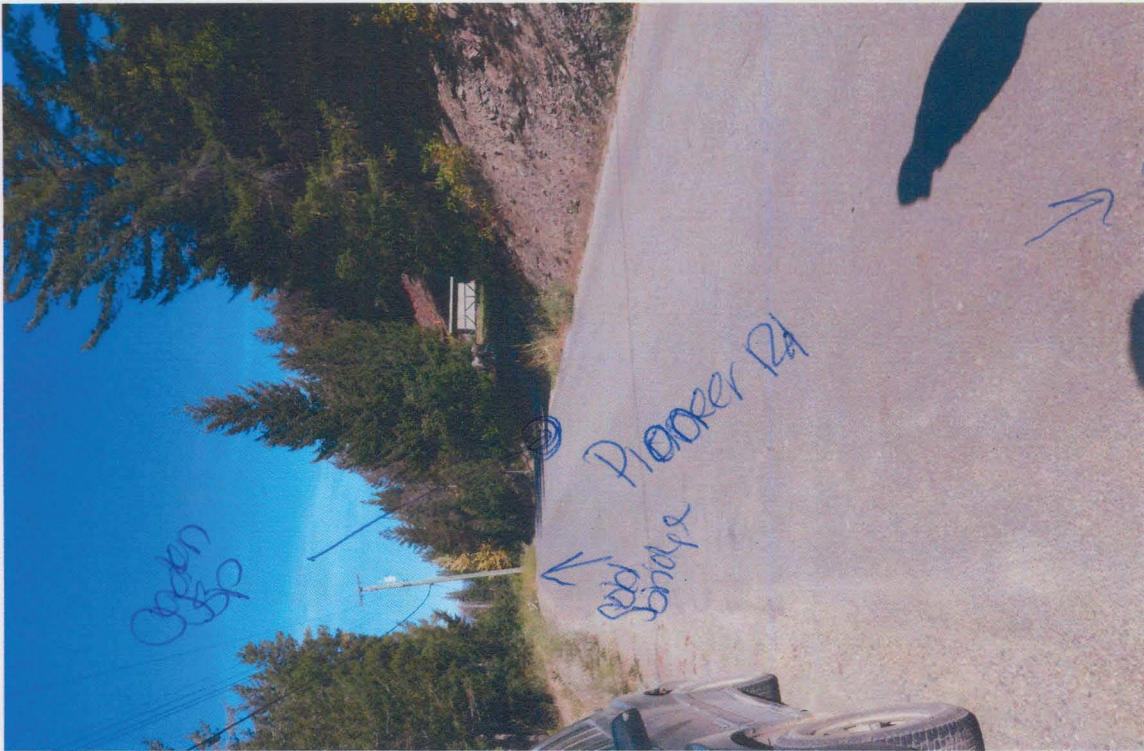
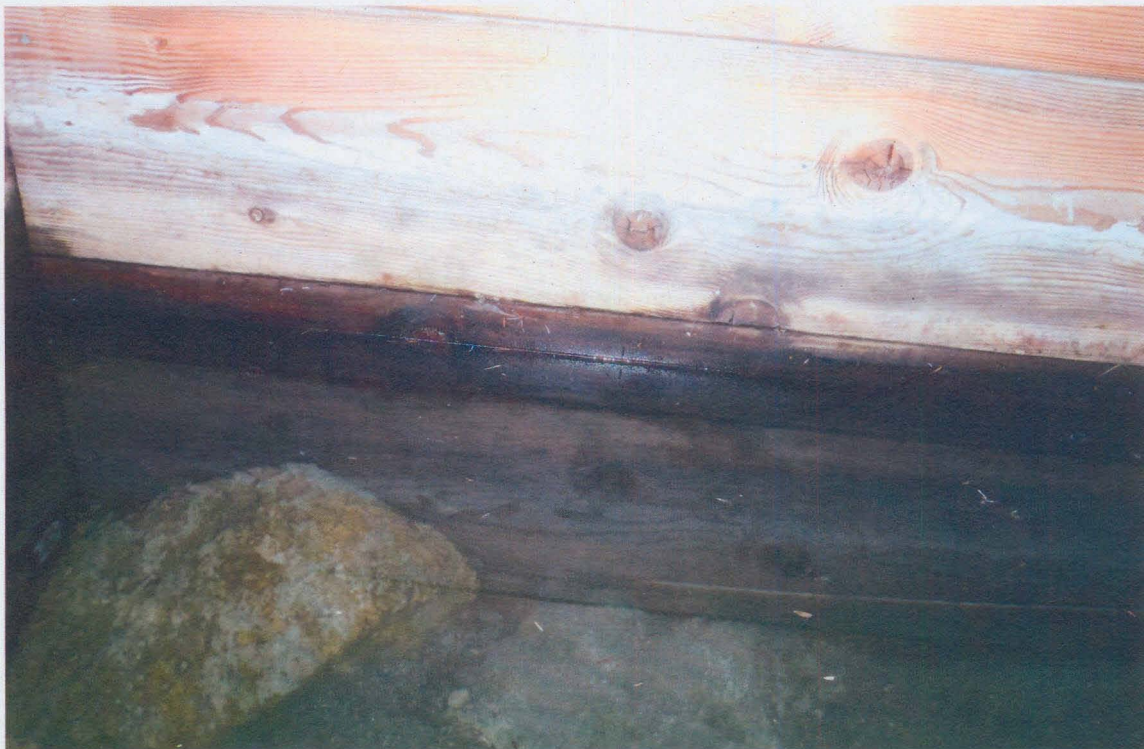
Inside collection box - draw down ~ 2 inches - recovered  
1cm in 2 hrs.
