CITY OF SURREY

Engineering Operations Department

Attached please find Flood Protection Inspection Report inspected June 2, 2009.

FLOOD PROTECTION INSPECTION REPORT

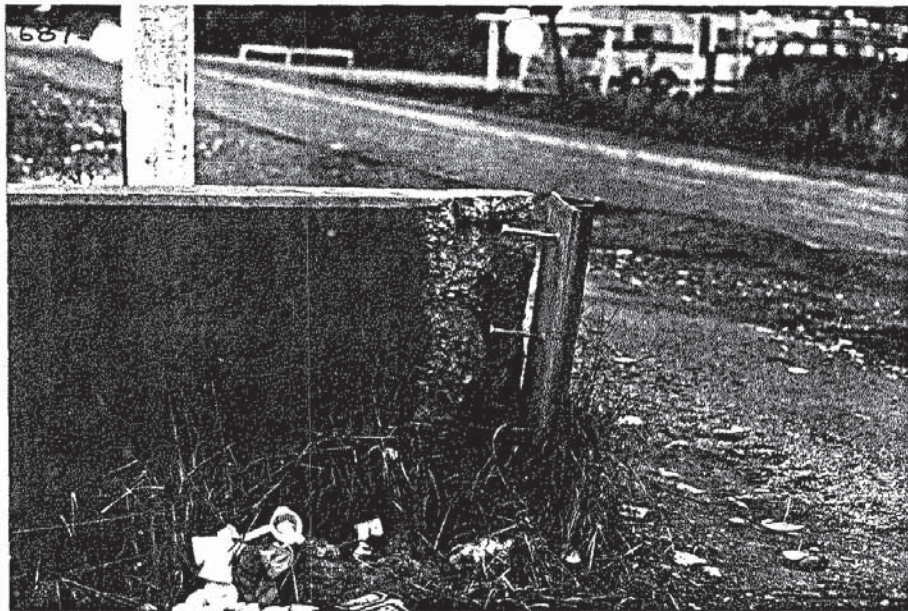
Old Yale Road at floodwall, upstream side of opening: Metal stop log slot is broken
off concrete, with damage to concrete at end of wall. (See photo 687-2). Some of
gates between floodwall and CNR have been vandalized.

Nov. 28, 1989. At foot of Old Yale Road. Metal stop log slot broken out of concrete floodwall. Surrey-South Westminster-Bridgeview.

Repair concrete end of floodwall at Old Yale and re-attach metal slot.

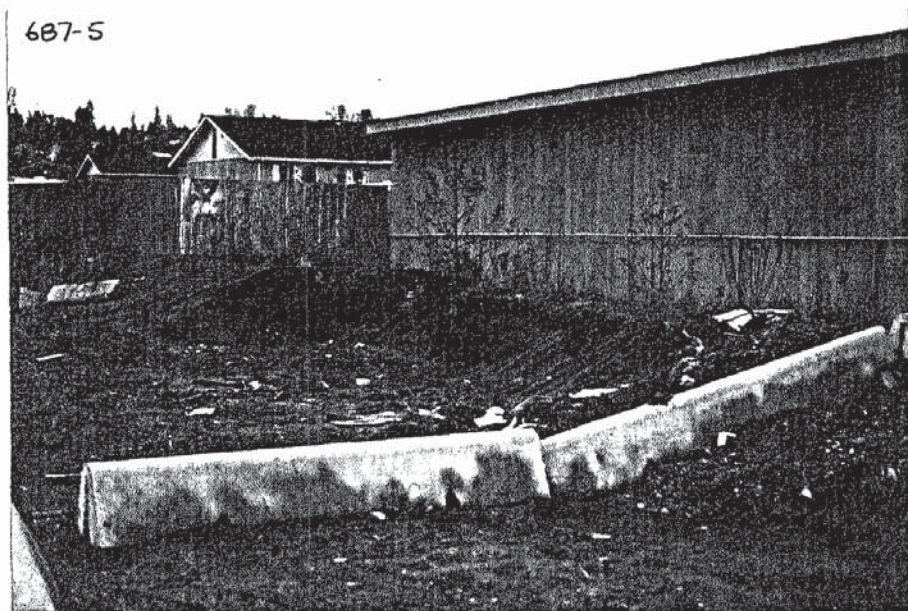
Nov. 28, 1989. Surrey-South Westminster-Bridgeview. Dyke stub at south side of Industrial Avenue at Bolivar Creek is an easy material source for 'midnight borrowers'.

Replace 'stolen' dyke fill at Bolivar Creek and Industrial Avenue. (Suggestion: Make fill
unattractive to potential 'borrowers'; i.e.: asphalt, etc.).

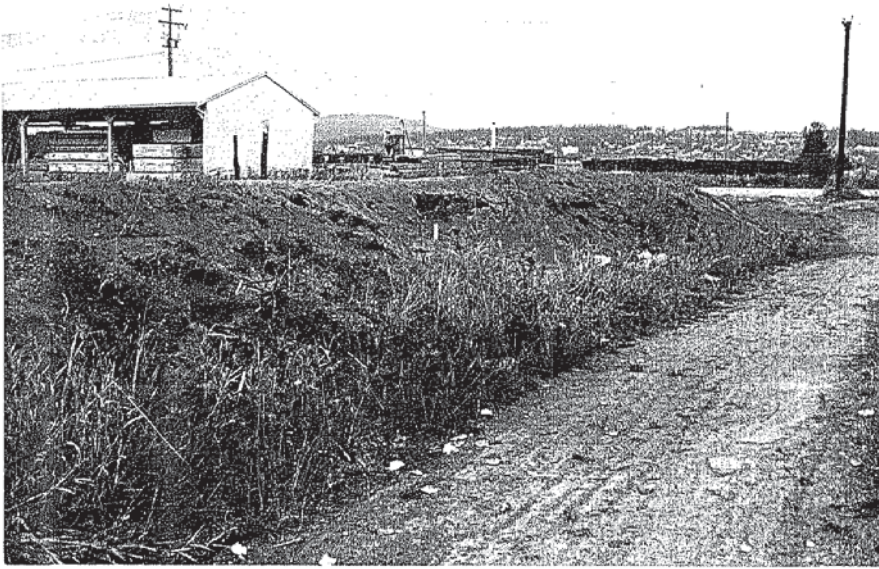
DAMAGE TO LIKE ALONG BOQUIAR CR.
- SUBSEQUENTLY REPAIRED BY SURREY.
