7300-20
2004
Happy Valley Elementary School
5291 Happy Valley Road
Langford, BC
Incident #NLG 04/10/14/10/01

FIRE/CAUSE DETERMINATION REPORT

Submitted by Ray Aitken, Fire Investigator
Office of the Fire Commissioner
Northern Regional Office (Prince George)
November, 2004

INCIDENT # - NLG 04 10 14 10 01
HAPPY VALLEY ELEMENTARY SCHOOL
3291 HAPPY VALLEY ROAD
LANGFORD, BC

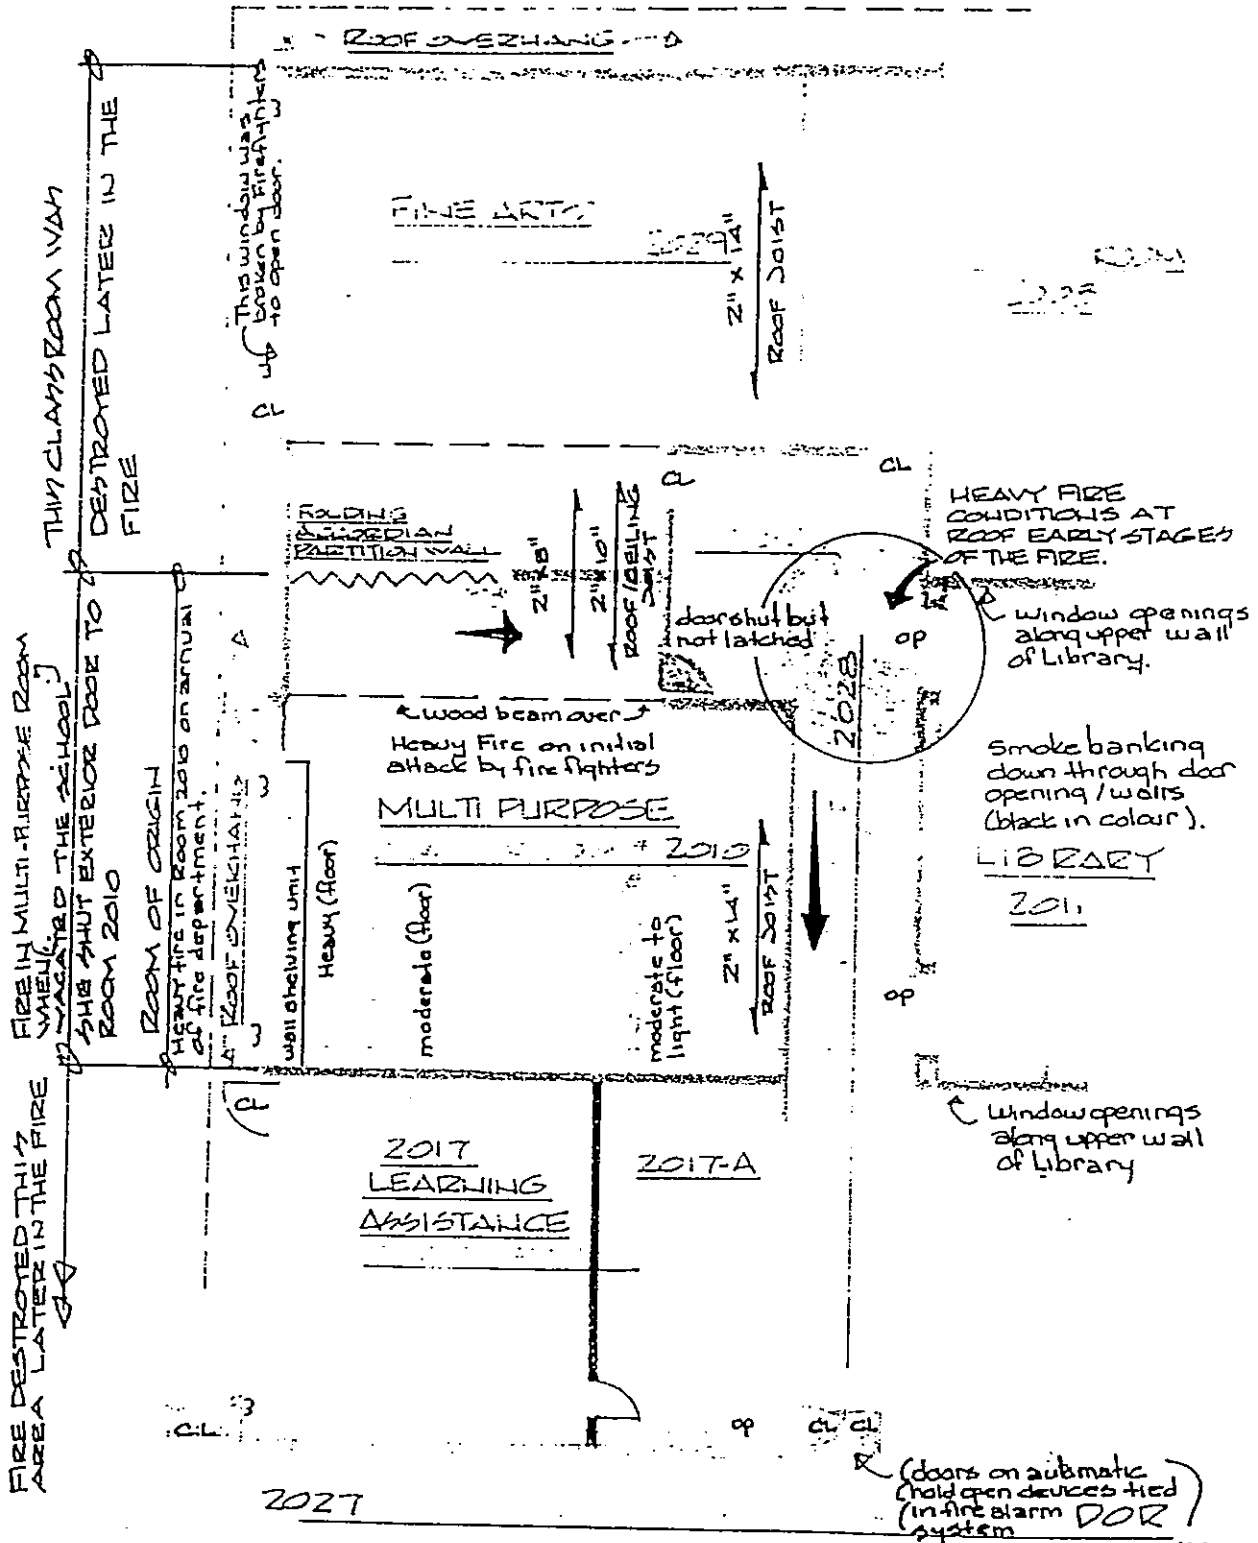
AREA OF ORIGIN - FIRE AND HEAT PATTERN INDICATORS RM 2010

In the opinion of the undersigned, upon first examining and then reconstructing the remaining structural building components (walls, doors etc,) and the different room content in the AREA OF ORIGIN as well as reviewing the fire and heat pattern indicators and the avenues of travel of the fire (in the initial and secondary stages) with the fire fighting crews it became obvious that the exact the POINT OF ORIGIN of this fire could not be determined by the undersigned due the extensive structural and content damage done by the fire in Multi-Purpose Room 2010.(See drawings A/2,A/6,A/7,A/8,A/9,A/10 and photographs 33,37,38,41 and 42).

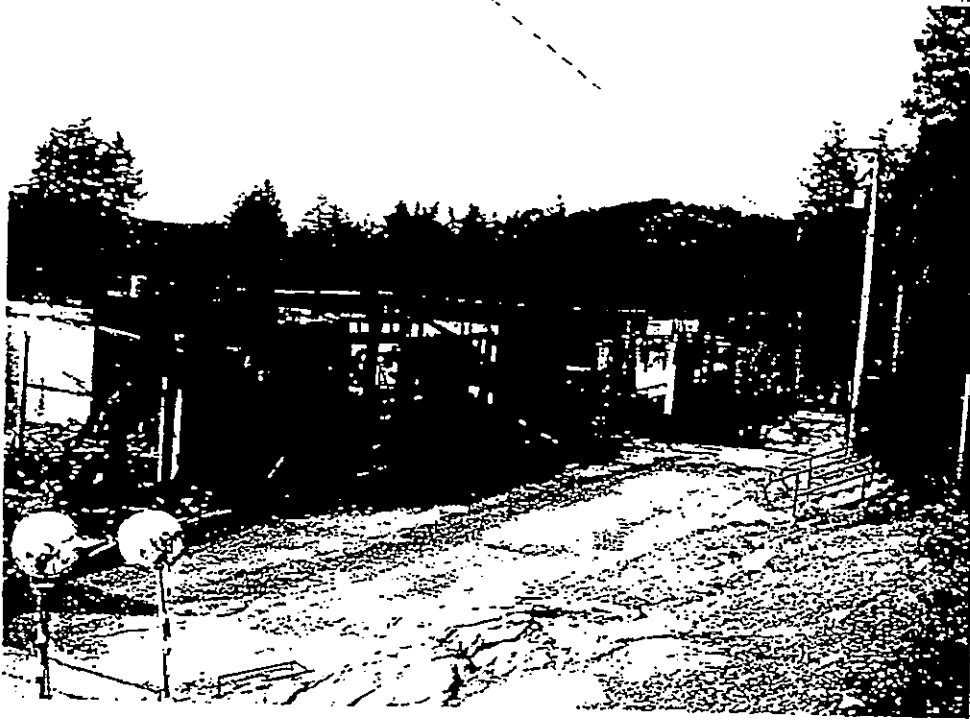
Figure 1 - Bravo Sector showing extent of fire damage

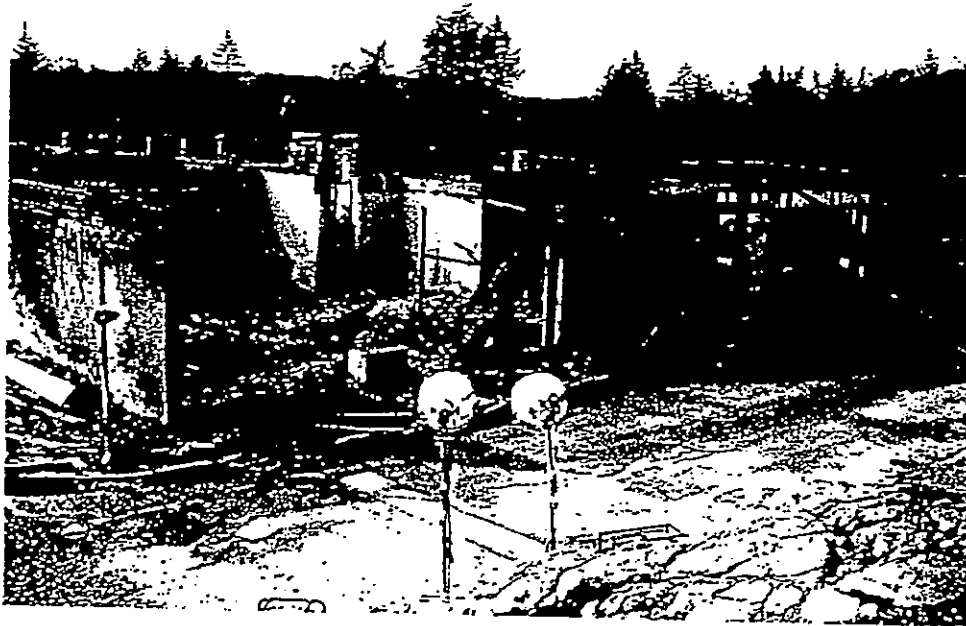
Figure 2 - Bravo Sector showing extent of fire damage

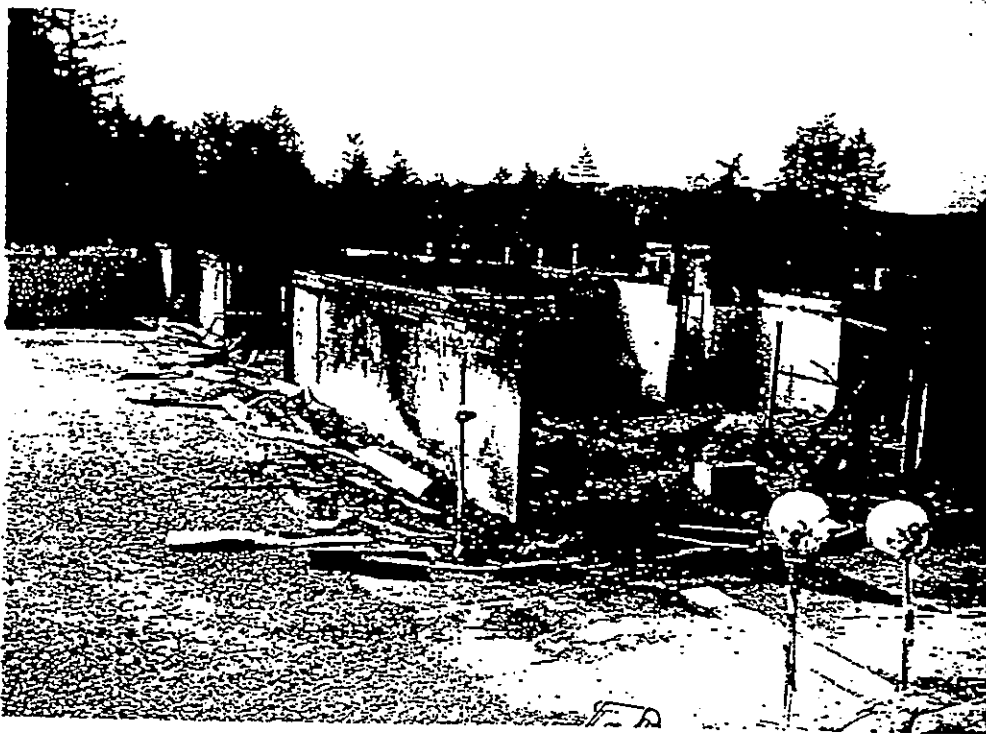
It was learned by the undersigned that at 10:57 hours a large volume of heavy smoke (black in colour) was now being observed by the fire fighting attack crews coming from within the roof cavity on both the BRAVO and CHARLIE sectors of the school. Also, flames (reddish/orange in colour) were being observed by firefighters in Classroom 2007 (Computer Room) on the rear CHARLIE Sector of the school. (See A/2 and A/14 and photographs 3 and 4).

Figure 3 - Bravo/Charlie Sectors showing extend of fire damage

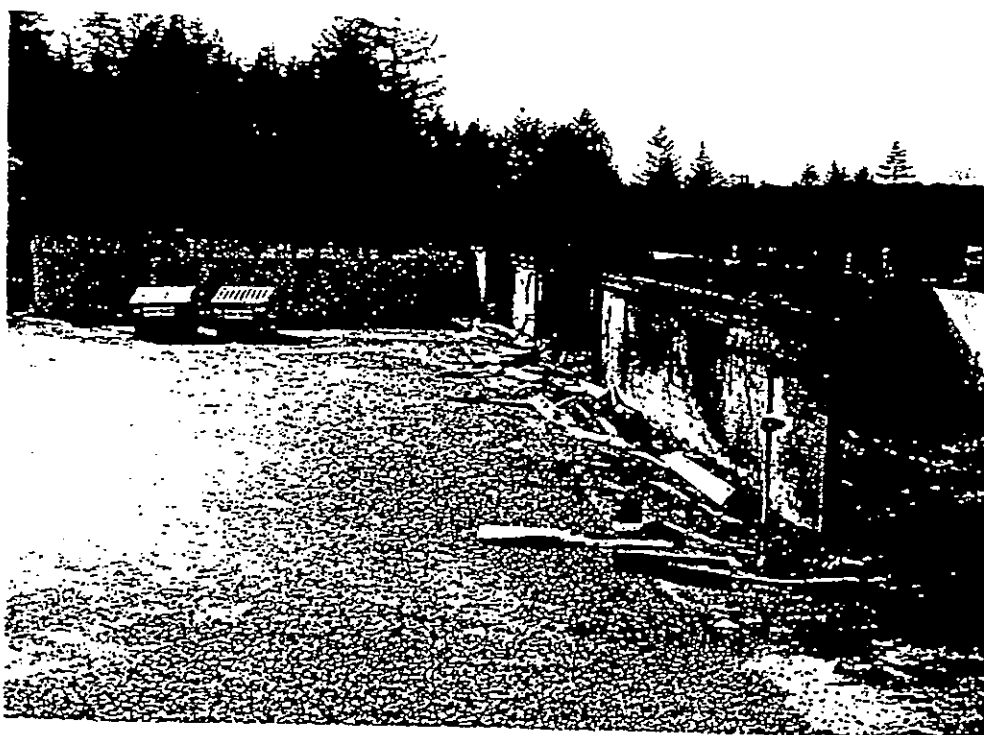
Figure 4 - Charlie Sector showing extent of fire damage

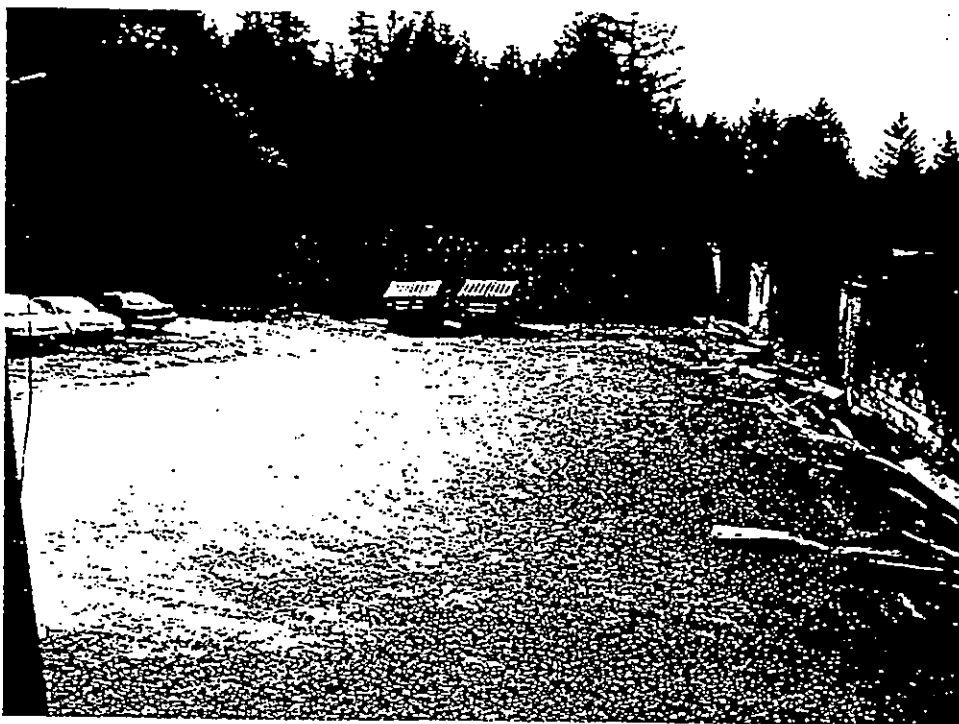
Figure 5 - Charlie Sector showing extent of fire damage

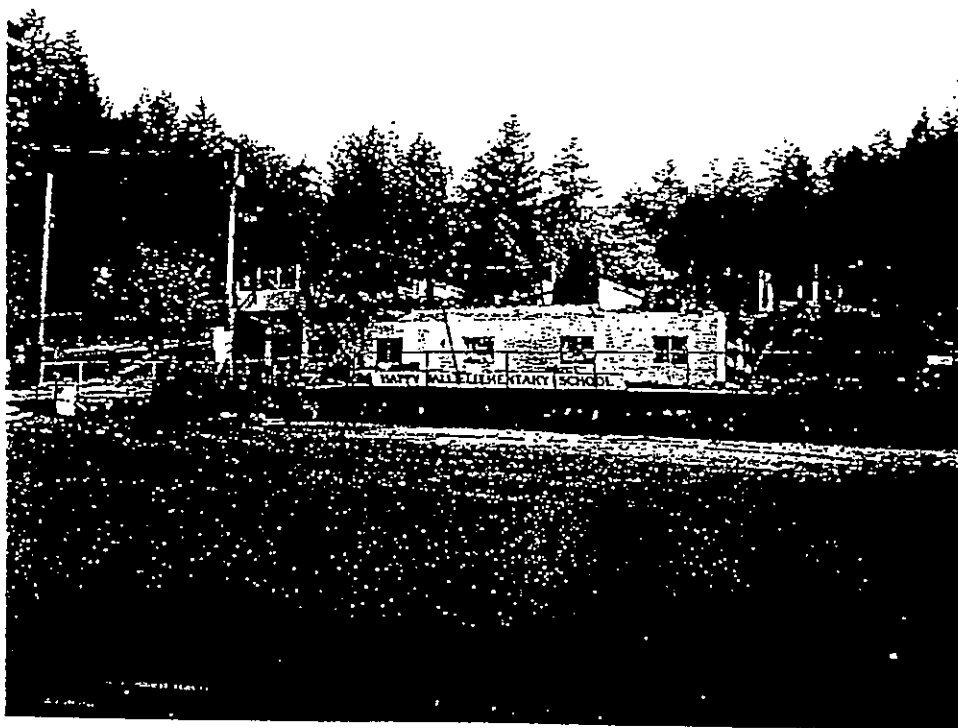
The undersigned began the external / internal perimeter examination on the front ALPHA Sector of the school structure and immediately observed that the fire had been contained by the firefighting crews and prevented from penetrating into the lower floor level at the front north west corner of the school. This area on the lower level of the school structure housed the Electrical Service Rooms 1001 / 1002 (locations of electrical / fire alarm / security service panels for the school), the adjoining Classroom [] (teacher) and her [] students and the Main Office (Administration Area) complete with supplemental offices. (See drawings S/1, A/1, A/2 and photographs 6-8).

The remaining rooms on the lower floor level of the school received more extensive structural fire damage. This was due in part to the upper floor collapsing into the lower floor at Main Office 1005 and the Washrooms 1010 / 1011, Staff Room 1009, Meeting Room 1008, Storage / Change Rooms 1012 / 1014 and Furnace Rooms 1015 / 1016. (See drawing A/1 and photographs 6-8).

Figure 6 - Alpha Sector showing extent of fire damage

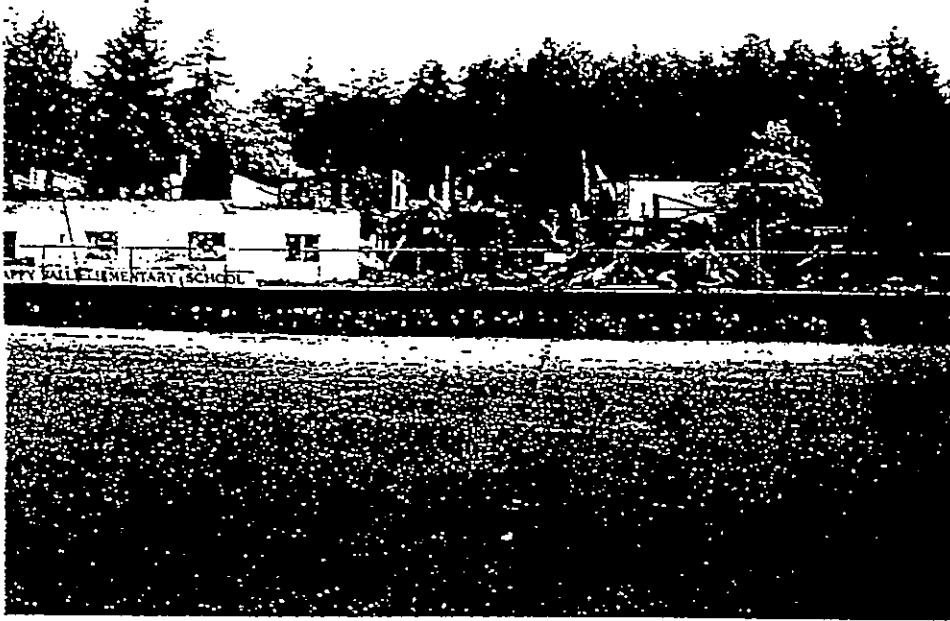
Figure 7 - Alpha Sector showing extent of fire damage

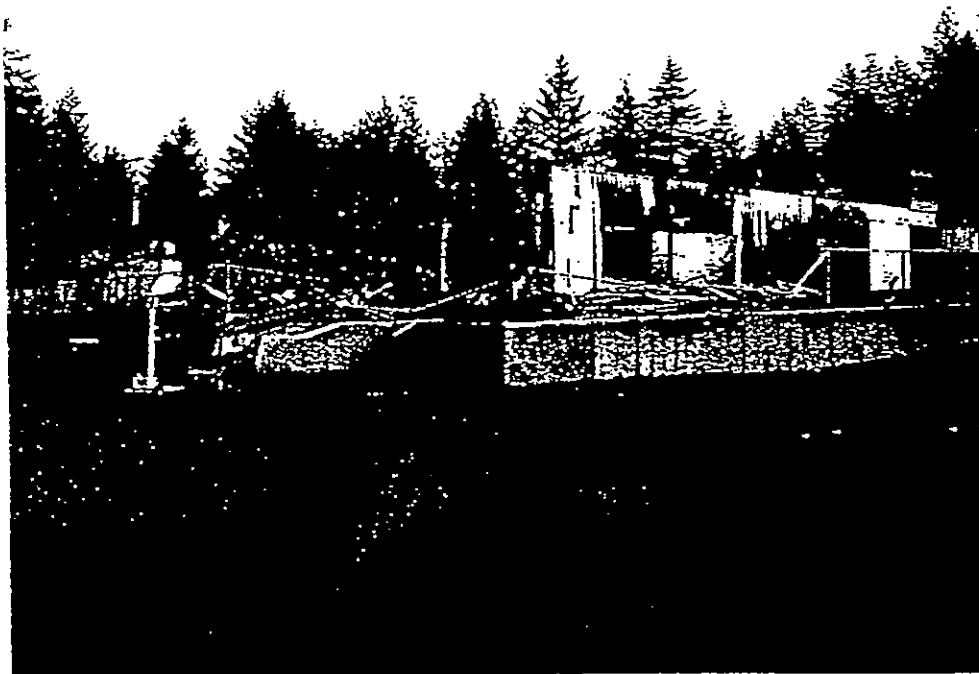
The undersigned proceeded to DELTA sector of the school and observed that the fire had heavily gutted an entire block of classrooms consisting Classrooms 2001 { 2002 { } 2003 { } and 2013 { } } Also; the undersigned observed the complete roof / ceiling assembly of the classroom block had been consumed by the fire leaving only the exterior / interior concrete block walls standing and all the combustible wood exterior/interior wall assemblies destroyed in Classrooms 2001 / 2002 / 2003 and 2013. Further, the interior room content in all the classrooms in this block had been subject to extreme temperatures leaving little or no salvage of value. (See drawing A/2 and photographs 10-13).

Figure 10 - Alpha/Delta Sector showing extent of fire damage

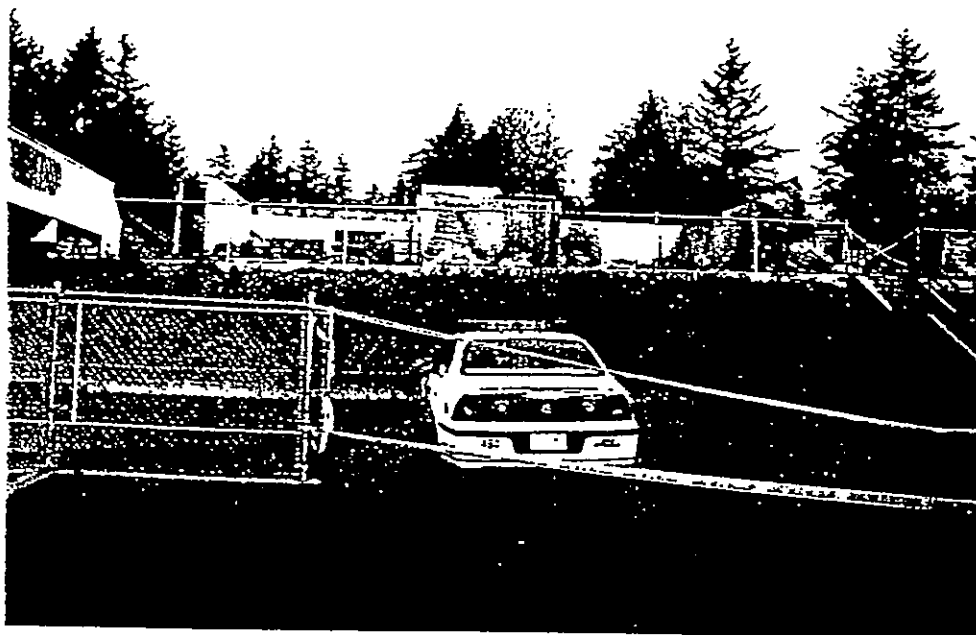
Figure 11 - Delta Sector showing extent of fire damage

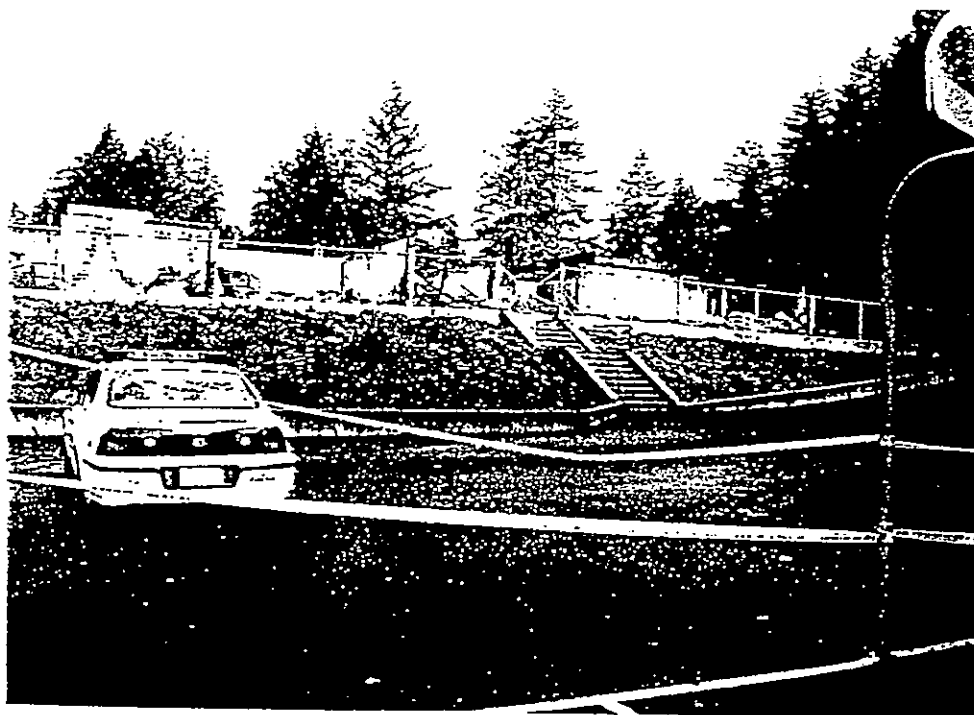
Figure 12 - Delta Sector showing extent of fire damage

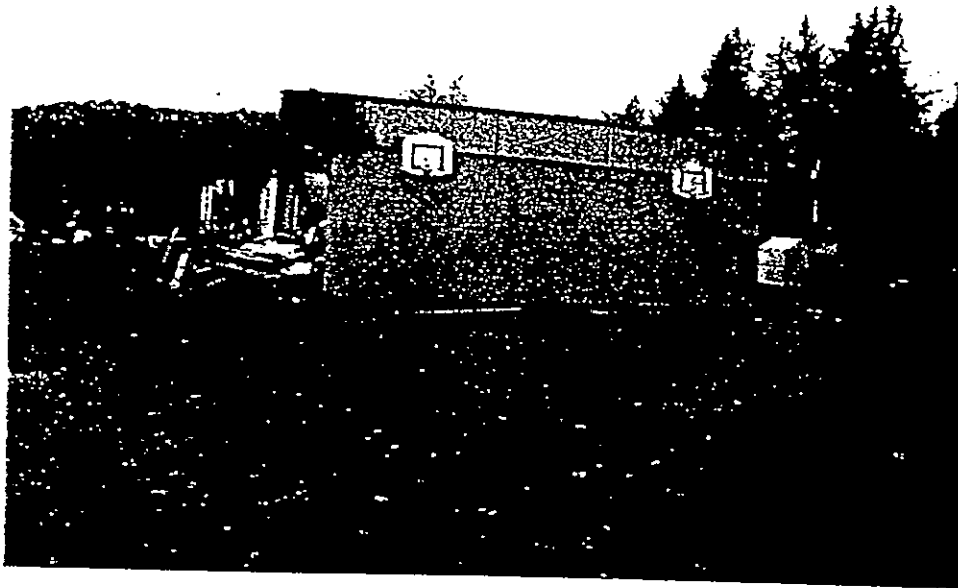
Figure 13 - Delta/Charlie Sectors showing extent of fire damage

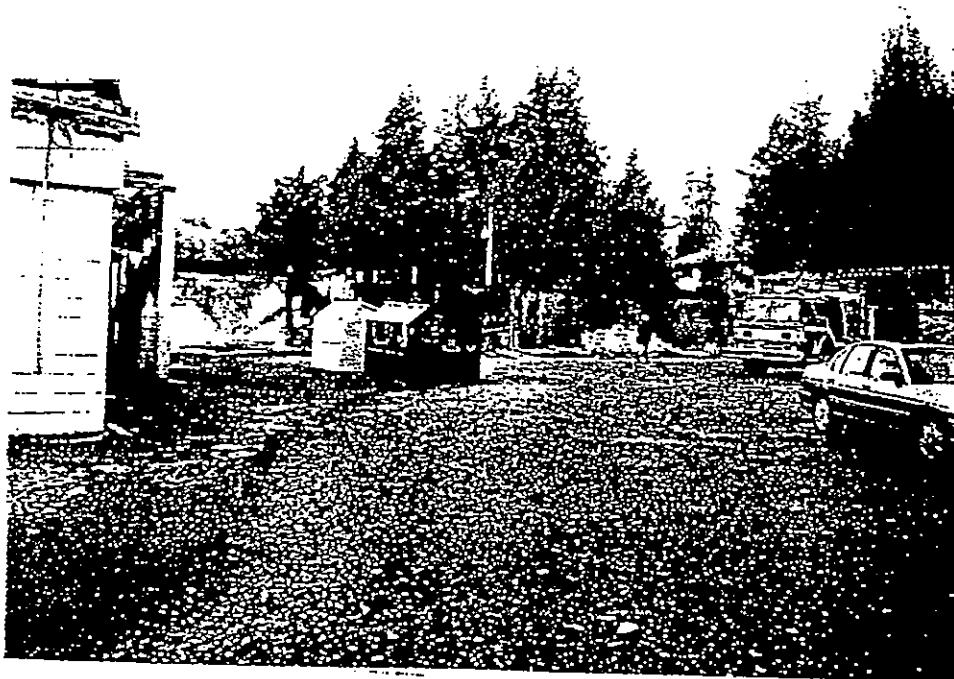
Figure 14 - Charlie Sector showing extent of fire damage

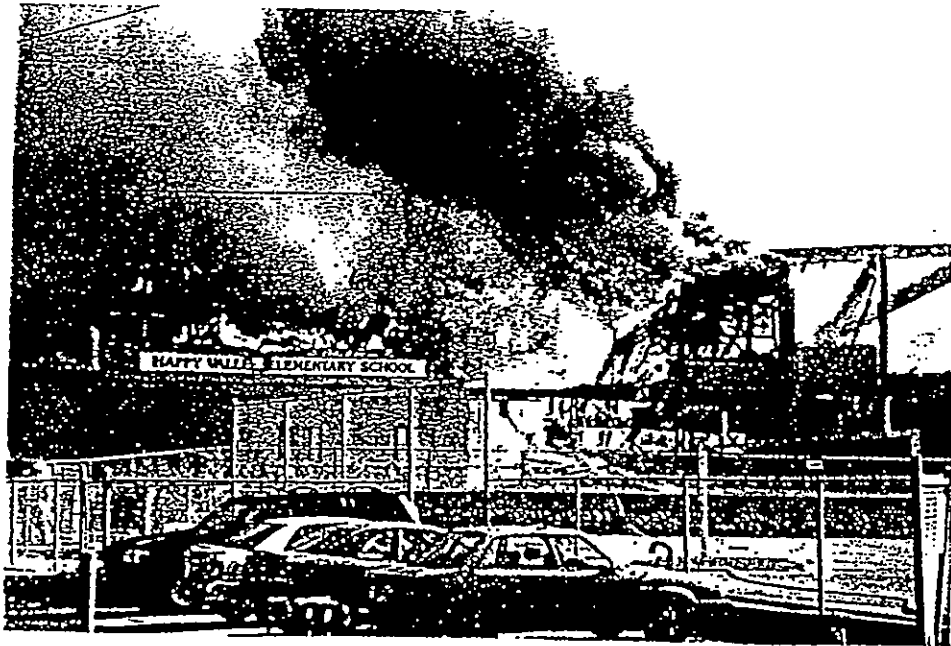
The undersigned observed that the complete upper floor was heavily gutted by the fire with the roof assembly, a number of exterior and interior combustible (wood frame) wall assemblies and most of the combustible (wood frame) floor assembly on the upper floor consumed by the fire with the exception of a small portion of the exterior wall at the intersection of the ALPHA / BRAVO sectors (Classroom 2018 and Corridor 2027). This upper floor area consisted of Classroom's 2018, 2019 and 2020, the upper Corridor 2027, Washrooms, 2014 / 2015, Medical Room 2021, Staff / Lunch Room 2022 / 2023 and the Gymnasium 2024 including Stage Area 2025 and Storage Room 2026). (See drawings A/2, A/7, A/14 and photographs 6-8, 15 and 16).

Figure 16 - Alpha Sector showing fire progressing **

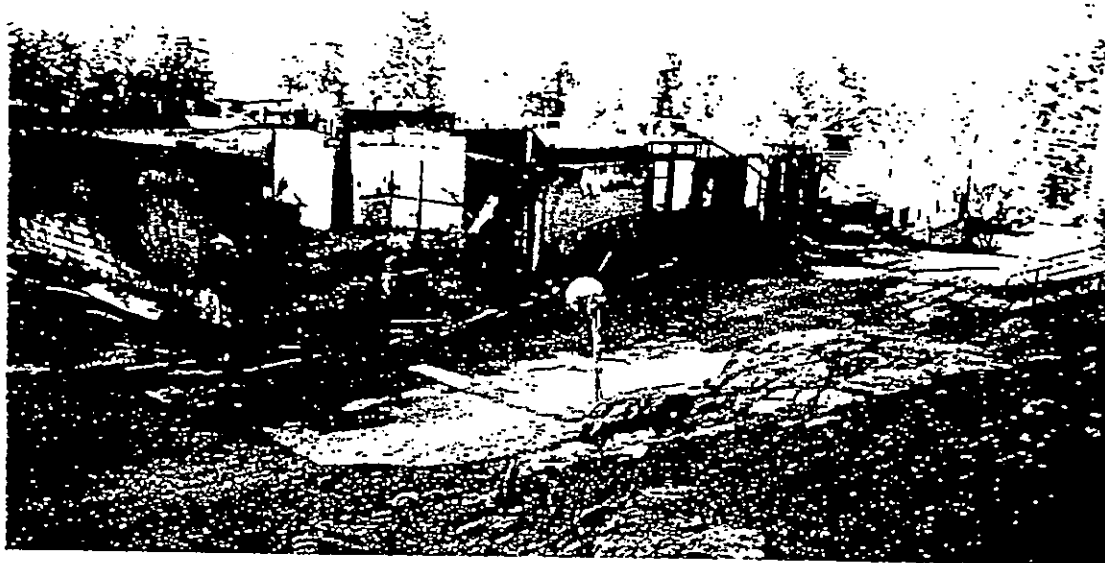
The undersigned proceeded to the exterior BRAVO sector of the school structure and observed that the fire had heavily gutted an entire block of classrooms consisting of Classrooms 2017 / 2017-A (Learning Assistance Rooms), Multi-Purpose Room 2010, Fine Arts Room 2029, interior Corridor 2028 (corridor access for Library 2011, Multi-Purpose Room 2010, Fine Arts Room 2019 and Classroom 2008). The undersigned observed the complete roof / ceiling assembly of this classroom block had been consumed by the fire leaving only the exterior / interior concrete block walls and parts of some of the combustible (wood frame) exterior / interior wall assemblies standing. The interior room content in all rooms within this classroom block had been subject to extreme temperatures leaving little or no salvage of value. (See drawings A/2, A/6-A/11 and photographs 1, 2, 17 and 18).

Figure 17 - Bravo Sector location of first sighting of fire **

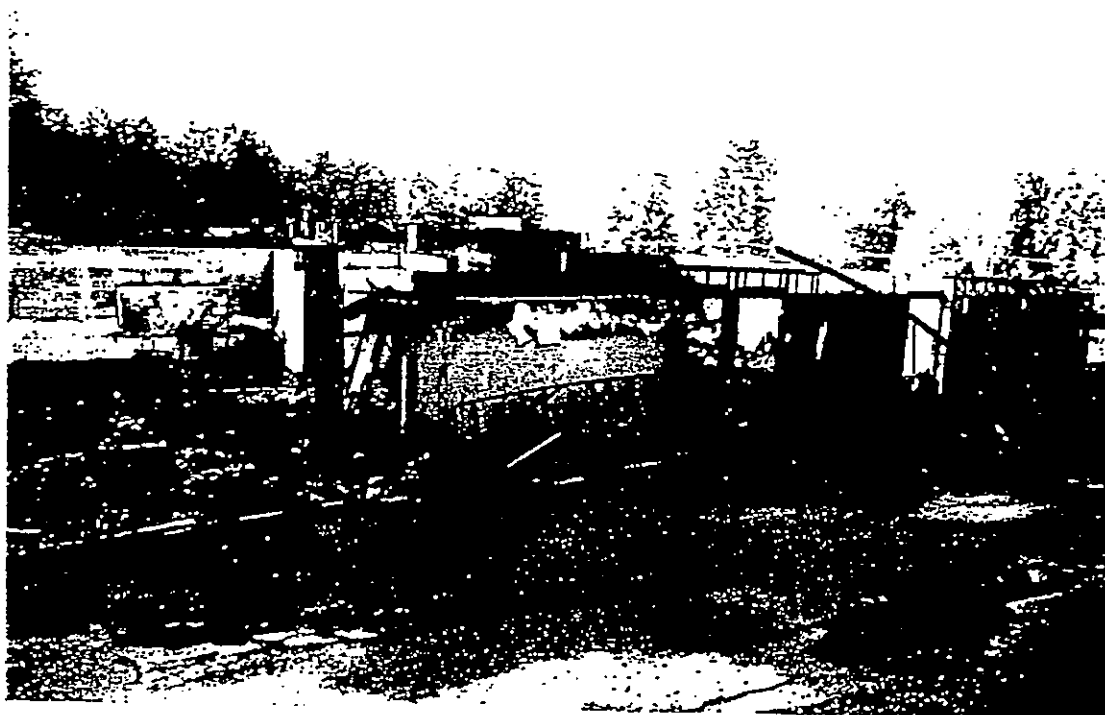
Figure 18 - Bravo Sector - fire and heat pattern indicators prior to reconstruction **

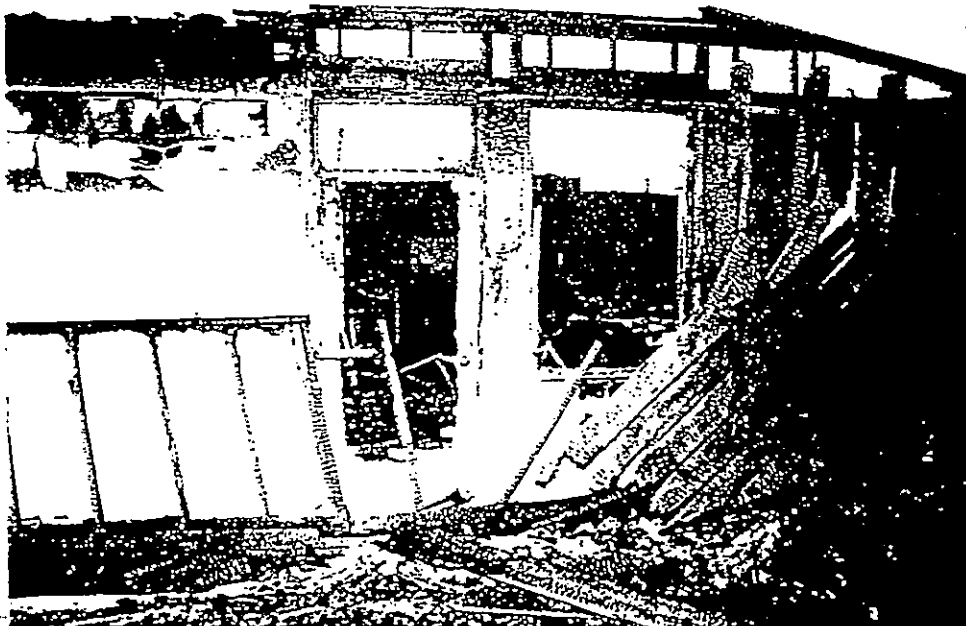
In the opinion of the undersigned upon completing the preliminary external / internal examination and documentation of the fire scene it appeared that the greatest degree of structural and content fire damage appeared to occur in the "BRAVO / CHARLIE / CENTER sectors of the school structure, thus suggesting that the fire was present in the BRAVO / CHARLIE / CENTER sectors in beginning or incipient stages of the fire. This was verified by teachers { } who, when exiting the structure at the BRAVO sector at different times (minutes apart) observed fire within Multi-Purpose Room 2010 as well as fire venting through the exterior wall window and door openings and rolling upward into the underside of the roof overhang (soffit). Also, it was verified by the first arriving fire crews that they were directed to the BRAVO sector of the school structure by the presence of moderate volumes of smoke and flames protruding from the exterior window and door openings and traveling upward into the roof overhang from within Multi-Purpose Room 2010. Therefore, with the preliminary external / interior examination completed and the visual sighting of the fire in Multi-Purpose Room 2010 by the teachers, students and firefighters noted, the fire investigation team began to concentrate their efforts within the Multi-Purpose Room 2010 in determining a cause of this structure fire. (See drawings S/1,S/2,A/2,A/5,A/7,A/10 and photographs 17-20,22,24 and 31-42).

Figure 20 - Bravo Sector - Exterior of Multi-Purpose Room 2010 prior to reconstruction **

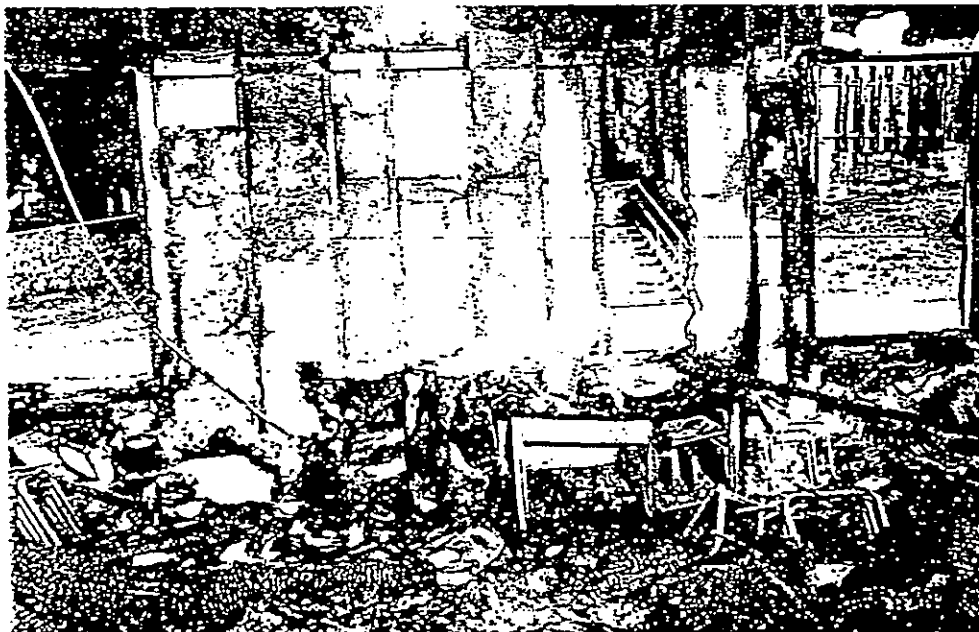
- The high heat pattern indicators (geometric patterns) observed on the remaining vertical surfaces of exterior combustible wood frame wall, the structural laminated wood beam (partial consumption, deep alligator charring), the remains of the interior wood / drywall partition walls (pointer and arrow patterns), in and around the sink and counter area, the remains of the exterior wood exit door and frame (V-patterns on vertical surfaces), the remains of the teacher's desk and the 2 tier wood constructed book shelf unit located on each side of the exit door along the exterior wall of Multi- Purpose Room 2010.

Figure 36 - Area of Origin - Multi-Purpose Room 2010 - Fire / Heat Pattern Indicators along exterior wall **

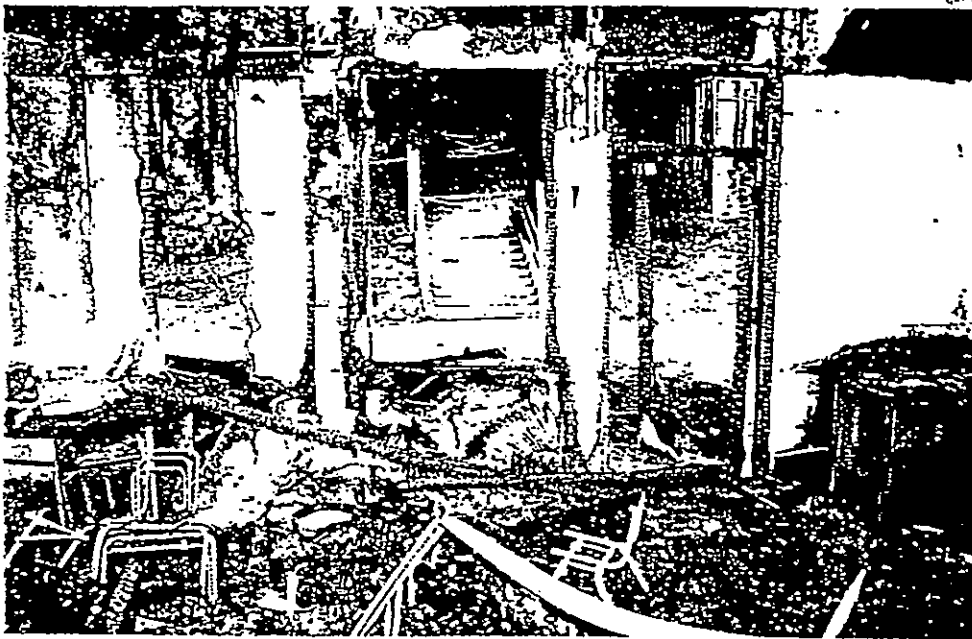
Figure 37 - Area of Origin - Multi-Purpose Room 2010 - Exterior door/window - fire and heat pattern indicators **

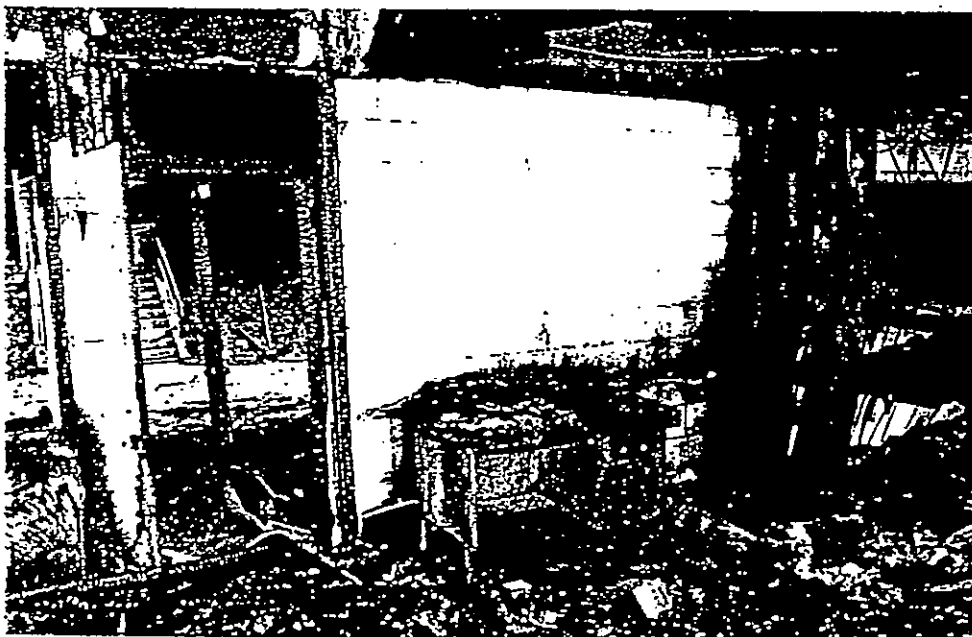
plate intact) and 2 wall mounted duplex outlets with plastic faceplate consumed by the fire (1 wall outlet with 2 black lights plugged "in" and 1 wall outlet with a light duty extension cord plugged "in"). All the indicators present indicated that the fire damage to these different electrical audio and duplex wall outlets, the appliances plugged "in" and their conductors (wiring) were external rather than internal and caused by the fire as it progressed and spread. (See drawings A/2,A/12,A/13 and photographs 31,34 and 38).

Figure 38 - Area of Origin - Multi-Purpose Room 2010 - exterior door/teachers desk - fire and heat pattern indicators **

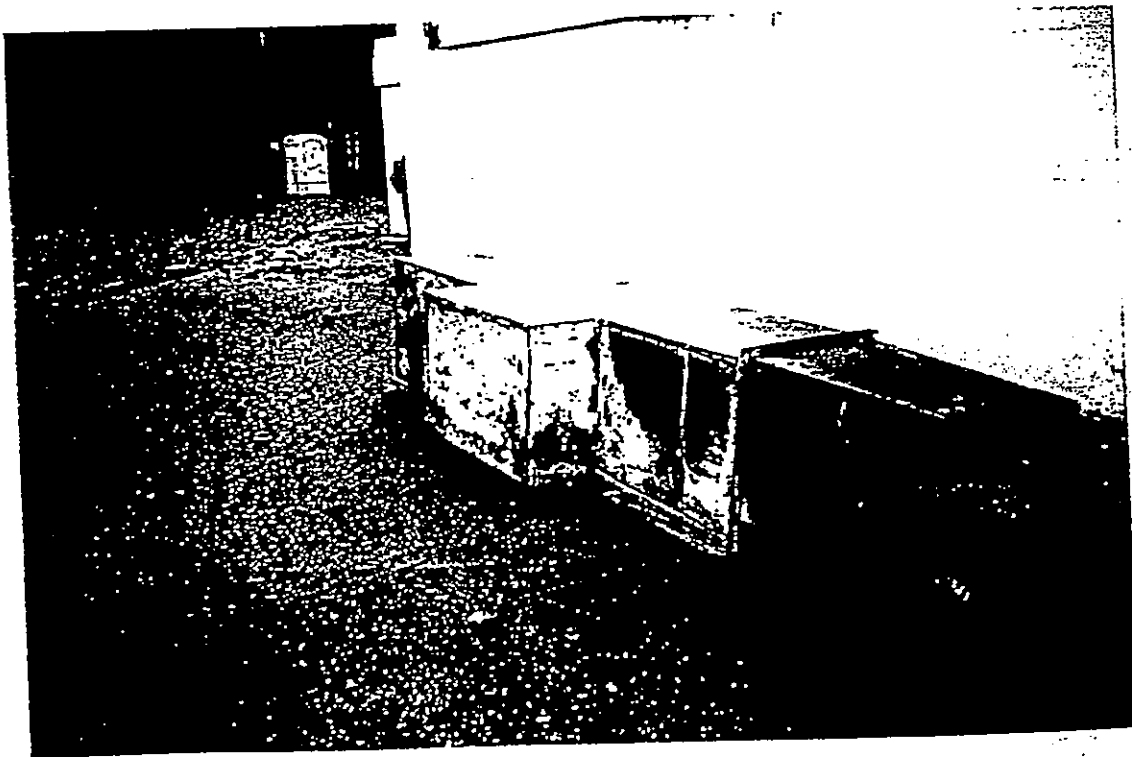
GILBERT was requested to examine an external roof mounted electrical heating unit that was mounted on the roof above Corridor 2027 and between Classroom 2013 and Library 2011. This electrical unit had been removed from its original position in the fire debris and placed at the rear of the school. The fire investigation team had been informed of some concerns with this roof mounted electrical heating. Upon completing his examination of the roof mounted electrical heating unit he was of the opinion that the faults present were external and not internal caused by the fire as it progressed and spread. (See drawing A/2 and photograph 52).

Figure 52 - Roof mounted electrical heating unit

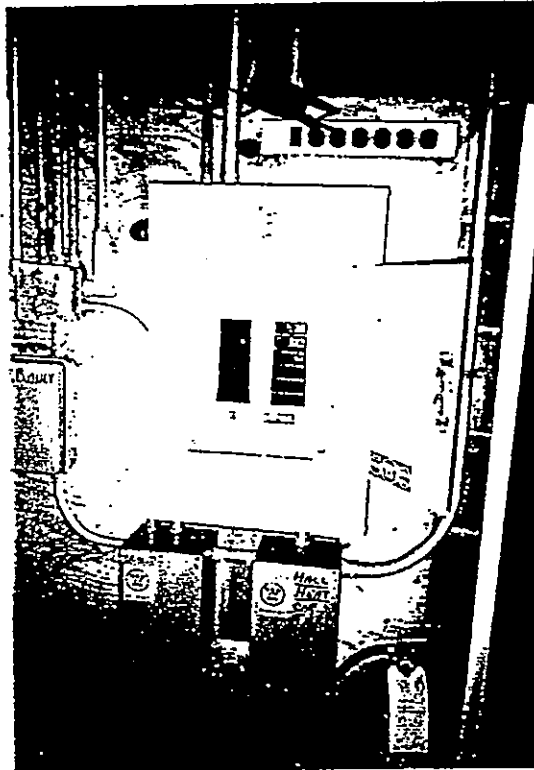
GILBERT started his examination by accessing the 2 Electrical Service Rooms 1001 / 1002 on the lower floor of the structure that were not structurally damaged by the fire. GILBERT examined the wall mounted electrical service panels, their associated circuitry / fusing and documented their conditions. GILBERT indicated to the undersigned that everything appeared normal with the exception of a few circuits that had their circuit breakers tripped. GILBERT indicated that because of the extent of structural damage it was going to be very difficult to examine the different circuitry once they had left the 2 Electrical Service Rooms 1001 / 1002. (See drawing A/2 and photographs 53 and 54).

Figure 53 - Electrical Service Panel - Room 1001

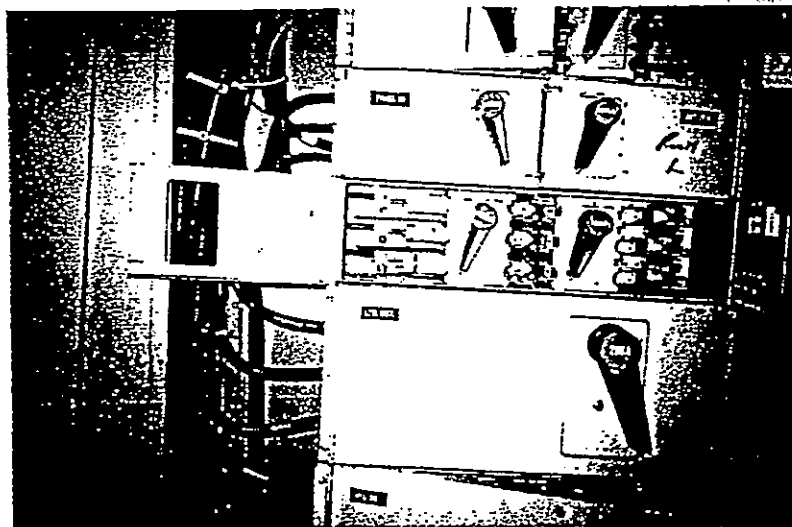
Figure 54 - Electrical Service Panels - Room 1002
