INCIDENT INVESTIGATION REPORT

| Notice of incident number 2012161980018 | Date of incident January 20, 2012 | Location of incident 19479 Highway 16 East Burns Lake, B.C. |
| Lead investigating officer Paul Orr | Investigation file number 2012-0013 | Incident outcome FATAL (2) INJURY (20) |

| Employer | Name and address | Employer ID | Industry classification |
|---|---|---|---|
| | Babine Forest Products Limited 19479 Highway 16 East Burns Lake, BC V0J1E0 | 328321 | 714022 Sawmill |

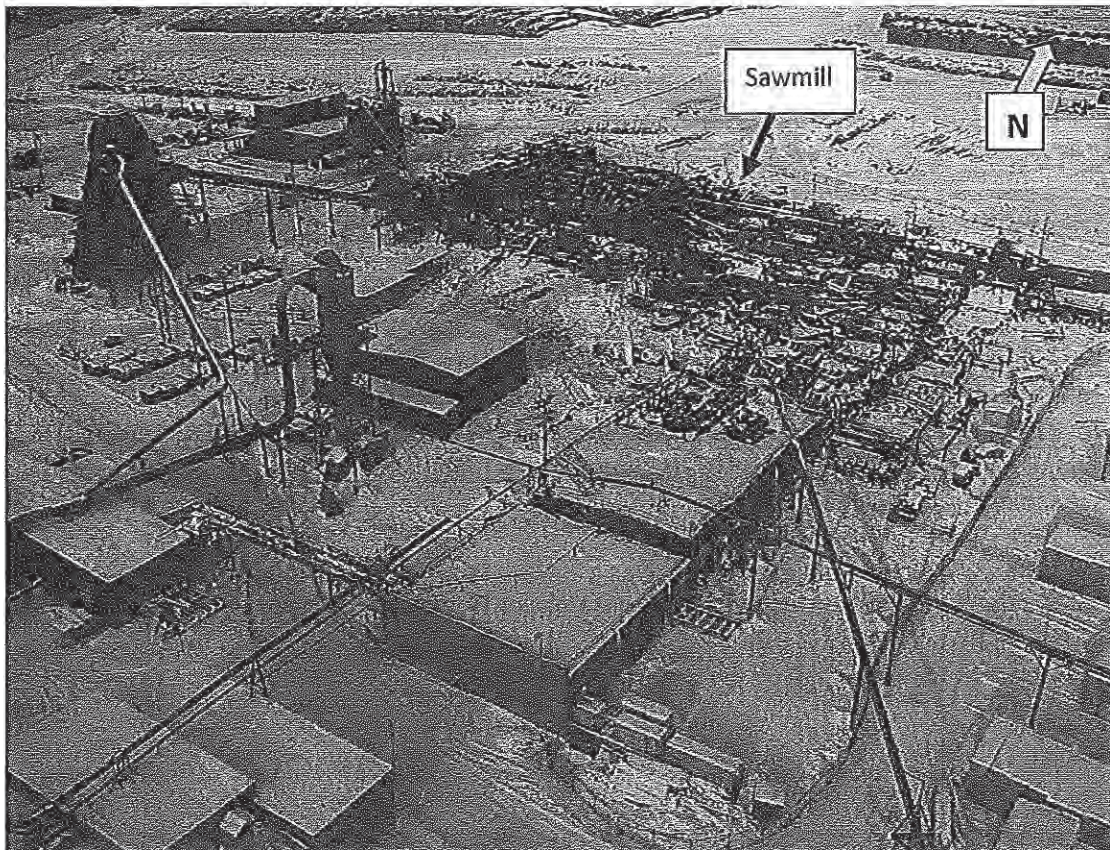
Figure 2: The sawmill after the explosion and fire on January 20, 2012.

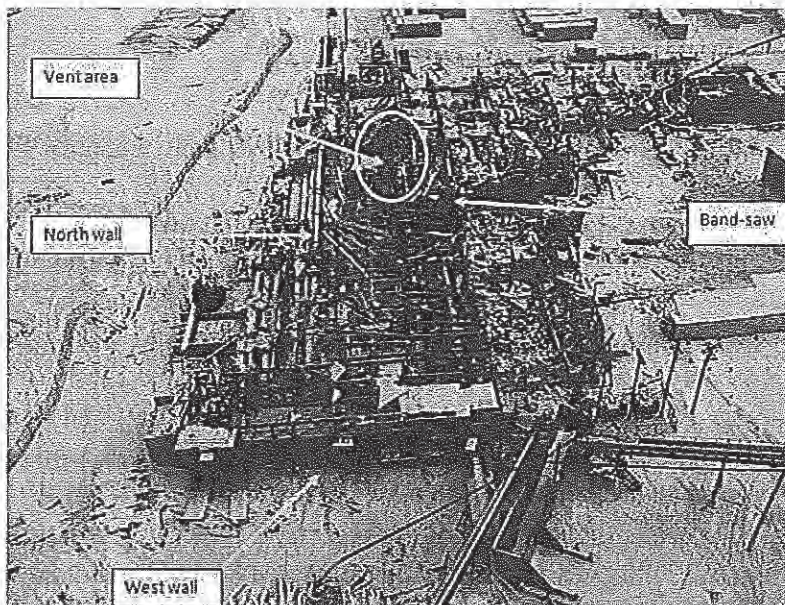
Aerial photographs of the mill site were taken and reviewed after the incident. These photographs show a large oval breach in the roof members of the building structure, as well as the path that the pressure wave took through the sawmill (Figures 4 and 5). From the breach, the gluelam (glued laminated timber) roof beams and steel members were pushed west. To the east of the breach the gluelam and steel beams have been thrown up and piled at the edge of the roof crater. At the northern end of the sawmill structure the outer walls were pushed out. Most of the other wall structures including the sorter and packaging areas of the mill were burnt but not displaced.

Figure 4: The sawmill as seen looking east. The vent area is shown by the yellow oval.

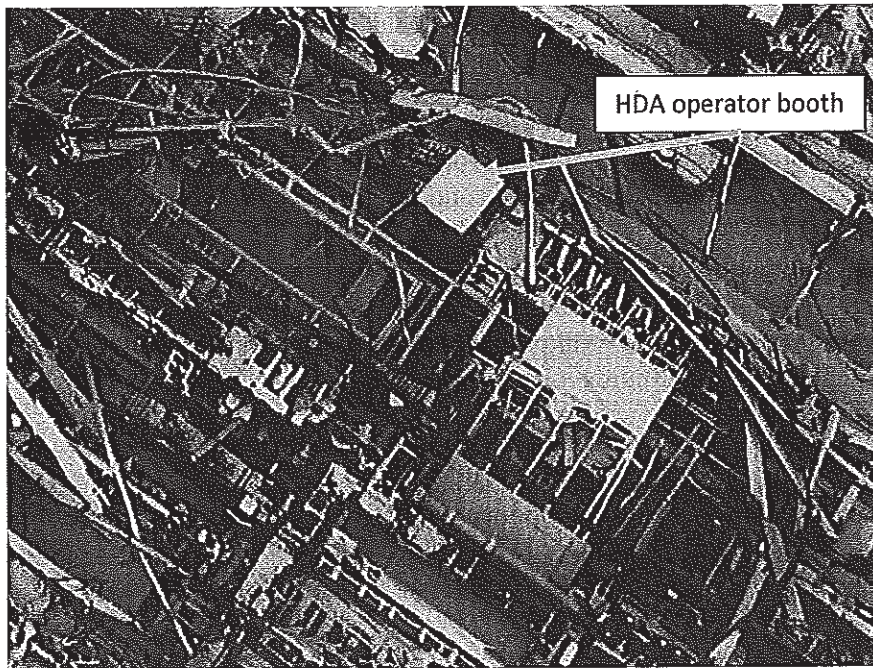
Figure 5: Close-up of the explosion vent area. Note the beams thrown out around this area. North is at top of the photograph; the horizontal double arbor (HDA) booth shown is located at D-19 (Appendix 3).

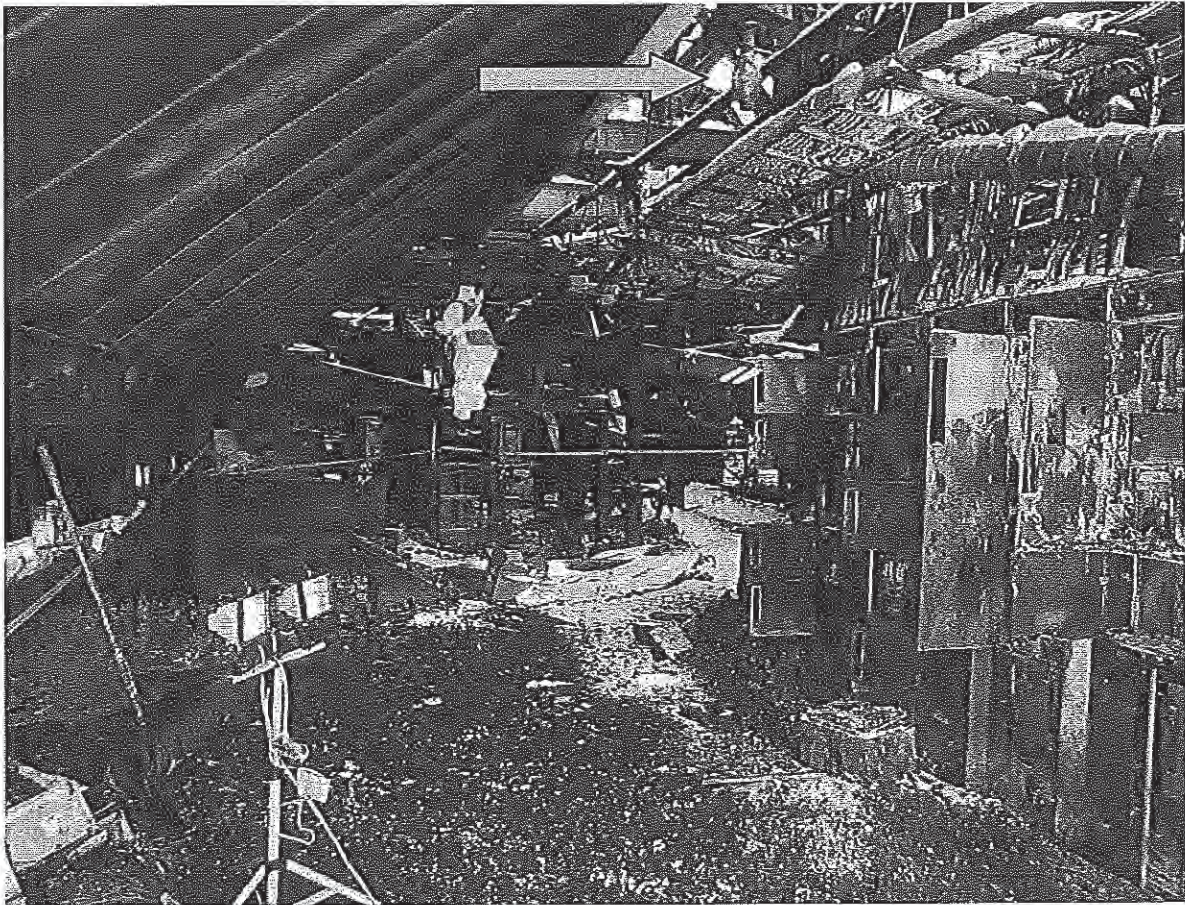
The available evidence did not support the hypothesis that a metal halide lamp failed catastrophically and initiated the explosion. In the areas where such lamps were present, there was no clear blast damage or blast directional indicators. The initial area where the investigation began, near the boiler room and MCC-10 electrical panel (H-16, Appendix 4), did contain metal halide lighting, but the bulb found in its fixture directly in front of the MCC-10 panel would likely not have survived intact if the explosion had originated near here or the full force of the explosion had reached this area.

Figure 7: This view looking east from in front of the boiler room (G-15, Appendix 4) shows the MCC-10 electrical cabinet on the right and conveyor 9-92 on the left. The metal halide bulb (yellow arrow) is intact.

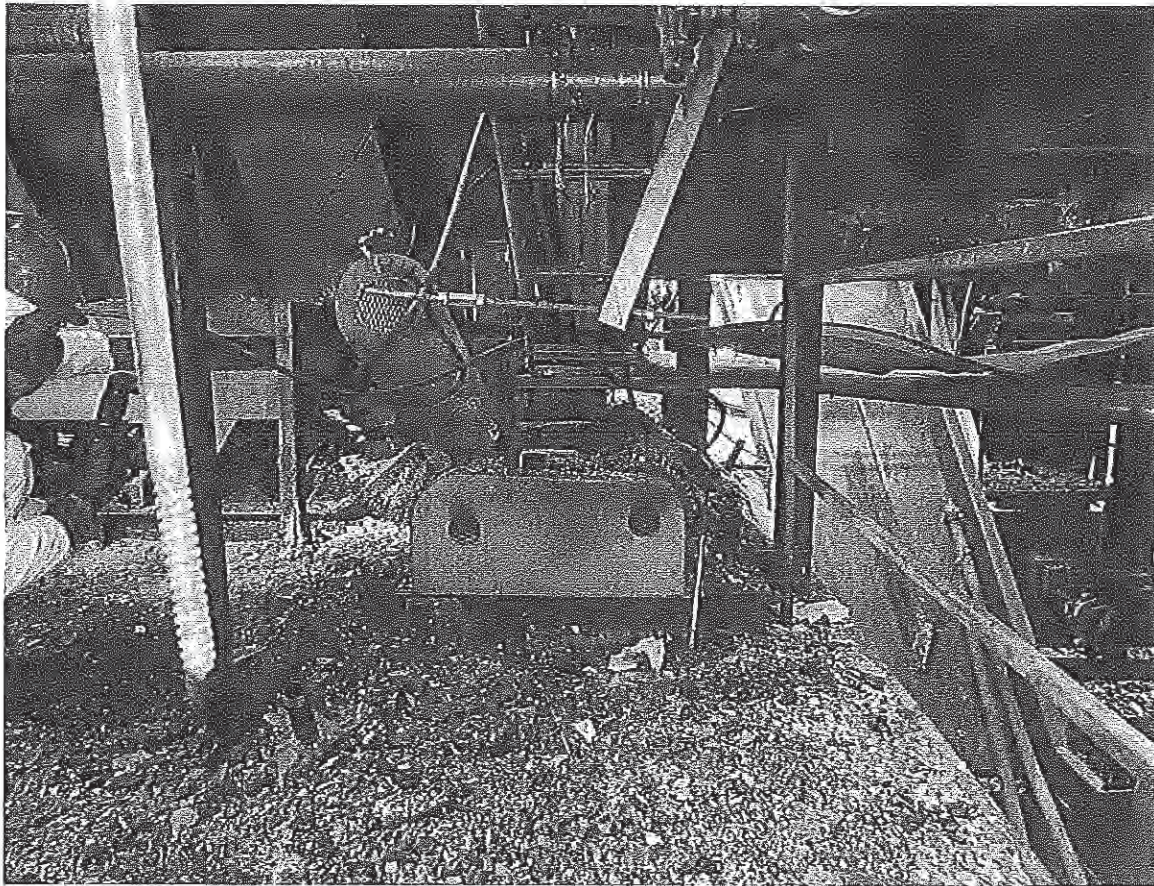
The motor was located in the half-basement, immediately below the #1 eliminator outfeed table, an area that was known to be very dusty. Because the output speed of the electrical motor (1,750 rpm) was too fast for the conveyor speed, the motor had been coupled with the 40:1 gear reducer to slow it down to a speed at which the driven conveyor could operate. The motor drove the gear reducer by means of two V-belts; in turn, the gear reducer turned the head-spool of the SEO waste conveyor by means of sprockets and a chain drive.

Figure 8: The motor and gear reducer assembly with guard, seen from north looking south. The drop to the full basement is at the right of the photograph.

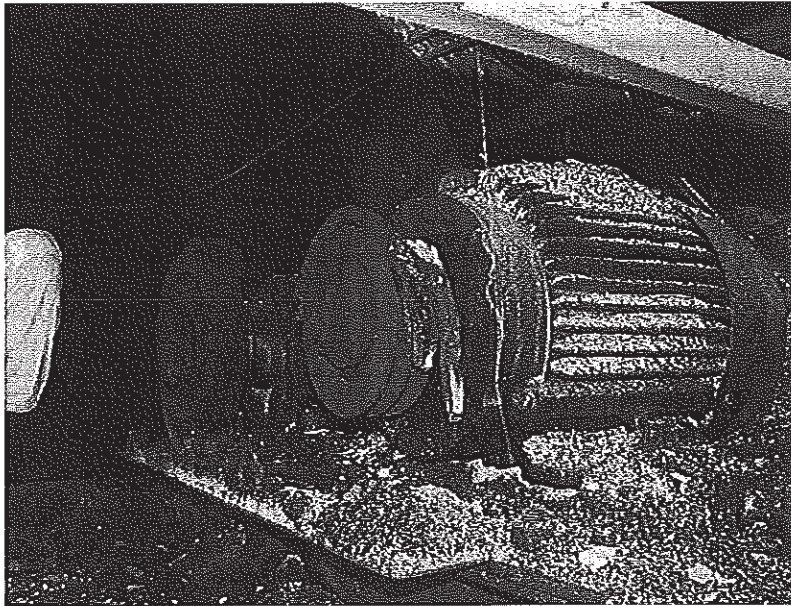
- The rear of the guard showed heavy burn damage in the centre area.
- The interior showed heavy fire damage, especially along the top.
- Within the interior of the guard, there were definite lines in the fire patterns. These lines angle away from the gear reducer sheaves and climb up the inside of the guard towards the motor sheaves.
- On the interior walls, there was evidence of very compacted wood dust residue.
- The two V-belts were burnt away between the motor and reducer.
- The V-belt remains were still sitting on the equipment sheaves.
- There was some un-burnt wood dust on the mounting plate within the guard.
- The front of the guard showed fire and smoke patterns emanating from the two inspection holes.
- The area outside the guard between the motor and reducer was significantly burnt.

Figure 9: Motor and gear reducer assembly shown with guard removed.

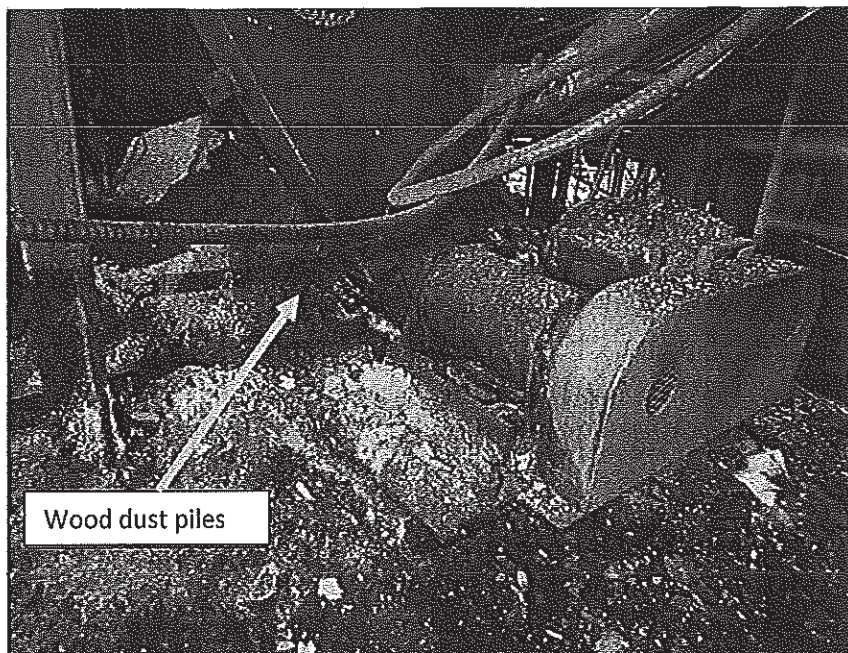
The area behind the motor and gear reducer, which is under the head-spool of the #2 SEO waste conveyor, contained excessive amounts of wood dust (Figures 10 and 11).

Figure 10: Excessive waste build-up was found under the eastern end of the #2 SEO waste conveyor 8R-25.

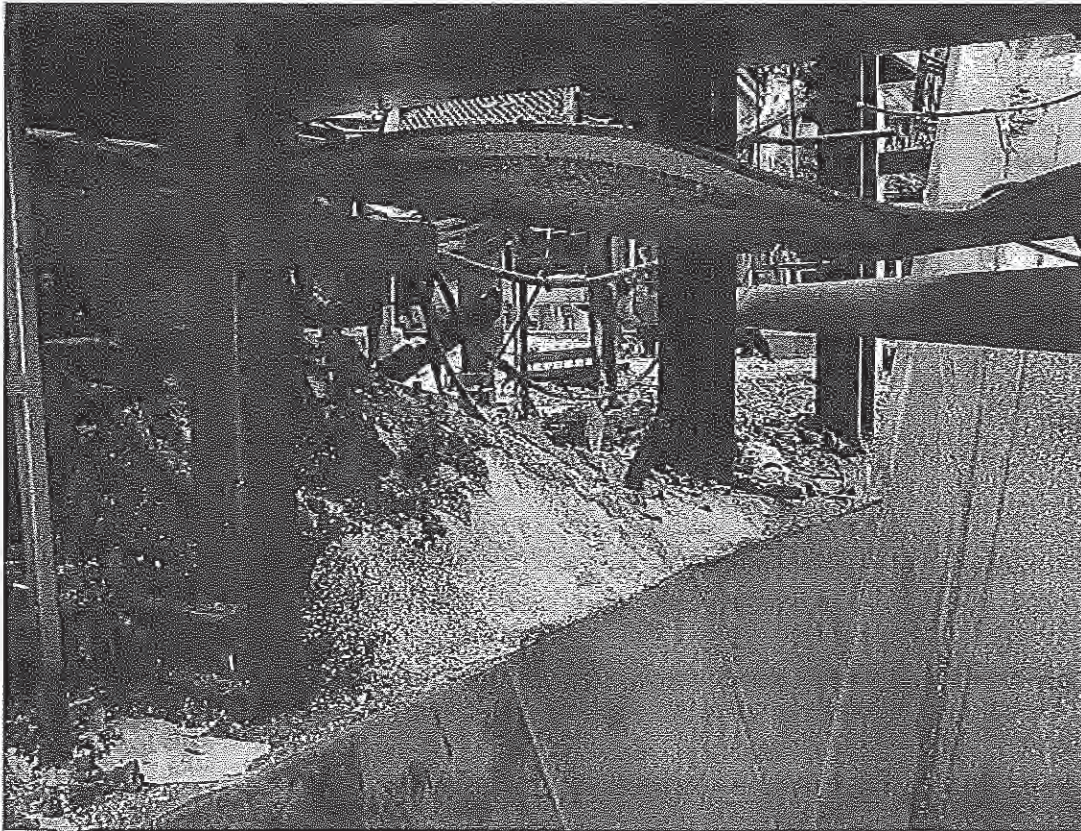
Figure 11: Excessive wood waste build-up was found behind the motor assembly.

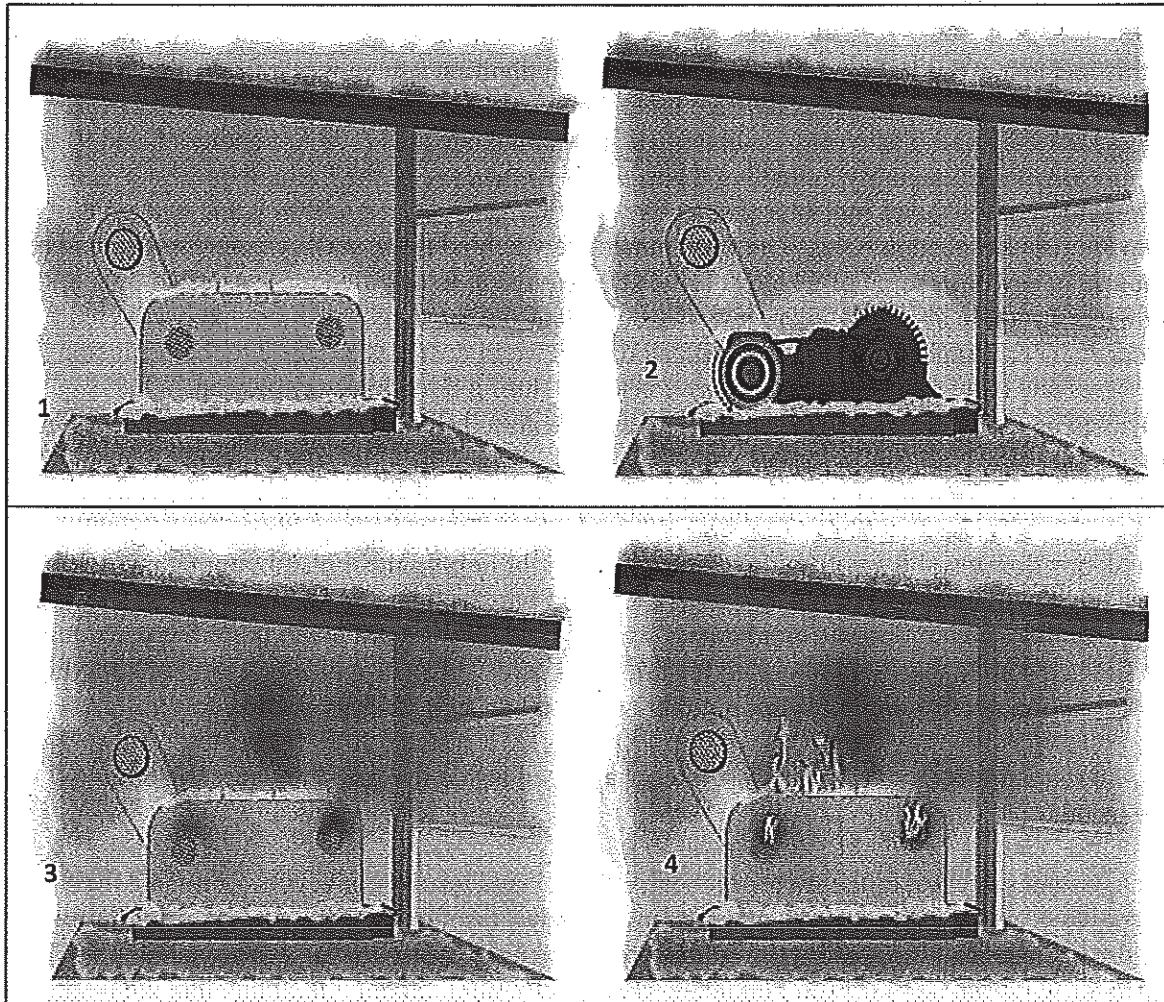
Figure 14: An artist's depiction of the most likely sequence of events within the V-belt guard:
(1): The motor-reducer assembly in place.
(2) The rotation of the V-belts and the build-up of saw dust (with the guard is removed for clarity)
(3) The smouldering fire created by the frictional heating of the V-belts through the compacted sawdust.
(4) The smoulder reaching areas where oxygen is available and a full flame develops. The explosion of the wood dust in the surrounding air followed.

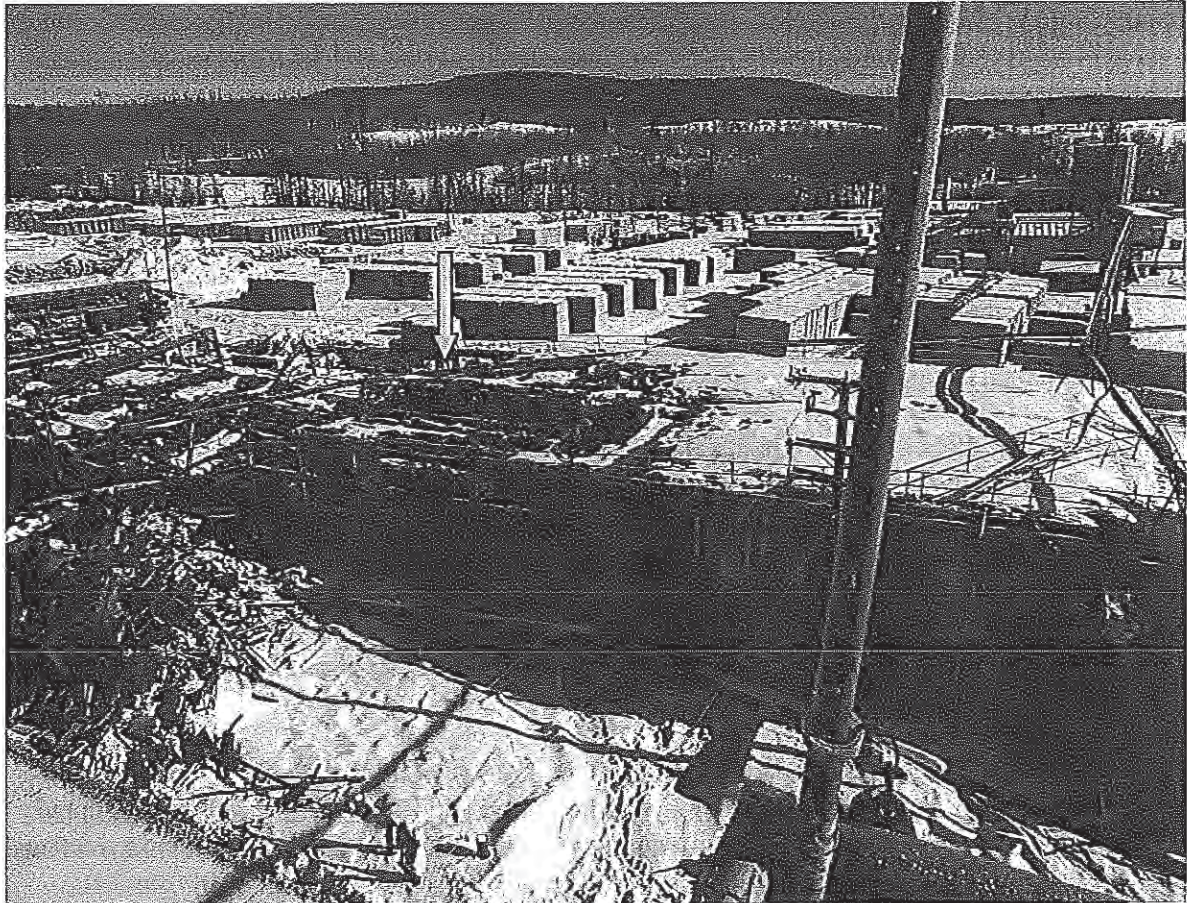
likely have made them ill. Gas did play a role in the fire following the explosion, however. The gas service line to the mill above the regulator mounted on the east wall of the sorter wing at V-27 (Appendix 3) was recorded as broken at 20:07 due to the explosion, and gas continued to flow freely until it was shut off at 20:47. This uncontrolled release of natural gas at 60 psi into the sorter wing of the mill fuelled the fire in this area, which ended up being one of the worst damaged areas of the sawmill structure (Figure 16). Natural gas was therefore a contributing fuel for the fire following the explosion in this incident.

Figure 16: View of the sorter wing of the sawmill, looking east. The yellow arrow indicates approximately where the natural gas line broke. The fire damage near this location is evident.

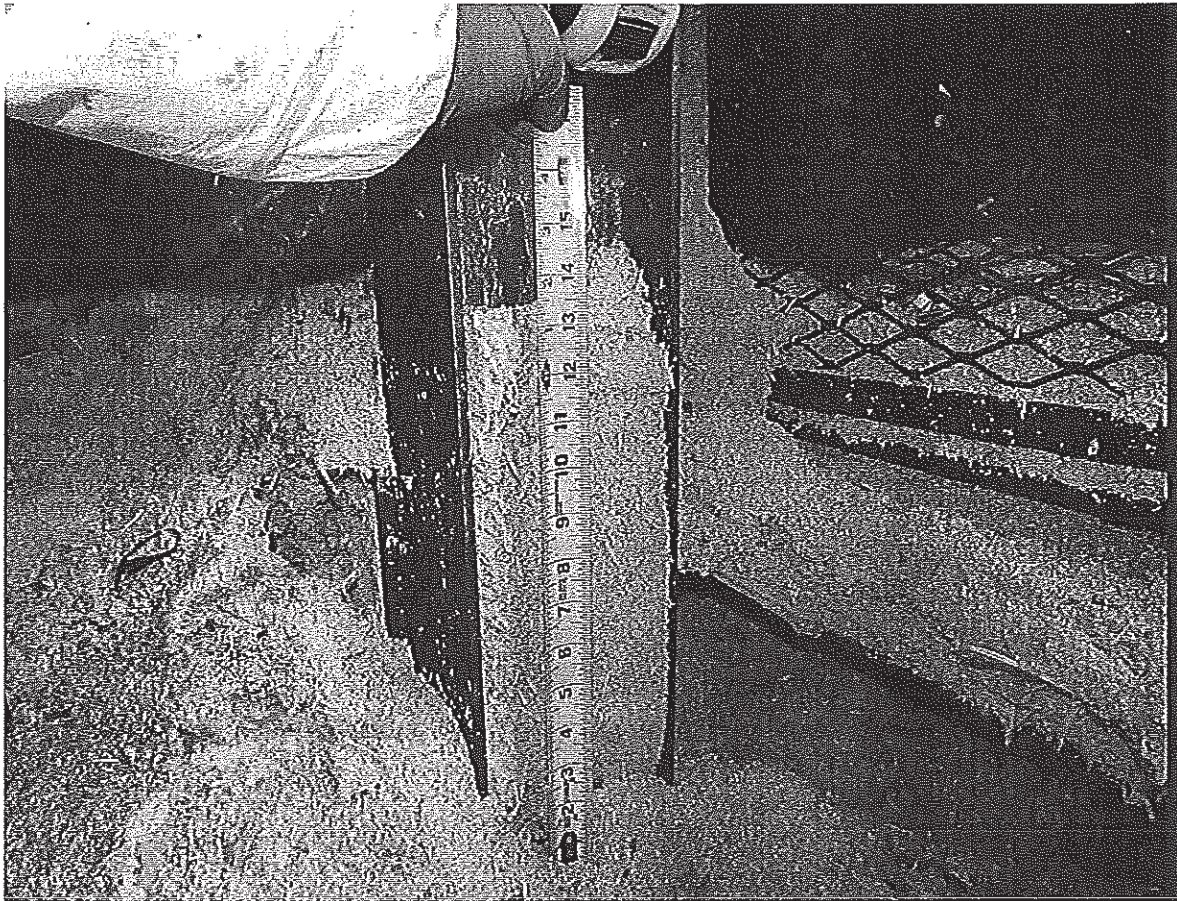
Figure 24: Dust accumulation in the area near conveyor 9-32 (C-25, Appendix 4. Photograph by WorkSafeBC, following the explosion.

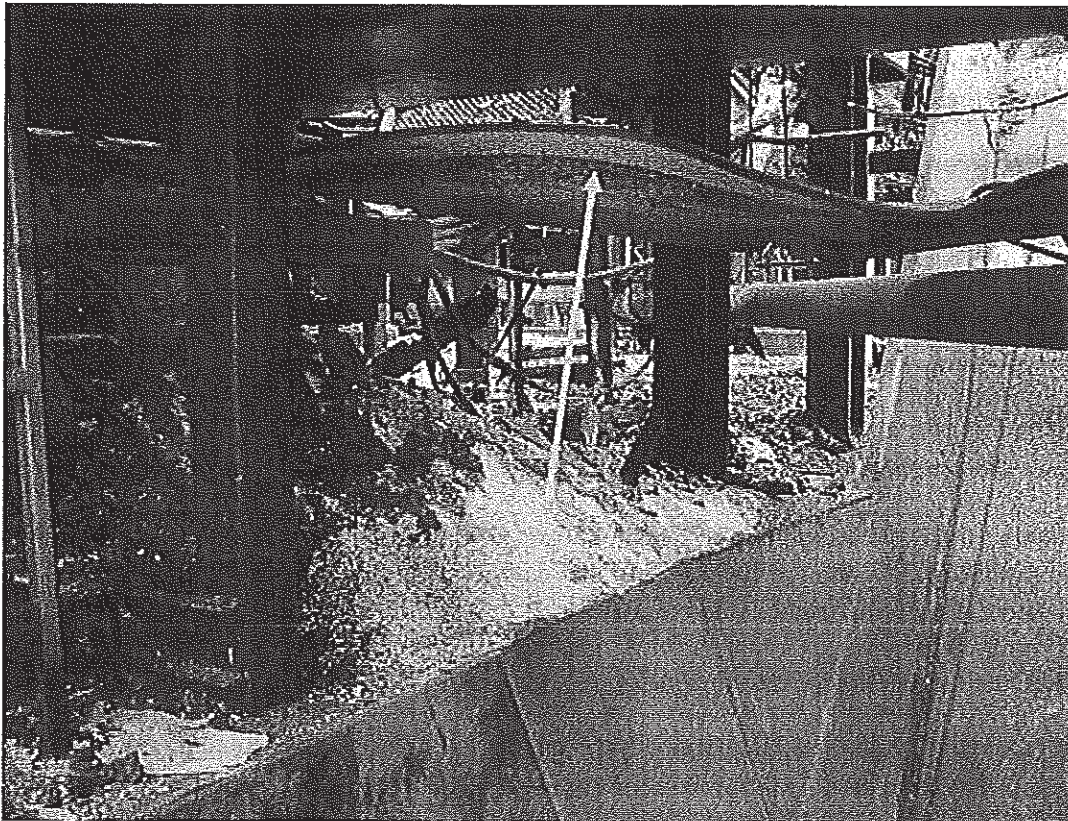
The area where the explosion originated was quite small, and was indicated by many obvious facts and physical evidence. The return belt for conveyor 8R-25 was found hanging immediately behind the 8R-25 motor drive. The heavy rubber reinforced belt was molded into a shape that went back and away from the motor drive. This could have occurred only with significant heat and pressure which molded the belt into this form which is opposite its design condition (Figure 28).

Figure 28: The conveyor belting behind the 8R-25 motor-reducer assembly. The yellow arrow indicates the pressure and heat forming of the belt.

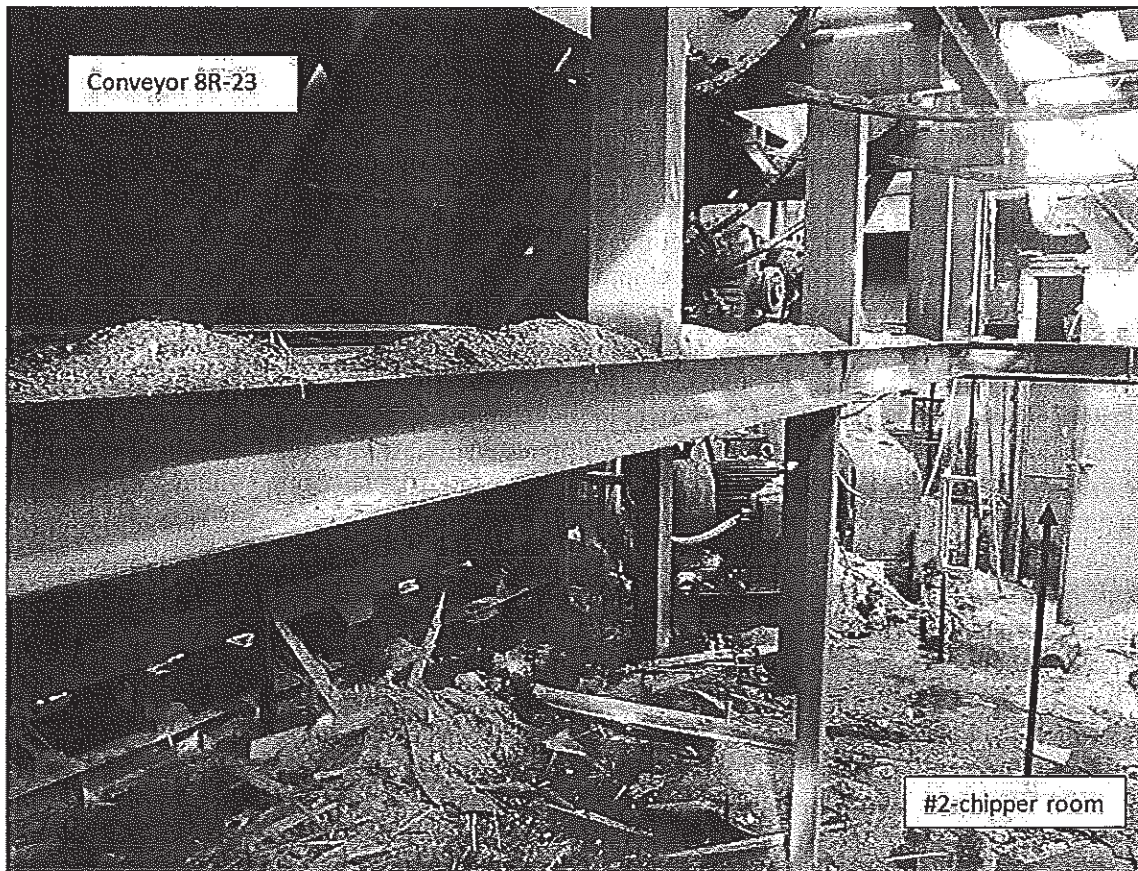
The #2 chipper vibrating infeed conveyor 8R-23 ran straight east and away from the 8R-25 motor drive. The north side of this conveyor where the explosion occurred was clean of wood dust and debris. The wood dust and debris remained untouched on the south side, and accumulations were present on the floor and on all the structural flanges and beams. The conveyor structure made a significant wall separating the area of origin of the explosion from the southern packaging areas of the sawmill; it protected the latter areas by preventing the explosion pressure and deflagration from expanding in their direction (Figure 29). The heavy damage seen in the sorter areas following the explosion was due to the 40-minute period when natural gas flowed freely after the natural gas supply line to the mill at the east wall of the sorter wing was severed (see section 2.3.2). The damage was due to fire fuelled by the natural gas supply, not from the explosion.

Figure 29: South side of the #2 chipper in-feed conveyor 8R-23. The wood waste on the structural flanges and floor were protected by the conveyor structure and were not disturbed by the explosion.

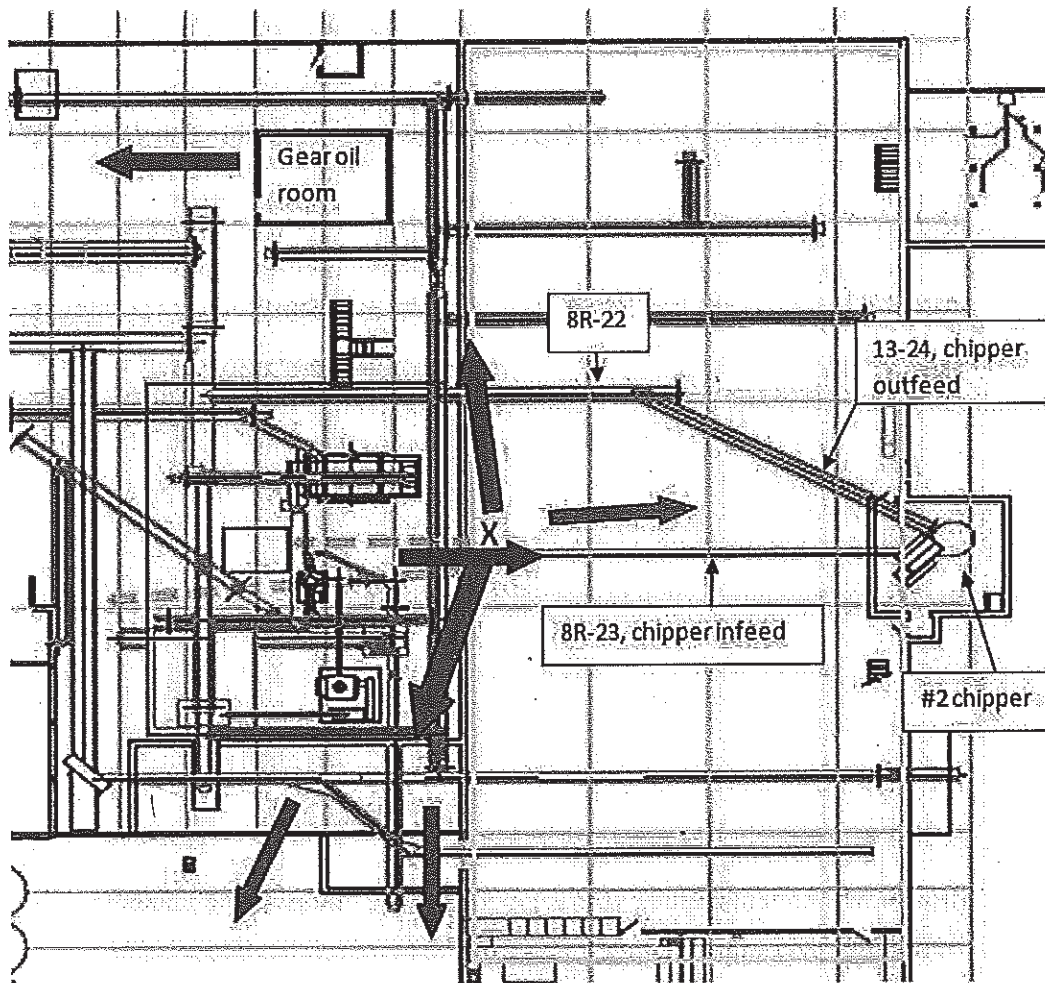
To the west of the 8R-25 motor drive were the vibrating screens and conveyors, oriented both north to south and east to west. The #3 screen skirting was buckled as a result of the explosion pressure travelling west from the motor drive. However, the area west of the origin was crowded with conveyor and screen structures that restricted the explosion's expansion in this direction; instead, much of the pressure was directed northward into the areas beneath the gang-saws (Figure 30). Compared with the rest of the mill, the basement layout was very open all along the north wall, running east to west. The gear oil room structure and equipment were pushed northwestward, and firefighting equipment in the vicinity of the gear oil room had been displaced in the same direction. The primary explosion was directed by the nearby structures and equipment and by the available fuel into the general area of E-24 (Appendix 3). It also expanded southwestward, into part of the area where the screens and edger conveyors were located (Figure 30).

Figure 30: Note the following in this enlarged diagram of the basement level near H-25 (Appendix 4): The blue arrow represents conveyor 8R-25. The red rectangle outlines the area where various screens and structures restricted the explosion pressure's expansion westward. The yellow rectangle outlines the half-basement area; everything to the left of it is full basement. The green arrows indicate the paths travelled by the explosion pressure.

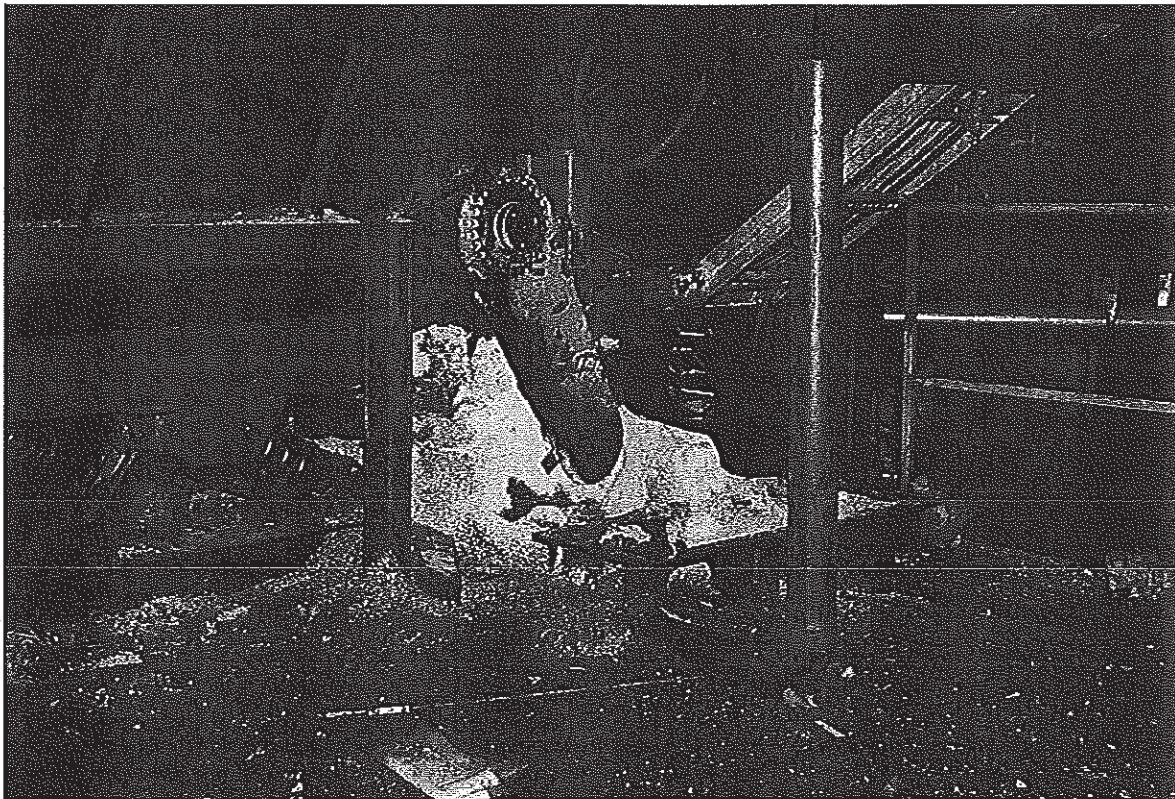
In the Babine explosion, it is believed that an open flame from the motor-reducer's V-belt guard, located in the basement level of the mill, likely ignited the dust mixture suspended in the air above the motor (Figure 34). Several large wood waste conveyors as well as the chipper and vibrating screens were in this general area, with the 8R-25 conveyor dumping into the chipper vibrating infeed conveyor directly above this location. All of these caused the dispersal of the fine wood dust into the air. A contained space of approximately 15,000 cubic feet (425 cubic metres) in this general area was bounded by the high conveyor wall sheeting and an exterior wall.

Figure 34: The 8R-25 motor mounting plate after removal of the motor-gear reducer assembly and guard. Note the amount of wood dust that was protected from the explosion.

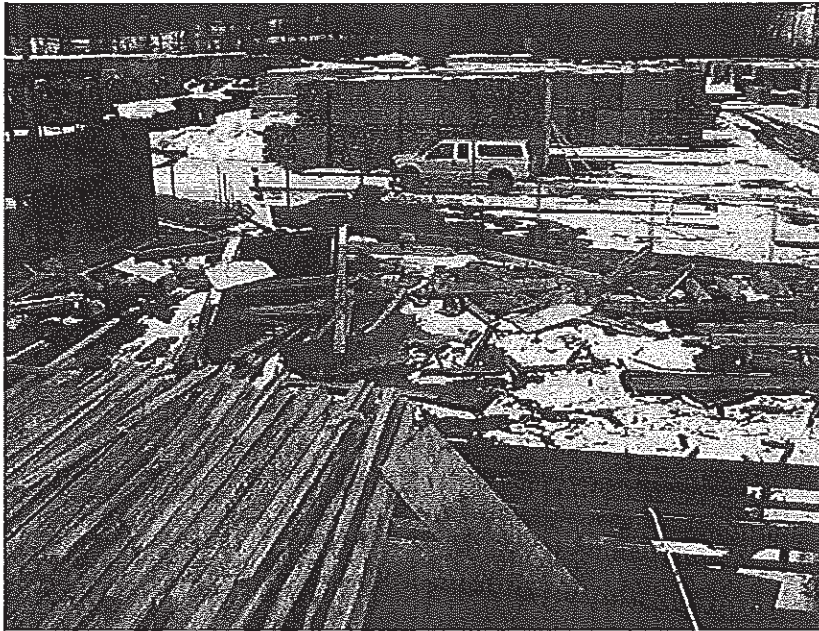
To the east, the sawmill wall was displaced and blown out into the log yard. The large exhaust fan was ripped from its attachment on that wall and thrown 60 feet out into yard along with the main sawmill structural members (Figure 35). The fan was 9 feet by 9 feet and very heavy. Even the lumber on the green chain outside the sawmill was displaced on this side of the mill as the overpressure escaped (Figure 36).

Figure 35: The large exhaust fan, indicated by the yellow arrow, was blown out approximately 60 feet from where it had been mounted on the mill's east wall.

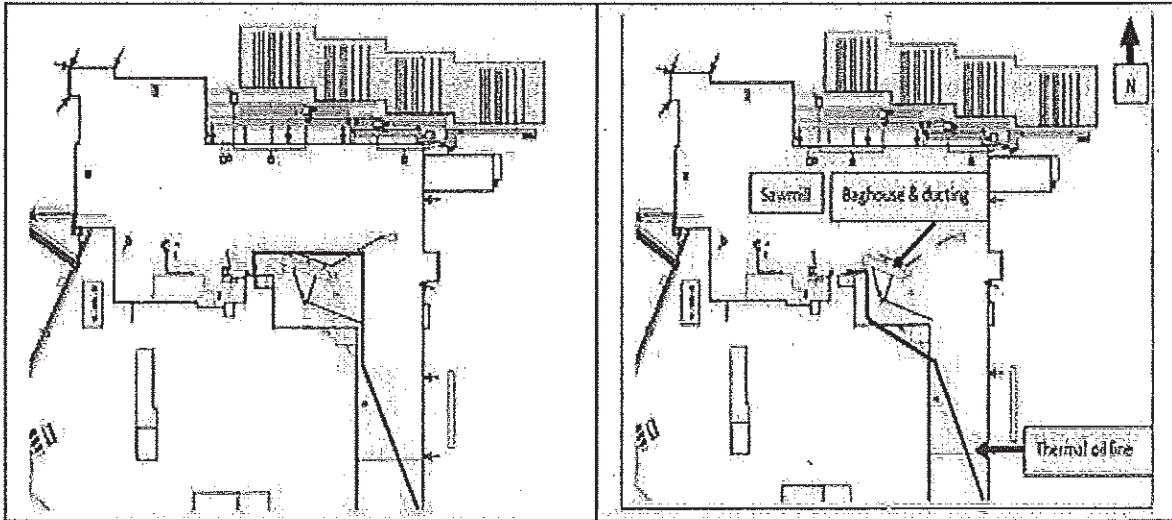
The heat generated by the incoming thermal front likely caused the oxygen/acetylene bottles located there (D-21, Appendix 4) to vent, which added fuel and oxygen to the explosion, thereby increasing the violence and pressure. The temperatures generated by a dust explosion are reported to be in a range of 1,725 to 3,225°C. The pressure vented through the roof near the HDA gang-saw operator booth. In the process, it displaced the thermal oil line located on the roof southward and also pushed the baghouse southward and off its original support structure (Figures 37–38).

Figure 37: The diagrams show the layout of the sawmill roof. The thermal oil line is shown in red. The left diagram shows the way the oil line was designed to cross the roof; the right diagram shows the oil line's location after the explosion.

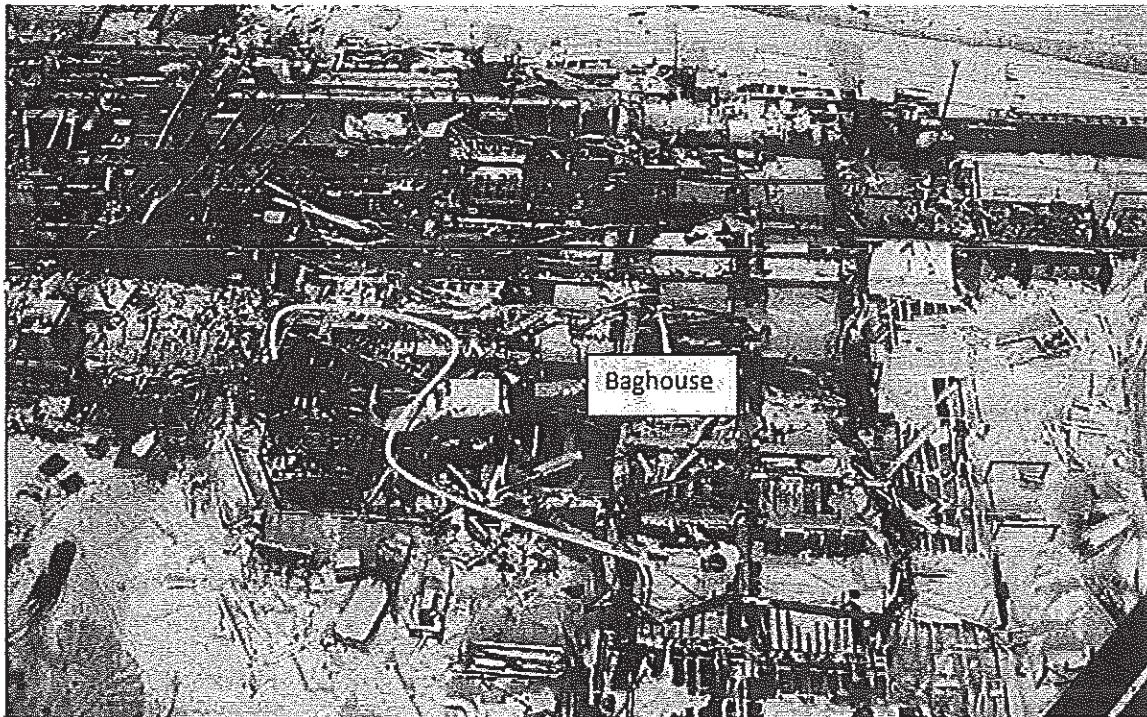
Figure 38: Aerial photograph showing the baghouse location and the thermal oil line (traced in yellow). The vented area in the roof is north of the baghouse.

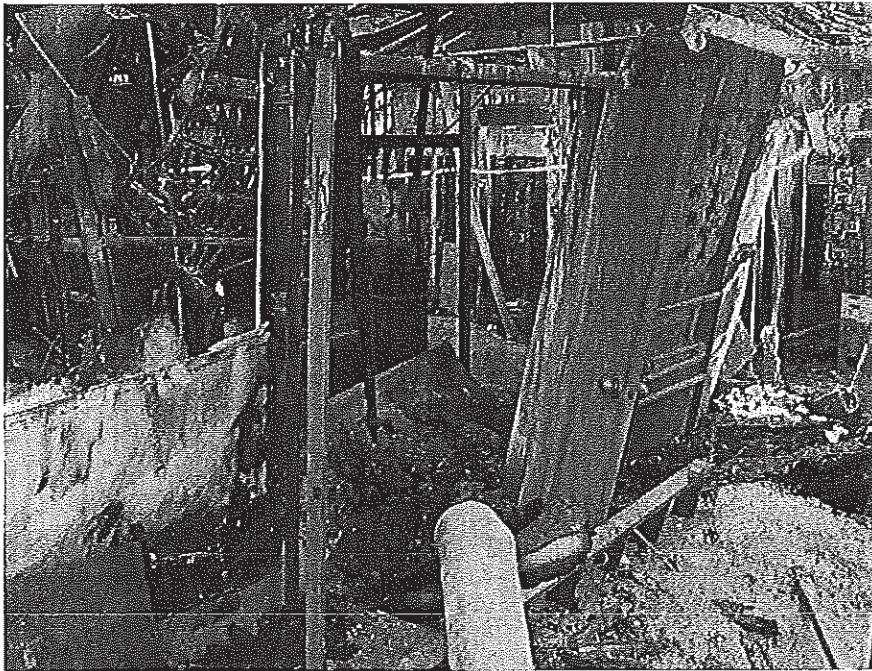
Along the south wall of the sawmill in the basement level, running along grid line G, is a corridor defined by the conveyors below line 3. There was little or no blast damage throughout this area, except to the walls of the power distribution centre (PDC) room (G-10, Appendix 4), which appear to have been pushed westward by the explosion pressure. The line 3 hydraulic room is near the PDC room (F-11, Appendix 4). There was evidence that it had been pushed westward, but the major damage that destroyed the room and walls is the post-incident fire (Figure 39). There is little violence associated with this damage, simply overpressure.

Figure 39: The line 3 hydraulic room looking south, the double doors pushed open westward. Some of the PDC electrical components are on the wall in the background.

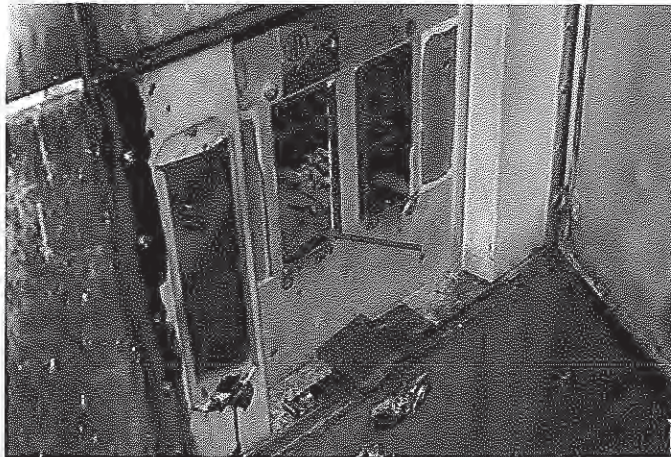
Clean pressurization air was not being supplied to MCC #9 and wood dust was found within the cabinets. Normal operation or failure of electrical equipment within MCC #9 are potential sources of ignition for a wood dust cloud or layer. MCC #9 was not identified as being a likely ignition source, however, wood dust found within MCC #9 presented a fire hazard.

Photograph 3: Example of wood dust accumulation in MCC #9

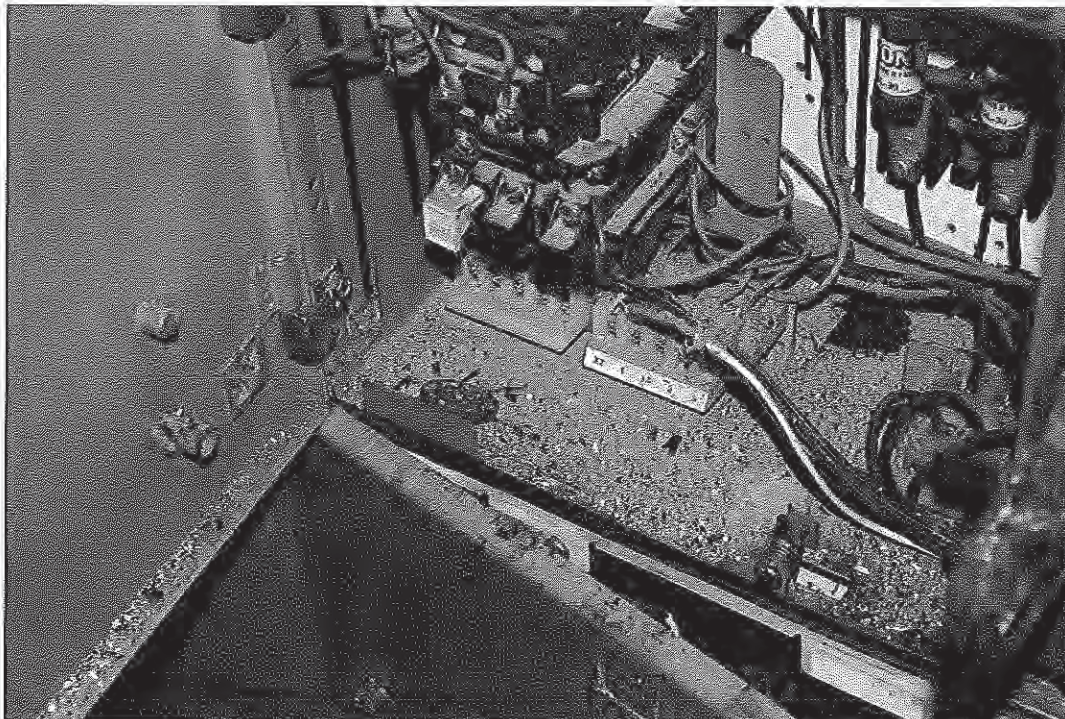
Clean pressurization air was not being supplied to MCC #10 and wood dust was found within the cabinets. Unsecured cabinet doors may have exposed electrical equipment to a combustible atmosphere outside of MCC #10. It is also possible that the cabinet doors were opened as a result of an explosion from within MCC #10. On the evidence currently available to the BC Safety Authority, the operation of or a failure of the electrical equipment within MCC #10 could have ignited a combustible cloud of wood dust that came into contact with it.

Photograph 4: Example of wood dust accumulation in MCC #10

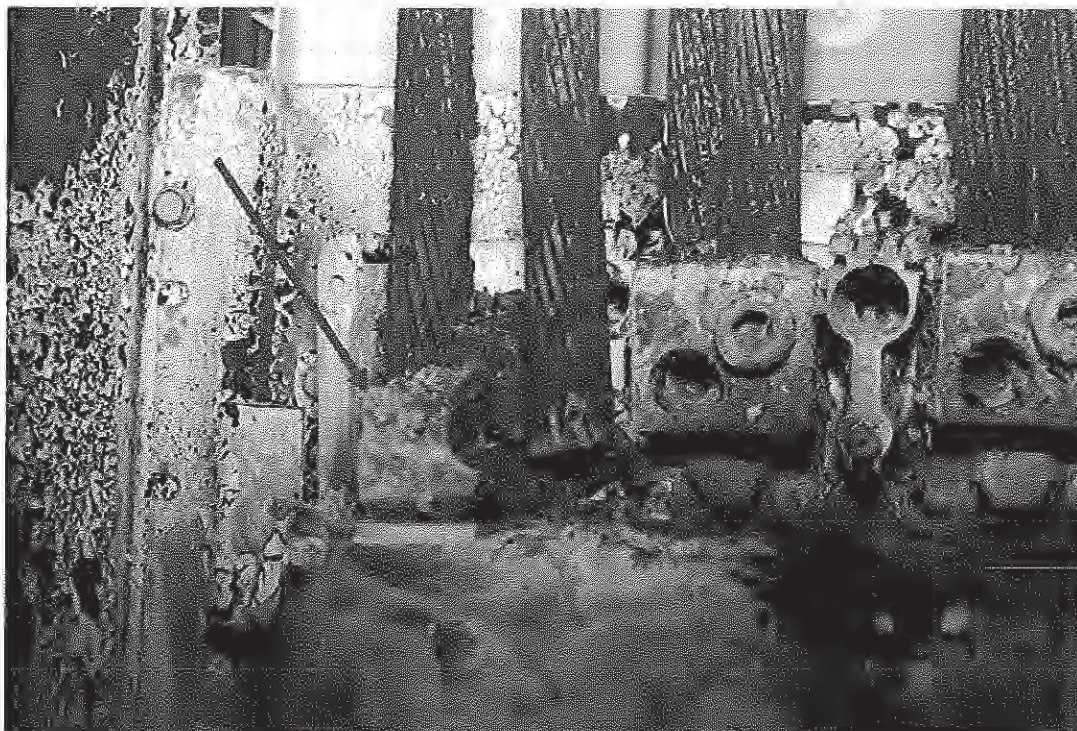
Photograph 5: Fractured feeder lug in cabinet 10-31

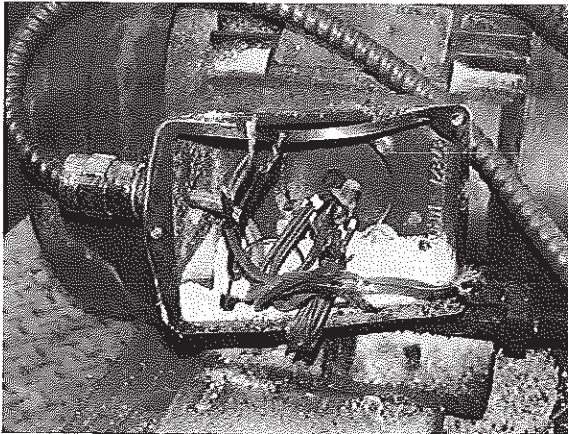
Photograph 8: Wood dust deposits within conveyor motor junction box labeled 8R-26.

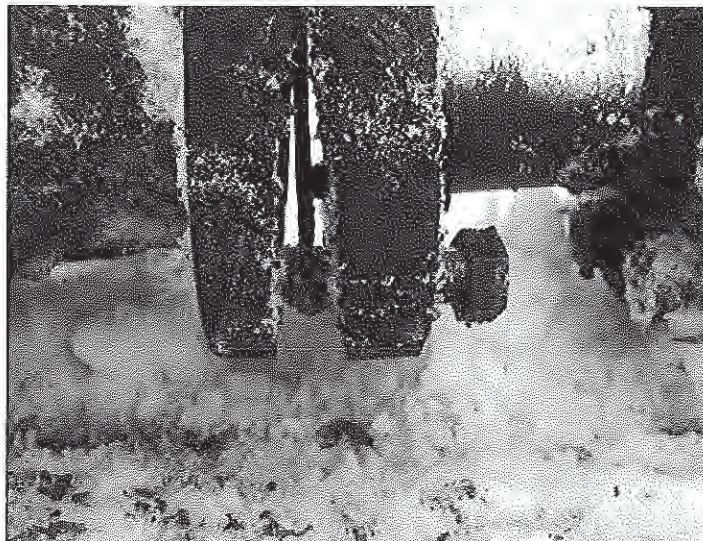
Photograph C1: Broken bolt at valve flange to heat exchanger
