From: Ullah, Aman FLNR:EX
Sent: Friday, March 30, 2012 2:34 PM
To: Davies, James W FLNR:EX
Subject: FW: Innergex - Unplanned Variance - Stokke Creek Facility
Attachments: image001.jpg

Please be advised that that at approximately 12:00 today (15 Mar 2012), there was an event at the Stokke Creek Hydro Facility which caused a low IFR event for approximately 3 hrs. Initial data indicates there was a slide upstream of the intake structure that caused a rapid decrease in creek flow.

- At approximately 12:00, the upstream Stokke Creek flow dropped suddenly and unexpectedly from 1.3 cms to 0.3 cms. Refer to Figure 1.
- The Harrison Lake area experienced heavy snowfall in the weeks prior to the event. A snow slide upstream of the intake is the most probable cause of the abrupt drop in creek flow.
- The blockage cleared itself and the upstream creek flow returned to pre-event levels at 15:00 (likely as the creek worked through the slide material).

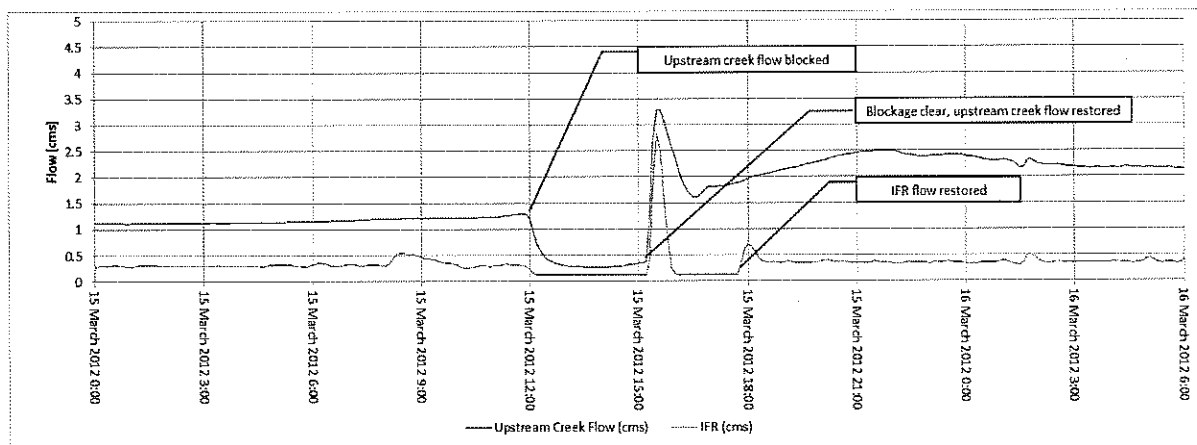
Figure 1: Upstream Creek and IFR Flow

- At approximately 12:00, the upstream Stokke Creek flow dropped suddenly and unexpectedly from 1.3 cms to 0.3 cms. Refer to Figure 1.
- The Harrison Lake area experienced heavy snowfall in the weeks prior to the event. A snow slide upstream of the intake is the most probable cause of the abrupt drop in creek flow.
- The blockage cleared itself and the upstream creek flow returned to pre-event levels at 15:00 (likely as the creek worked through the slide material).

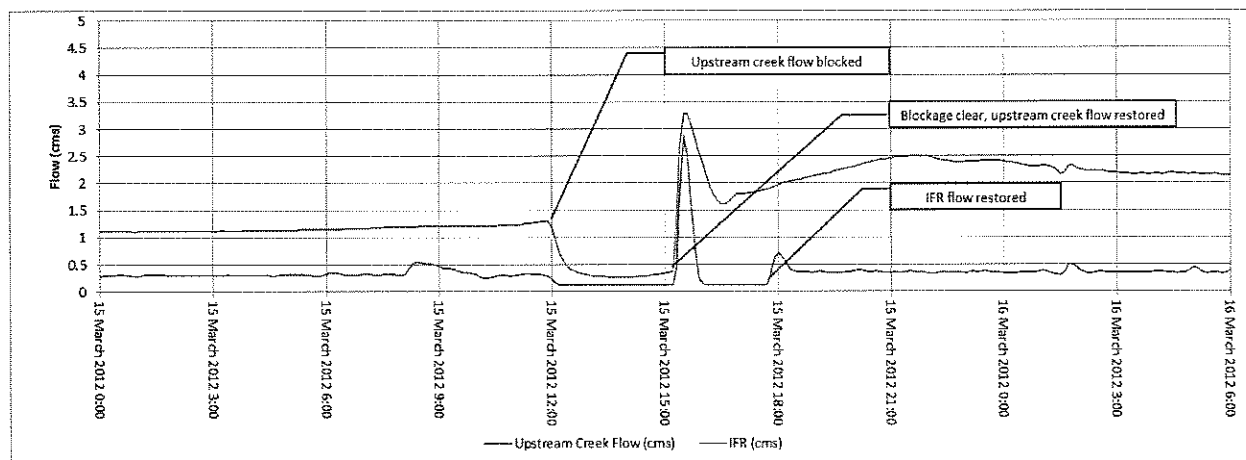
Figure 1: Upstream Creek and IFR Flow

- At approximately 12:00, the upstream Stokke Creek flow dropped suddenly and unexpectedly from 1.3 cms to 0.3 cms. Refer to Figure 1.
- The Harrison Lake area experienced heavy snowfall in the weeks prior to the event. A snow slide upstream of the intake is the most probable cause of the abrupt drop in creek flow.
- The blockage cleared itself and the upstream creek flow returned to pre-event levels at 15:00 (likely as the creek worked through the slide material).

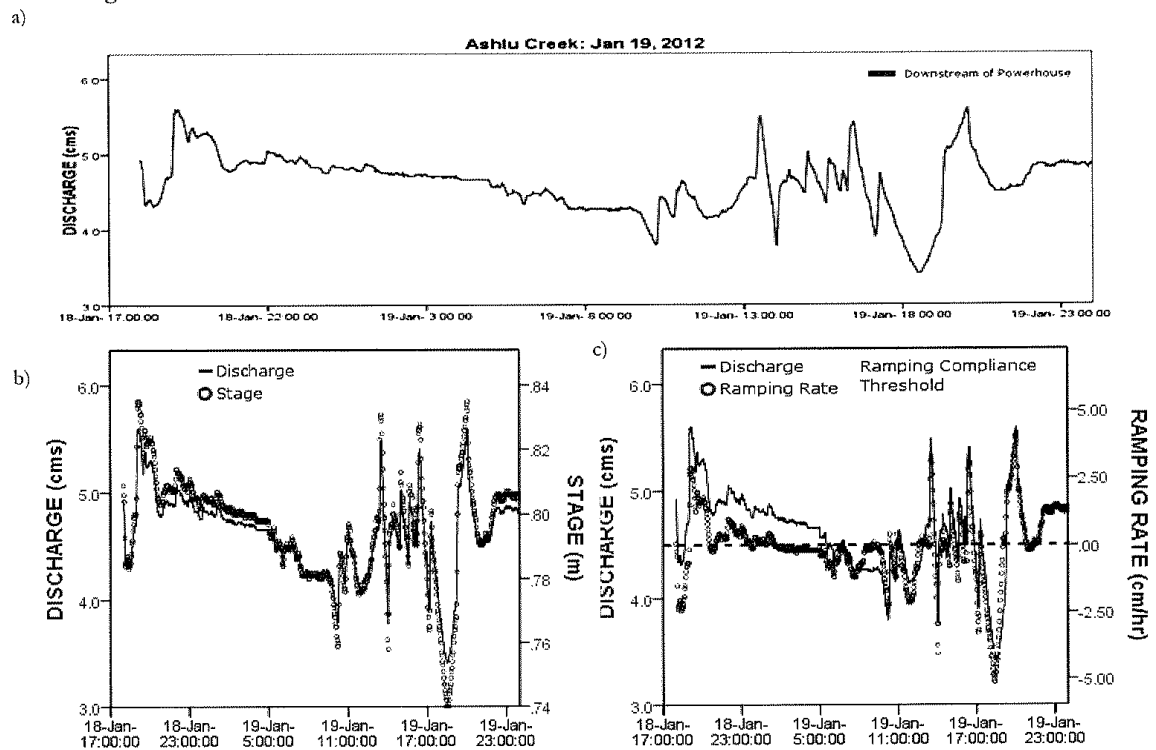
Figure 1. Discharges from January 18 to January 20, 2011; a) at the downstream permanent gauges over time, b) in relation to stage at the downstream permanent gauge (ASU-DSL01) on January 19, and c) in relation to ramping rates at downstream permanent gauge (ASU-DSL01) on January 19 – the ramping criteria of -4.0 cm/hr is shown by the yellow reference line. Discharge values are estimates based on the uncertain rating curve since the November 2010 landslide.

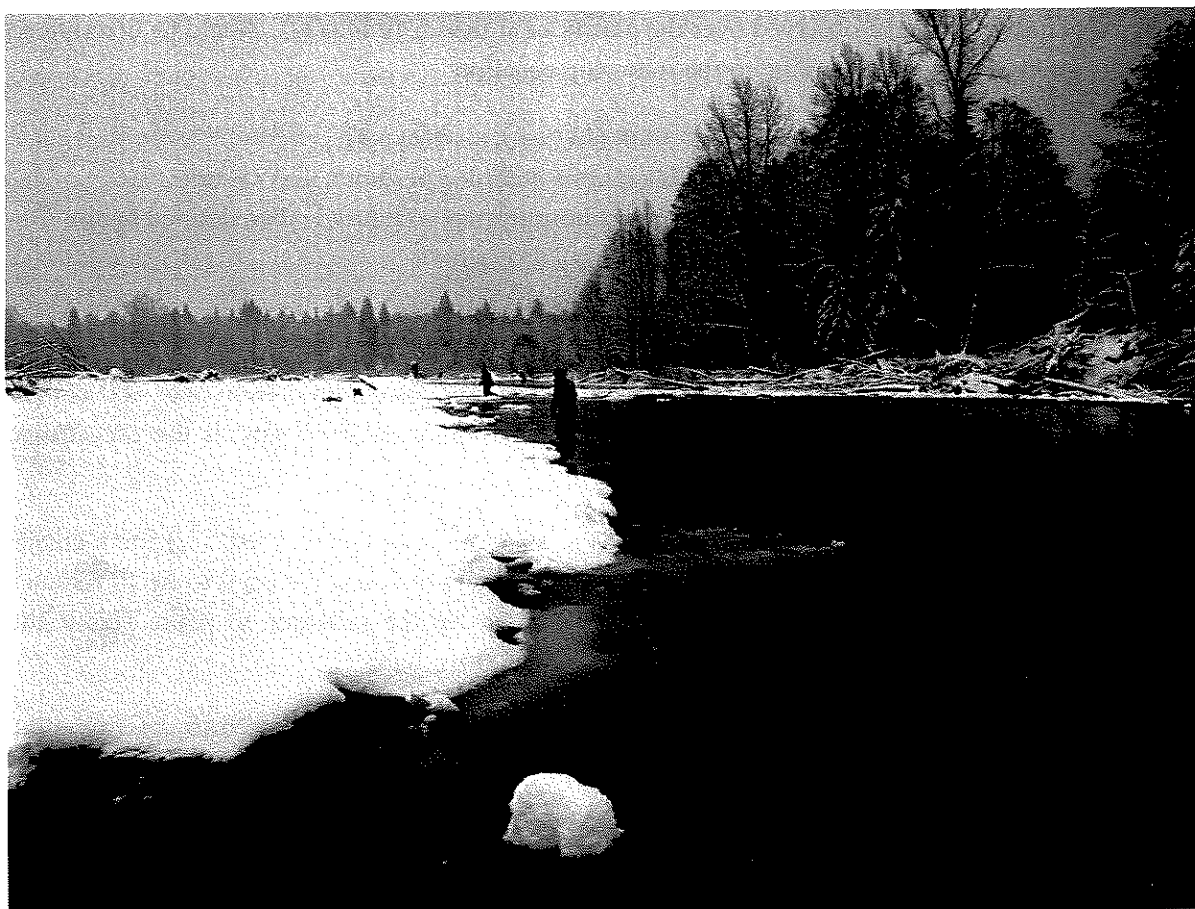
Figure 2. Potential stranding habitat at ASU-DSSD05 on January 20, 2012.

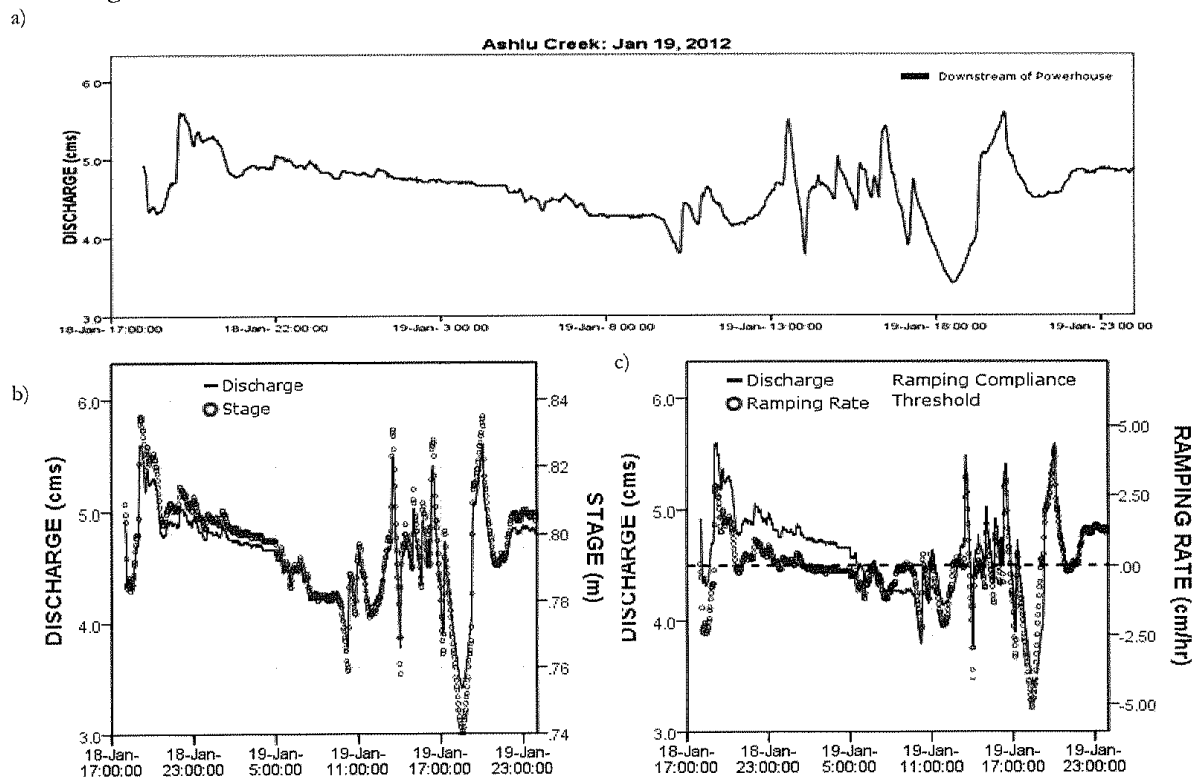
Figure 1. Discharges from January 18 to January 20, 2011; a) at the downstream permanent gauges over time, b) in relation to stage at the downstream permanent gauge (ASU-DSL01) on January 19, and c) in relation to ramping rates at downstream permanent gauge (ASU-DSL01) on January 19 – the ramping criteria of -4.0 cm/hr is shown by the yellow reference line. Discharge values are estimates based on the uncertain rating curve since the November 2010 landslide.

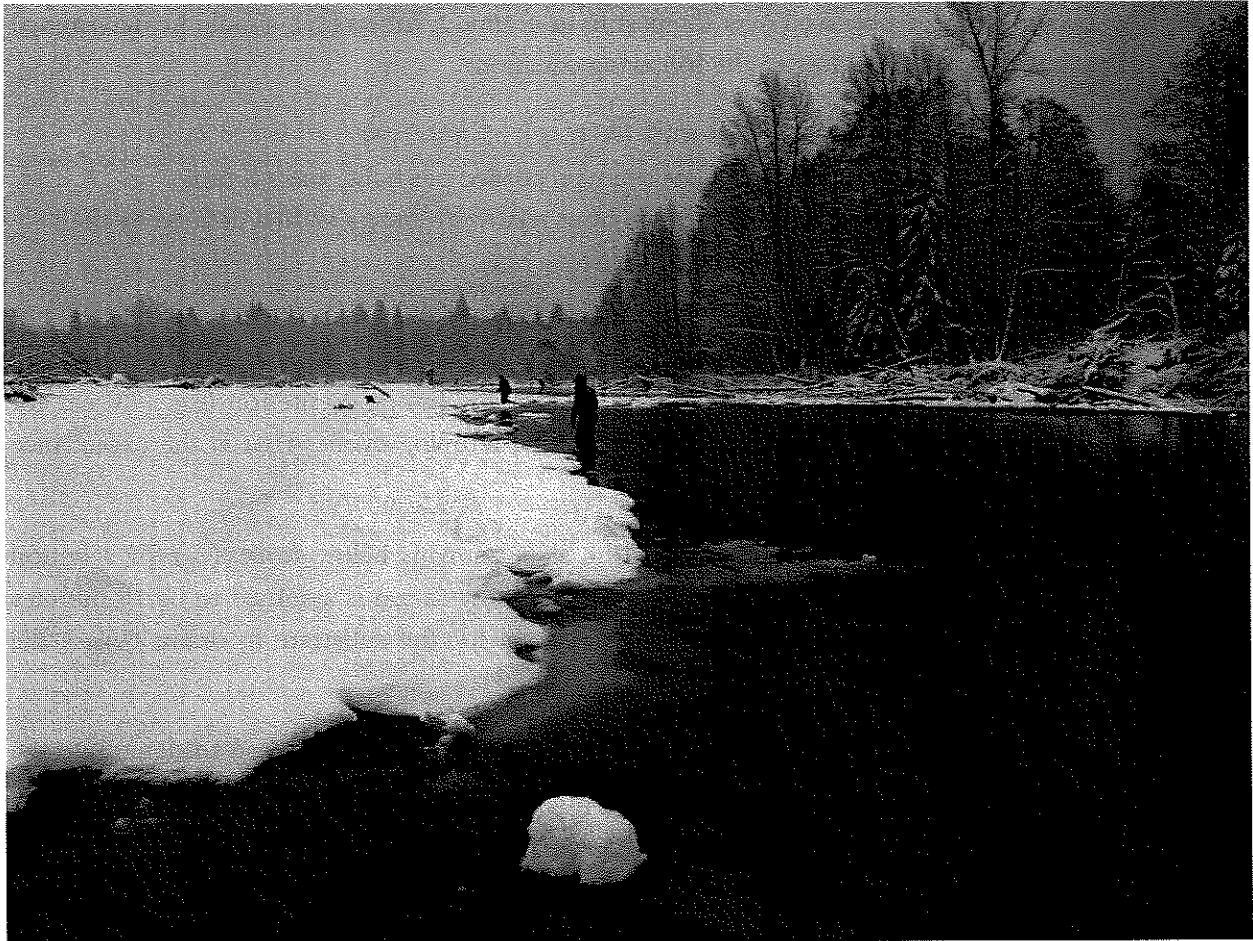
Figure 2. Potential stranding habitat at ASU-DSSD05 on January 20, 2012.

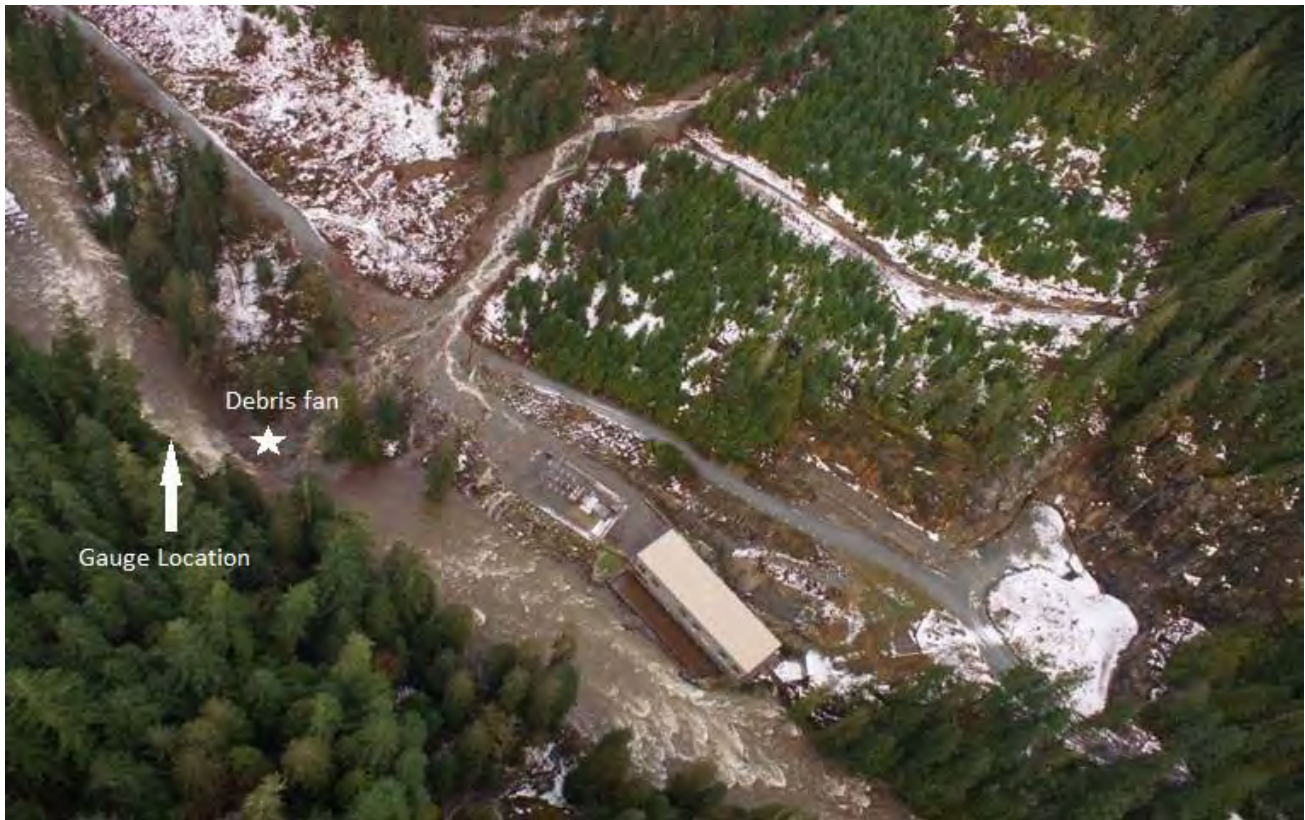
Photo 1: Debris flow just south (left) of the Ashlu River powerhouse at 2.7km. Photo taken November 28, 2011.

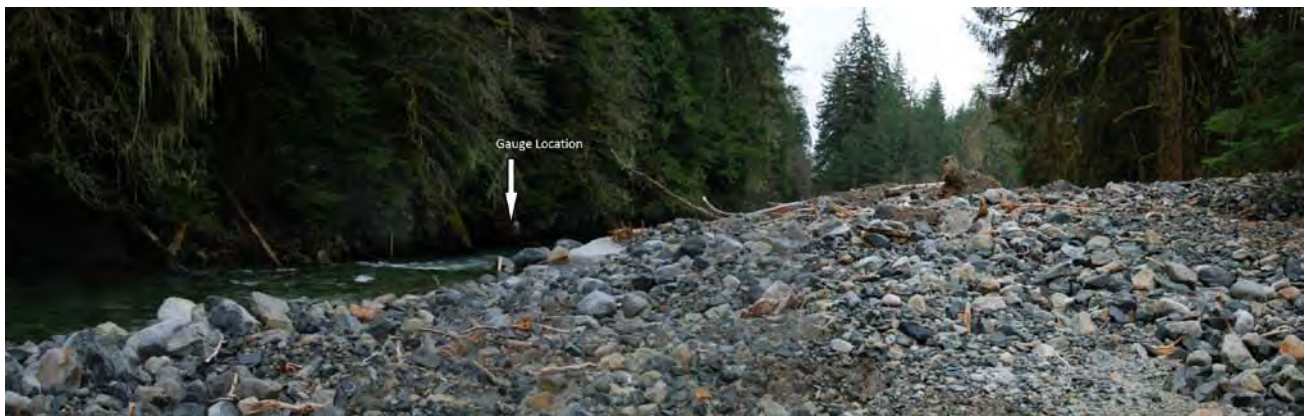
Photo 2: Looking downstream from above slide path. Location of hydrometric gauge is shown. Photo taken December 7, 2011.
