**Re: Burnaby Lake Coal Derailment Recovery Plan Review**

## MILE 122.7 DERAILMENT – COAL RECOVERY PLAN FOR SILVER CREEK, BURNABY LAKE AND BRUNETTE RIVER

# ENVIRONMENTAL MANAGEMENT PLAN – SILVER CREEK AND BURNABY LAKE COAL RECOVERY PROGRAM

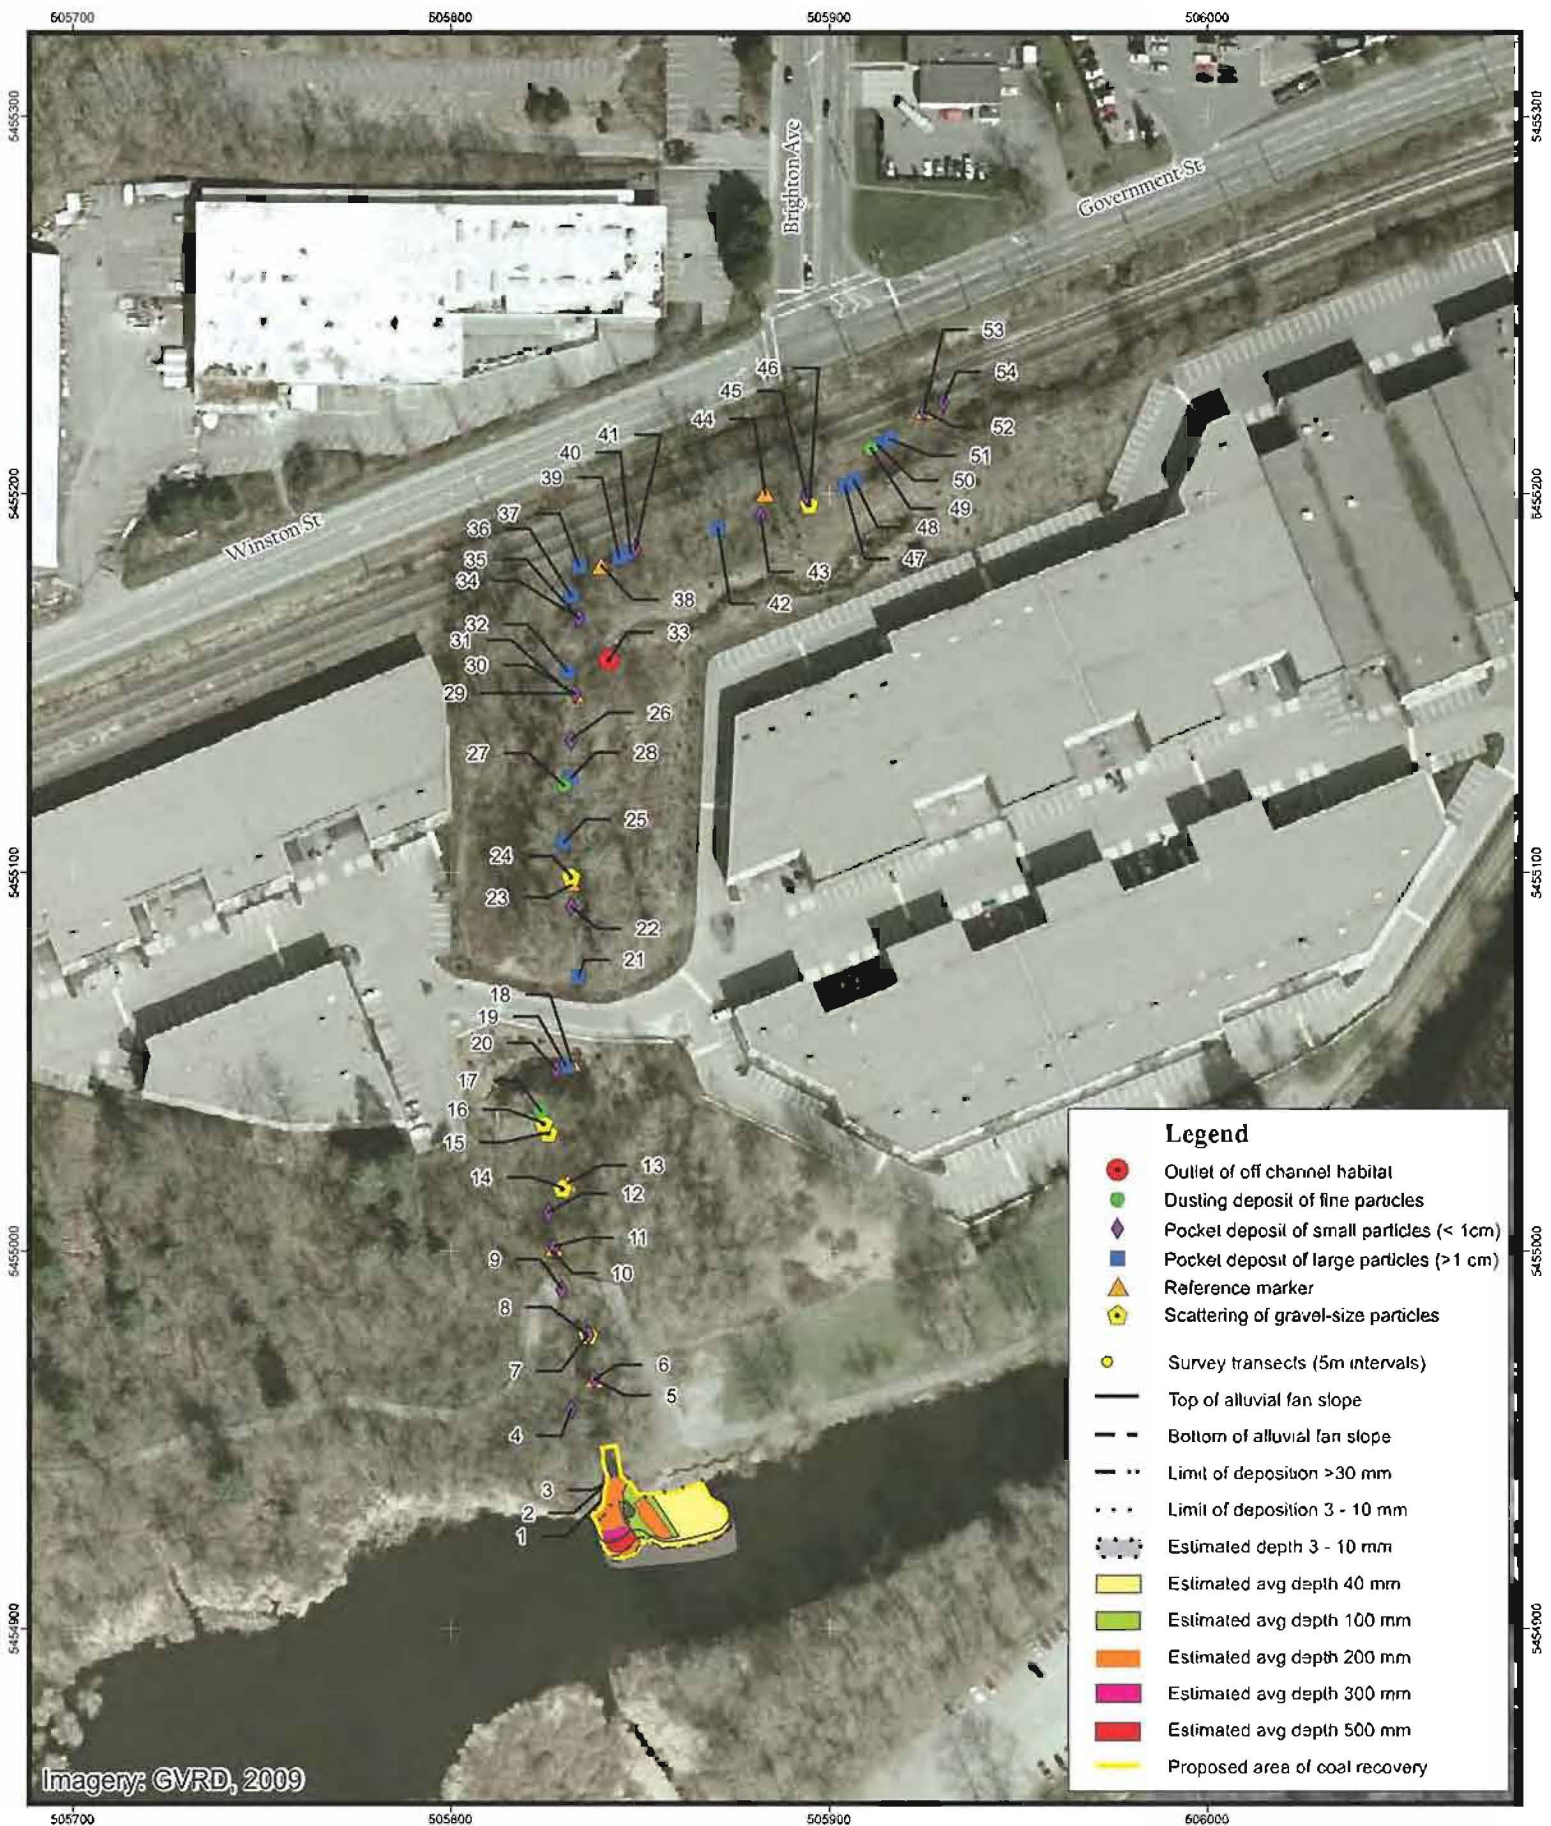
**Figure 1-2. Overview of Coal Deposition Areas in Silver Creek and Burnaby Lake**

The Burnaby Lake deposition assessment identified an estimated 76 m<sup>3</sup> of coal deposited on the alluvial fan of Silver Creek at the confluence with Burnaby Lake. The deposition was characterized by three (3) general categories;

Coarse gravel size particles were generally confined to the western (upstream) end of the fan where one channel of Silver Creek enters Burnaby Lake on the west side of a vegetated bar. Mixed fines and small gravel were generally confined to the secondary channel on the east side of the vegetated bar, as well as within Silver Creek just upstream of the alluvial fan. The depth of coal deposition varied across the alluvial fan, with the thickest deposits observed at the outer edge of the fan along the flow path of main channel around the vegetated bar. In addition a thin layer of fine deposition (3 – 10 mm deep) was observed off shore from the alluvial fan. A dusting of deposition also extended downstream of the alluvial on the north side Burnaby Lake outlet channel towards Cariboo Dam but was only 1 mm deep (Triton, 2014b; Figure 1-3).

Recommendations for these deposition areas include leaving the material in place (e.g., for thin off shore layers of deposition), removal by hand near sensitive habitats (e.g., turtle basking platforms) and removal with equipment (e.g., vac truck).

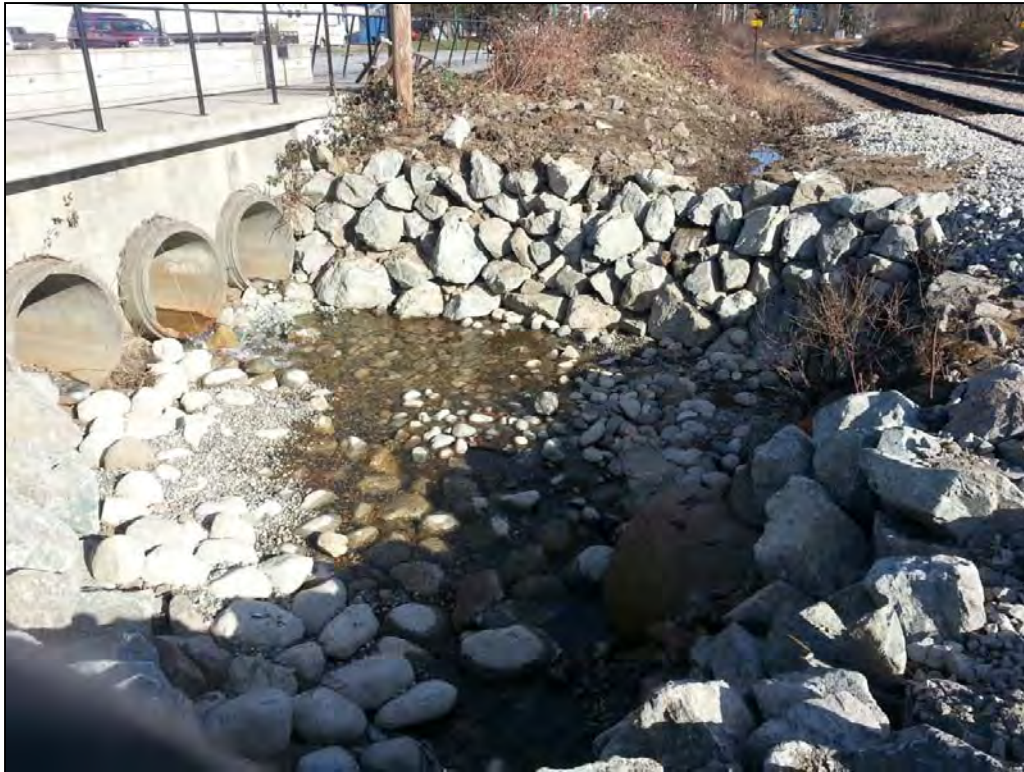
Silver Creek is a non-gazetted stream entering the railway ROW via three (3) municipal storm water pipes (Photo 1). Field surveys conducted in January 2014 indicated an average channel width of 4.06 m and an average wetted width of 3.22 m. Mean water depth at the time of survey ranged from 0.05 m to 0.26 m. Riffle and glide habitat units were common and the survey crew noted few pools with residual depths >0.3 m. The substrate was dominated by small cobble (SC) and large gravel (LG), with areas of extensive sand deposition along with exposed clay seams. Available cover was categorized as low (L) to moderate (M), and was provided mainly by undercut bank (U) and accumulations of large and small woody debris (LWD and SWD), with some overstream vegetation (OV) (Photo 2).

**Photo 1. City of Burnaby storm sewer outfall upstream of the railway ROW**

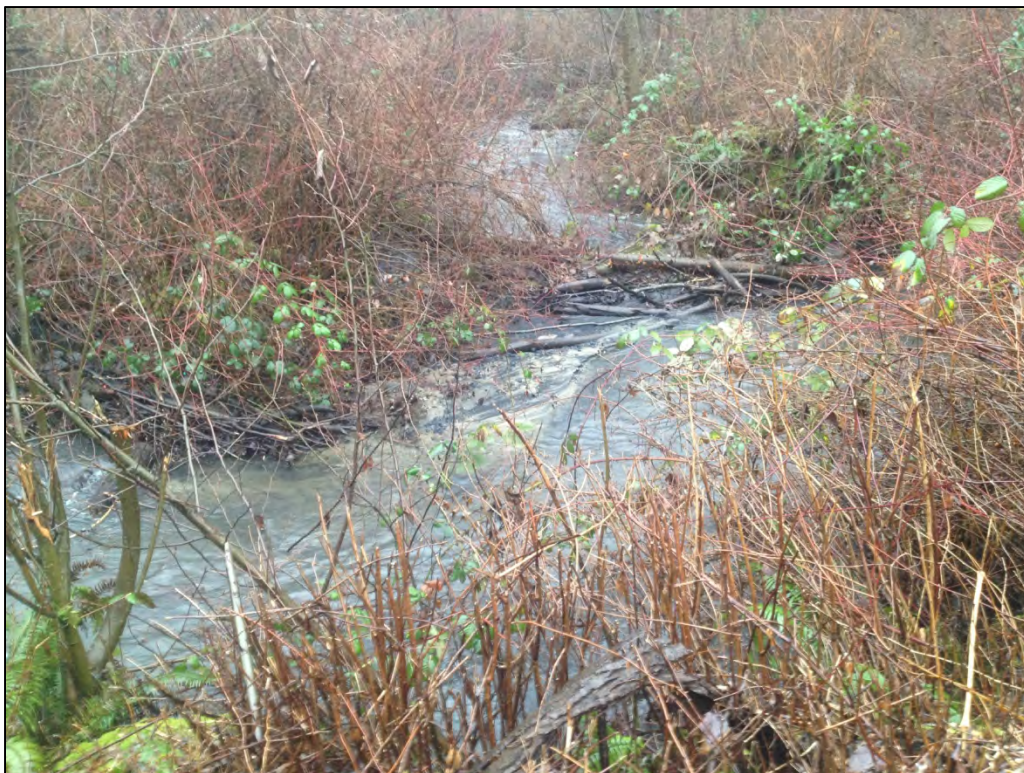
**Photo 2. Silver Creek downstream view**

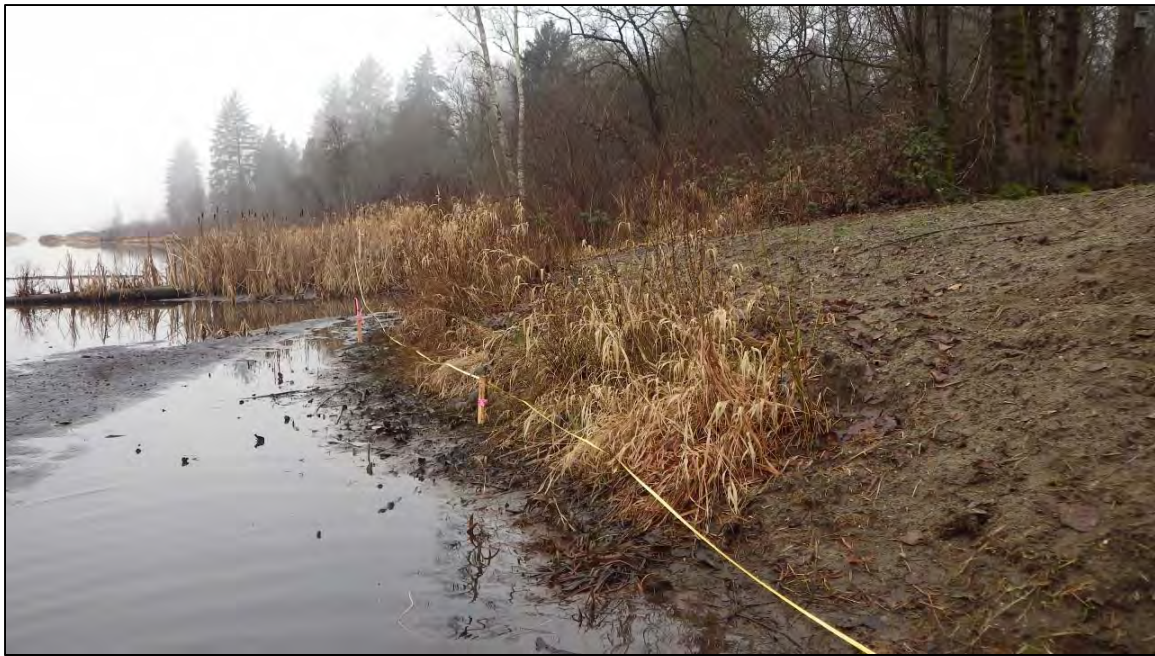
Photo 3: Turtle nesting beach and immediately adjacent offshore habitat

- If the nesting substrate is deemed to be unsuitable for turtles (e.g., due to inadvertent mixing of organic material from coal recovery operations or raking), the substrate will be replaced with a suitable mixture of sand and other material as specified by MFLNRO

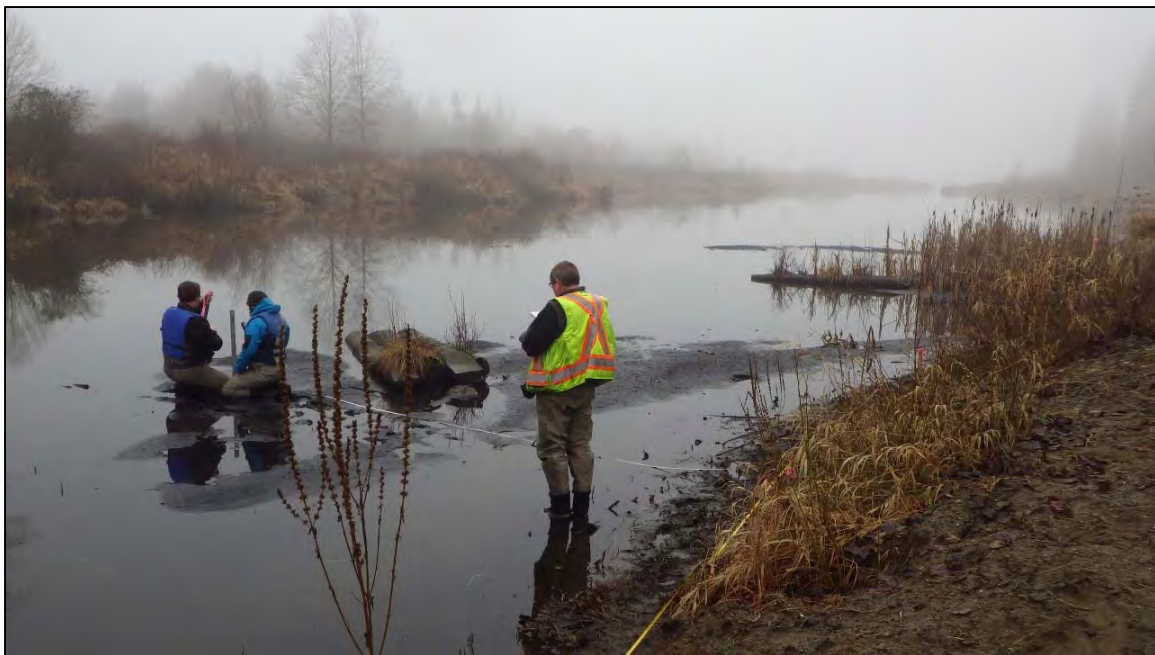
Photo 4: Turtle nesting beach and immediately adjacent offshore habitat
