A	<p>Licensee/ Tenure Holder: THOMPSON CREEK MINING LTD.</p> <p>BAG 4001 FRASER LAKE BC V0J3A0</p> <p>Operator/Contractor: THOMPSON CREEK MINING/ SCOTT M In Attendance: James Smith/ Tony Carrol/ Chris Parks/ Clayton Gross/ Julie Orban/ Scott Morrison/ Andrew Chewter</p> <p>Compliance Summary Comments: Inspection of the Thompson Creek/ Mt Milligan Project was conducted by the EAO staff as well as FLNRO C&E staff to inspect for compliance with Mt Milligan, EA certificate and EMP's and CEMP's. Plans used to assist in the inspection criteria were the Table of Commitments, the EMP, and the CEMP as well as spill and prevention and contingency plan, sediment and erosion control plans.</p> <p>6.34 Archaeological and cultural heritage resource management plan main objectives are identify, record and assess any of these features with-in or adjacent to the project. There was no other features found on location other than the pre-identified j-3/GgRs-5 which had low impact and required no mitigation. The proponent has done a Archaeological Impact Assessment pre construction 2007 and has managed this requirement.</p> <p>6.3.3 Air Quality Management Plan has been developed to protect and manage a

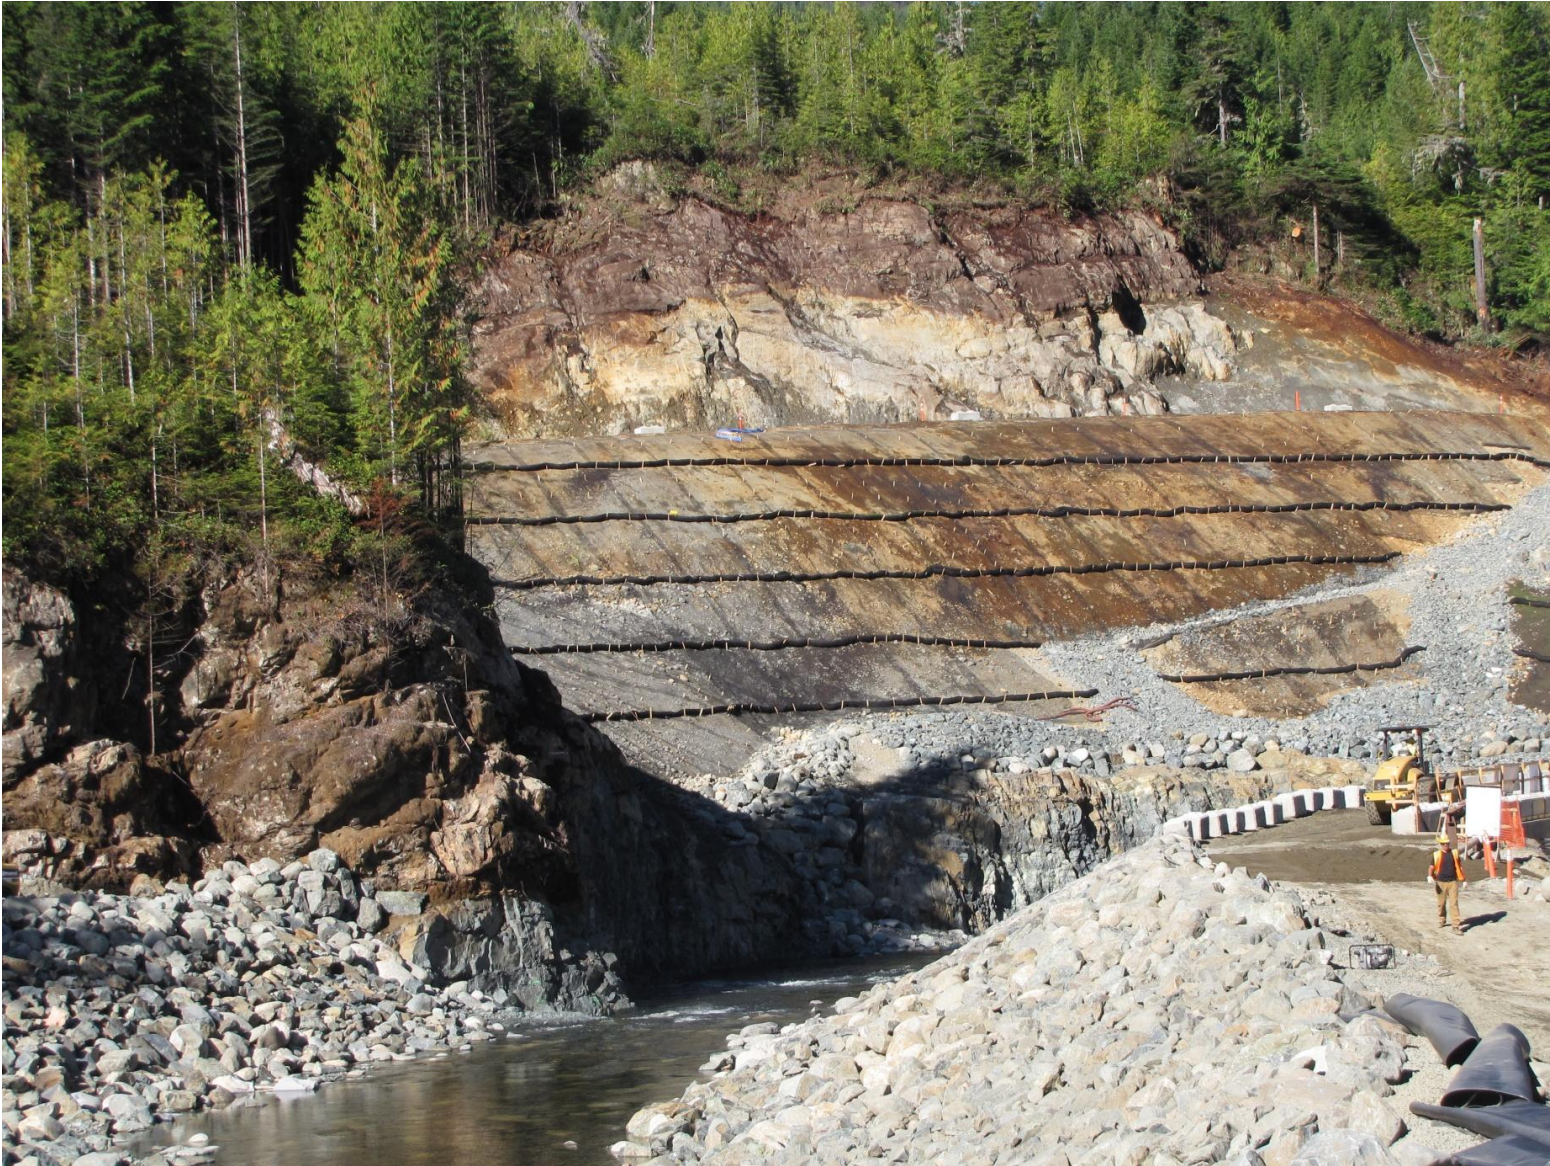
Photo 1 - Exposed soil above temporary diversion channel

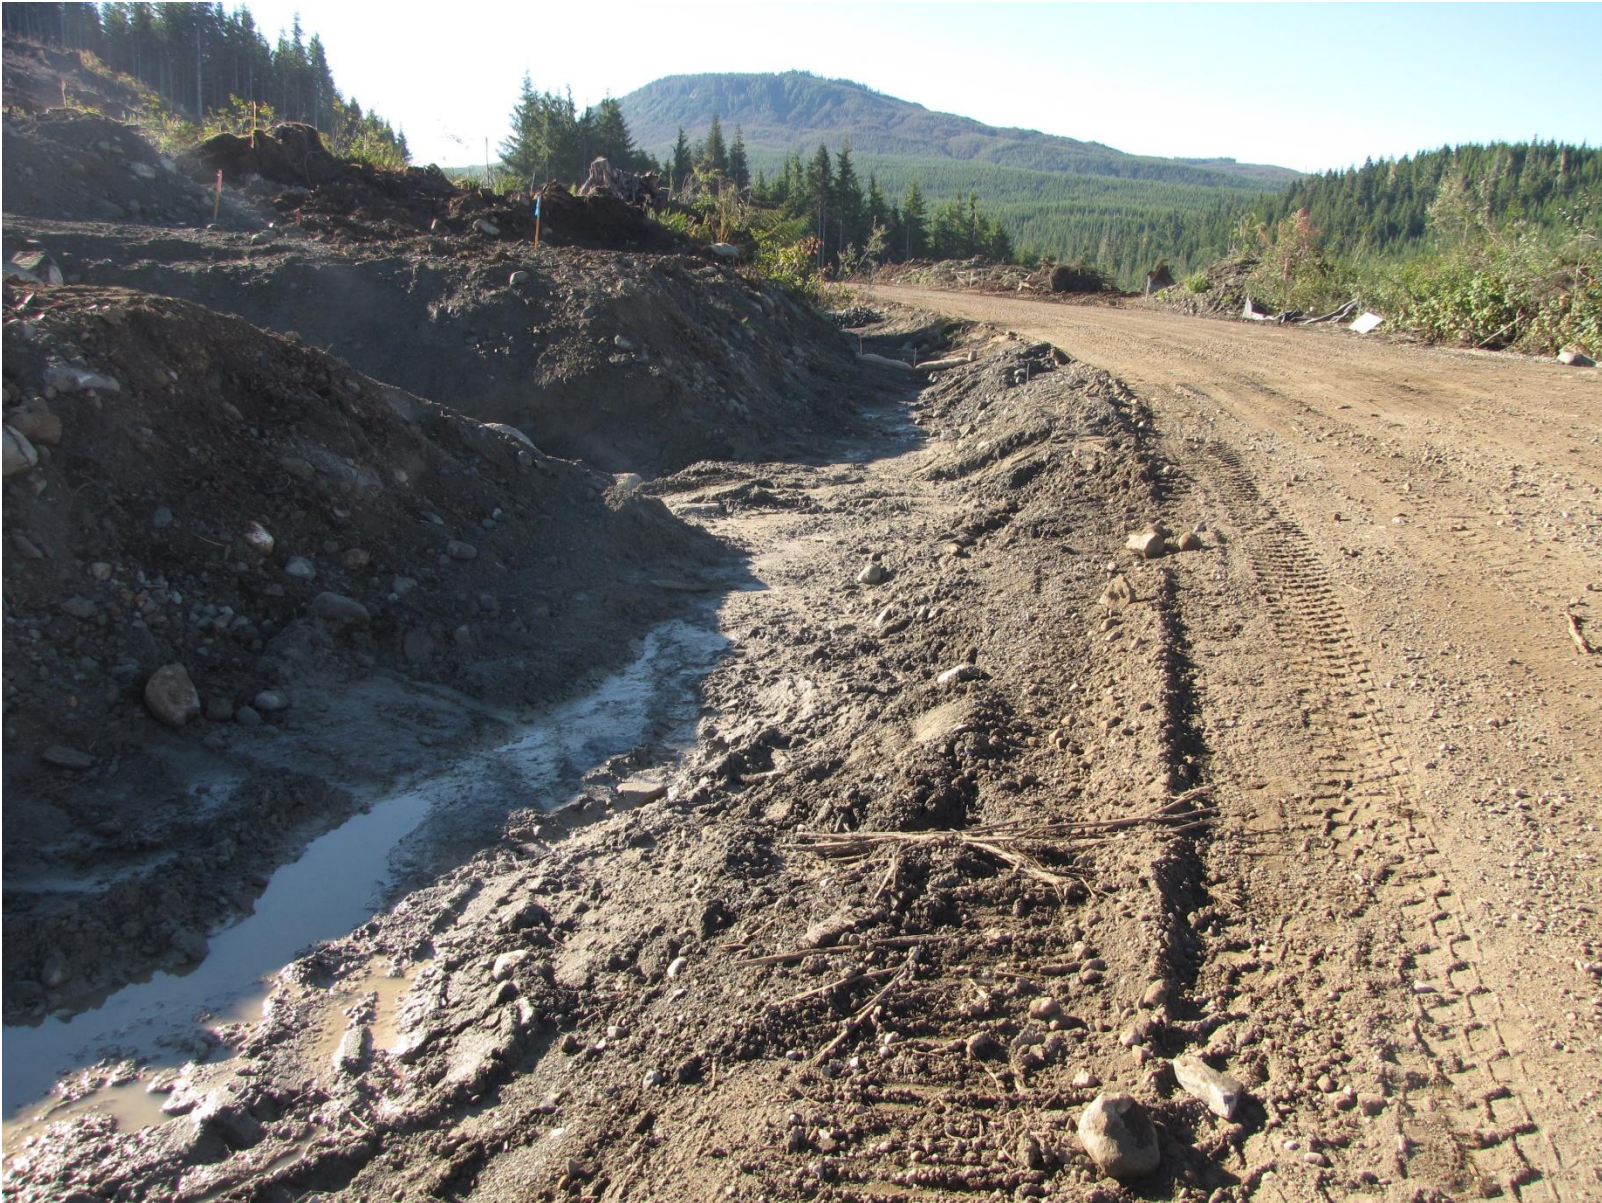
Photo 2 - exposed soil along Kokish Main road

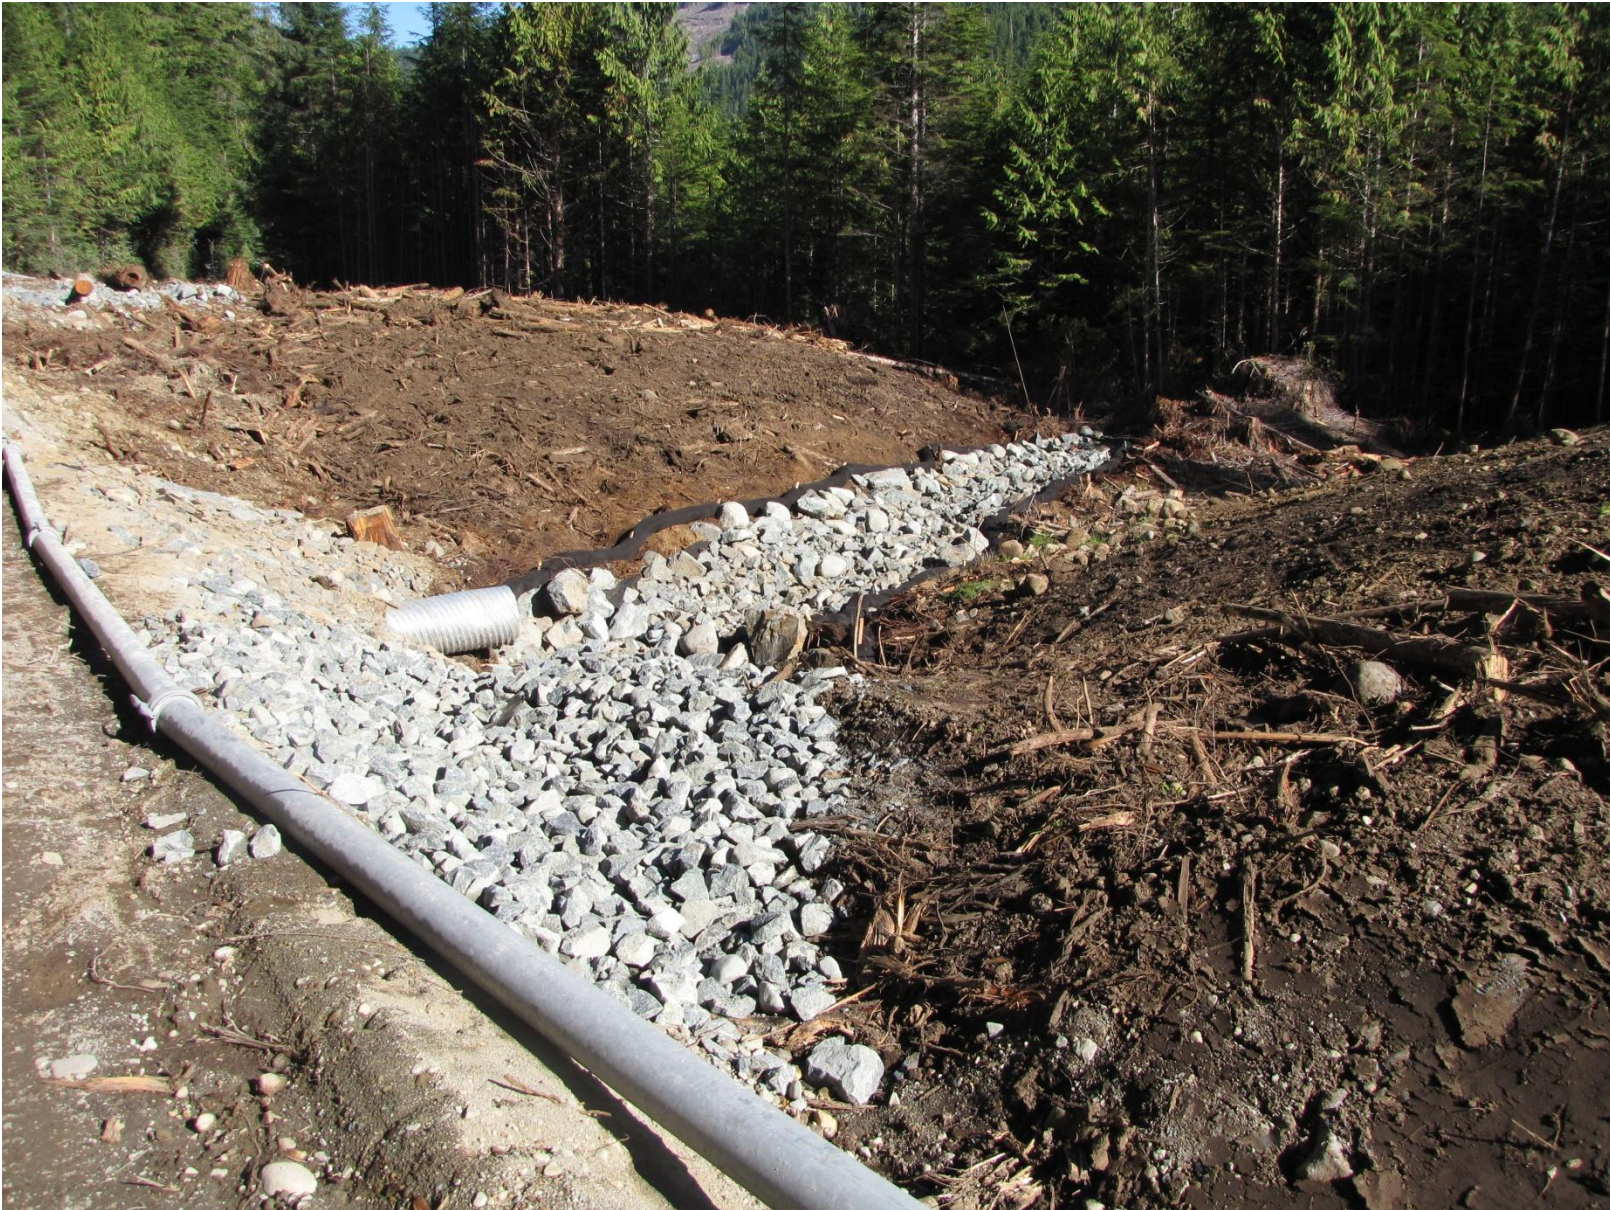
Photo 3 - Rock armouring in stream channel

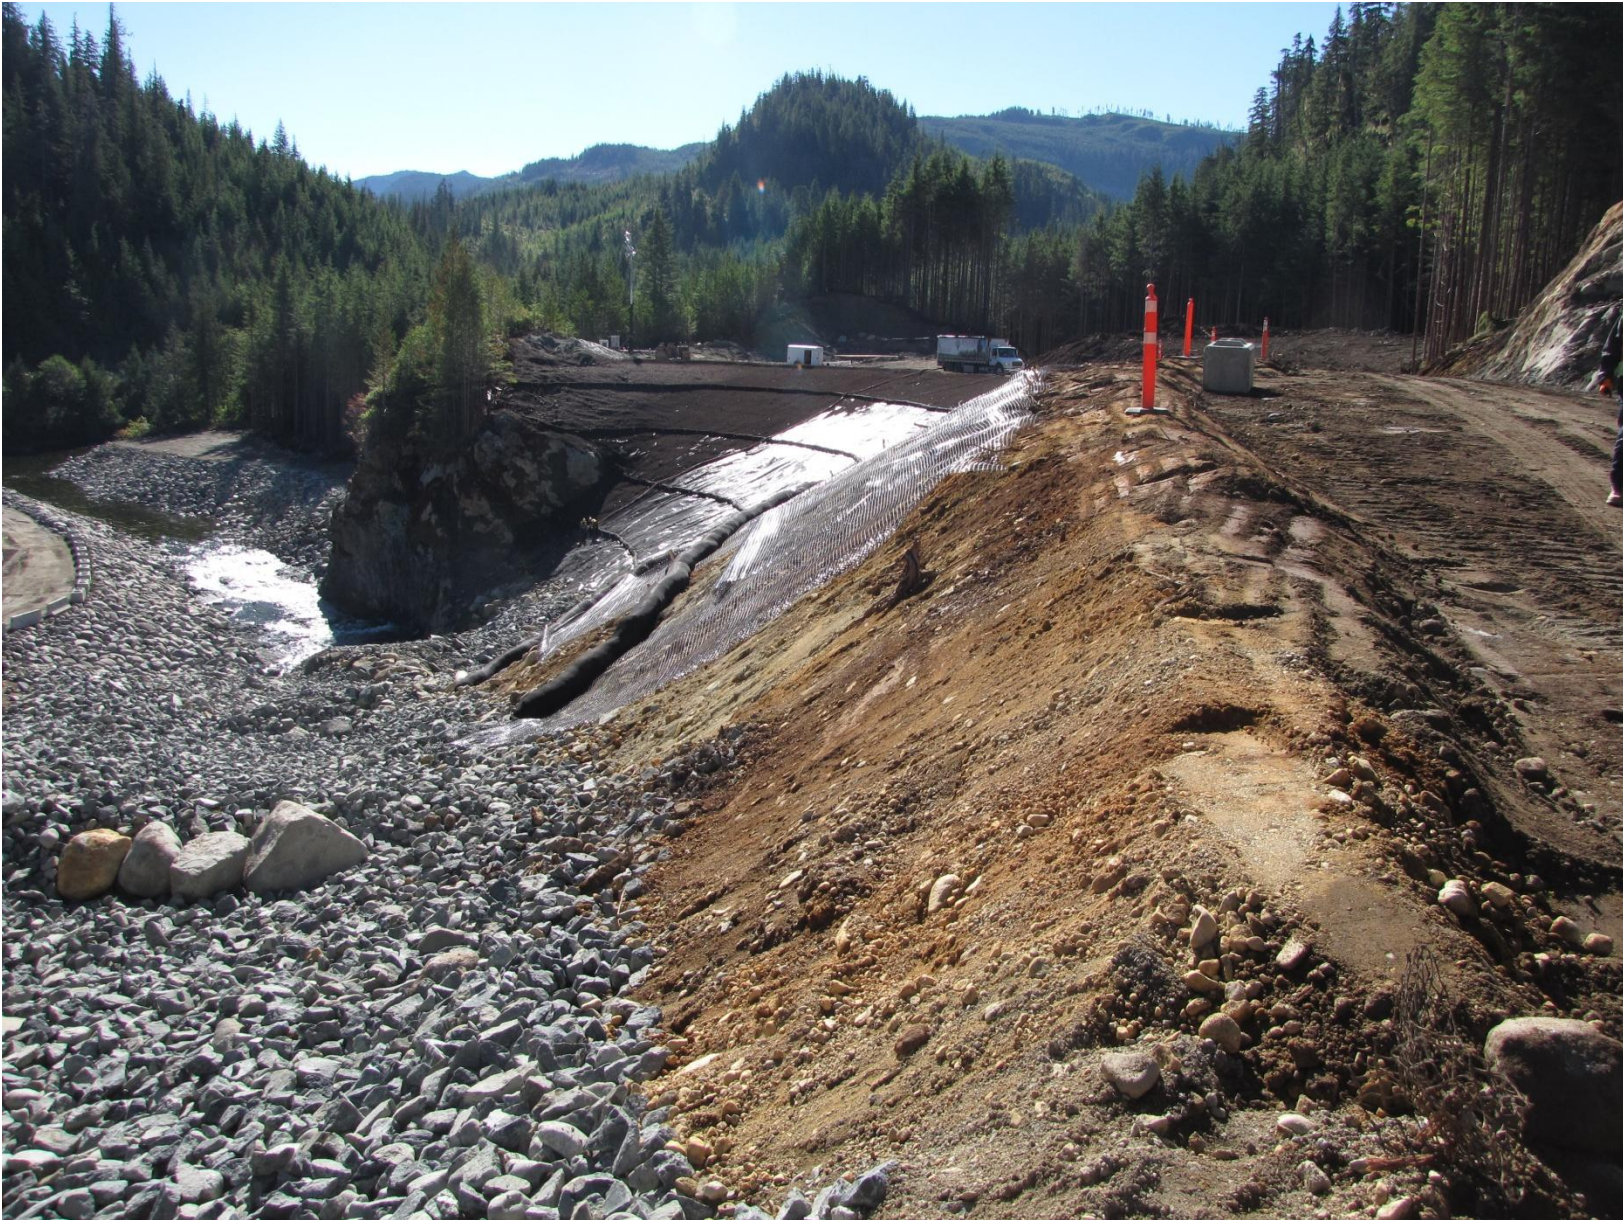
Photo 4 - Hydroseeding over geotextile mesh with compost mixture for slope stability and erosion control

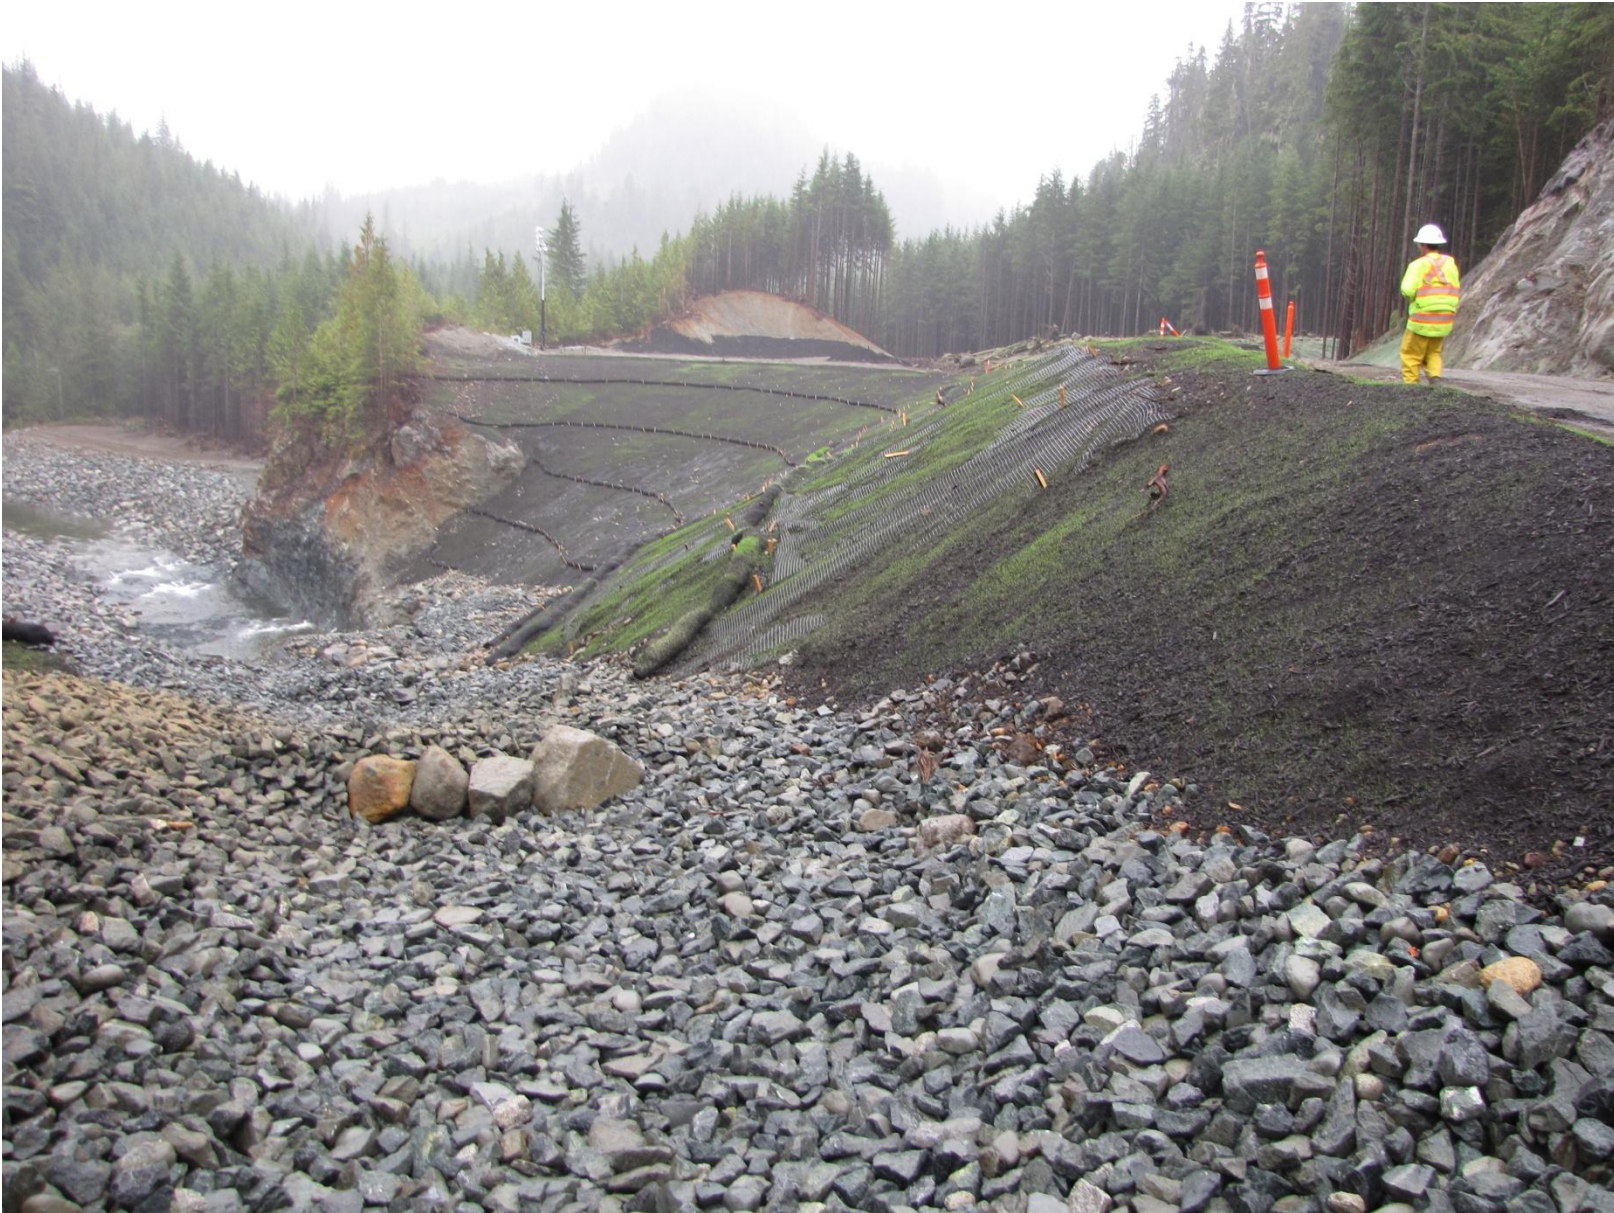
Photo 5 - slope above temporary diversion channel September 28. Hydroseeding germination

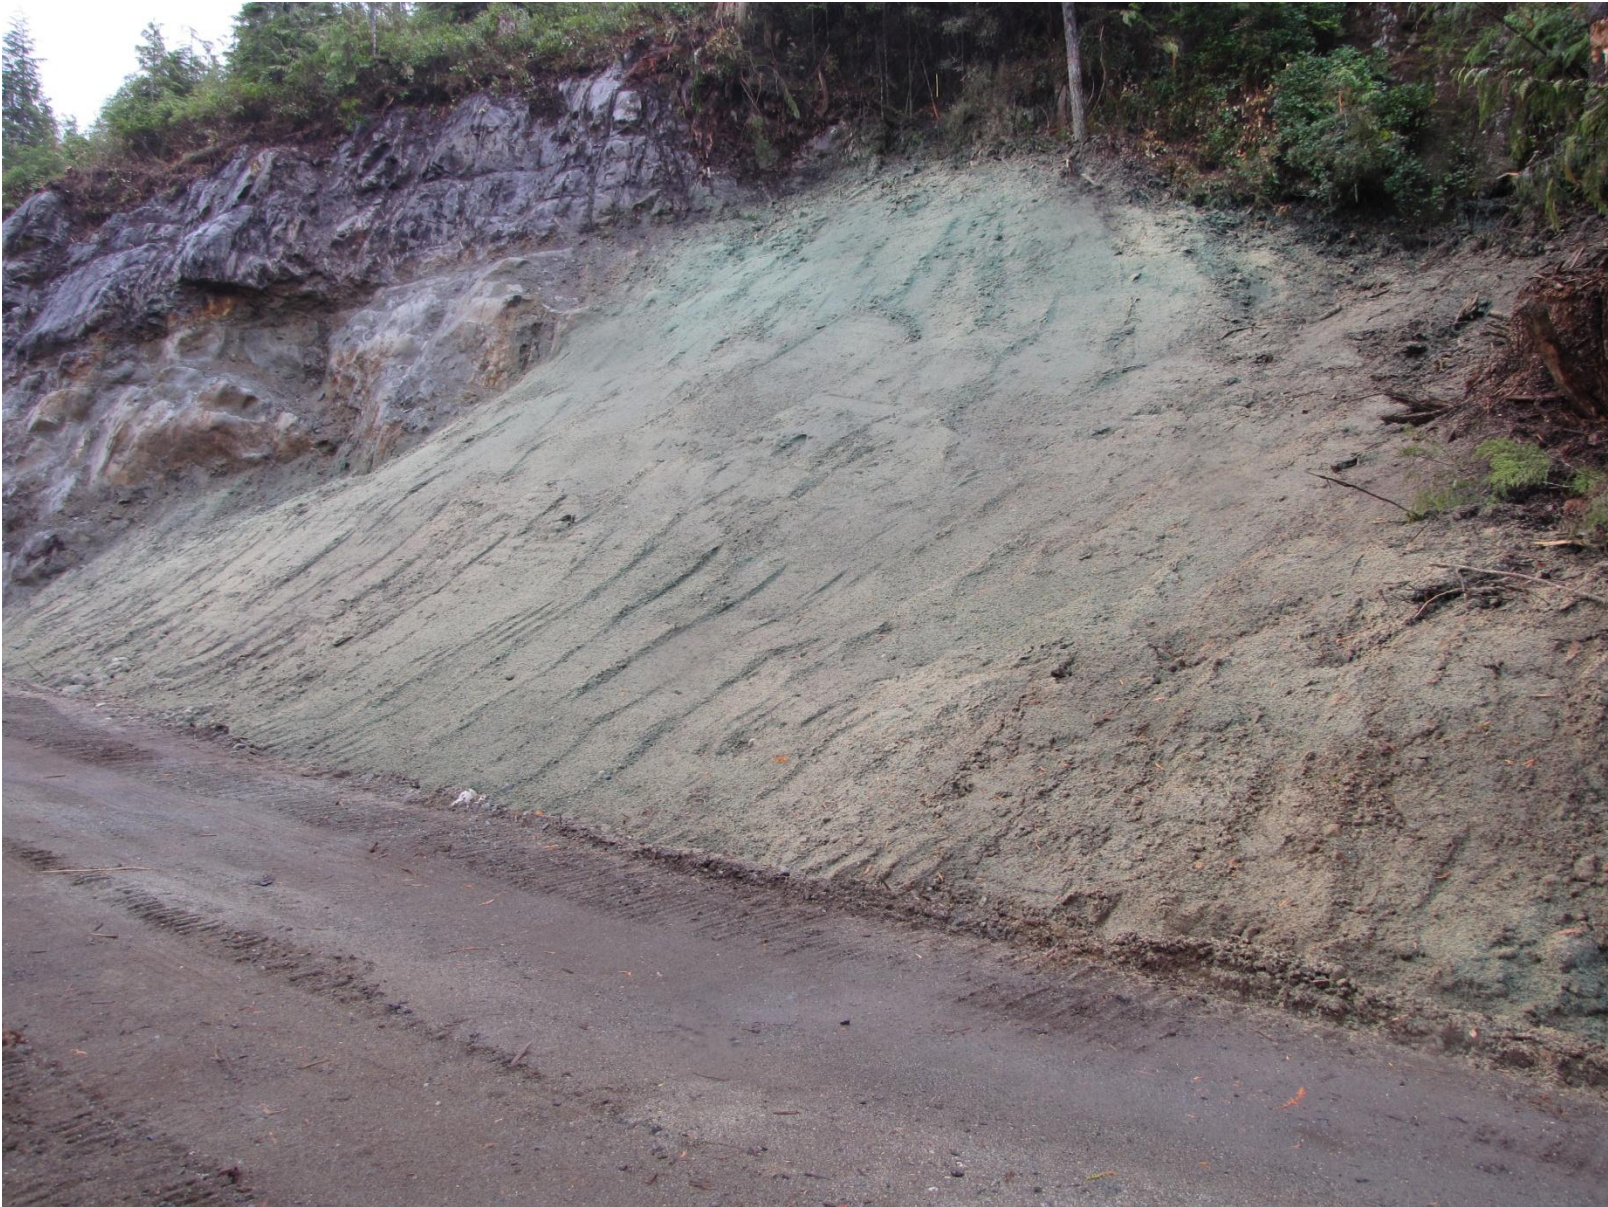
Photo 6 - Hydroseeding along Kokish Main road

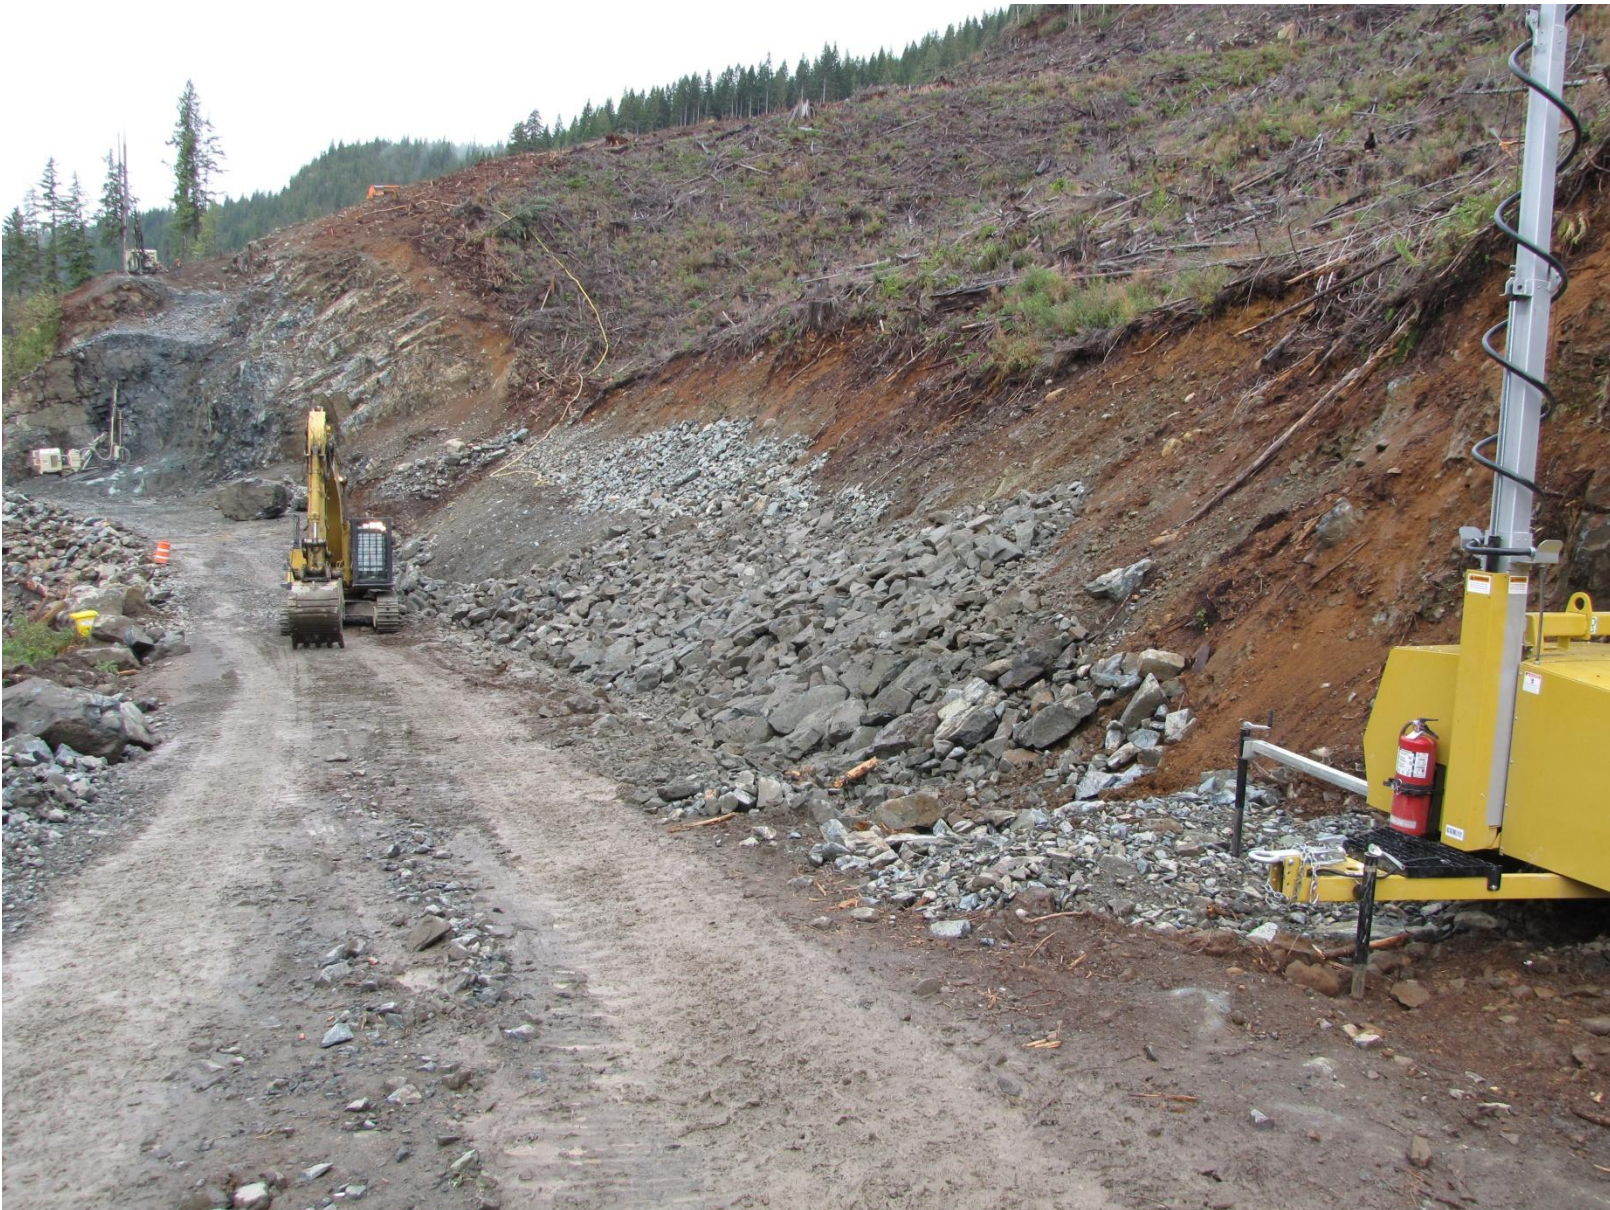
Photo 7 - Rock armouring of ditchline to minimize sedimentation

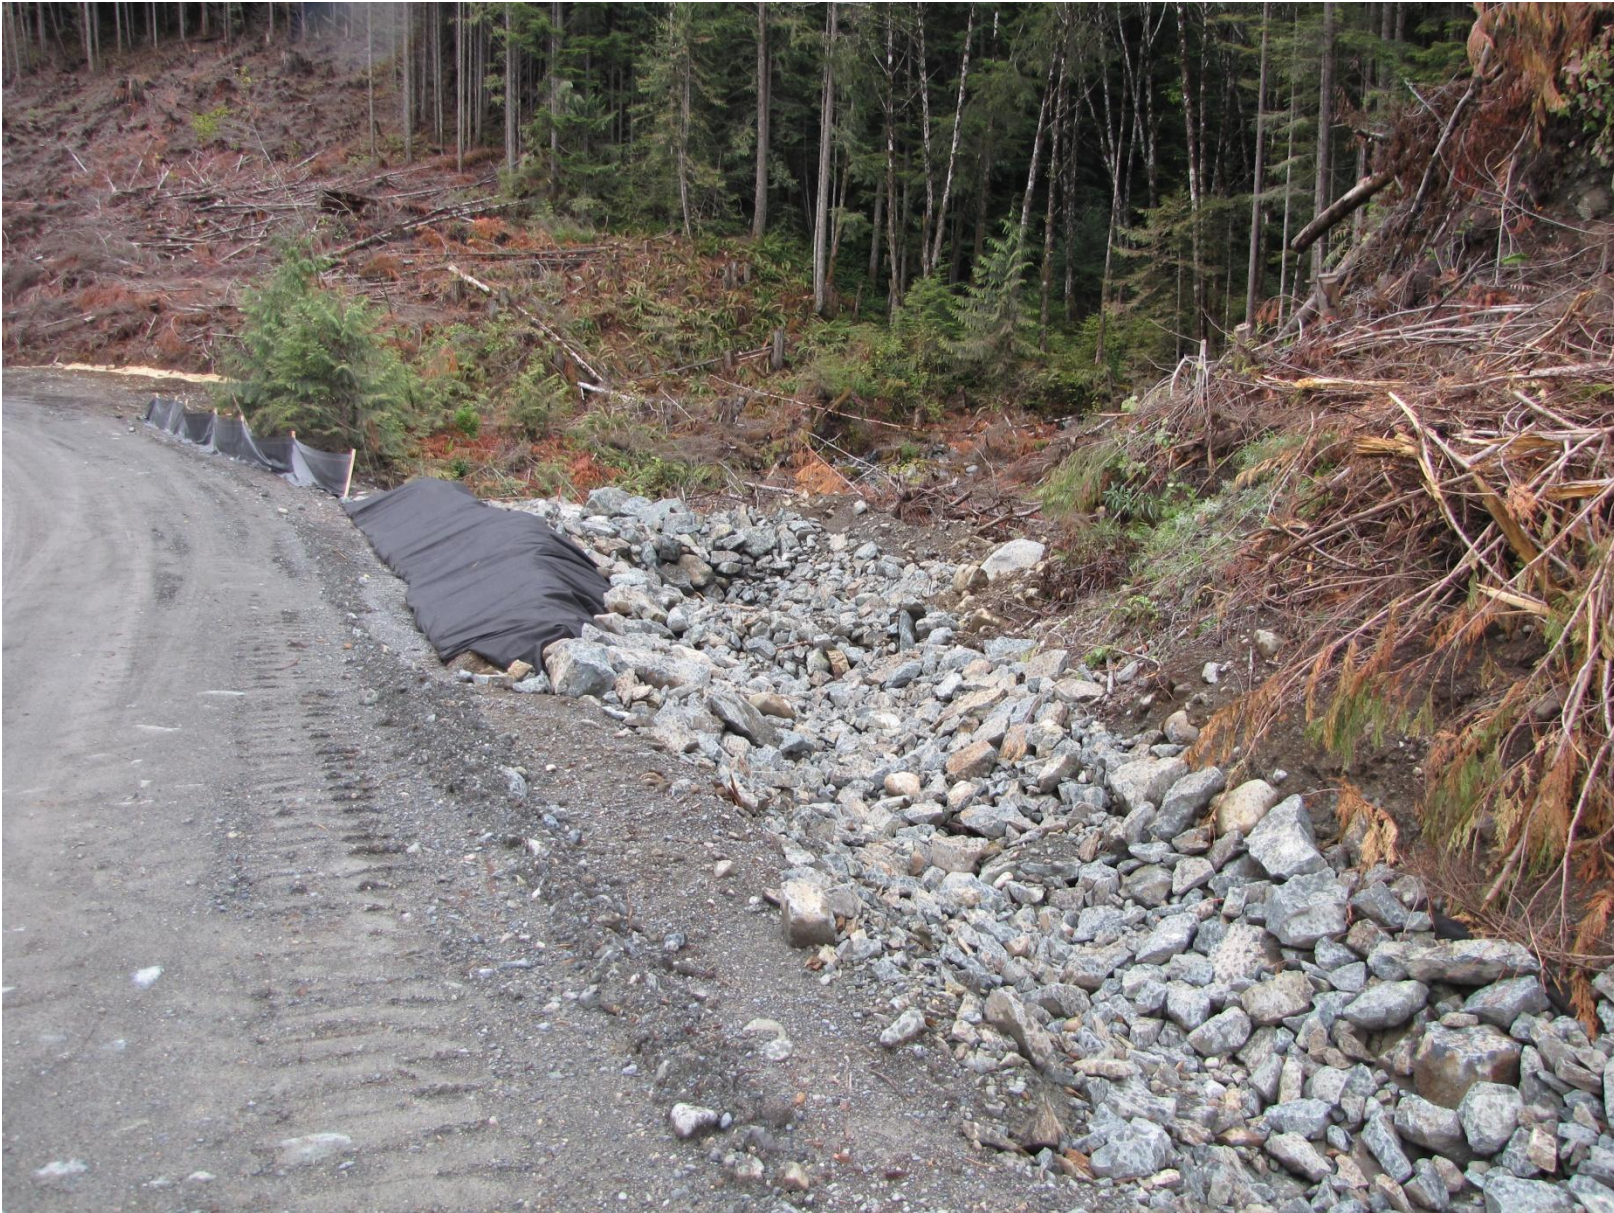
Photo 8 - October 17, ditchline armouring and sump for sediment settling prior to crossing road and flowing into Kokish River.

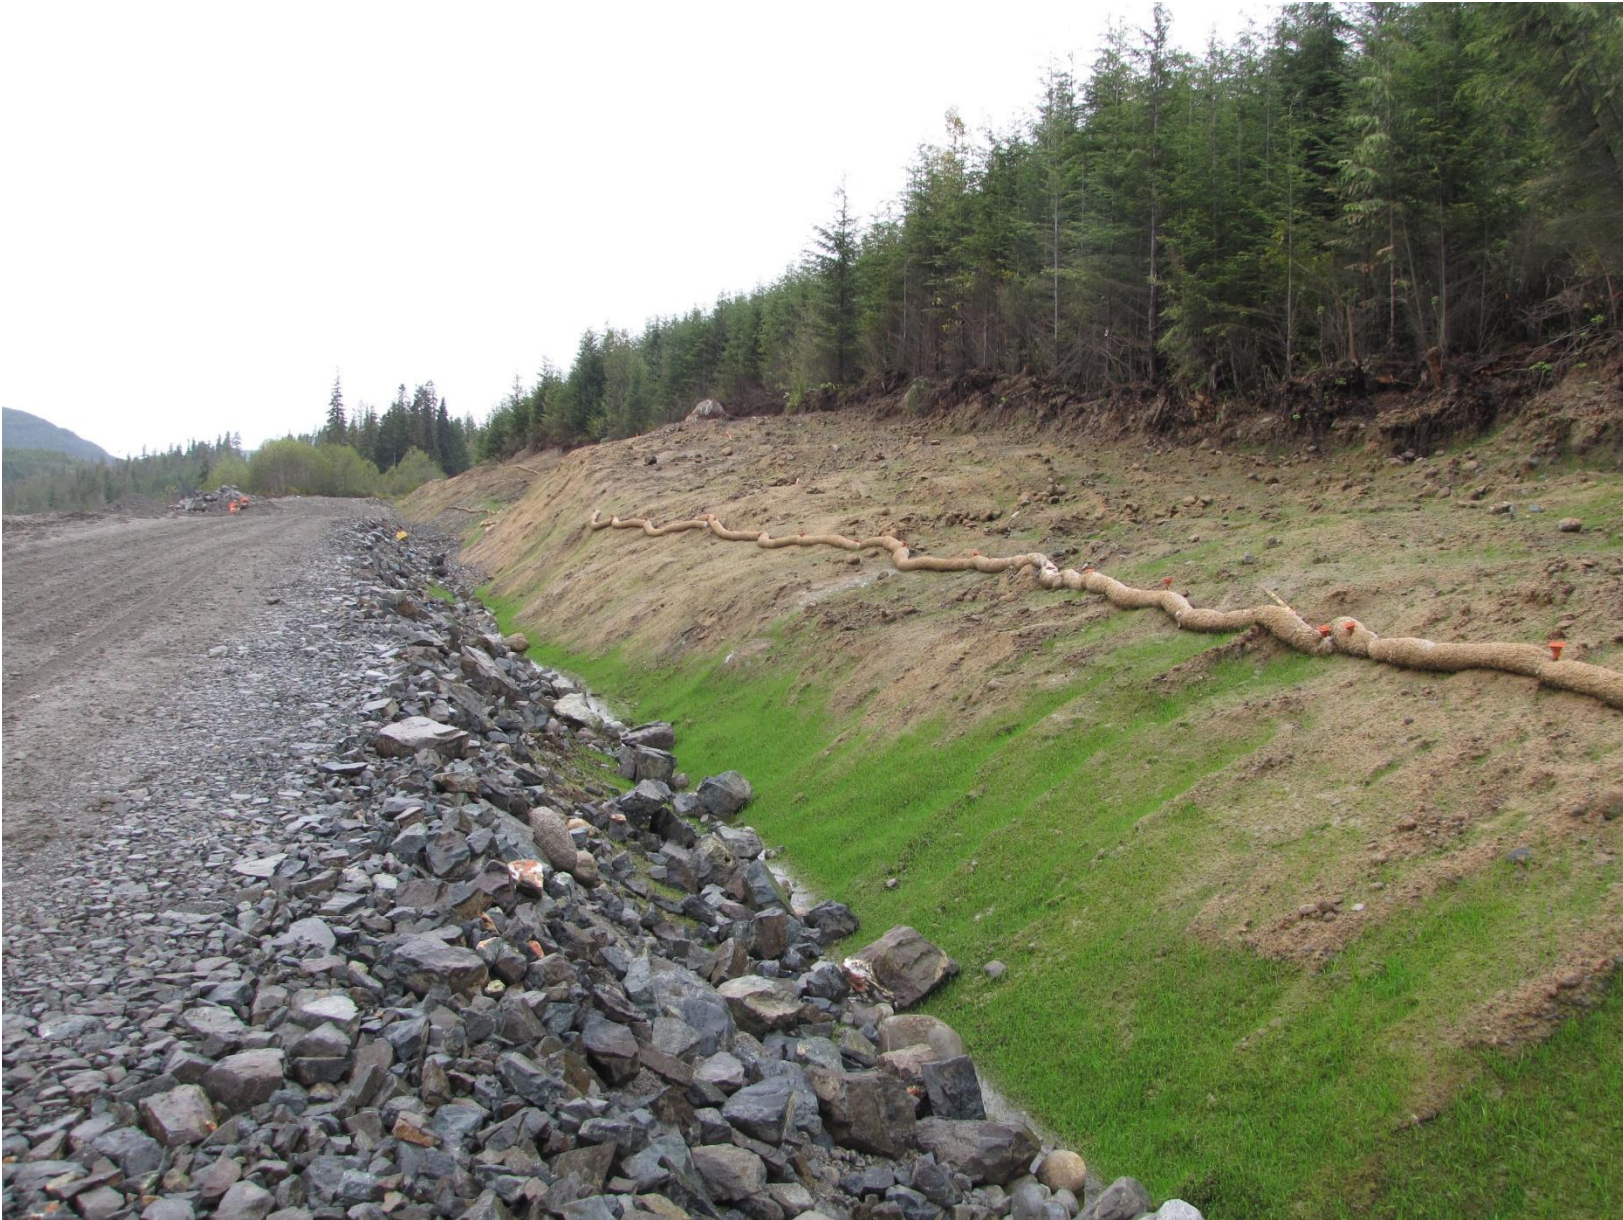
Photo 9 - hydroseeding of exposed slope and rock armouring of ditchline

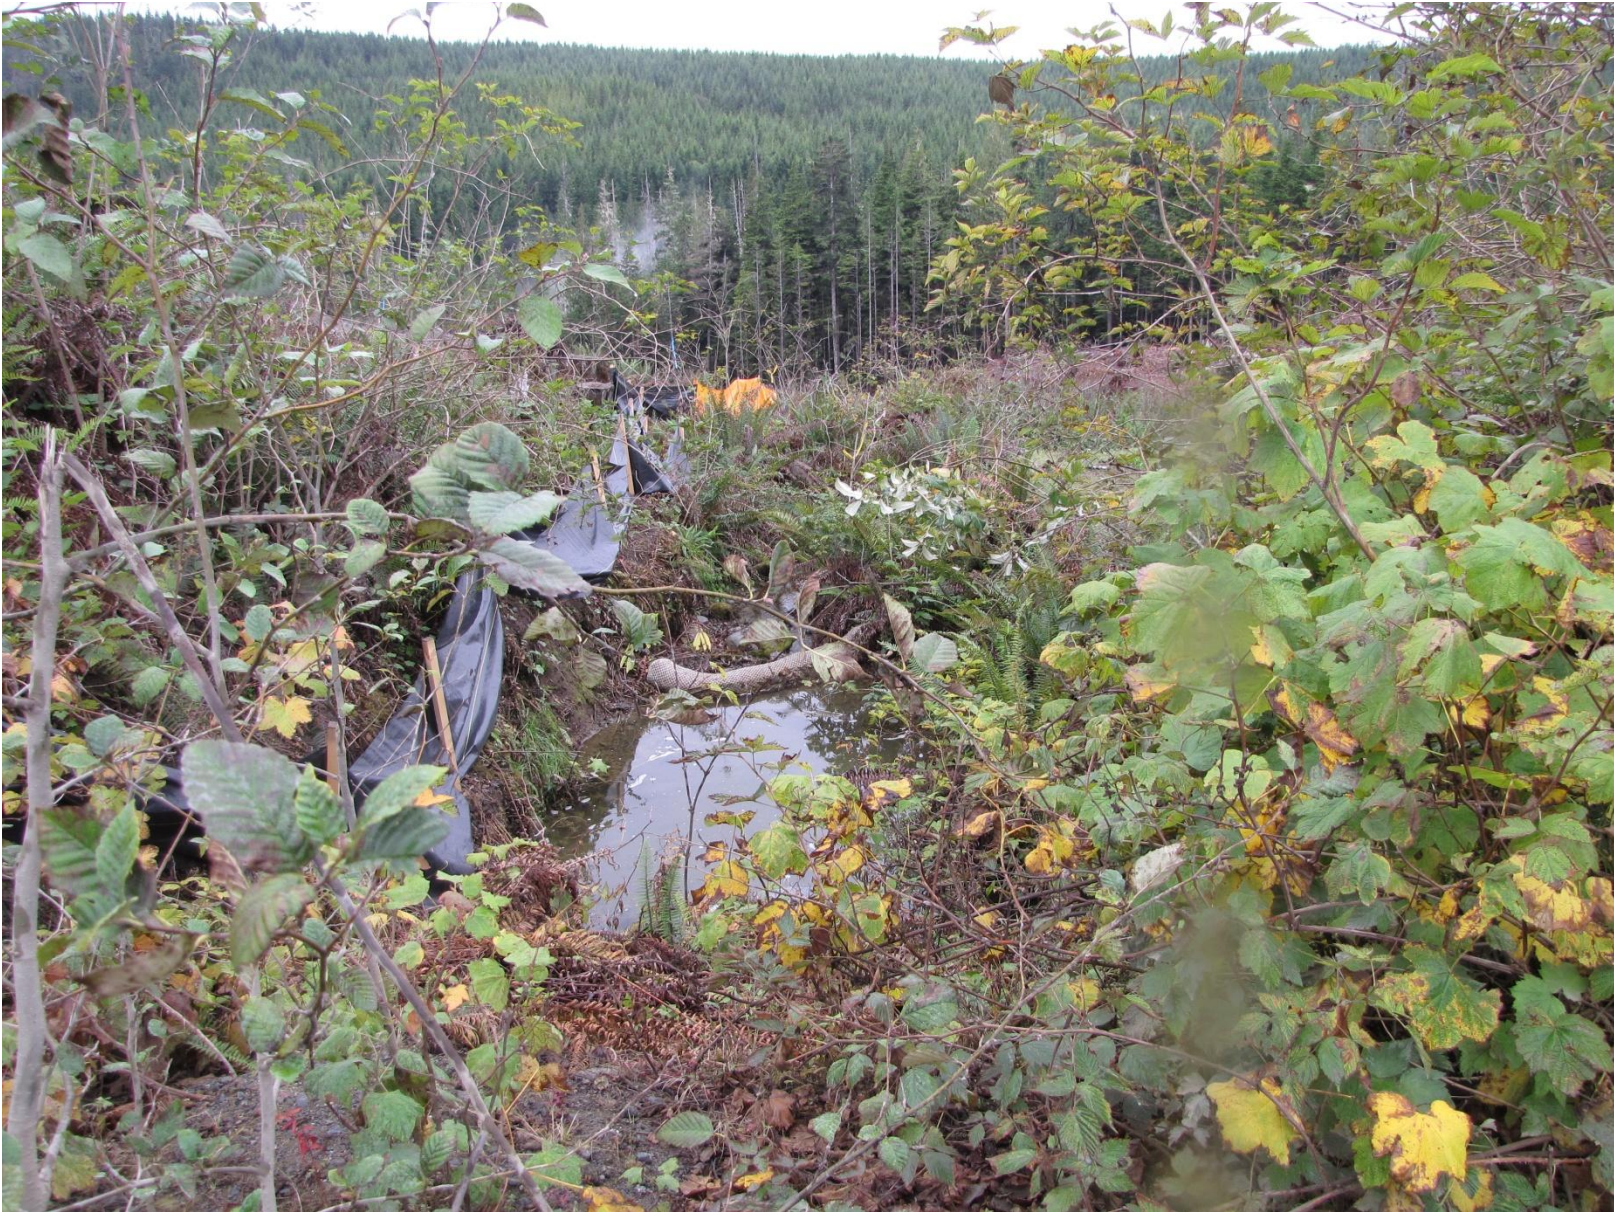
Photo 10 - French drain outflow

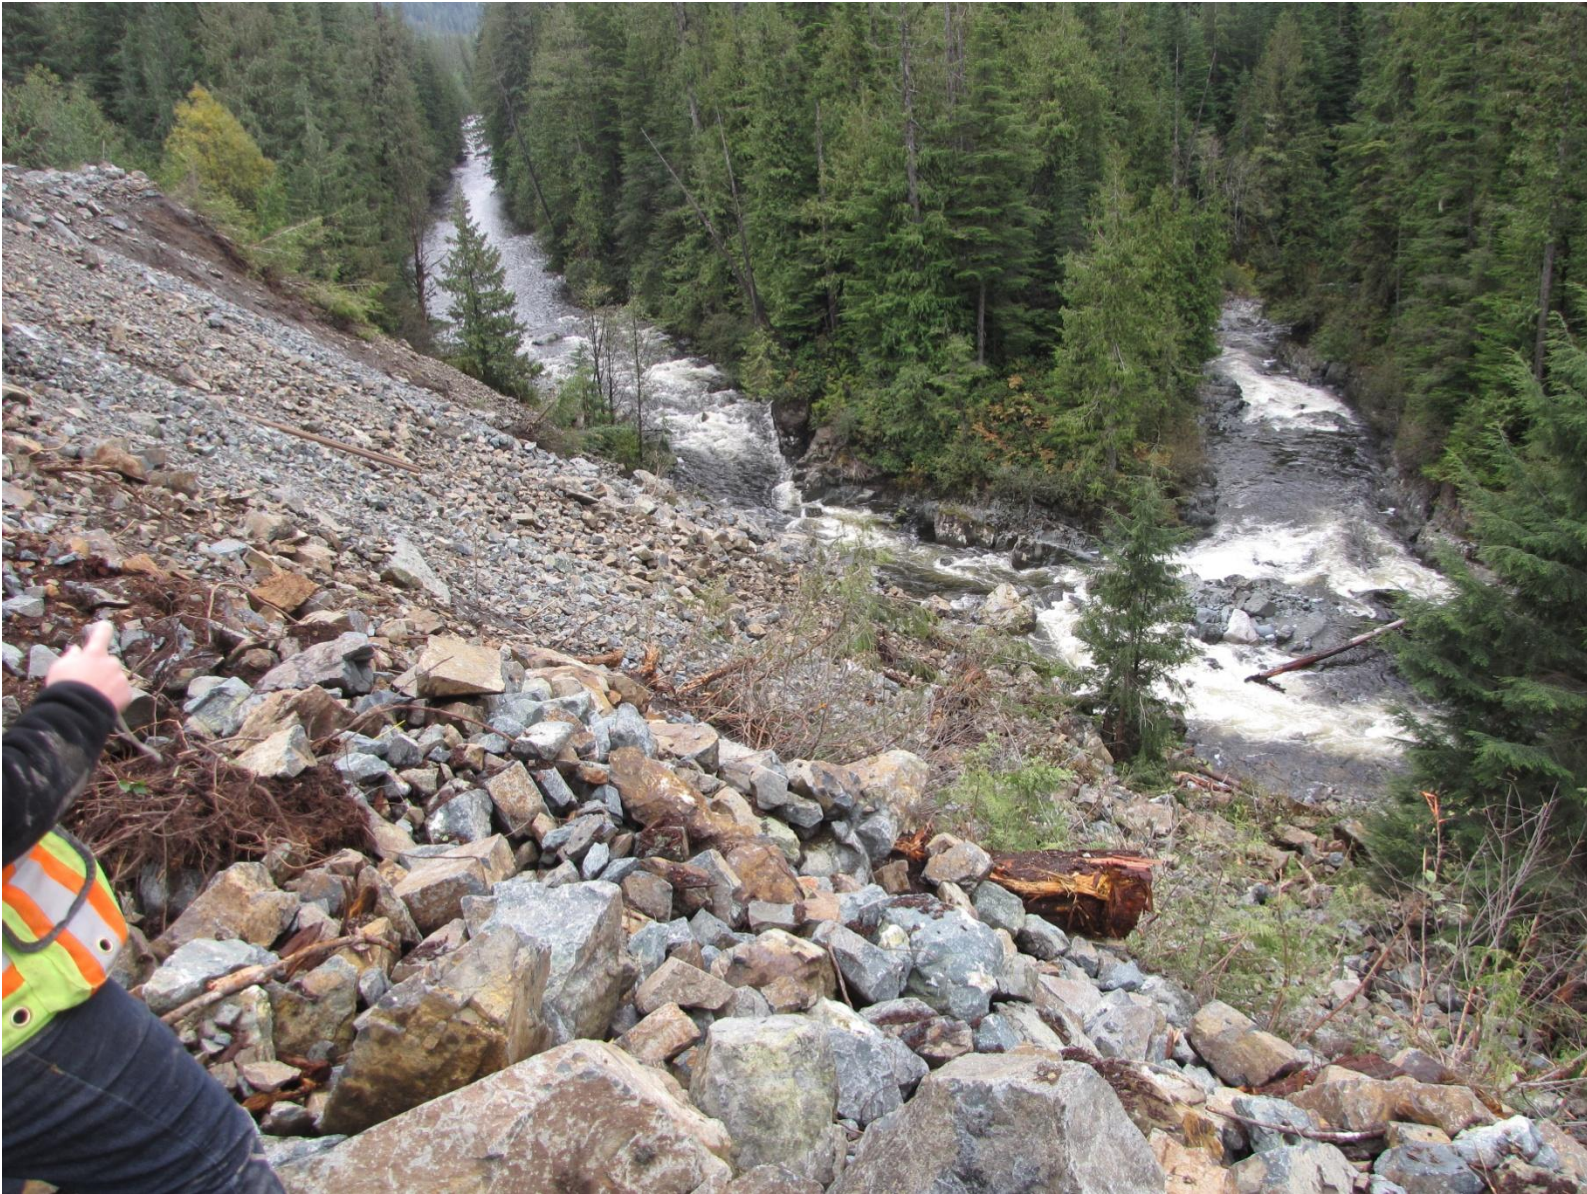
- o During blasting a rock knob broke off and a large amount of rock slid down slope to the Kokish River bank and into the wetted perimeter of the river. Witnesses stated that it was clean rock and no spike in sedimentation was observed in the river at the time. A biologist and blasting expert were brought to the scene and reports should be available from the proponent. The assessment indicated the impacts to fish habitat are minimal but there are some concerns that the narrowed river channel may cause increased flow velocities that may be un-passable by fish. Biologists report to follow.

Photo 11 - Blast rock that slid into Kokish River.
