A	<p>Licensee/ Tenure Holder: THOMPSON CREEK MINING LTD.</p> <p>BAG 4001 FRASER LAKE BC V0J3A0</p> <p>Operator/Contractor: THOMPSON CREEK MINING/ SCOTT M In Attendance: James Smith/ Tony Carrol/ Chris Parks/ Clayton Gross/ Julie Orban/ Scott Morrison/ Andrew Chewter</p> <p>Compliance Summary Comments: Inspection of the Thompson Creek/ Mt Milligan Project was conducted by the EAO staff as well as FLNRO C&E staff to inspect for compliance with Mt Milligan, EA certificate and EMP's and CEMP's. Plans used to assist in the inspection criteria were the Table of Commitments, the EMP, and the CEMP as well as spill and prevention and contingency plan, sediment and erosion control plans.</p> <p>6.34 Archaeological and cultural heritage resource management plan main objectives are identify, record and assess any of these features with-in or adjacent to the project. There was no other features found on location other than the pre-identified j-3/GgRs-5 which had low impact and required no mitigation. The proponent has done a Archaeological Impact Assessment pre construction 2007 and has managed this requirement.</p> <p>6.3.3 Air Quality Management Plan has been developed to protect and manage a

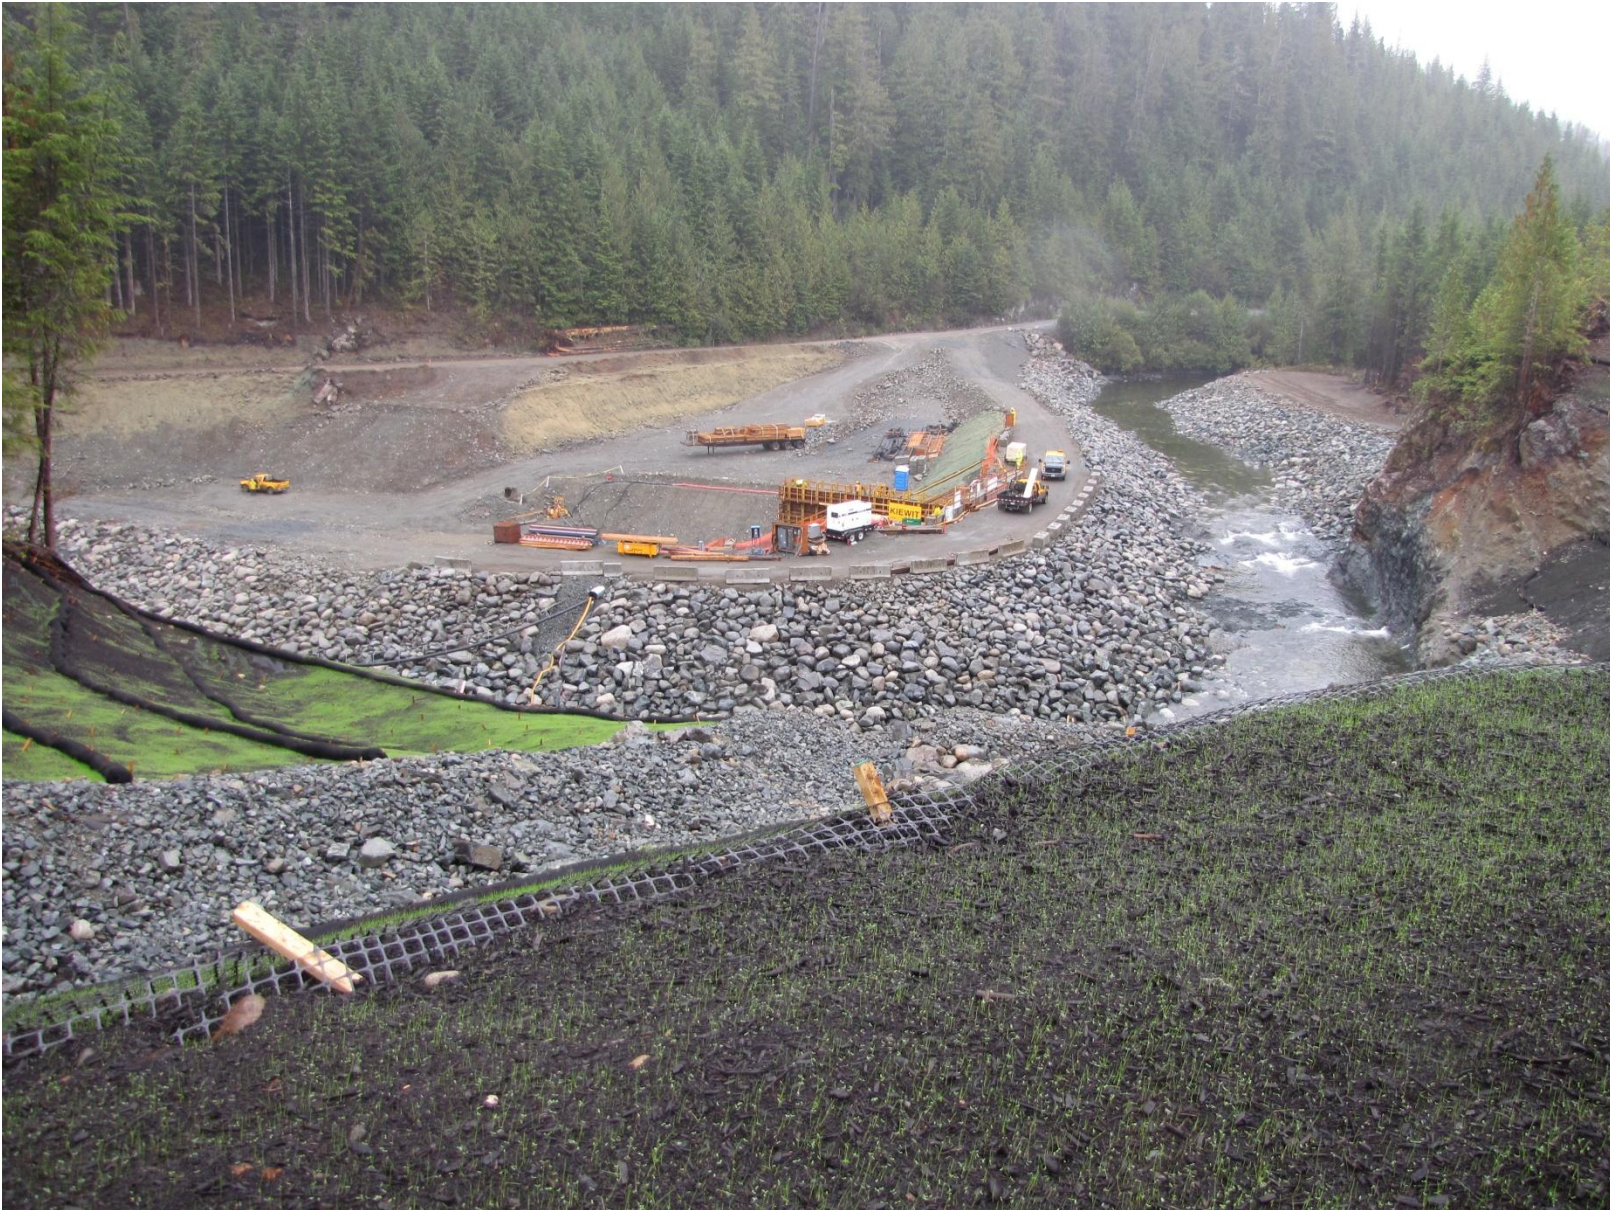
Photo 12 - Temporary diversion channel

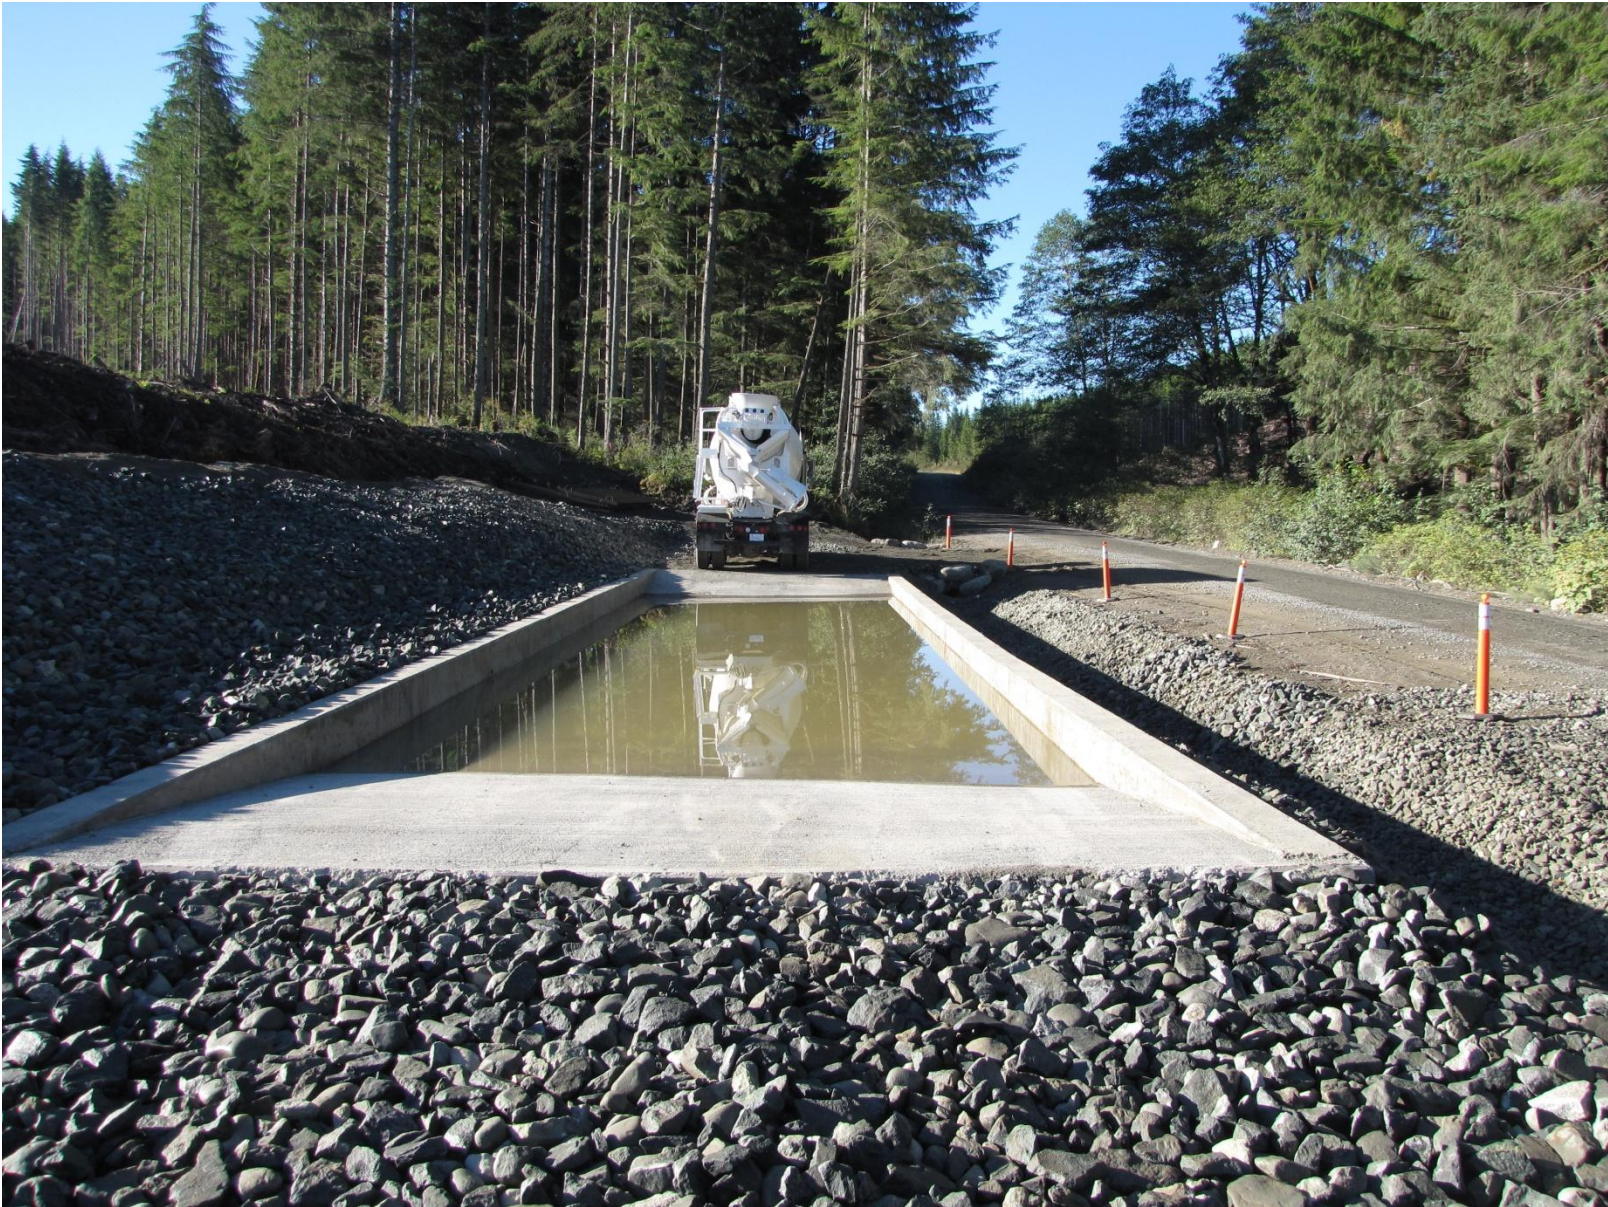
Photo 13 - Wheel washing facility.

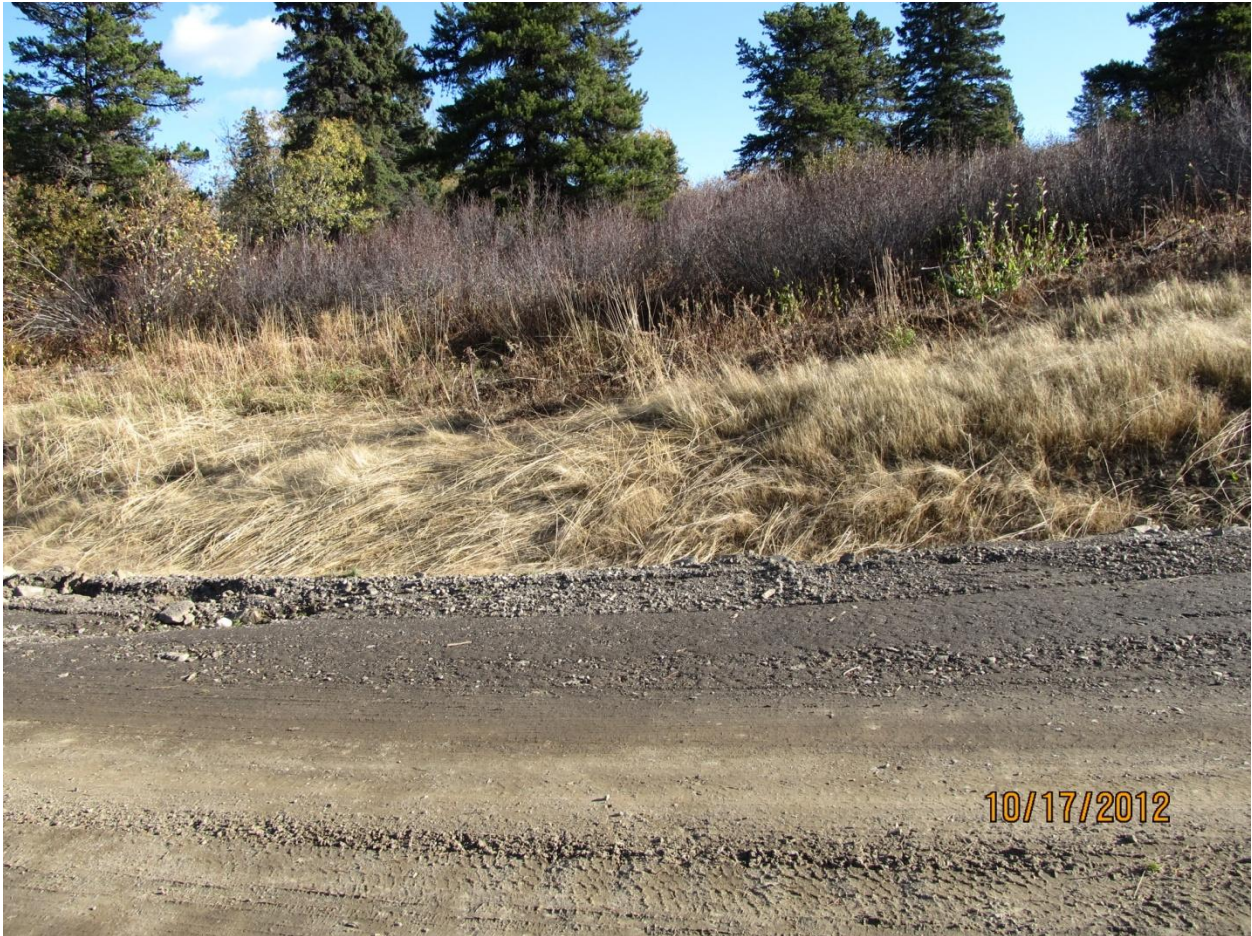
A road - Has 80% vegetation cover from hydro seeding last year. There are some locations along the road where the hydro seeding was not effective. Mortenson has these areas identified and has them prepared for seeding this fall before snowfall. All tower sites have been reclaimed with natural soil material from the site and have been seeded. All tower sites have been sloped to guidelines. This section of road had relatively gentle slopes in the ditchlines where rock armouring was not required, although some rock was put in place regardless.

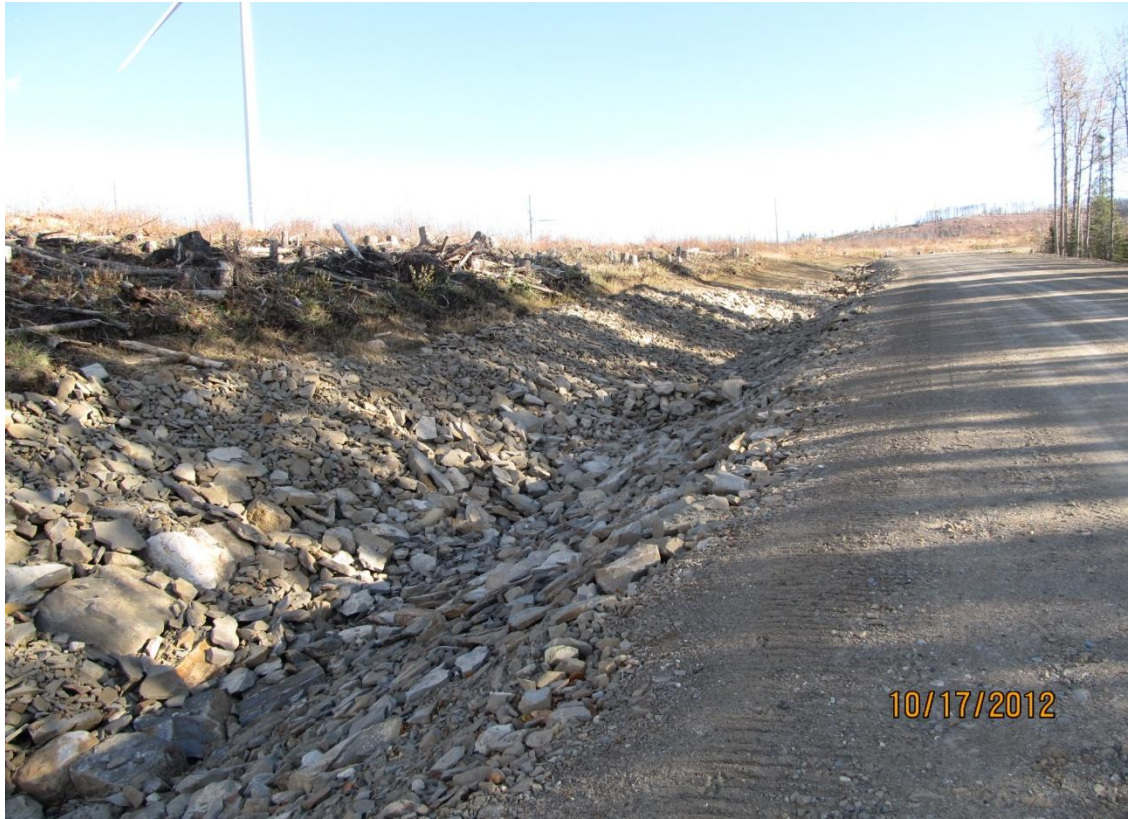
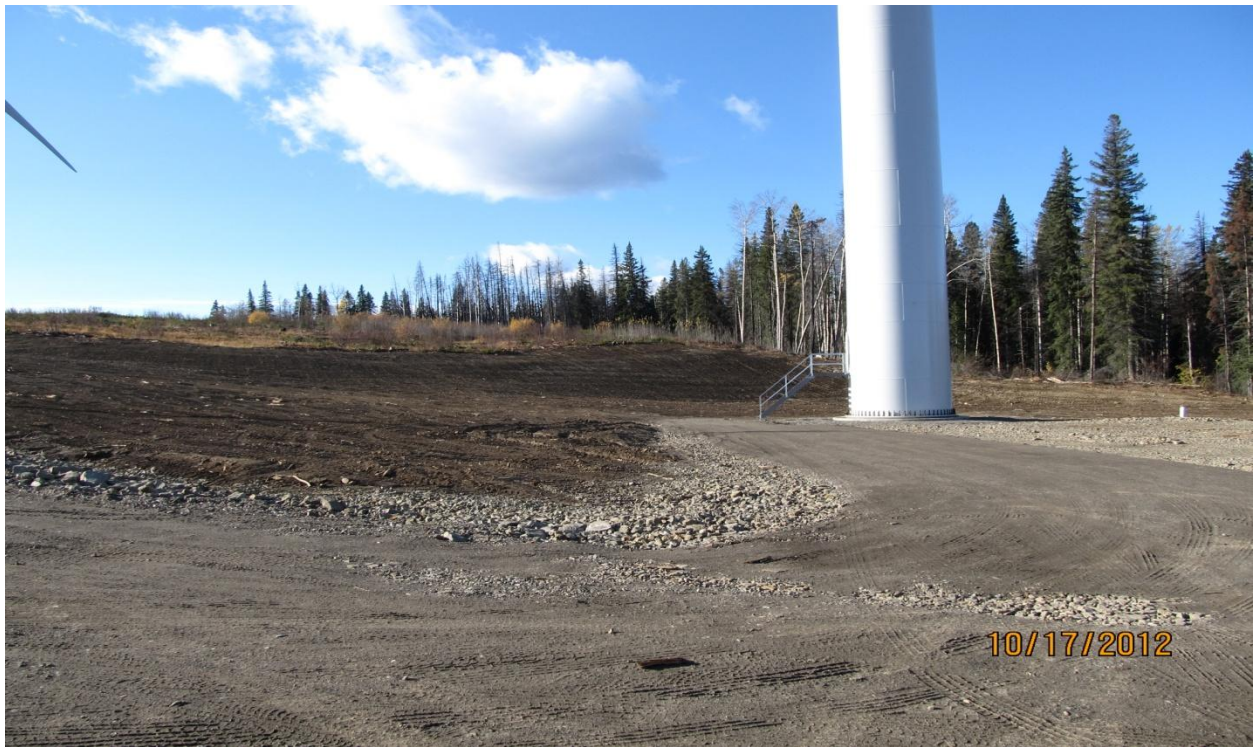
C road - Ditching was very well done. An abundance of rock armouring and check dams had been constructed and all were to guidelines. Mortenson believes that hydro seeding was only effective on 50% of the area seeded last year. They have identified areas to be reseeded and the new areas that have to be seeded. Seeding will be completed this fall before snowfall. All tower sites have been reclaimed with the natural stockpiled materials on site. All tower sites have been sloped to guidelines.

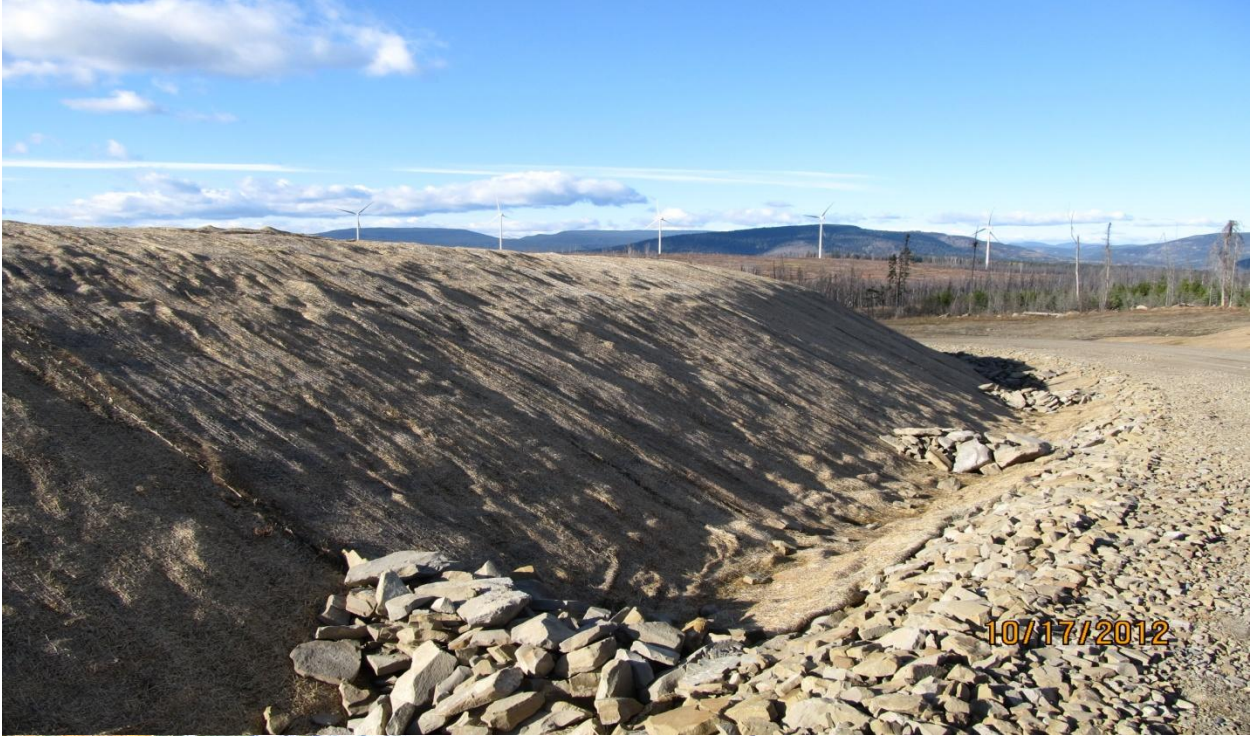
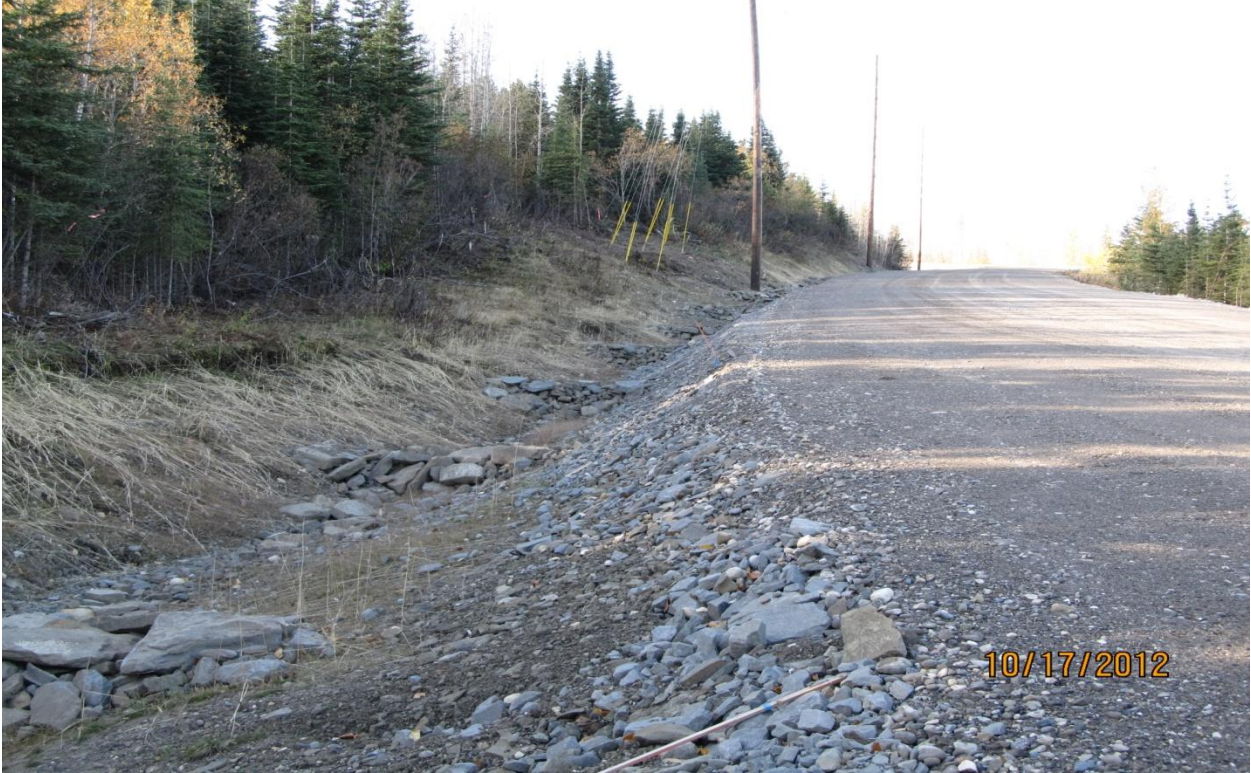
G road - This is where one of the biggest issues was from last year. Major work has been completed to correct drainage and erosion issues. Rock armouring and check dams are now in place. Tower sites are all reclaimed with natural soil and materials from on site and have been properly sloped. Mortenson has done an exceptional job.

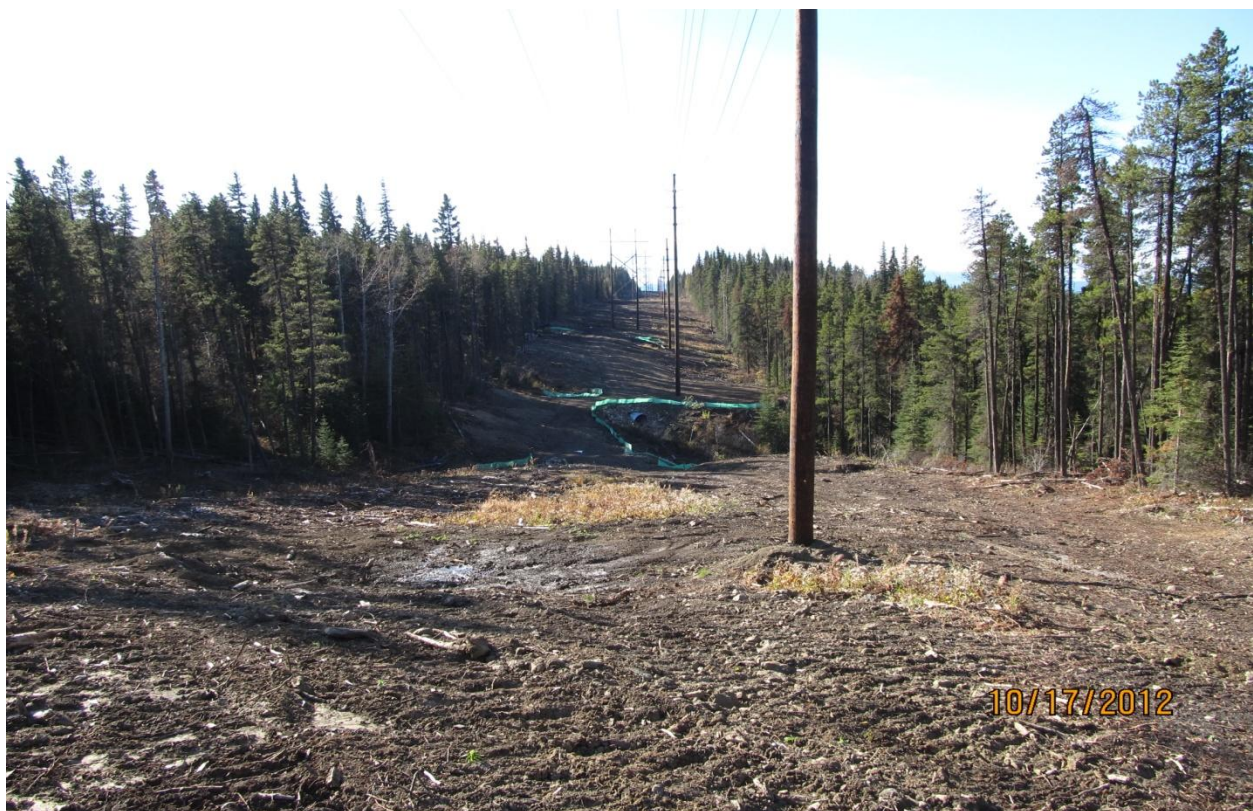
Last year there was a potential problem slope down to a stream that was identified. This area was looked at again on this inspection. It was noted that the slope has not been cross ditched and there is a very high potential for erosion and sedimentation problems. Ben Kelly from Mortenson informed me that he will have this slope cross ditched and seeded within one week of the inspection. This will be an area that should be revisited to ensure the work has been completed.

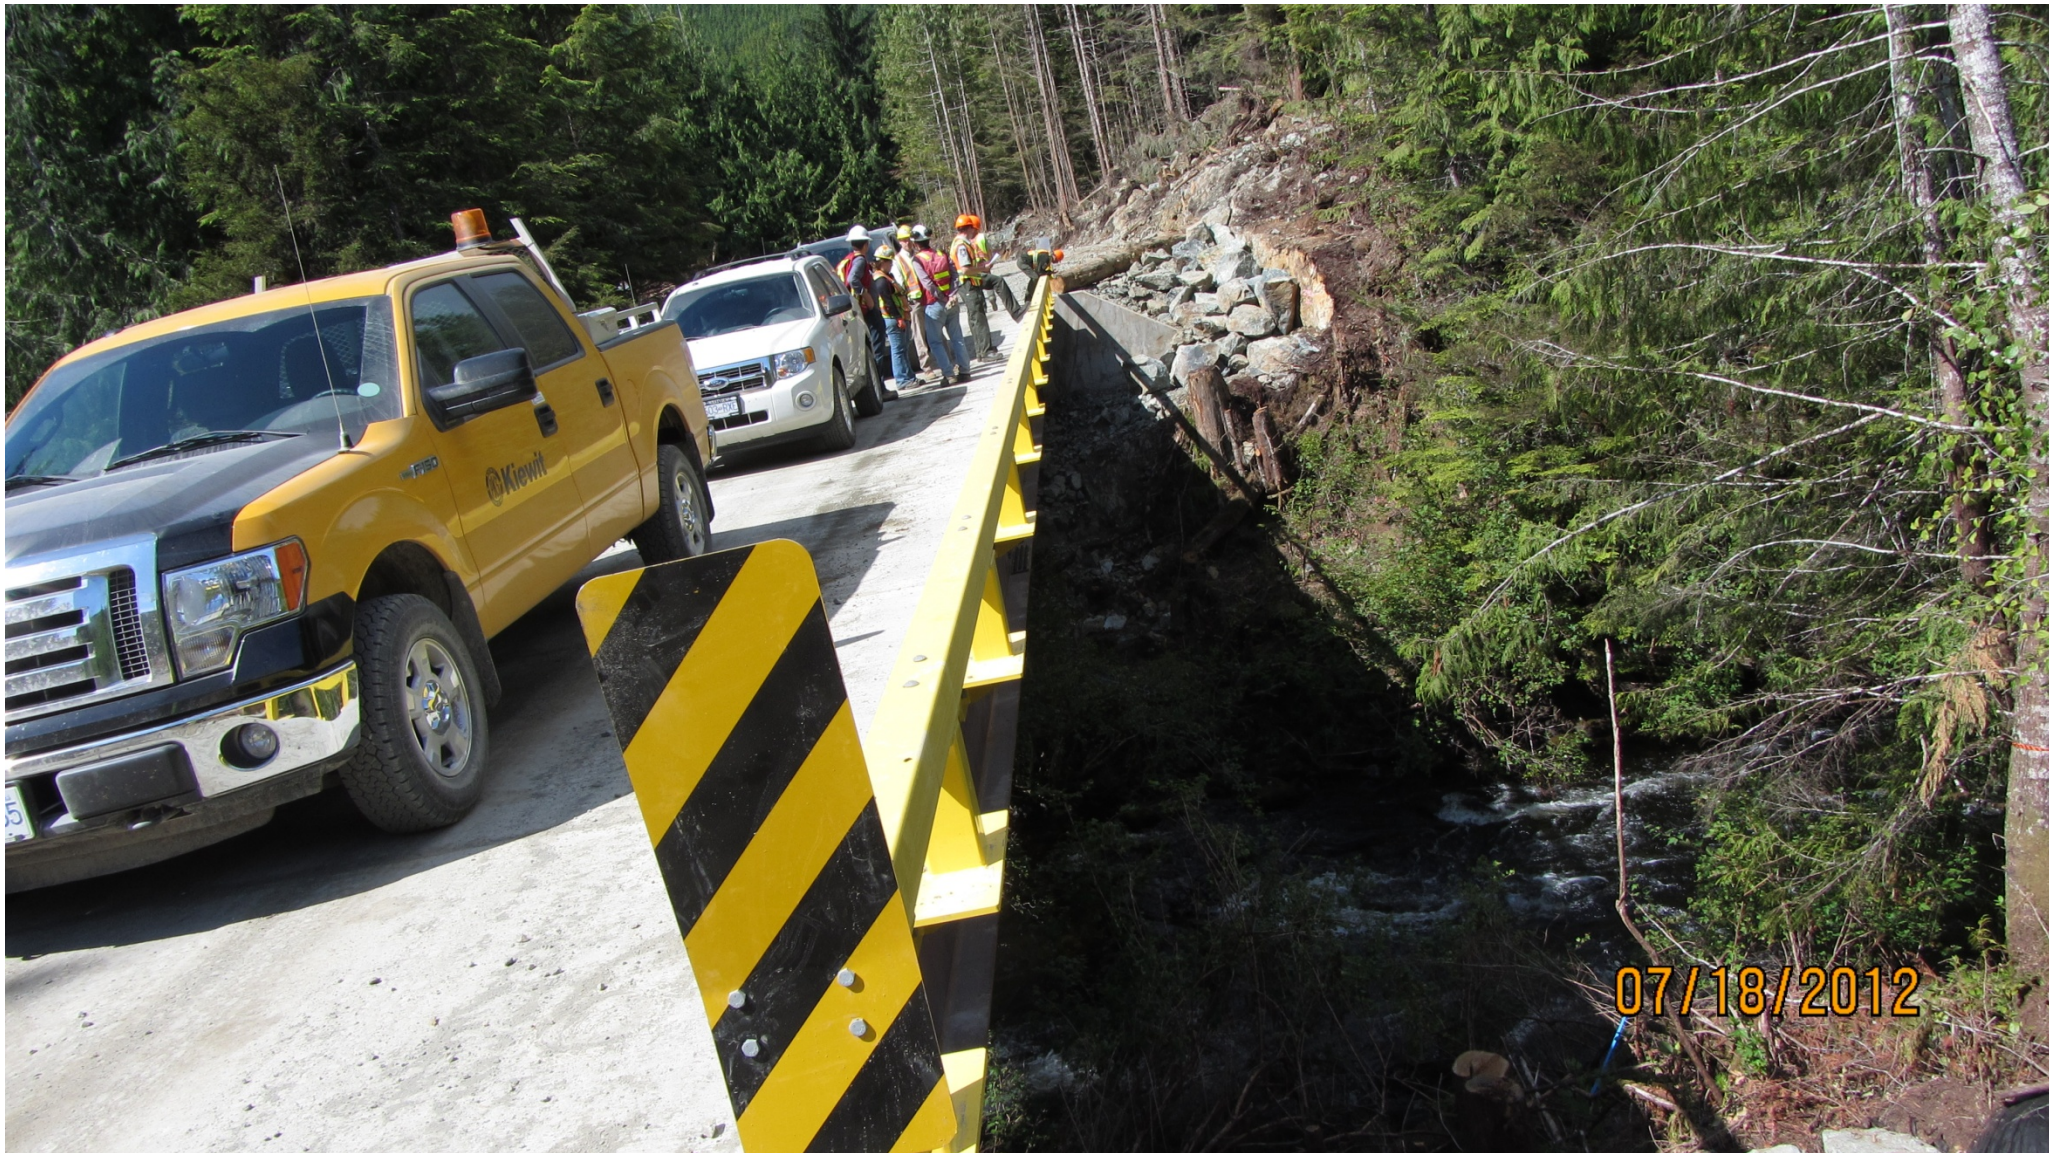
Attachment 1 – Clear Span Bridge

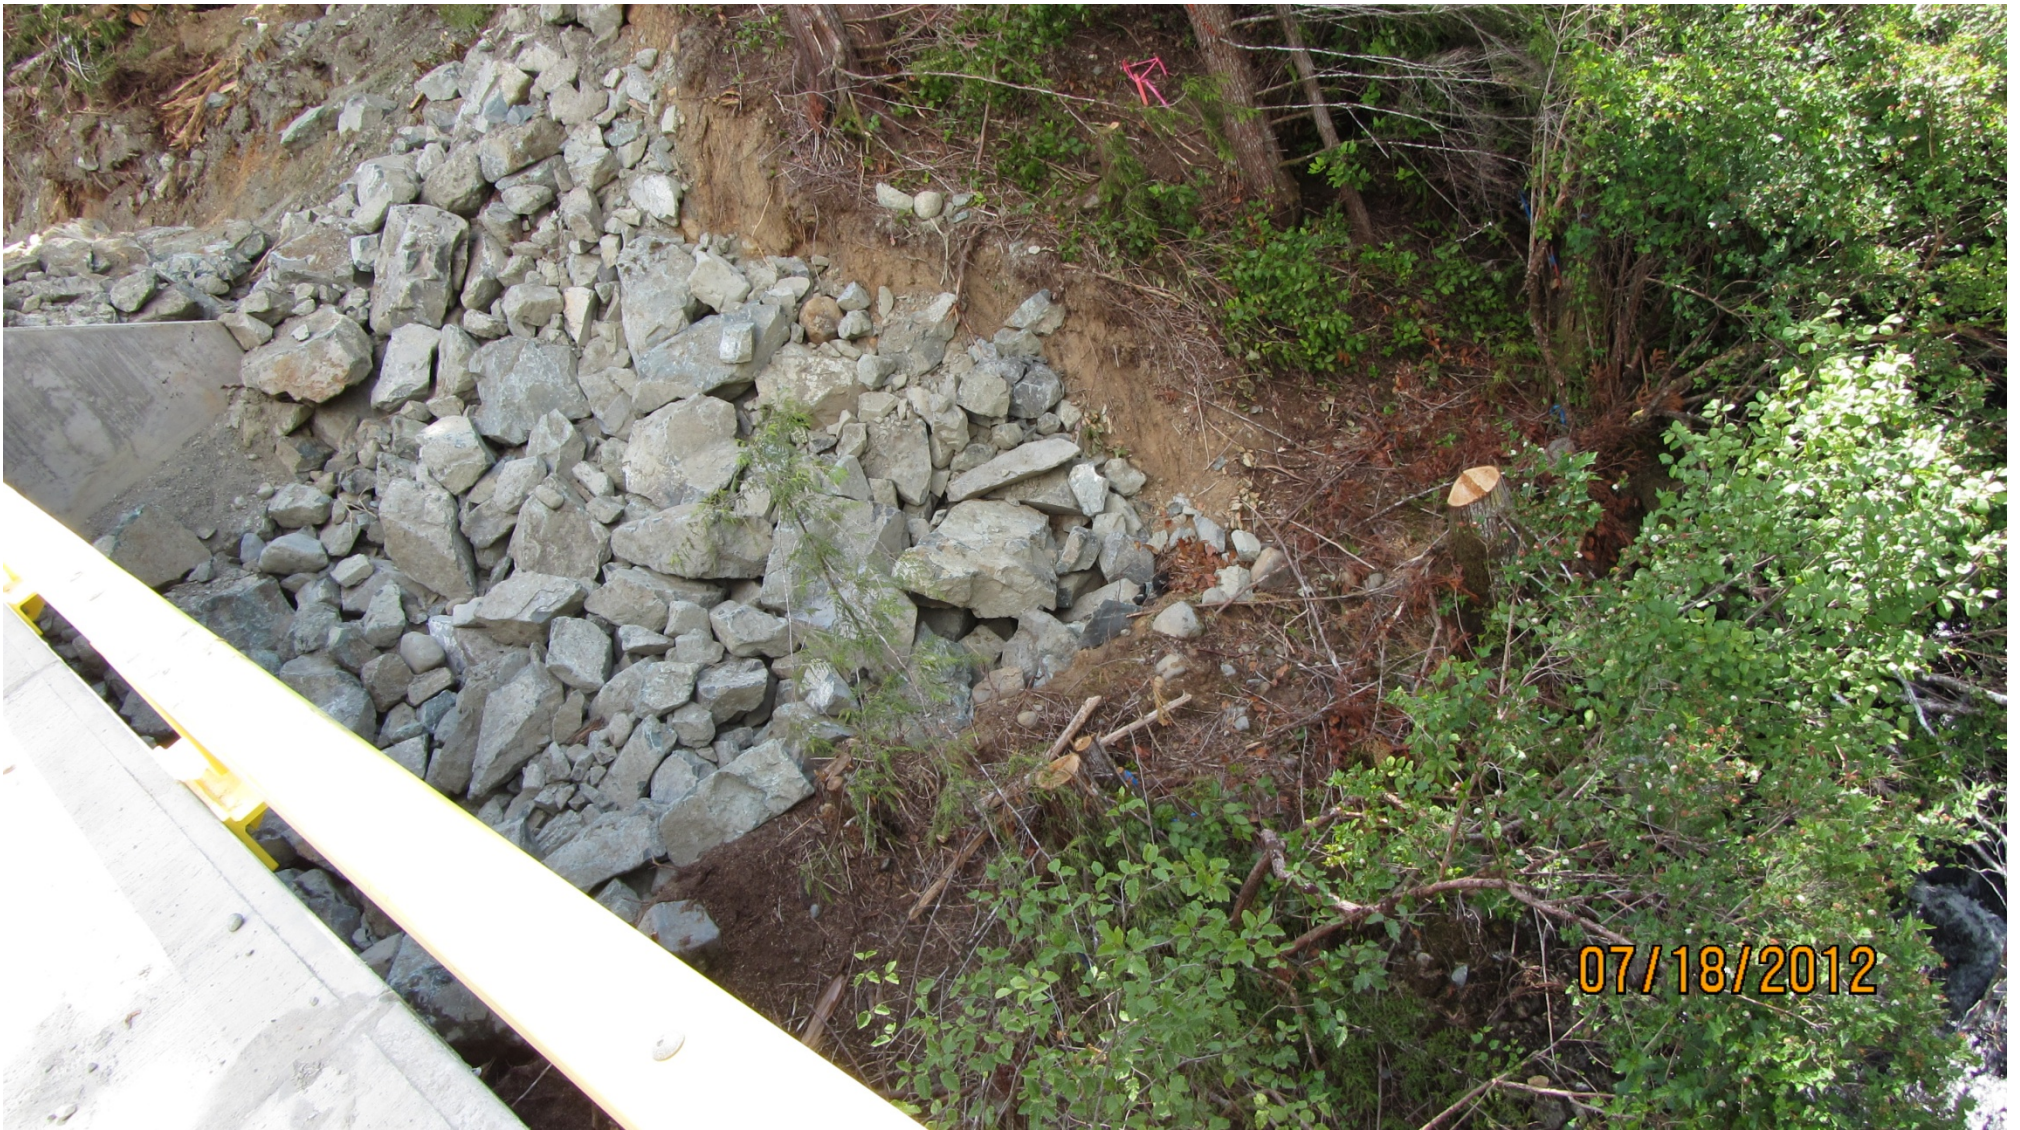
Attachment 2 - Erosion and Sediment control on Clear Span Bridge

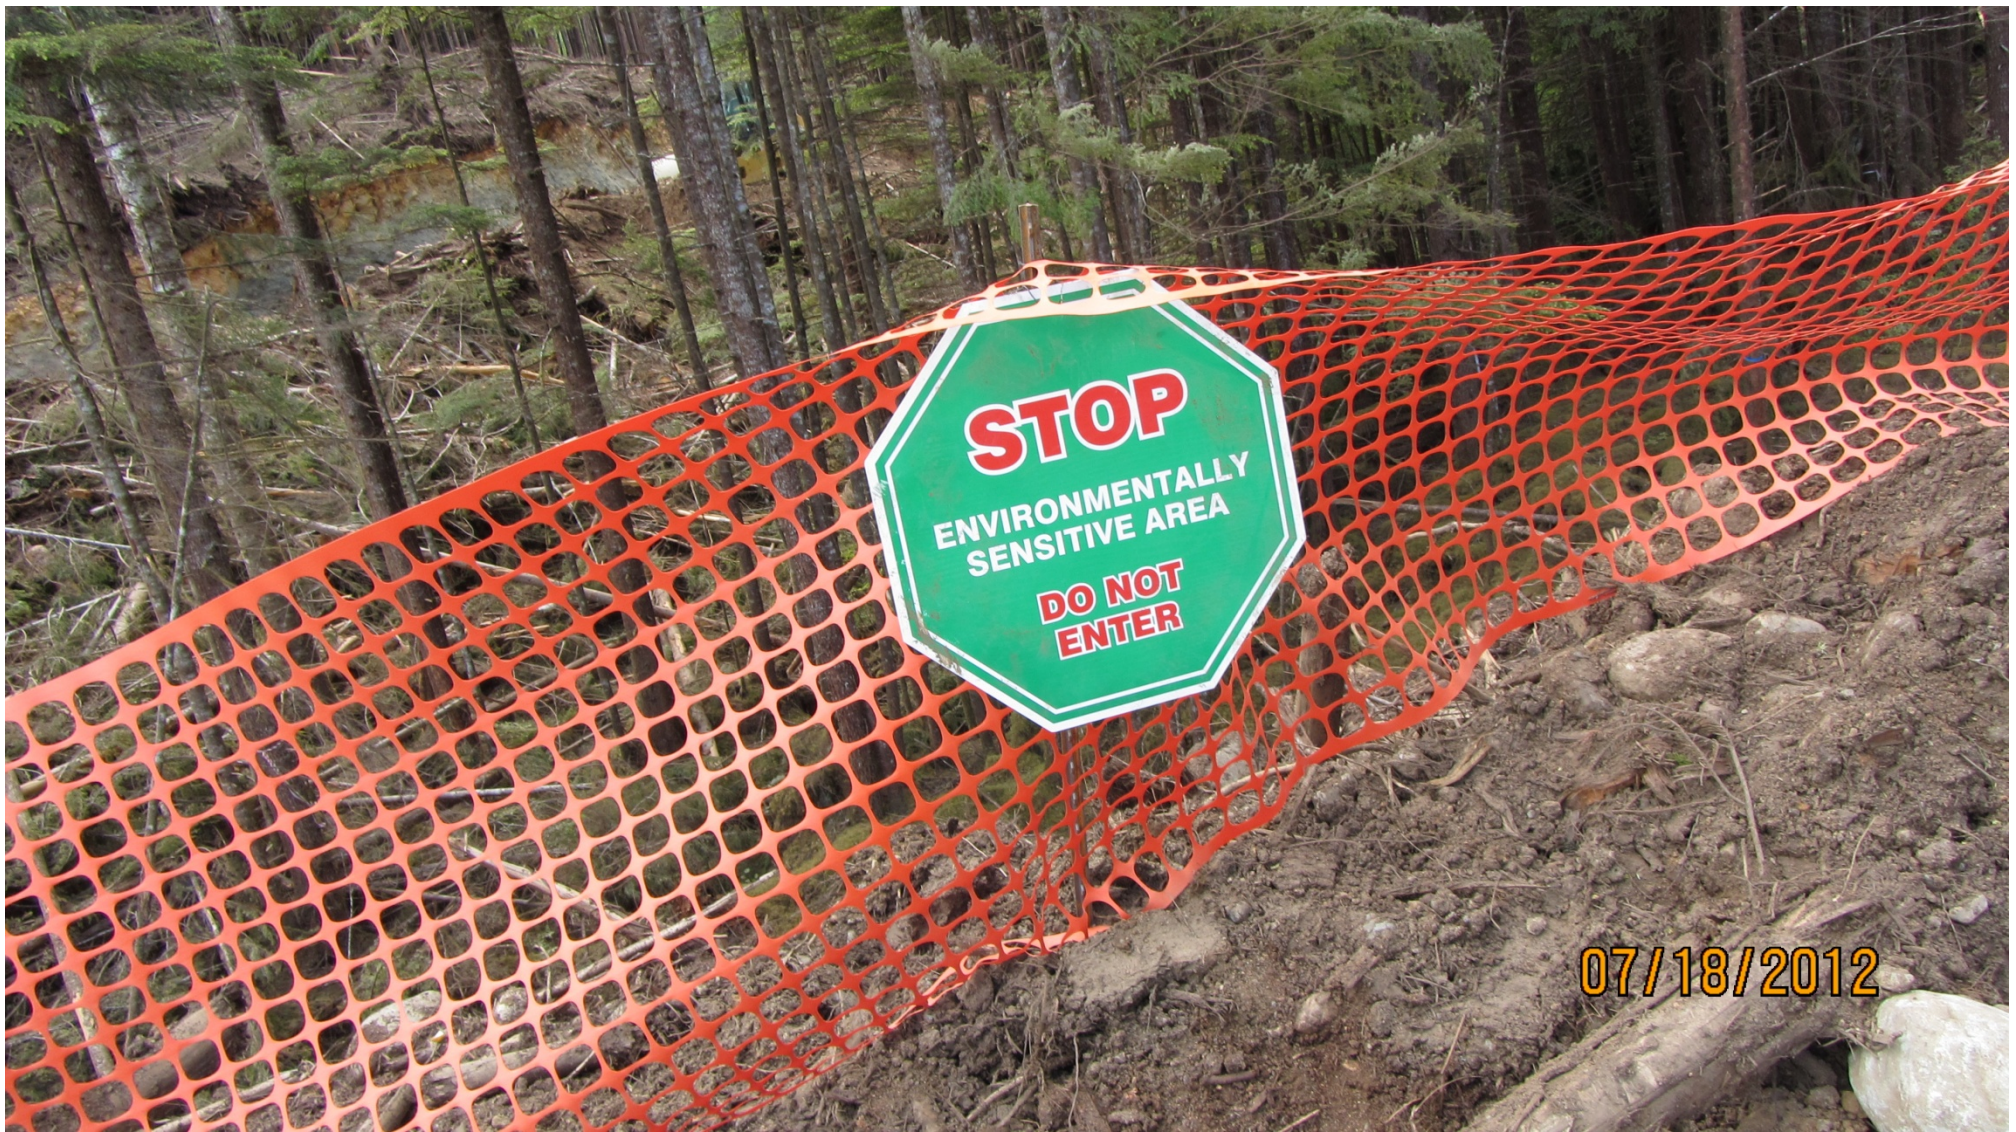
Attachment 3 - Sensitive environment area sign

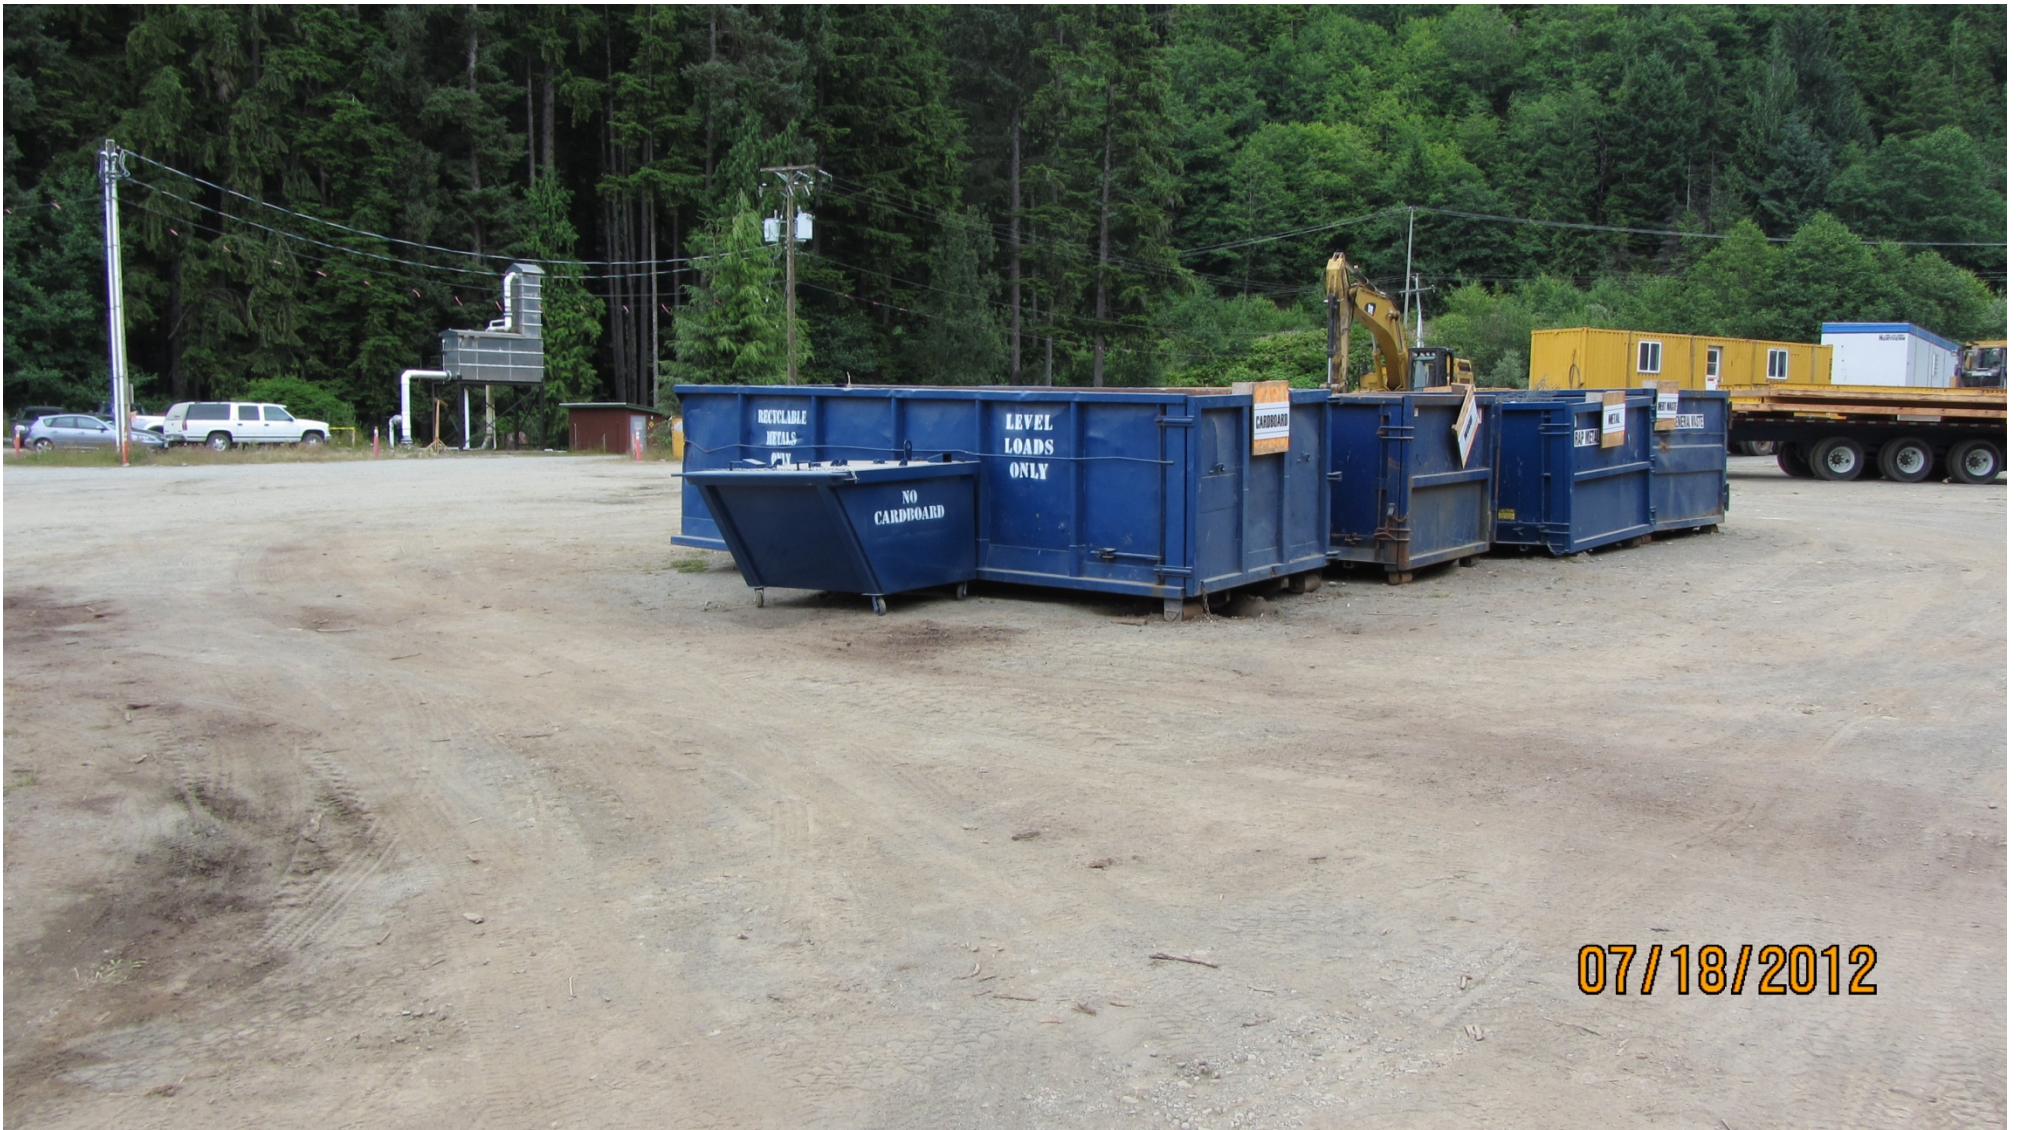
Attachment 5 - Waste Disposal

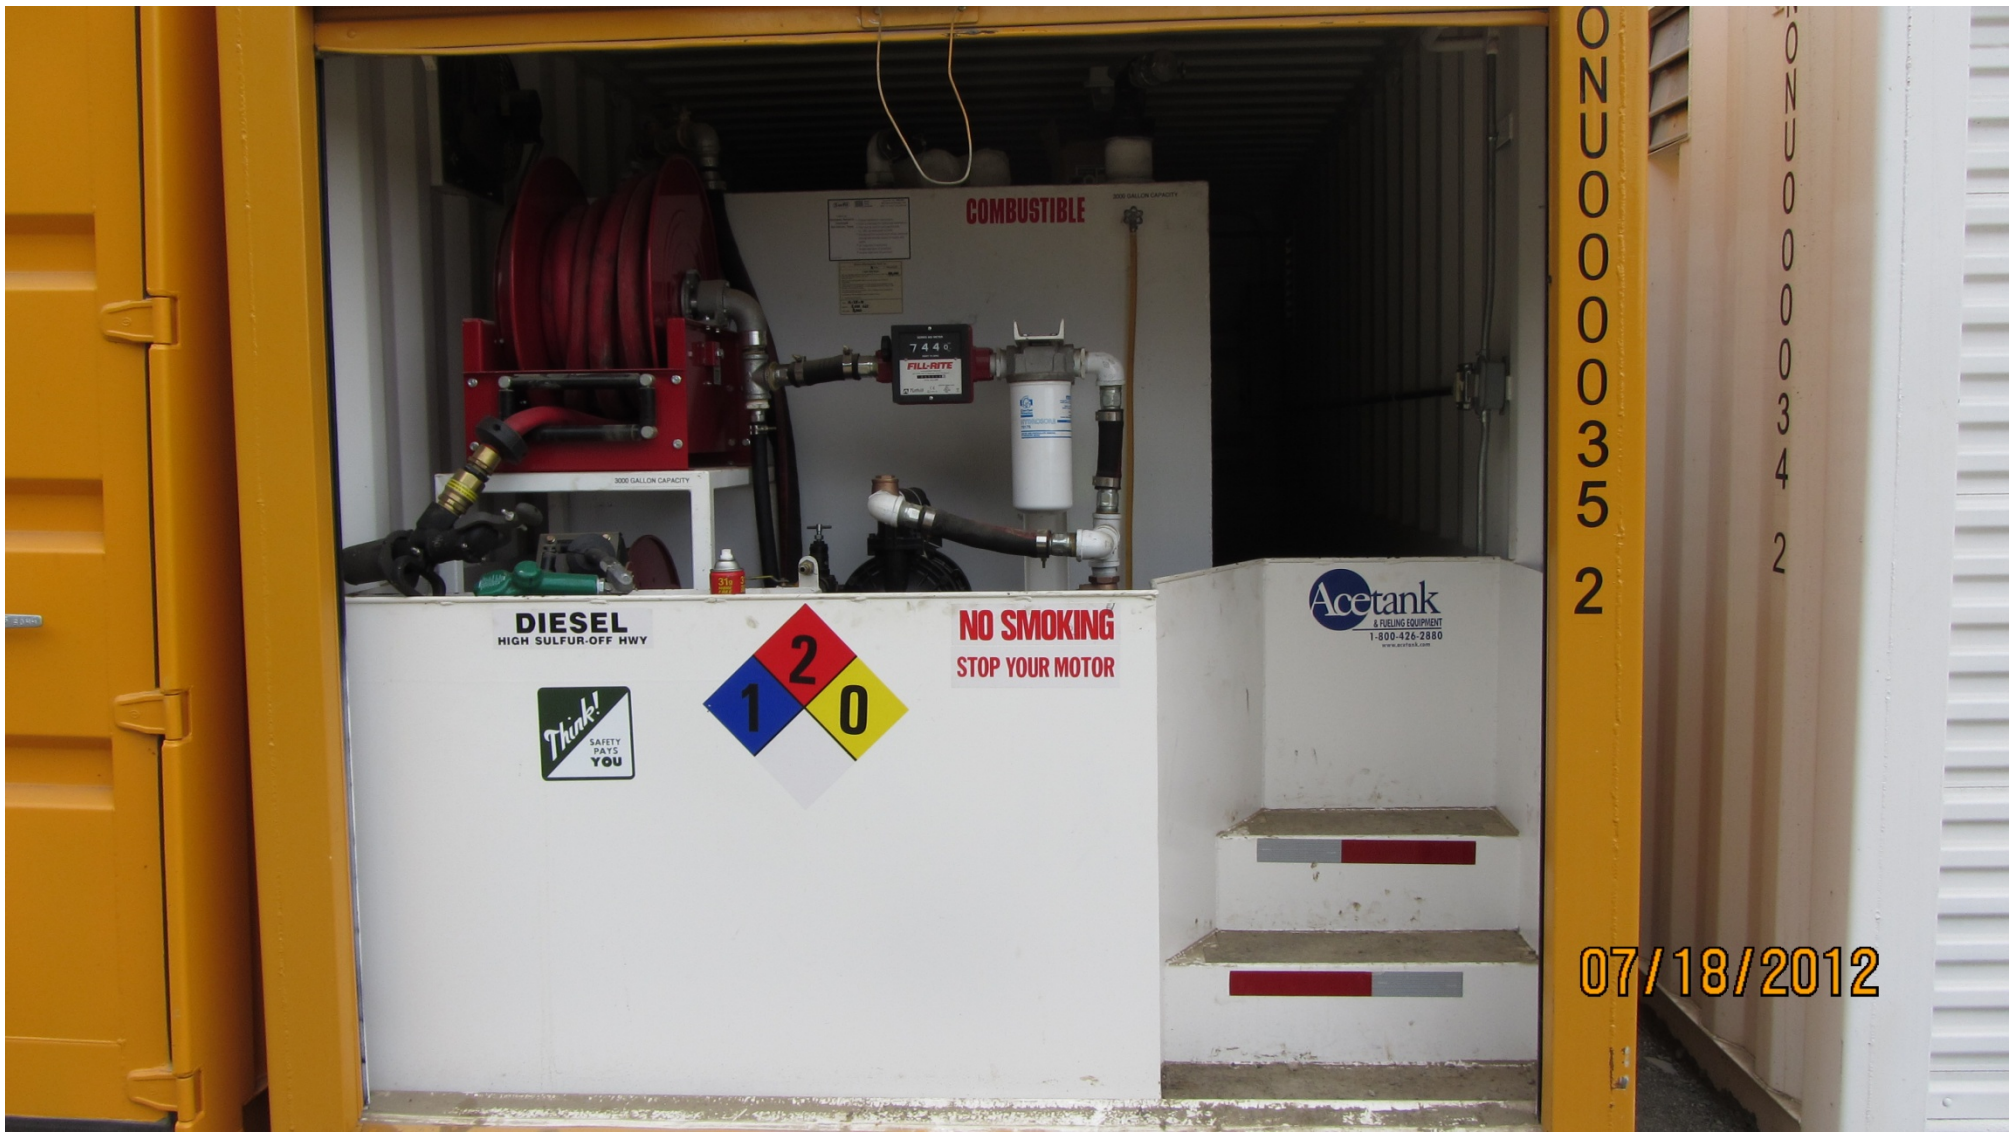
Attachment 6 - Fuel storage tank labelled as "high sulphur - off hwy"
