A	<p>Licensee/ Tenure Holder: THOMPSON CREEK MINING LTD.</p> <p>BAG 4001 FRASER LAKE BC V0J3A0</p> <p>Operator/Contractor: THOMPSON CREEK MINING/ SCOTT M In Attendance: James Smith/ Tony Carrol/ Chris Parks/ Clayton Gross/ Julie Orban/ Scott Morrison/ Andrew Chewter</p> <p>Compliance Summary Comments: Inspection of the Thompson Creek/ Mt Milligan Project was conducted by the EAO staff as well as FLNRO C&E staff to inspect for compliance with Mt Milligan, EA certificate and EMP's and CEMP's. Plans used to assist in the inspection criteria were the Table of Commitments, the EMP, and the CEMP as well as spill and prevention and contingency plan, sediment and erosion control plans.</p> <p>6.34 Archaeological and cultural heritage resource management plan main objectives are identify, record and assess any of these features with-in or adjacent to the project. There was no other features found on location other than the pre-identified j-3/GgRs-5 which had low impact and required no mitigation. The proponent has done a Archaeological Impact Assessment pre construction 2007 and has managed this requirement.</p> <p>6.3.3 Air Quality Management Plan has been developed to protect and manage a

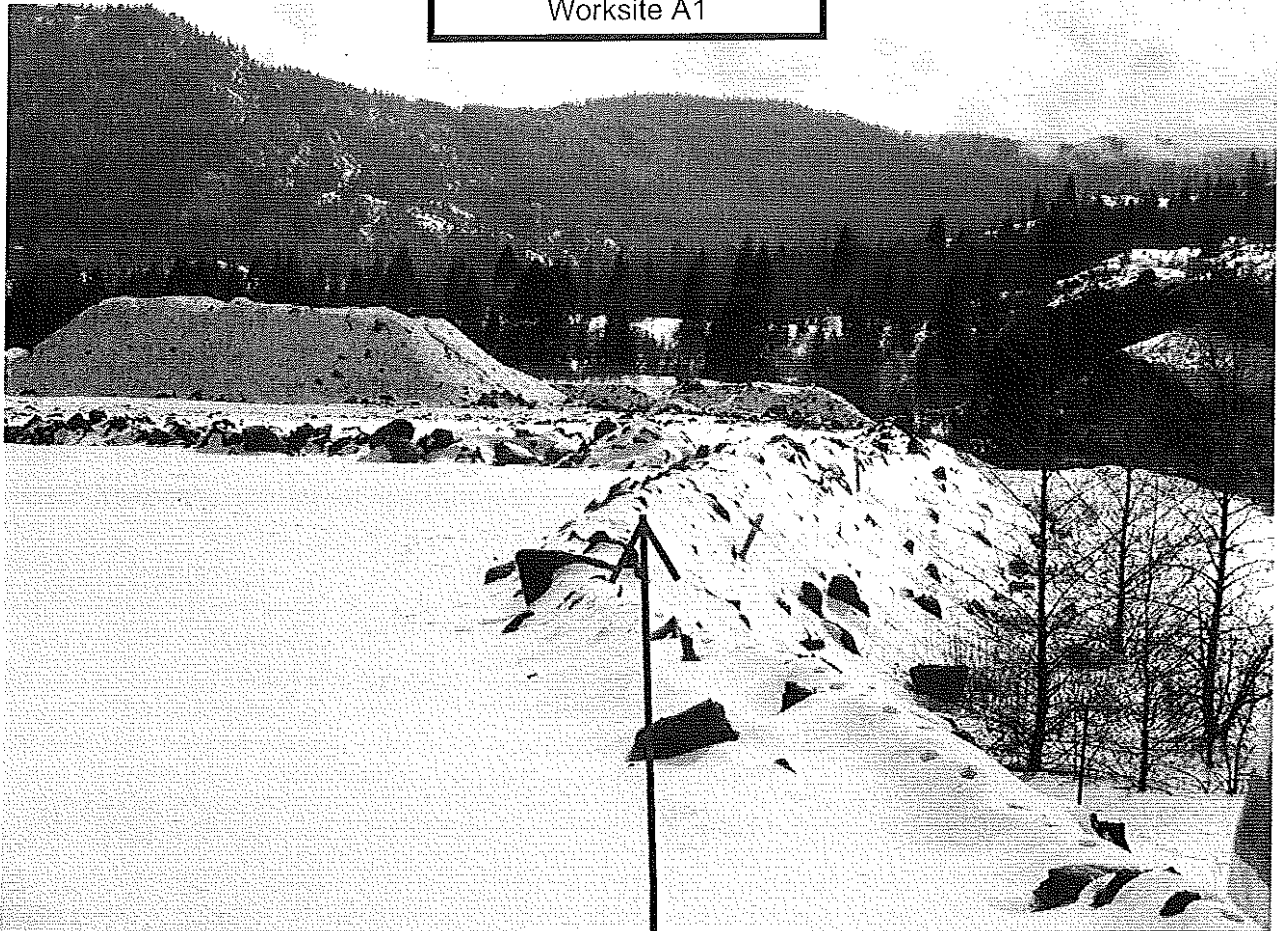
Worksite A1

No Perimeter Fencing

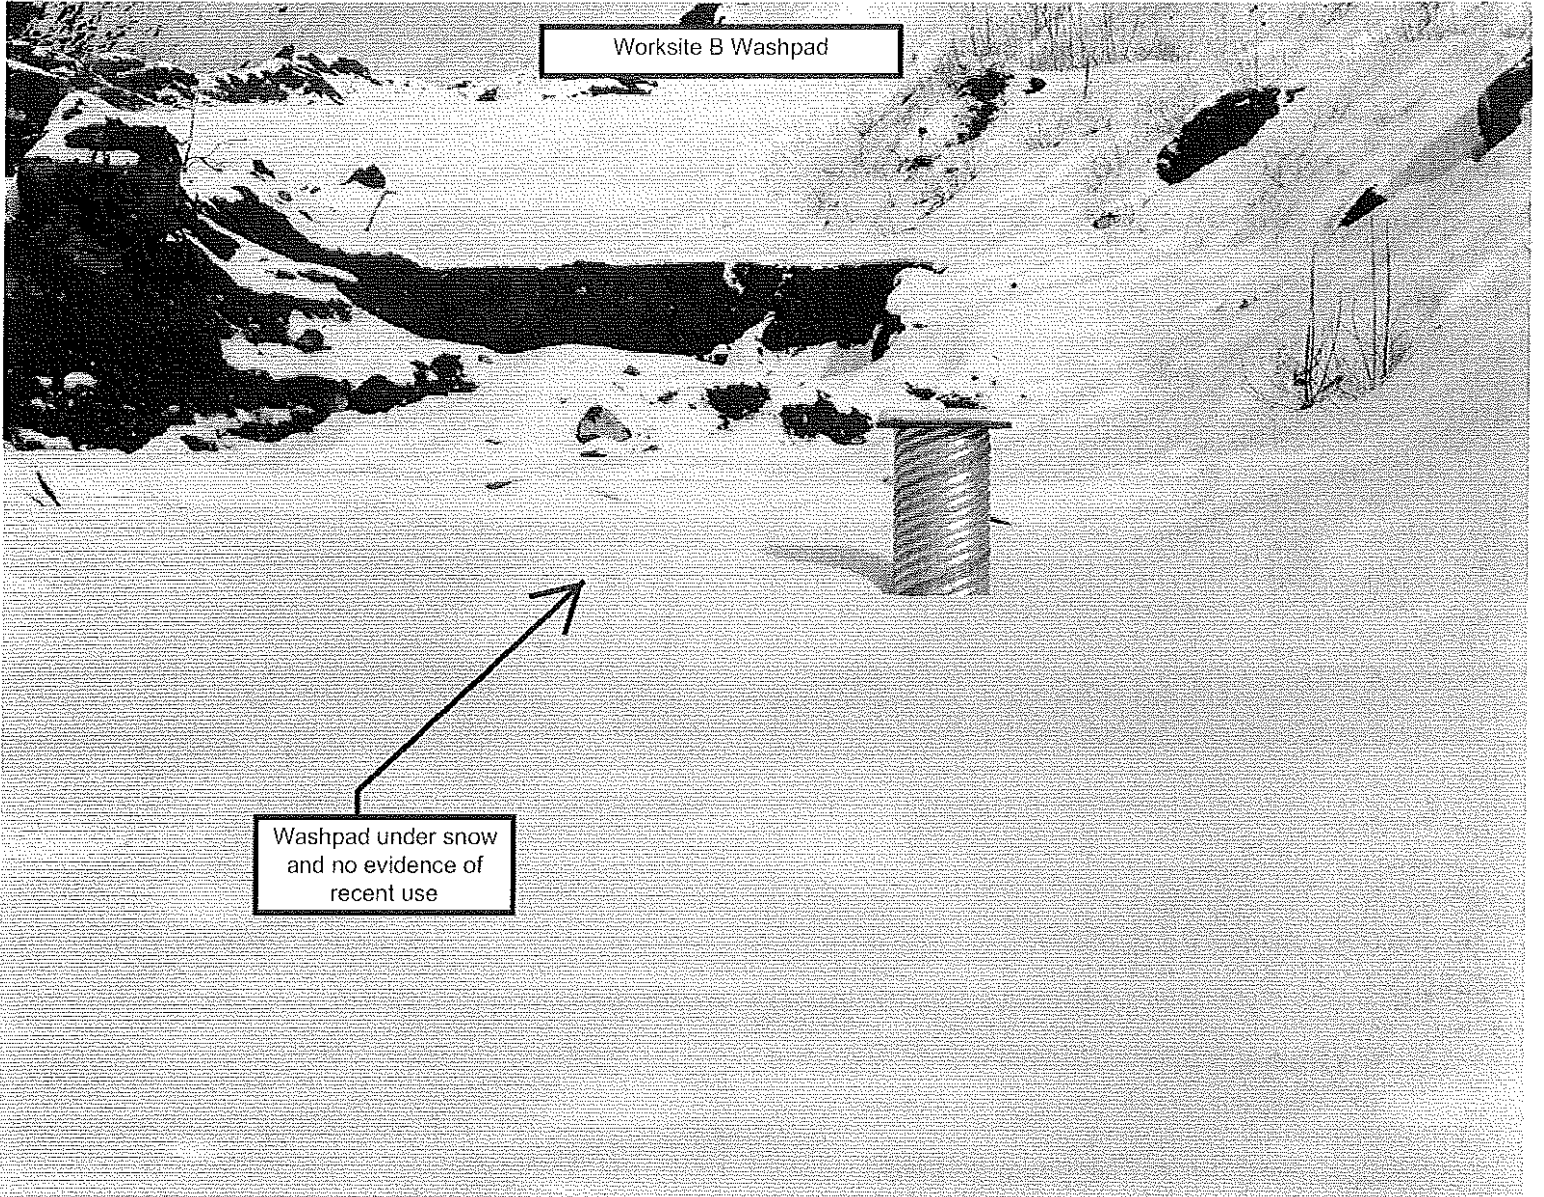
Worksite B Washpad

Washpad under snow
and no evidence of
recent use

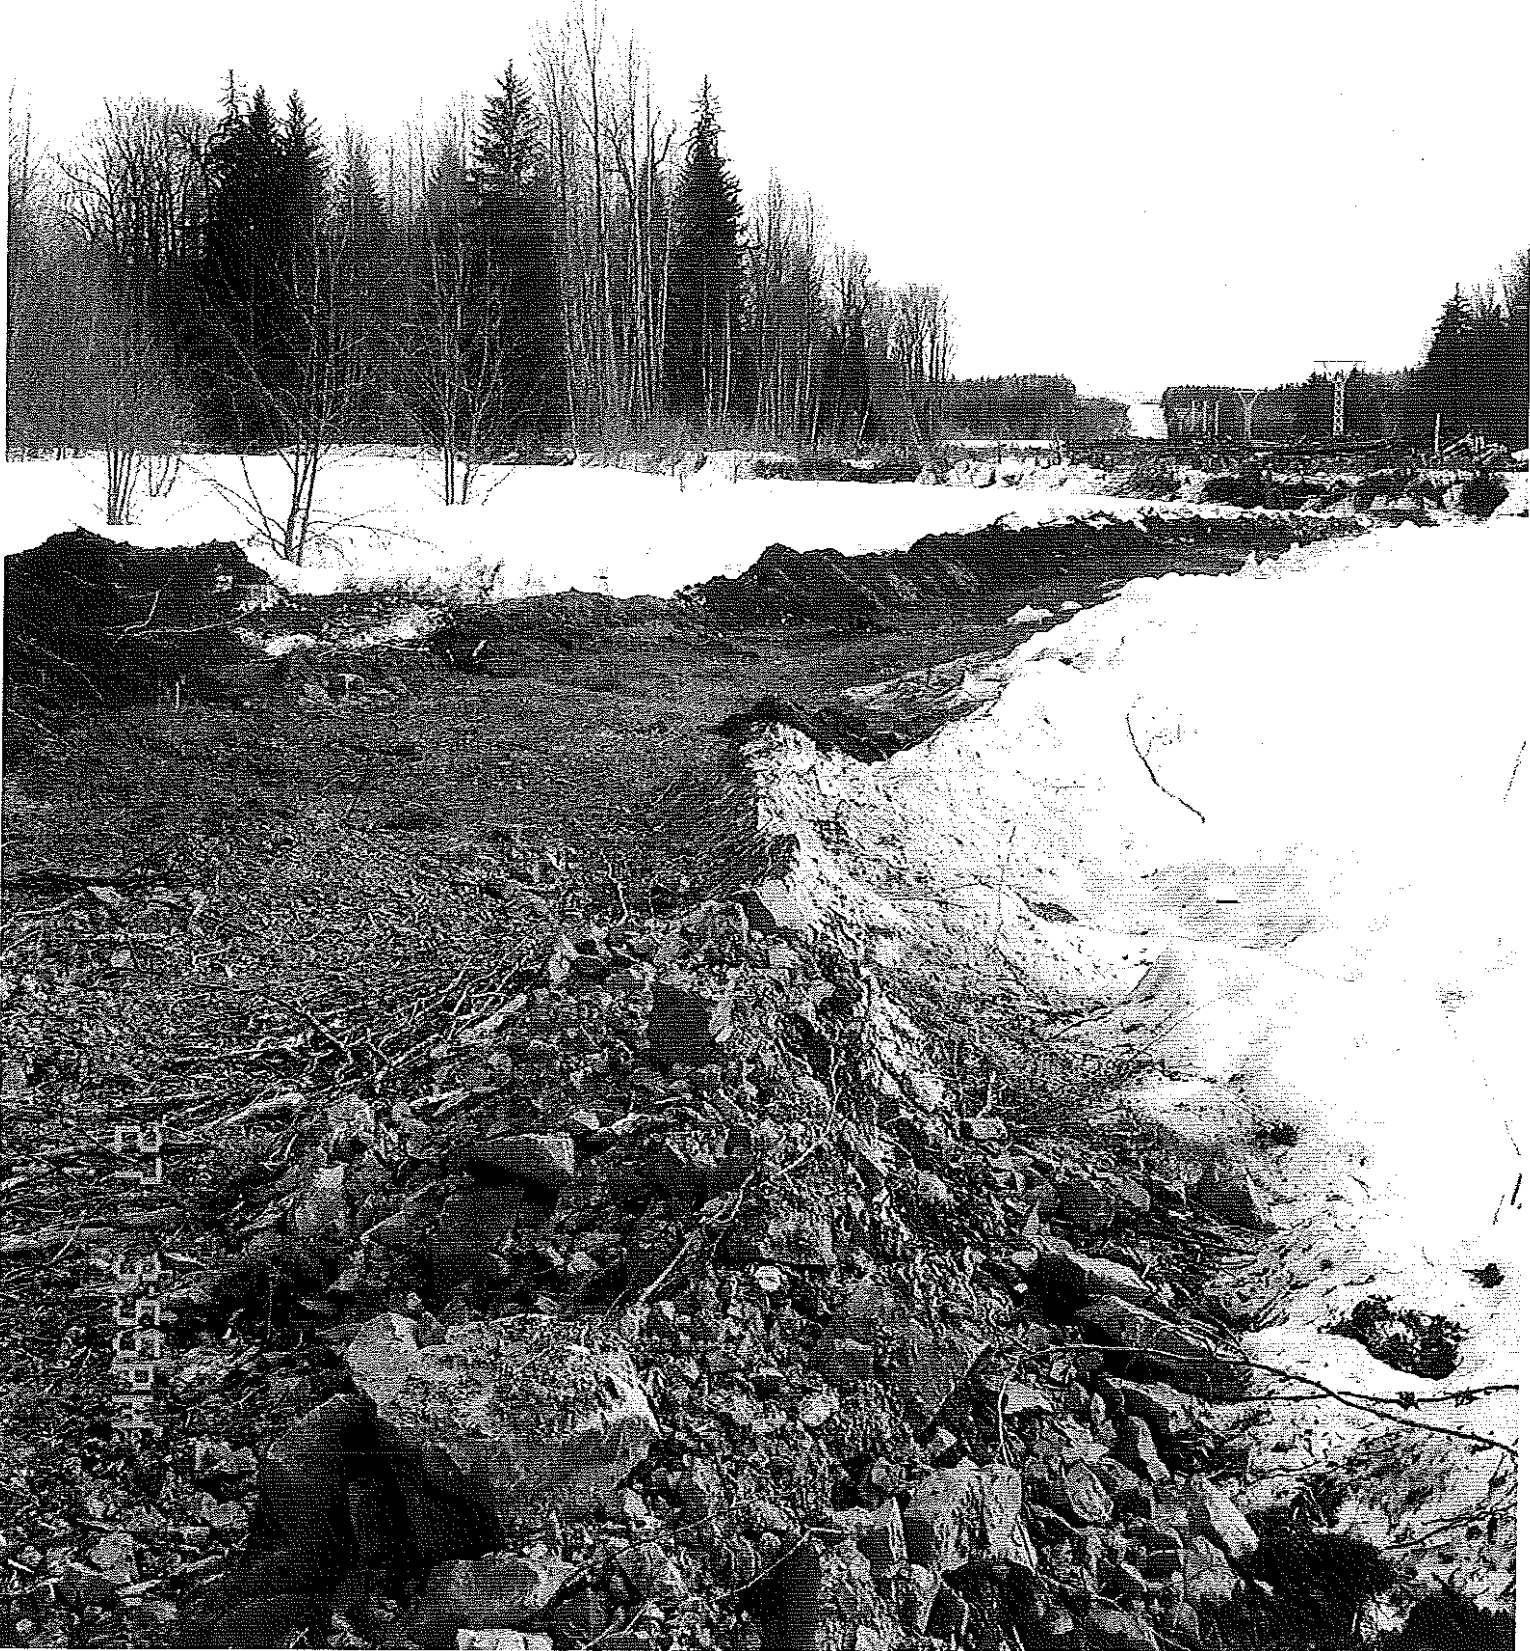
Fish stream crossing

Heavy equipment tracks indicate that at least several crossings have been made

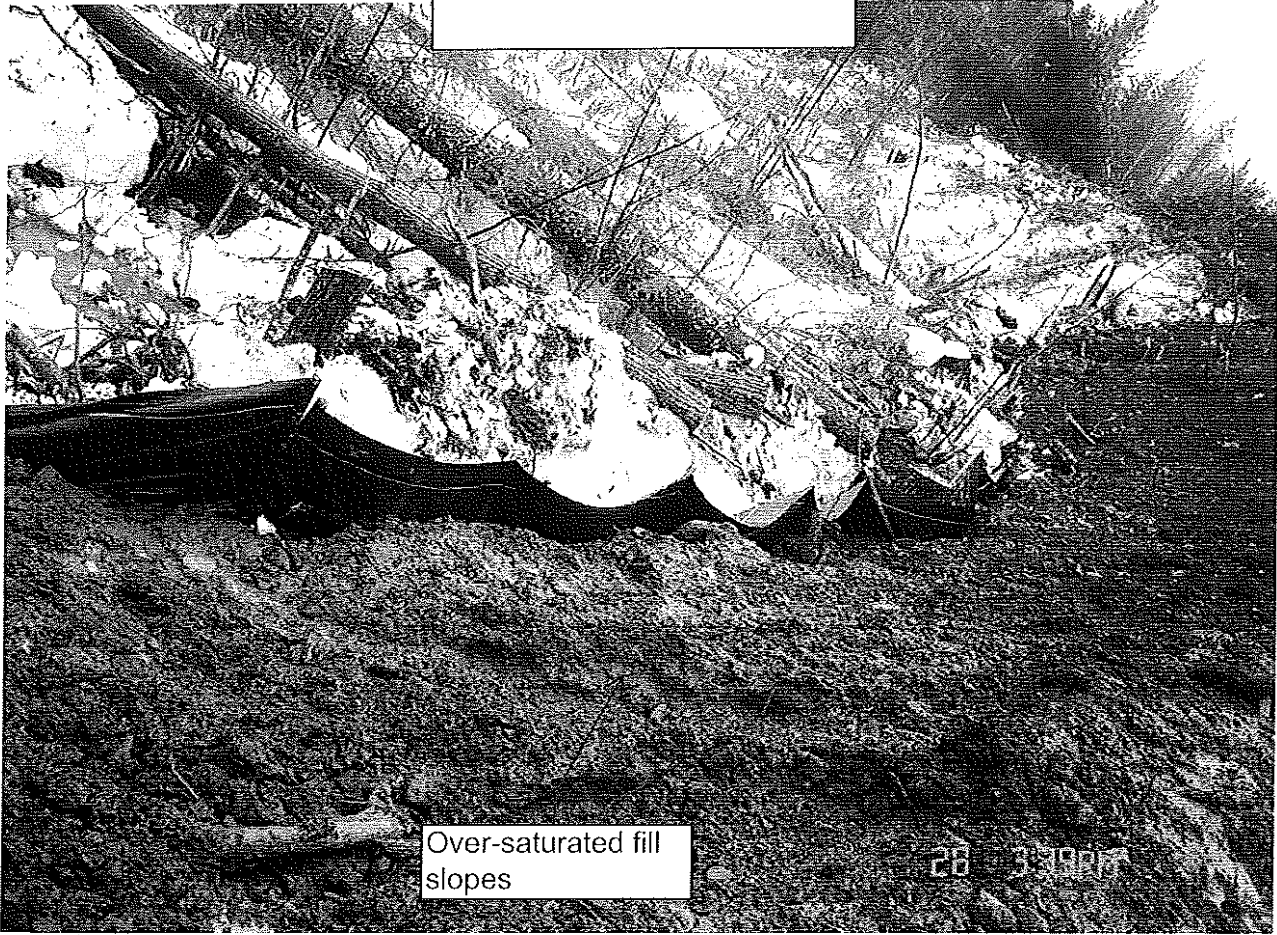
Sediment fencing failing due to fill slope movement

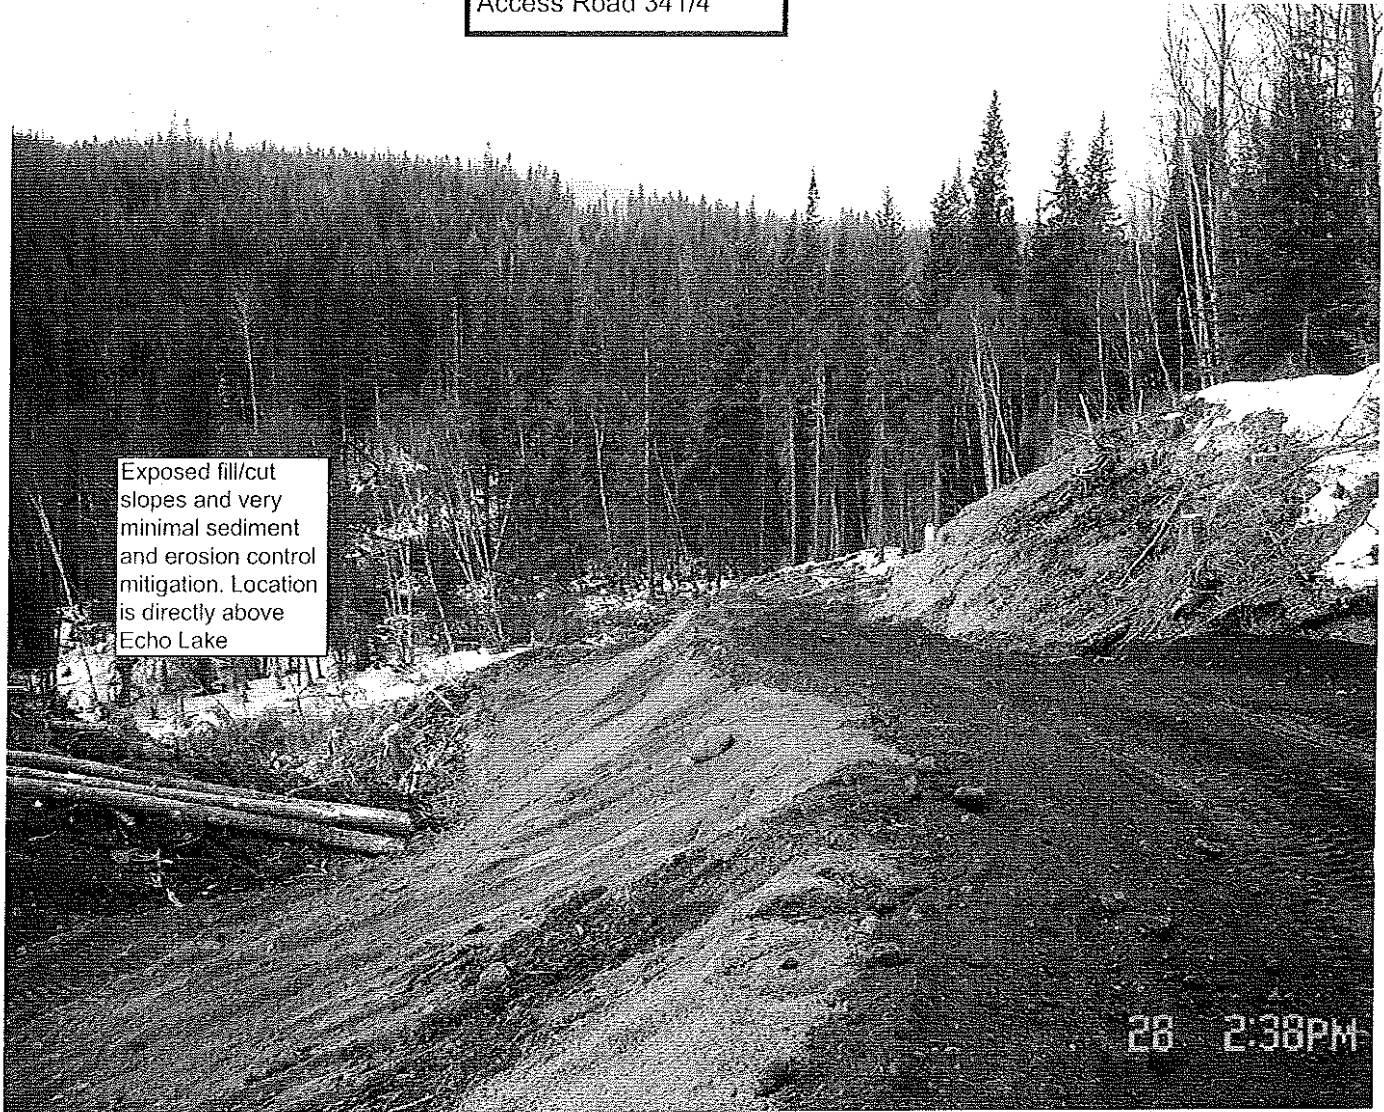
Access Road 341/4

Exposed fill/cut slopes and very minimal sediment and erosion control mitigation. Location is directly above Echo Lake

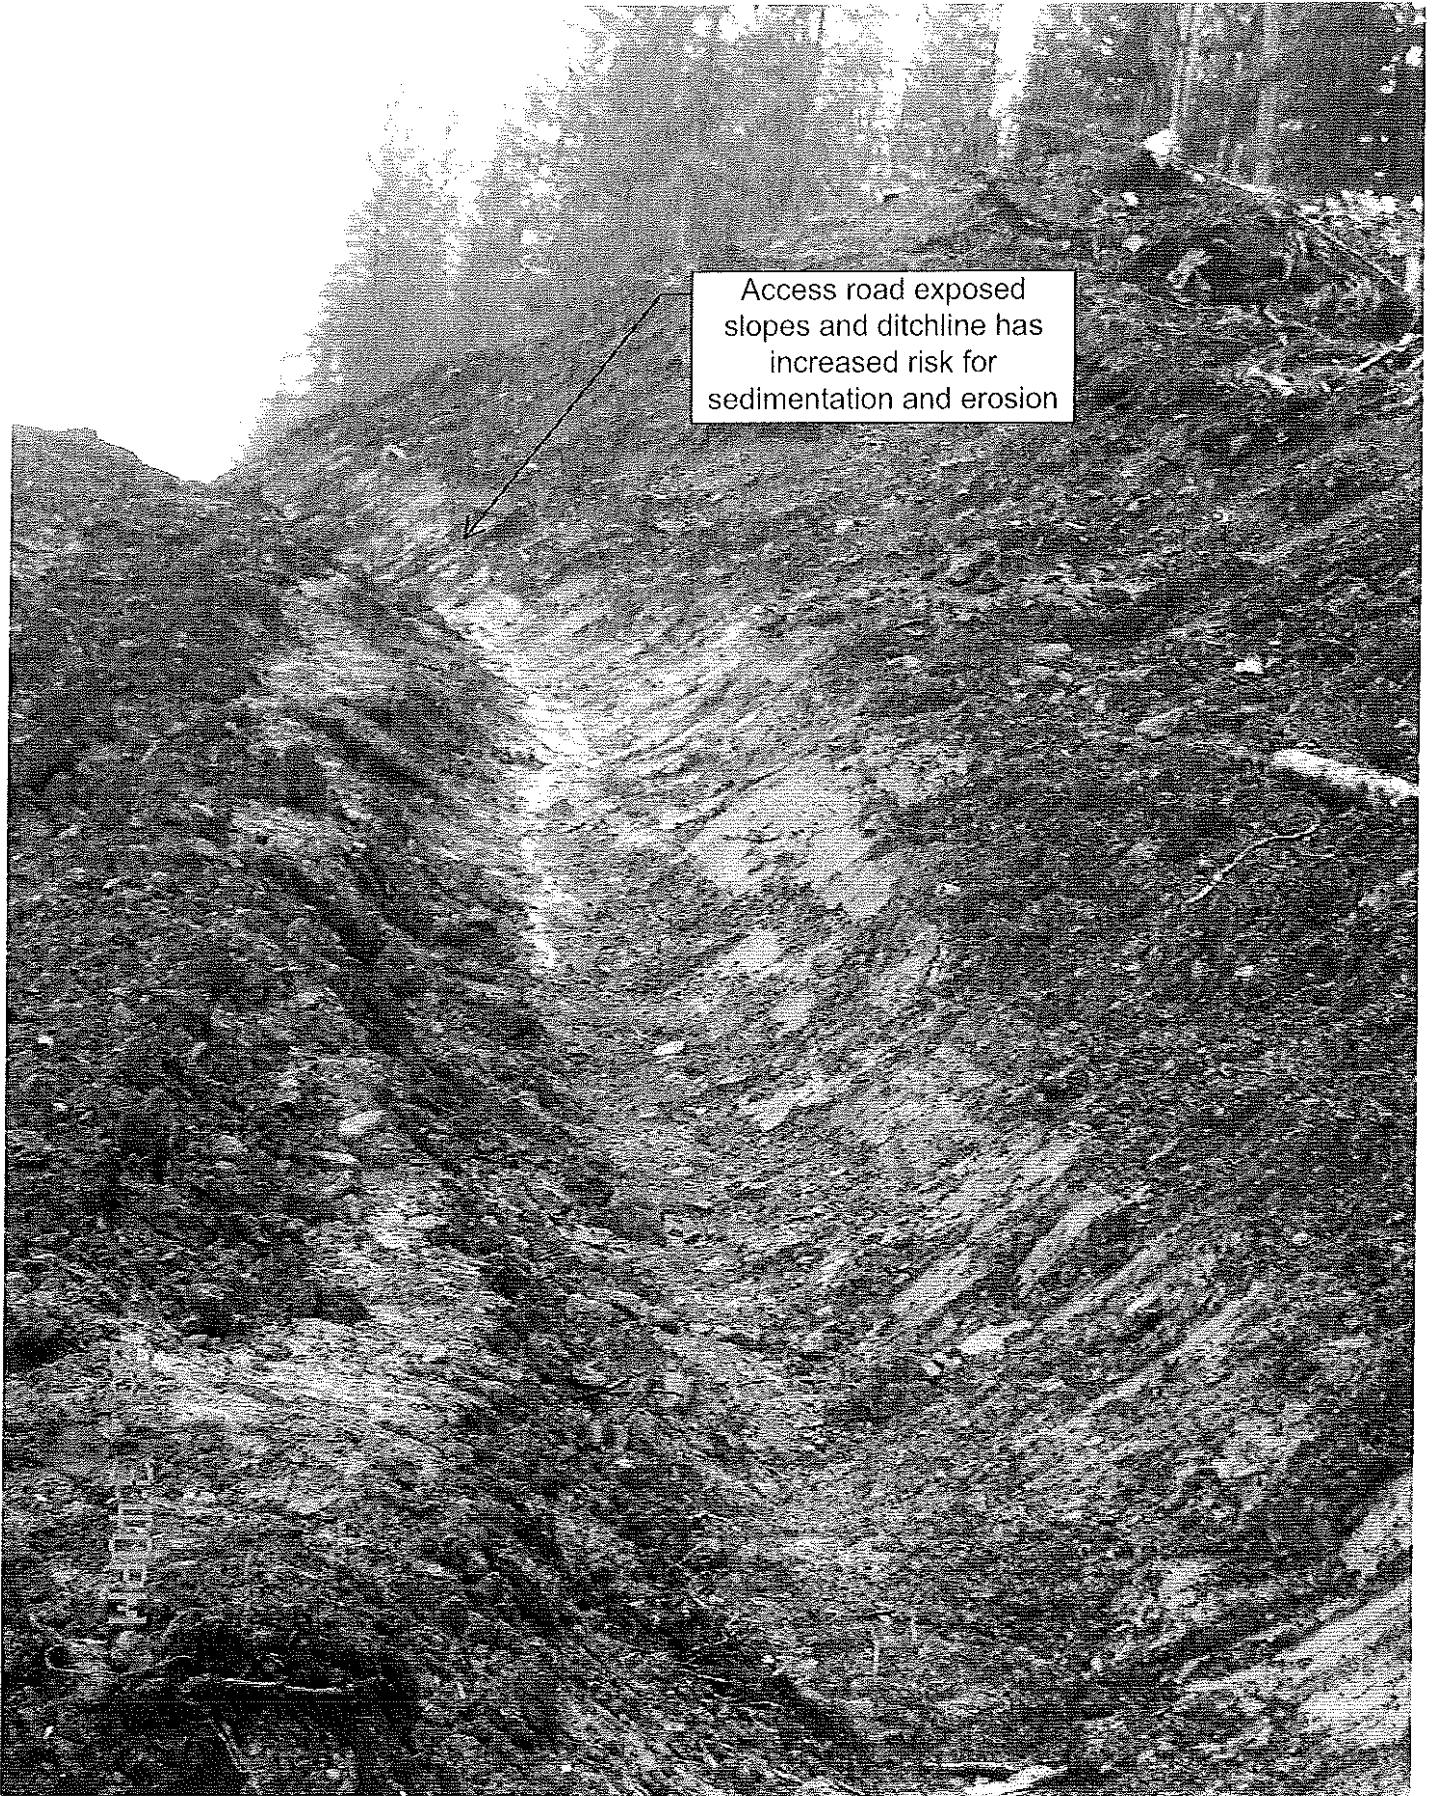
Access road exposed slopes and ditchline has increased risk for sedimentation and erosion

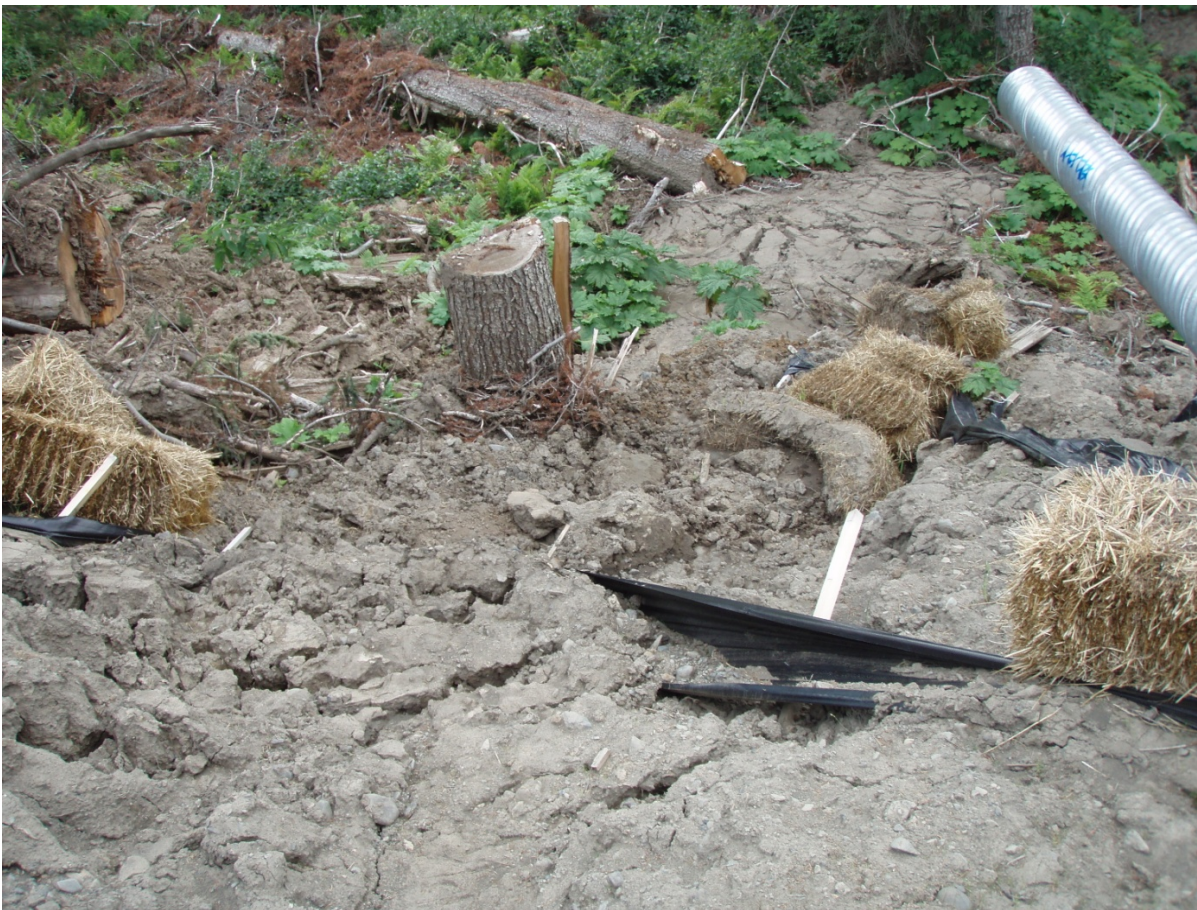
5.3 Sediment and Erosion Control

306-1 The environmental monitor commented that the sediment dam on 306-1, constructed with hay bales is failing but is too dangerous to action at the present time . Sediment and erosion control methods in the ditchline are not as effective or maybe contributing to the erosion of the road and sediment transport. It is the opinion of the Natural Resource Officer that if a permanent solution is not completed prior to the fall freshet that there will be significant impacts to the surrounding resources. See attached pictures.

The failure of the sediment and erosion control measures has allowed the transport material off the site.

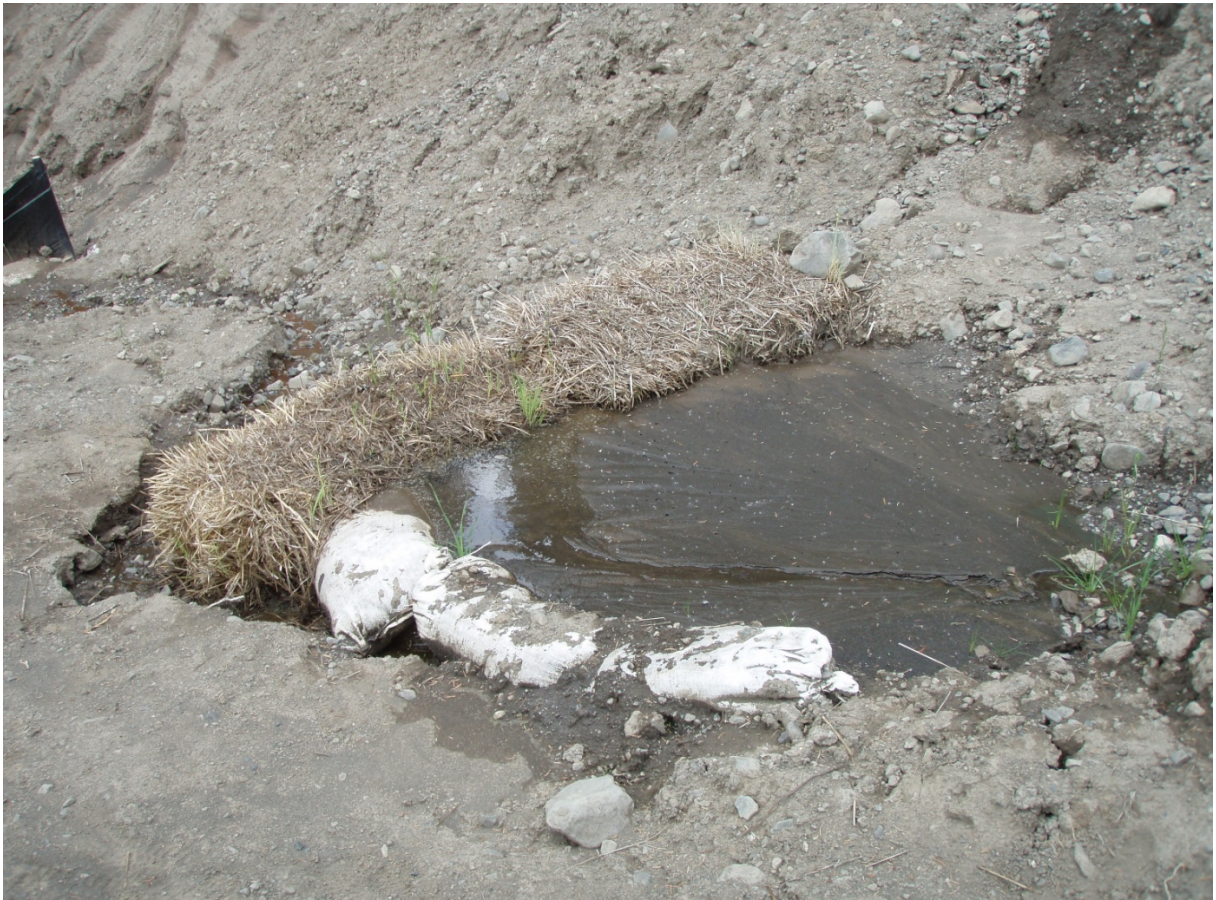
5.3 Sediment and Erosion Control

The effectiveness of the sediment and erosion control methods is compromised due to the lack of maintenance in a timely manner.

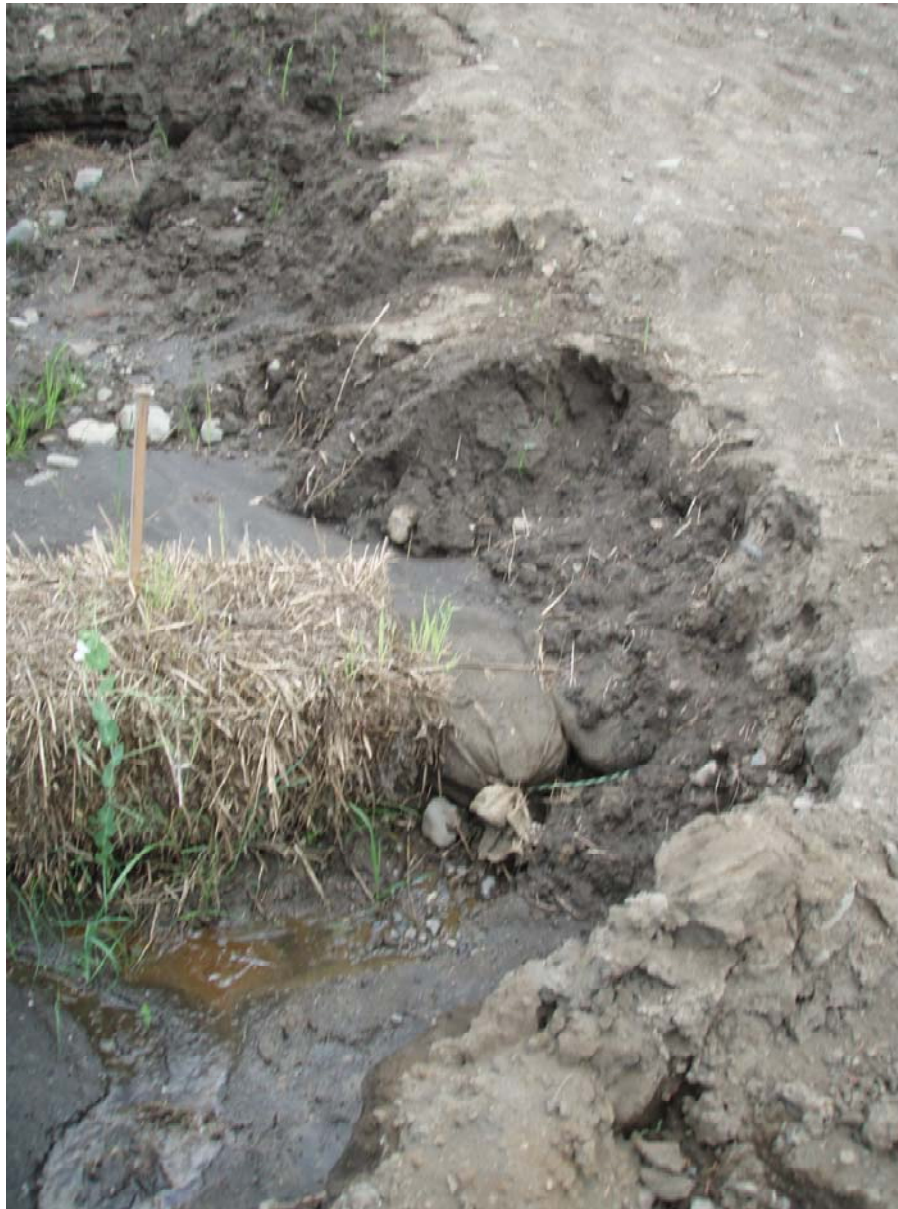
5.3 Sediment and Erosion Control

Erosion of the fine grained road building material

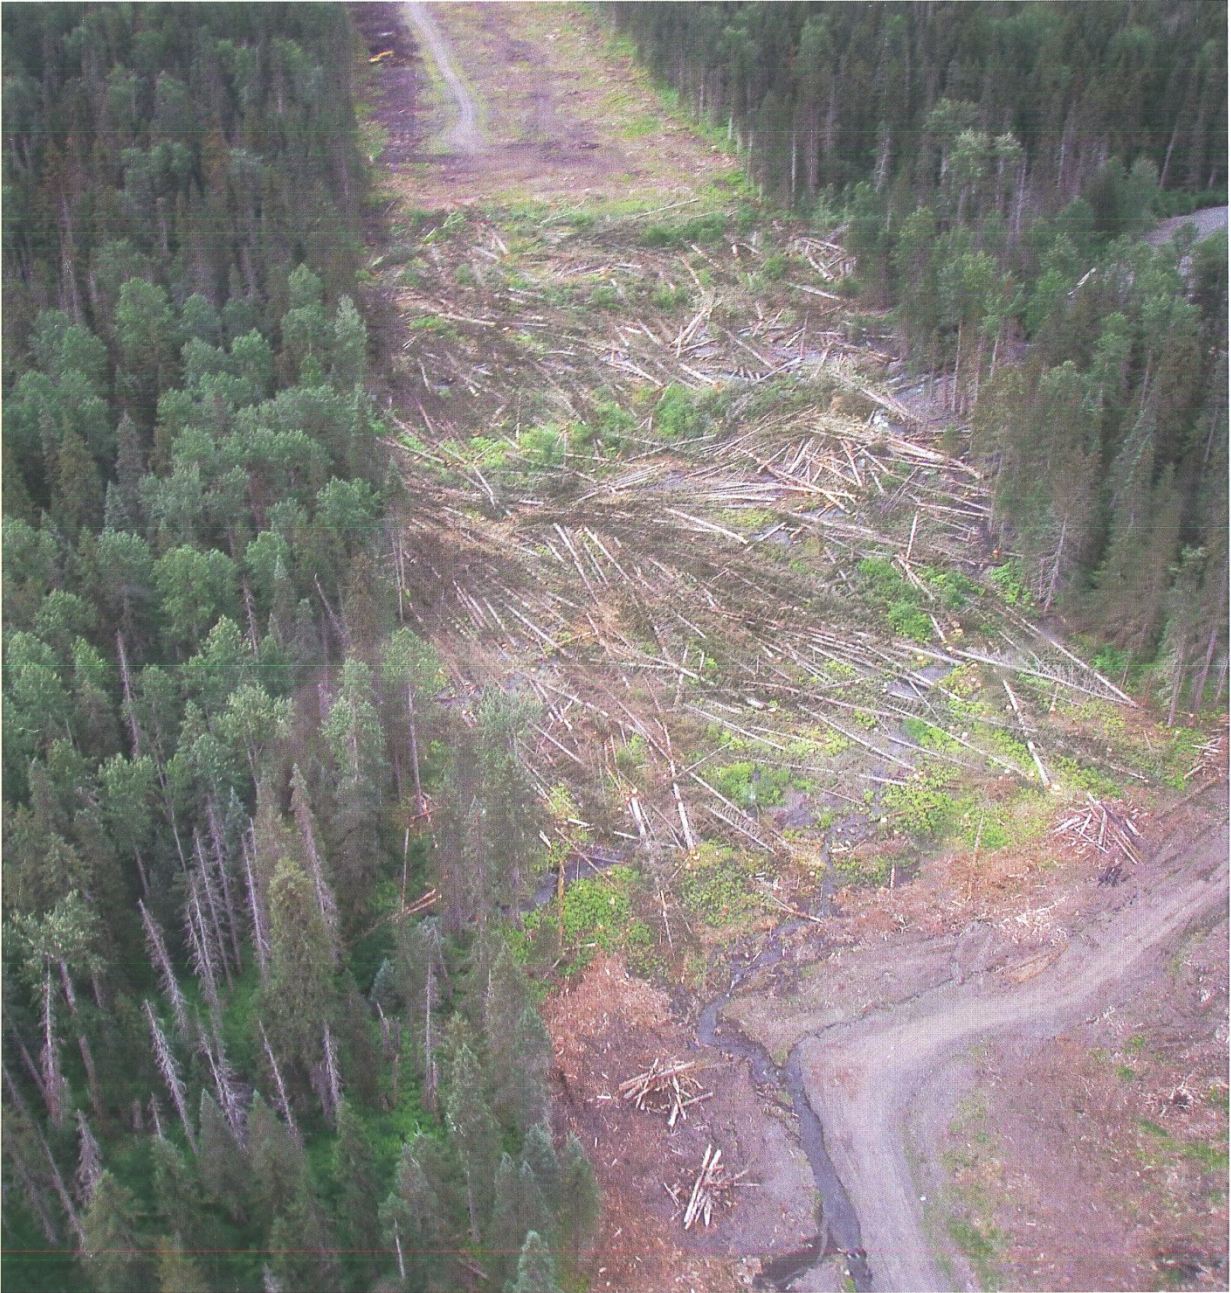
316-1 The hydro line r/w was felled in the winter and Revision creek meanders through the felled wood. Revision crk is on an alluvial fan. Part of the creek now runs down the ditchline of road 316-1. Gord Piddock of Valard communicated that the timber was felled and then the creek meandered through. Concerns regarding the sedimentation and erosion of the ditchline and road surface if more of the creeks flow establishes in the ditchline. See attached pictures

Revision Creek flows from the top right of the picture into the felled right of way. The creek braids into many channels, one channel has been established in the ditchline of 316-1. The Environmental Management Plan (EMP), figure 58 of 63 confirms fish bearing water bodies in the meandering channels of Revision Creek.

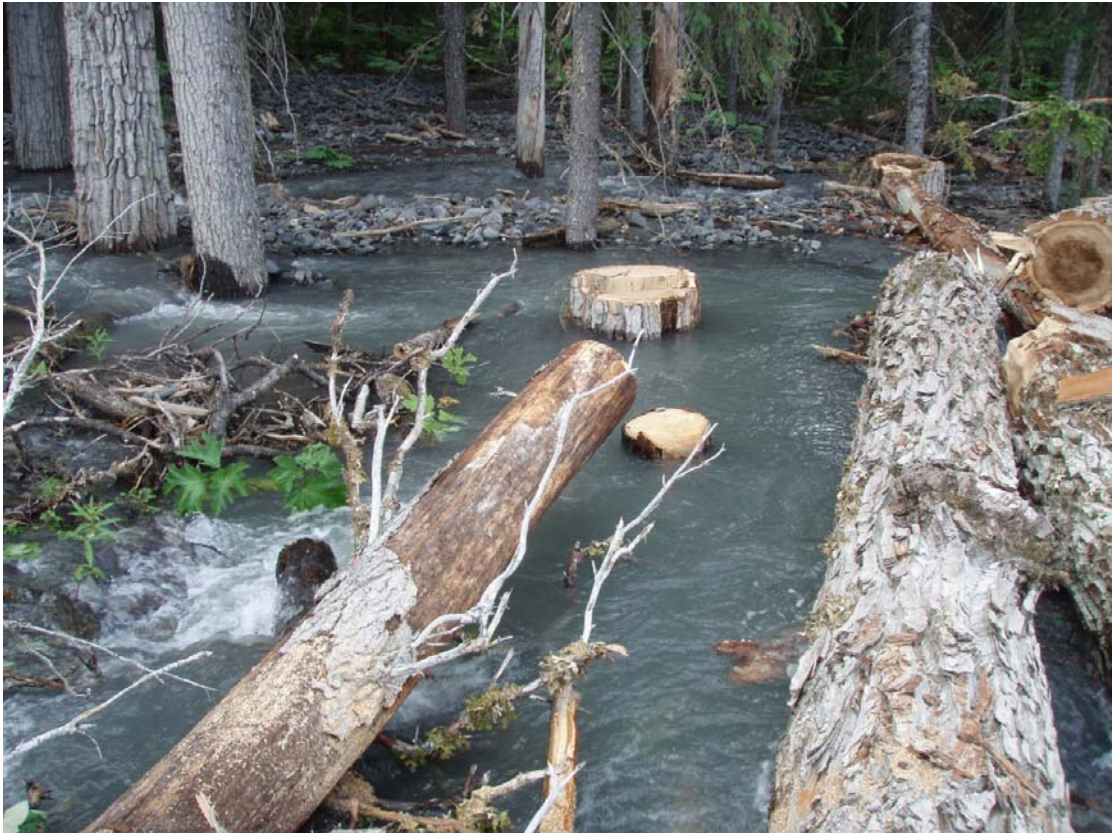
Land clearing on the alluvial fan of Revision Creek.

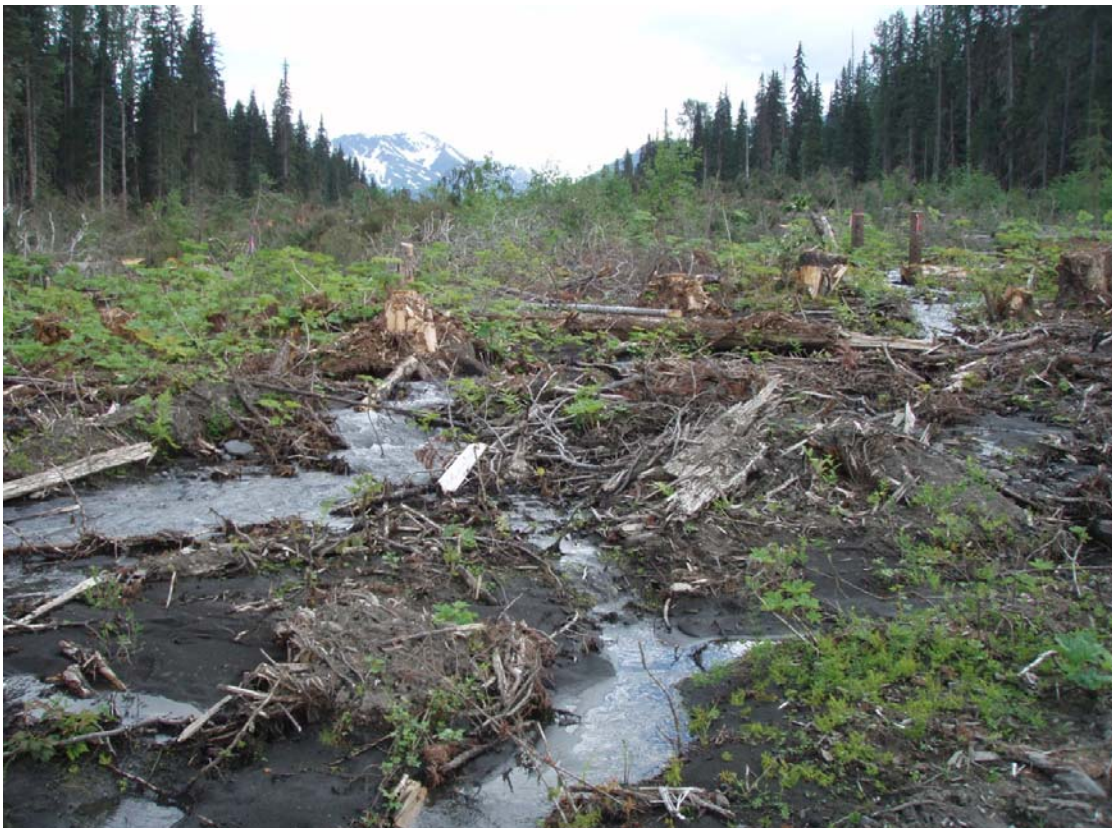
Revision creek meandering through the NTL right of way.

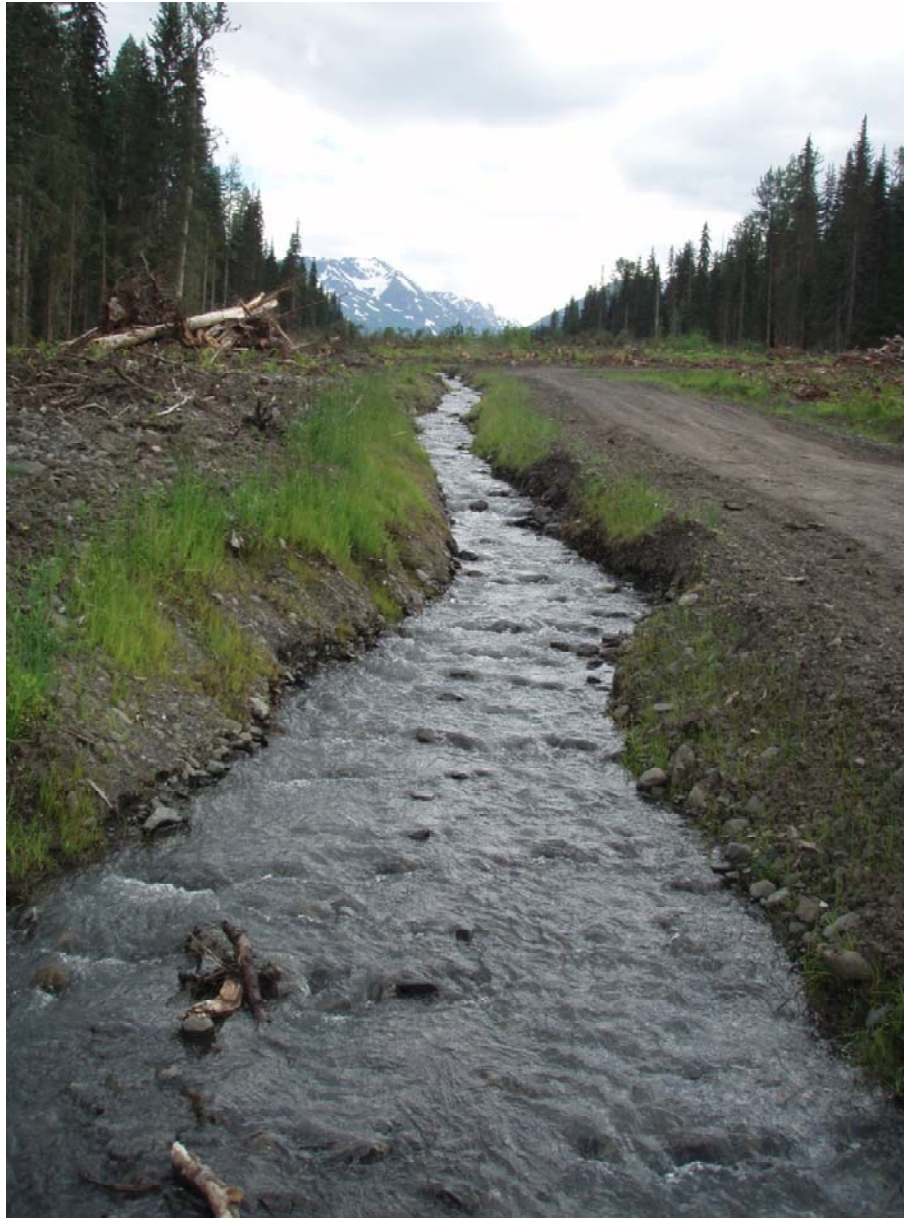
Some of Revision creek running down the ditchline of new access road.
