BRIEFING NOTE

- Update on the explosions and fires at the Babine Forest Products mills at Burns Lake
Not Responsive

- In November 2012, WorkSafeBC completed its investigations into the explosion on January 20, 2012 at the Babine Forest Products Company in Burns Lake
Not Responsive

This incident investigation report sets out WorkSafeBC's analysis and conclusions with respect to the cause and underlying factors leading to the workplace incident of January 20, 2012, at the Babine Forest Products Limited sawmill located at 19479 Highway 16 East in Burns Lake, British Columbia. The purpose of this report is to identify and communicate the findings of this incident to support future preventive actions by industry and WorkSafeBC.

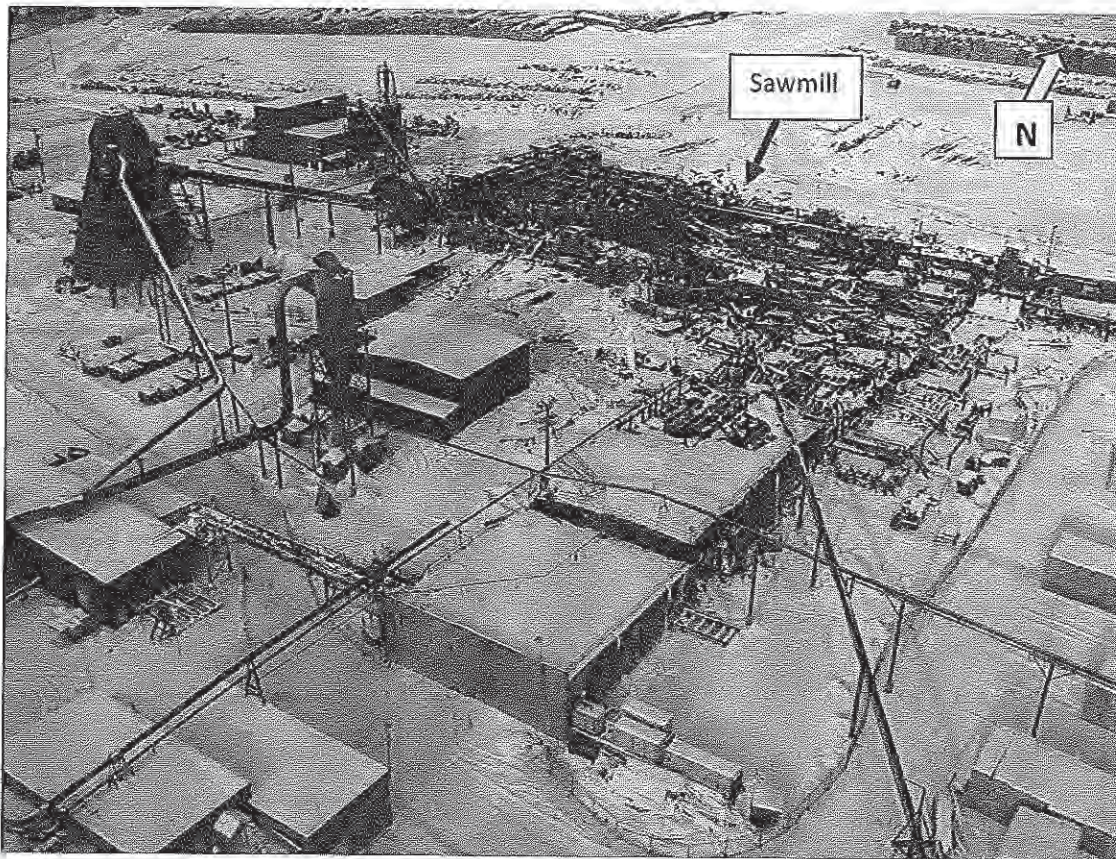
Figure 2: The sawmill after the explosion and fire on January 20, 2012.

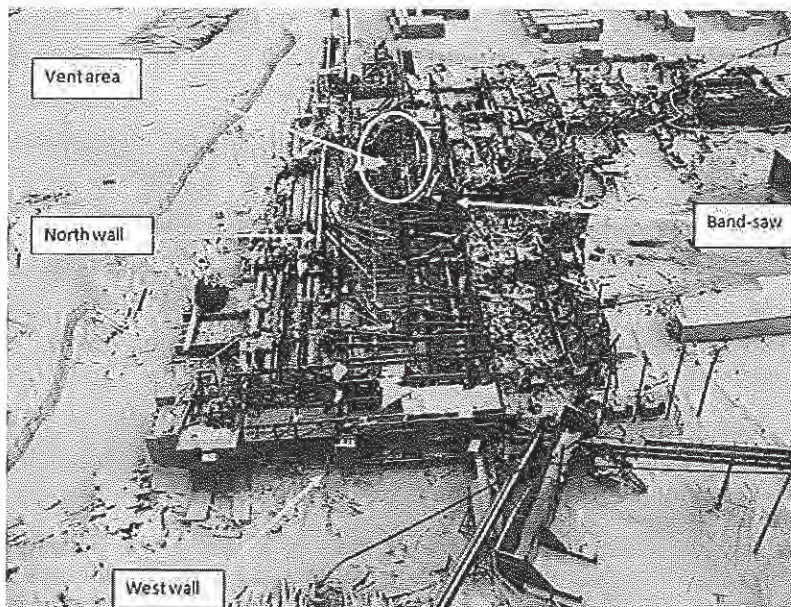
Aerial photographs of the mill site were taken and reviewed after the incident. These photographs show a large oval breach in the roof members of the building structure, as well as the path that the pressure wave took through the sawmill (Figures 4 and 5). From the breach, the gluelam (glued laminated timber) roof beams and steel members were pushed west. To the east of the breach the gluelam and steel beams have been thrown up and piled at the edge of the roof crater. At the northern end of the sawmill structure the outer walls were pushed out. Most of the other wall structures including the sorter and packaging areas of the mill were burnt but not displaced.

Figure 4: The sawmill as seen looking east. The vent area is shown by the yellow oval.

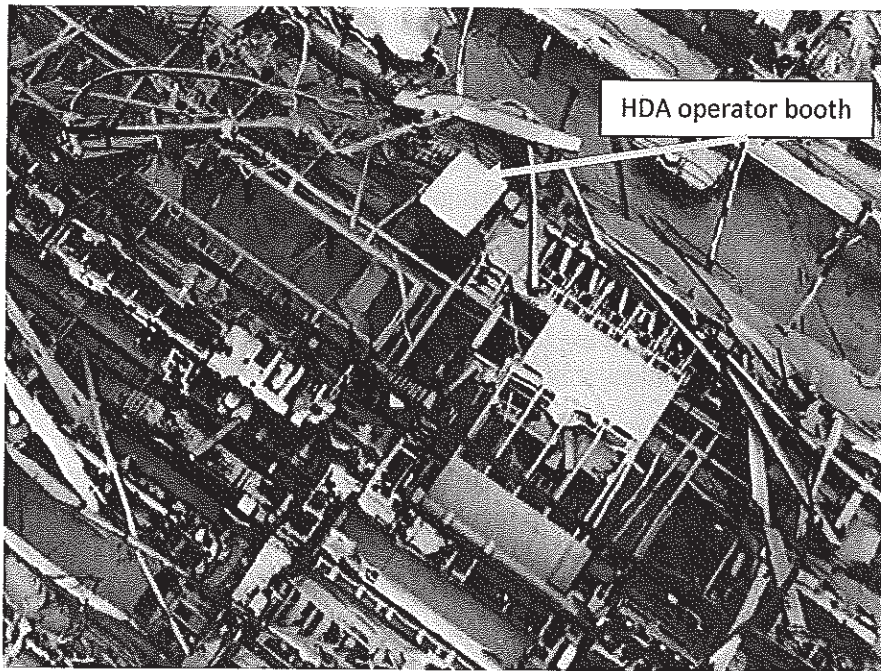
Figure 5: Close-up of the explosion vent area. Note the beams thrown out around this area. North is at top of the photograph; the horizontal double arbor (HDA) booth shown is located at D-19 (Appendix 3).

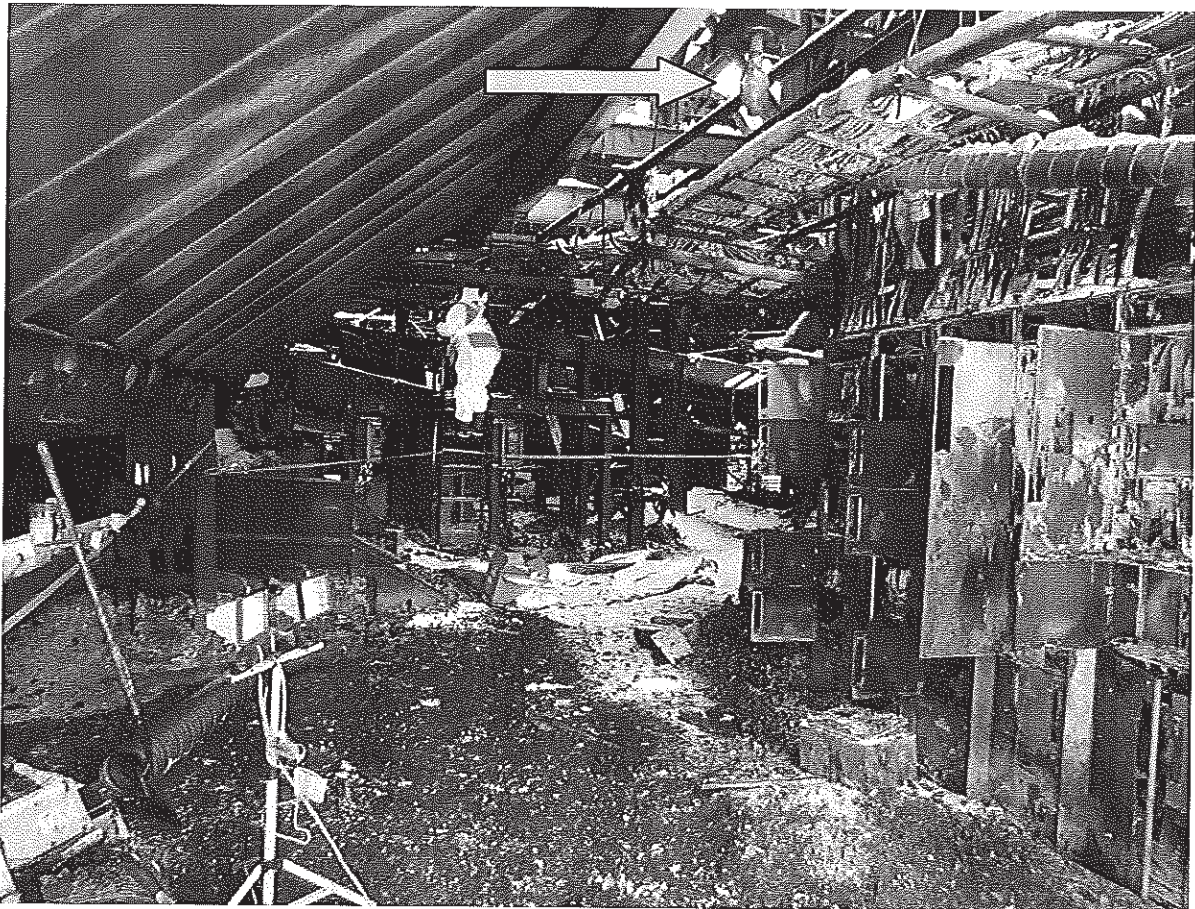
The available evidence did not support the hypothesis that a metal halide lamp failed catastrophically and initiated the explosion. In the areas where such lamps were present, there was no clear blast damage or blast directional indicators. The initial area where the investigation began, near the boiler room and MCC-10 electrical panel (H-16, Appendix 4), did contain metal halide lighting, but the bulb found in its fixture directly in front of the MCC-10 panel would likely not have survived intact if the explosion had originated near here or the full force of the explosion had reached this area.

Figure 7: This view looking east from in front of the boiler room (G-15, Appendix 4) shows the MCC-10 electrical cabinet on the right and conveyor 9-92 on the left. The metal halide bulb (yellow arrow) is intact.

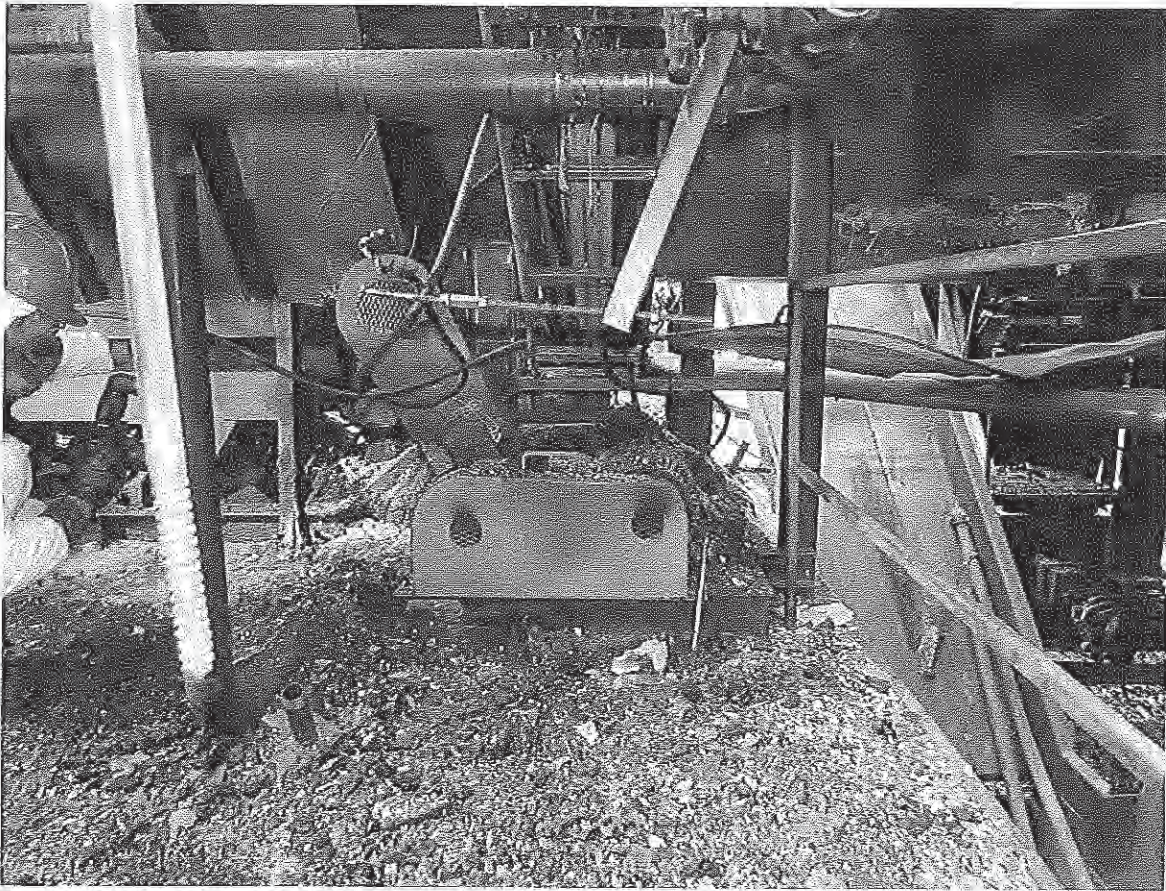
The motor was located in the half-basement, immediately below the #1 eliminator outfeed table, an area that was known to be very dusty. Because the output speed of the electrical motor (1,750 rpm) was too fast for the conveyor speed, the motor had been coupled with the 40:1 gear reducer to slow it down to a speed at which the driven conveyor could operate. The motor drove the gear reducer by means of two V-belts; in turn, the gear reducer turned the head-spool of the SEO waste conveyor by means of sprockets and a chain drive.

Figure 8: The motor and gear reducer assembly with guard, seen from north looking south. The drop to the full basement is at the right of the photograph.

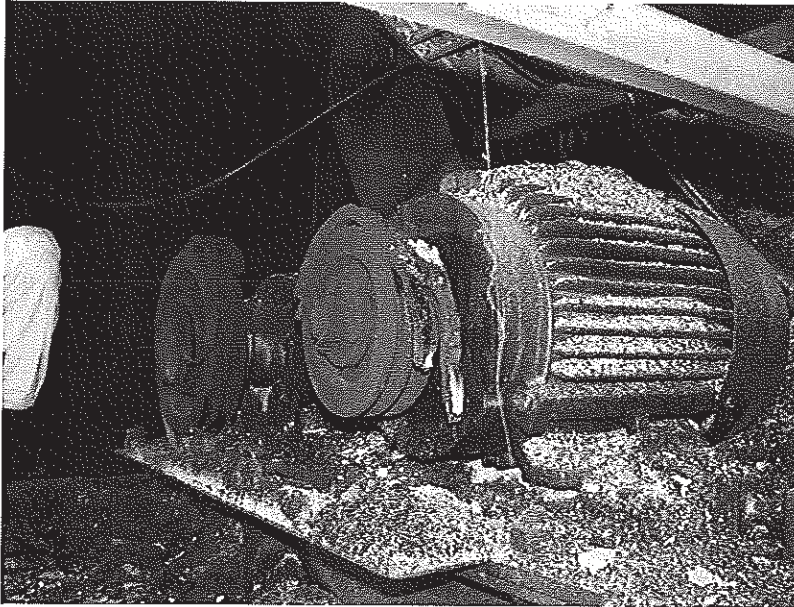
- The rear of the guard showed heavy burn damage in the centre area.
- The interior showed heavy fire damage, especially along the top.
- Within the interior of the guard, there were definite lines in the fire patterns. These lines angle away from the gear reducer sheaves and climb up the inside of the guard towards the motor sheaves.
- On the interior walls, there was evidence of very compacted wood dust residue.
- The two V-belts were burnt away between the motor and reducer.
- The V-belt remains were still sitting on the equipment sheaves.
- There was some un-burnt wood dust on the mounting plate within the guard.
- The front of the guard showed fire and smoke patterns emanating from the two inspection holes.
- The area outside the guard between the motor and reducer was significantly burnt.

Figure 9: Motor and gear reducer assembly shown with guard removed.

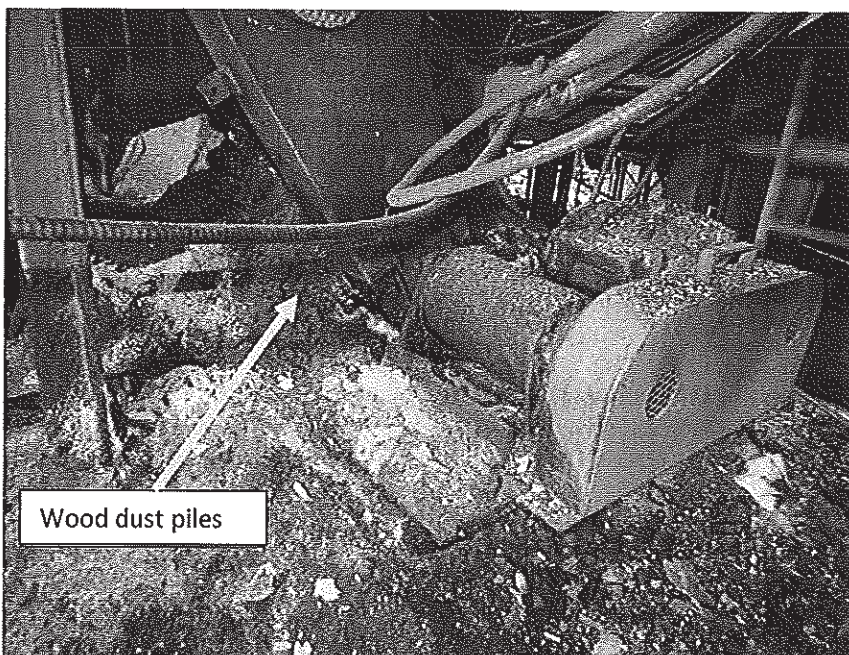
The area behind the motor and gear reducer, which is under the head-spool of the #2 SEO waste conveyor, contained excessive amounts of wood dust (Figures 10 and 11).

Figure 10: Excessive waste build-up was found under the eastern end of the #2 SEO waste conveyor 8R-25.

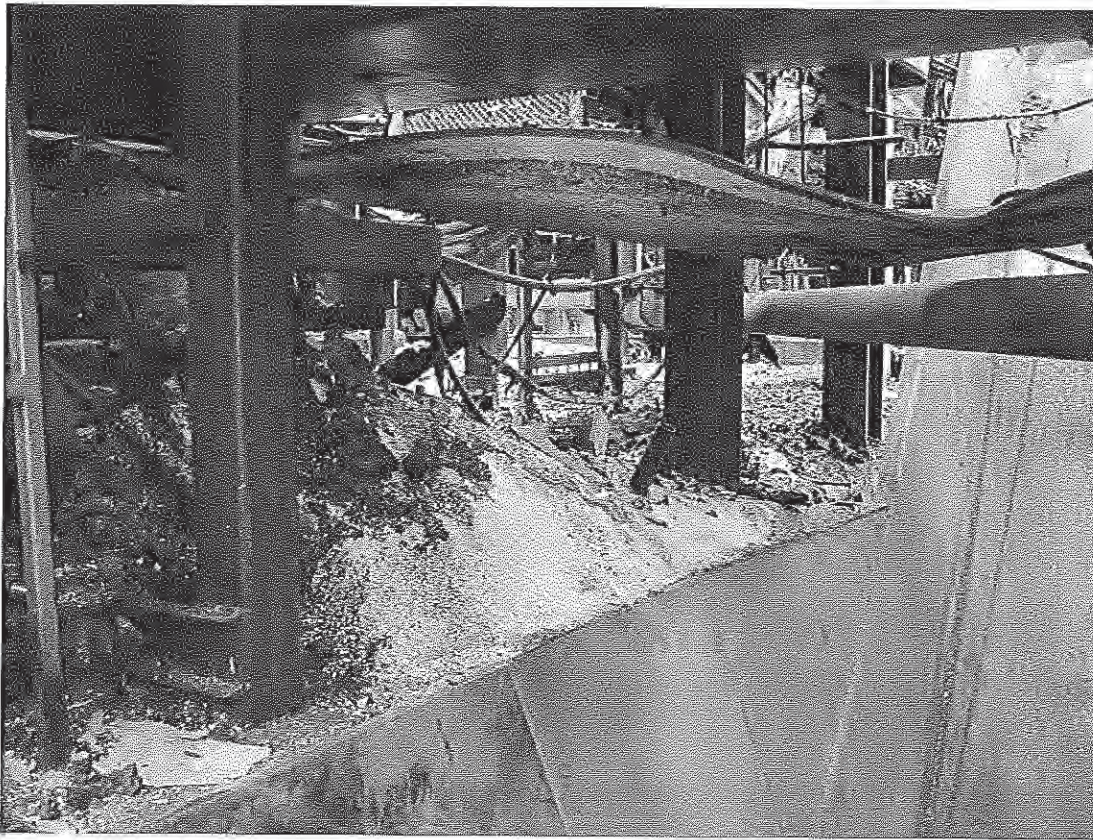
Figure 11: Excessive wood waste build-up was found behind the motor assembly.

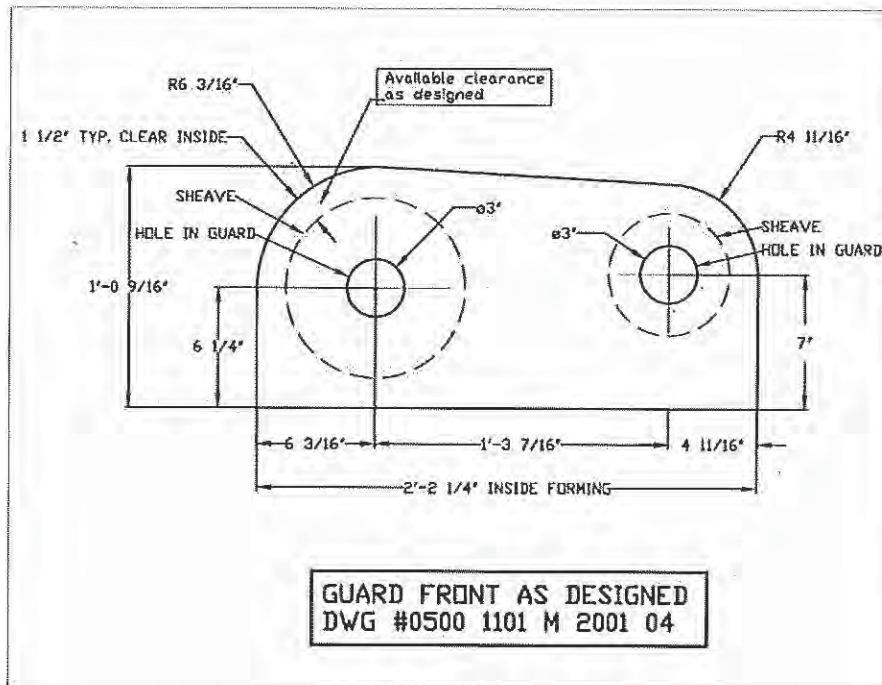
Babine submitted to WorkSafeBC the maintenance and work order records for the motor and reducer set. The records show that conveyor 8R-25 was a recent modification that was designed and installed by an outside contractor in late summer 2011. The motor and drive unit was installed by the contractor but the wiring was done by mill electricians. The conveyor was re-tensioned in October 2011; subsequently, a replacement guard for the chain drive had to be constructed because the chain was making contact with the inside of the original guard.

Figure 12: The original design drawing as re-created by WorkSafeBC. The red circles represent the sheaves within the guard. The gear reducer is to the left, while the motor is to the right.

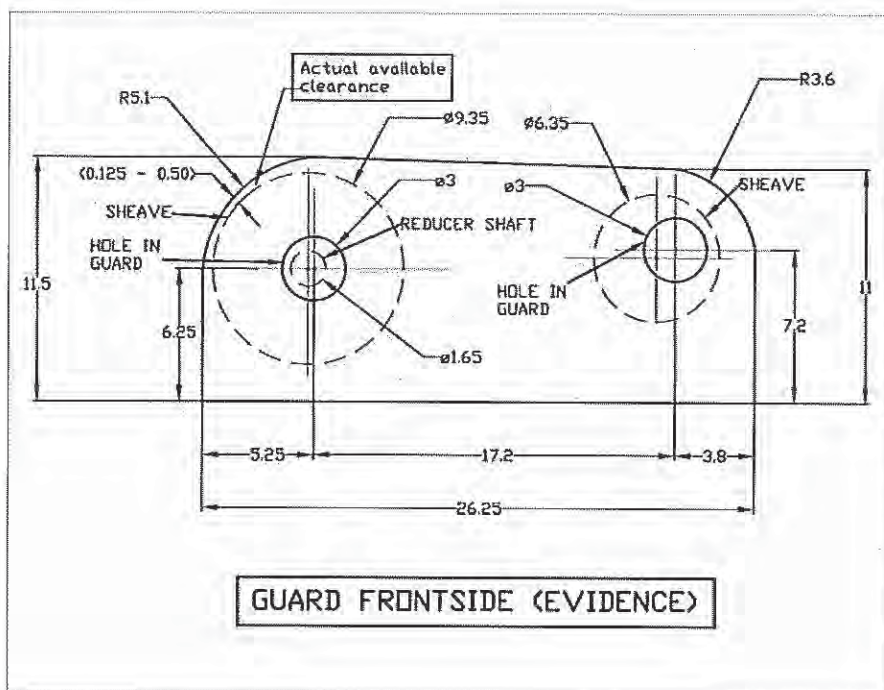
Figure 13: The actual clearance available within the guard as calculated by WorkSafeBC.

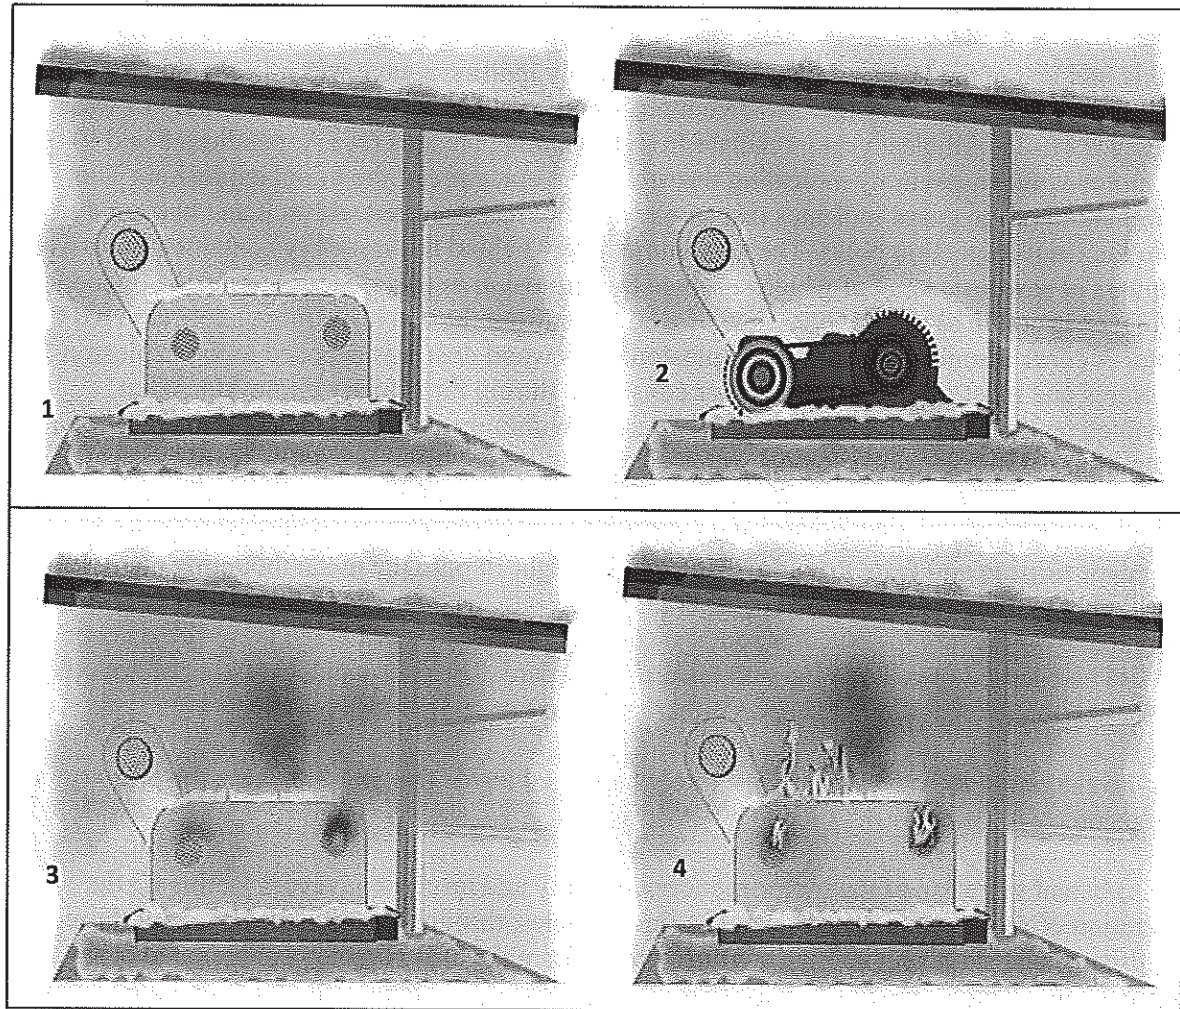
Figure 14: An artist's depiction of the most likely sequence of events within the V-belt guard:
(1): The motor-reducer assembly in place.
(2) The rotation of the V-belts and the build-up of saw dust (with the guard is removed for clarity)
(3) The smouldering fire created by the frictional heating of the V-belts through the compacted sawdust.
(4) The smoulder reaching areas where oxygen is available and a full flame develops. The explosion of the wood dust in the surrounding air followed.

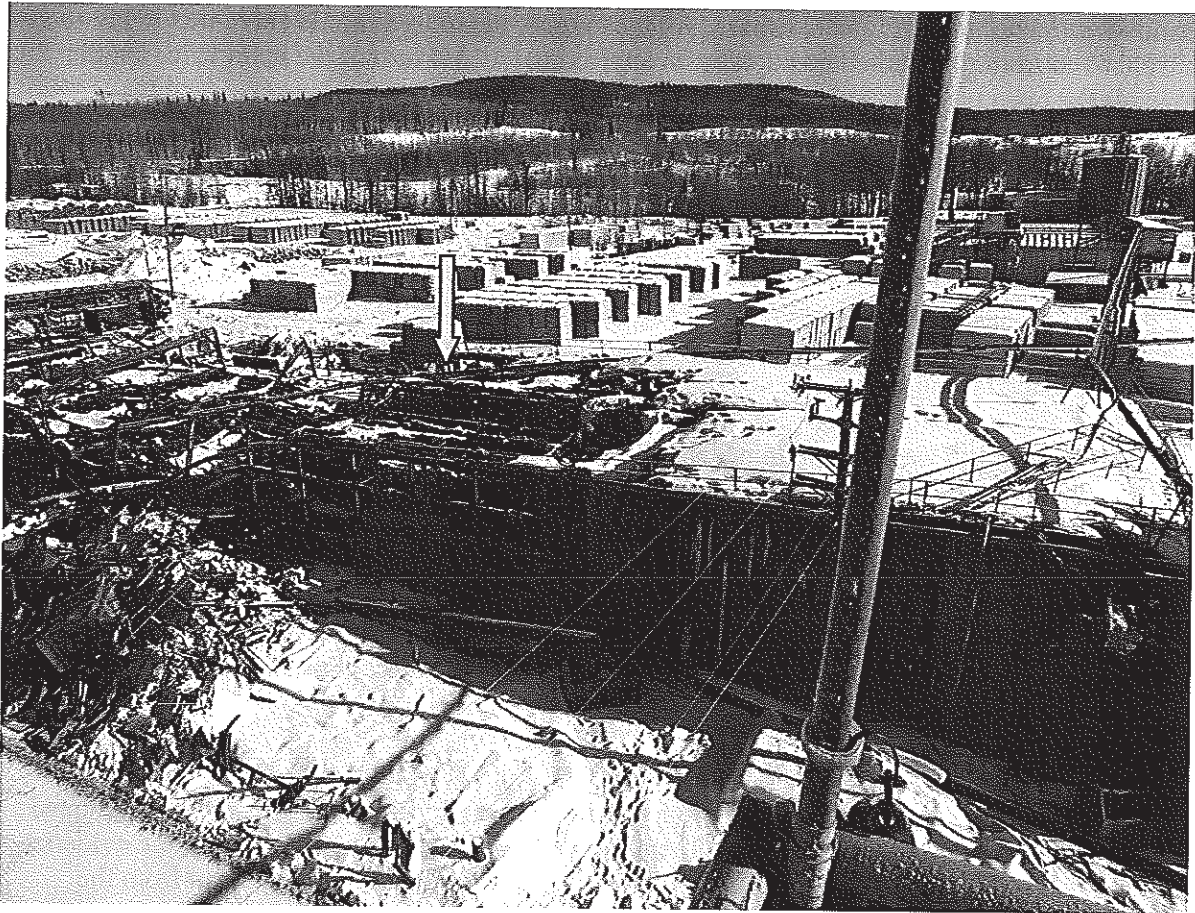
likely have made them ill. Gas did play a role in the fire following the explosion, however. The gas service line to the mill above the regulator mounted on the east wall of the sorter wing at V-27 (Appendix 3) was recorded as broken at 20:07 due to the explosion, and gas continued to flow freely until it was shut off at 20:47. This uncontrolled release of natural gas at 60 psi into the sorter wing of the mill fuelled the fire in this area, which ended up being one of the worst damaged areas of the sawmill structure (Figure 16). Natural gas was therefore a contributing fuel for the fire following the explosion in this incident.

Figure 16: View of the sorter wing of the sawmill, looking east. The yellow arrow indicates approximately where the natural gas line broke. The fire damage near this location is evident.

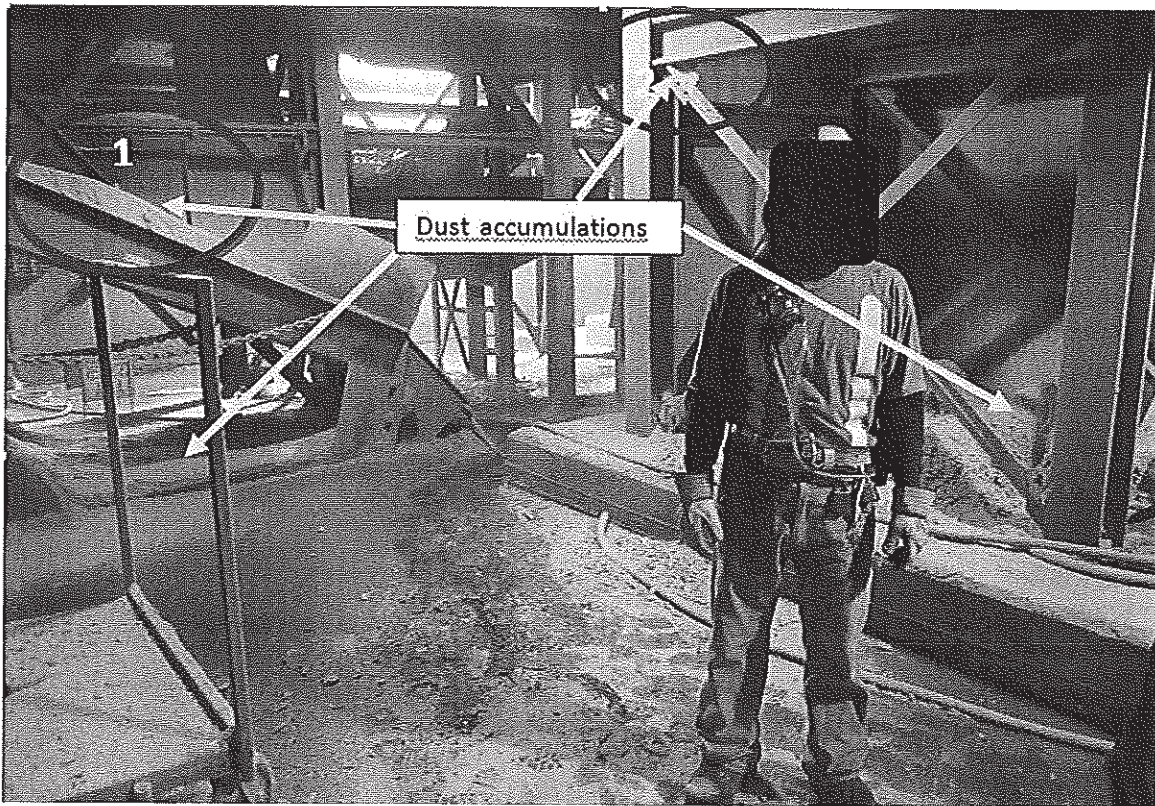
Figures 17 to 24 illustrate the unacceptable problem with dust accumulation at the sawmill.

Figure 17: Dust accumulations in the basement level of the sawmill. (Photograph by WorkSafeBC, November 22, 2011.)

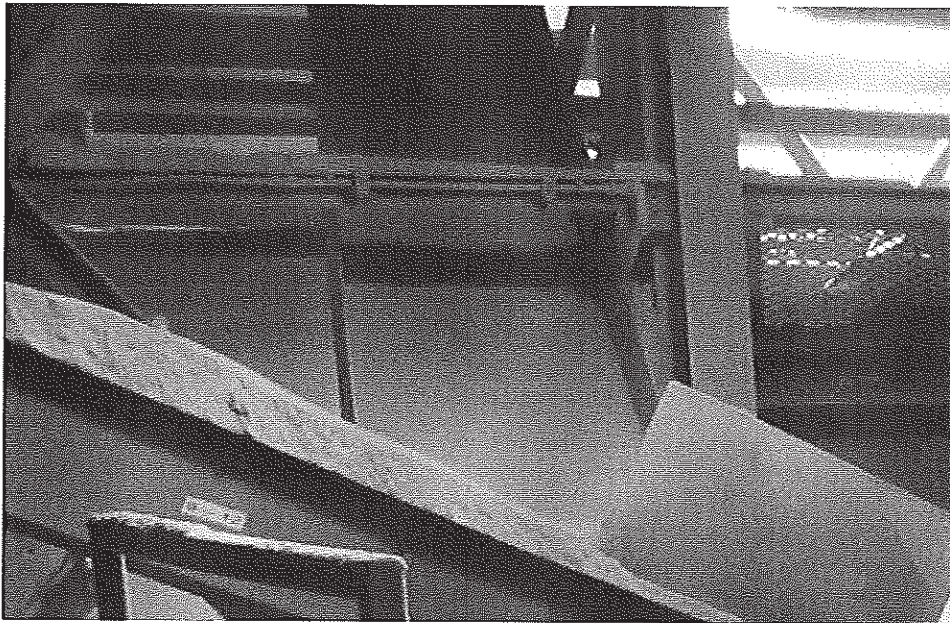
Figure 18: Dust on the conveyor labelled (1) in Figure 17. (Photograph by WorkSafeBC, November 22, 2011.)

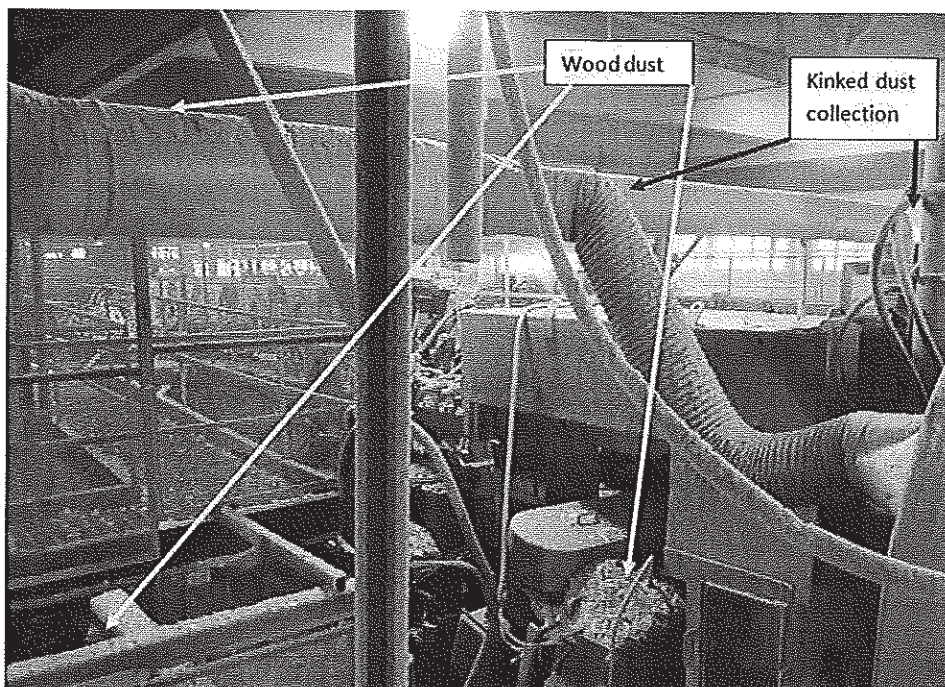
Figure 19: Wood dust on bandsaw equipment and ducting as well as the kinked areas which restrict flow. (Photograph by WorkSafeBC, November 23, 2011.)

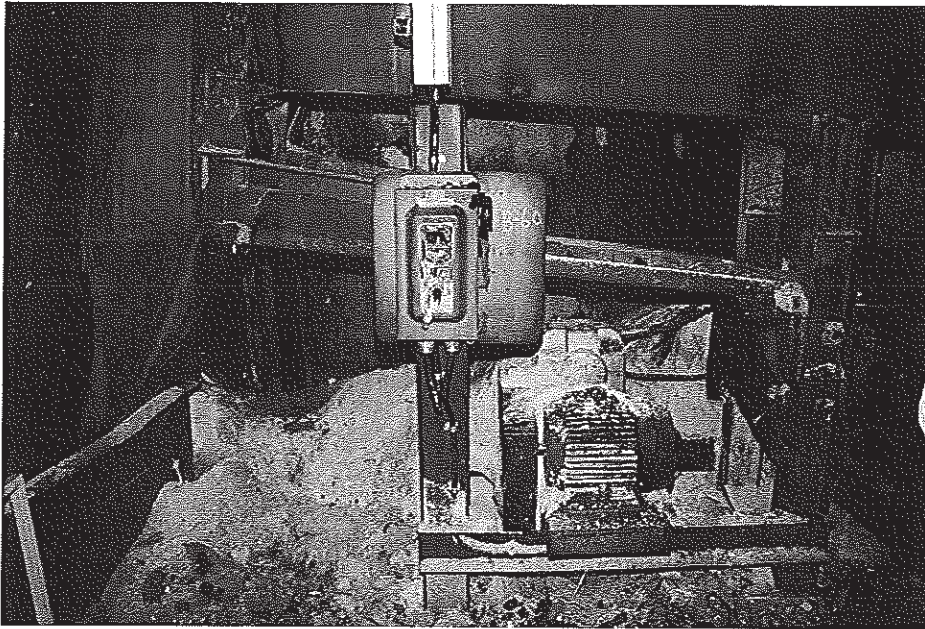
Figure 20: Wood dust and waste accumulations around the head-spool of waste conveyor 9-36 where it terminates and dumps into the main north wall waste conveyor 6-53 (C-25, Appendix 4). This wood waste was protected from the explosion travelling west over the conveyor structure. (Photograph by WorkSafeBC, following the explosion.)

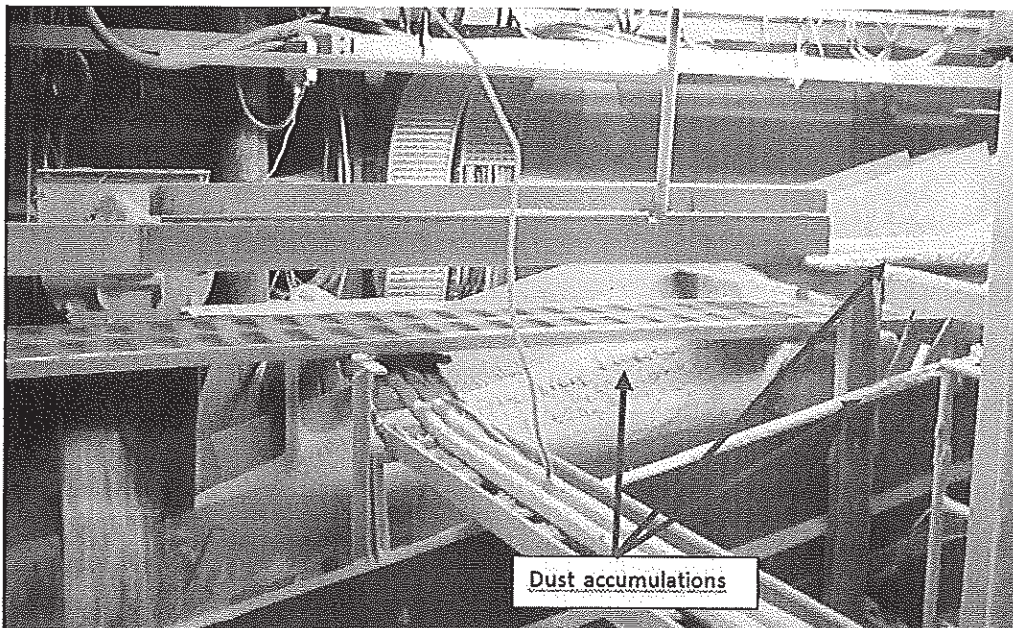
Figure 21: Dust accumulations near H1-23 (Appendix 4). (Photograph by WorkSafeBC, November 22, 2011.)

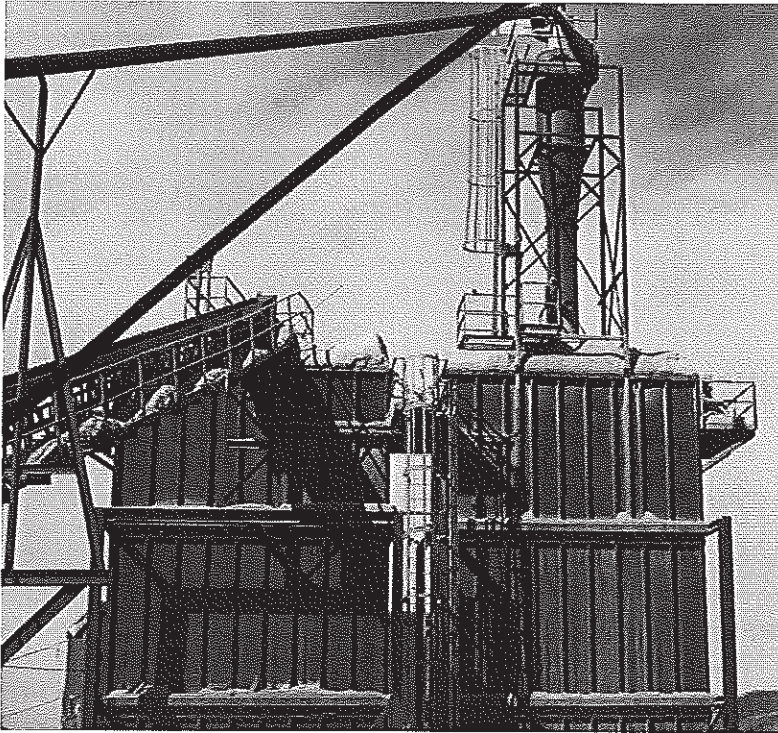
Figure 22: Storage bins to the west of the sawmill, with dust accumulations 2 to 3 feet high. (Photograph by WorkSafeBC, after the incident.)

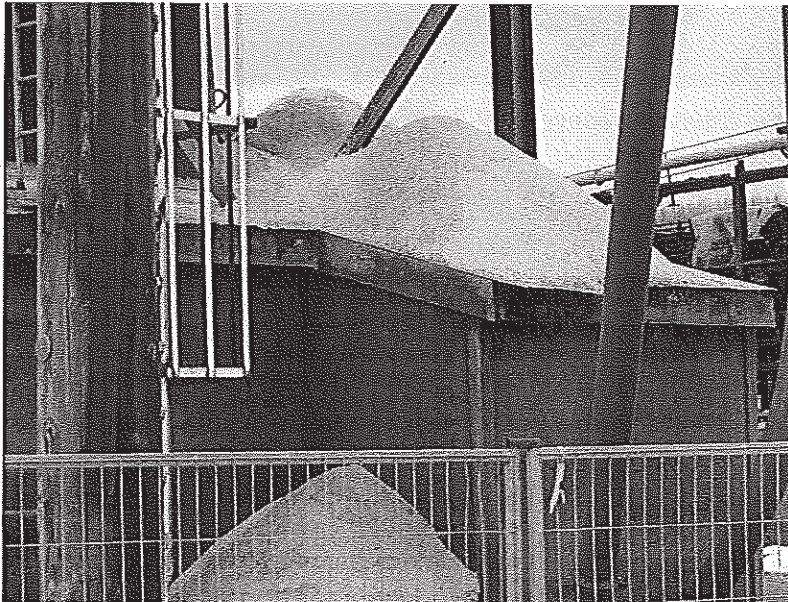
Figure 23: Dust accumulations in the area immediately south of the sawmill, beside the sorter wing. (Photograph by WorkSafeBC, after the incident.)

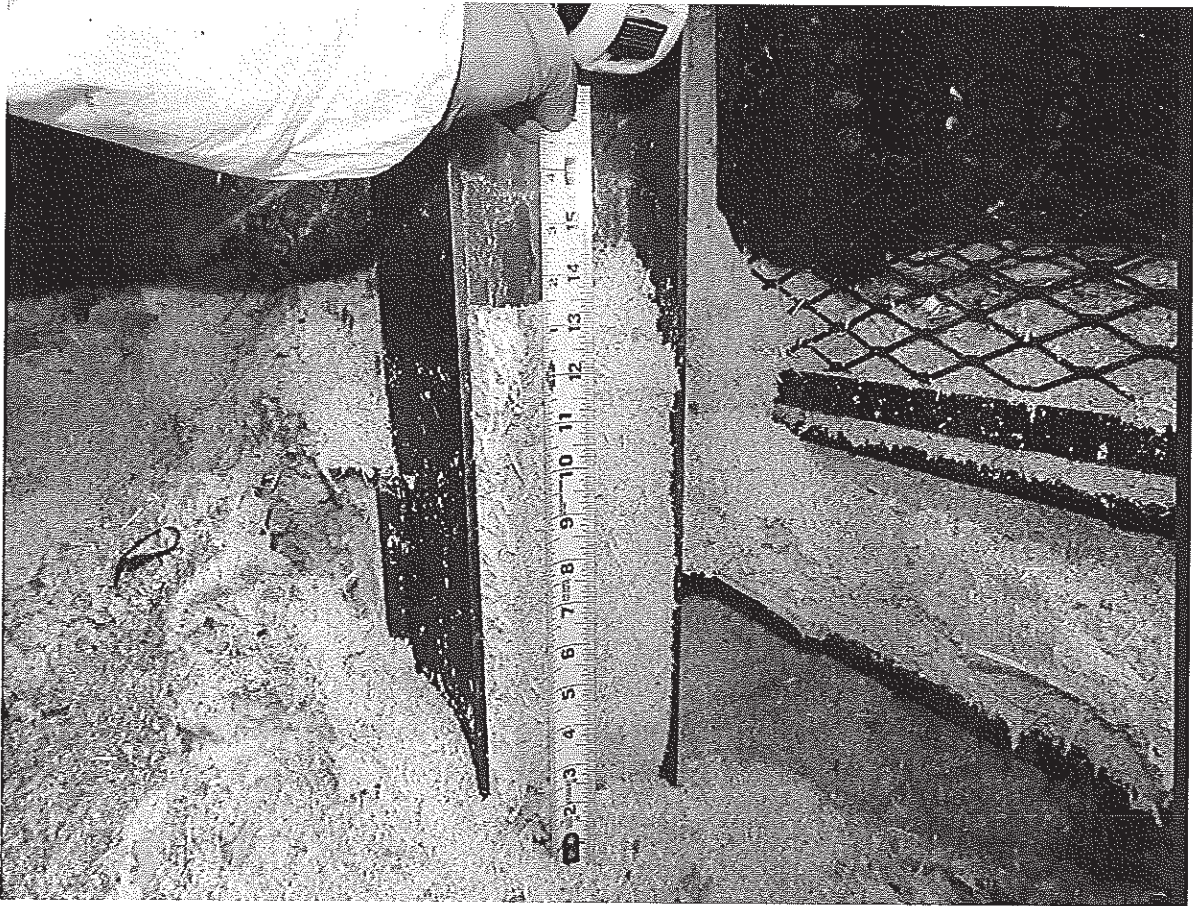
Figure 24: Dust accumulation in the area near conveyor 9-32 (C-25, Appendix 4. Photograph by WorkSafeBC, following the explosion.

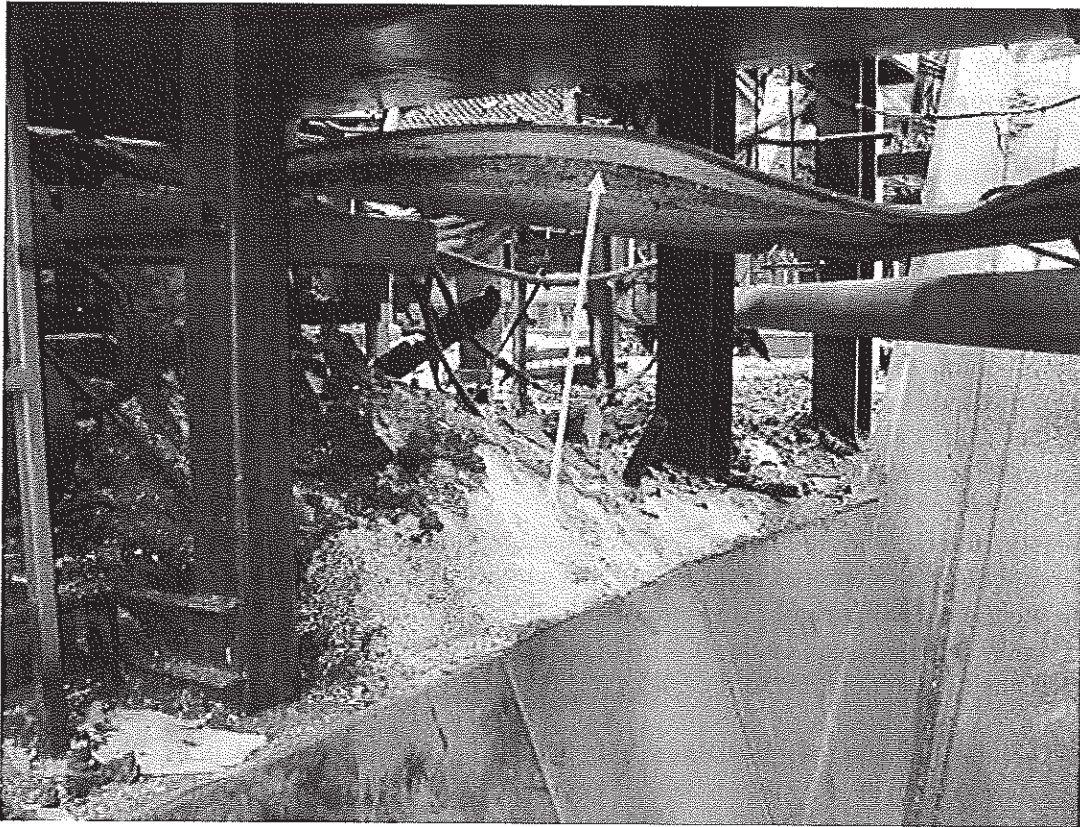
The area where the explosion originated was quite small, and was indicated by many obvious facts and physical evidence. The return belt for conveyor 8R-25 was found hanging immediately behind the 8R-25 motor drive. The heavy rubber reinforced belt was molded into a shape that went back and away from the motor drive. This could have occurred only with significant heat and pressure which molded the belt into this form which is opposite its design condition (Figure 28).

Figure 28: The conveyor belting behind the 8R-25 motor-reducer assembly. The yellow arrow indicates the pressure and heat forming of the belt.

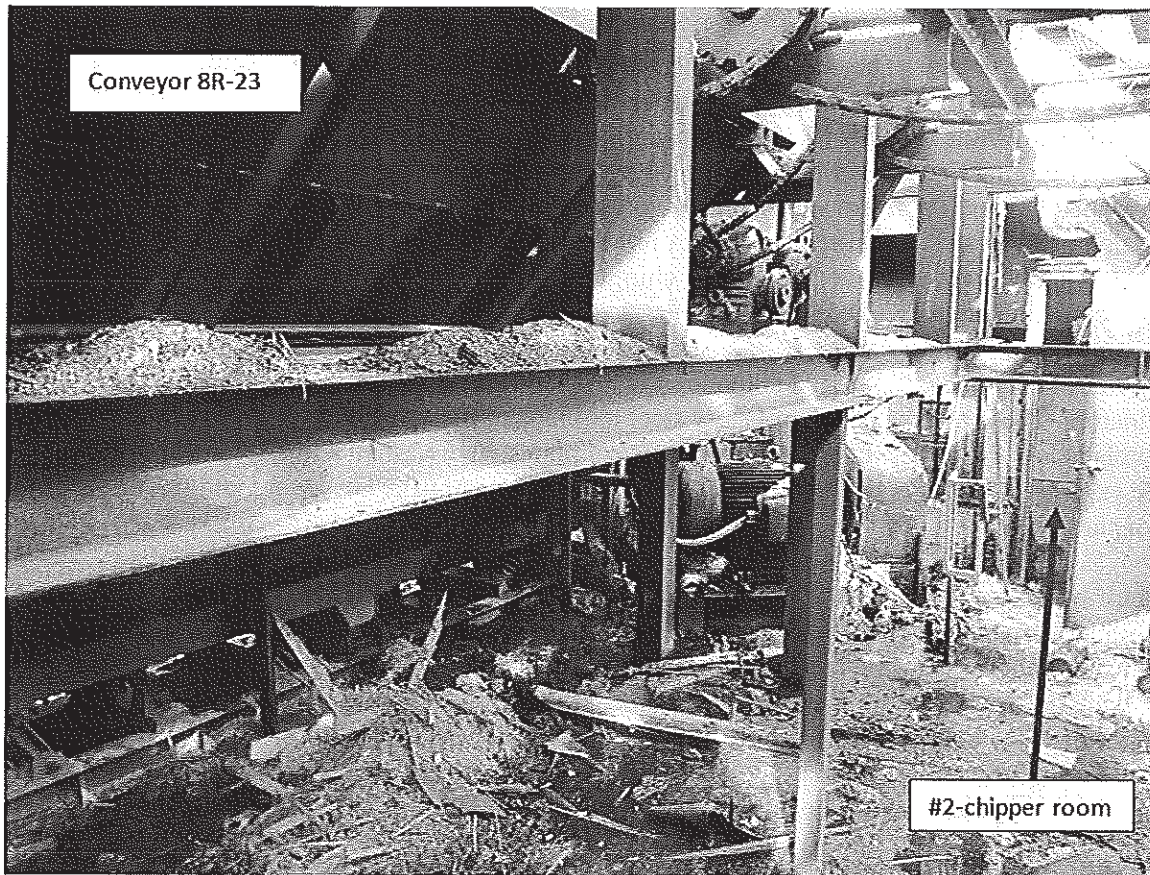
The #2 chipper vibrating infeed conveyor 8R-23 ran straight east and away from the 8R-25 motor drive. The north side of this conveyor where the explosion occurred was clean of wood dust and debris. The wood dust and debris remained untouched on the south side, and accumulations were present on the floor and on all the structural flanges and beams. The conveyor structure made a significant wall separating the area of origin of the explosion from the southern packaging areas of the sawmill; it protected the latter areas by preventing the explosion pressure and deflagration from expanding in their direction (Figure 29). The heavy damage seen in the sorter areas following the explosion was due to the 40-minute period when natural gas flowed freely after the natural gas supply line to the mill at the east wall of the sorter wing was severed (see section 2.3.2). The damage was due to fire fuelled by the natural gas supply, not from the explosion.

Figure 29: South side of the #2 chipper in-feed conveyor 8R-23. The wood waste on the structural flanges and floor were protected by the conveyor structure and were not disturbed by the explosion.

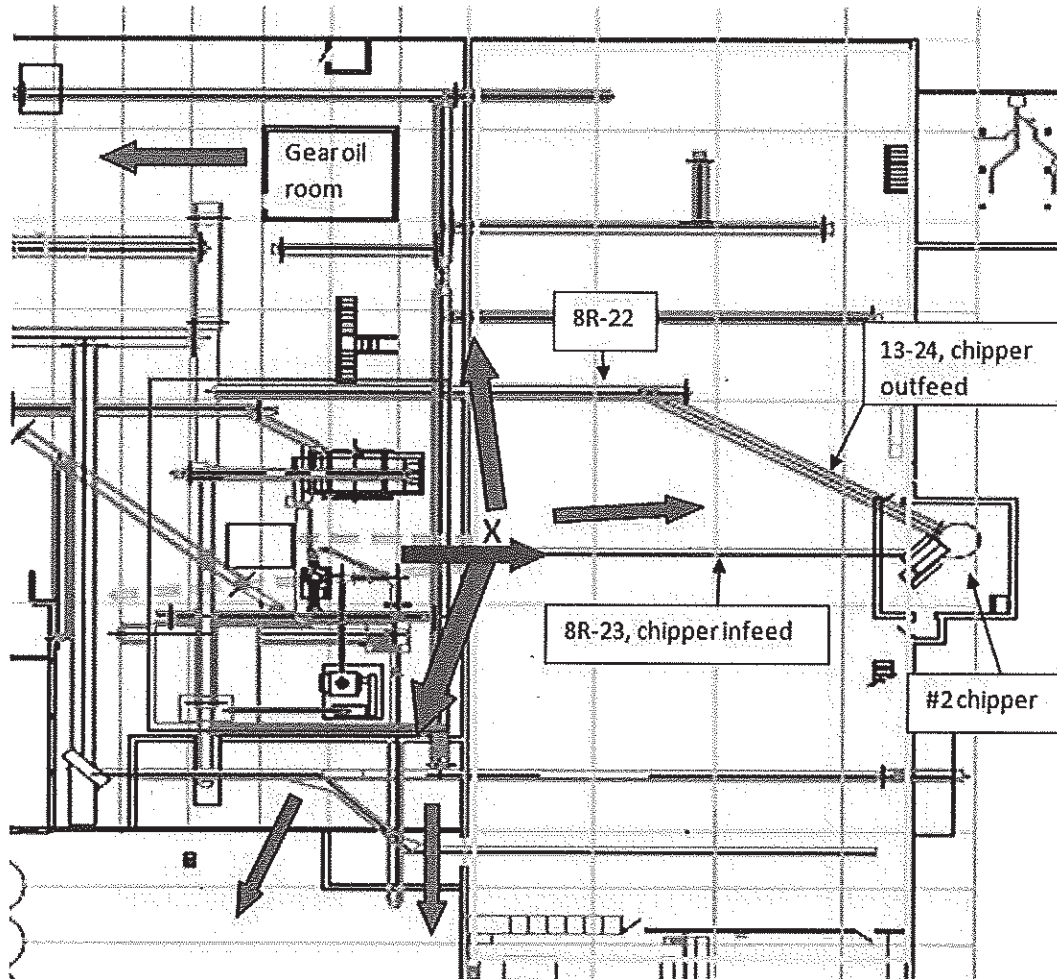
To the west of the 8R-25 motor drive were the vibrating screens and conveyors, oriented both north to south and east to west. The #3 screen skirting was buckled as a result of the explosion pressure travelling west from the motor drive. However, the area west of the origin was crowded with conveyor and screen structures that restricted the explosion's expansion in this direction; instead, much of the pressure was directed northward into the areas beneath the gang-saws (Figure 30). Compared with the rest of the mill, the basement layout was very open all along the north wall, running east to west. The gear oil room structure and equipment were pushed northwestward, and firefighting equipment in the vicinity of the gear oil room had been displaced in the same direction. The primary explosion was directed by the nearby structures and equipment and by the available fuel into the general area of E-24 (Appendix 3). It also expanded southwestward, into part of the area where the screens and edger conveyors were located (Figure 30).

Figure 30: Note the following in this enlarged diagram of the basement level near H-25 (Appendix 4): The blue arrow represents conveyor 8R-25. The red rectangle outlines the area where various screens and structures restricted the explosion pressure's expansion westward. The yellow rectangle outlines the half-basement area; everything to the left of it is full basement. The green arrows indicate the paths travelled by the explosion pressure.

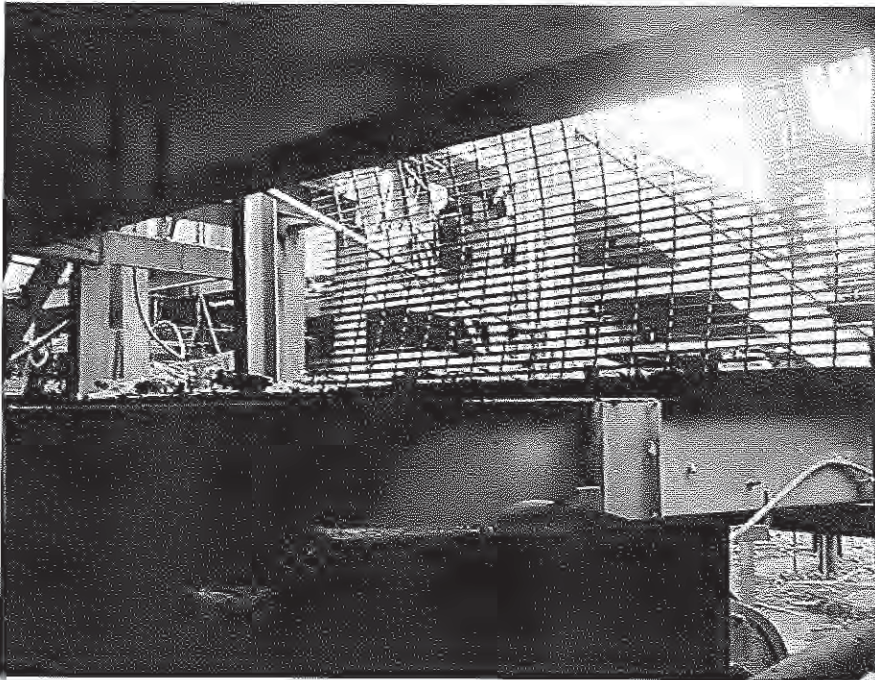
Figure 32: View from between the ignition point at the 8R-25 motor-reducer assembly and the #2 eliminator position. The grating was bent by the force of the explosion pressure.

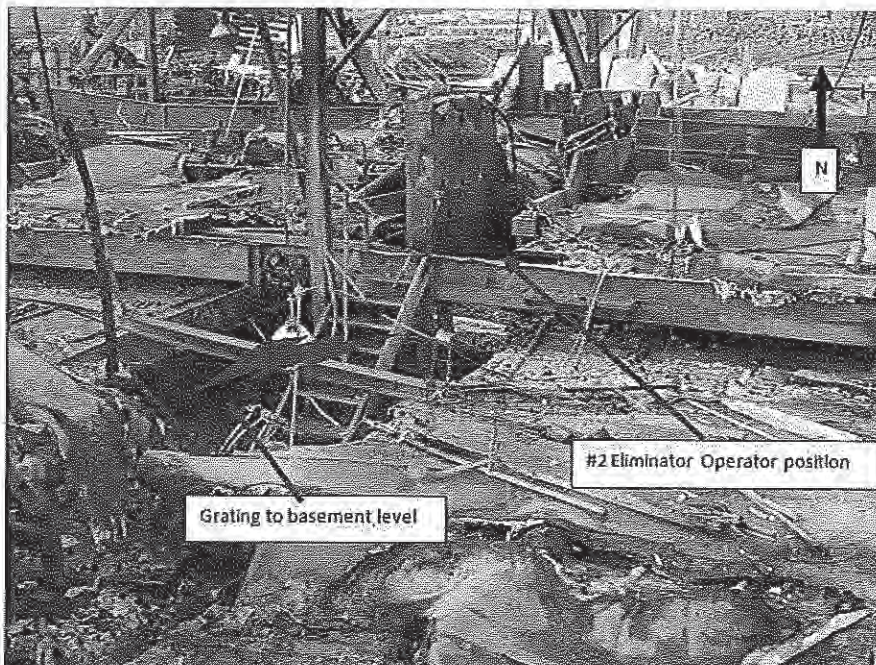
The #2 Eliminator Operator stated that he felt a strong rush of air and heat from behind and saw flames after feeling the shock wave. The explosion pressure beneath the eliminator tables vented through the walkway grating directly into the #2 Eliminator Operator's work area, approximately 30 feet to the northeast on the operating level (Figure 31). The bent grating is shown in Figure 32 and the path of the explosion in Figure 33. The floor under the eliminator tables was clean of all debris and wood waste due to this explosion pressure as discussed previously.

Figure 33: Photograph showing #2 Eliminator Operator's position and the path of the explosion.
