BRIEFING NOTE

- Update on the explosions and fires at the Babine Forest Products mills at Burns Lake
Not Responsive

- In November 2012, WorkSafeBC completed its investigations into the explosion on January 20, 2012 at the Babine Forest Products Company in Burns Lake
Not Responsive

This incident investigation report sets out WorkSafeBC's analysis and conclusions with respect to the cause and underlying factors leading to the workplace incident of January 20, 2012, at the Babine Forest Products Limited sawmill located at 19479 Highway 16 East in Burns Lake, British Columbia. The purpose of this report is to identify and communicate the findings of this incident to support future preventive actions by industry and WorkSafeBC.

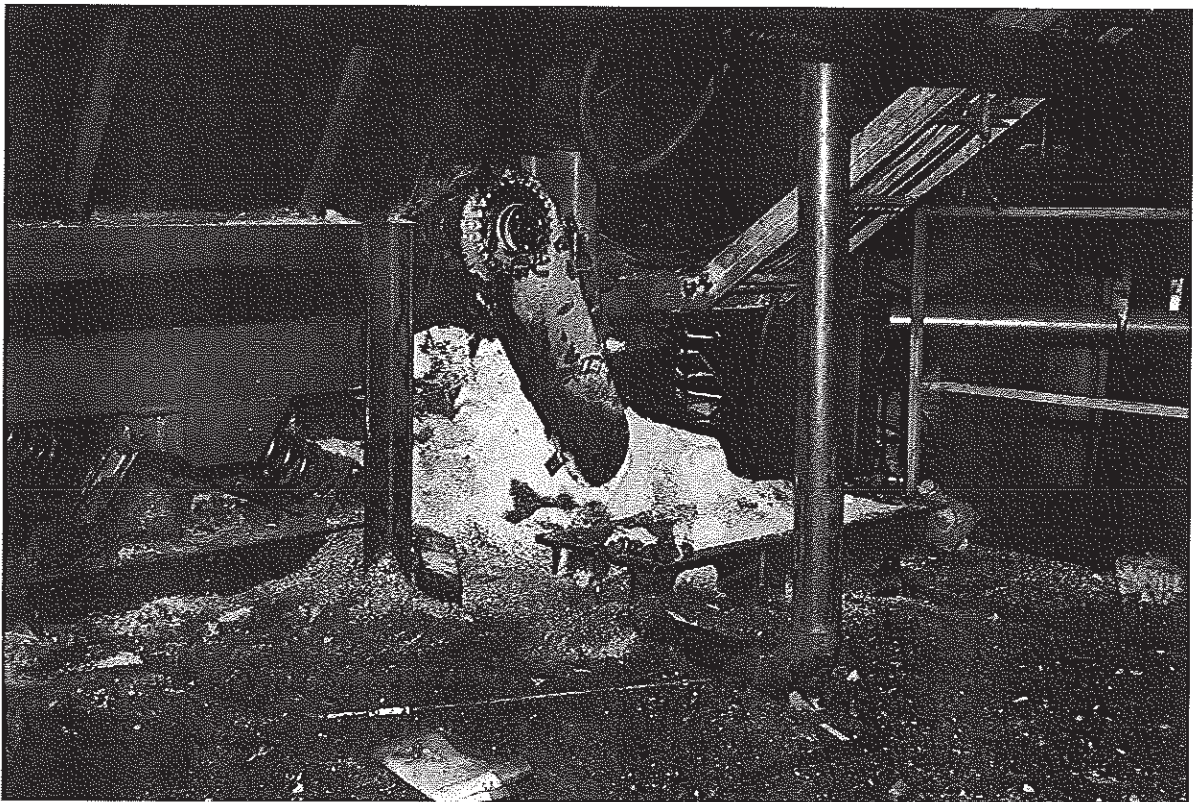
In the Babine explosion, it is believed that an open flame from the motor-reducer's V-belt guard, located in the basement level of the mill, likely ignited the dust mixture suspended in the air above the motor (Figure 34). Several large wood waste conveyors as well as the chipper and vibrating screens were in this general area, with the 8R-25 conveyor dumping into the chipper vibrating infeed conveyor directly above this location. All of these caused the dispersal of the fine wood dust into the air. A contained space of approximately 15,000 cubic feet (425 cubic metres) in this general area was bounded by the high conveyor wall sheeting and an exterior wall.

Figure 34: The 8R-25 motor mounting plate after removal of the motor-gear reducer assembly and guard. Note the amount of wood dust that was protected from the explosion.

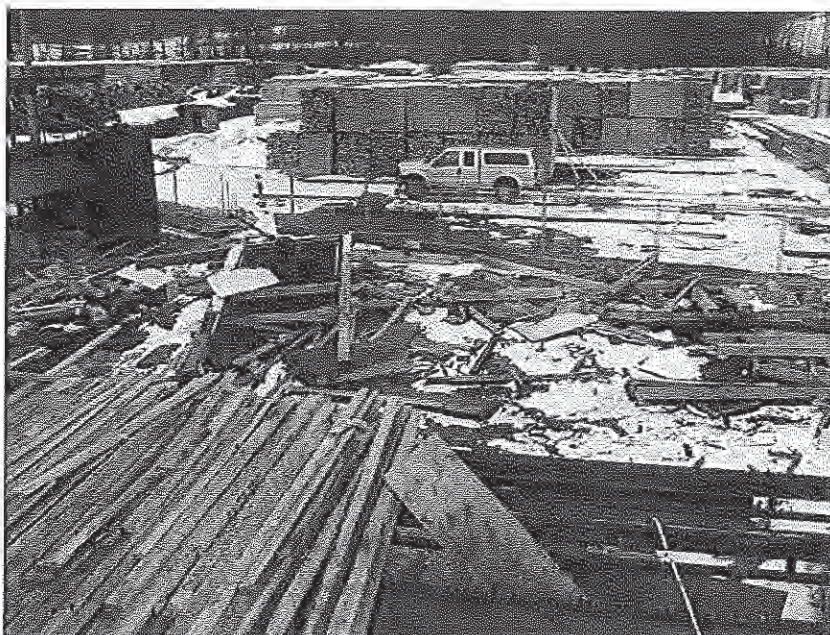
To the east, the sawmill wall was displaced and blown out into the log yard. The large exhaust fan was ripped from its attachment on that wall and thrown 60 feet out into yard along with the main sawmill structural members (Figure 35). The fan was 9 feet by 9 feet and very heavy. Even the lumber on the green chain outside the sawmill was displaced on this side of the mill as the overpressure escaped (Figure 36).

Figure 35: The large exhaust fan, indicated by the yellow arrow, was blown out approximately 60 feet from where it had been mounted on the mill's east wall.

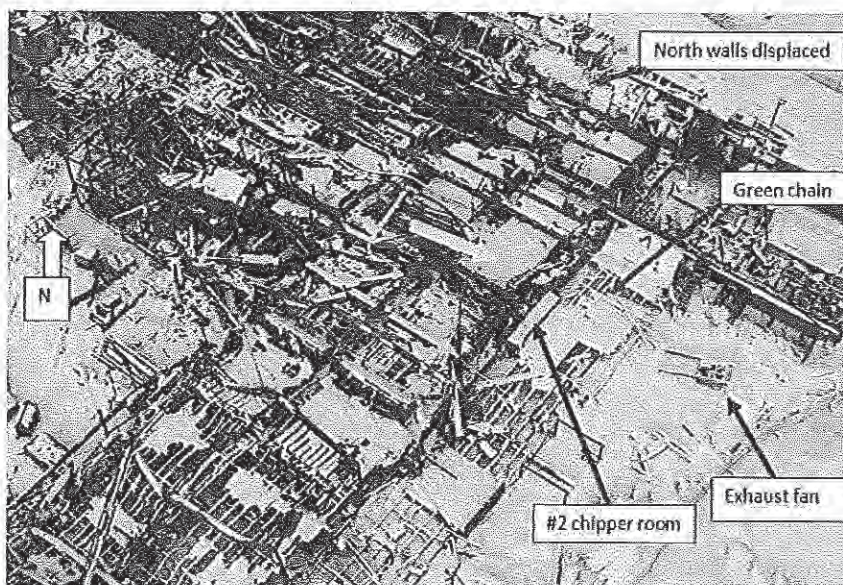
Figure 36: Aerial photograph of the east side of the sawmill. The large yellow arrow indicates the easterly direction of the explosion's expansion from the point of origin. Note that the lumber on the green chain is disturbed only where it was not protected by the #2 chipper building.

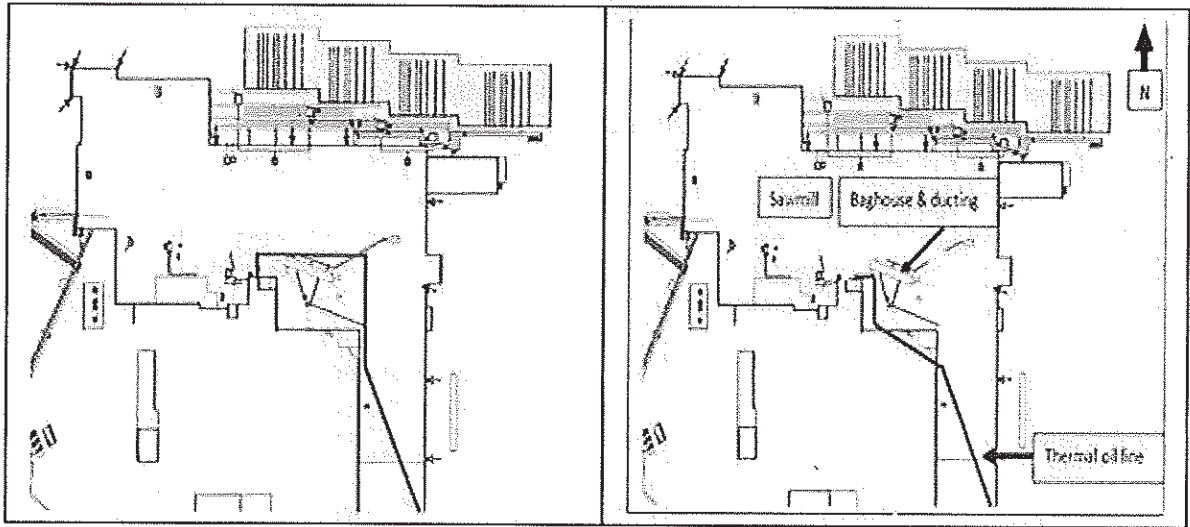
The heat generated by the incoming thermal front likely caused the oxygen/acetylene bottles located there (D-21, Appendix 4) to vent, which added fuel and oxygen to the explosion, thereby increasing the violence and pressure. The temperatures generated by a dust explosion are reported to be in a range of 1,725 to 3,225°C. The pressure vented through the roof near the HDA gang-saw operator booth. In the process, it displaced the thermal oil line located on the roof southward and also pushed the baghouse southward and off its original support structure (Figures 37–38).

Figure 37: The diagrams show the layout of the sawmill roof. The thermal oil line is shown in red. The left diagram shows the way the oil line was designed to cross the roof; the right diagram shows the oil line's location after the explosion.

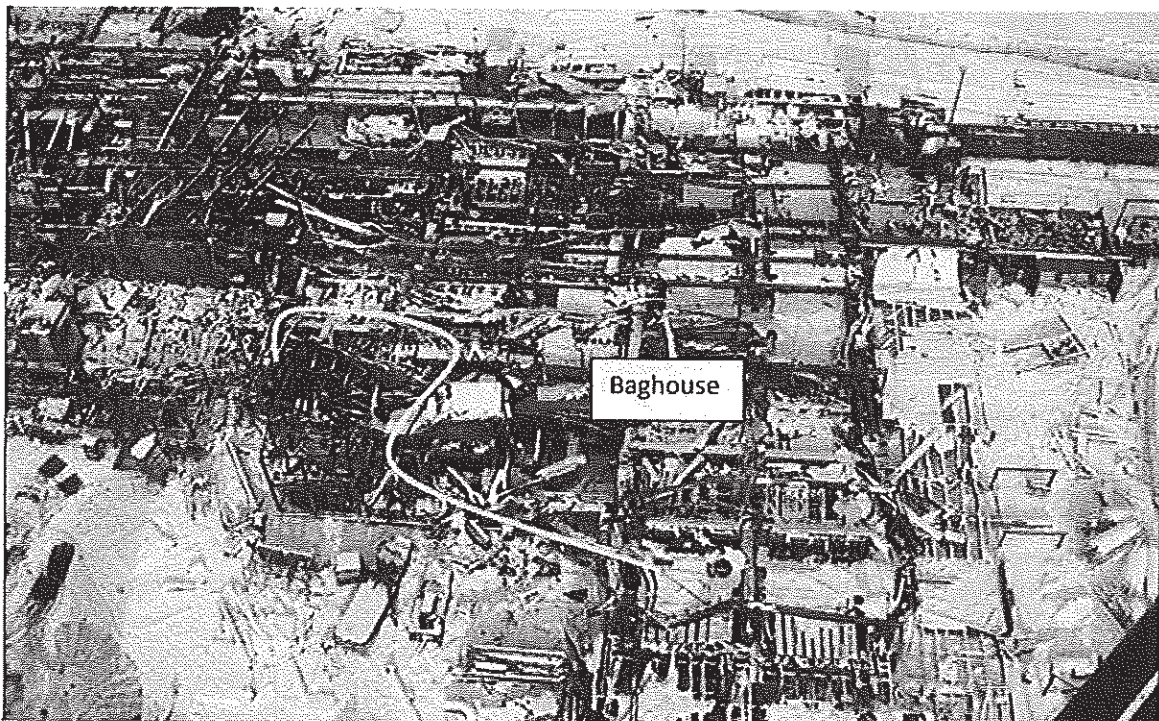
Figure 38: Aerial photograph showing the baghouse location and the thermal oil line (traced in yellow). The vented area in the roof is north of the baghouse.

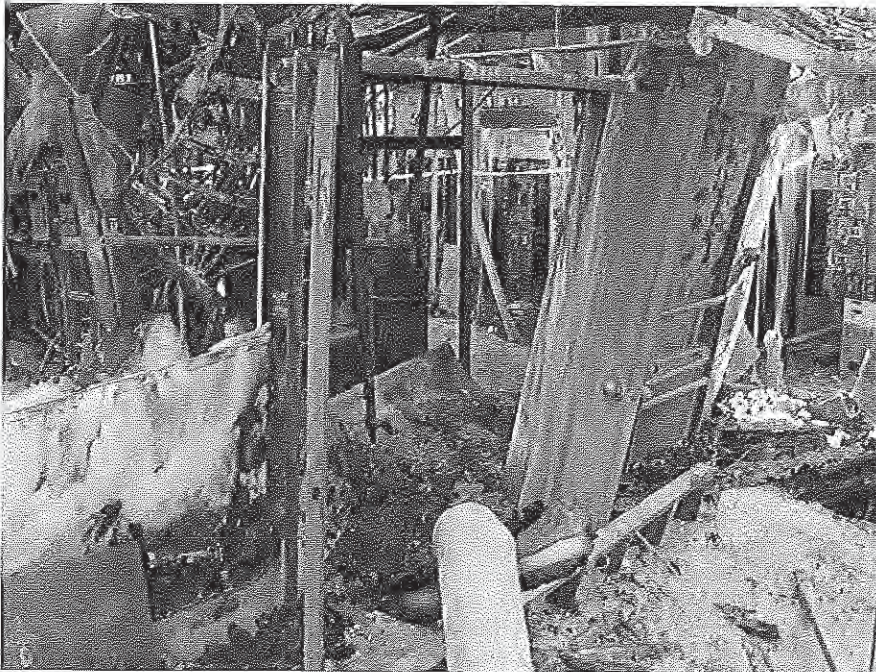
Along the south wall of the sawmill in the basement level, running along grid line G, is a corridor defined by the conveyors below line 3. There was little or no blast damage throughout this area, except to the walls of the power distribution centre (PDC) room (G-10, Appendix 4), which appear to have been pushed westward by the explosion pressure. The line 3 hydraulic room is near the PDC room (F-11, Appendix 4). There was evidence that it had been pushed westward, but the major damage that destroyed the room and walls is the post-incident fire (Figure 39). There is little violence associated with this damage, simply overpressure.

Figure 39: The line 3 hydraulic room looking south, the double doors pushed open westward. Some of the PDC electrical components are on the wall in the background.

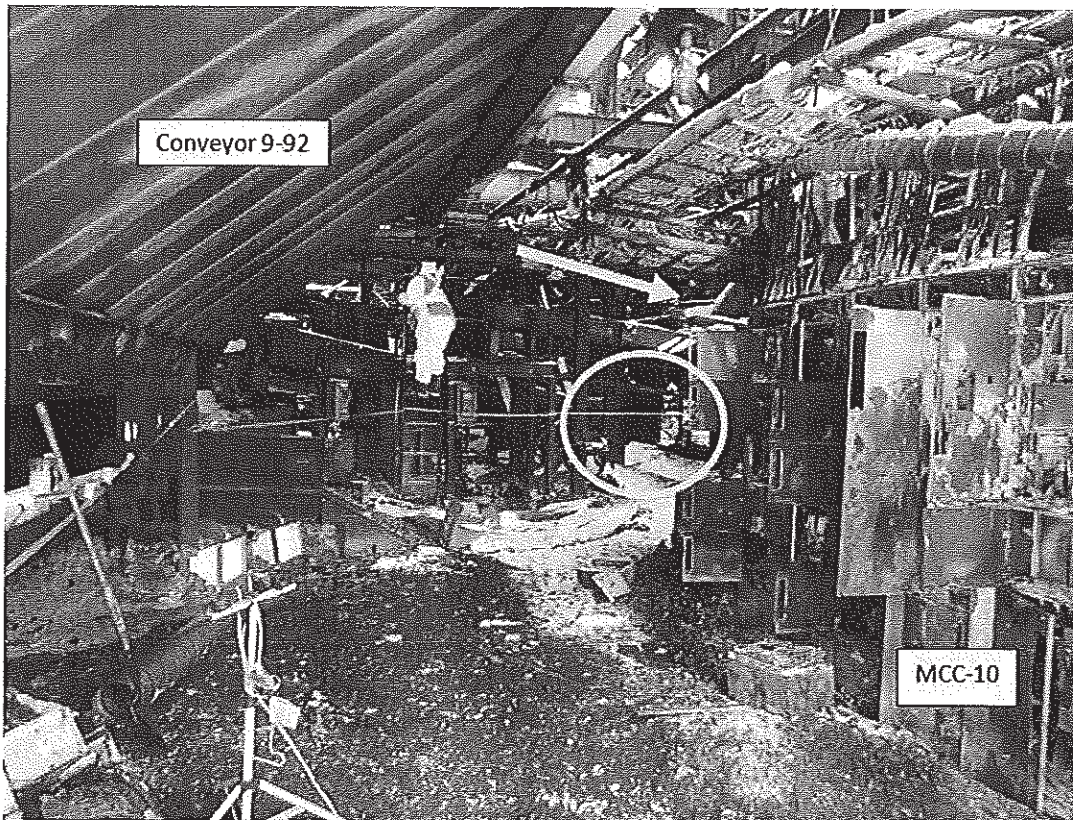
The structure and materials between the conveyors under production lines 2 and 3 were relatively undamaged except where affected by the sawmill fire. Figure 40 shows the corridor east of the PDC room, between the south wall and line 3. Note the large accumulations of wood waste remaining beneath conveyor 9-92. This indicates that the explosion did not originate here, and that it had little strength as the explosion pressure travelled from east to west through this area.

Figure 40: This view is looking east from in front of the boiler room. The explosion pressure and thermal front likely took a path travelling towards the reader from the east, under the conveyors and screens in the area outlined by the yellow circle. Other access was restricted by the conveyor structures. The yellow arrow indicates the location of the #1 chipper.
