Fire Investigation Report

Incident No. TLA 11 01 05 23 01

Property Classification Marina Fire

Date of Fire January 05, 2011

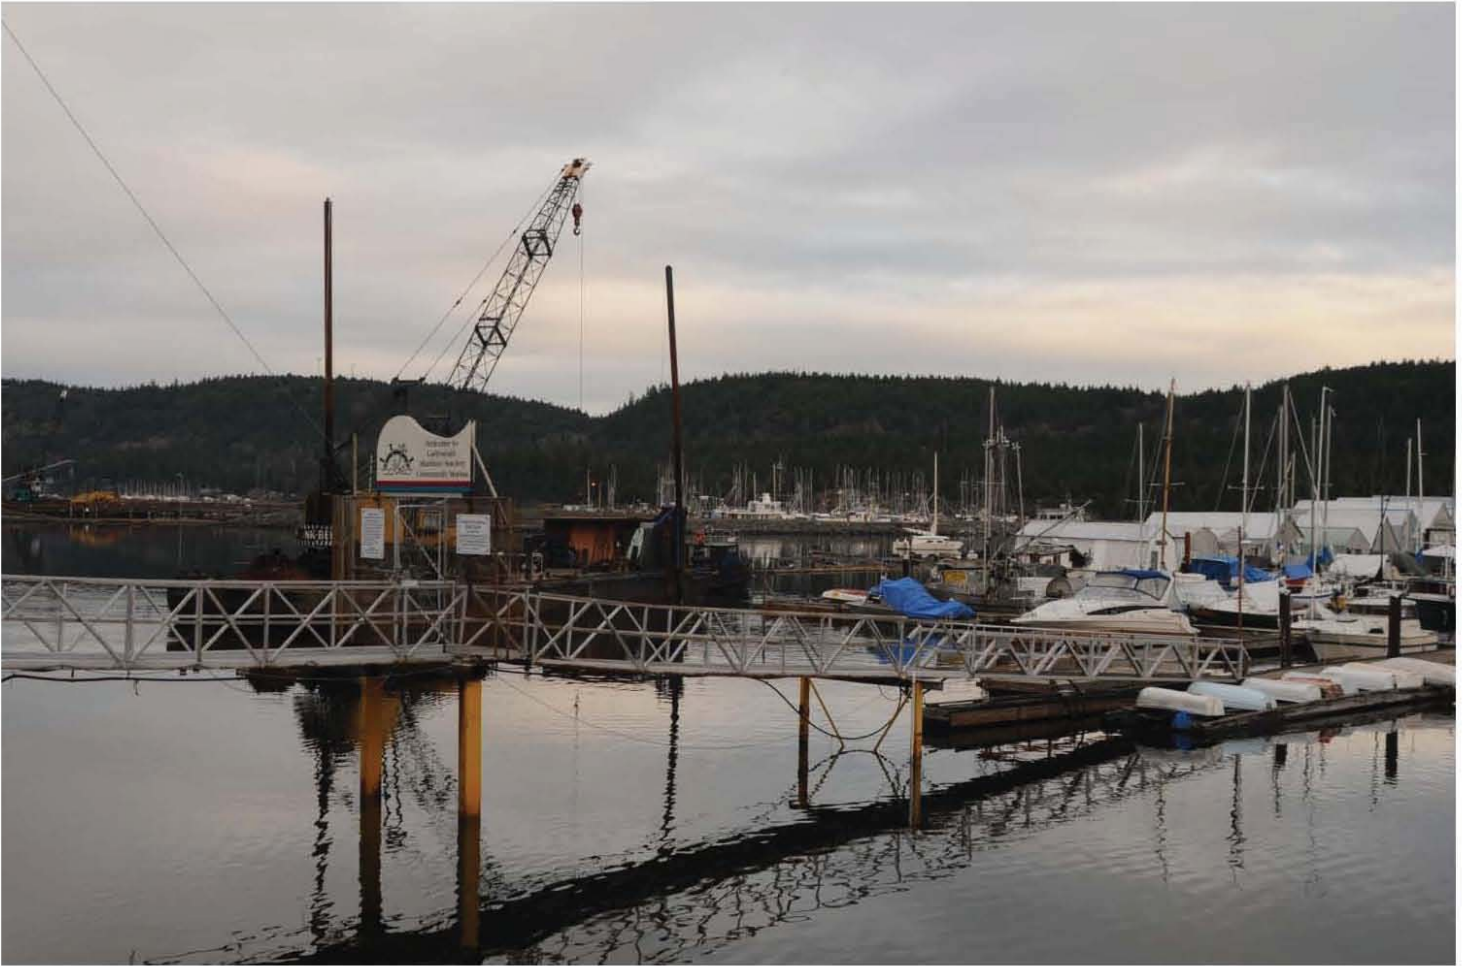
Photo #001 - Main ramp to Ladysmith Maritime Marina dock

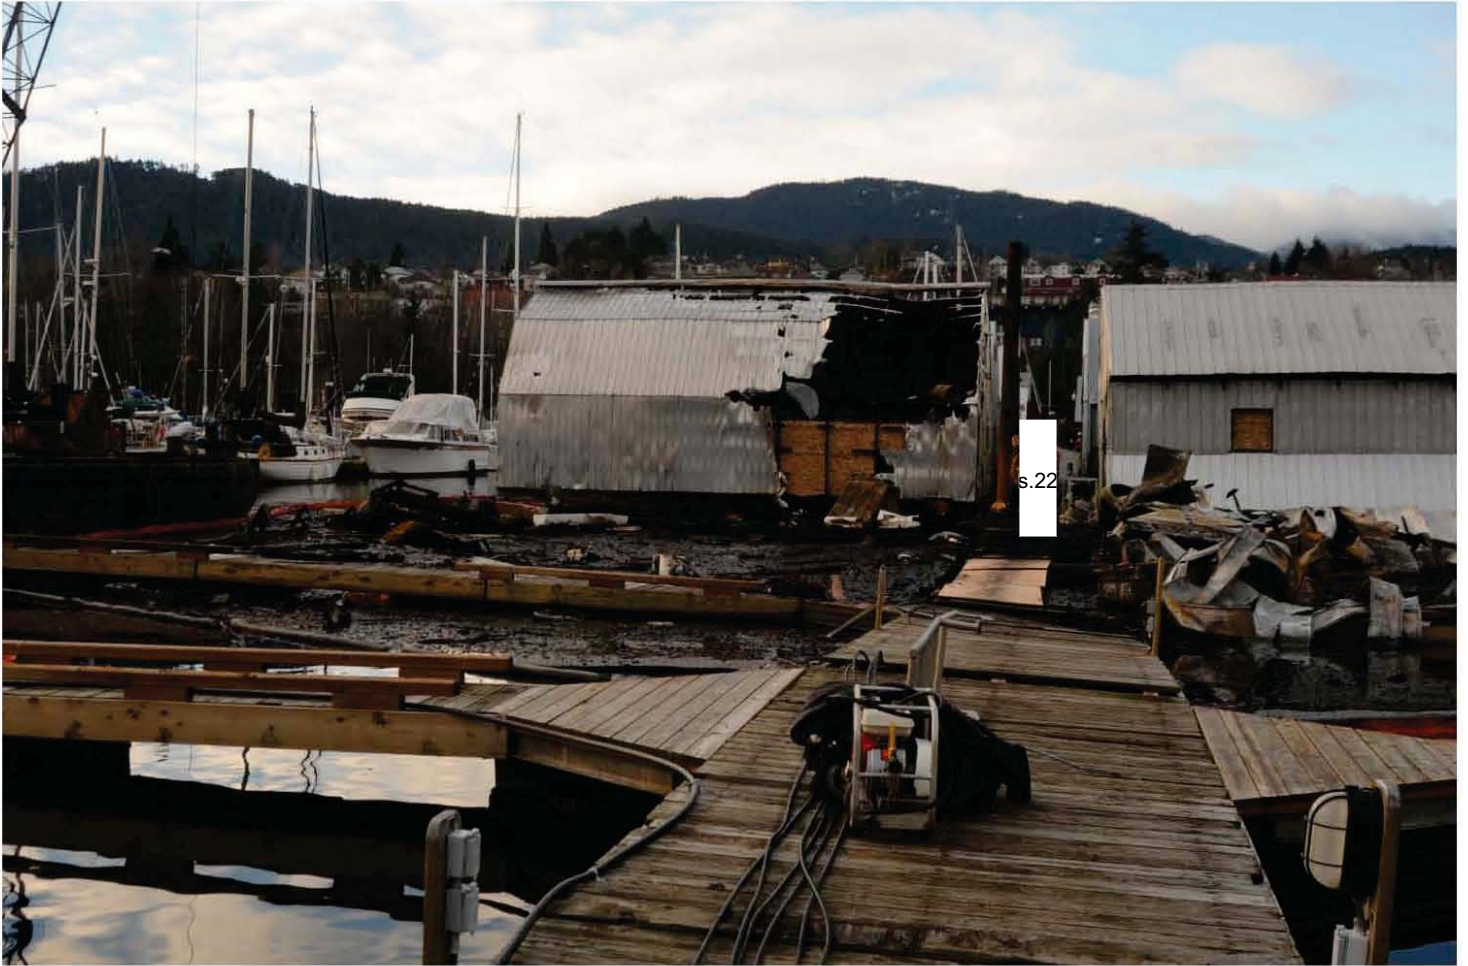
The fire was reported at 0000H on January 05, 2011, through the 9-1-1 system. On arrival, members of the Ladysmith Fire Rescue discovered multiple vessels and boathouses were fully engulfed by flames. Fire was moving from the south side of the fire involvement finger to the north side of the finger.

Photo #002 - View of the fire consumed & damaged boathouses

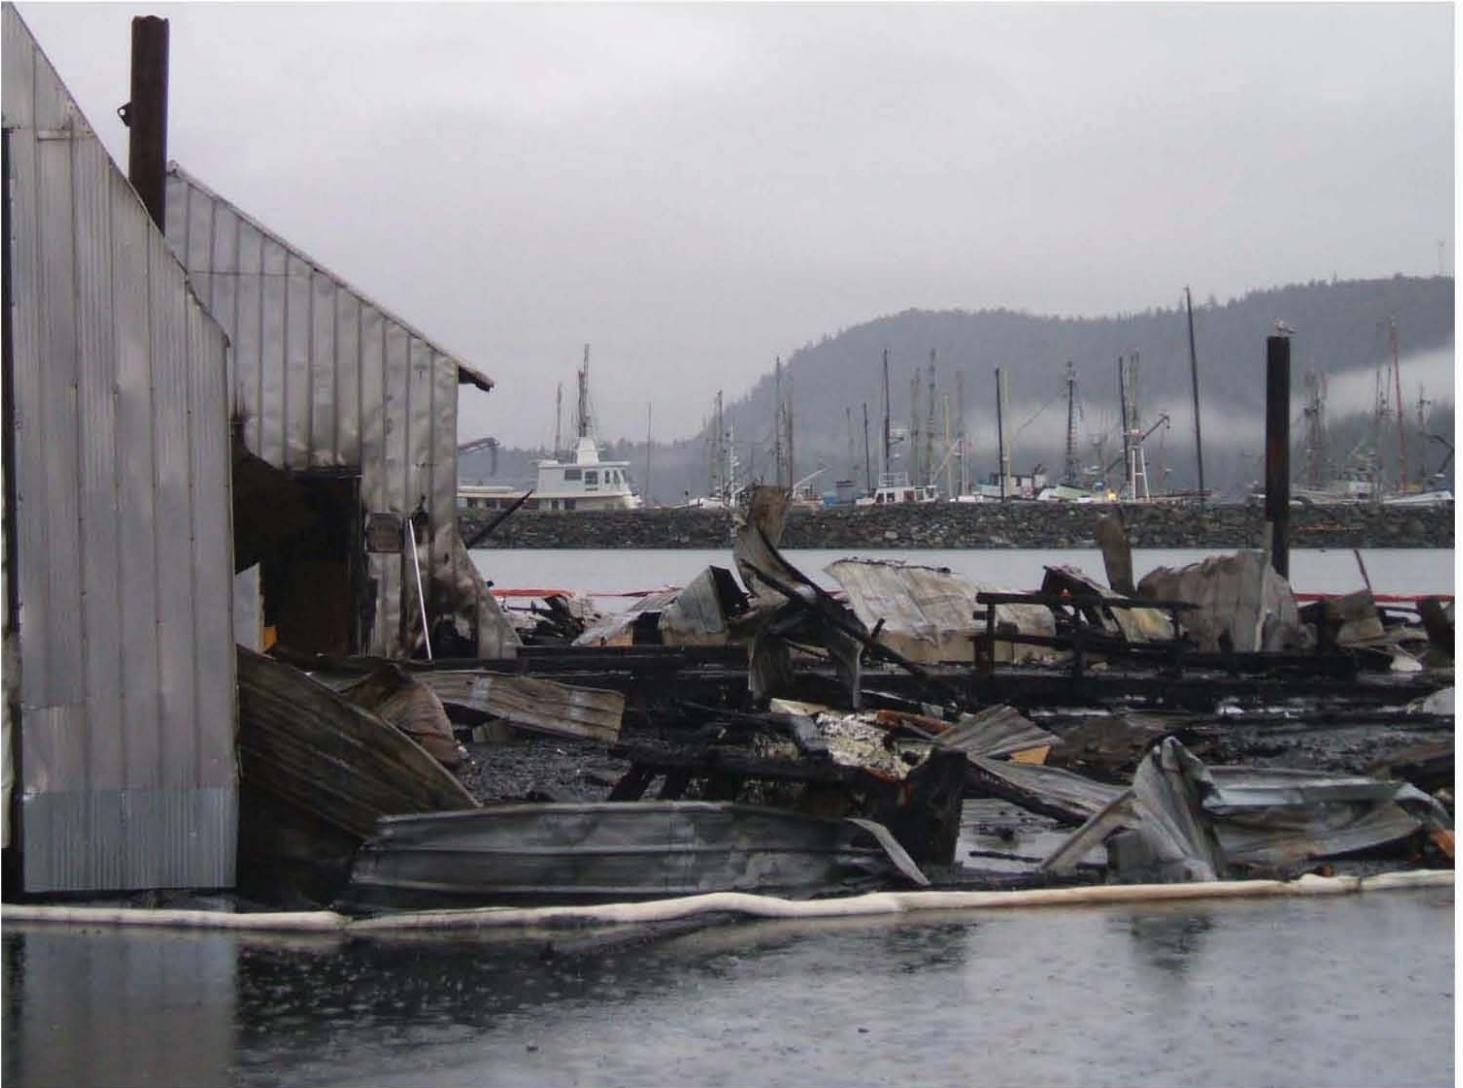
Photo #003 - View of the destroyed boathouses

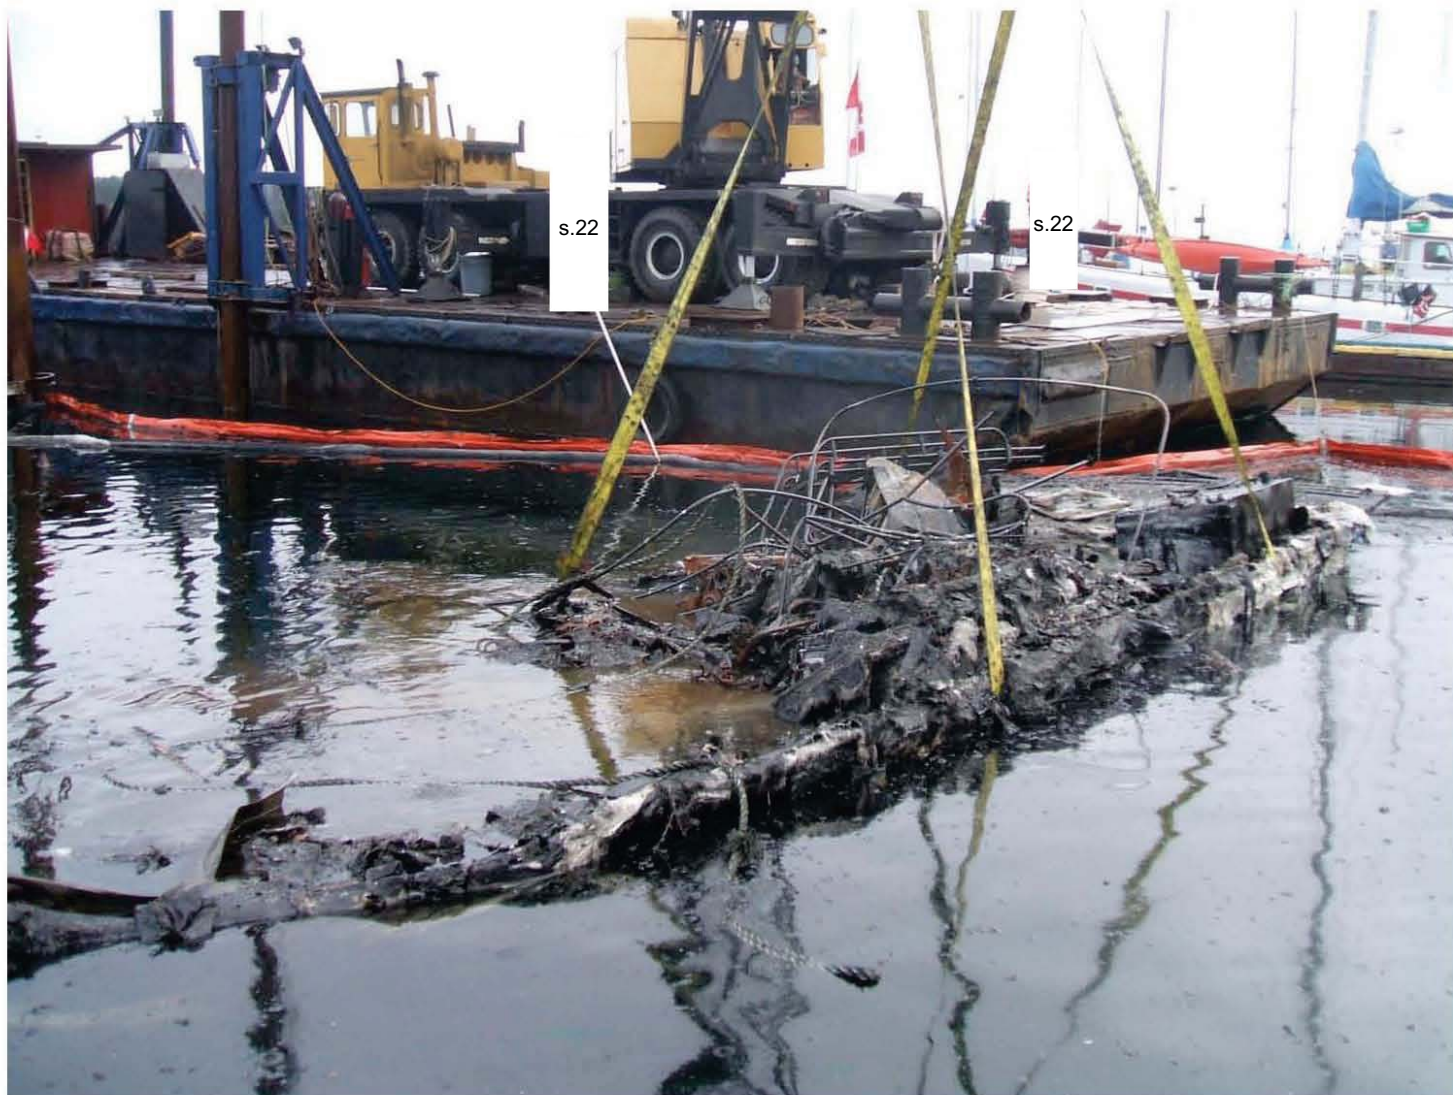
The s.22 vessel burnt to the water line (photo #004) and sank to the bottom of the ocean. Drivers secured the vessel and a crane lifted up vessel (photo #004, #007, #008, #009) and placed on a floating barge. Due to extend of the fire, I suspect the fire started in the sleeping quarters. In this area we recovered remains of power bar, timer and the Caframo 9206 deluxe heater unit (see drawing & photo #013, #014, #016 & #017)).

Photo #004 - Raising the boat call "

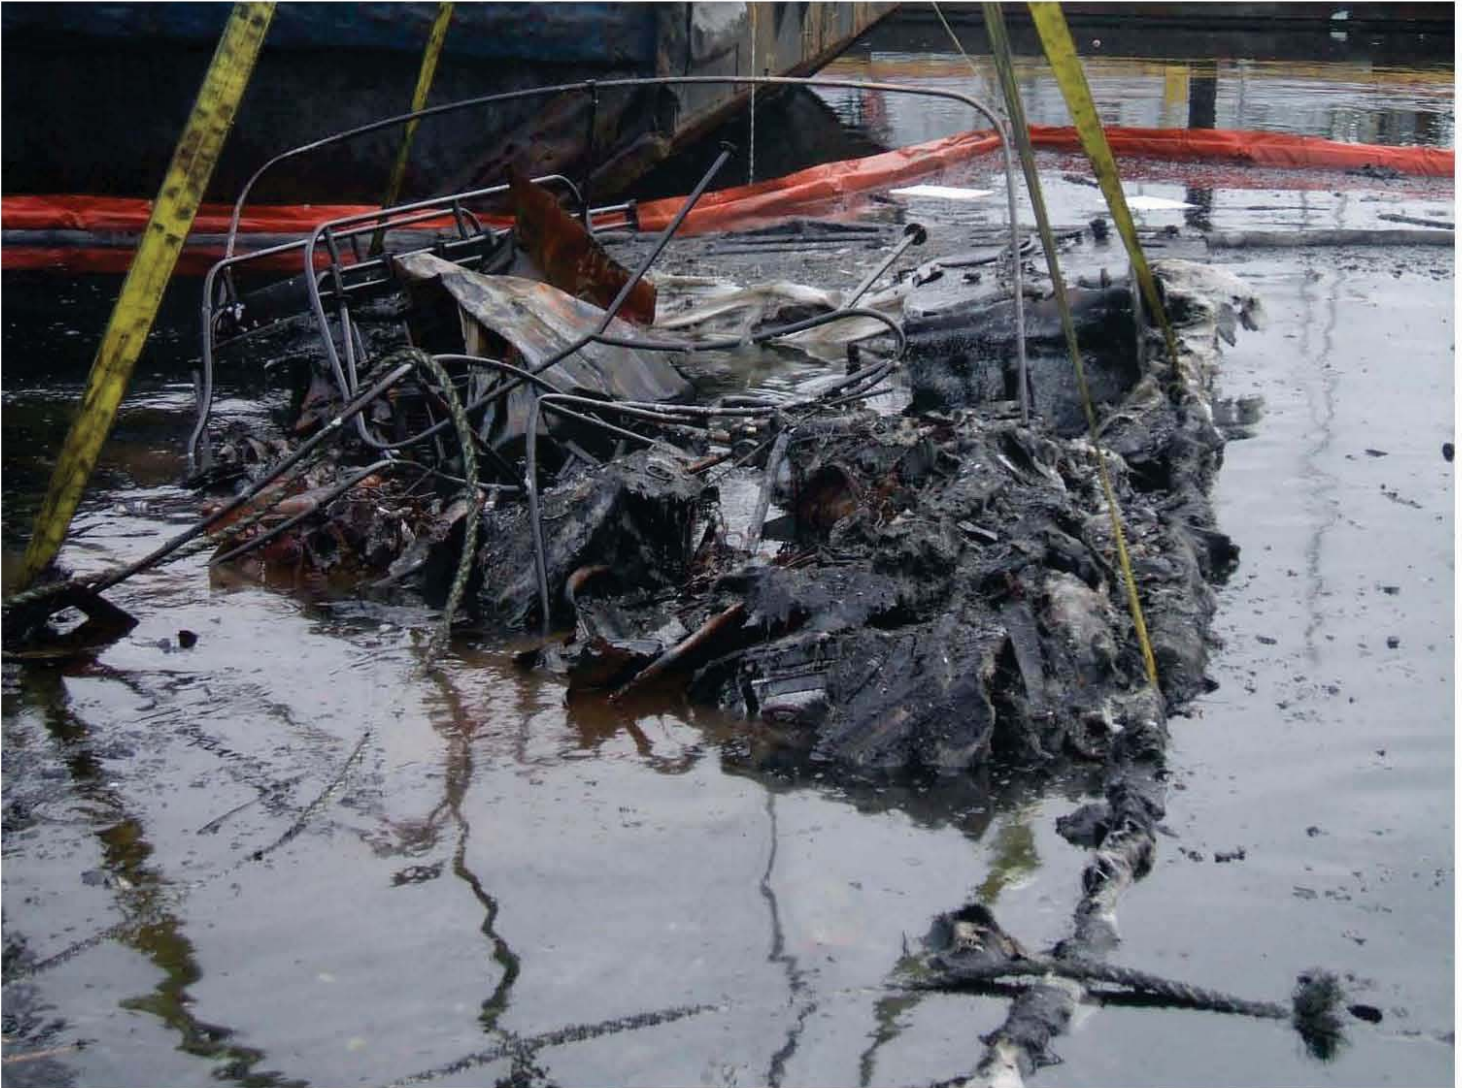
Photo #005 - Raising the boat call " s.22 "

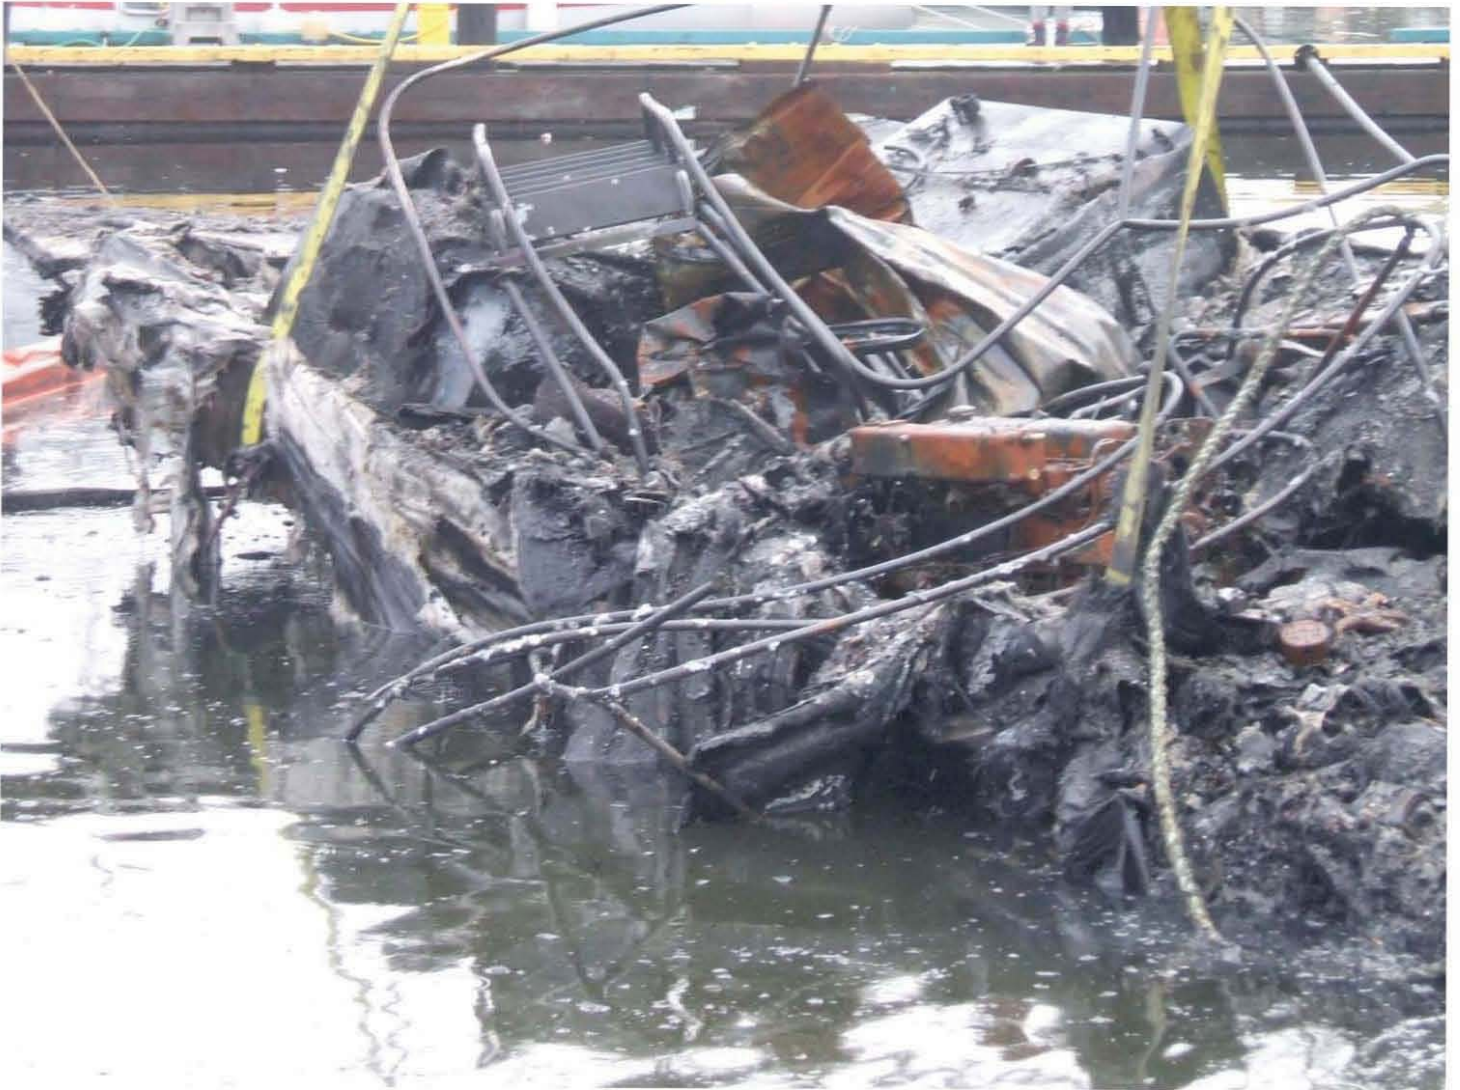
Photo #006 - View of the boat called " s.22 "

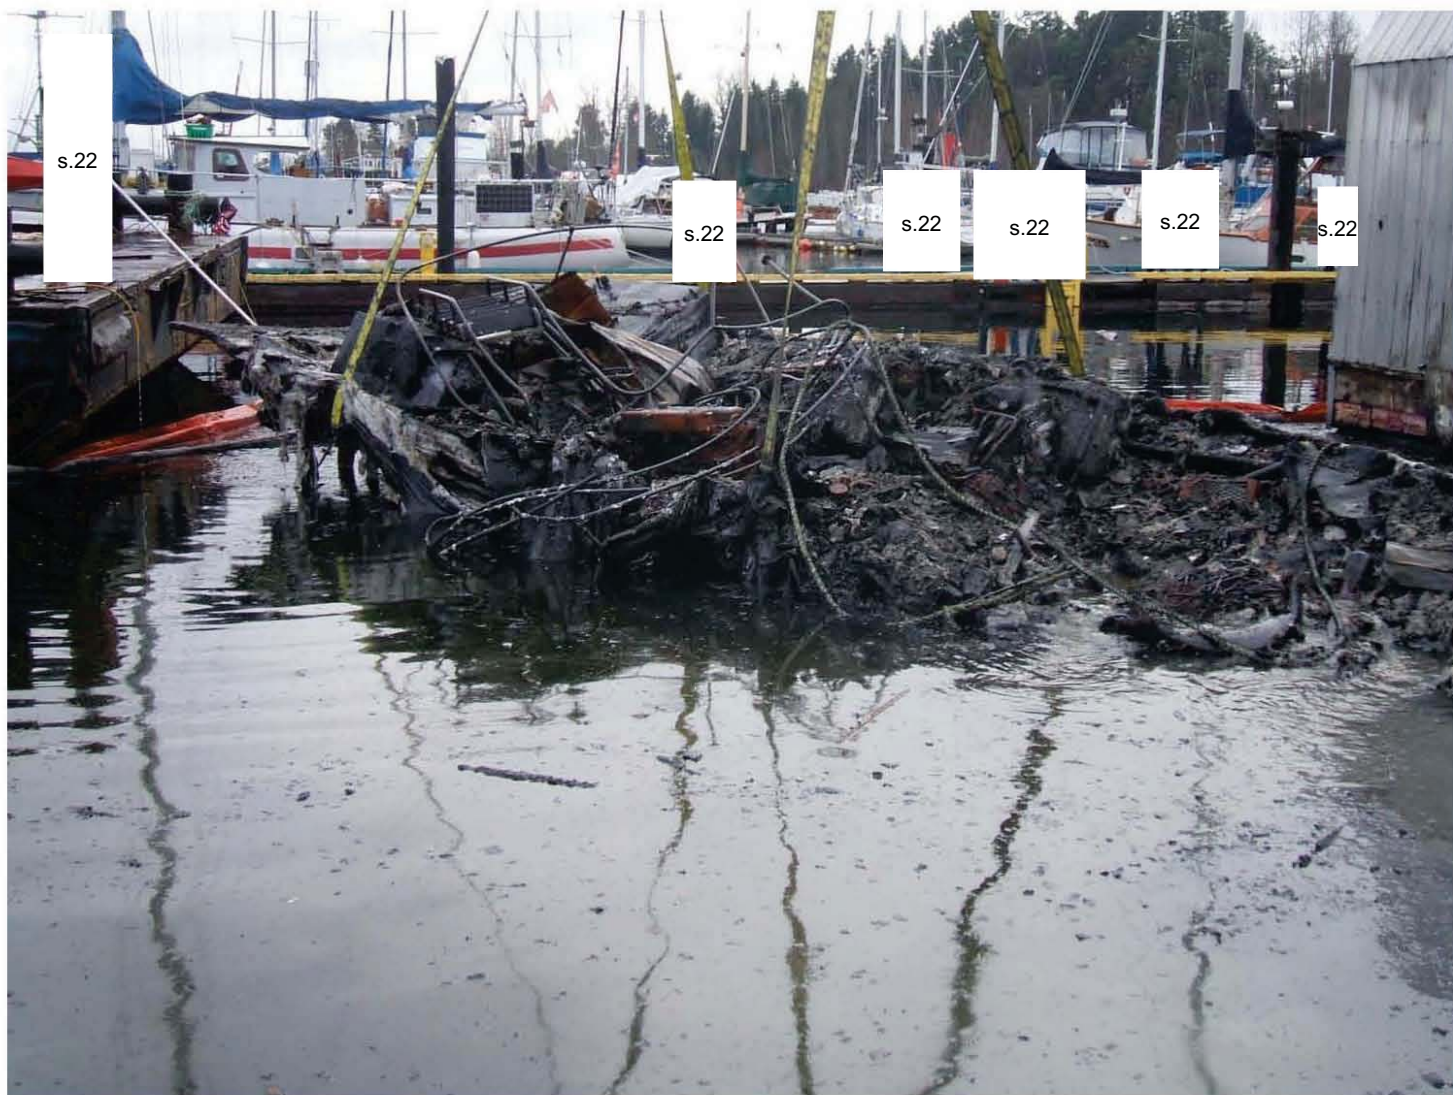
Photo #007 - View of the boat called "

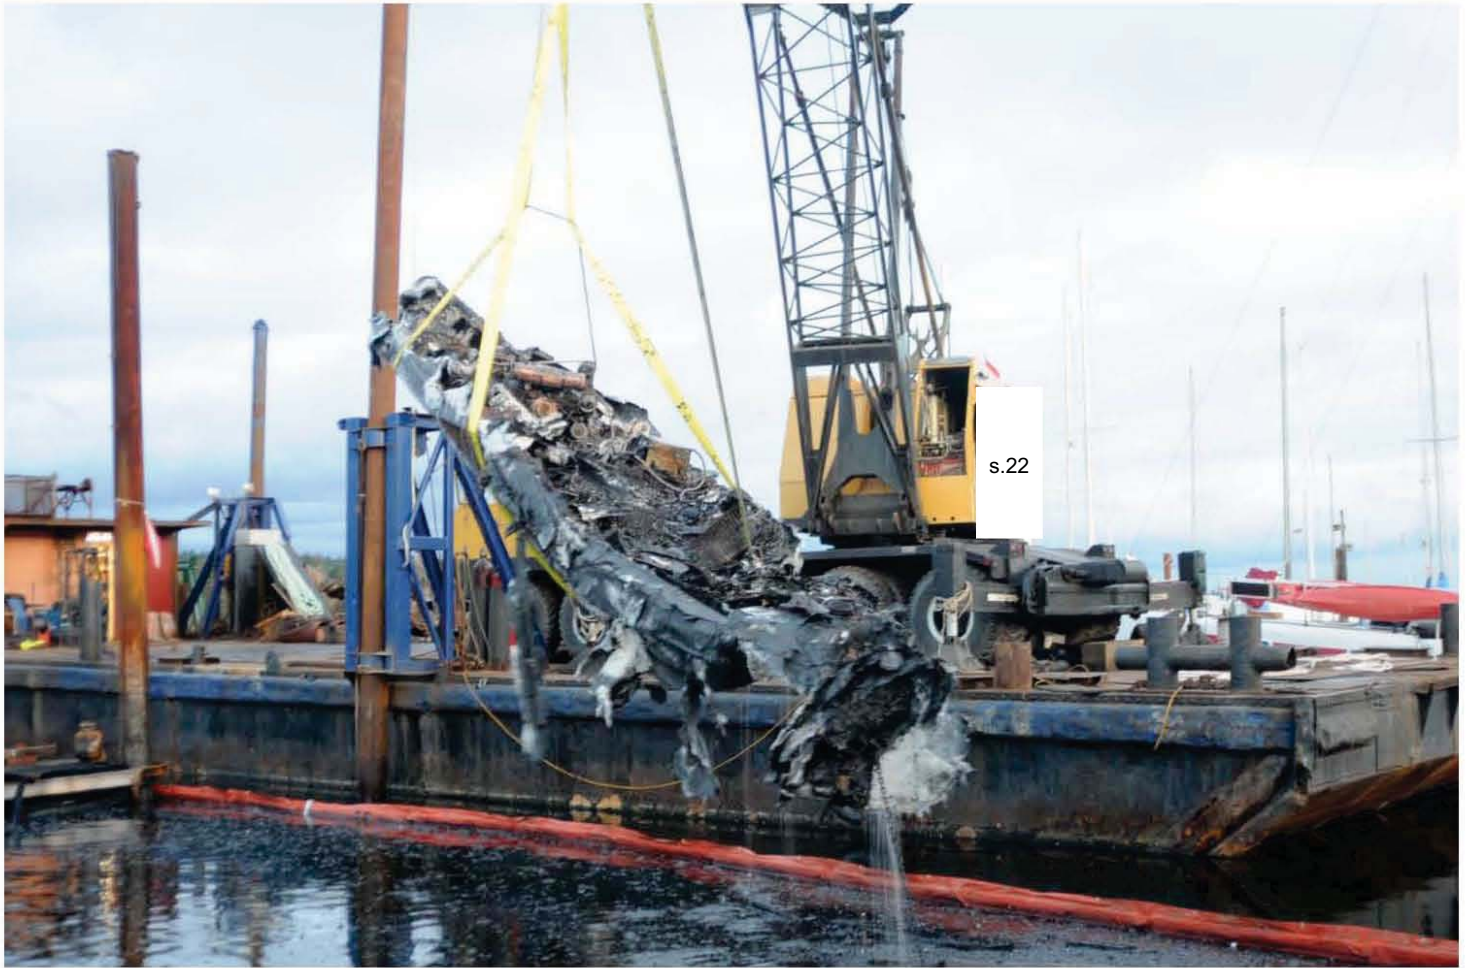
Photo #008 - View of the boat " s.22 " been placed on the barge

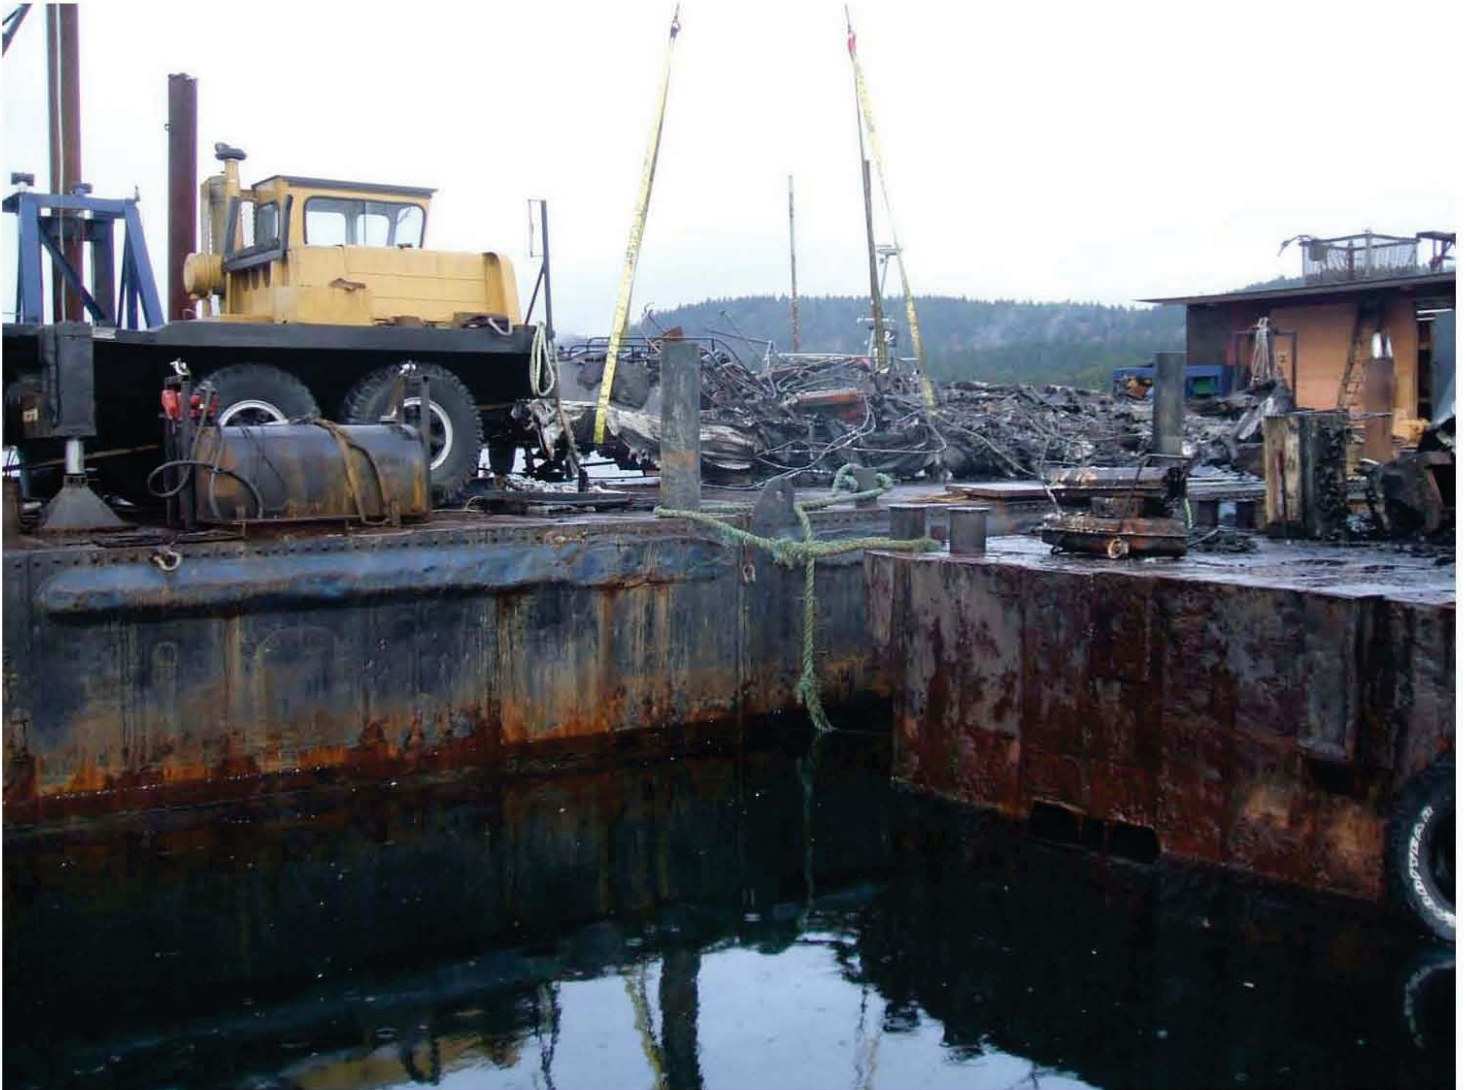
Photo #009 - View of the boat " s.22 " on the barge

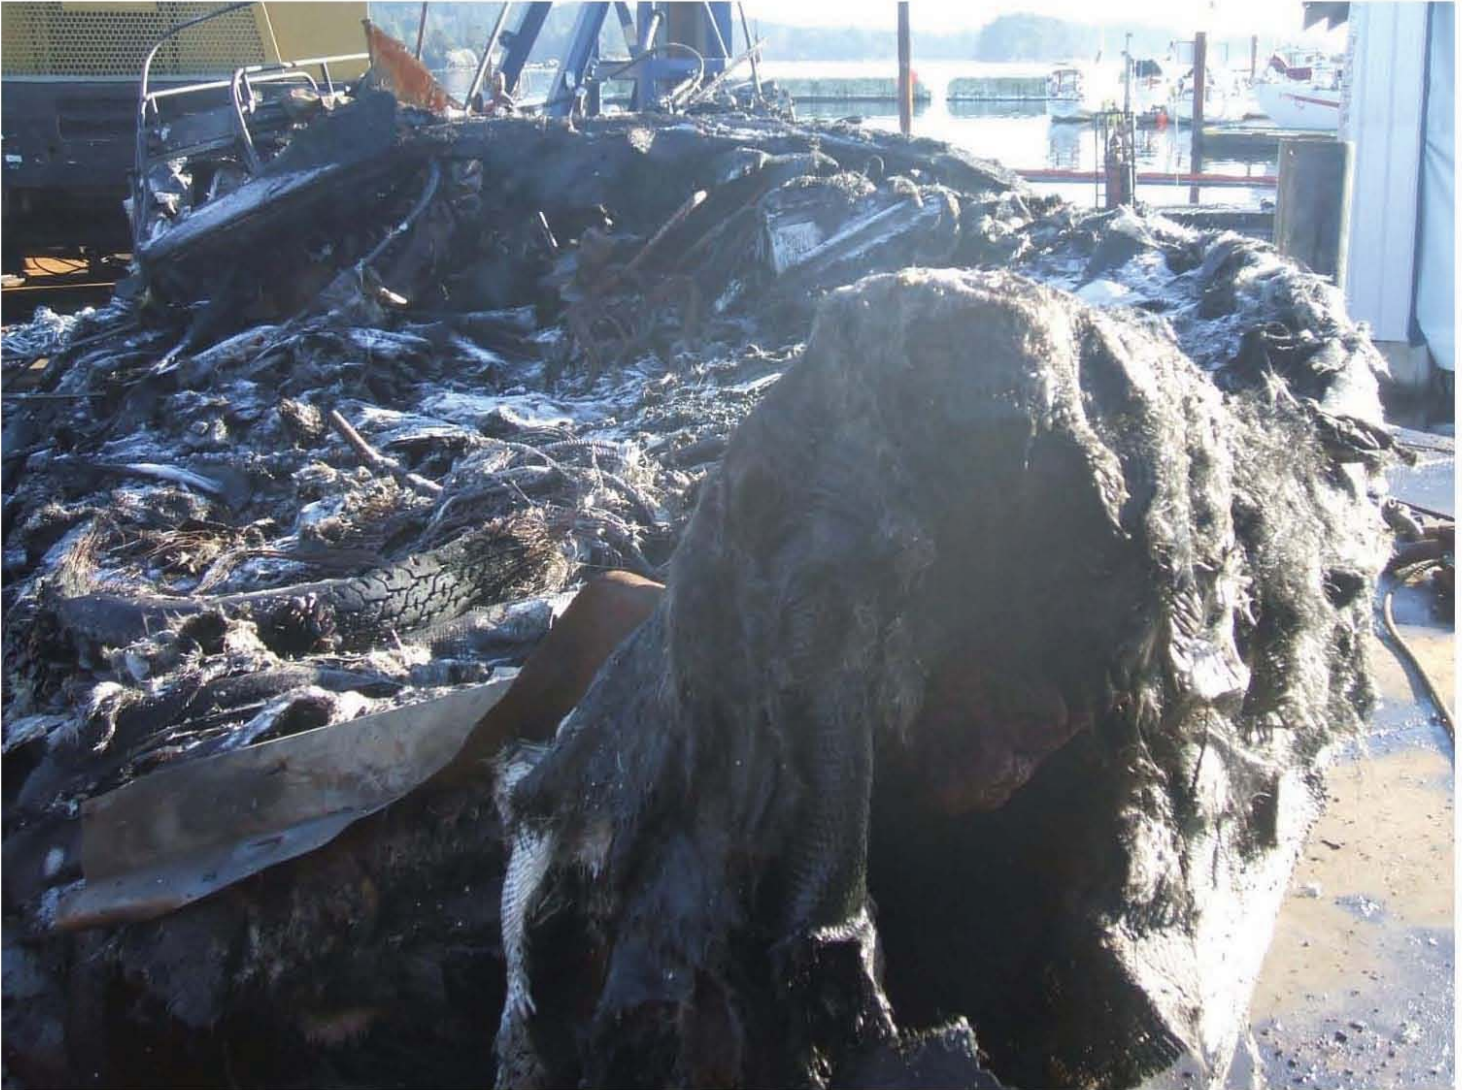
Photo # 010 - View from the bow of the boat

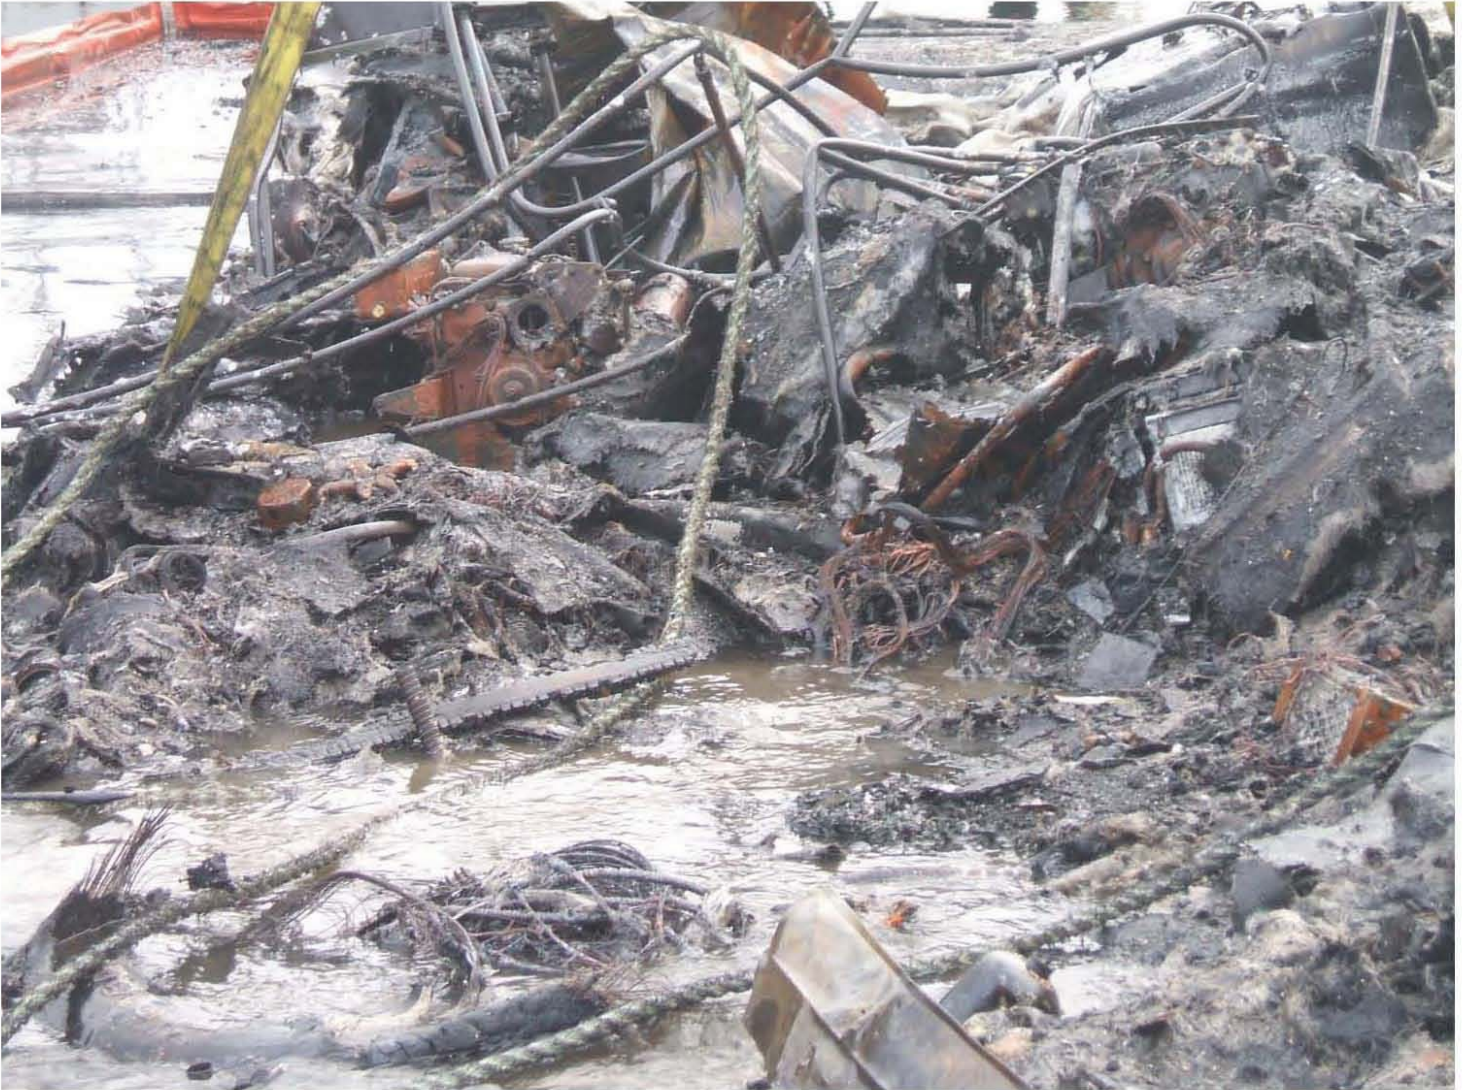
Photo # 011 - View of the boat interior

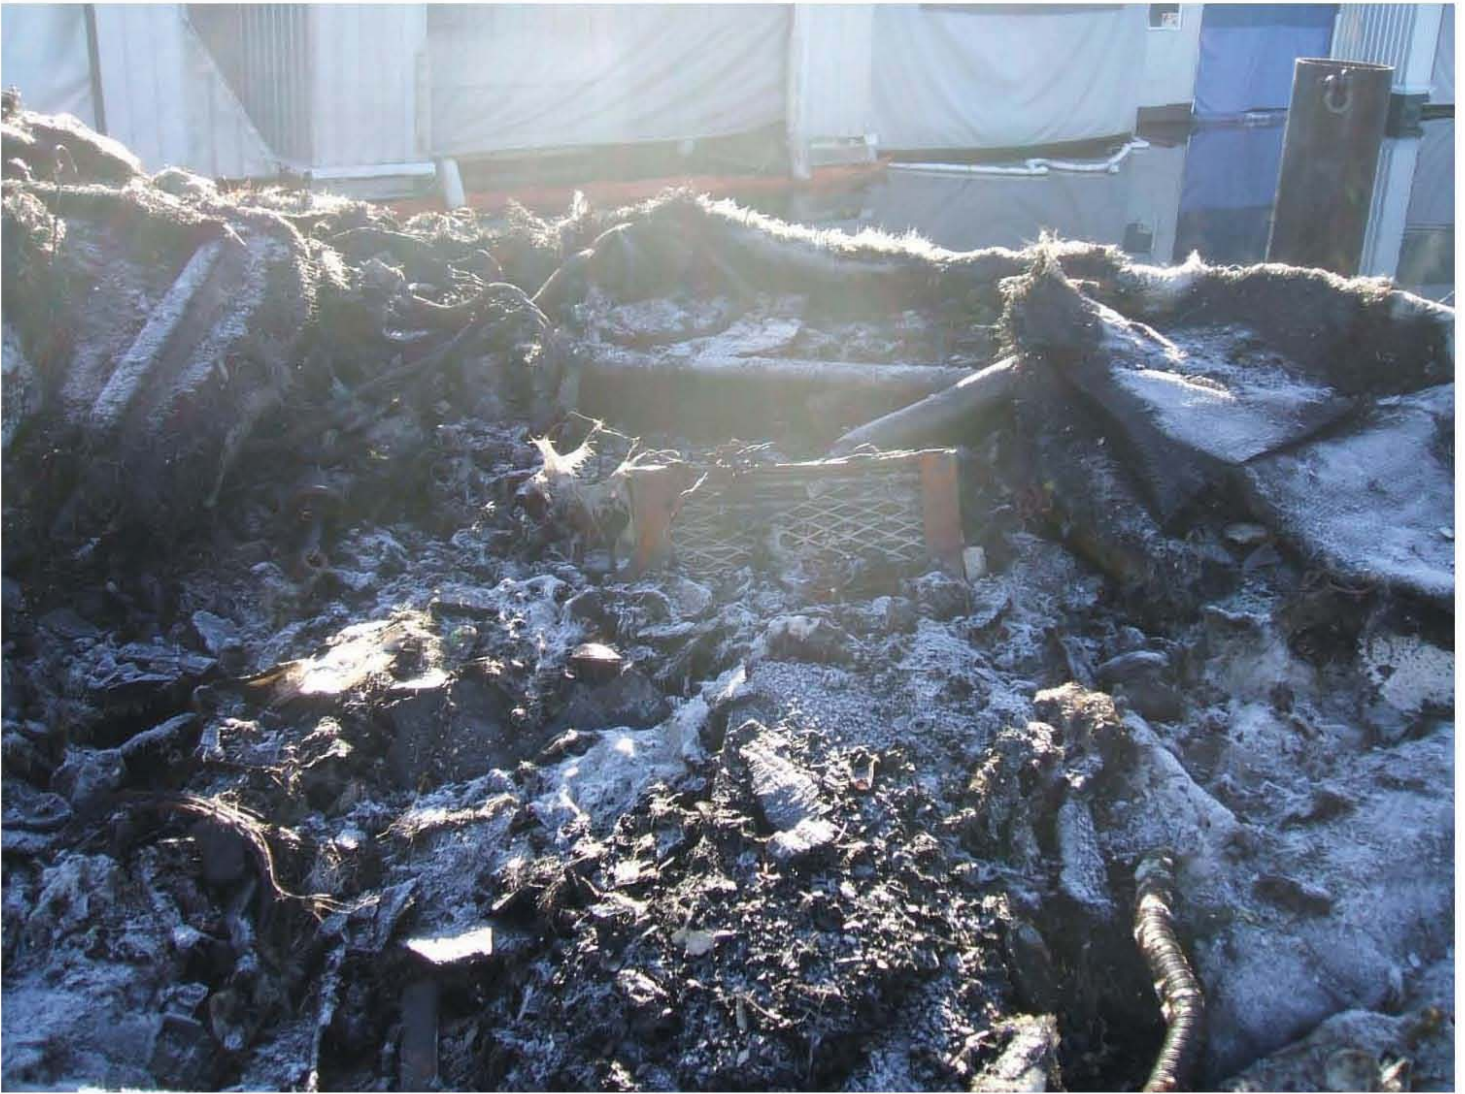
A point of origin could not be determine due to extended fire damage

Photo #012 - View of the sleeping quarters

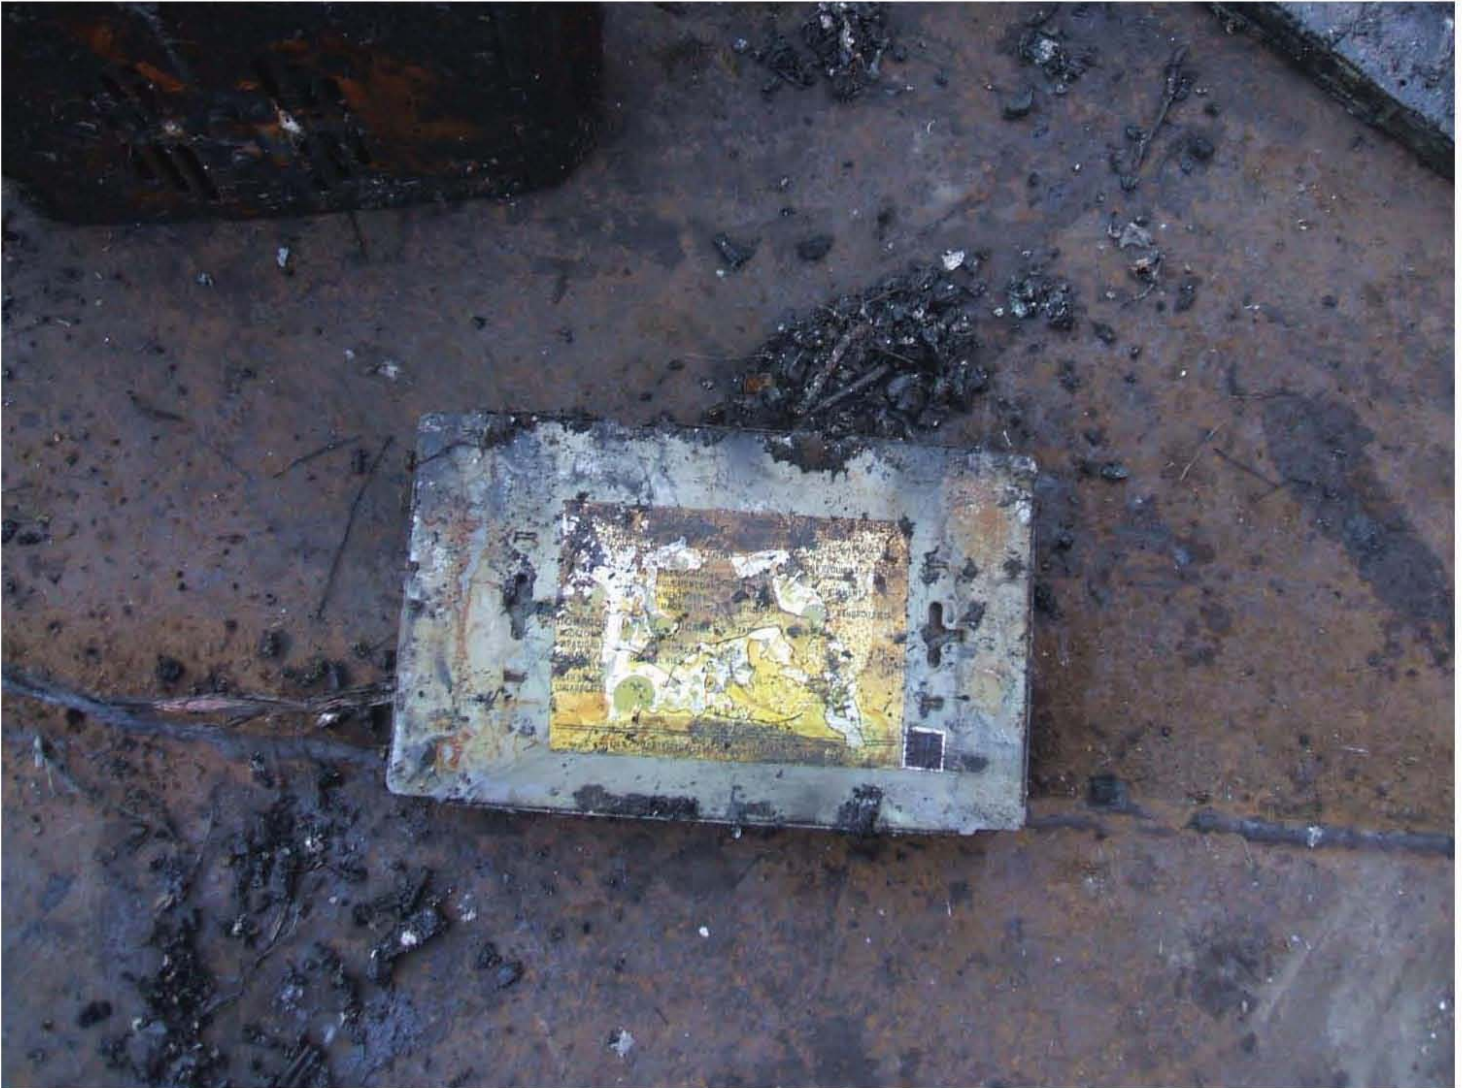
The s.22 vessel was on shore power at the time of the fire. The only things running on the vessel was a Caframo 9206 deluxe heater unit (photo #014 & #016) which had been connected to a power bar (photo #015 & #016) which was powered by a timer unit (photo #013 & #017) from the shore power onboard the vessel. The timer could operate up to 4 hours per day. No one has been onboard the vessel since December 21, 2010.

Photo #013 - View of the electric timer

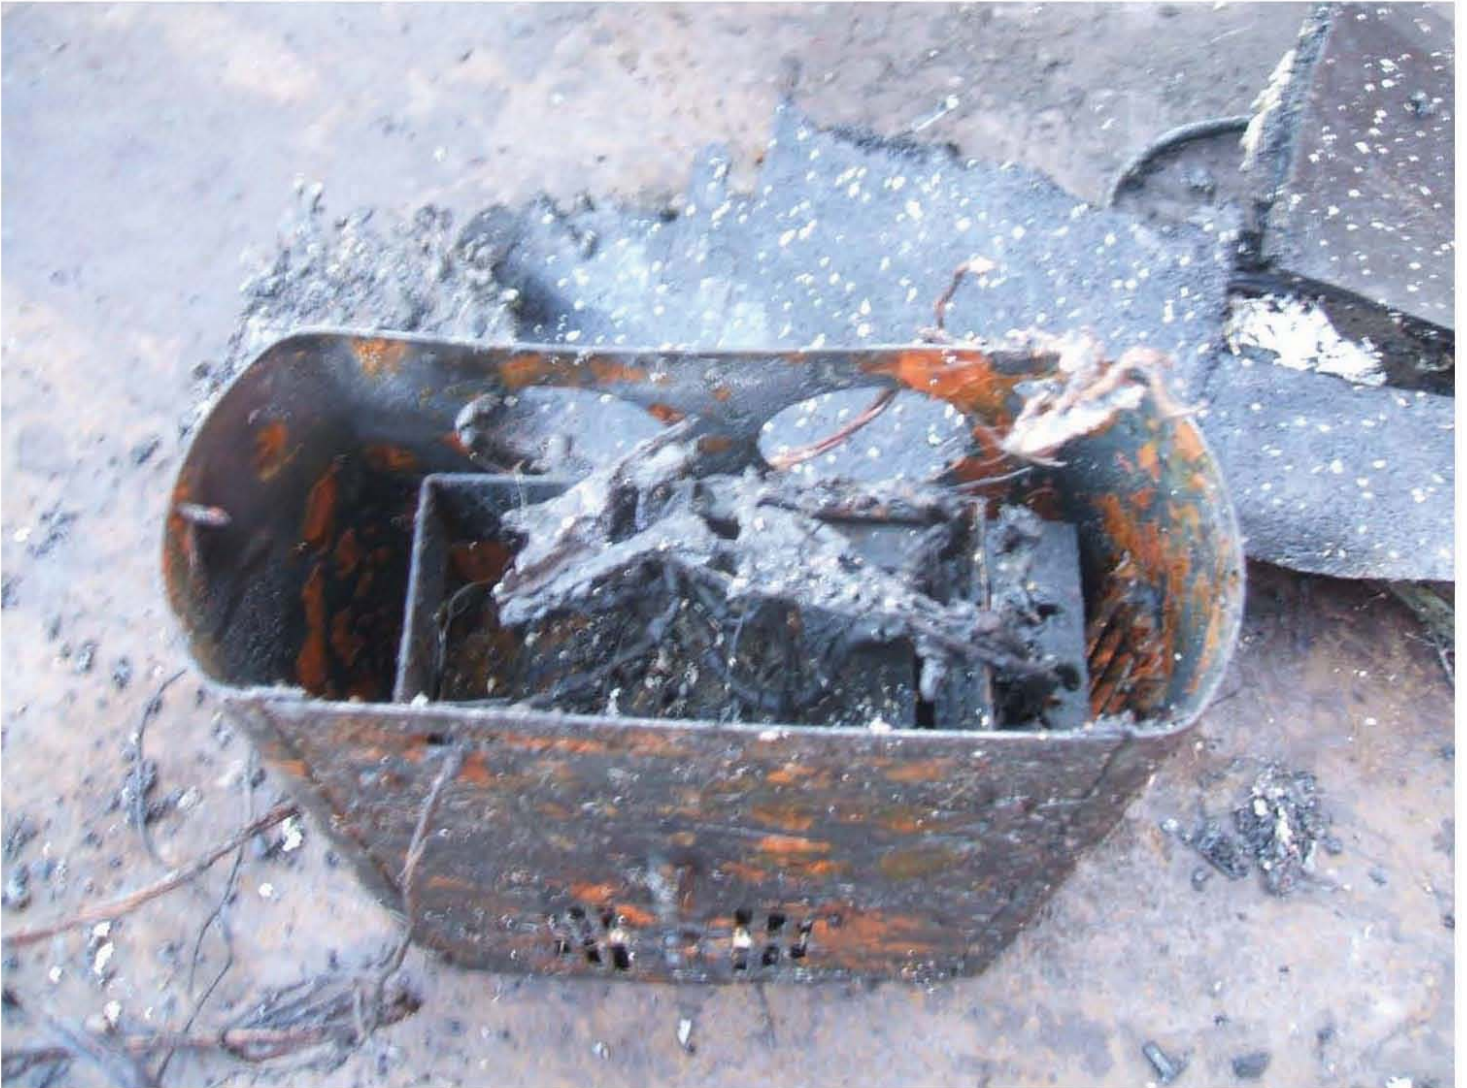
Photo #014 - View of the electric heater fan
