Fire Investigation Report

Incident No. TLA 11 01 05 23 01

Property Classification Marina Fire

Date of Fire January 05, 2011

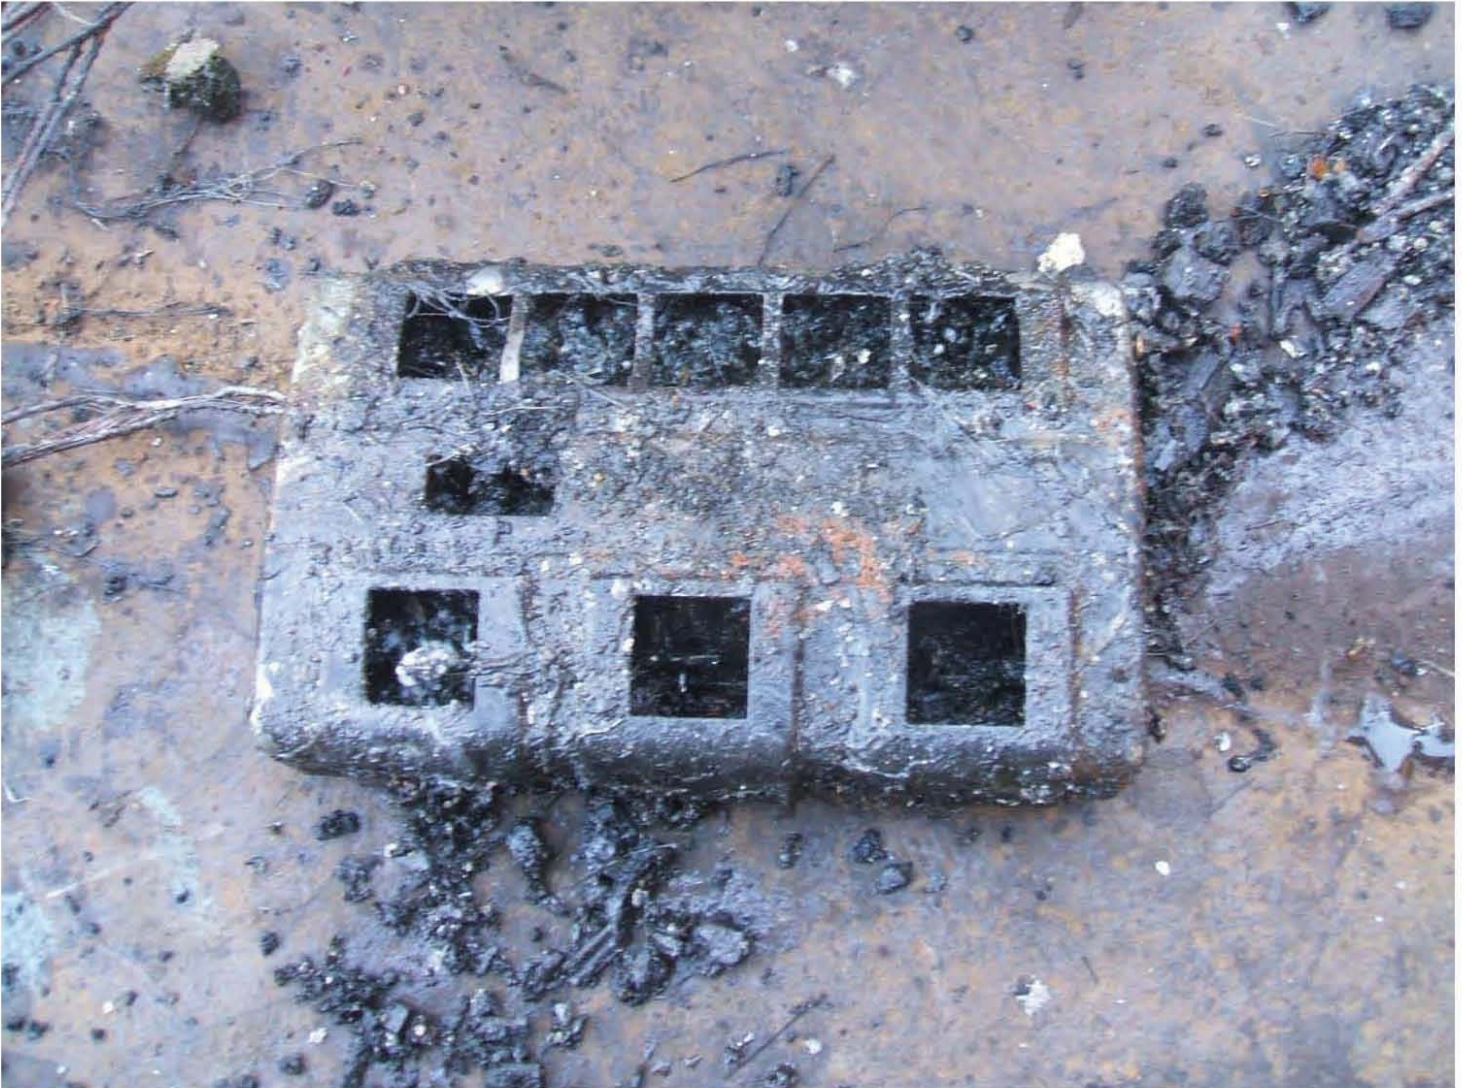
The s.22 vessel was on shore power at the time of the fire. The only things running on the vessel was a Caframo 9206 deluxe heater unit (photo #014 & #016) which had been connected to a power bar (photo #015 & #016) which was powered by a timer unit (photo #013 & #017) from the shore power onboard the vessel. The timer could operate up to 4 hours per day. No one has been onboard the vessel since December 21, 2010.

Photo #015 - View of the power bar

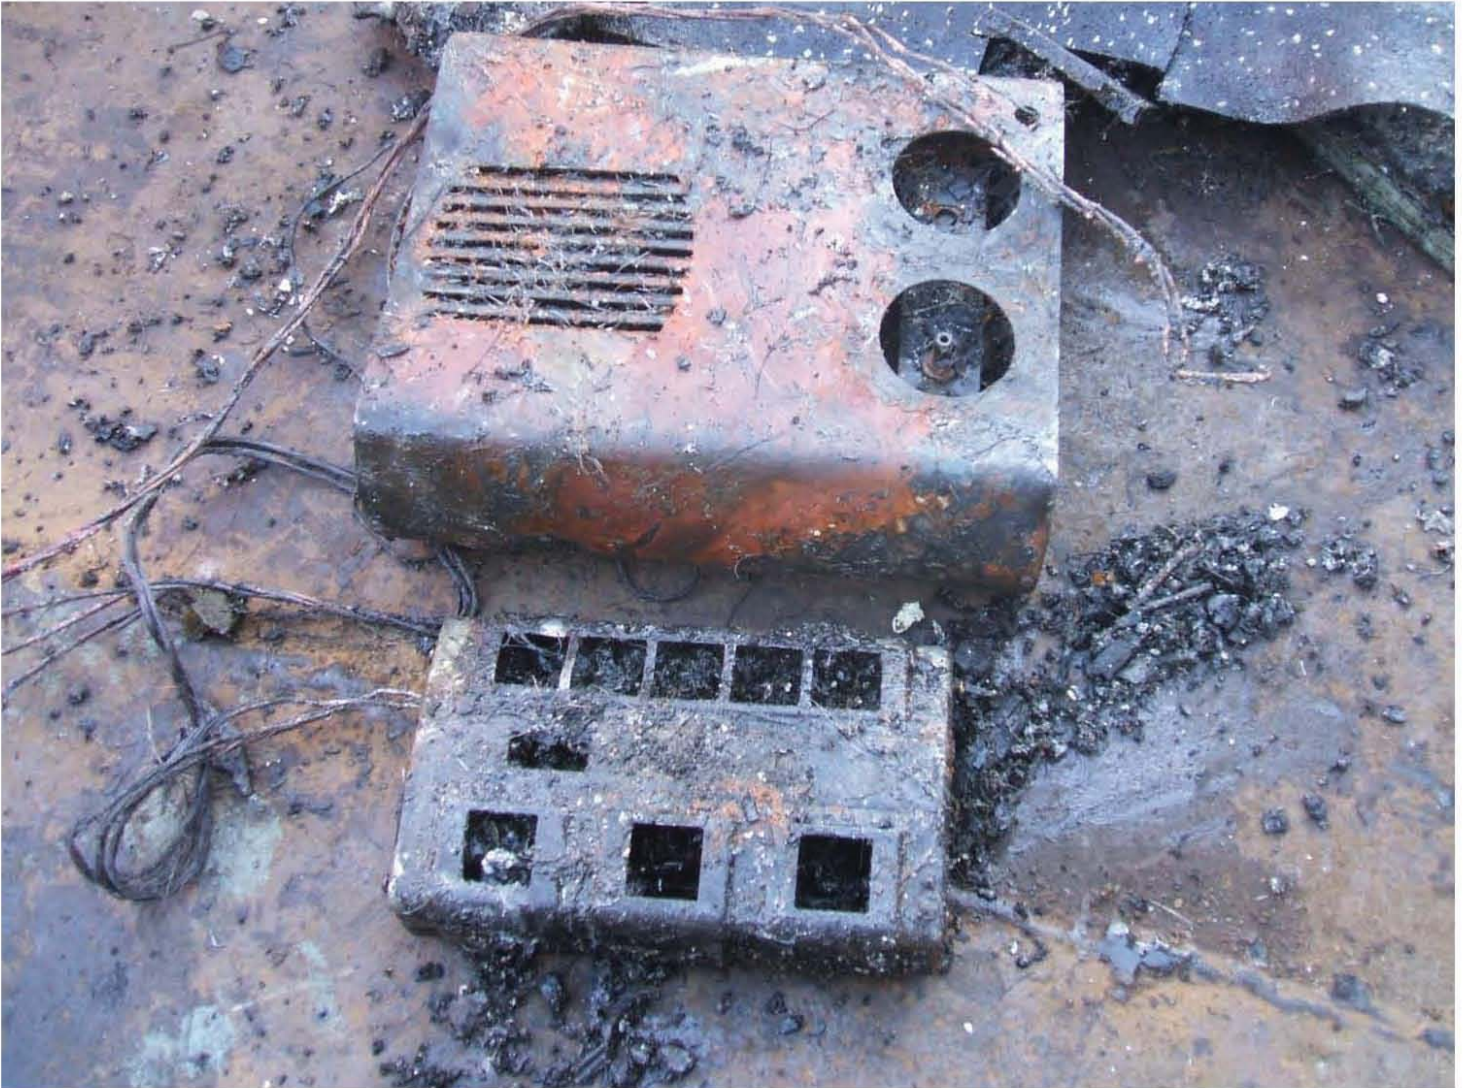
Photo #016 - View of the heater fan and power bar

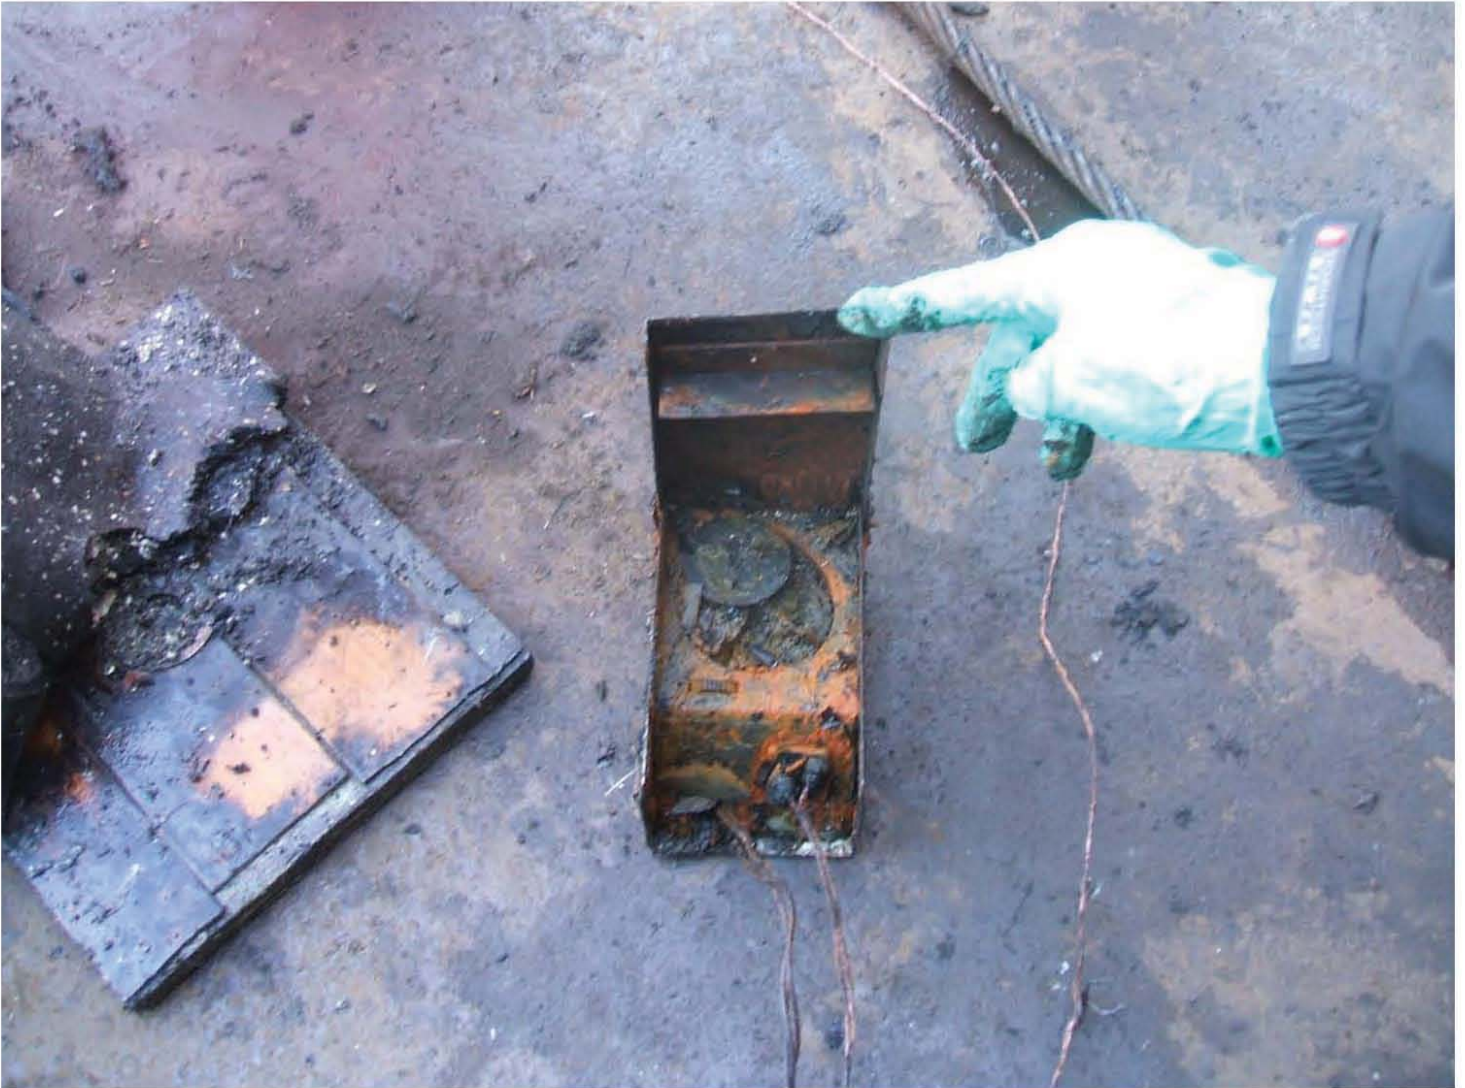
Photo #017 - Inside view of the timer
