EVERGREEN LINE RAPID TRANSIT PROJECT

SPAN S1-55 INCIDENT INVESTIGATION REPORT

Project No. 511325	Revision: 0	Page
	Doc No. 511325-00000-SWSL-30RA-0001	Issued	
			2014-04-08
DOCUMENT TITLE: SPAN S1-55 INCIDENT INVESTIGATION REPORT

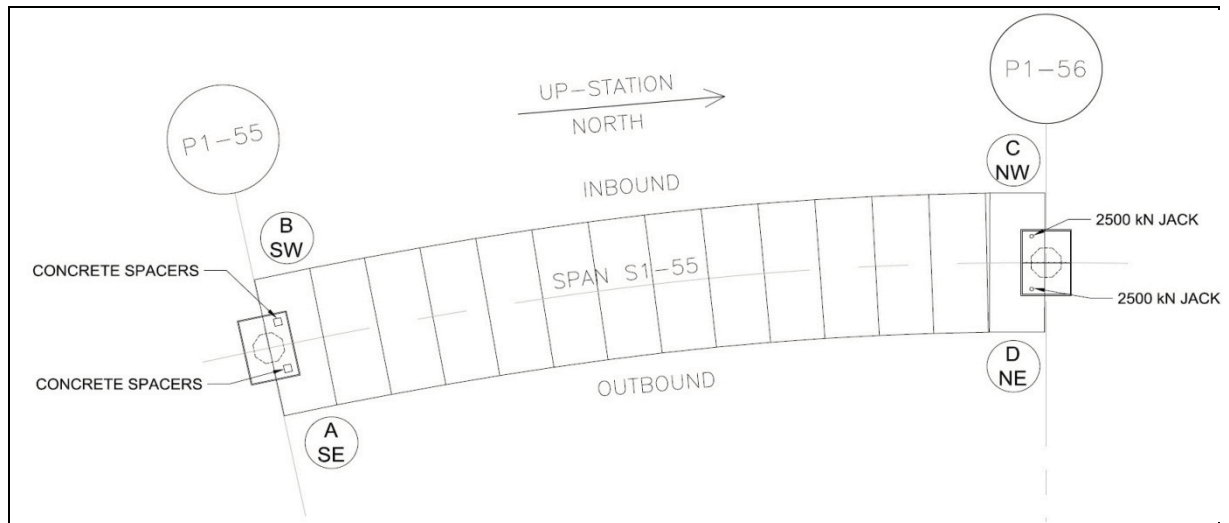
Span 1-55 is located between piers 1-55 and 1-56 and is a “middle” span of what will ultimately be a four span continuous structure. At the time of the incident it was a simple span supported on four temporary supports (two supports at each pier). For the purposes of this report, North is identified as the direction of the “Up-Station” on the following figure.

- Orientation of the horizontal slider plates. The northwest support (location C in the above figure) had the stop blocks positioned on the uphill (longitudinal) and upslope (lateral) sides. The northeast support (location D in the above figure) had the stop blocks positioned on the uphill (longitudinal) and downslope (lateral) sides.

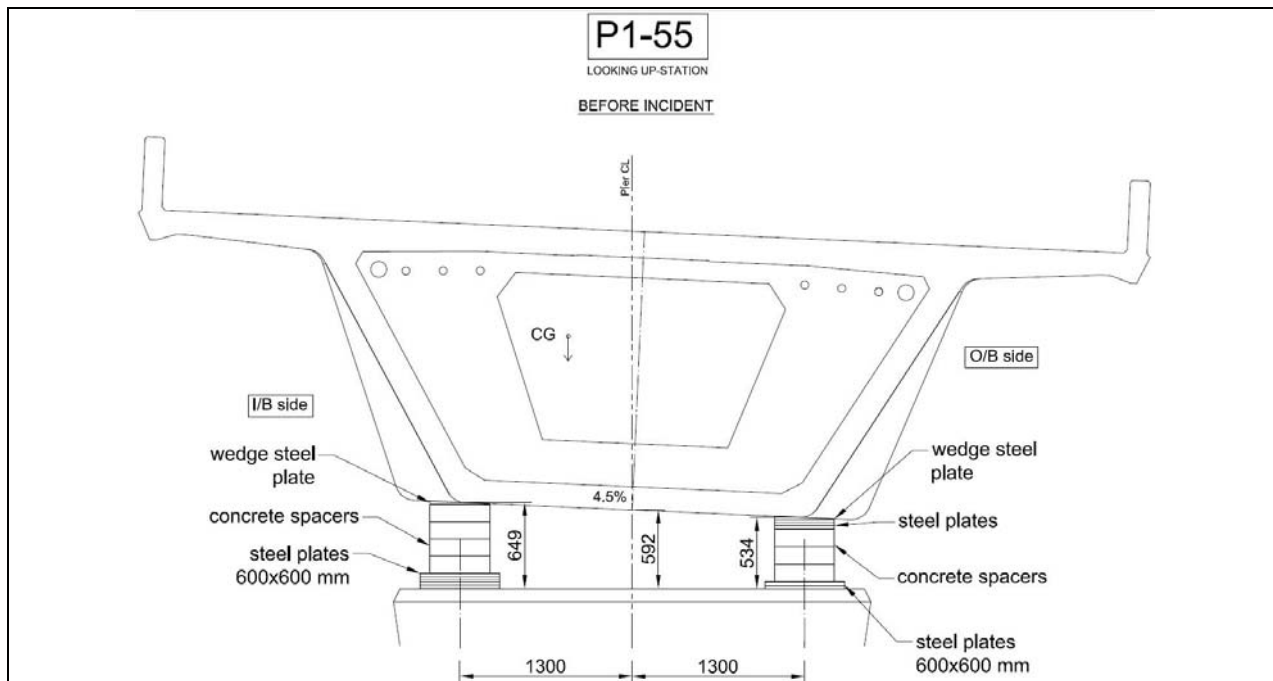
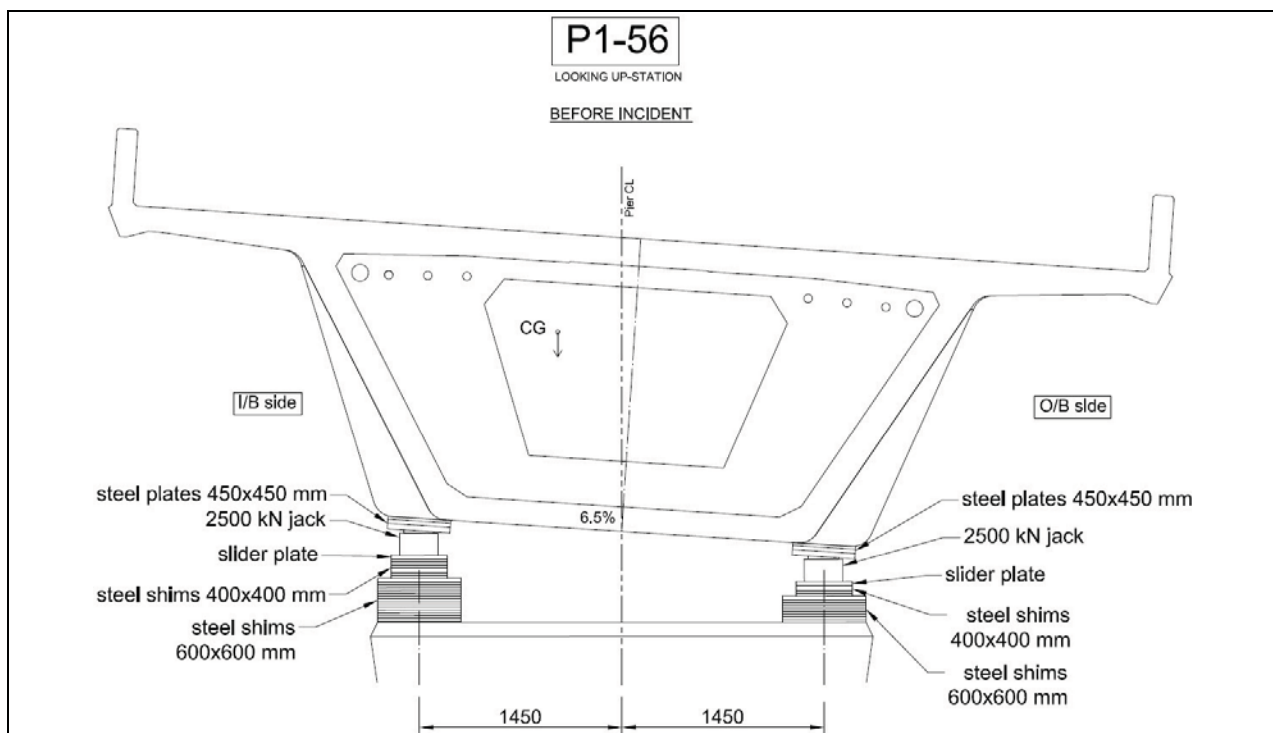
3.2 Before the incident, the supports at Pier P1-55 and P1-56 were as shown below:

- The south end of span 55 (pier 55) was on two “fixed” temporary supports consisting of solid steel shims plates on the pier cap concrete, steel C-channel framed boxes with a concrete infill (the “concrete spacers”), and solid steel tapered wedge plates at the underside of the pier segments to accommodate the cross-fall slope. Between the concrete spacers, thin layers of particle board were used to even out the contact surfaces between the concrete spacers.

- The north end of span 55 (pier 56) was on two “sliding” supports each consisting of solid steel shim plates on the pier cap concrete, a steel slider plate with Teflon pads/lithium grease, a 250 ton hydraulic jack with a tilt saddle (to take up the cross-fall and longitudinal slope), and solid steel flat plates at the underside of the pier segments.

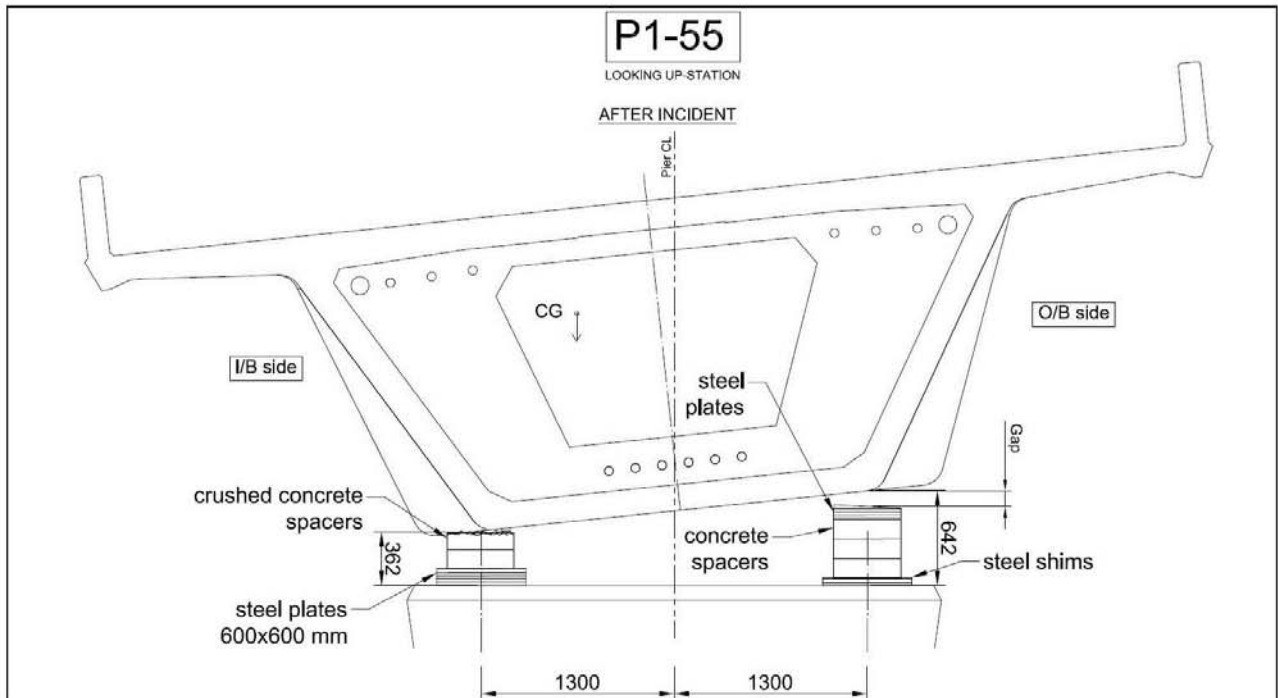
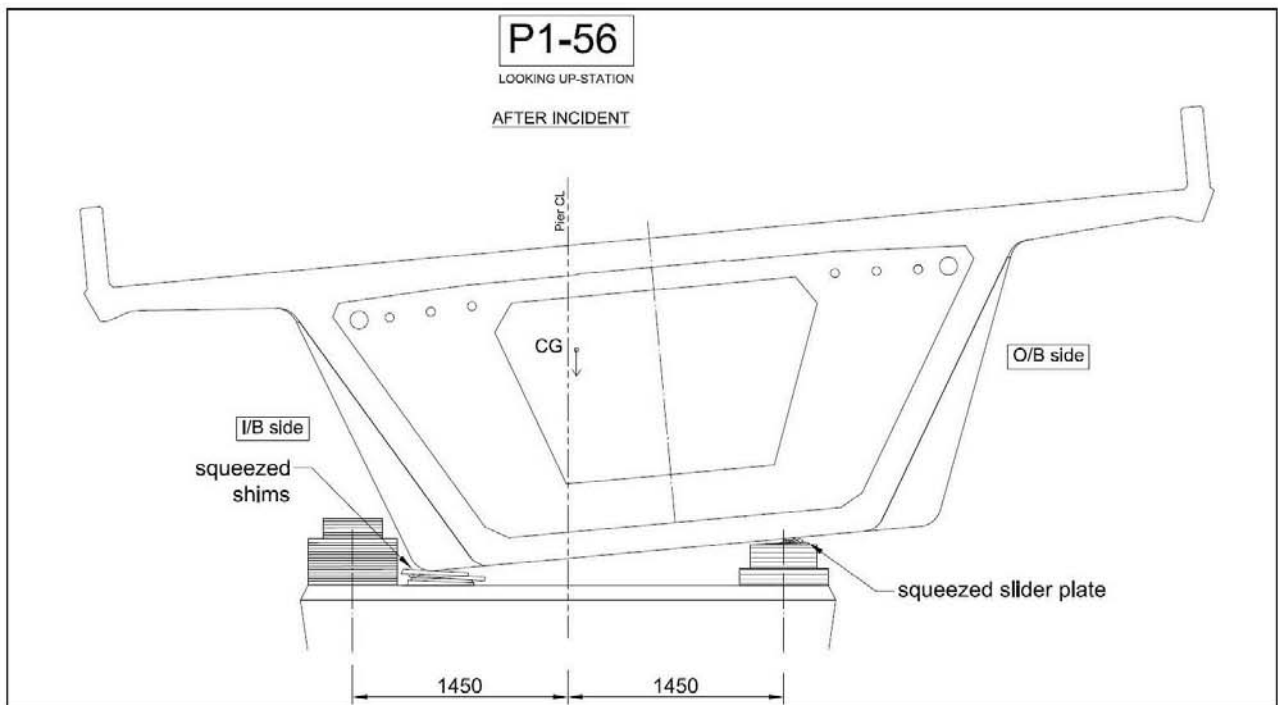
3.3 After the incident, the supports at Pier P1-55 and P1-56 were as shown below:

The most likely failure mechanism is scenario two where the lateral movement occurred first at pier 56. At the time of the incident, insufficient lateral restraint at the north pier allowed the north end of span 55 to slide eastwards, displacing the hydraulic jacks, and dropping off the supports. The resulting rotation of the beam caused an upward and then downward motion of the south west corner of the beam, failing two concrete spacers at the southwest support (location B).

The triggering event for the movement at the north end is attributed to a reduction in the friction between the hydraulic jacks and the Teflon pad / lithium grease that the jacks sit on. This reduction of friction occurred while the top of the pier cap was being heated to promote curing for a concrete pour at this location. The higher heat at the pier top reduced the coefficient of friction of the lithium grease which reduced the restraining friction force allowing the beam to move. Once the beam began to move, it overcame the lateral restraints that were in place at the jack stop blocks.

Immediately following the incident, both failure scenarios were analyzed and temporary works were identified to ensure the stability of the span regardless of the root cause. Additional hydraulic jacks were installed around the temporary supports to provide redundant vertical support. Prior to re-opening Como Lake Avenue, and in preparation for the re-instatement works, two lateral restraints were designed and installed on the piers locking in each end of span S1-55 against any horizontal movement.

- In addition to the standard erection plans for typical spans, site specific temporary support plans shall be designed at all non-typical locations and areas of high grades and cross-slopes, identifying shimming materials and configuration, use of wedge plates, hydraulic jacks and provisions for additional lateral restraints if required,.
- The site erection engineer shall review all temporary support set-ups and confirm they meet the design.
