Bedwell River Trail

Ministry of Forests
South Island District

Traverse & Trail Assessment

Central Westcoast Forestry Society
September, 97

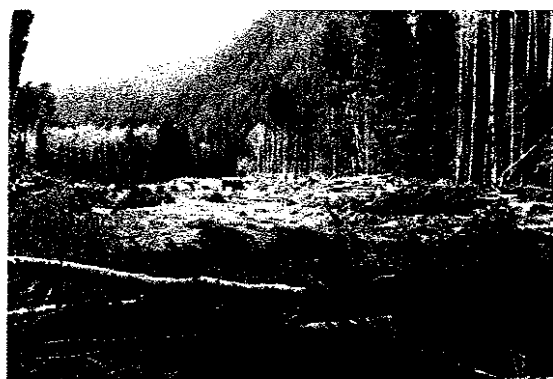
Fig. 3, Shot #19, pkg. #2

0+000 East edge of private lot owned by David Footes. Road bed is the trail base. Pit run gravel was used for the road construction. Overland construction was used over the flood plain. The photo below is looking back on the tie point traverse/road, at David Foote's camp & dry sort.

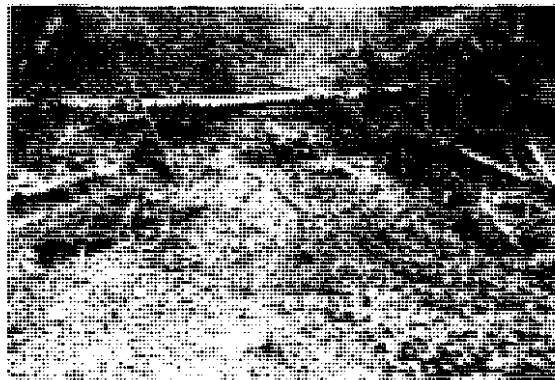
Fig. 4, Shot #31, ppg. A7

0+226.6 A 2m by 5m wooden culvert. The culvert is partially washed out with the stringers partially exposed and unbinding. Loose gravel at sections can be potentially hazardous. The creek is 10 to 15 meters wide in spots and may contain fish or have fish potential. Upon examining underneath this structure, I noticed a cathedral effect as the gravel was eroding from the bottom up, and only then collapsing. This poses a serious safety concern, because it is not obvious but very common on all such structures on this trail. This area has a very low gradient. Further assessment is required before further options or recommendations can be made.

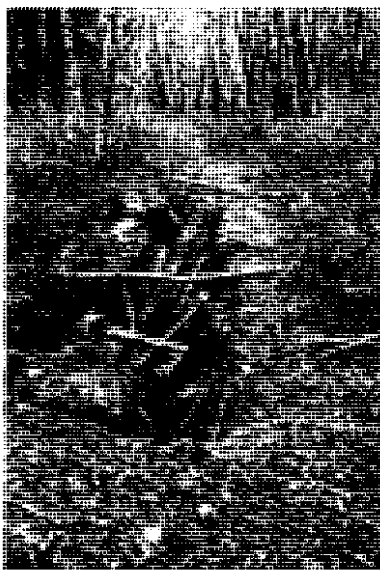
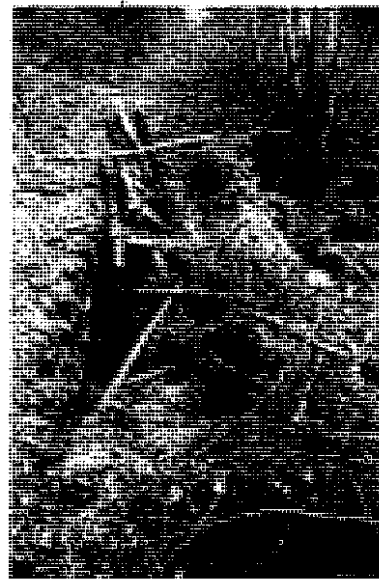
0+288.9 A 3m by 15m wooden culvert. The stringers are rotten and falling into the creek. The creek has fish bearing potential and has a low gradient. Further assessment is required before recommendations with options can be made. Specific site plan need to be developed.

The two previous photos were taken from each end of this structure. The photo below was taken looking back down the trail and captures a glimpse of the creek on the left.

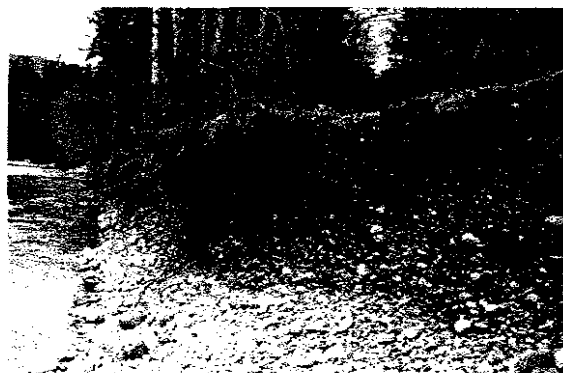
0+403 - 0+855 This whole section of the road has been washed-out by the Bedwell River. A by-pass has been flagged, lightly brushed, and traversed. Extensive grubbing and further brushing is required to clearly delineate this re-route. Soil conditions might require a board walk structure or gravel trail be constructed. Due to the eroding riverbanks, the head of this bypass may need to be moved back to a more stable point. Further assessment, under winter conditions, is required to determine if this is truly the best route or approach because of the number of potential problem creek crossings in the approaching one hundred meter stretch.

0+403.5 The road has been washed-out by the river from this station on. The first photo below shows the view upriver from this station and the second was taken below the station, from the river's edge looking back up to the station.

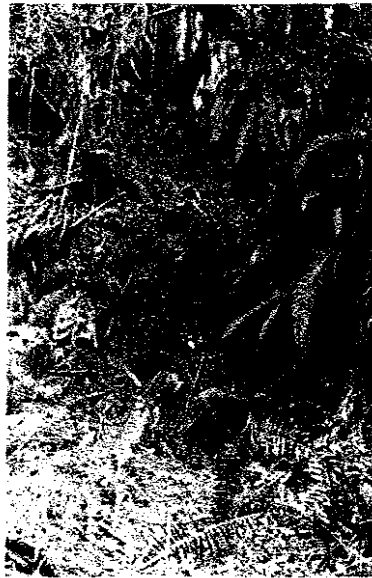
Fig. 10, Shot #7, pkg. #3

0+425.3 The trench here is part of the by-pass route and needs to be spanned.

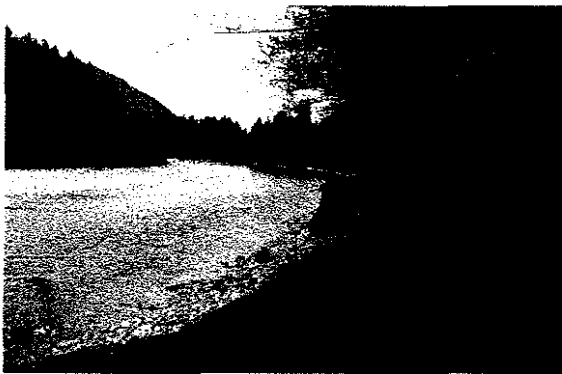
Fig. 11, Shot #8, pkg. #3

0+856.8 End of the wash-out by-pass, back onto the old road.

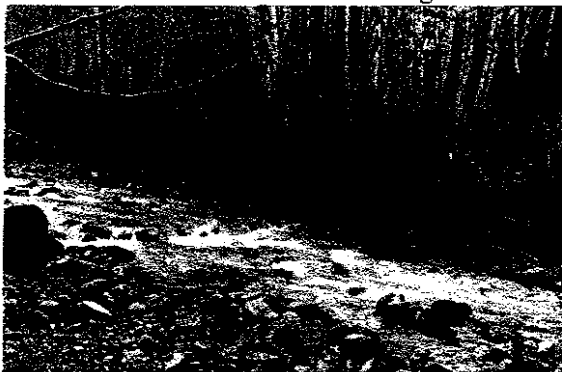
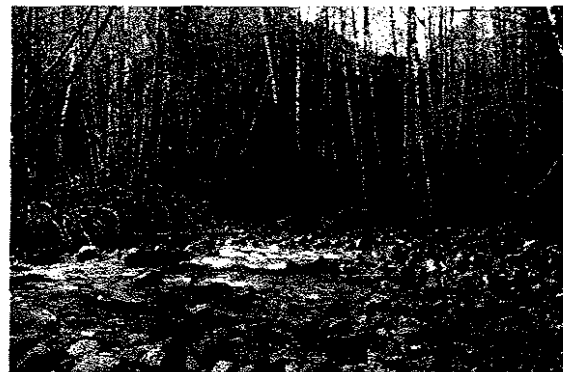
1+325 Bypass of washed out bridge. The creek torrent has washed out the structure, at one point leaving a 3-4 meter drop off at the road crossing. A bypass to the upper slope has been worn and crossing on the creek cobbles is the issue. At low water the crossing is easy, but may be a bit damp, in the summer the creek is dry. The creek has a 10% gradient and is more than likely impossible to cross in a torrent. . Further assessment is required before recommendations with options can be made. A specific site plan needs to be developed if any changes to the current situation were to be considered.

1+388.5 The creek is easily forded in this area. The first photo of the ford and the second photo is of washed-out is where the bridge use to be.

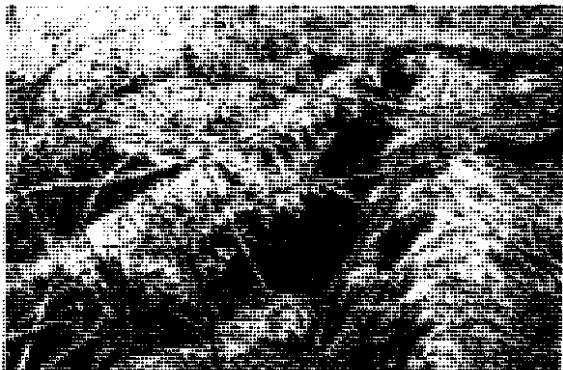
1+919.4 A 15.4 m bridge crossing over Penny Creek. This structure is very rotten and poses a danger to anyone crossing it. The water was deep and flowing, when first observed in April, but dry, except for pools, in August. The ends of the bridge deck are separating from the roadbed, about a metre gap exists at the north end. Another problem is the cathedral effect, hiding potentially dangerous footing. The potential for injury at this site is high and needs to be addressed. This creek has very high fish bearing potential, many small fish were seen on several occasions. Further assessment, especially environmental, is required before recommendations with options can be made. A specific site plan needs to be developed. The first photo below is from the station looking along the bridge, the second photo is from the north bank of the creek looking at the east side of the bridge.

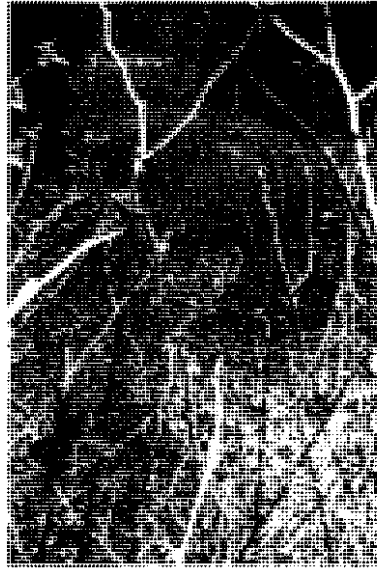
Fig. 24, Shot #20, p. 47

A slide on the low side of the road has recently occurred. It traveled down the side hill approximately 200 meters. In the deposition zone the slide is 30 to 50 meters wide. Another failure will probably occur at the 2+982.2 mark. The fill slope has stress cracks along this section for ten to twenty meters. The majority of the road bed will remain intact after the occurrence.

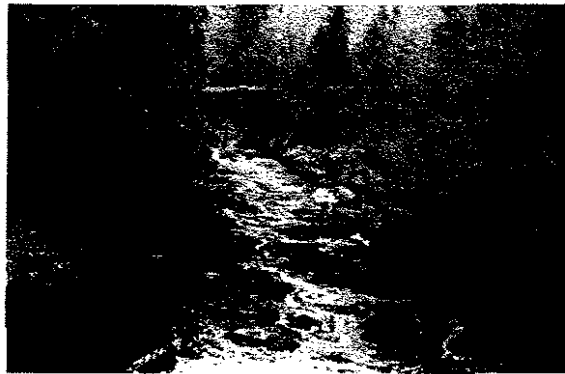
Fig. 26, Shot #16, pkg. #4

3+806.2 The centre of the suspension bridge, the photo below is looking upstream to the single remaining stringer of the old bridge.

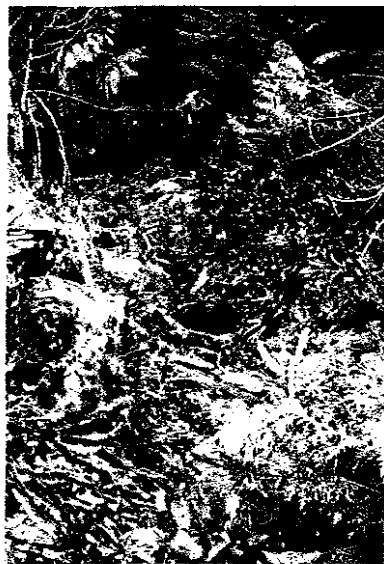
3+844.2 & 3+882.0 The two photos below are of the two wet spots on this section of the trail Both need to be worked on to minimize and further braiding, boardwalks would best address this.

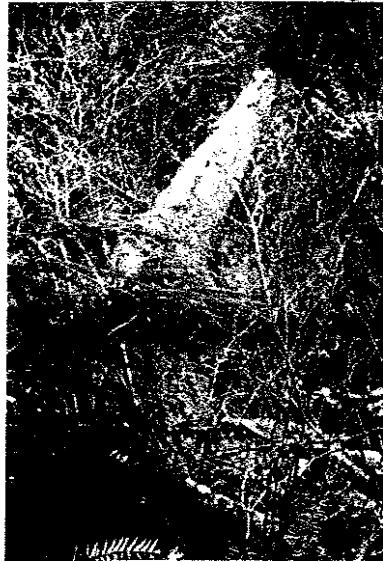
3+980.8 The by-pass trail rejoins the old road bed at this station. The two photos below are of the old log stringer that was by-passed. The first one was taken from the other side of the river, from this station, and the second one was taken just a few metres back of the station. The bush at the edge of the canyon obscures the stringer until you are right at it.
