Post-Crash Vehicle Inspection Report

2012-23079

04-20120514-043

Date: May 25, 2012

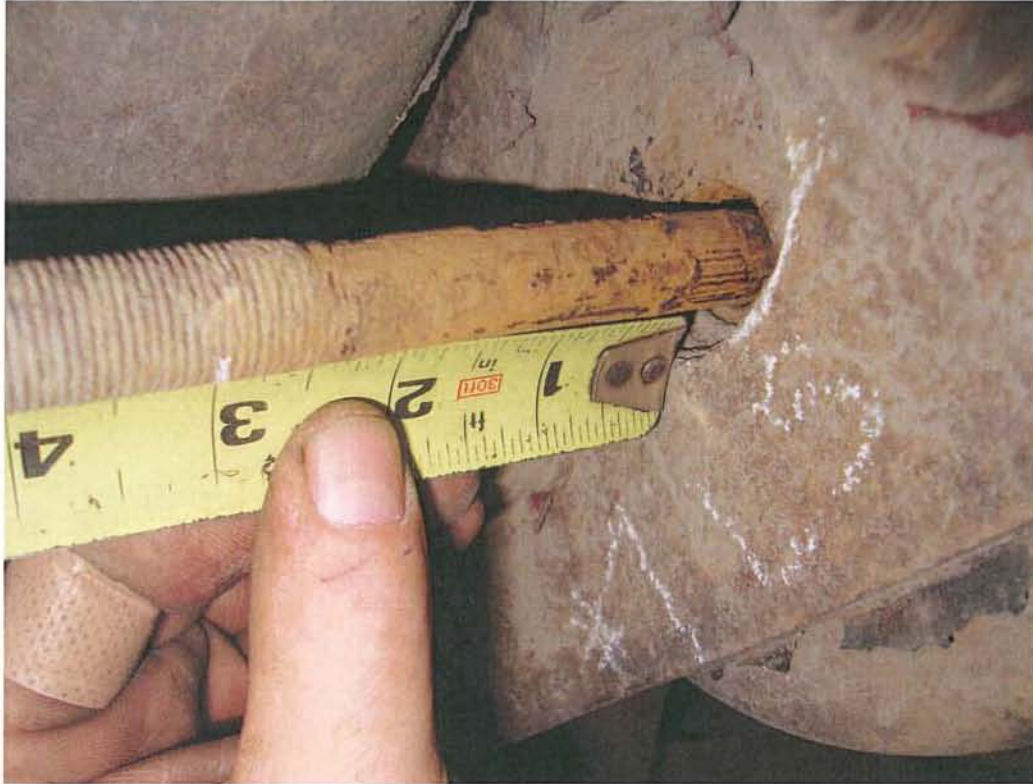
Axle #	Type	Left	Right	Adjustment limit
1	20 Regular stroke	1 5/8"	1 3/8"	1 3/4"
2	20 Regular stroke	1 1/4"	1 1/4"	1 3/4"
3	30 Regular stroke	1 5/8"	1 3/4"	2"
4	30 Regular stroke	1 5/8"	1 5/8"	2"
5	30 Long stroke	1 5/8"	1 3/4"	2 1/2"
6	30 Long stroke	1 7/8"	1 3/4"	2 1/2"
7	30 Long stroke	3"	2 5/8"	2 1/2"
8	30 Long stroke	3"	3"	2 1/2"
9	30 Long stroke	2 3/4"	0" loose brake pot	2 1/2"

Photo # 5 – axle #7 left side brake stroke

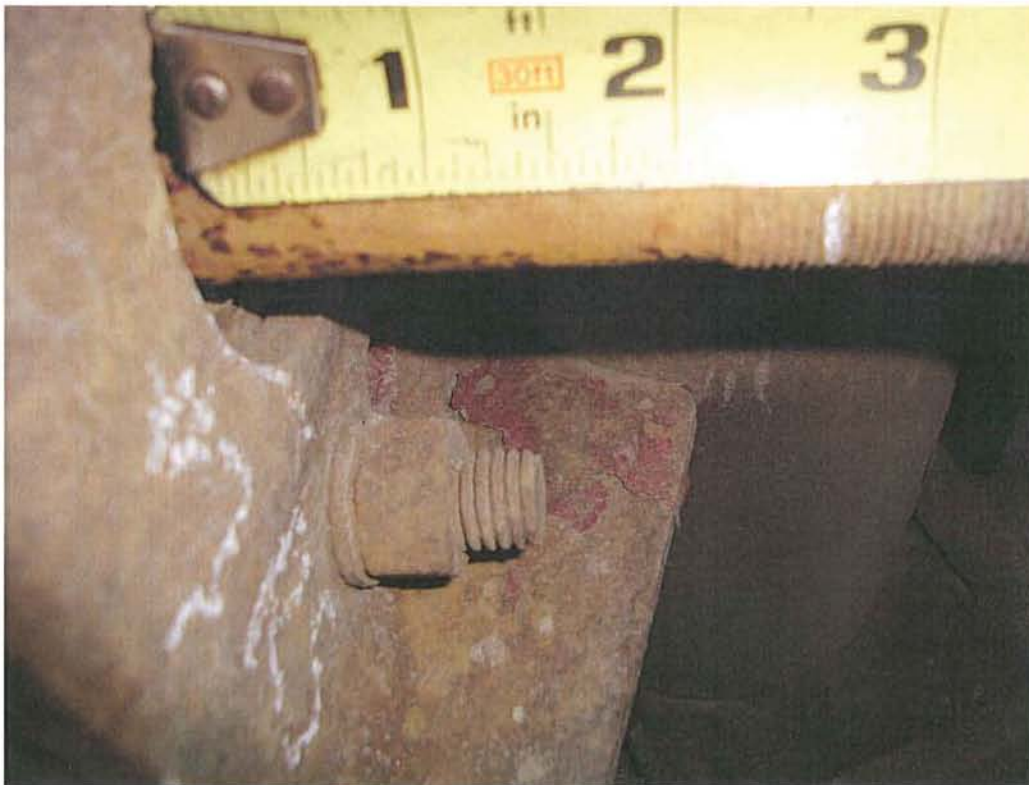
Photo # 6 – axle #7 right side brake stroke

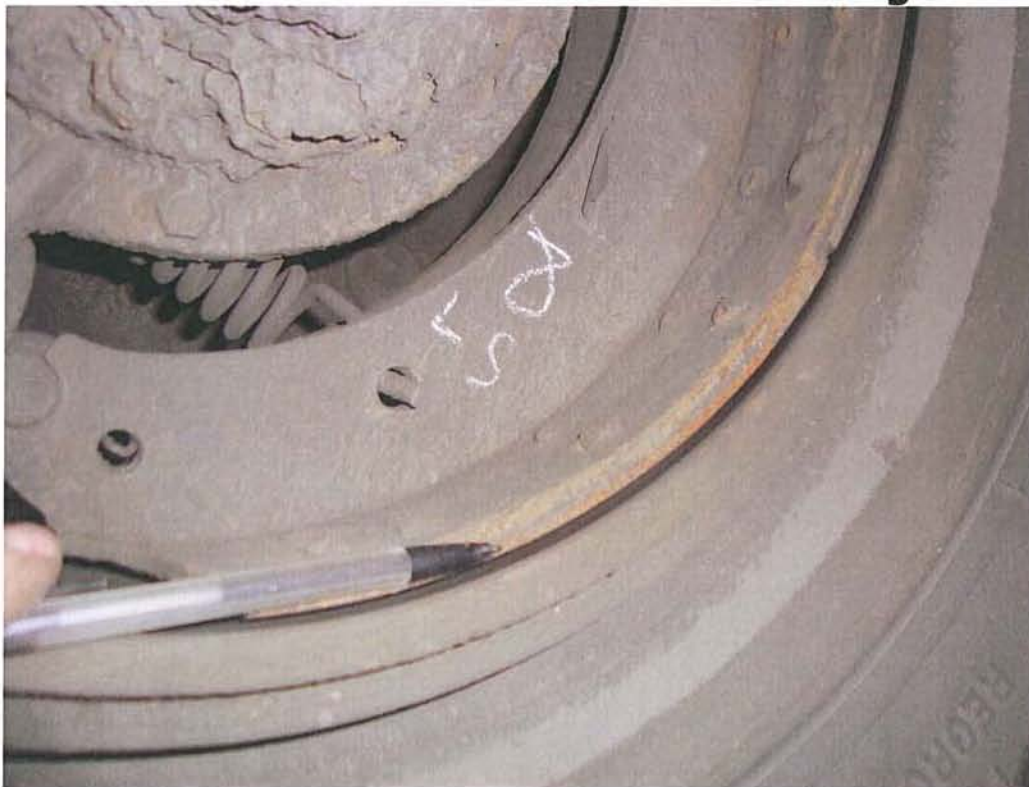
- The brakes on axles #7, #8 and #9 were not in adjustment (MVAR Div #7 Schedule #24).
- The brake chamber push rod clevises and pins on axles #7, #8 left side and #9 right side were worn excessively (MVAR Div #7 Schedule #25).

Photo # 12 – axle #8 left push rod, worn clevis and pins
