09 June 2014

From: Joseph Kenny, P.Eng, R.P.F.  
Engineering Group Leader - North  
Engineering Branch,

**Re: Spinner Road Instability Issues.**

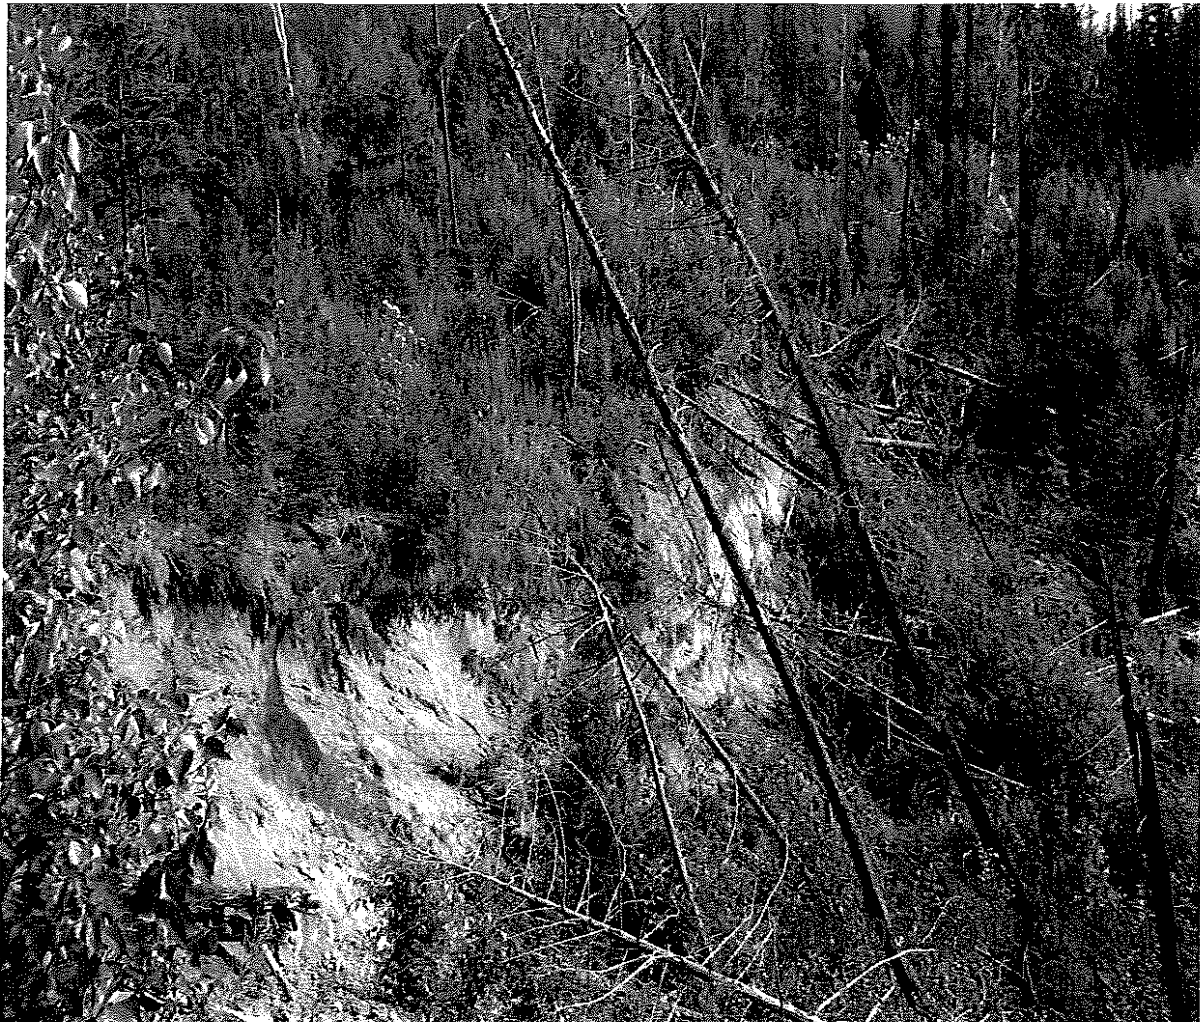
Photo #1 View of head scarp within block

Upon reviewing the site it was discovered that the failure did not initiate directly off of the deactivated road but rather started approximately 40m down slope of the road. In reviewing the deactivated road above the site it did not appear that the road construction or the deactivation contributed to the failure. The road had been deactivated to reasonable standard and natural drainage in the area had been re-established.

A possible contributing factor to the failure may have been the harvesting of the block and the methods used to harvest, although this cannot be definitively stated based on the information reviewed.

It is not known whether there was a Terrain Stability Assessment (TSA) completed for this block prior to harvesting but given the magnitude of the slide that occurred, terrain in the area, soils types and moisture regime in the area it is felt that this site should have had a TSA completed prior to harvesting. The results of this assessment should have been incorporated into the harvesting plans. Recommendations that would have been expected to be included in the report would have been recommendations for harvesting methods to minimize ground disturbance of the area, season of harvest recommendations, wind firming of boundaries, possibly some retention, and road construction and deactivation prescriptions to maintain natural drainage patterns.

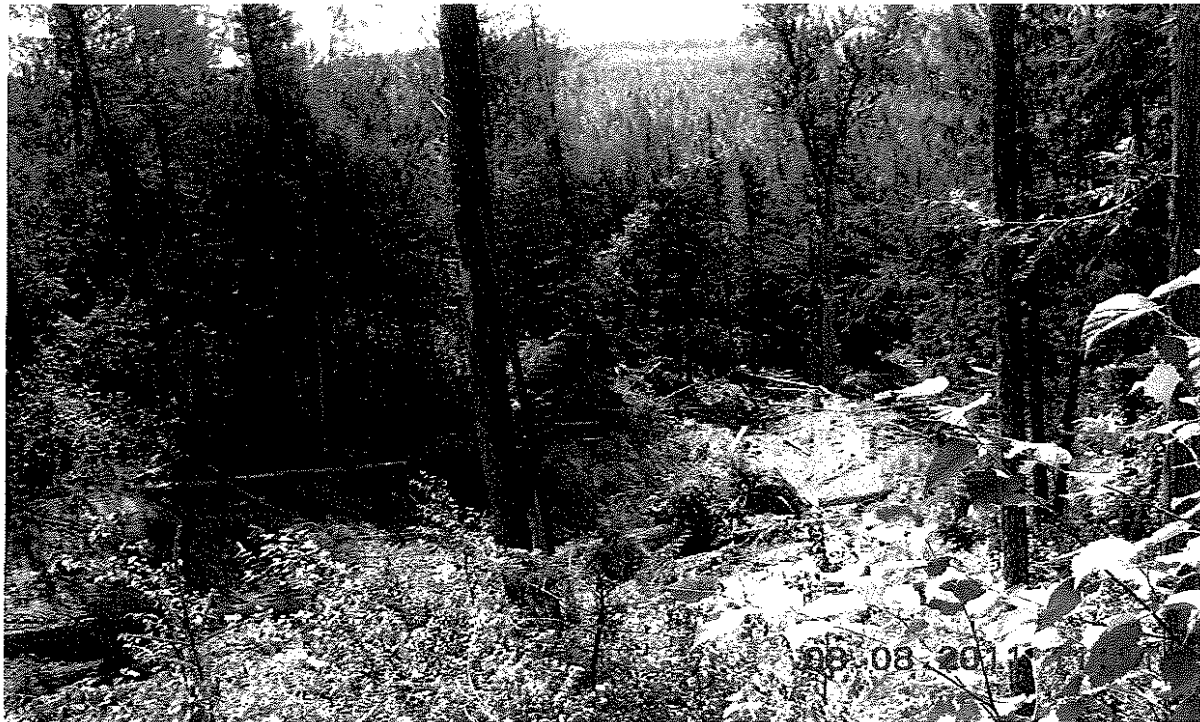
Photo #2 View of slide path down through standing timber

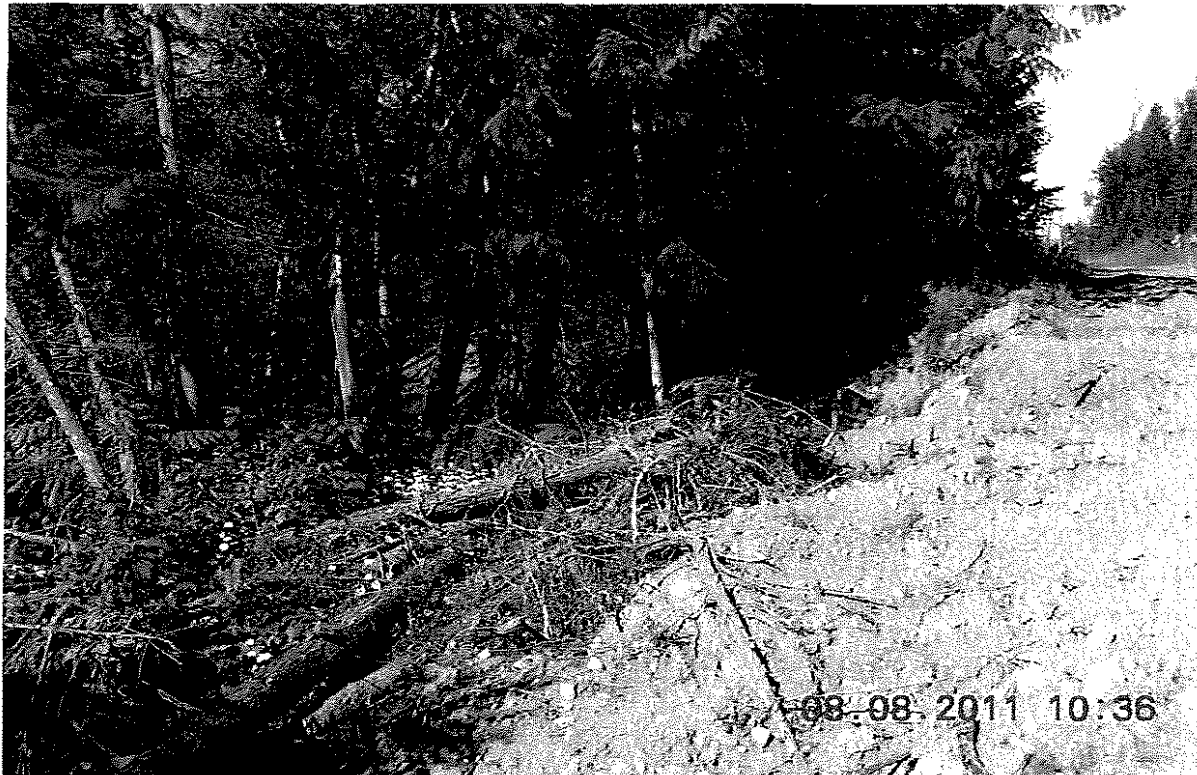
Site #2 consisted of fill and cut slope failures in various states. Photo #3 to # 7 show several views of this road section and the some of the issues. Some repair works had already been done to reopen the road prior to our site inspection. Having no records of how the site was originally constructed and or what the site looked like follow the failure makes it difficult to ascertain what actually had occurred at the site prior to the site repairs but several consistent issues were noted along the length of road section up the hill. The original road appears to be constructed using cut and fill techniques and no end haul or full bench cuts appear to have been done. Cut and fill slopes were over steepened in areas, fills were loosely placed and organics were visible in the grade at several failed section. Additionally it was noted that there was few cross drain culverts and the ditchline was not well maintained.

Given the above noted conditions of the road it appears that the road had several failures both on the cutslopes and fill slope during the early spring of 2012. These failures were due to unsuitable original construction practices for the terrain encountered, lack of ongoing maintenance required to ensure road prism is well drained via the ditch line

Subsequent to the failures the road was reopened. The repairs conducted to reopen the road consisted of pushing slide debris off the road and on to the fill slope and into the surrounding trees and regravelling and grading of the road in sections. Photo #8 shows a typical picture of debris piled up in the trees. The repairs that were done to reopen the road are totally inappropriate for the site and are actual cause ongoing further problems with the stability of the slopes. By pushing loose debris over on the fill slope this is loading weight on the fill slope and decreasing the overall stability of the area.

**Photo #3 View cutslope slope failure debris pushed over fill slope**

Appropriate repairs for this section of road should consist of hauling slide debris away from the site and depositing it in a stable area, pulling back failed cutslopes and rebuilding as required, resloping failed cutslopes and stabilizing as necessary, re-establishing the ditchline and ensuring functional cross drains in appropriate locations. These are just few works that would be required to help stabilize the site. This site should be reviewed by an appropriate professional and a detailed stabilisation plan should be developed. The road in its current state is highly unstable and very susceptible to future stability related issues. In fact between the time the repairs were done and my site visit the slope had continued to fail as witness by the excavator tracks over the top of a recent head scarp shown in Picture # 5.

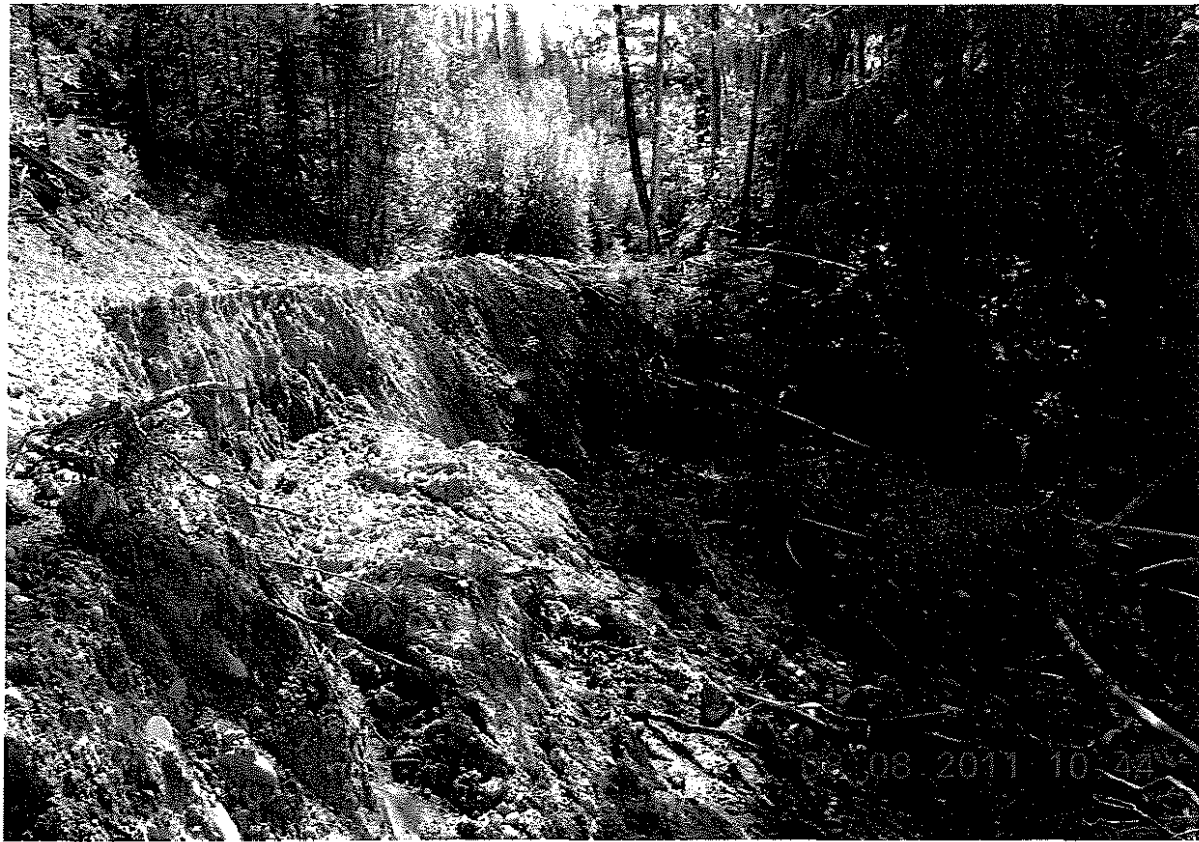
**Photo #4 View of fill slope failure – post repair**

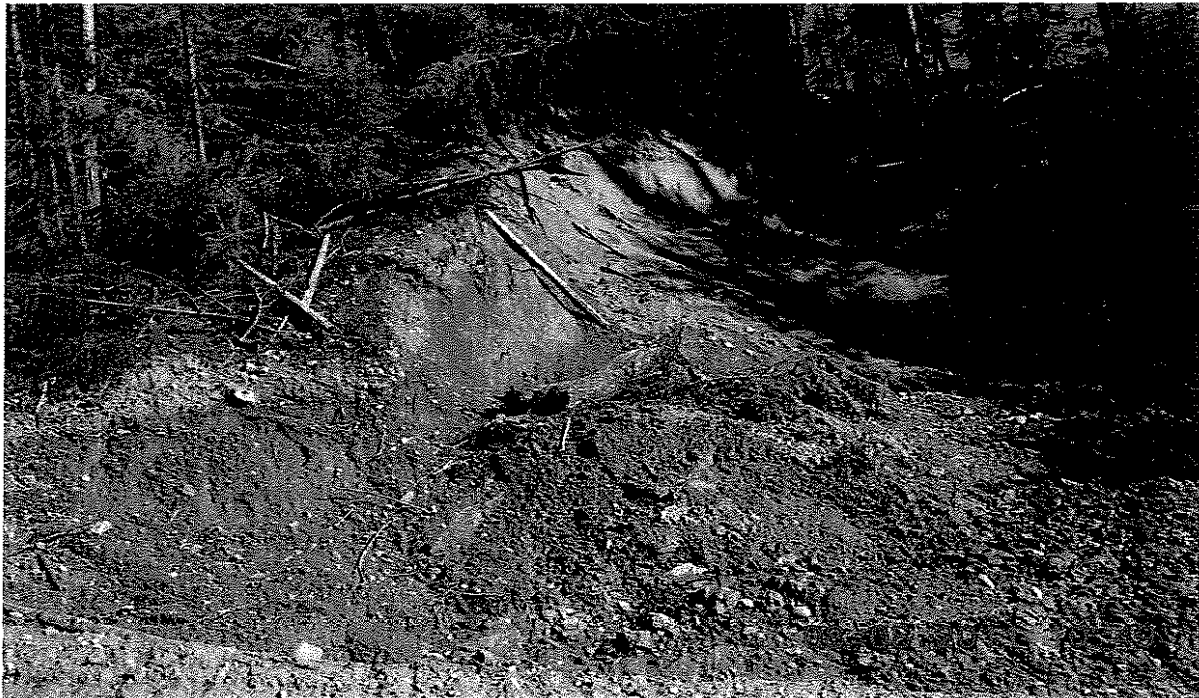
**Photo #5 Cutslope failure post repair**

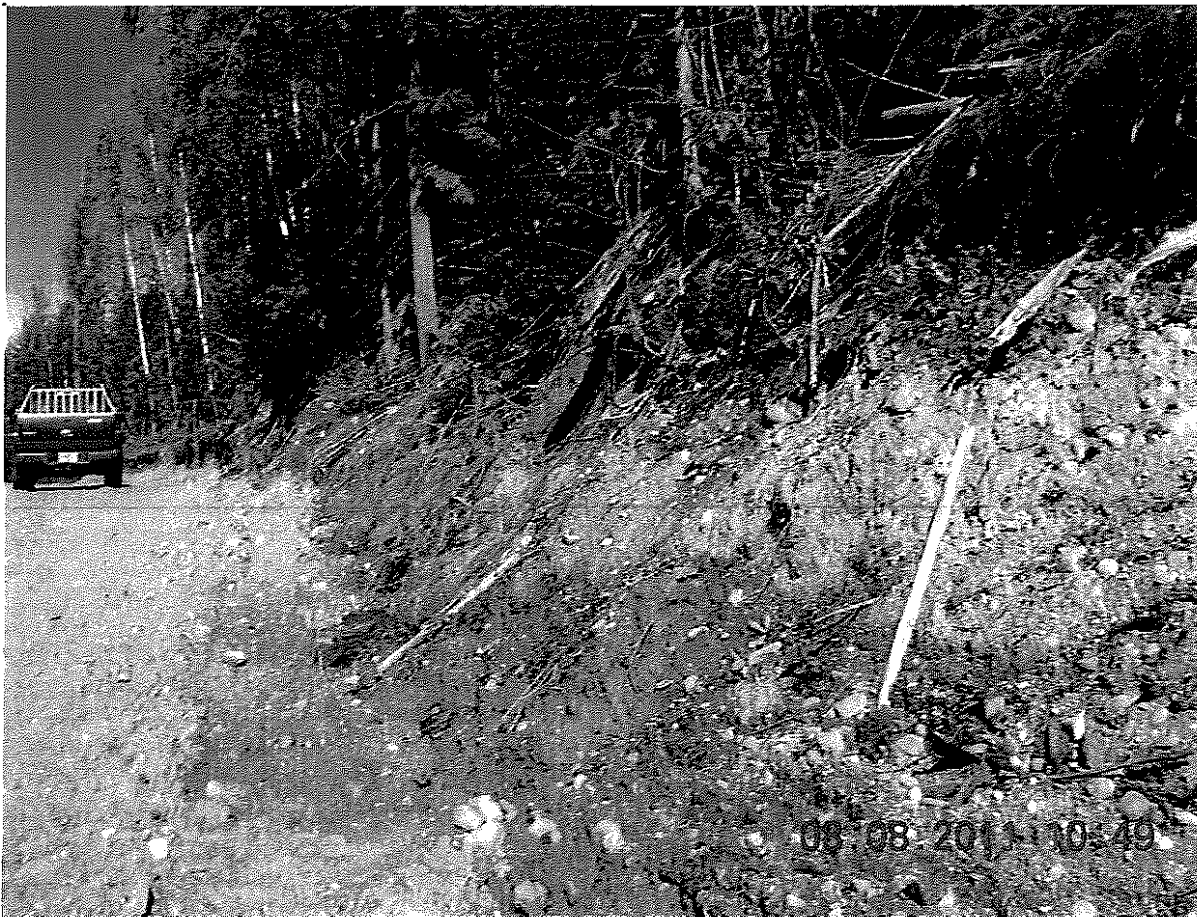
**Photo #6 View of failing cutslope and lack of functional ditchline.**

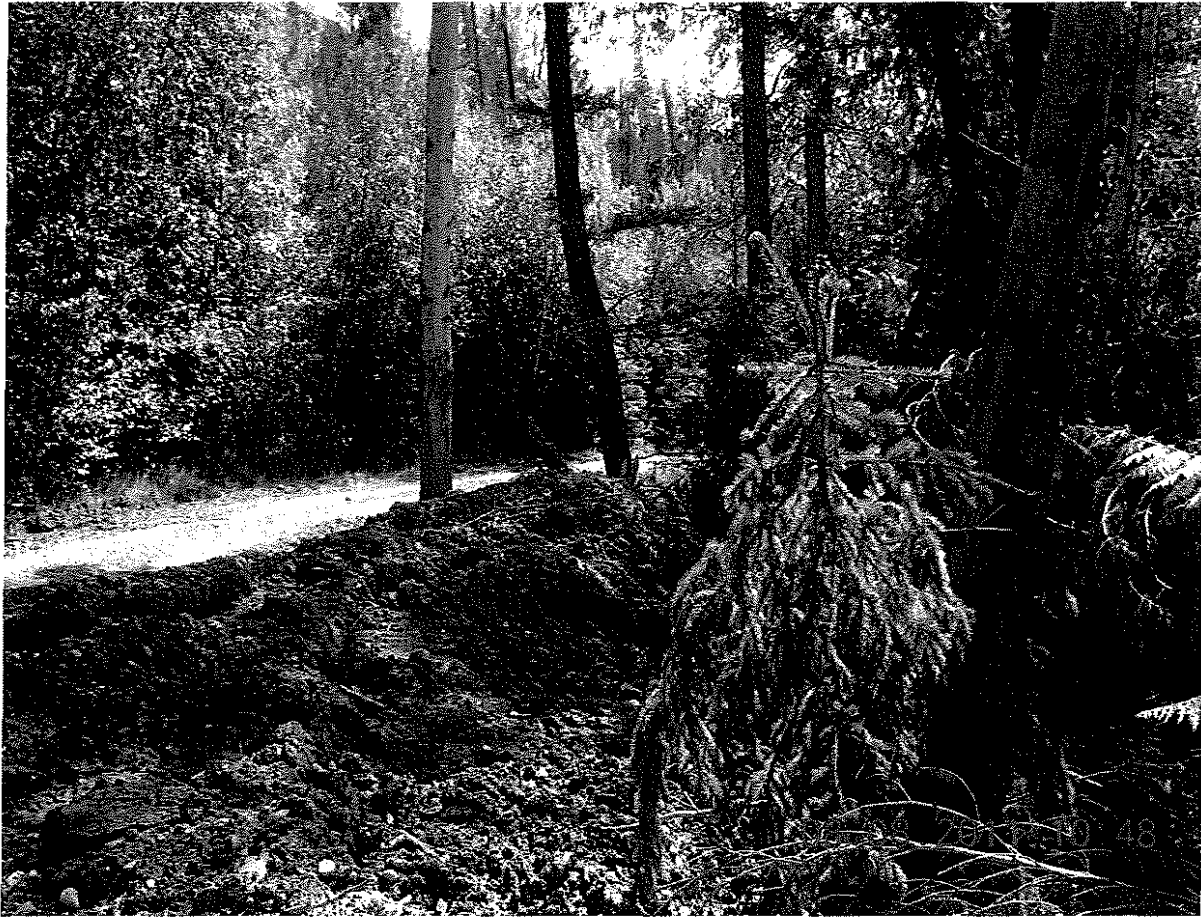
**Photo #7 Debris pushed off road and piled in trees**

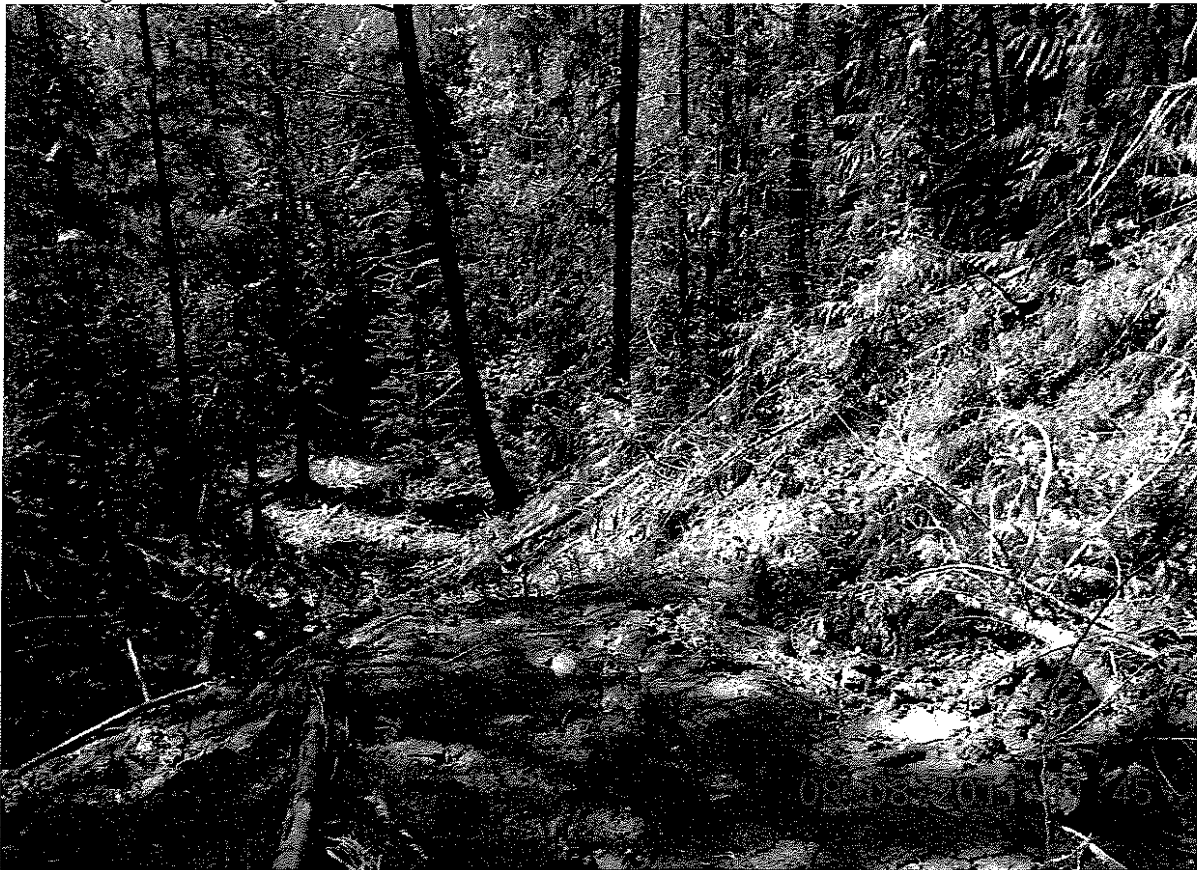
Site #3 consisted of a failure that started mid slope between the upper and lower roads in what appeared to be a selectively harvested area. Photo # 8 and Photo # 9 show a view looking down the failure and view of the head scarp respectively. Photo # 10 shows seepage exiting the slope just above the head scarp. Soils in the area were firm to stiff silts and clays which were poorly drained. It was also observed throughout the slope that many trees exhibited pistol butting which is an indication of marginal slope stability.

In reviewing the site it appeared that over all a high retention level was maintained but it appeared that the harvesting was concentrated on the removal of the over story dominant fir. In this situation the less stable lower storey was left in place resulting in a residual stand that was not very wind firm and numerous blow down were noted. This blow down caused increase site disturbance. It was also noted that the slope failure that occurred in the yarding corridor was within a natural draw. Although yarding in a draw will make the yarding operation easier, these locations are much more sensitive to site disturbance and are more prone to slope stability problems post logging. This is in large part due to the fact that natural draws will concentrate surface and subsurface flows inherently decreasing slope stability. Photo # 11 shows an adjacent corridor that was harvested where the corridor was not located in a draw and the residual stand is more wind firm, as can be seen in the photo the post harvesting corridor is much more stable.

Although I did not review the logging plan or any Terrain Stability Assessment (TSA) completed for the block and I am not aware if any were conducted prior to harvesting the block, I believe that both of these documents should have been completed prior to the harvesting of the block and should have highlight the hazards associated with this slope as well as noting the inherent risks associated with not taking the adequate precautions for harvesting the slope. The harvesting of this slope and the methods used to harvest it appear to be a large contributing factor of the failure.

Photo #8 View looking down slide path / yarding corridor

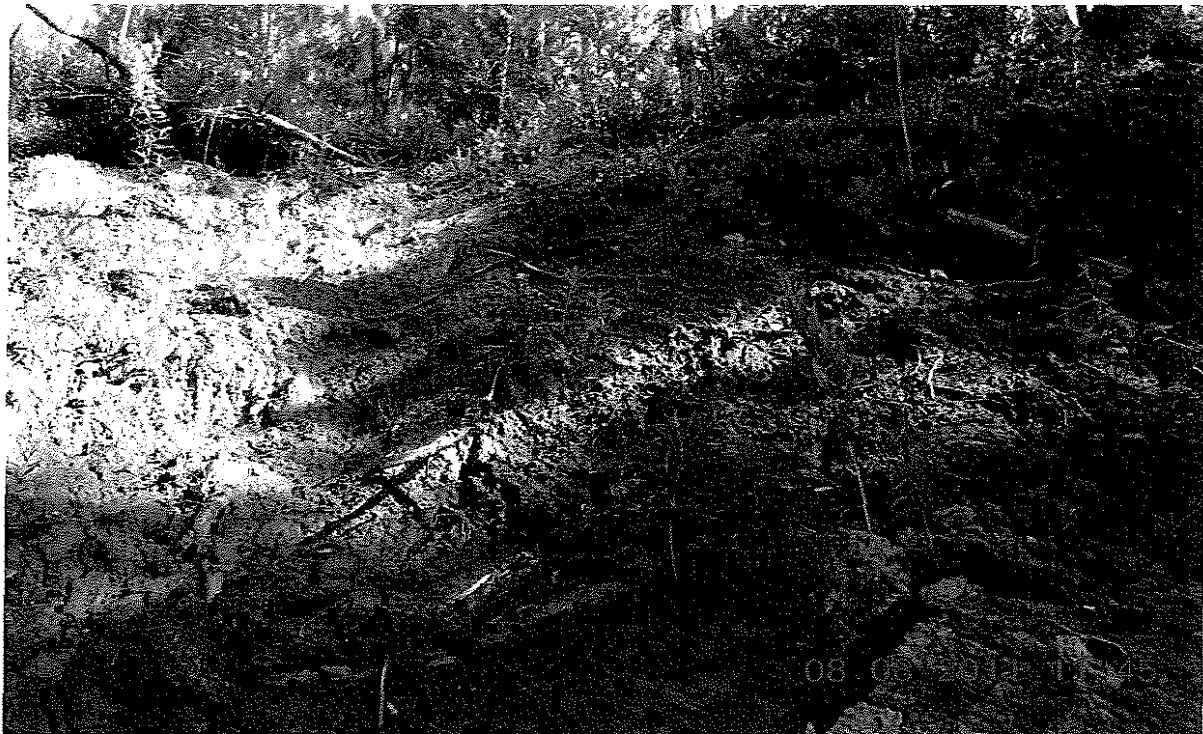
Photo #9 View look at head scarp of failure.

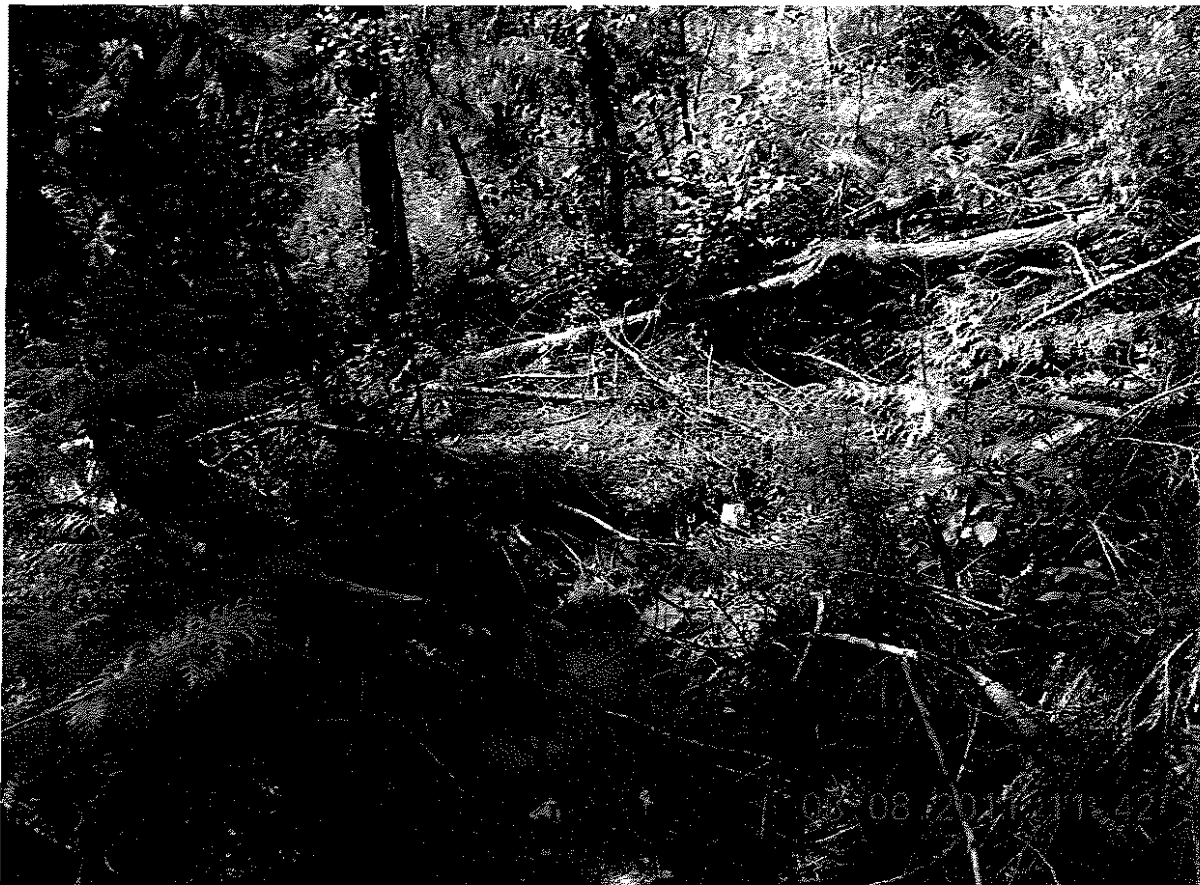
Photo # 10 View seepage above head scarp

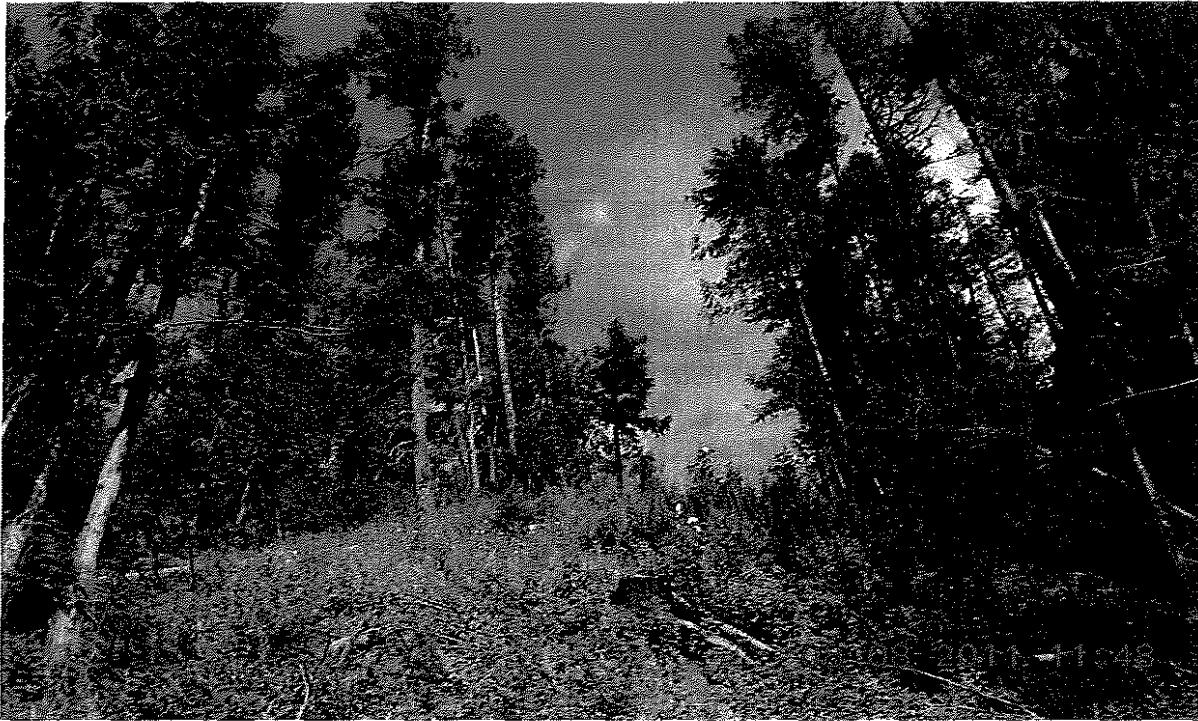
Photo # 11 View adjacent logging corridor
