FIRE DEPARTMENT

Re: Issuance of Fire Services Act Section 25(3)

Subject Property:
Three Gables Hotel
Harbans Randhawa
360 Martin St.
Penticton B.C.
V2A 5K4

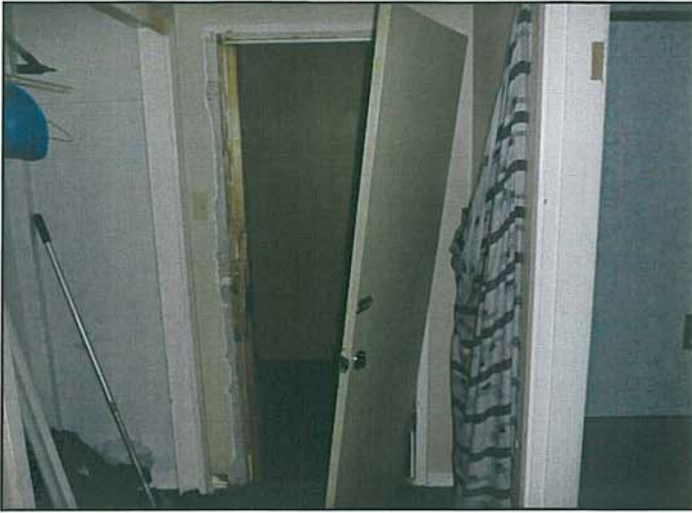
All suite doors are hollow, non-rated, non-self-closing and not latching which is contrary to the British Columbia Building Code. Currently these doors would allow for rapid fire growth beyond the room of origin. Photo 1 is an example of a suite door that has been recently forced open, this behavior occurs on a regular frequency. Kicking the doors open results in damage to the door and door frame preventing the doors from latching. As a result of this ongoing behavior, the residents are securing their suites with pad locks from the exterior. This creates a significant safety issue for the resident occupying the suite; fellow residents could intentionally lock that person in the suite with this hardware. To date the R.C.M.P have responded to this building for this exact concern, an elderly male was assaulted and then locked inside his suite.

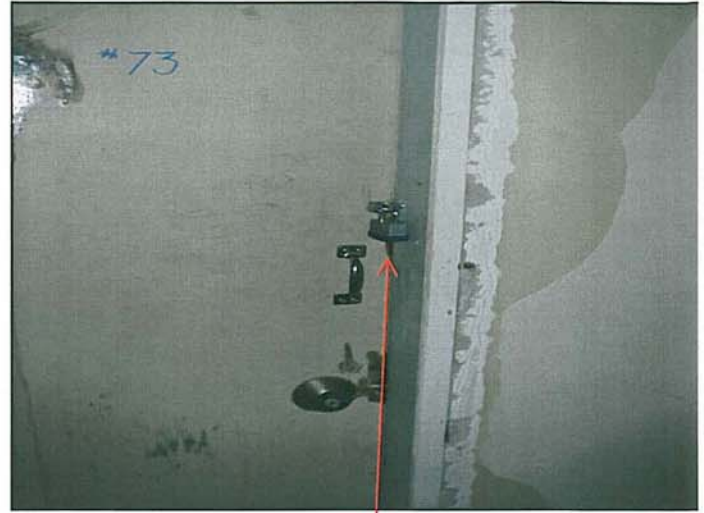
Photo 2

Pad Lock

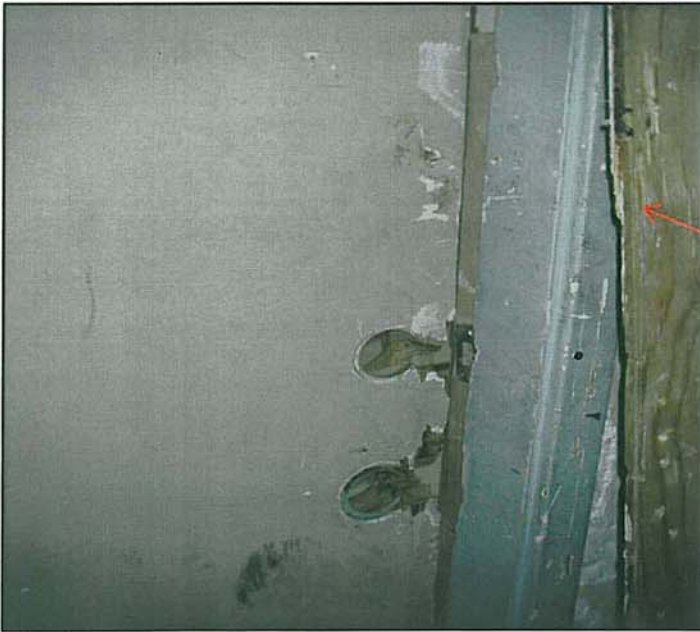
Plywood has been completely removed

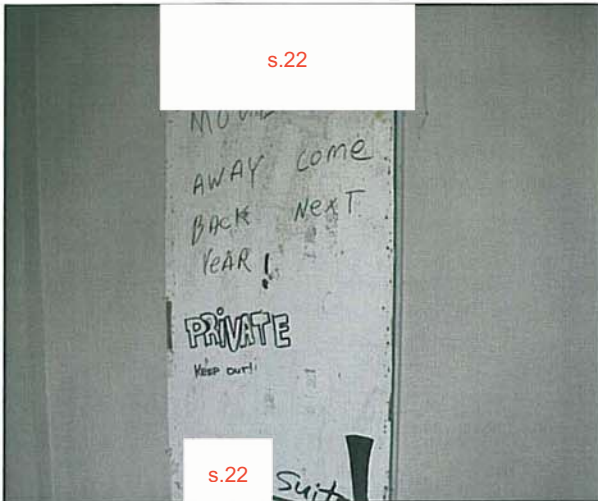
Photo 3

From ongoing pressure from the Penticton Fire Department the owner attempts to secure the suites with broken doors by using plywood to block access to the suites.(photo 3) However due to the lack of presence by the owner, transients are able to enter the hotel and pry the plywood open and occupy these suites.(photo 4) At any given time the owner could not accurately tell you how many tenants he has or how many rooms are occupied.(photo 5) In previous fire inspection I have found people sleeping in the boiler room.

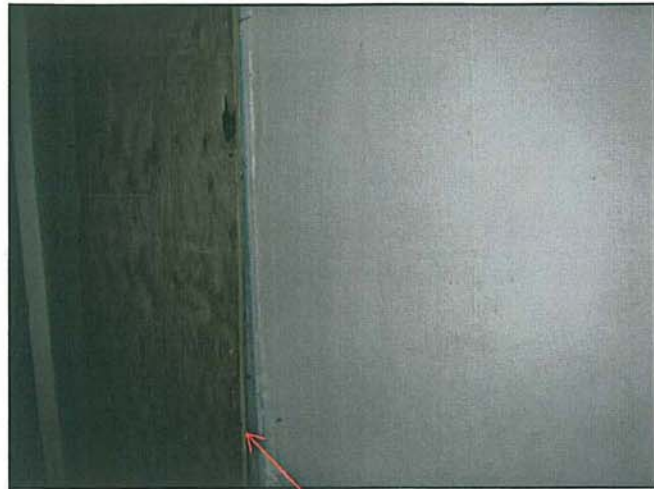
Photo 4

Non Residents that
have pried open the
plywood to access suite

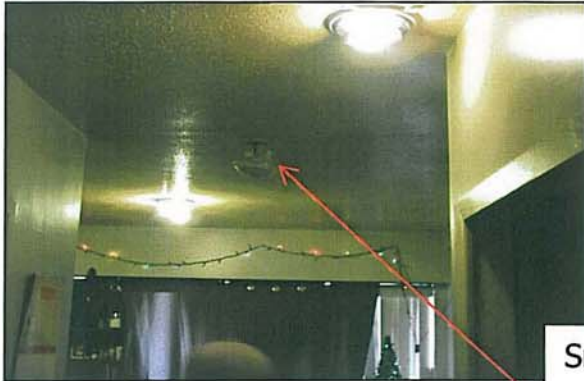
Due to the owners lack of policing of this occupancy the fire and life safety equipment provided is often vandalized, stolen or tampered with. Photo 6 is an example of a smoke alarm that has been covered with plastic; this practice significantly delays any early detection of fire and places all residents without early detection. Photo 7 is an example of a missing smoke alarm that again would prevent the early detection of fire.

Smoke alarm
covered in
plastic

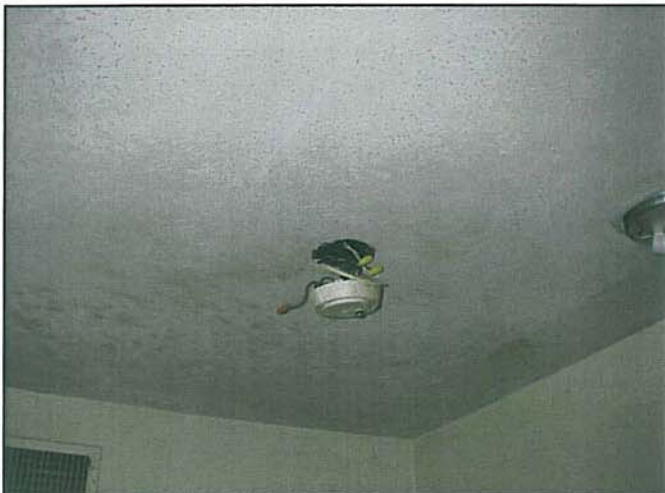
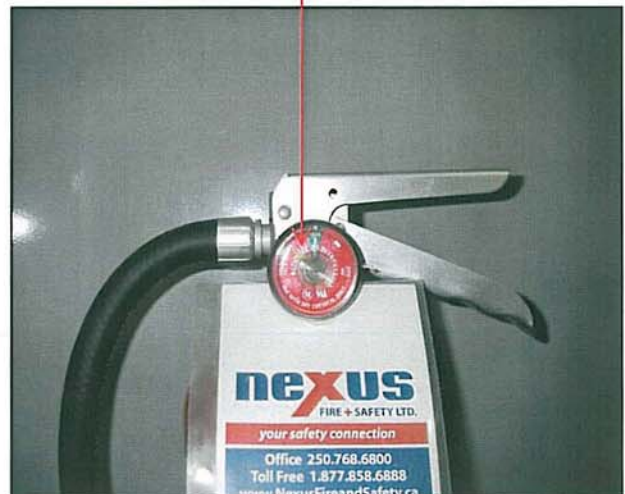
Empty Fire
Extinguisher

Photo 8 is a damaged smoke alarm within a suite. Photos 6, 7, and 8 indicate that 3 of the 17 suites do not have operational smoke alarms. Taking into account the lack of functional smoke alarms eliminates any chance of early fire detection and places all residents and

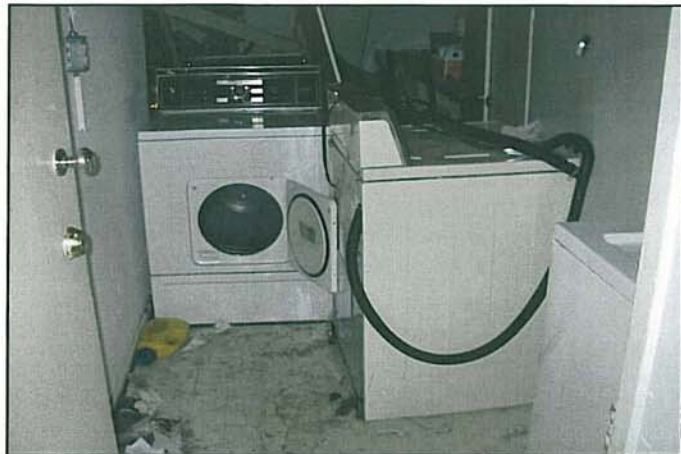
Photo 9 is the common laundry room, the door to this room is not a 45 min rated door and does not latch, and you can see in this photo that housekeeping is not maintained. Photo 10 shows in detail the amount of storage within the laundry room. The risk of fire occurring within the laundry room is significantly increased, due to the large amount of storage and lack of housekeeping. Without the appropriate fire rated door, any fire occurring within this space would rapidly spread beyond its place of origin and endanger all residents.

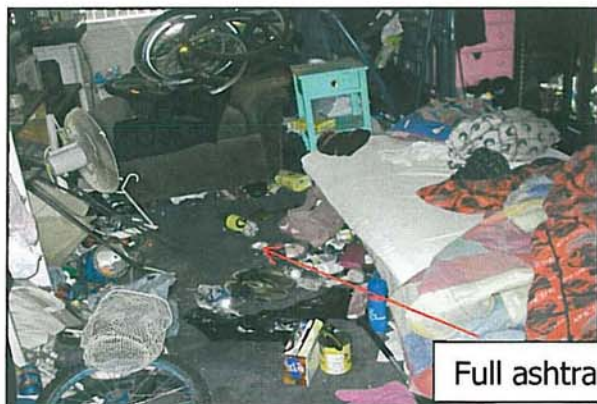
Photo 11

Full ashtray / Drug equipment

Photos 11 & 12 are of two separate occupied suites; the contents within these suites constitutes a larger than normal fire load. This volume of combustible material within these suites would support the rapid development of a fire and toxic gases, and spread beyond the room of origin. This would compromise exit corridors and possibly allow the fire to extend to neighboring suites.

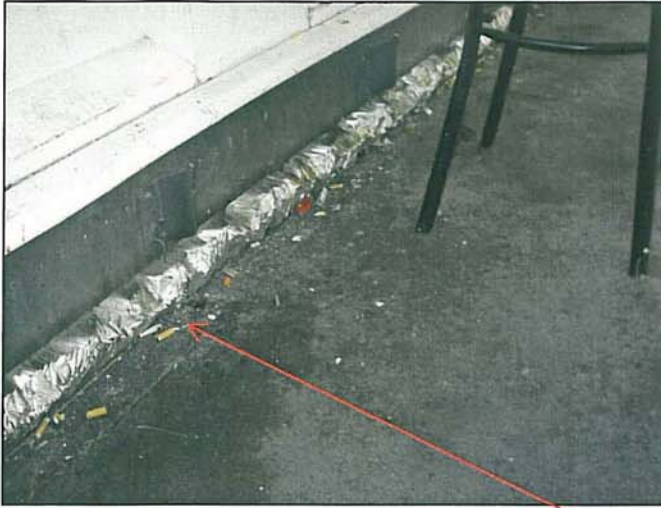
Photo 13

Photo 13, 14 and 15 are all close ups of the exit corridor seen in photo 16. On a daily basis, residents and non-residents gather in this corridor to party. (photo17) You can see on any given day an accumulation of furniture within the exit corridor. (photo18)

The use of an exit corridor as an assembly facility creates specific fire hazards that endanger all occupants, the careless disposal of smoker's material and use of combustible furniture within the exit corridor provides a competent ignition source and fuel supply to create a rapidly developing fire that could easily travel throughout the building.

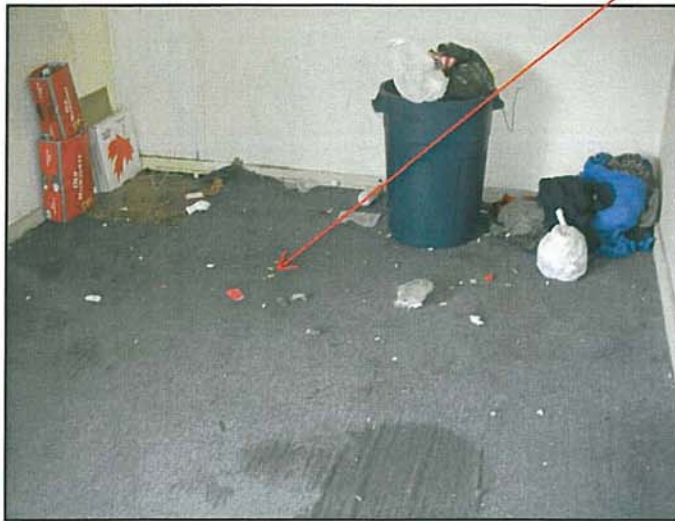
Photo 15

Smokers Material

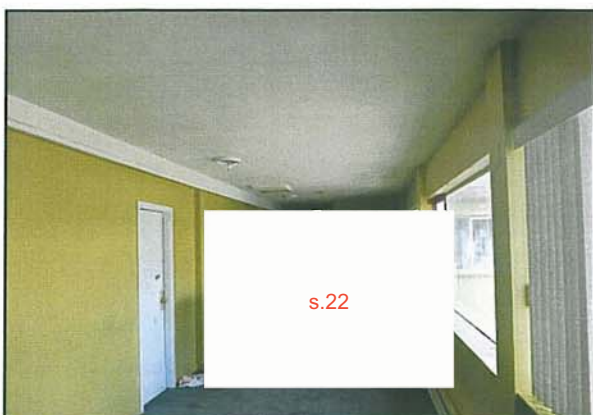
Photo 17 was taken after the OFC order section 22a was issued April 7, 2014; the owner painted the walls and doors, and made minor repairs. Since this time no improvements have been made;

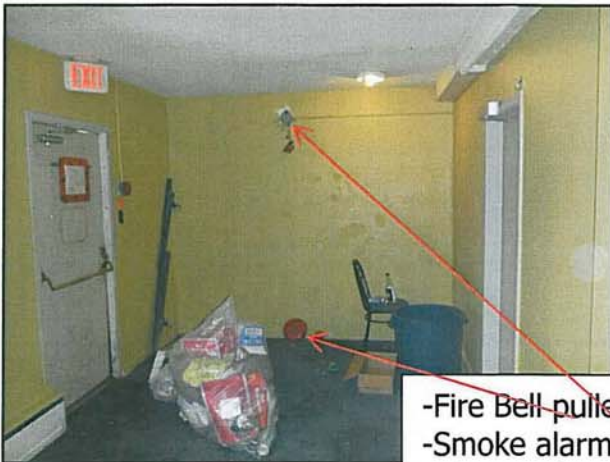
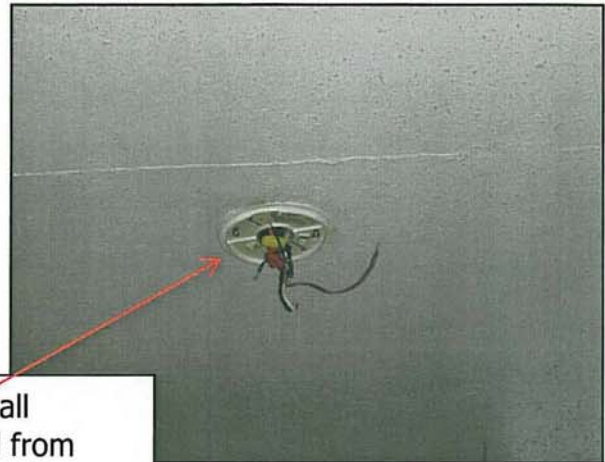
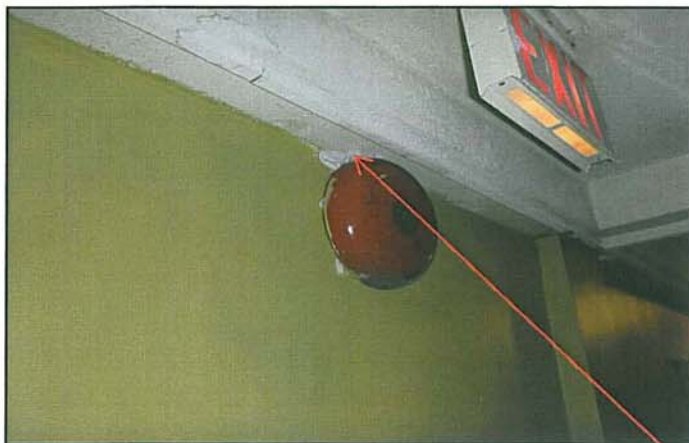
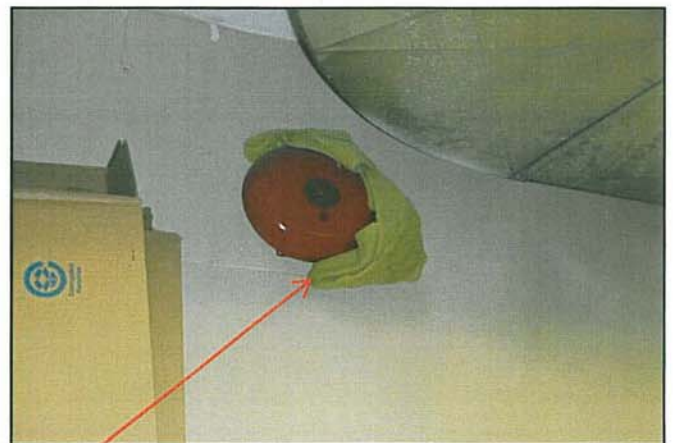
-Fire Bell pulled from wall
-Smoke alarm removed from suite

Alarm bells that have been stuffed with rags

Photos 19 to 24 were taken this morning after fire crews were called for bells ringing at 01:00, residents stated that the bells had been ringing for approximately 40 minutes prior to a call being made to the fire dept. Crews identified that a pull station had been activated, fire bells had been either ripped off the wall or stuffed with rags. Photo 22 is the fire bell that is located in the liquor store; none of the residents have a key to the store so I am assuming that the owner placed the rag in the bell and that this condition has existed for a long time. This supports the fact that the owner does not place any value in the maintenance of the life safety equipment. The fire department issued a Fire Watch and arranged to have a local security company perform this duty as the PR was not answering the phone.

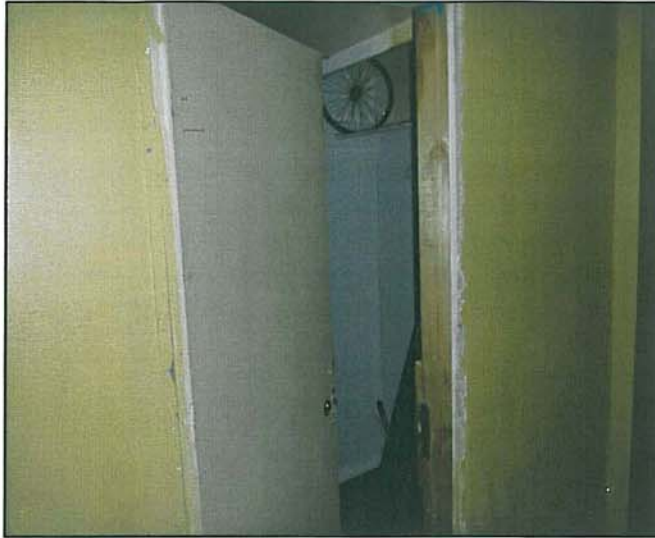
Photo 23

This door was kicked open last night

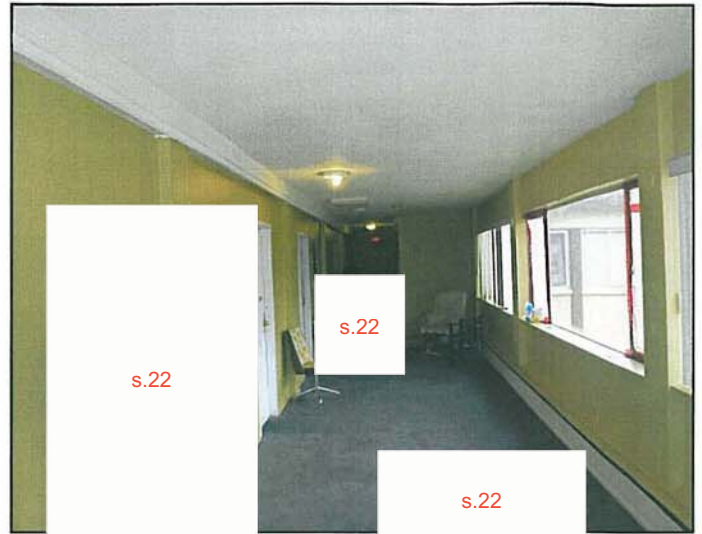
Photo 24

Photo taken at 08:30 June 13; June 12 there was no combustible furniture in exit corridor
