2021 WET WEATHER/ FREEZE-THAW SHUTDOWN GUIDELINES TRANSFER STATION – QUADLING ROAD, ABBOTSFORD, BC (Use BCTS Chinook Area Wet Zone):

We are pleased to attach our design report for the Evans Quarry Debris Management and Drainage Improvements project. The report includes information gathered from various site visits held in 2021 and 2022. The report Appendices contains the Issue for Permit (IFP) drawing set, a copy of a memo sent to MOTI regarding the temporary drainage and infiltration tests done on site, as well as recommendations for site shutdown in inclement weather.

The overall scope of the work was to assess the residual landslide geotechnical hazard on the MOTI site, provide geotechnical and hydrotechnical recommendations relative to removal of the debris on the MOTI site and to undertake permit level design for the restoration of drainage across the site.

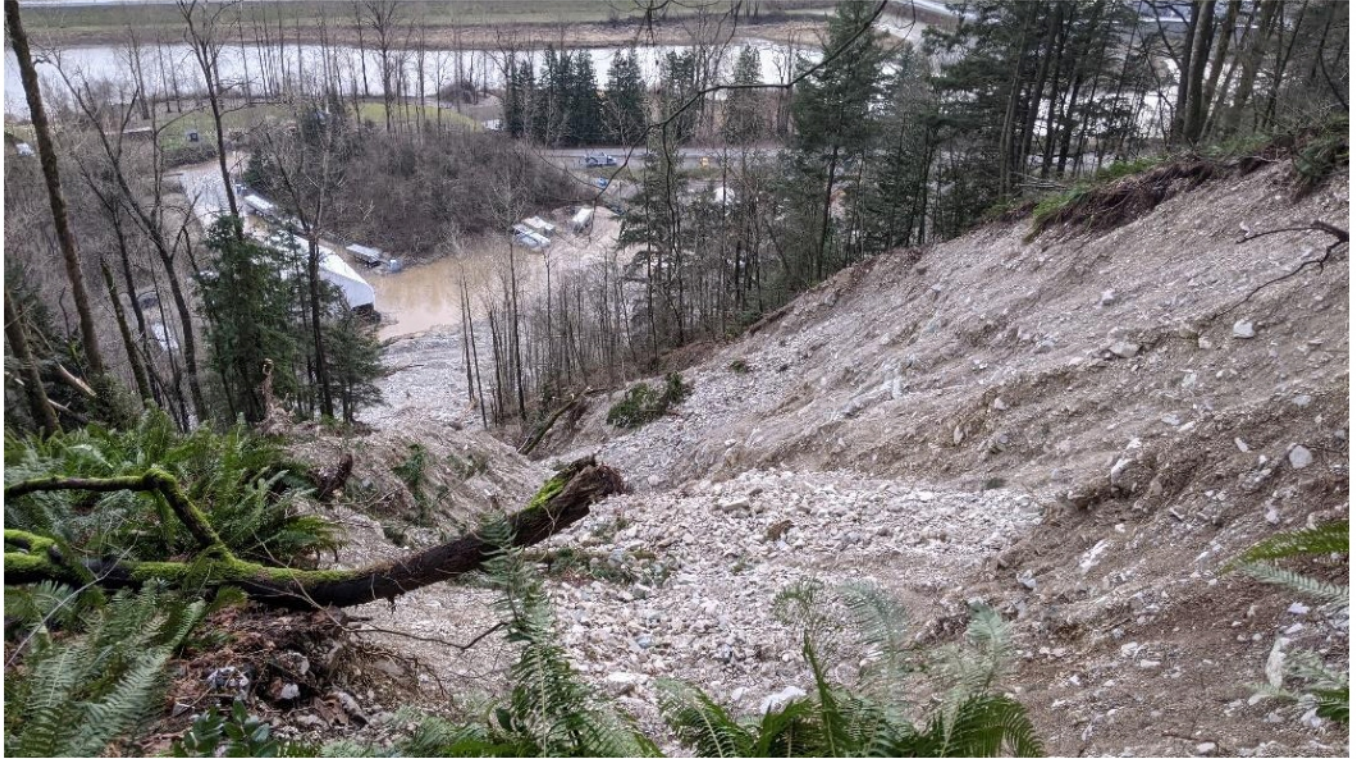
Tension cracks were observed behind the southwest corner of the slide which appeared to be older and may represent a portion of the slide which did not fail during the main slide event but may be prone to future failure. An open crack was noted during the site visit in January suggesting displacement during the slide event. Shallow sliding in loose, coarse granular material was observed on nearby slopes to the north, sometimes associated with fills along old skid trails. Photo 2 shows a view down the northern failure. The initial failure likely had much steeper slopes in the upper part of the slide. Subsequent local failures have likely reduced the slope angles and contributed to the accumulation of colluvium visible in the centre of the image.

Photo 2: View looking downslope from the crest of the northern slide east toward the WCRL structure, and the Sumas River on December 17, 2021.

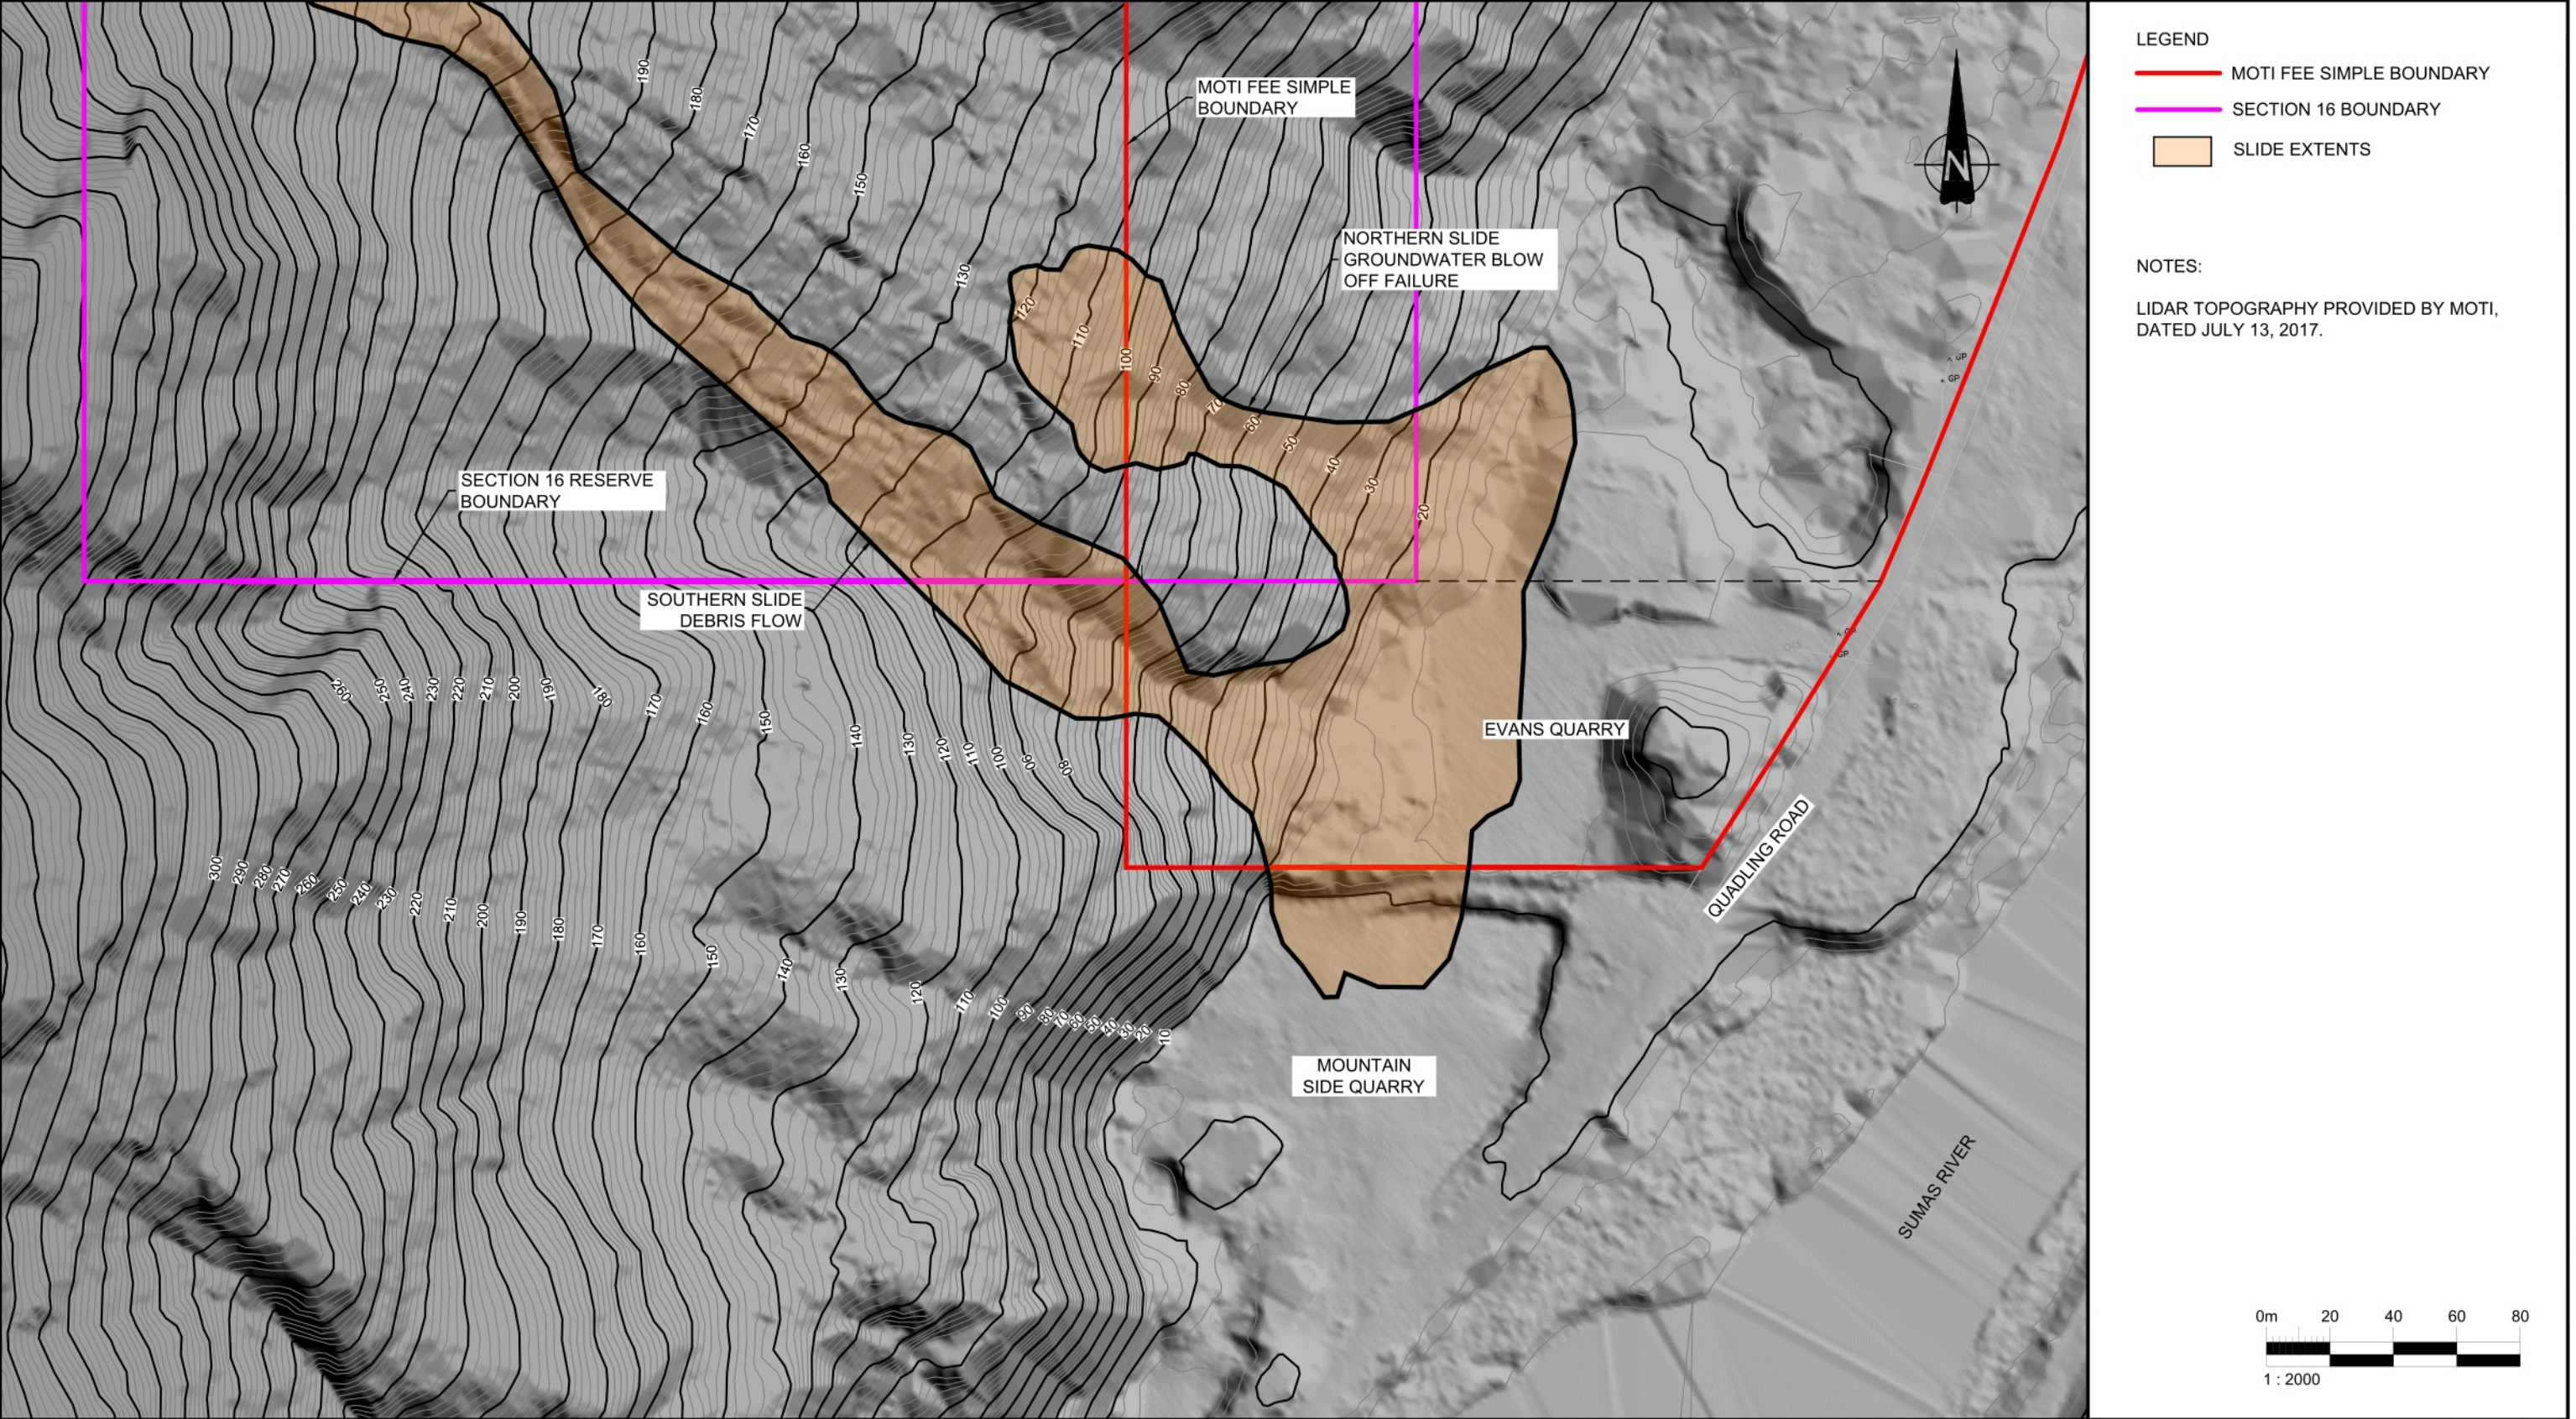
northern and southern slides, respectively occur at the middle portions of the debris fans. Figures 2, 3 and 4 attached show the pre-slide and post slide LiDAR and results of the DEM subtraction.

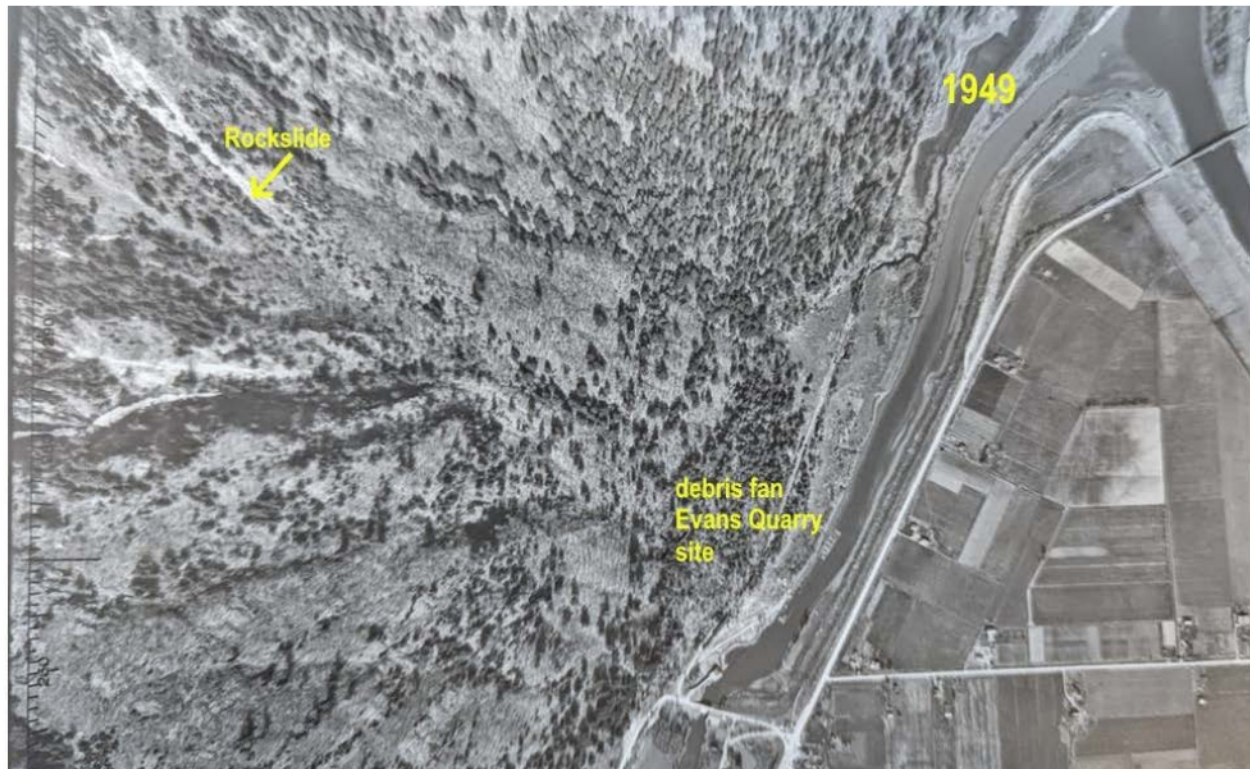
Photo 3 Air photo from 1949

1949 – shallow sliding and accumulation of scree in main and south catchments; craggy rock visible; narrow rockslide on north side of main catchment – runout did not extend to valley floor. Wide debris fan from Barrowtown north; Quadling Road had been road built; single small structure had been built alongside road.

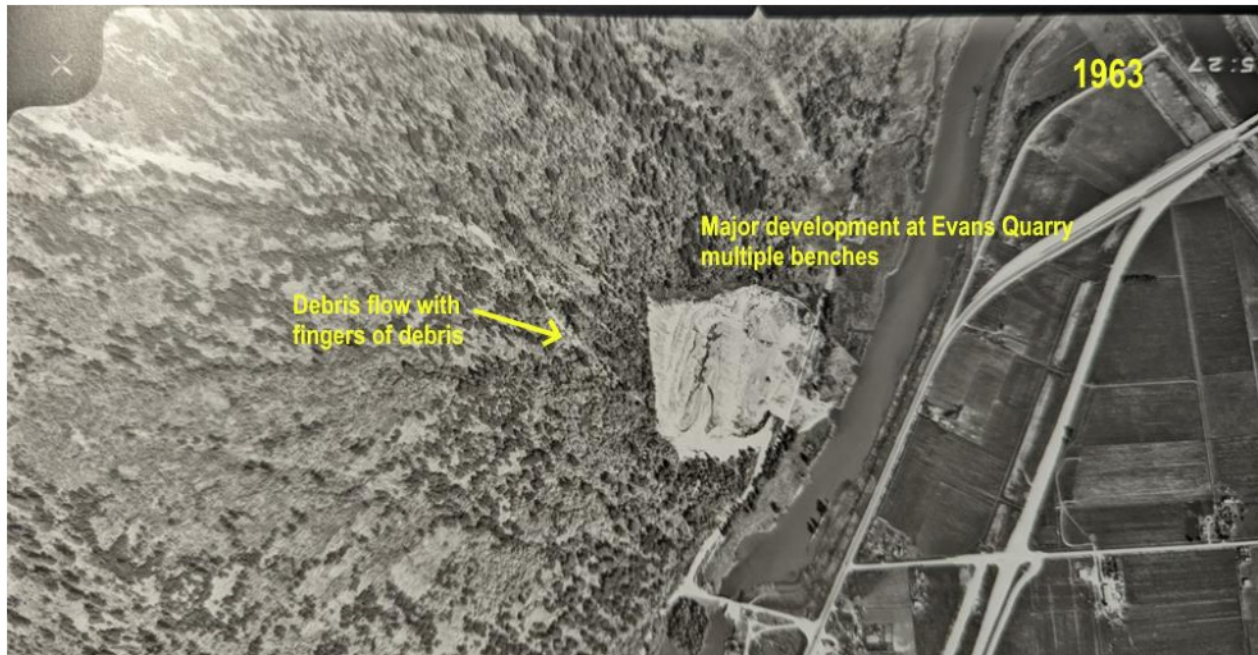
Photo 4 Air photo from 1963

1963 – Major pit development at Evans quarry had mined out debris fan; one main and two or three smaller benches above developed into granular material; distal end of a recent debris flow finger entered the pit on the west side.

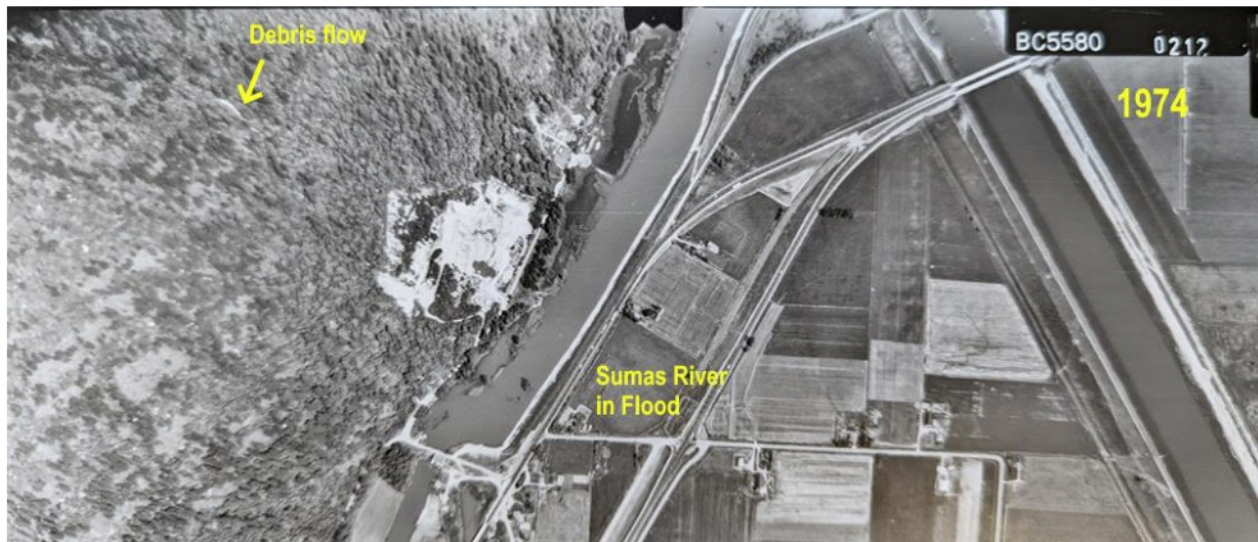
Photo 5 Air photo from 1974

1974 – New clearing and gravel/quarry development on Quadling Road just north of Evans Quarry. Finger of debris visible upslope of pit but disappears below canopy – difficult to determine if extended into pit area as only partially visible below forest canopy. Photo was taken during a period of high water, Sumas River below the pump station was at high elevation Quadling Road.

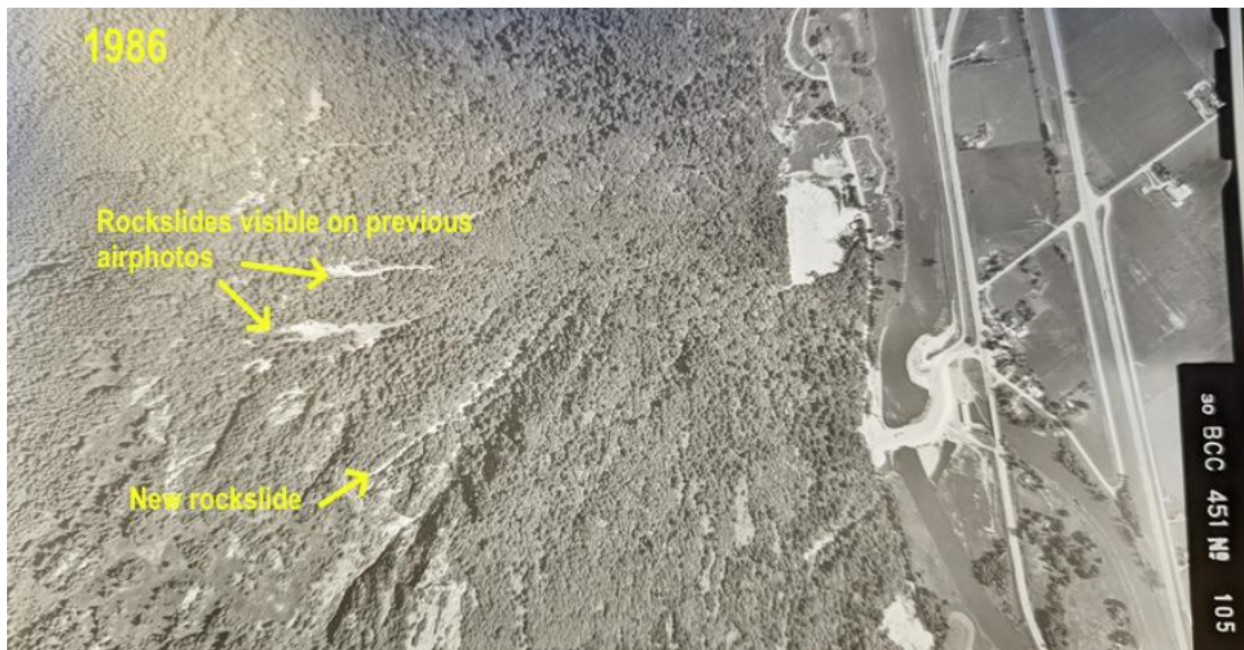
Photo 6 Air photo from 1986

1986 – North pit has been reclaimed and is vegetated. Main pit appears spent – no sign of active working face. New linear debris / rockslide on the northern headwall of the southern catchment basins. Fill has been placed on section below Quadling Road where current residences are located.

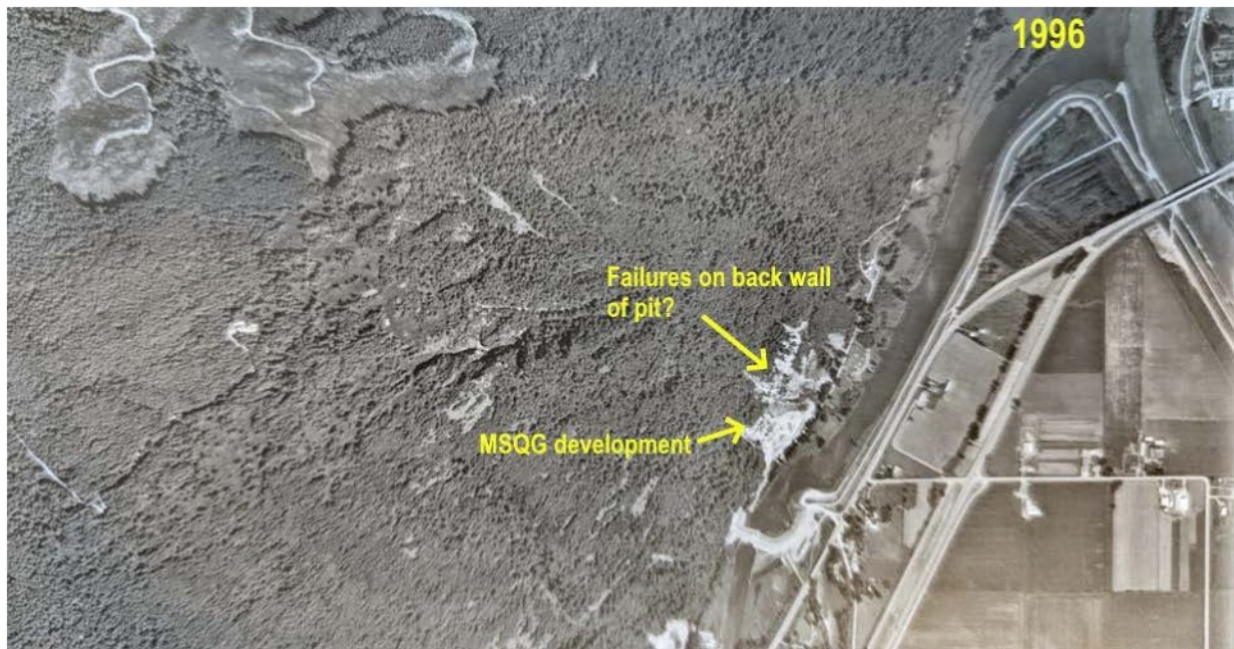
Photo 7 Air photo from 1996

1996 – Clearcut logging on top of Sumas Mountain on plateau above the drainage. Continued reclamation of the main pit. Failures on back of pit wall. Structures located in the reclaimed north pit site. Development of MSQG property to the south.

- 5 Groundwater blow off failures appear to have previously occurred on the back wall of Evans Quarry as seen in the 1996 air photo. The November 2021 event appears to have been the largest to date, at least over the period covered by the air photos.

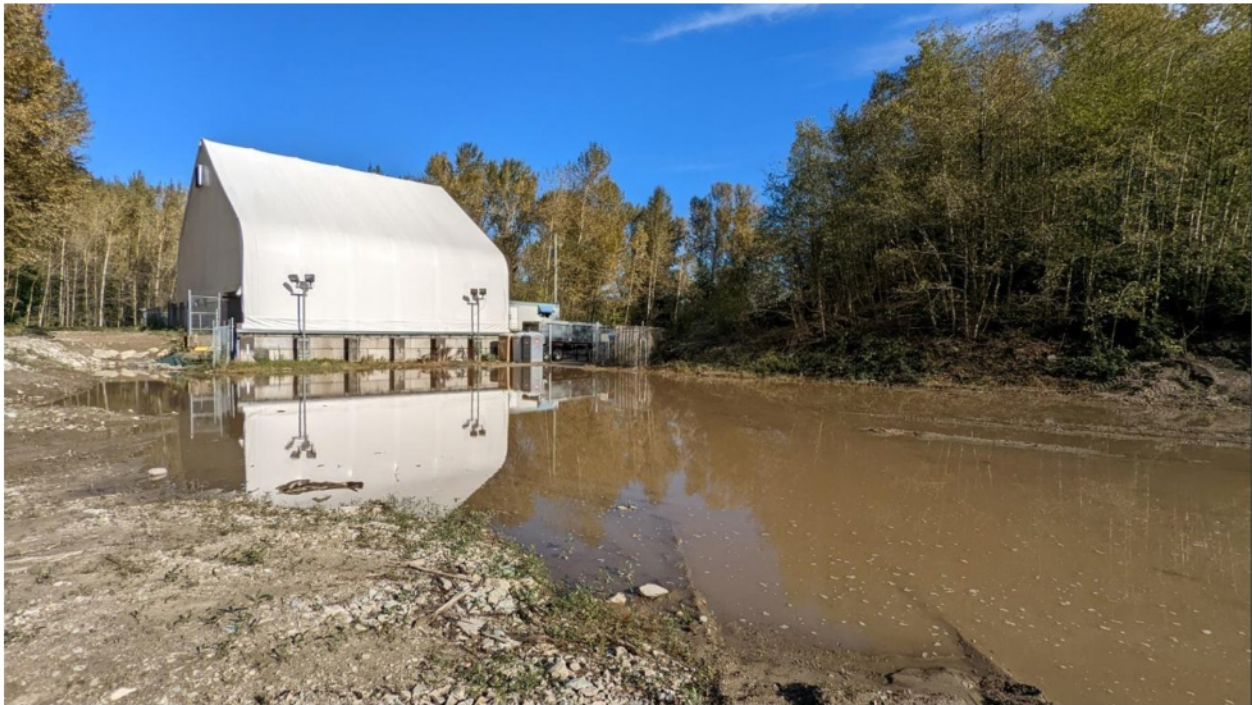
Figure 2 Ponded water on site on November 2nd 2022.

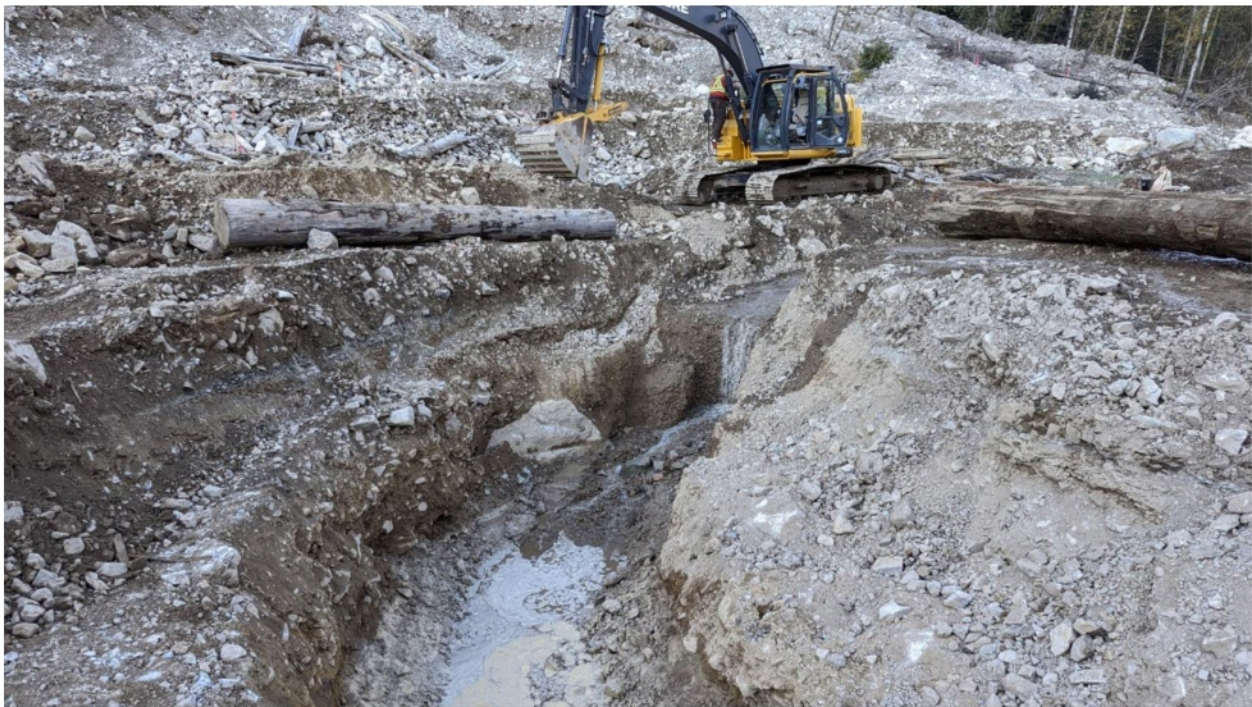
On completion, the ditch successfully drained the flooded area into the soakaway (Figure 5). On November 3rd, Chris Davidson, P.Geo., returned to site with the excavator operator. The parking lot area, which had been flooded since the November 2021 event, was cleaned of mud for use by West Coast Reductions Limited.

Figure 5 Water flowing into the soakaway (note small water fall in right centre)

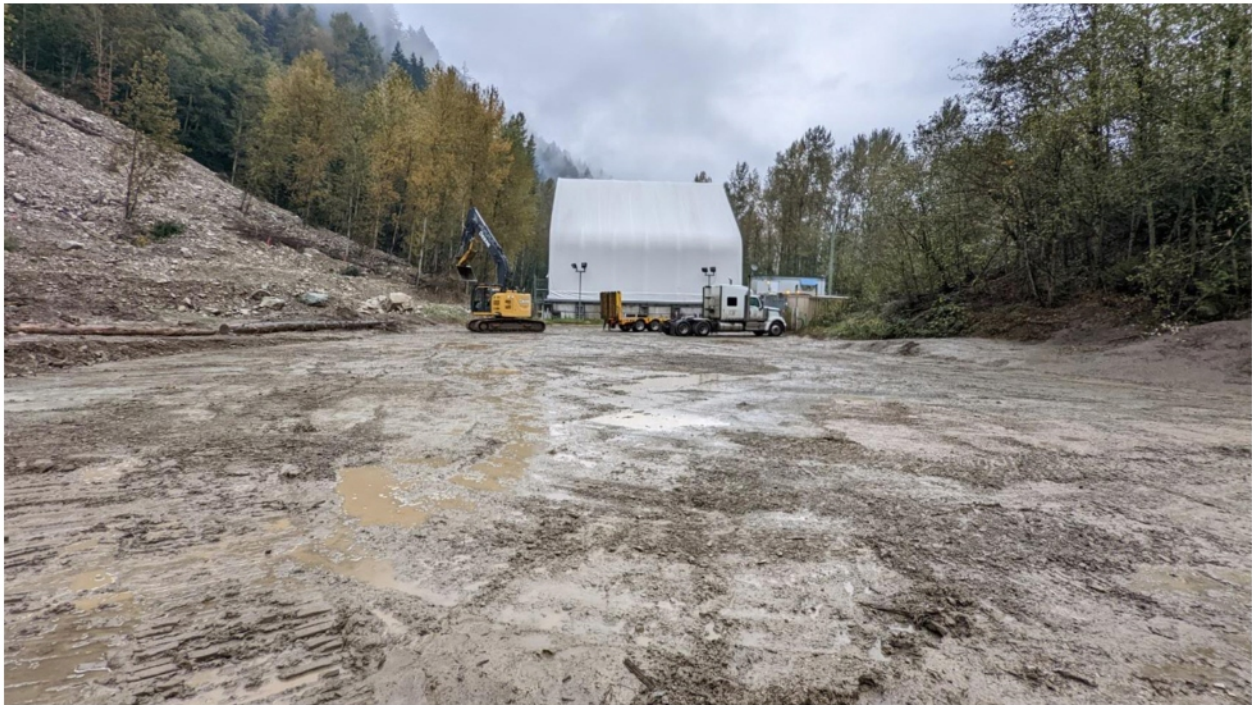
Figure 6 Photo showing site after the ditch and infiltration pit had been constructed

As a safety measure, some of the large logs that had been stockpiled on site were placed around the soakaway to prevent vehicles or pedestrians from falling into the pit accidentally.
