MOUNT POLLEY MINING CORPORATION		
MOUNT POLLEY MINE		
TAILINGS STORAGE FACILITY MAIN EMBANKMENT FOUNDATION DRAIN FLOWS		
<b><i>Knight Piésold</i></b> CONSULTING	PROJECT NO. 11162/13	REV.
	REF. NO.	REV.
FIGURE 5.8

TAILINGS STORAGE FACILITY  
STAGE 3 TAILINGS EMBANKMENT  
INSTRUMENTATION  
SECTIONS - SHEET 2 OF 2

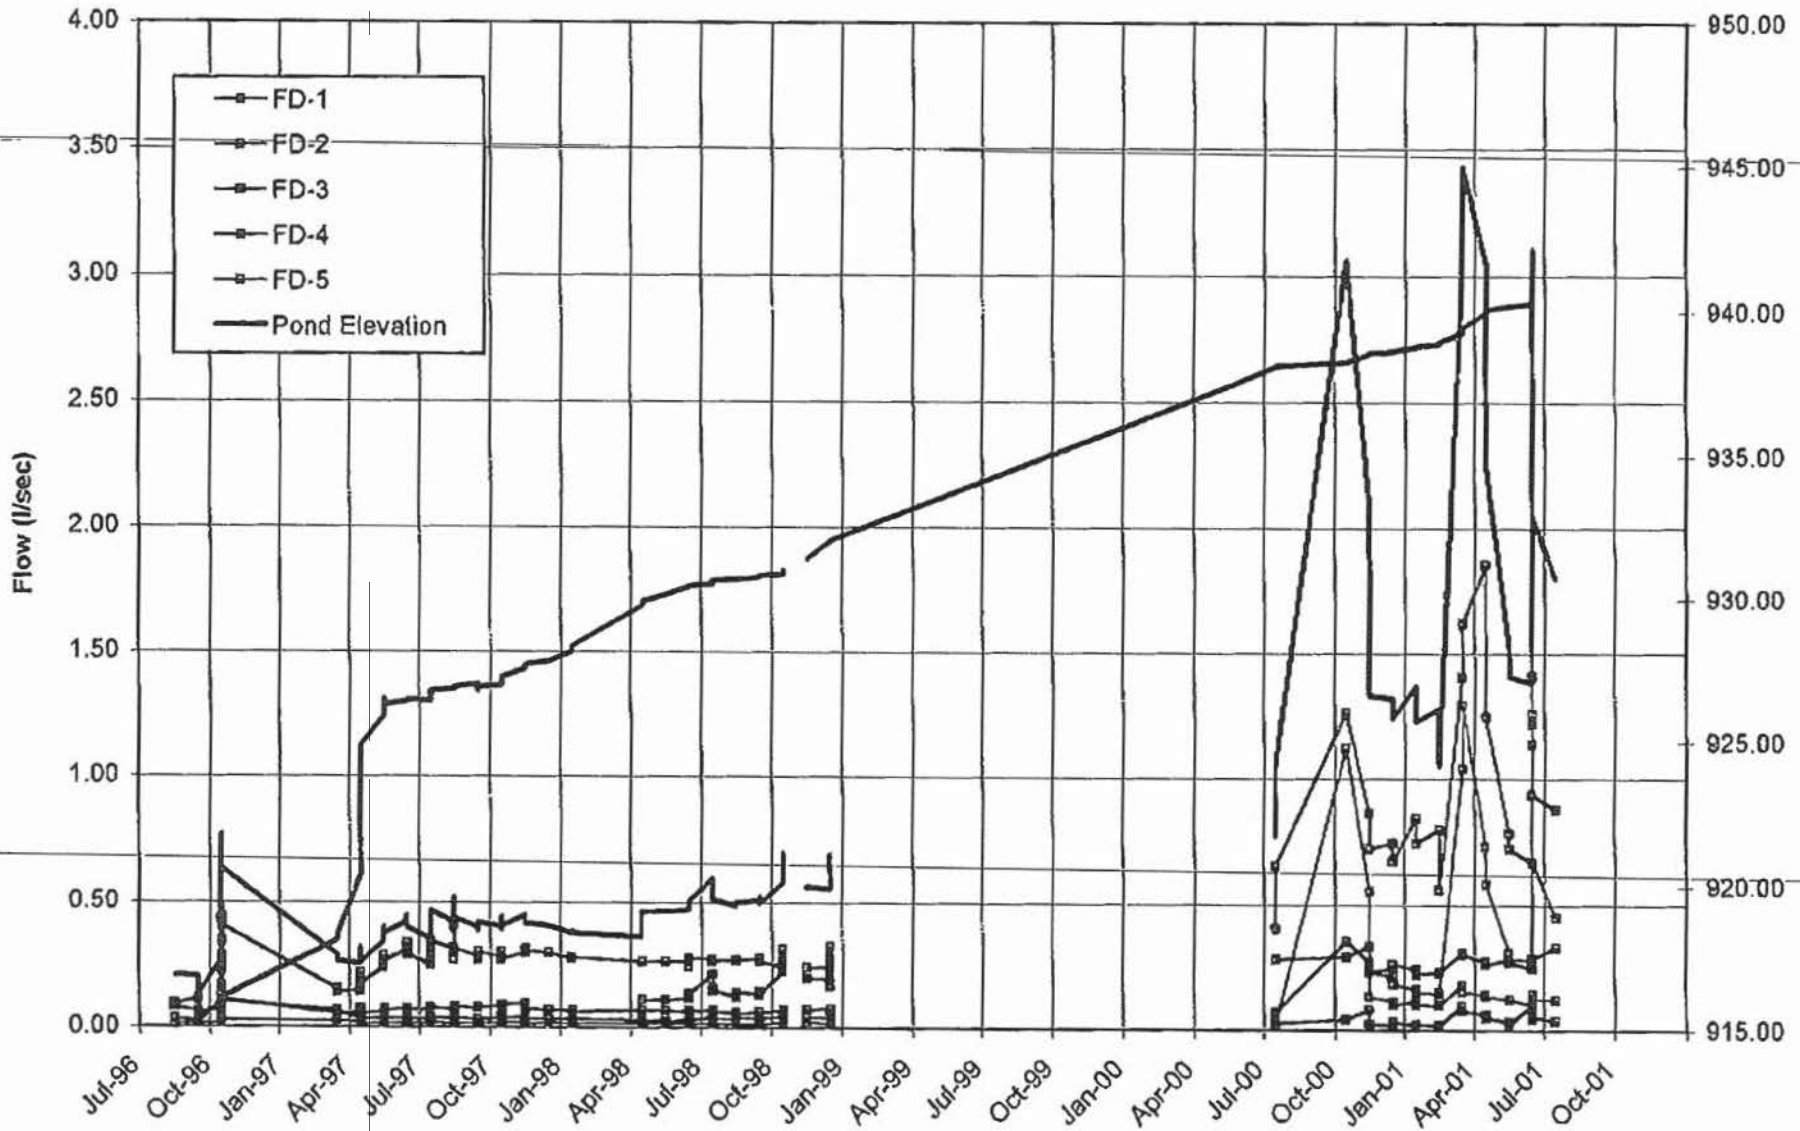
MOUNT POLLEY MINING CORPORATION			
MOUNT POLLEY MINE			
TAILINGS STORAGE FACILITY MAIN EMBANKMENT FOUNDATION DRAIN FLOWS			
<b>Knight Piésold</b> CONSULTING	PROJECT NO. 11162/13	REF. NO.	REV.
	FIGURE 5.8

Drains flows were recorded on July 6, 2001. The results from the foundation drains and upstream toe drain are shown on Figures 5.8 and 5.9.

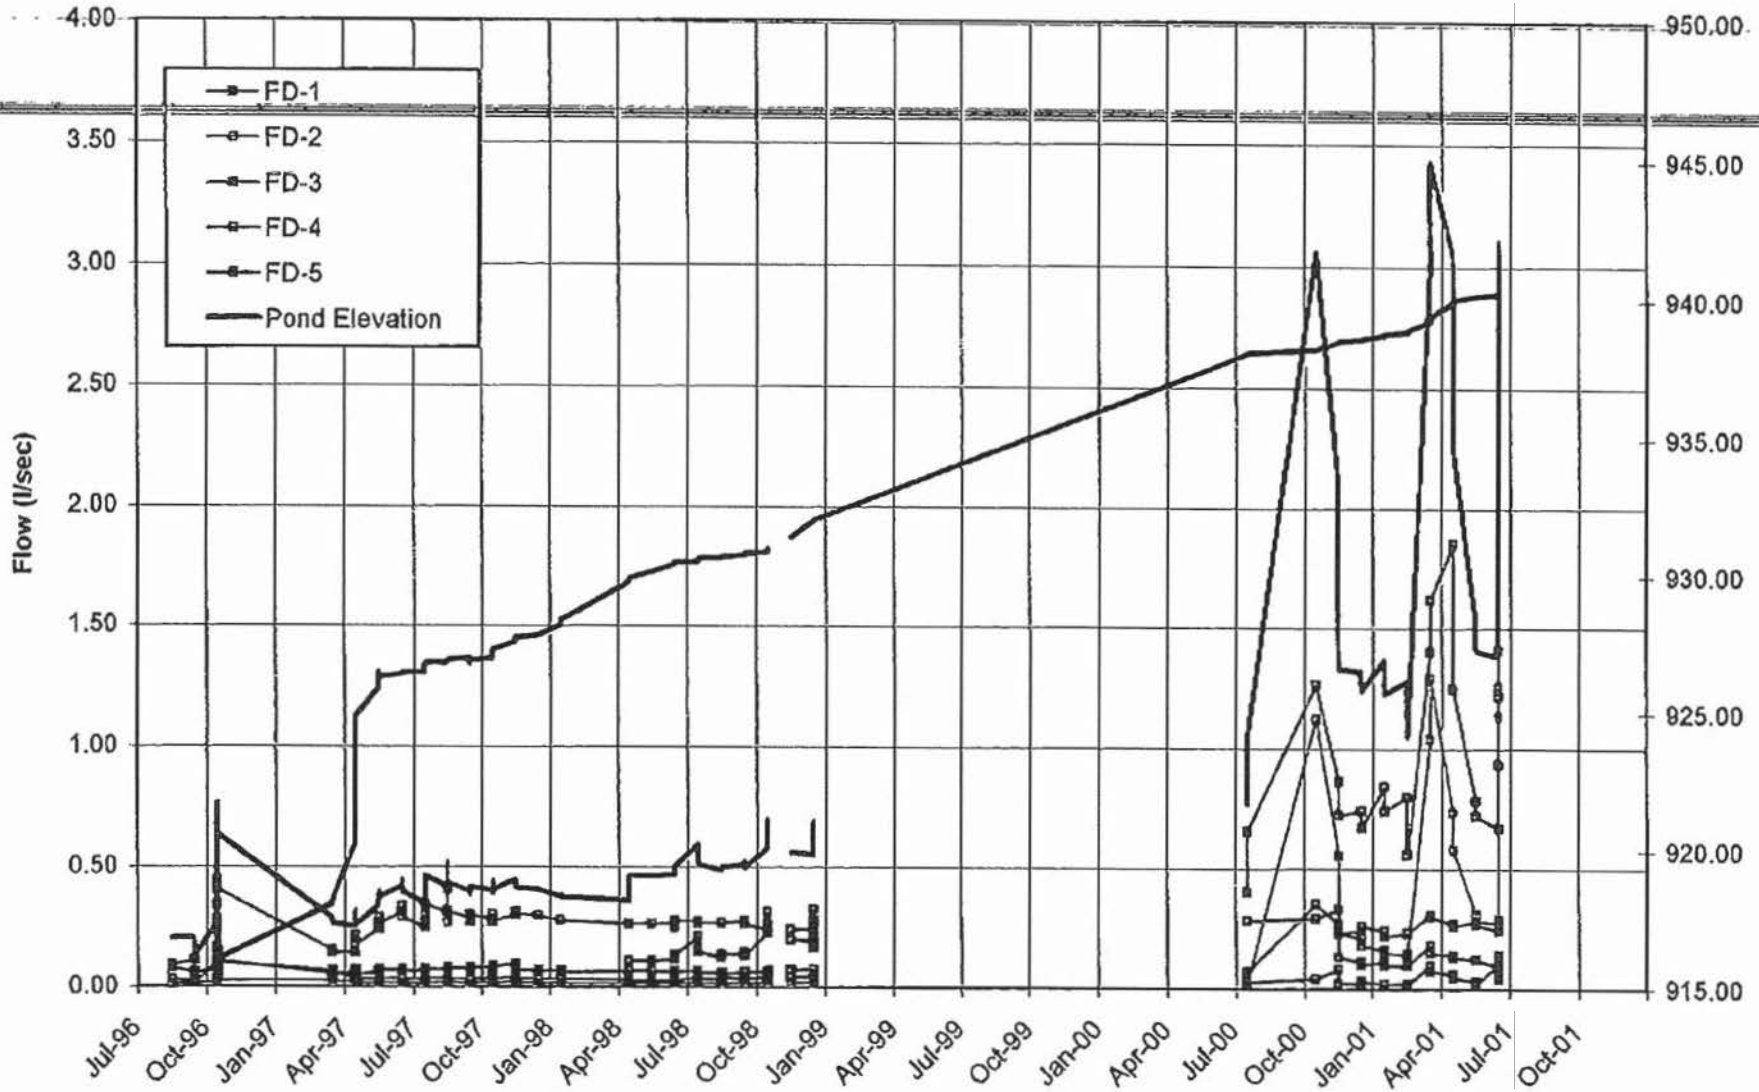
MOUNT POLLEY MINING CORPORATION		
MOUNT POLLEY MINE		
TAILINGS STORAGE FACILITY MAIN EMBANKMENT FOUNDATION DRAIN FLOWS		
	PROJECT NO.	REF. NO.
	11162/13	
REV.		
FIGURE 5.7

Drains flows were recorded on June 27, 2001. The results from the foundation drains and upstream toe drain are shown on Figures 5.7 and 5.8.

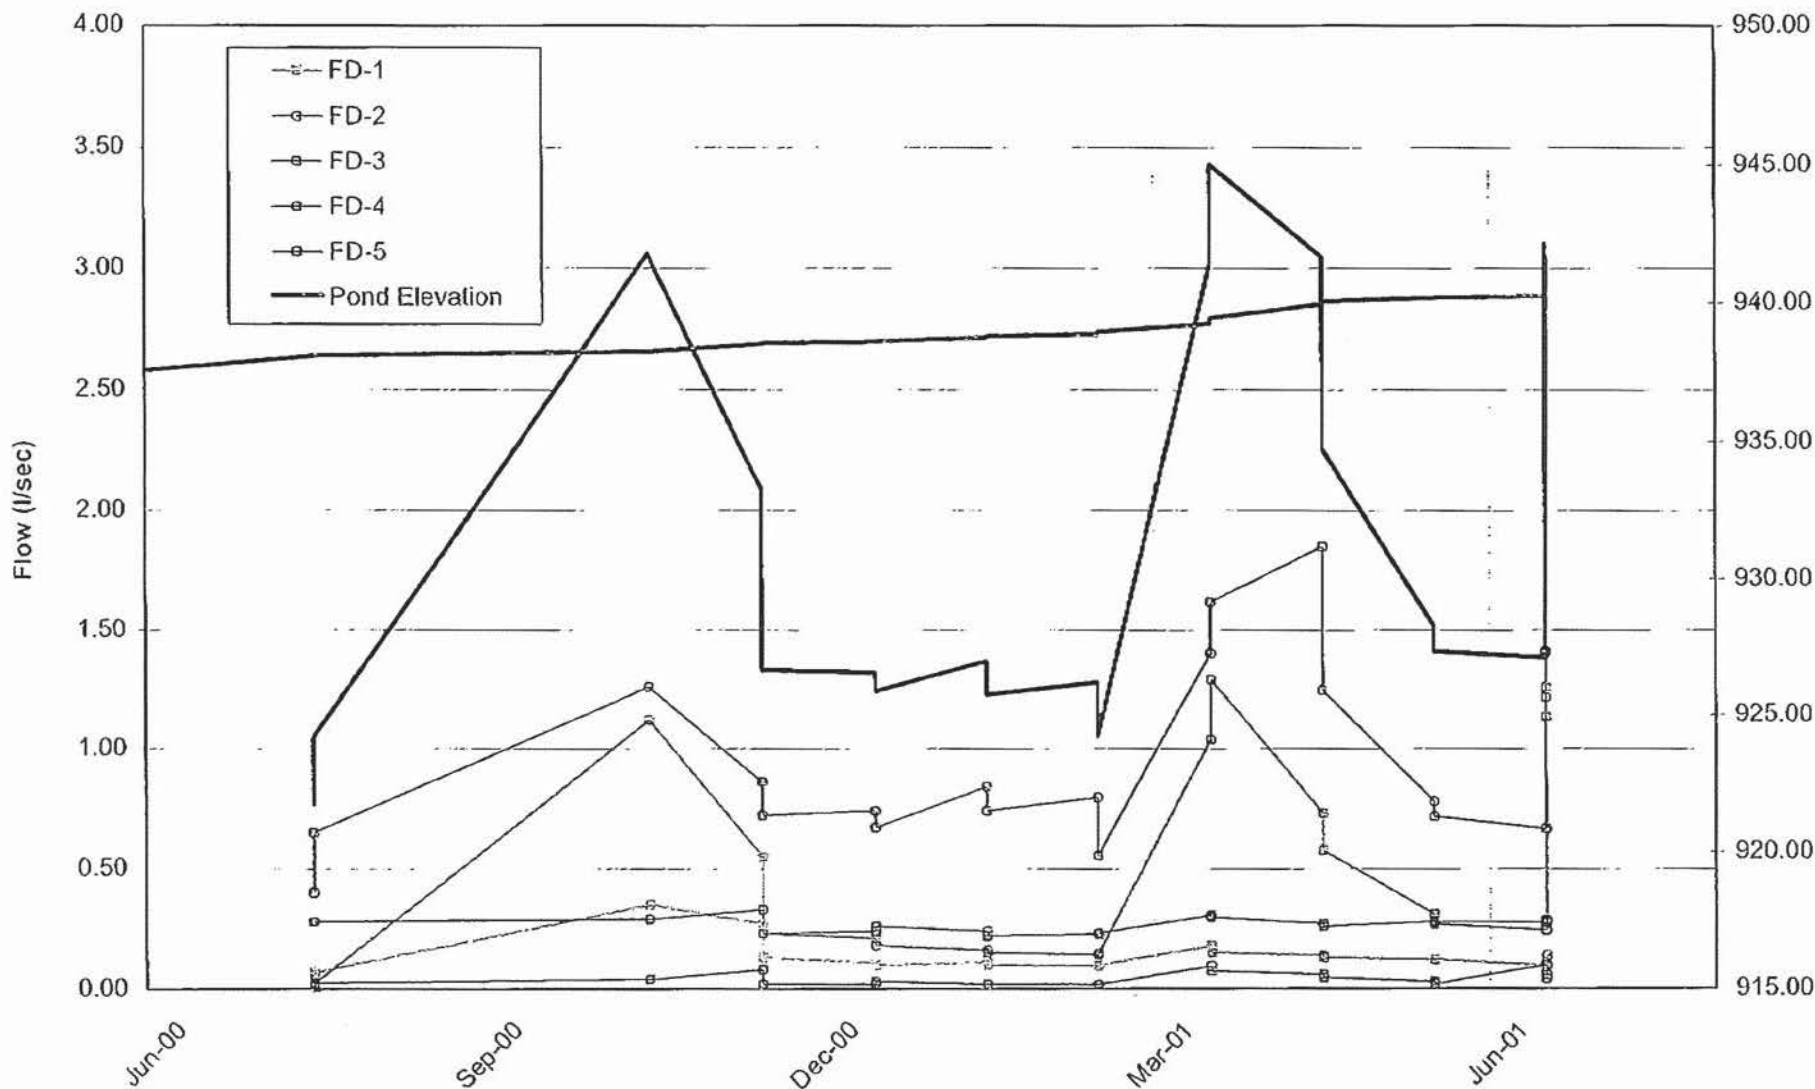
Drains flows were recorded on June 15, 2001. The results from the foundation drains and upstream toe drain are shown on Figures 5.7 and 5.8.

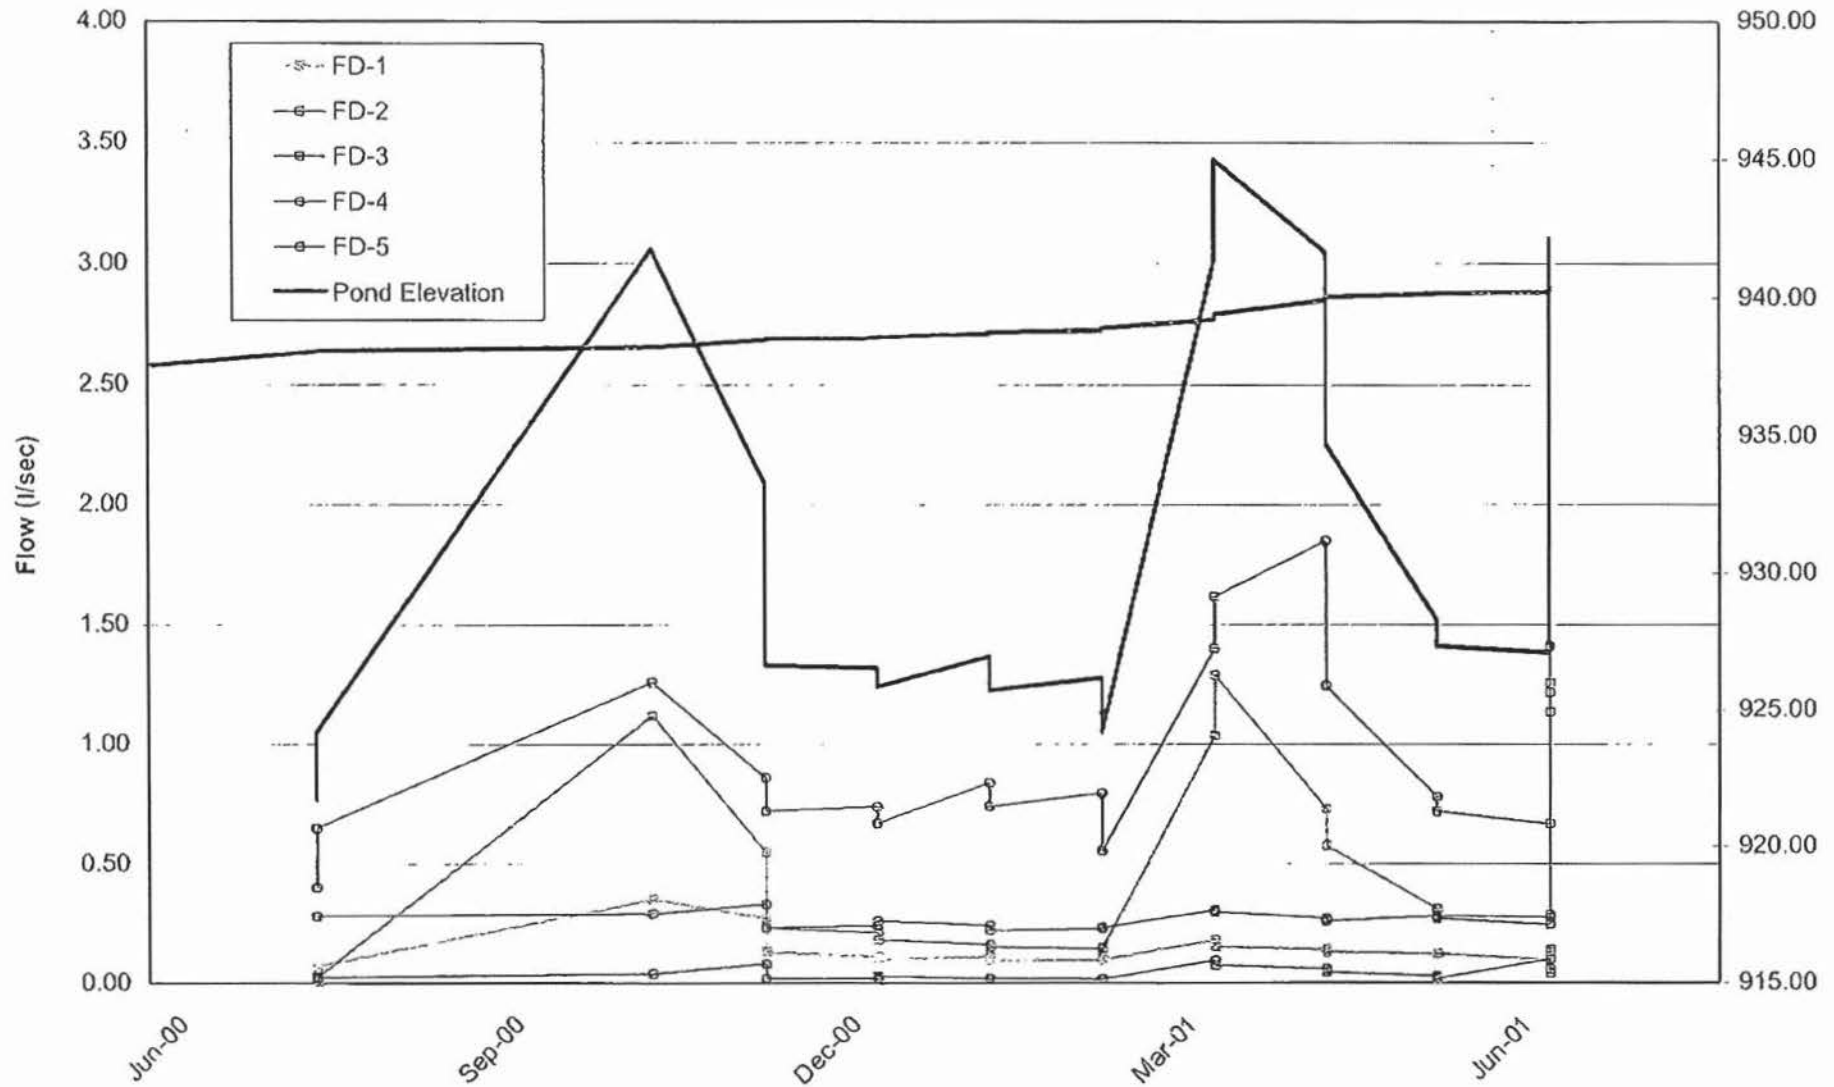
MOUNT POLLEY MINING CORPORATION		
MOUNT POLLEY MINE		
TAILINGS STORAGE FACILITY MAIN EMBANKMENT FOUNDATION DRAIN FLOWS		
<b>Knight Piésold</b> CONSULTING	PROJECT NO. 11162/13	REF NO.   REV
FIGURE 5.7

Drains flows were recorded on June 8, 2001. The results from the foundation drains and upstream toe drain are shown on Figures 5.7 and 5.8.

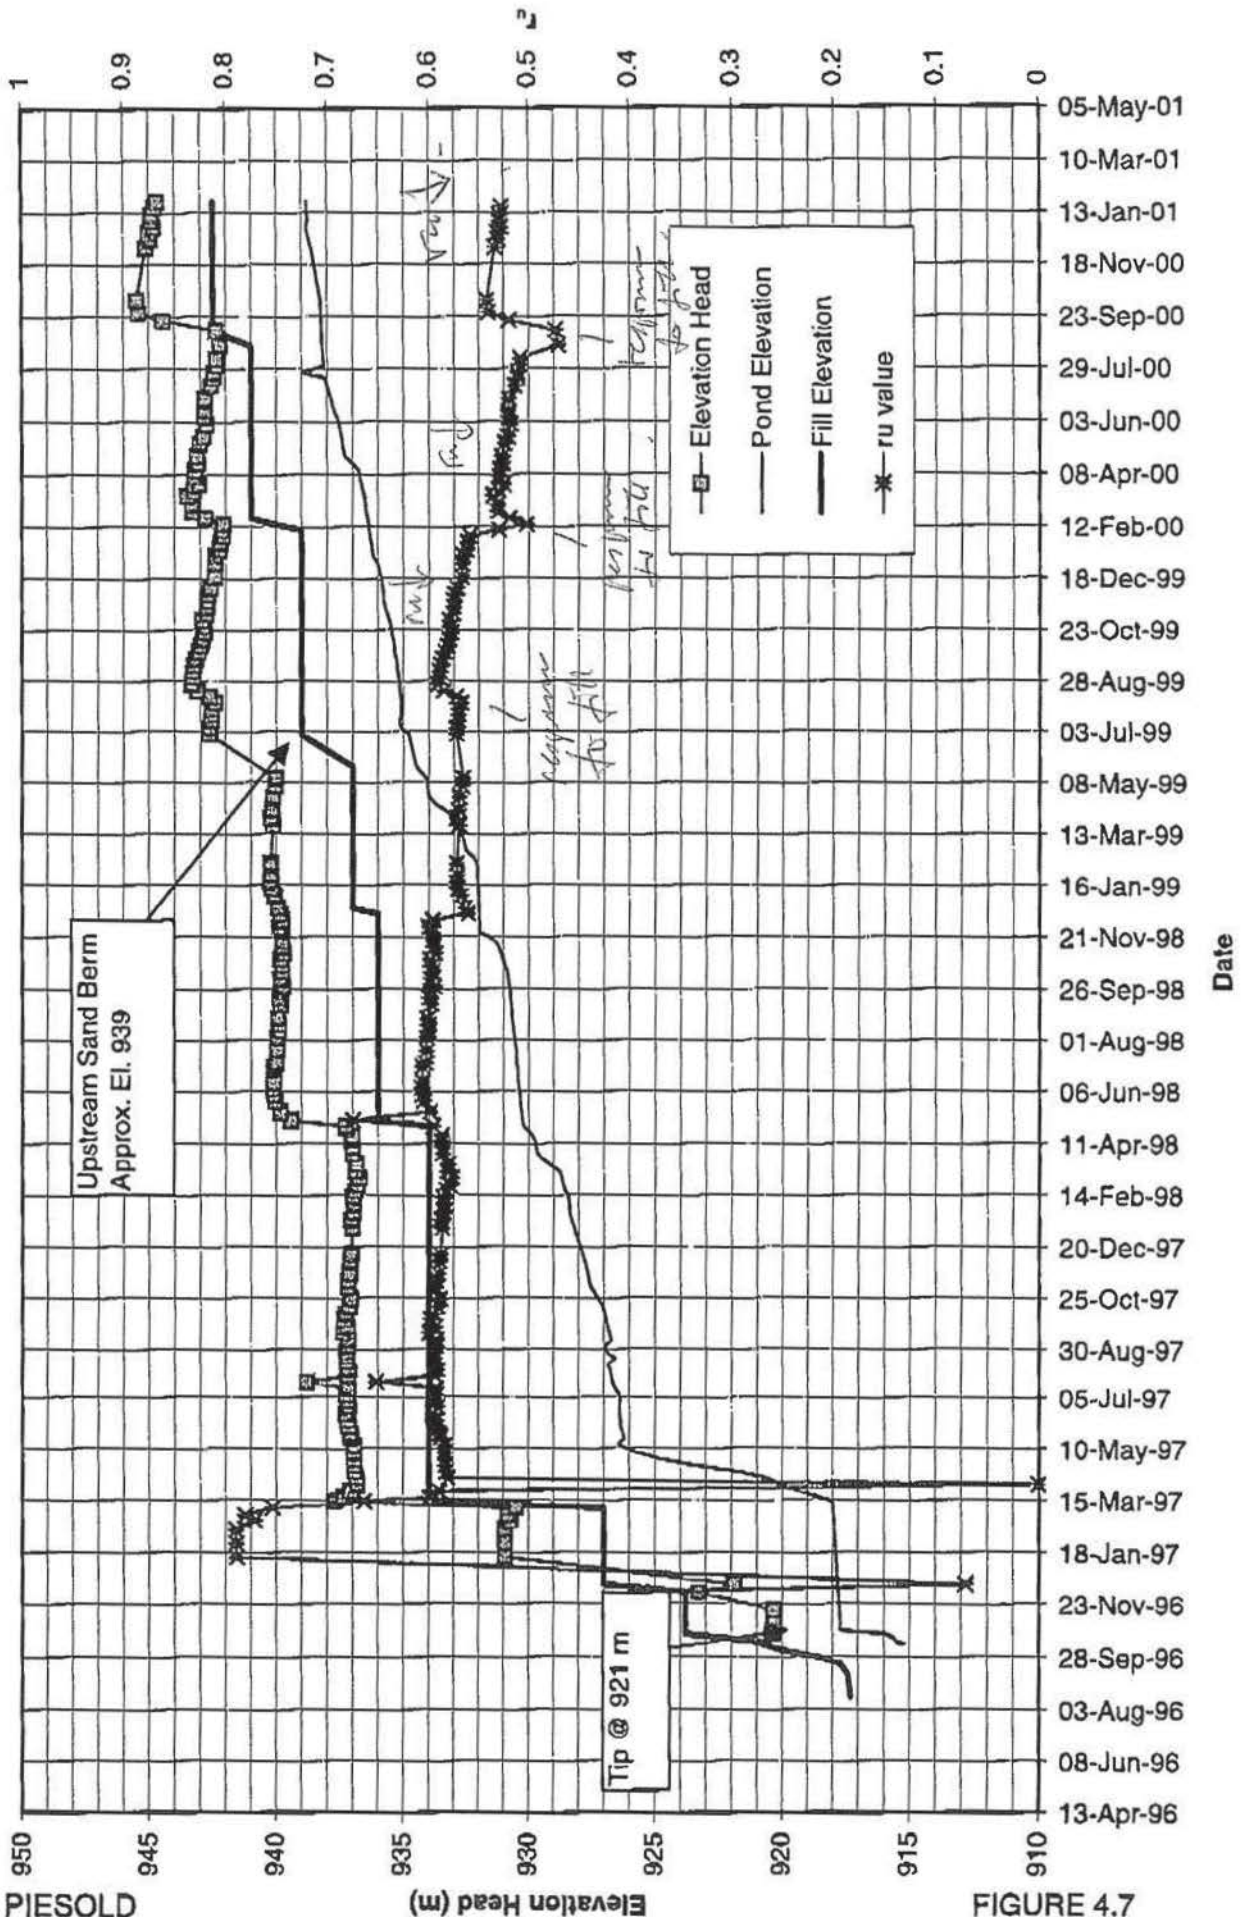
**MOUNT POLLEY MINING CORPORATION**  
**MOUNT POLLEY PROJECT**  
**PIEZOMETER C2-PE2-05**  
**(Glacial Till Fill EL. 924.8 m)**

Piezometer C2-PE2-05 is also located in the Stage 1A glacial till fill. This instrument historically showed little or no reaction to construction, but indicated a slow, steady increase in pore pressure over time. This suggests that pore pressures in the fill around C2-PE2-05 are reaching a steady state condition as the phreatic surface moves through the fill. It should be noted that the pressure head registered by this piezometer is approximately 10 m. This is similar to other piezometers located in comparable locations in the glacial till fill.
