MOUNT POLLEY MINING CORPORATION		
MOUNT POLLEY MINE		
TAILINGS STORAGE FACILITY LONG TERM UPSTREAM TOE DRAIN FLOW ESTIMATES		
Knight Piésold CONSULTING	PROJECT / ASSIGNMENT NO. VA01-00001/14-A	REF NO. VA07-00362
	FIGURE 4	
		REV. 0

**MOUNT POLLEY MINING CORPORATION
MOUNT POLLEY MINE**

**TAILINGS STORAGE FACILITY
REPORT ON 2010 ANNUAL INSPECTION**

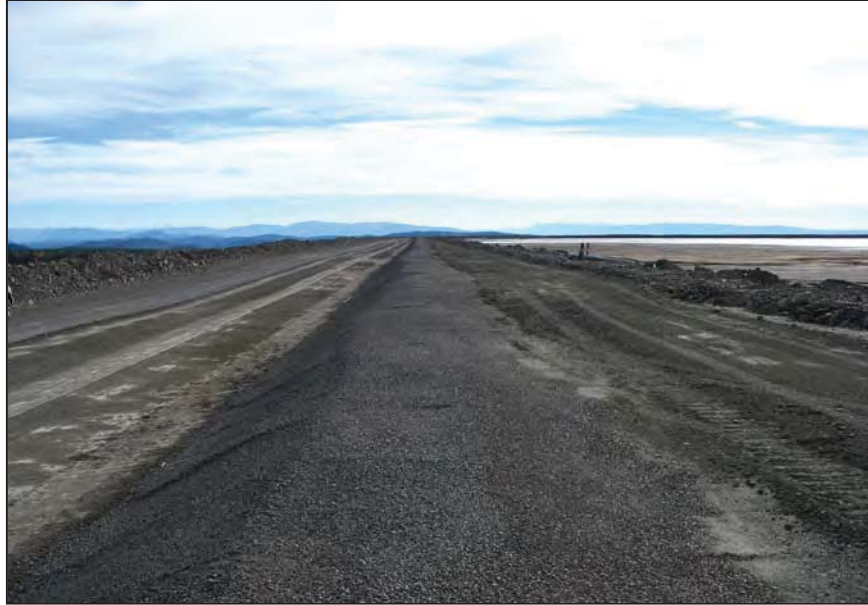
PHOTO 1 – Perimeter Embankment Crest.

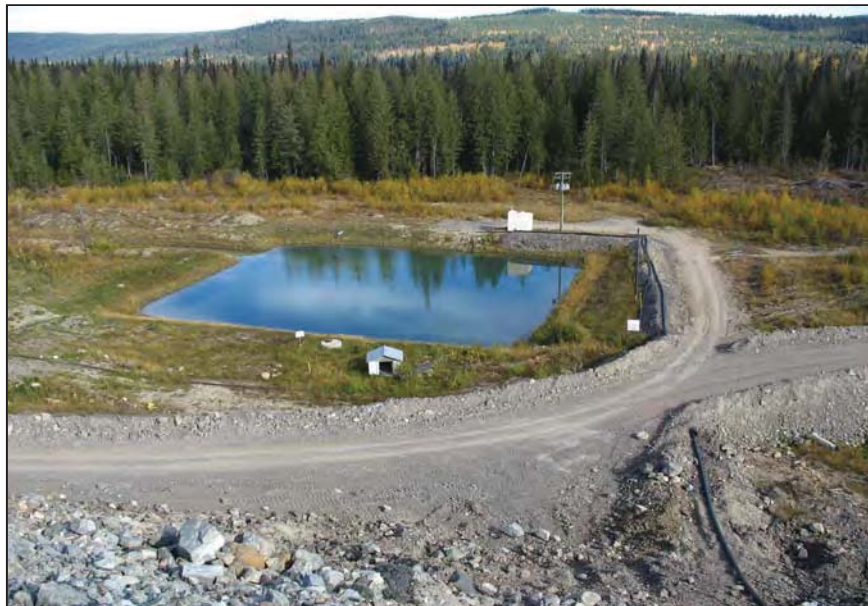
PHOTO 2 – Perimeter Embankment Seepage Collection and Recycle Pond.

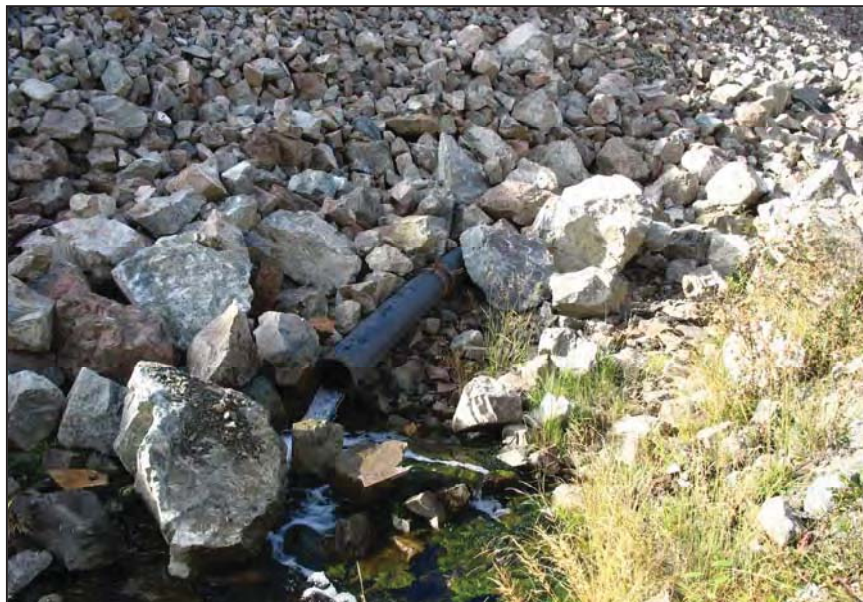
PHOTO 3 – Perimeter Embankment Toe Drain Flow.

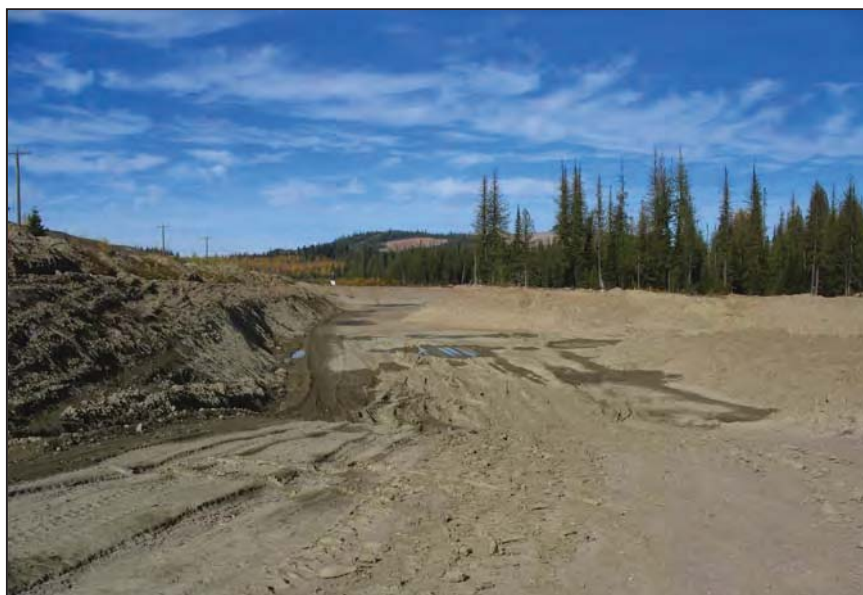
PHOTO 4 – Glacial Till borrow Downstream of Perimeter Embankment.

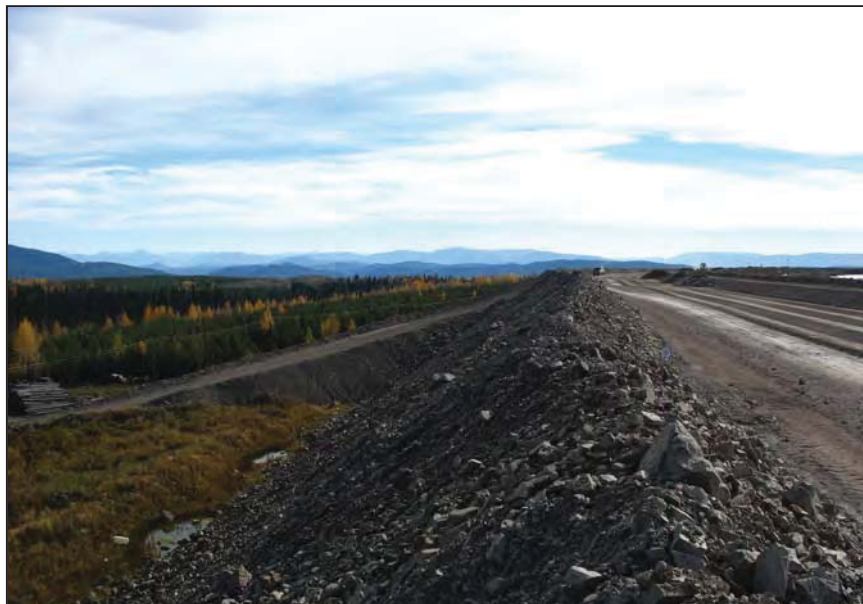
- A tension crack was observed at the Perimeter Embankment at an approximate chainage of 3+400. The tension crack is in the Zone C material at the downstream edge of the embankment crest. The tension crack was apparently identified two months earlier by the grader operator and was approximately 10 to 15 m long. The area has since been graded over but portions of the tension crack are still visible. The location of the tension crack in relation to the downstream slope is not an uncommon occurrence in rock slopes as the outer edge of the material typically receives less compaction effort. A tension crack does not necessarily indicate a plane of weakness in fill materials but it can't be ignored either. The tension crack is located on a section of the Perimeter Embankment located upstream of the Zone S borrow area.

PHOTO 5 – Tension Crack Location at the Perimeter Embankment.

It is recommended that a stability assessment be completed for this area to assess whether the borrow area configuration has any impact on the integrity of the current, and ultimate embankment section. It should also be noted that the identification of a tension crack, or any other abnormal observation at the tailings dam, should be reported to the design engineer immediately and prior to any remedial action being taken.

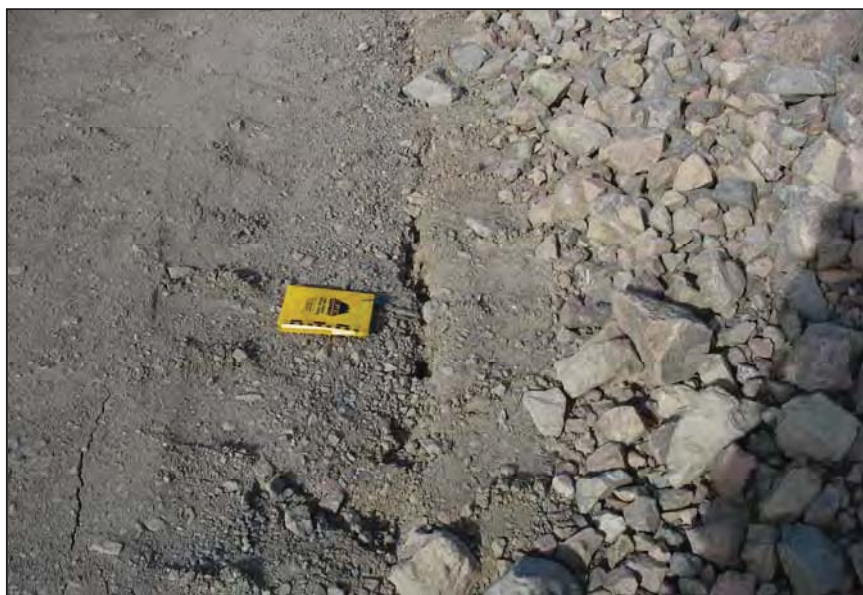
PHOTO 6 – Tension Crack at the Perimeter Embankment.

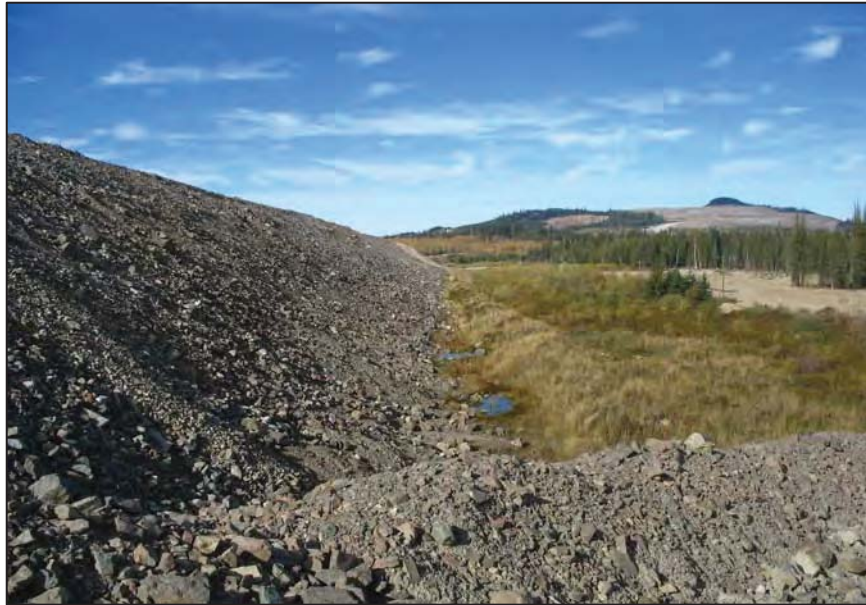
PHOTO 7 – Downstream Slope of Perimeter Embankment.

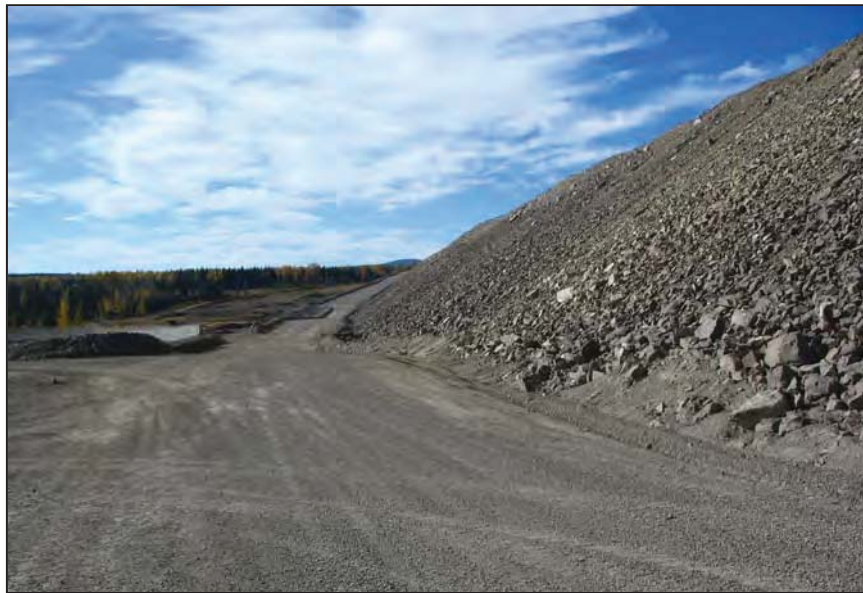
- Other than the tension crack mentioned above, no signs of distress were identified at the tailings embankments. The embankment slopes were approximately planar and there was no evidence of cracking, bulging or slumping in the embankment fill. The embankment crest appeared to be relatively level with no signs of differential settlement or distress. There was no evidence of animal burrowing.
- No major unexpected or uncontrolled seepage was observed from the embankments, including fill slope and foundations.
- The tailings embankments currently have a downstream slope of approximately 1.4H:1V. This was previously constructed as an interim slope to balance the construction material requirements with the waste production schedule for that particular year. This short term slope configuration still exists.

PHOTO 8 – Downstream Slope of Main Embankment.

It is recommended that the downstream slope of the Main Embankment be evaluated during the Stage 7 design phase to assess whether it requires flattening at this time.

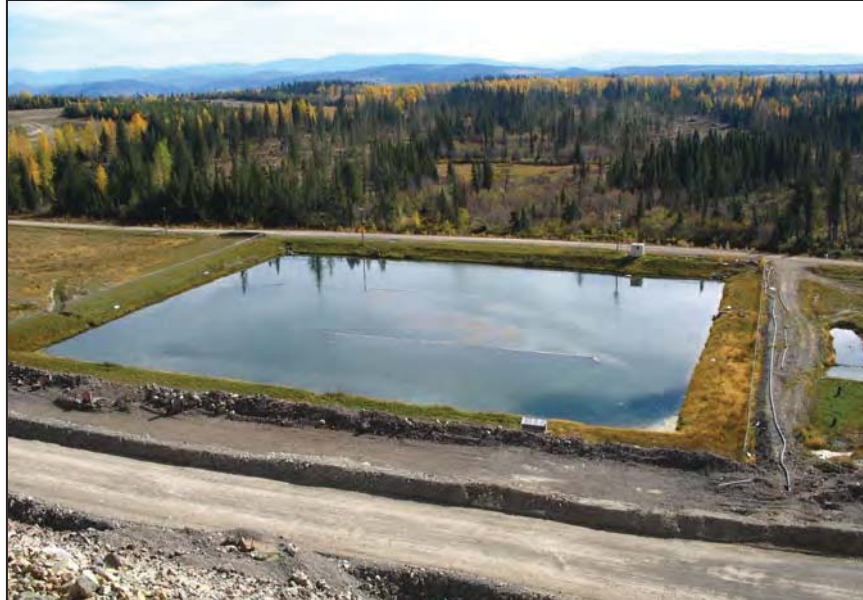
PHOTO 9 – Main Embankment Seepage Collection and Recycle Pond.

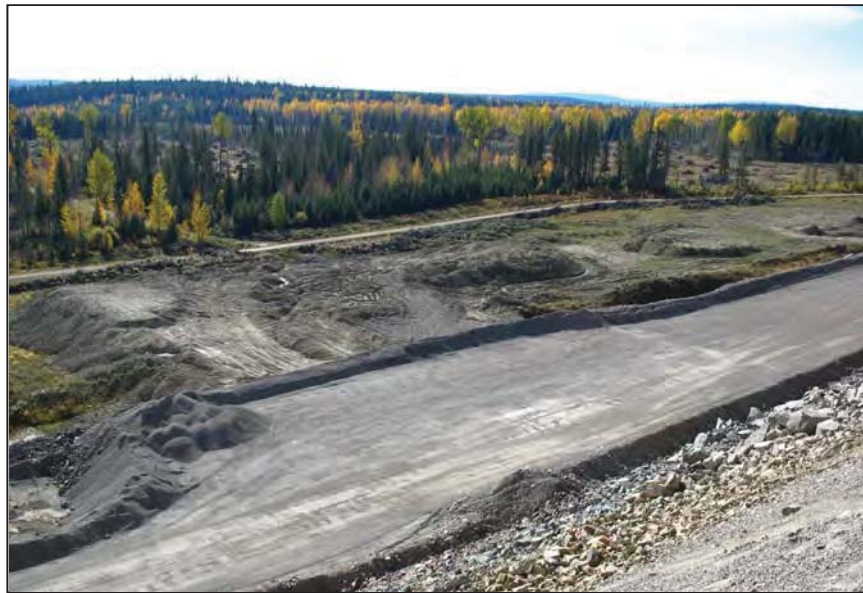
- Slight deviations measured in the lacustrine unit in Inclinator SI01-02 resulted in the recommendation for constructing a downstream buttress². The results of the stability assessment recommended a buttress be constructed downstream of the Main Embankment to an elevation of 920 m for a crest elevation of 958 m, the crest elevation for the Stage 6b embankment. The Stage 6b buttress footprint, which extends to both sides of the Main Embankment Seepage Collection and Recycle Pond, is shown on Drawing VA101-1/29-210. The letter also recommended that the buttress be constructed prior to the commencement of the Stage 6b construction program, which did not happen.

PHOTO 10 – Main Embankment Buttress.

It is recommended that the Main Embankment buttress requirements and timing be re-evaluated as part of the Stage 7 design of the TSF.

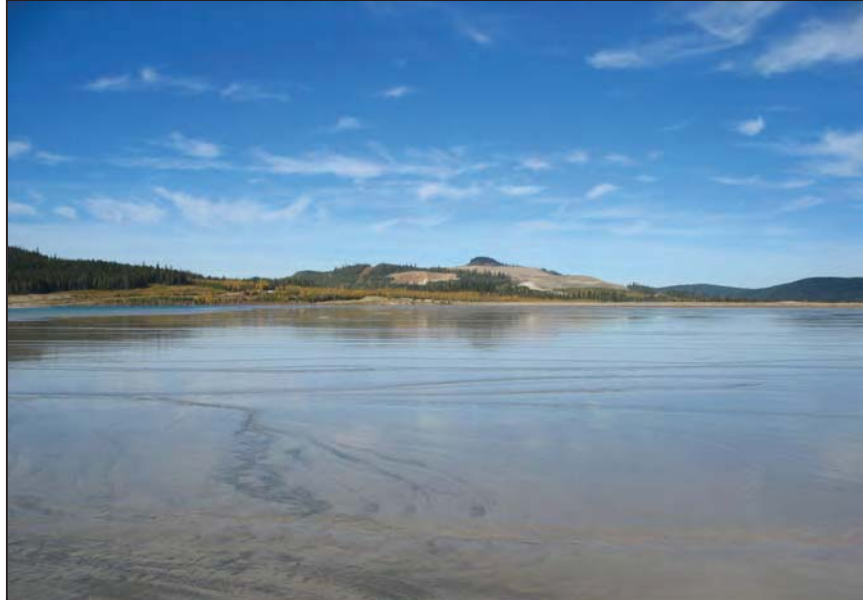
MPMC is currently single point discharging tailings near the northwest corner of the TSF. Prolonged discharge from this location has resulted in the supernatant pond migrating towards the Main and South Embankments where there is a lack of beach development. The beached tailings, when left to drain and consolidate, form the competent foundation required for the modified centerline construction embankment raises.

PHOTO 11 – Tailings Beach, From Main Embankment looking towards Perimeter Embankment.

It is recommended that MPMC adhere to the previous recommendations and develop a tailings management strategy that results in the MEMPR requirements for beach development along all of the embankments.

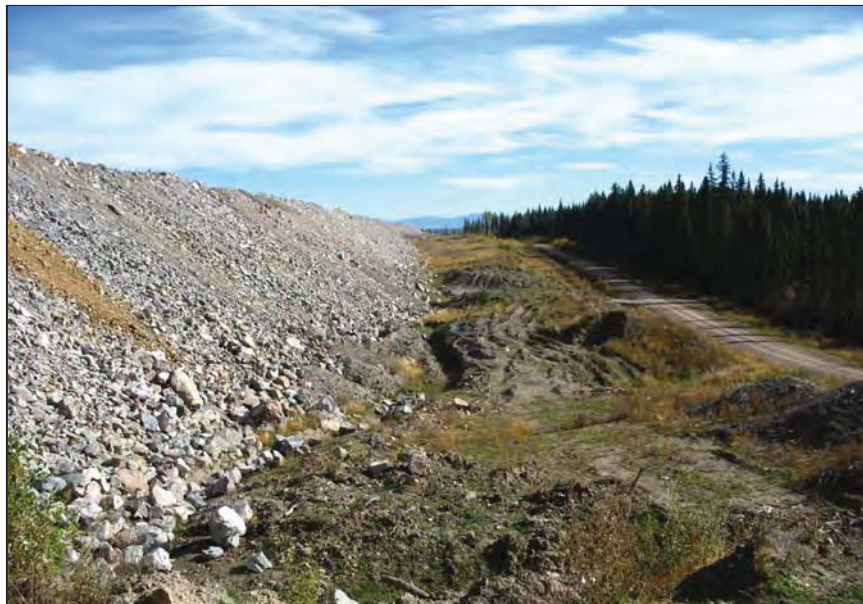
PHOTO 12 – Downstream Slope of South Embankment.

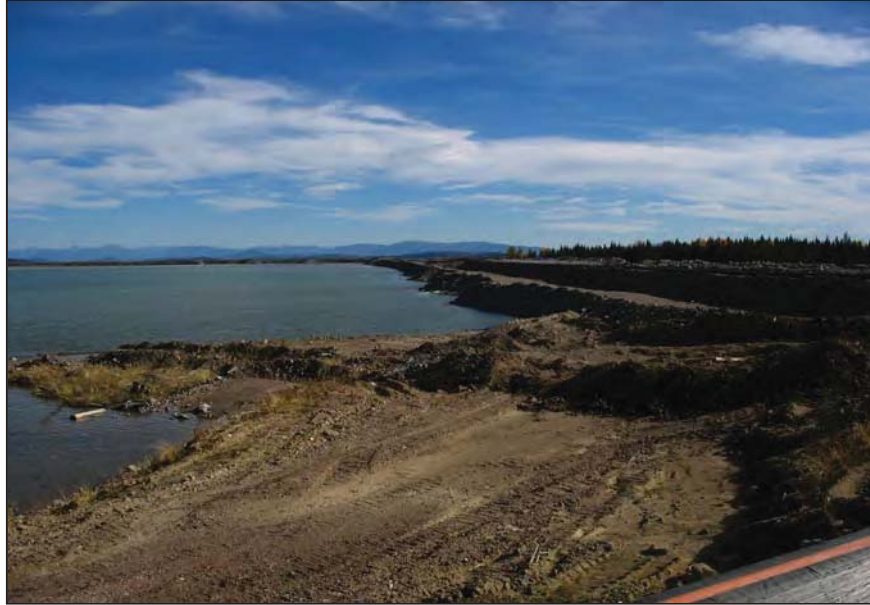
PHOTO 13 – South Embankment – Supernatant Pond adjacent to the dam

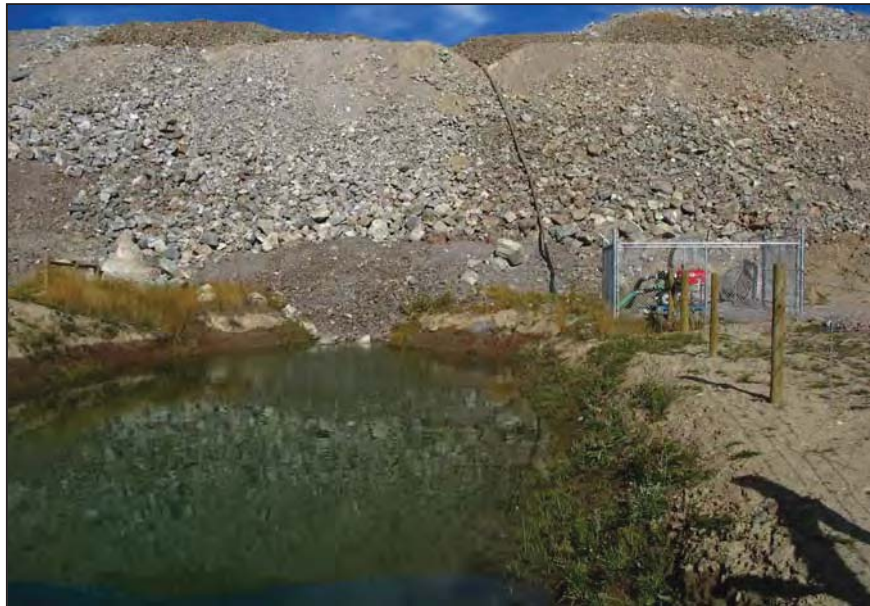
PHOTO 14 – South Embankment Seepage Collection and Recycle Pond.

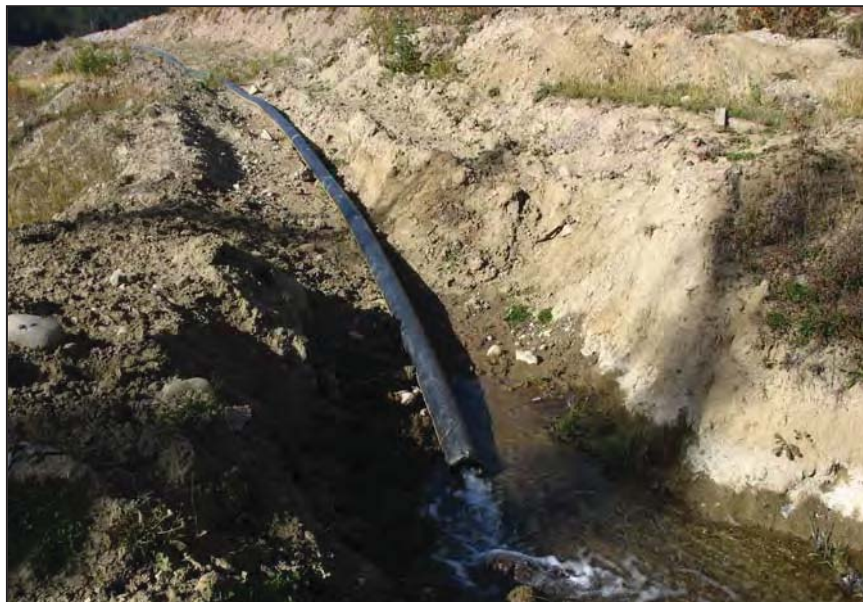
PHOTO 15 – South Embankment Upstream Toe Drain flow.

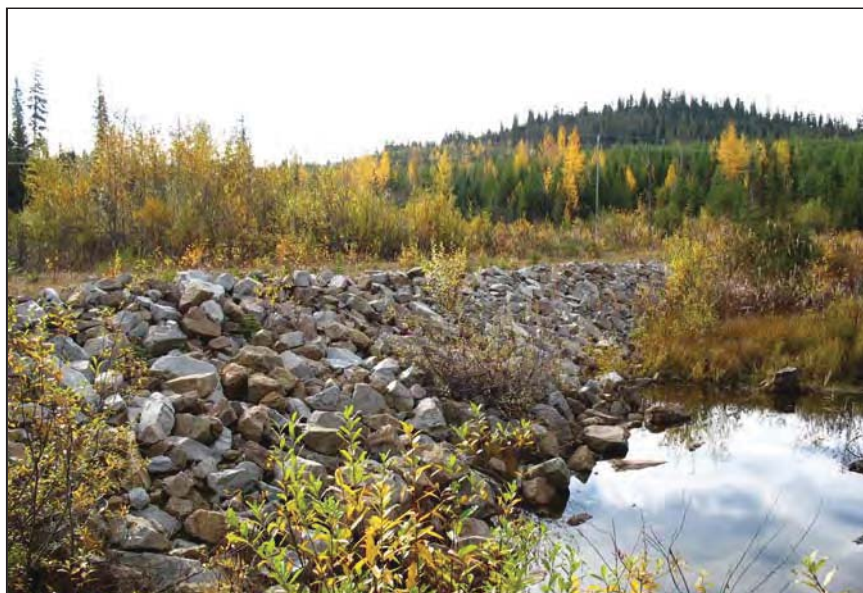
PHOTO 16 – South Bootjack Dam.
