Province of British Columbia  
MINISTRY OF ENERGY, MINES AND  
PETROLEUM RESOURCES  
Mining & Mineral Division  
Report of Inspector of Mines  
(Issued pursuant to Section 15 of the *Mines Act*)

Inspection Report

NAME OF MINE	Westside Pit	LOCALITY	51.022, -118.221 Revelstoke
OWNER/OPERATOR	Interoute Construction Ltd.	ADDRESS	PO Box 9297 Revelstoke BC V0E 3K0
MANAGER	Roy Rokosh	AREAS INSPECTED	Pit and proposed expansion.

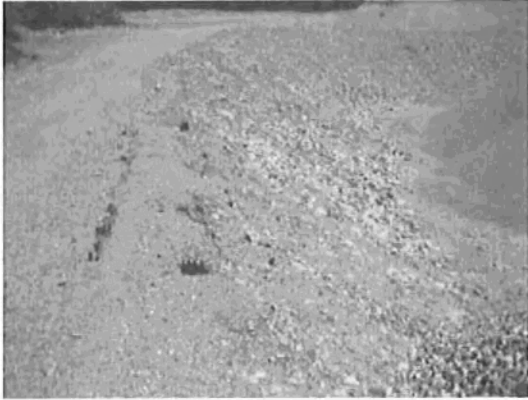
The proposed new mining area was viewed as well as the exsisting tree buffer.

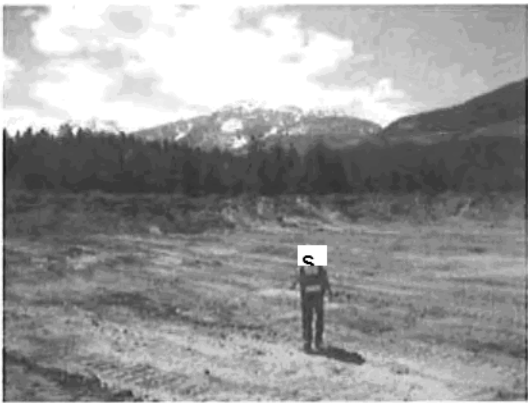
Looking downstream from the mine access road toward the pit boundary.

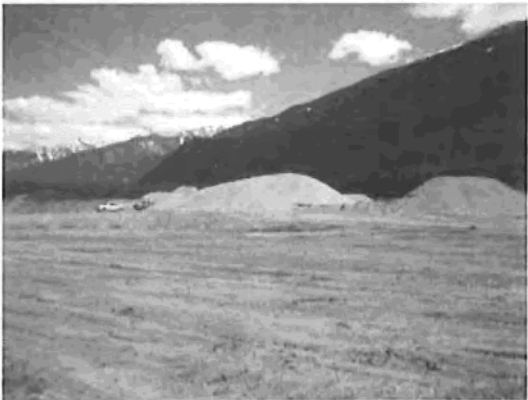
Looking upstream , from the downstream boundary, note stockpiles from exsisting pit.

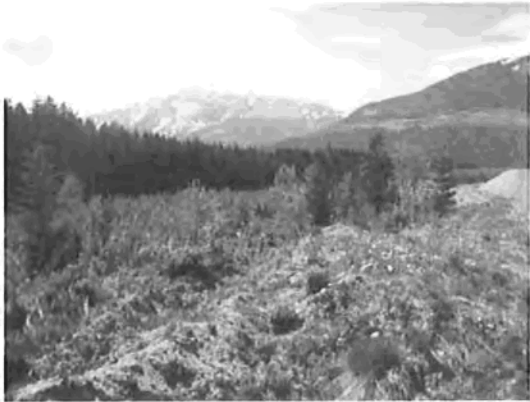
Looking downstream from the upstream border of the exsisting pit (Coulmbia River tree buffer on left with additional buffer of replanted trees in the foreground).

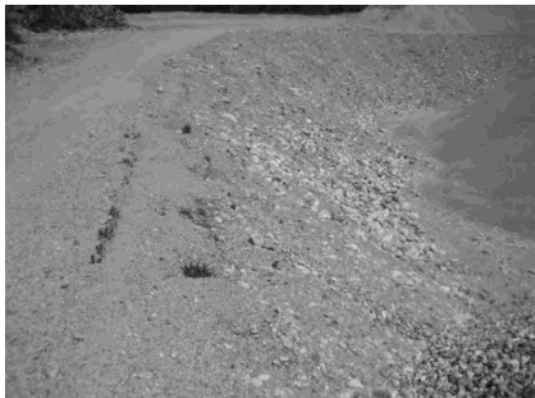
The proposed new mining area was viewed as well as the exsisting tree buffer.

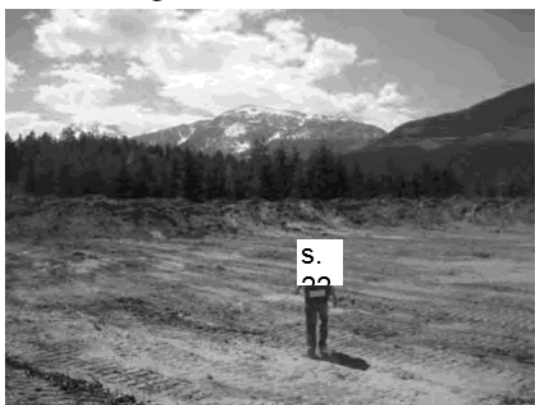
Looking downstream from the mine access road toward the pit boundary.

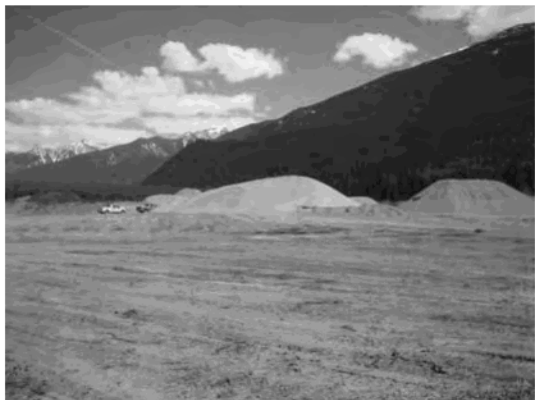
Looking upstream , from the downstream boundary, note stockpiles from exsisting pit.

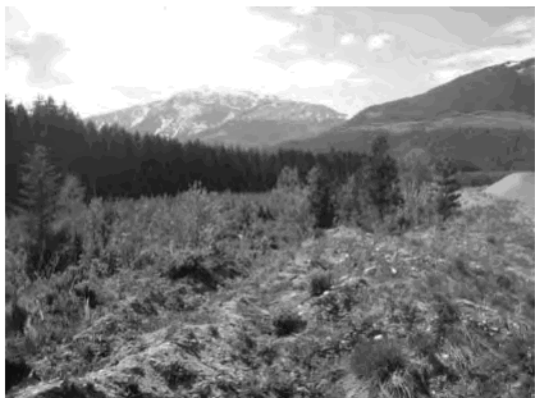
Looking downstream from the upstream border of the exsisting pit (Coulmbia River tree buffer on left with additional buffer of replanted trees in the foreground).

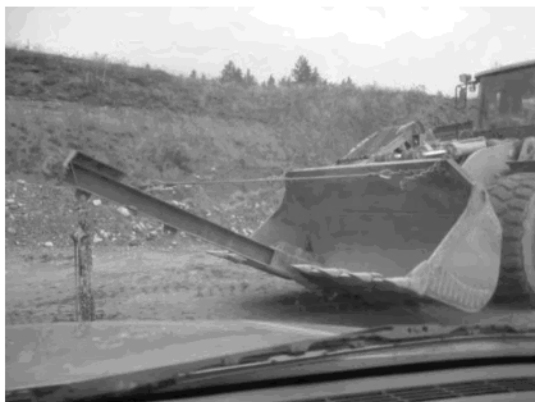
## SECTION : 4.18.2 Safe Working Load

A lifting device attached to the loaded bucket was observed. When asked, the operator did not know if the device was engineered or what the lifting capacity was. The manager shall have the lifting device removed from service until the unit is certified and has the appropriate load rating installed pursuant to section's 4.18.2 & 4.18.8 of the Health Safety and Reclamation Code.

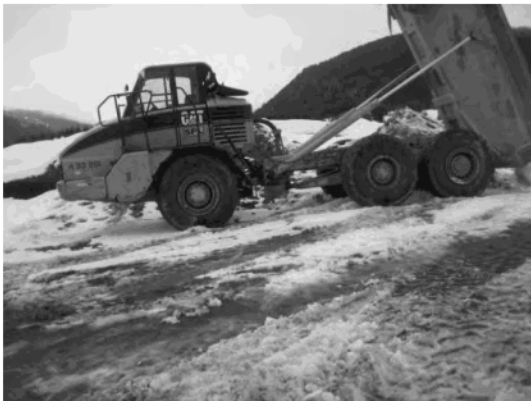
SECTION : 4.9.4 Vehicle Requirements

The haul truck located at the pit entrance did not have wheel chocks. Additionally the loaders are not equipped with wheel chocks. The manager shall ensure all rubber tired mobile equipment over 7000 kg gross vehicle weight have a minimum of two wheel chocks which shall be used whenever necessary pursuant to section 4.9.4 of the Health Safety and Reclamation Code, to be reviewed with all employees at the mine.

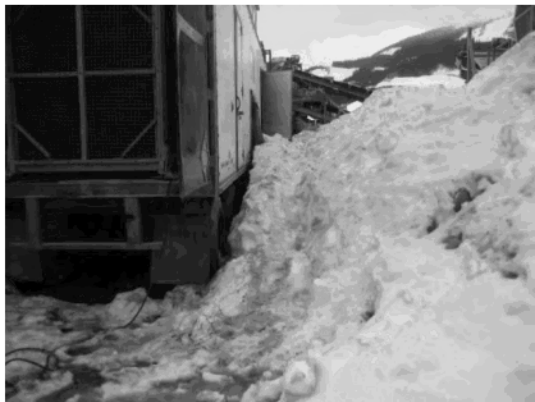
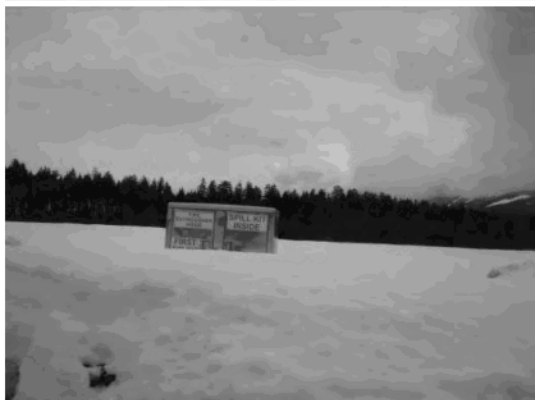
## SECTION : 1.9.1 General Workplace Conditions

Snow accumulations in and around the working areas have created a substantial hazard to slips and falls. The first aid / spill kit shed was not accessible. The manager shall have access to all areas re-established pursuant to section 1.9.1 of the Health Safety and Reclamation Code, to be completed immediately.

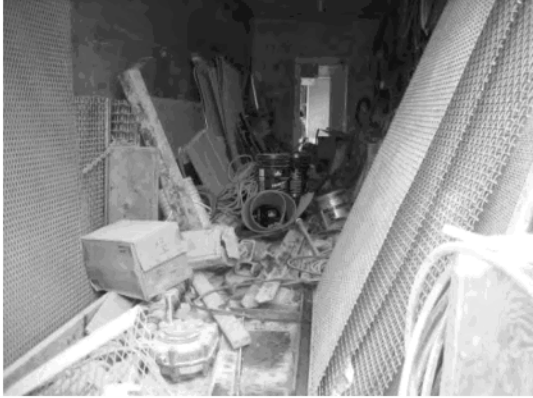
SECTION : 2.2.1      Workplace to Be Hazard Free

The parts van is in need of cleaning. Tracks where the employees had walked on top of the parts were observed. The manager shall have this van cleaned out pursuant to section 2.2.1 of the Health Safety and Reclamation Code, to be completed immediately.

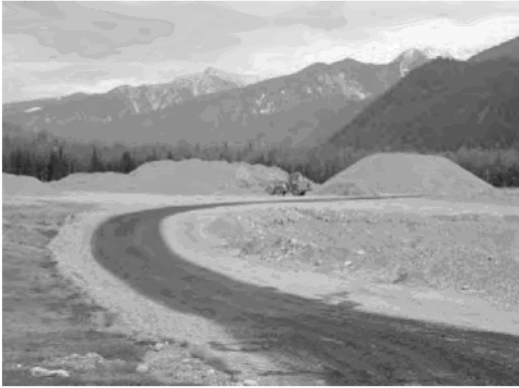
It was good to see the dust suppression calcium on the roads leading into the pit area as well all the Hydro-seeding that had been done in the surrounding area.

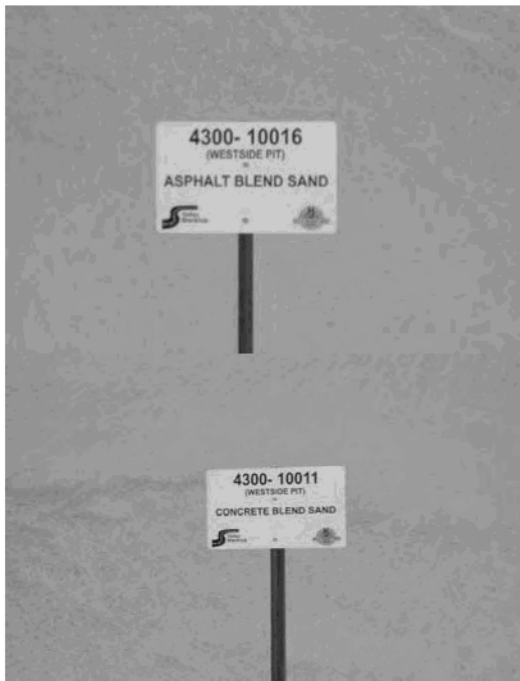
1<sup>st</sup> - It was noted with a South Westerly wind blowing there was allot of dust coming off the concrete blend and asphalt blend piles.

Wherever practicable, water sprays or other dust suppression means and devices shall be used at every dusty place where work is carried out and where it is impractical to do so, personal protective equipment shall be supplied and worn by all persons working in that location.

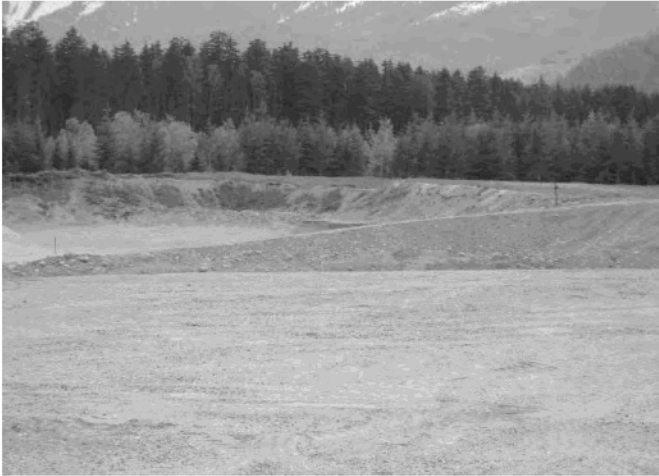
2<sup>nd</sup> – It was noted that in certain areas the berm was not of sufficient height to the equipment around the pit.

The manager shall remedy immediately.

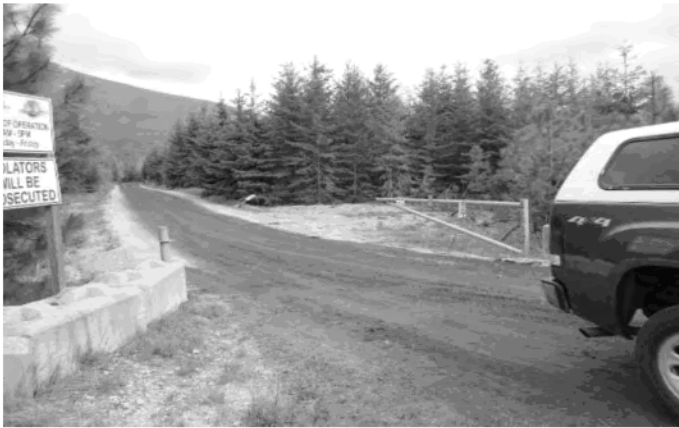
**3<sup>rd</sup>** - For the 45 minute duration the inspectors were inspecting the operation, no one was around the area or came back to the operation. The road leading into the pit area was not secured from outside personal and the entrance gate was left open for anyone to enter.

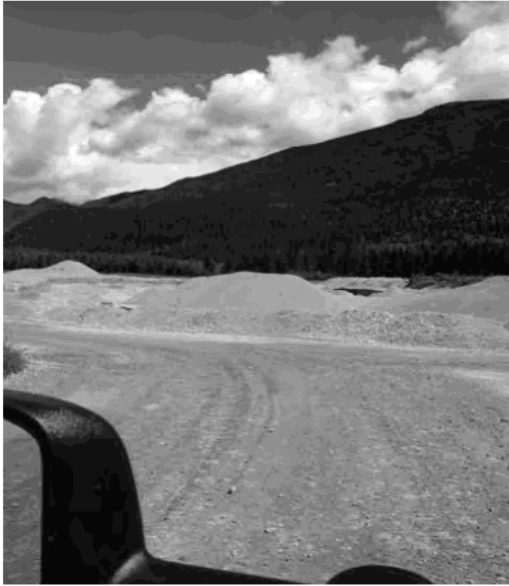
As can be seen from this picture when arriving at the pit there is no dust visible coming from the crushing area.

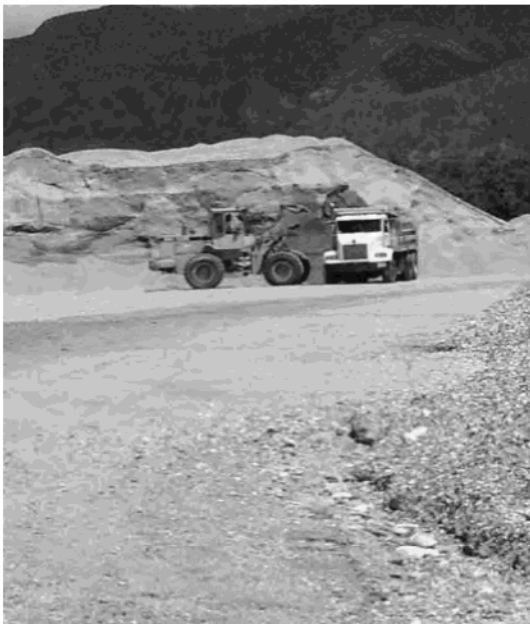
This picture was taken while a loader was loading a gravel truck and there was no dust being generated for this loading activity.

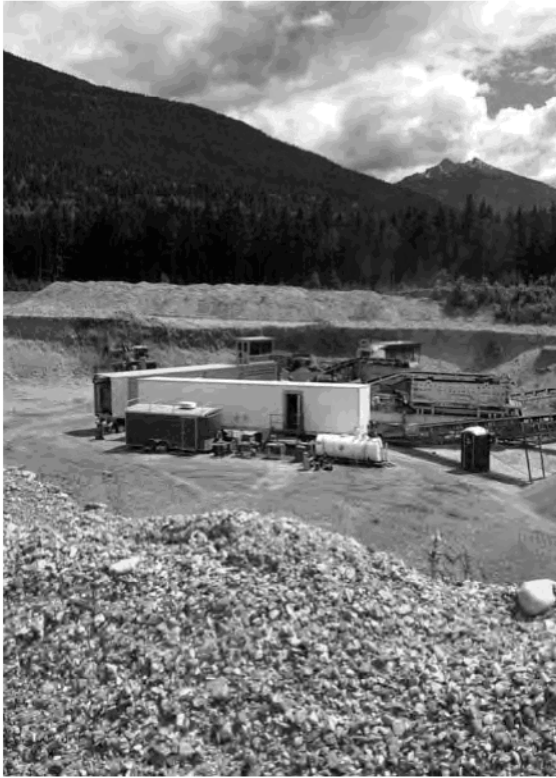
This picture is overlooking the crusher and a slight haze can be seen coming from around the MF cone crusher. This slight dusting was certainly not migrating from the site but may be a hazard to unprotected workers walking on the ground in this area. This condition needs to be further investigated by Valley Black Top/Selkirk Paving.

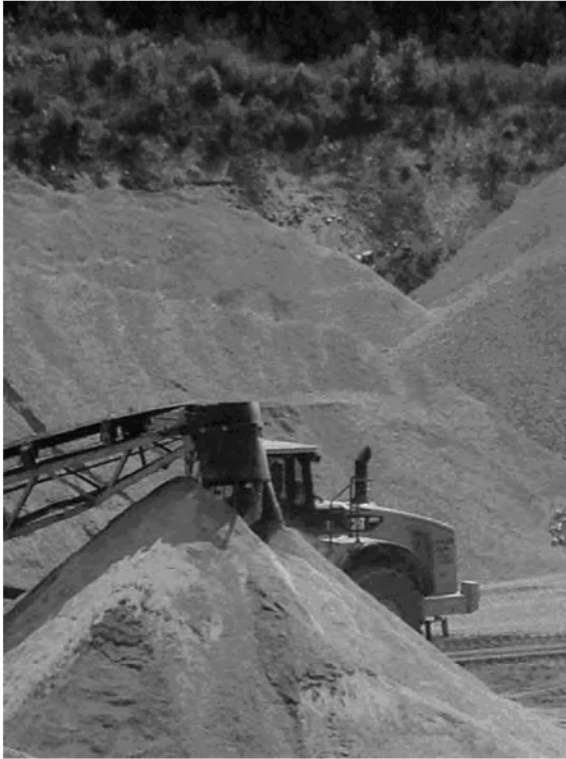
This picture is of the discharge end of the manufactured fines conveyor. No visible dust could be seen coming from neither this belt nor any other conveyor discharge that was observed during this inspection.

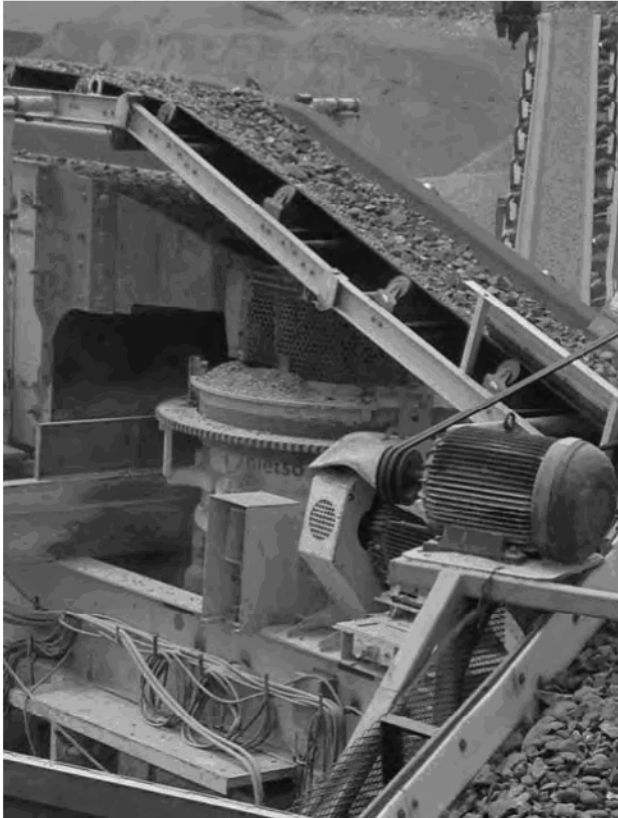
This picture is of the cone crusher for the manufactured fines. This area does produce a small amount of dust which appears to be from the crusher drive motor and belts pulling dust from the crusher. This dust was not of any quantity that would migrate from this local area but could be hazardous to unprotected workers working in this area. Once again this possible worker exposure needs to be evaluated by Valley Black Top/Selkirk Paving.
