Re: Mine Inspection February 9, 2010
Property: Kelly Pit

Mining & Mineral Division
Report of Inspector of Mines
(Issued pursuant to Section 15 of the *Mines Act*)

Inspection No.: 17393
File: 18080-02-02
Mine No.: 1620302
Permit No.:
Emp/Cont: 0 / 0
Orders H&S: 8 RECL: 0
Stop Work: 0

| NAME OF MINE | Kelly Pit | LOCALITY | Revelstoke Hwy 23N |

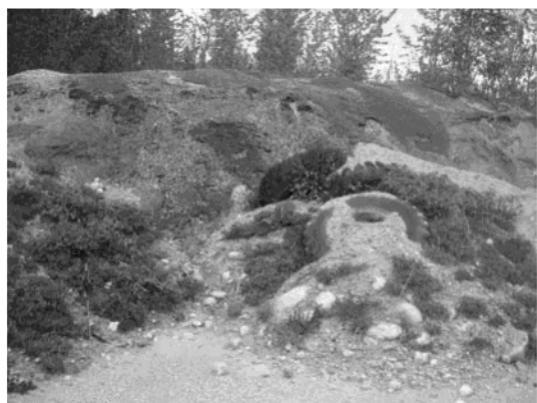
A pile of road construction waste material was noted on the mine site, this pile included used tires. The manager shall forthwith have the tires removed from site and provide clarification on the plan for the assorted waste materials.

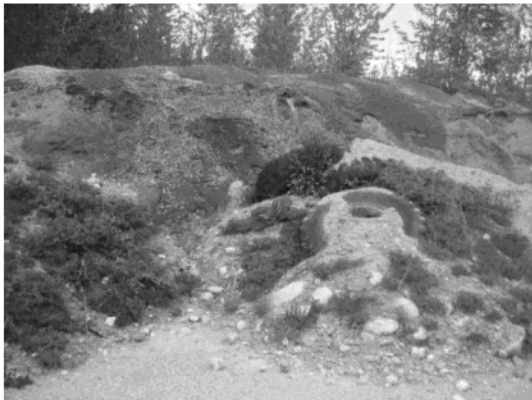
A pile of road construction waste material was noted on the mine site, this pile included used tires. The manager shall forthwith have the tires removed from site and provide clarification on the plan for the assorted waste materials.

This item is going to be passed onto our Maintenance Contractor for their comment.

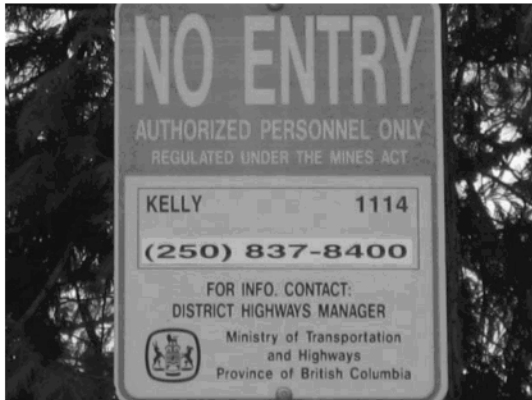
The response to the May 12, 2010 inspection was that while it might take more than ten days a gate would be installed. No evidence of a gate or an alternate access control methods was found. The manager shall ensure site access is controlled pursuant to section 1.3.1 through 1.3.3 of the Health, Safety and Reclamation Code, to be completed within thirty days.
