Government takes action on Chief Inspector of Mines' recommendations

Investigation Report
of the Chief Inspector of Mines

MOUNT POLLEY MINE
MOUNT POLLEY MINING CORPORATION
SUBSIDIARY OF
IMPERIAL METALS CORPORATION

MOUNT POLLEY TAILINGS STORAGE FACILITY BREACH, AUGUST 4, 2014

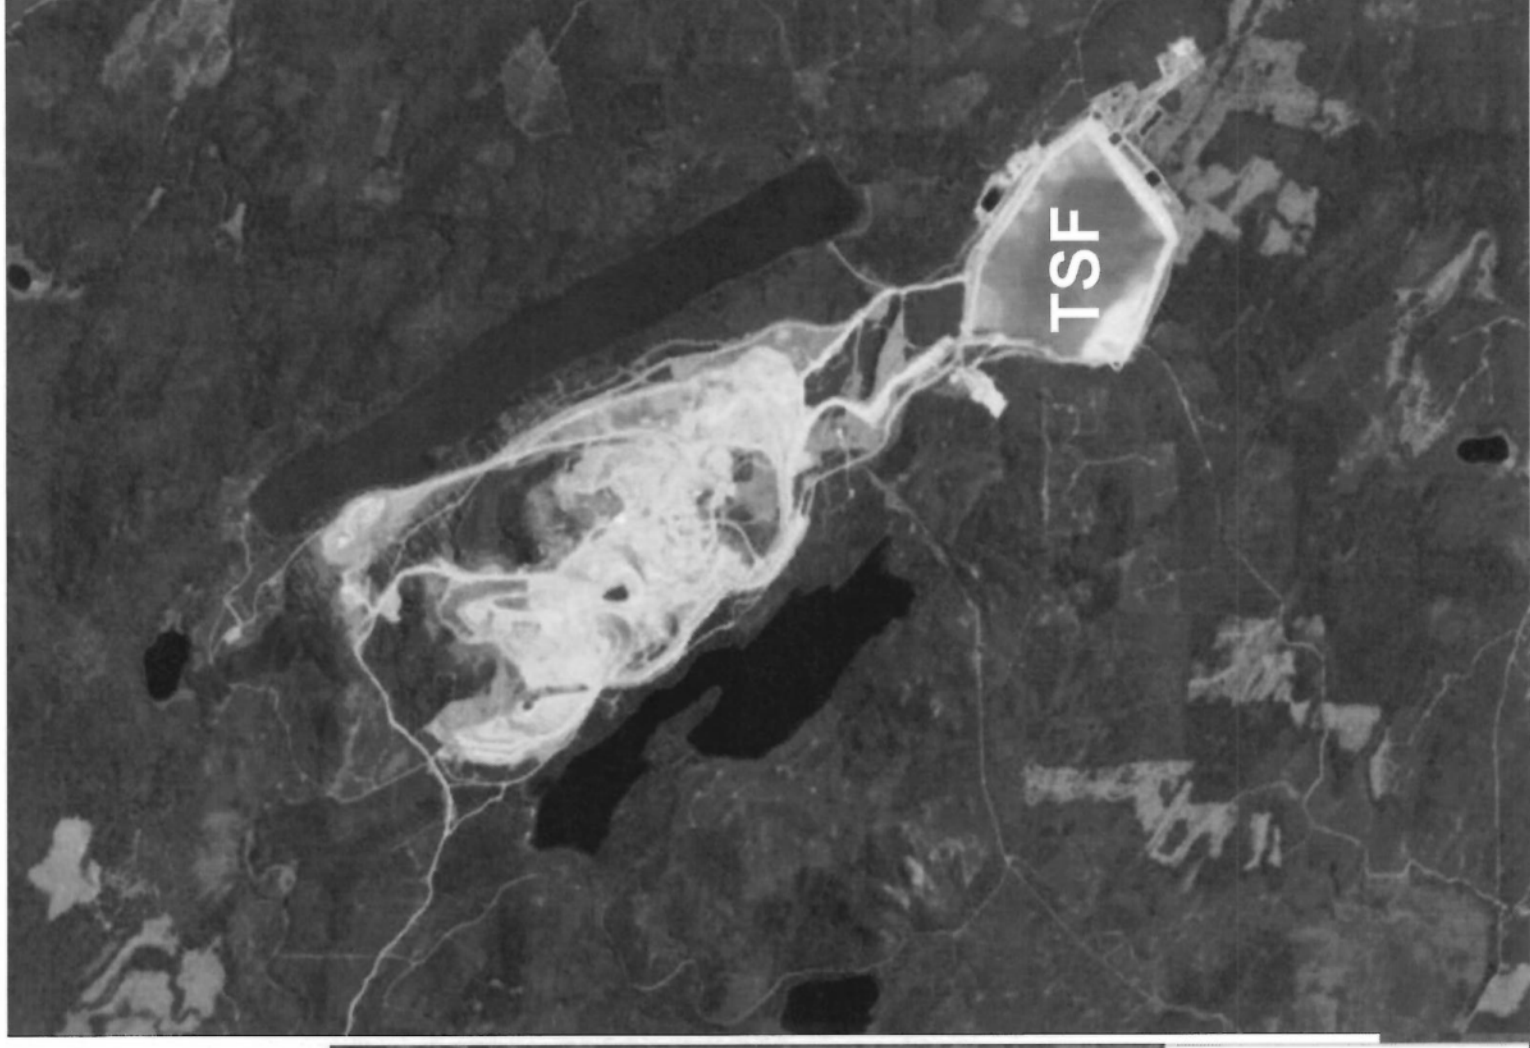
BREACH AREA

PERIMETER EMBANKMENT

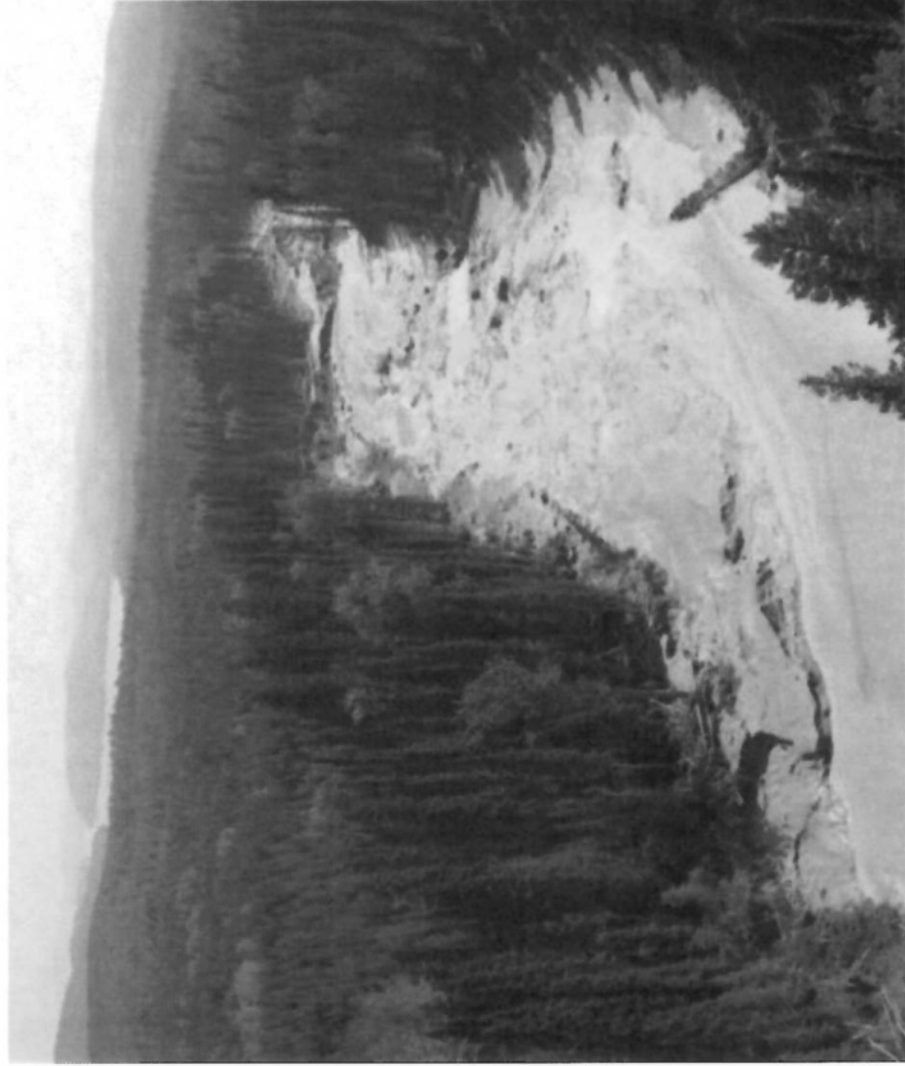
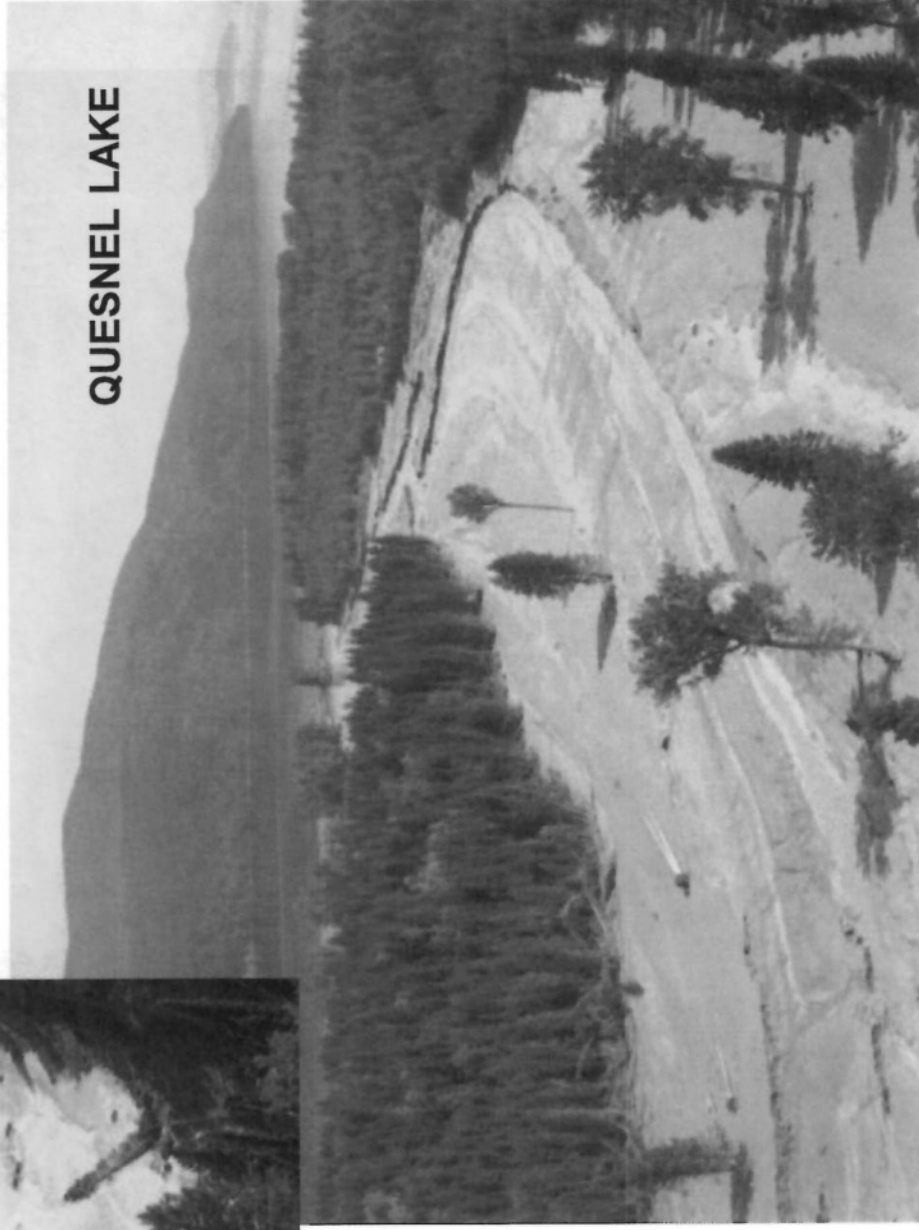
**DEBRIS FIELD THOUGH
HAZELTINE CREEK**

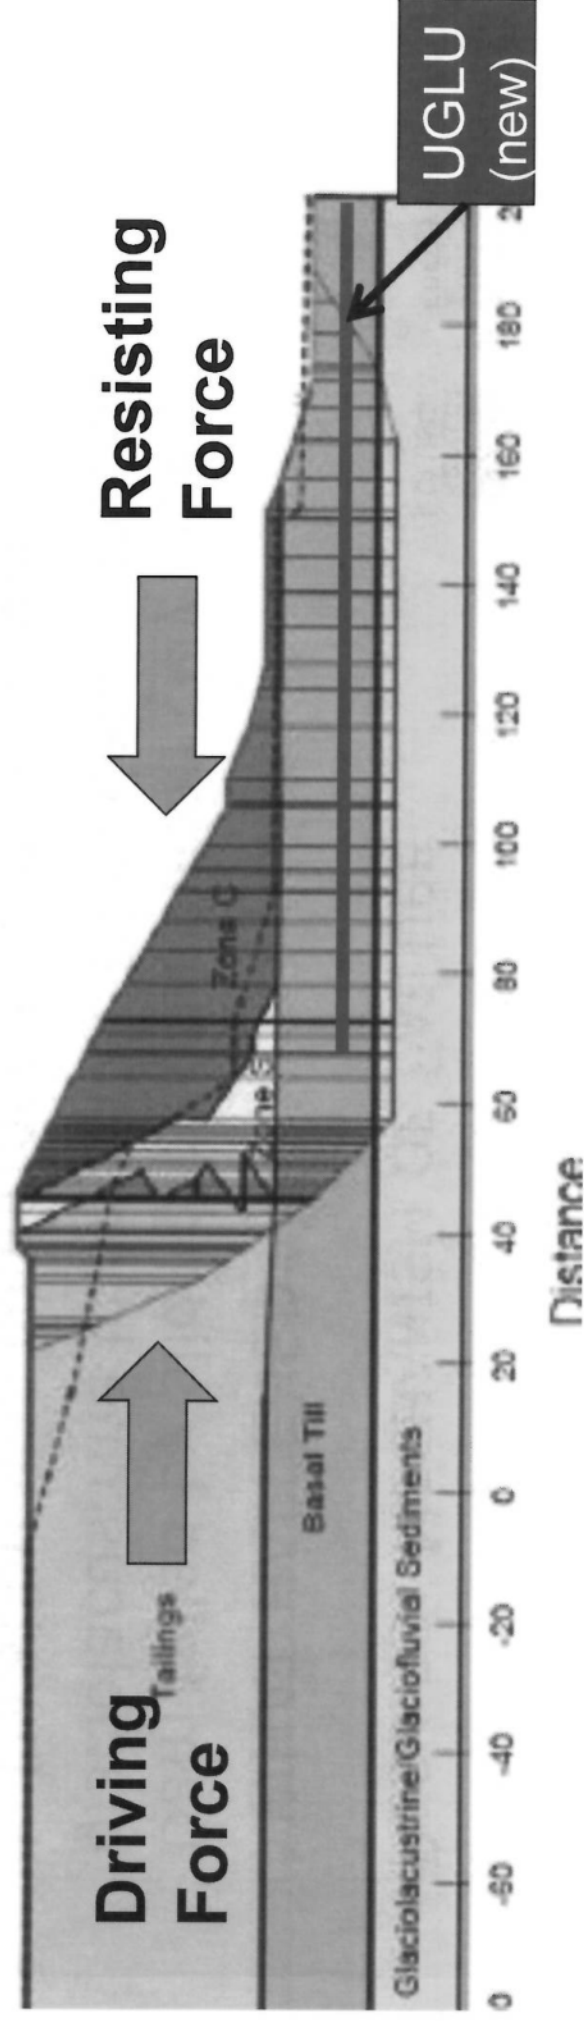
RESULTS: MECHANISM OF FAILURE

Dam failed by sliding on foundation clay layer, glaciolacustrine in origin at 10 m depth (UGLU)

- Location was confirmed in area of breach
- 40 m high steep embankment subjected UGLU to stresses initiating progressive failure of dam
- Comprehensive analysis builds upon Expert Panel

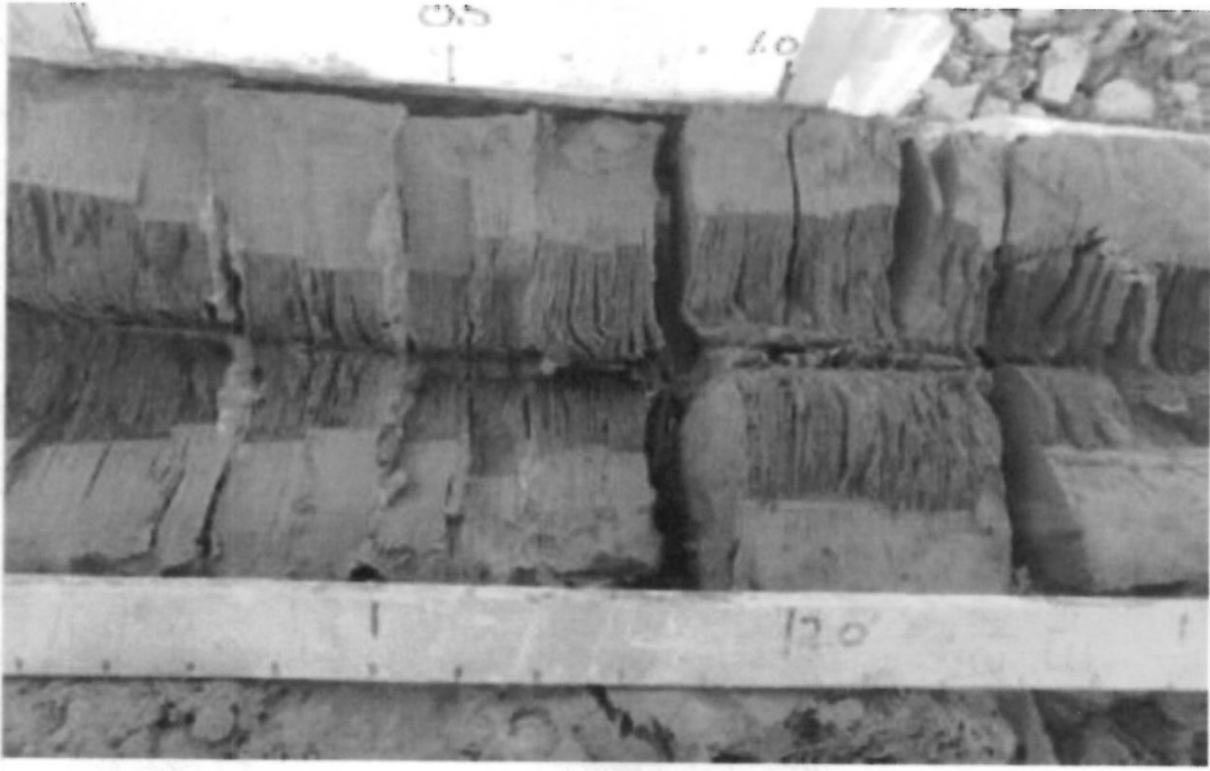
Undisturbed clay outside failed embankment area

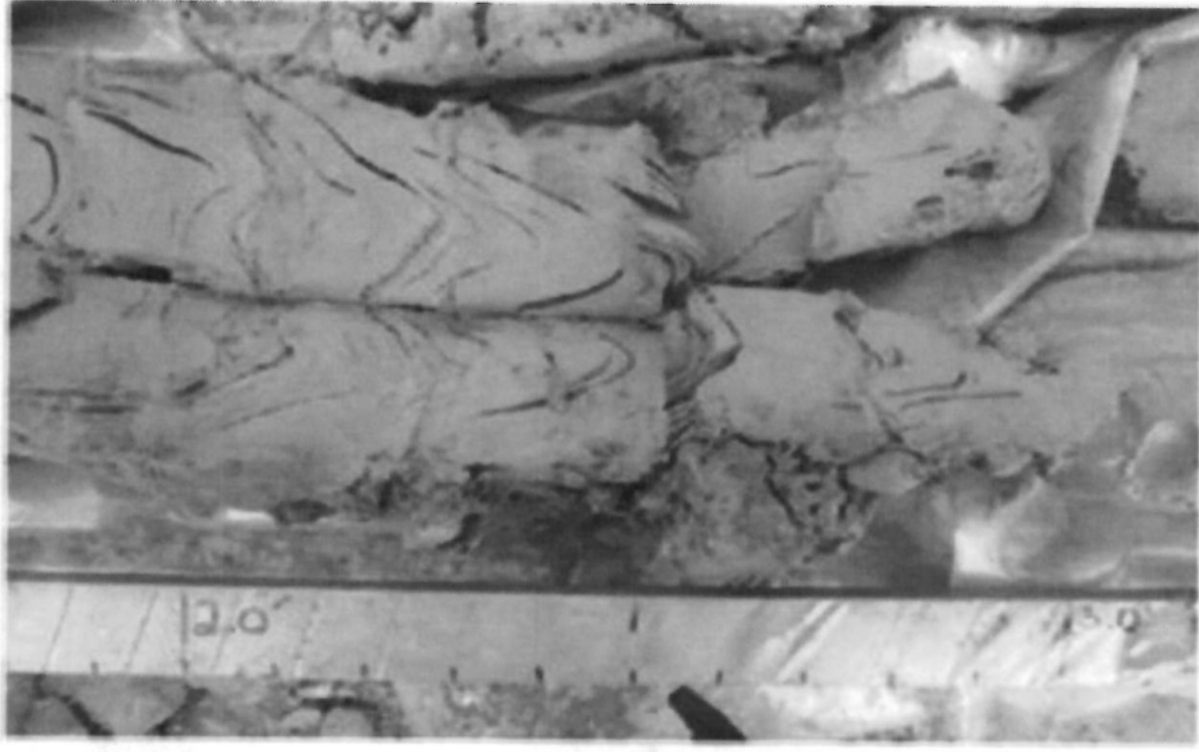
Disturbed clay below failed embankment area

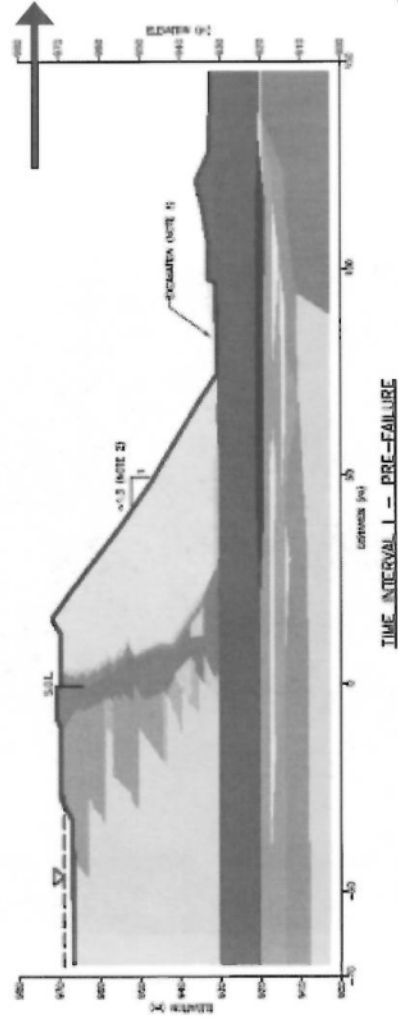
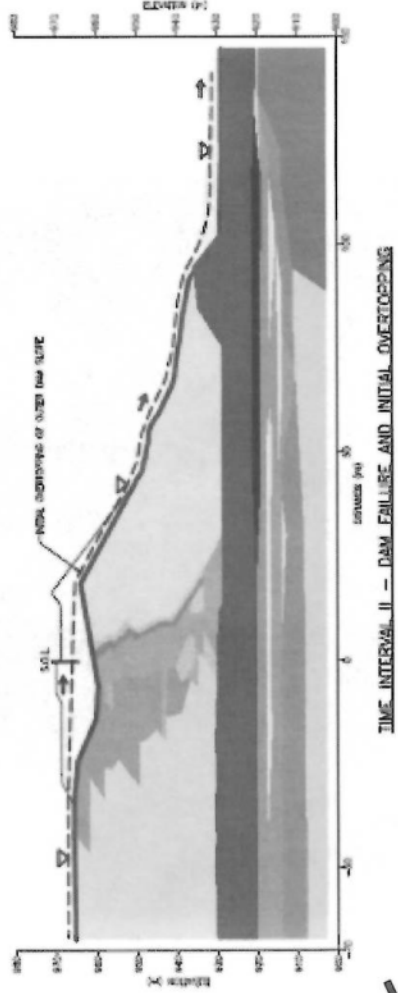
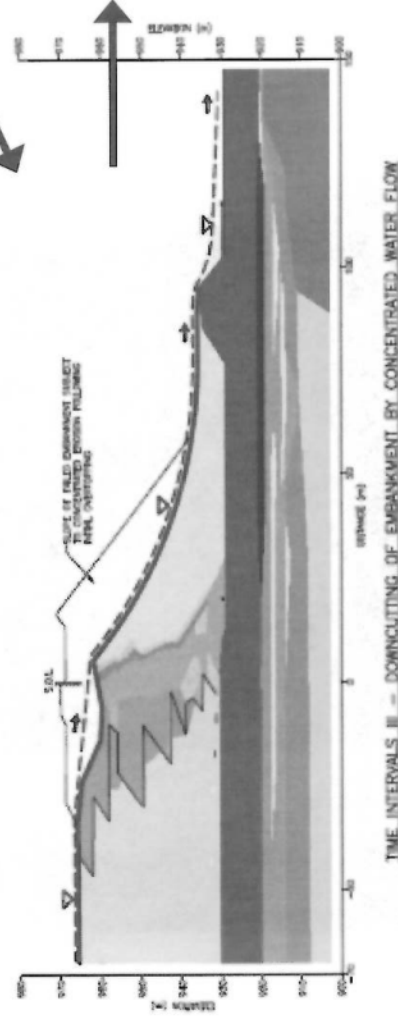
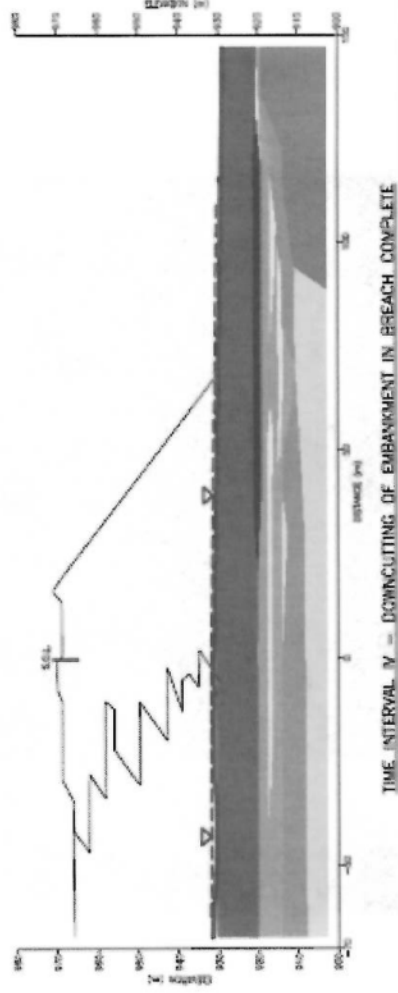
Conceptual Sequence of Dam Failure through Reconstructed Breach Section

FAILURE PROGRESSION LED TO BREACH

Erosion followed the failure as the water overtopped the slumped crest of the embankment.

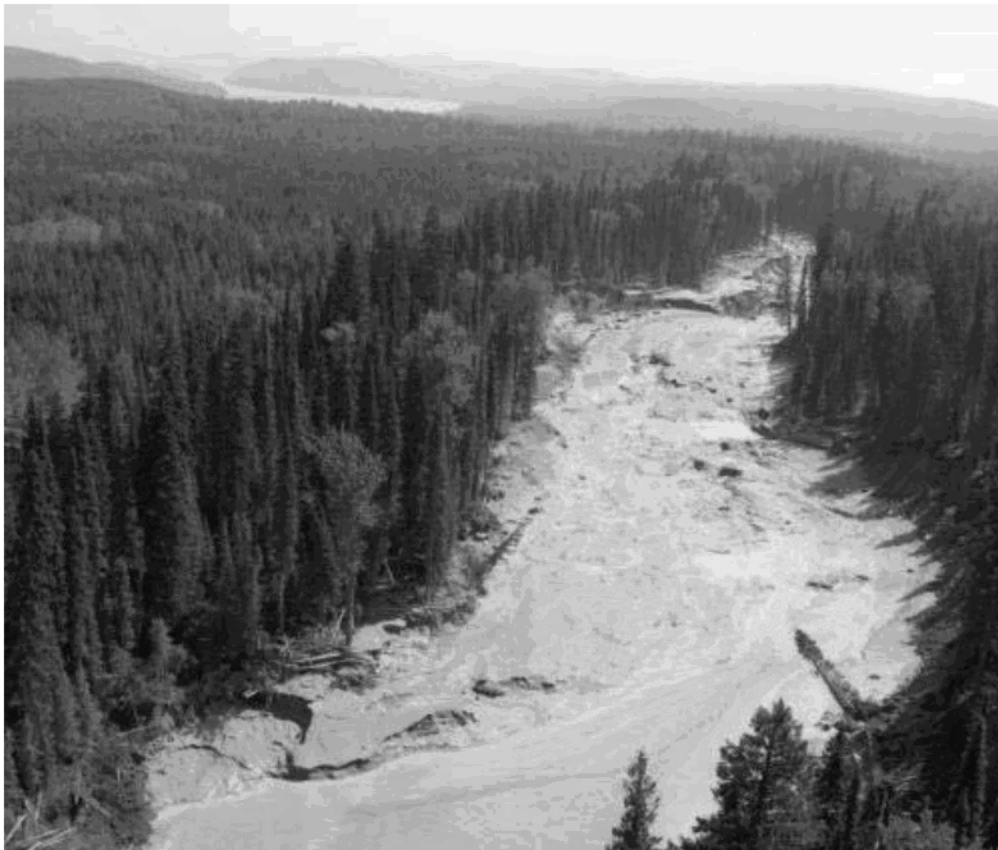
**DEBRIS FIELD THROUGH
HAZELTINE CREEK**

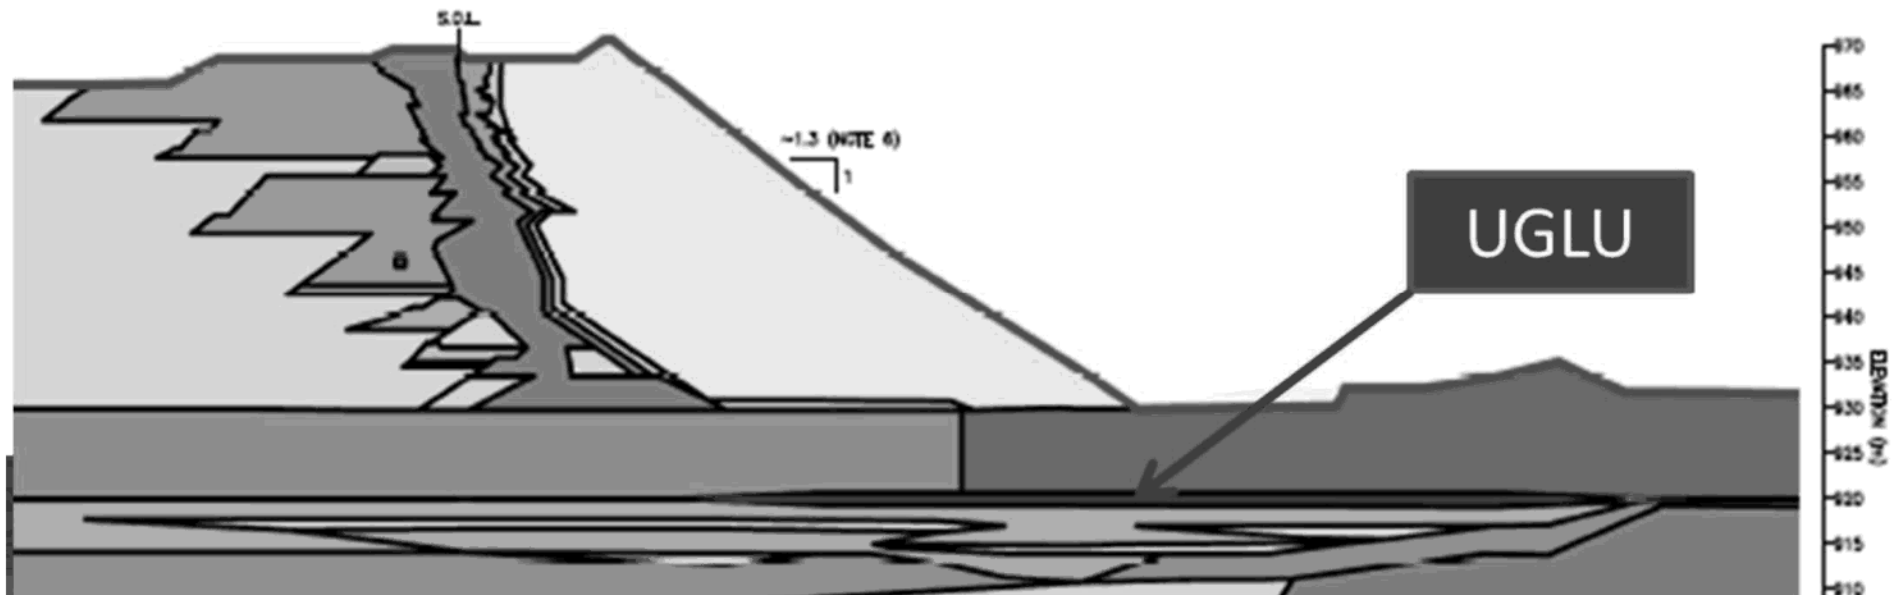
RESULTS: MECHANISM OF FAILURE

Dam failed by sliding on foundation clay layer, glaciolacustrine in origin at 10 m depth (UGLU)

- Location was confirmed in area of breach
- 40 m high steep embankment subjected UGLU to stresses initiating progressive failure of dam
- Comprehensive analysis builds upon Expert Panel

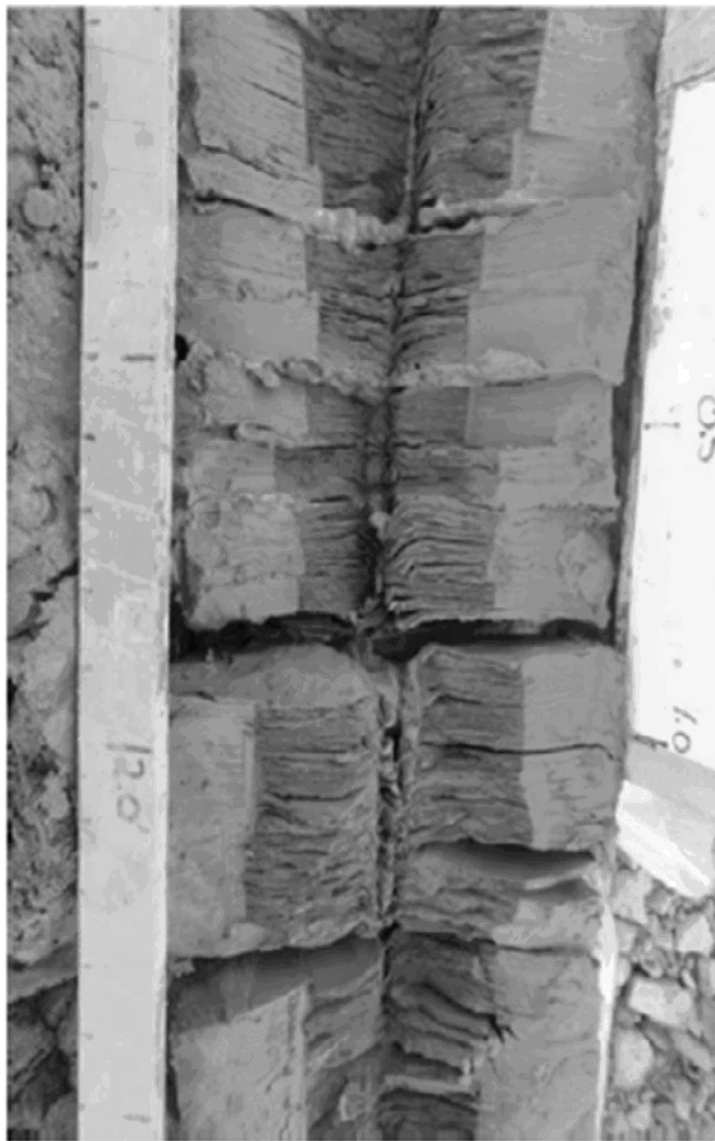
Undisturbed clay outside failed embankment area

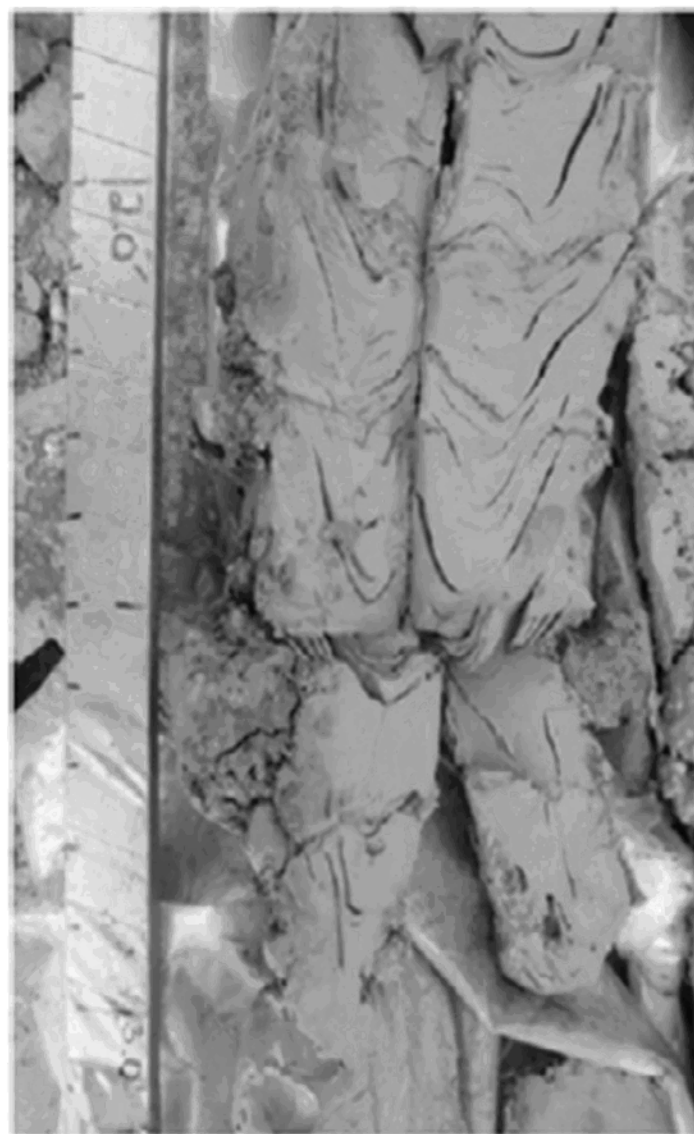
Disturbed clay below failed embankment area

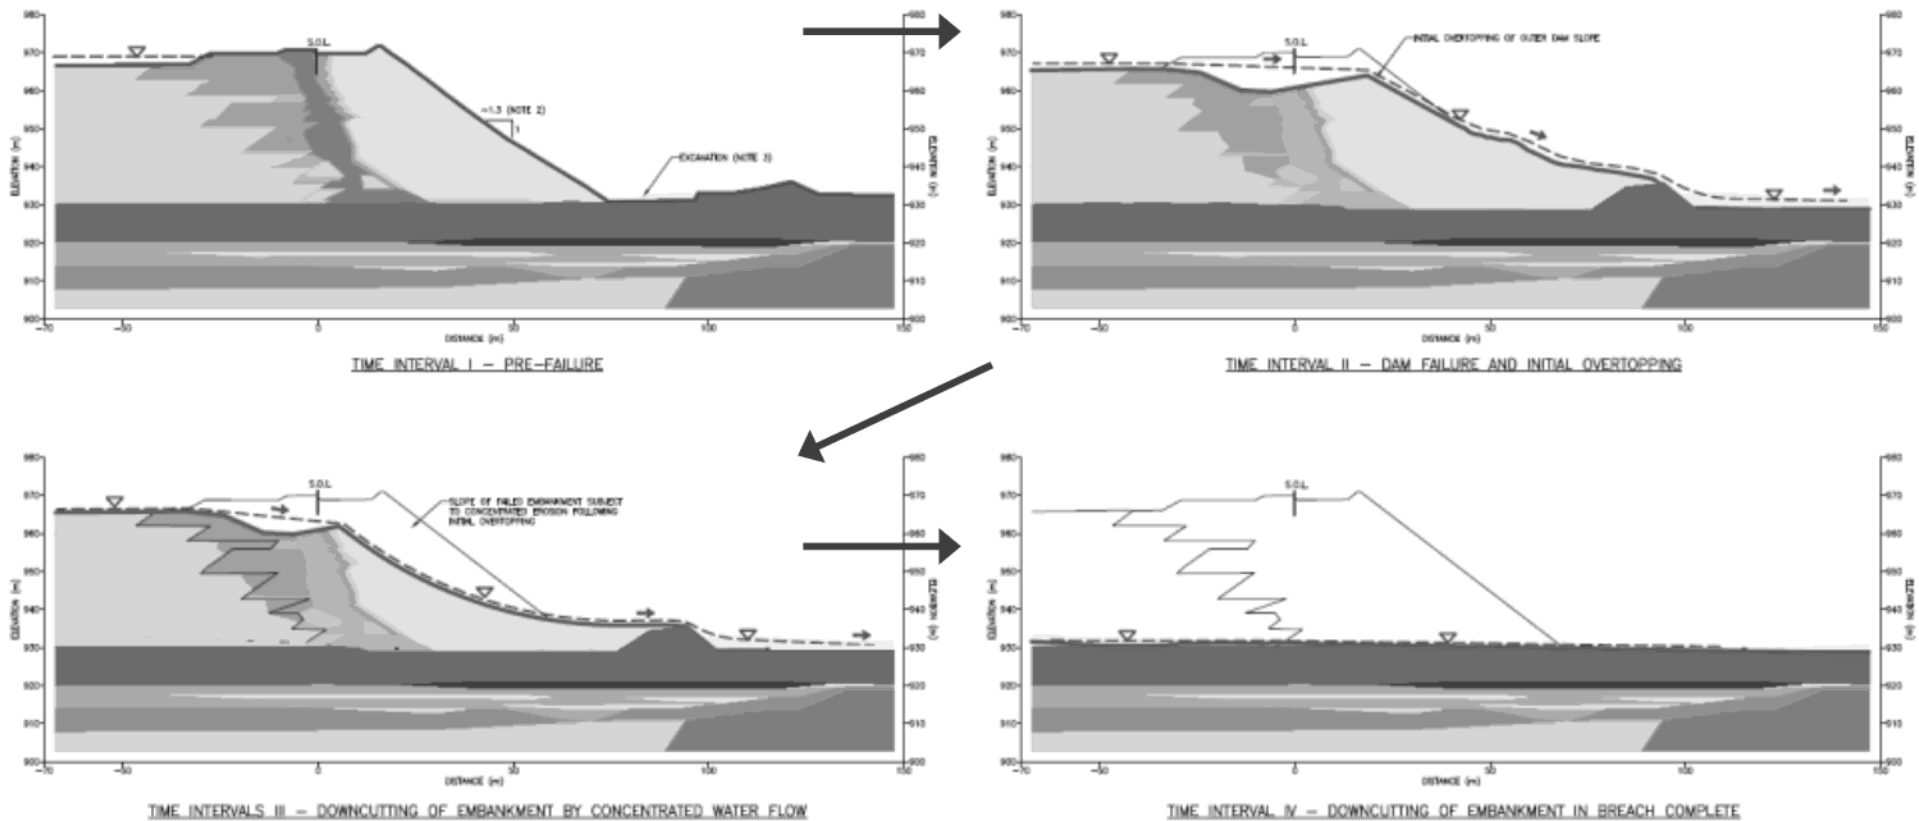
Conceptual Sequence of Dam Failure through Reconstructed Breach Section

FAILURE PROGRESSION LED TO BREACH

Erosion followed the failure as the water overtopped the slumped crest of the embankment.
