Re: Tulsequah Chief M-232 Mines Act Permit Amendment for care and maintenance monitoring and reporting activities.

EP System: <u>AMS</u>	Inspection Status: <u>FINAL</u>	
System Number: <u>105719</u>	Inspection No: <u>23226</u>	
EP System Status: <u>Active</u>	Inspection Date: <u>2015-10-15</u>	
Region: <u>Skeena</u>	Office: <u>Smithers</u>	
Trigger: <u>Planned</u>	Incidents of Non-Compliance Observed: <u>Yes</u>	
Non-Compliance Decision Matrix Level: <u>Level 1</u>	Non-Compliance Decision Matrix Category: <u>Category B</u>	
Inspector Name(s): <u>Neil Bailey</u>	Risk Ranking: <u>0 to 1 = Low</u>	
Audit: <u></u>	Total Non-Compliance(s): <u>2</u>	
Regulated Party: <u>CHIEFTAIN METALS INC.</u>		
Regulated Party Contact(s): <u>Rob Marsland</u> <u>Senior Environmental Engineer</u>		
Mailing Address: <u>Chieftain Metals Inc. c/o Terry Chandler, Executive Vice President, Unit 118, 1515 Broadway St, Port Coquitlam BC V3C 6M2</u>		
Phone No: <u>(604) 836 7559</u>	Fax No: <u></u>	
Contact Email: <u>rob.marsland@chieftainmetals.com</u>

Project Name: <u>Tulsequah Chief Mine Project</u>	Inspection Status: <input type="text"/>
Certificate #: <u>M02-01</u>	Inspection No: <input type="text"/>
Cer

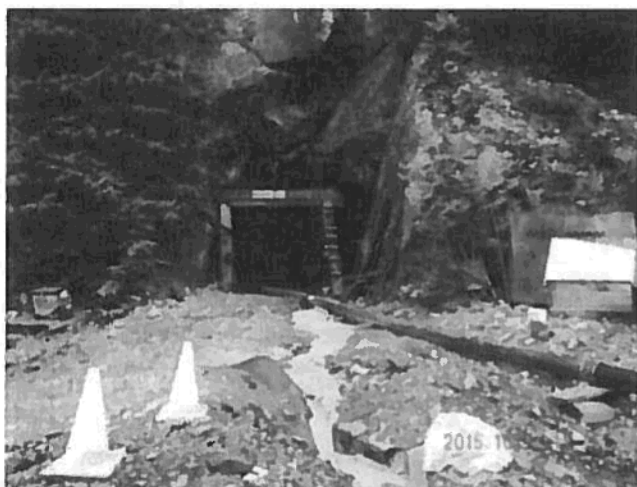
Photo 3: The black pipe is diverting neutral drainage captured underground; The Fe stained drainage (acidic) is flowing freely from the portal and is captured in a pipe in the foreground.

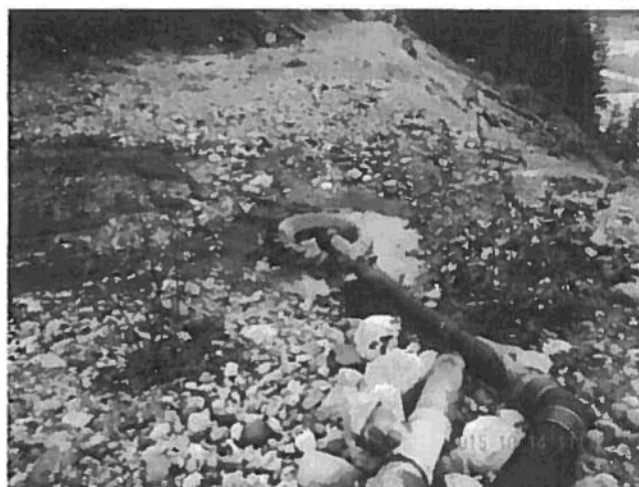
Photo 4: The neutral drainage is combined with the Portal Creek drainage into a HDPE pipe and diverted away from historical waste rock to the Tulsequah River

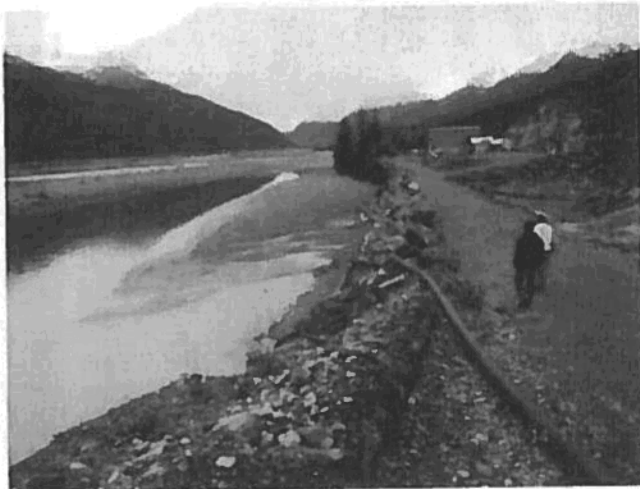
Photo 8: 5200 acidic portal discharge to Tulsequah River

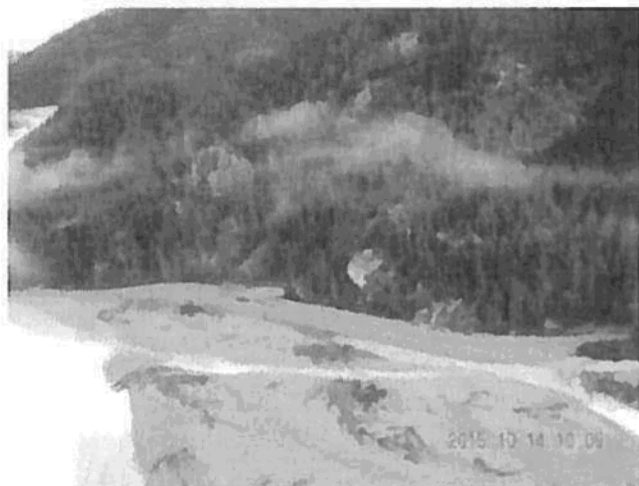
Other than clearing, and some minor construction of berms the areas reserved for PAG and NAG waste rock storage has been minimal (Photo 18). Access to these areas from the main mine site is good; the causeway remains in good condition (Photo 17).

Photo 17; Causeway between mine and Rogers Creek area.

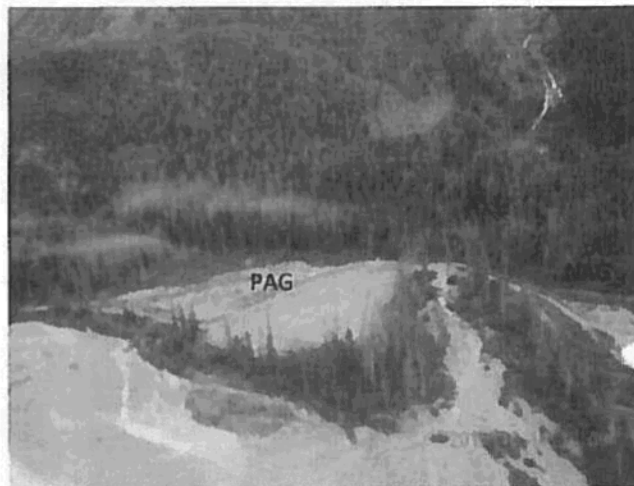
Photo 18: Clearing for the PAG and NAG waste rock areas.

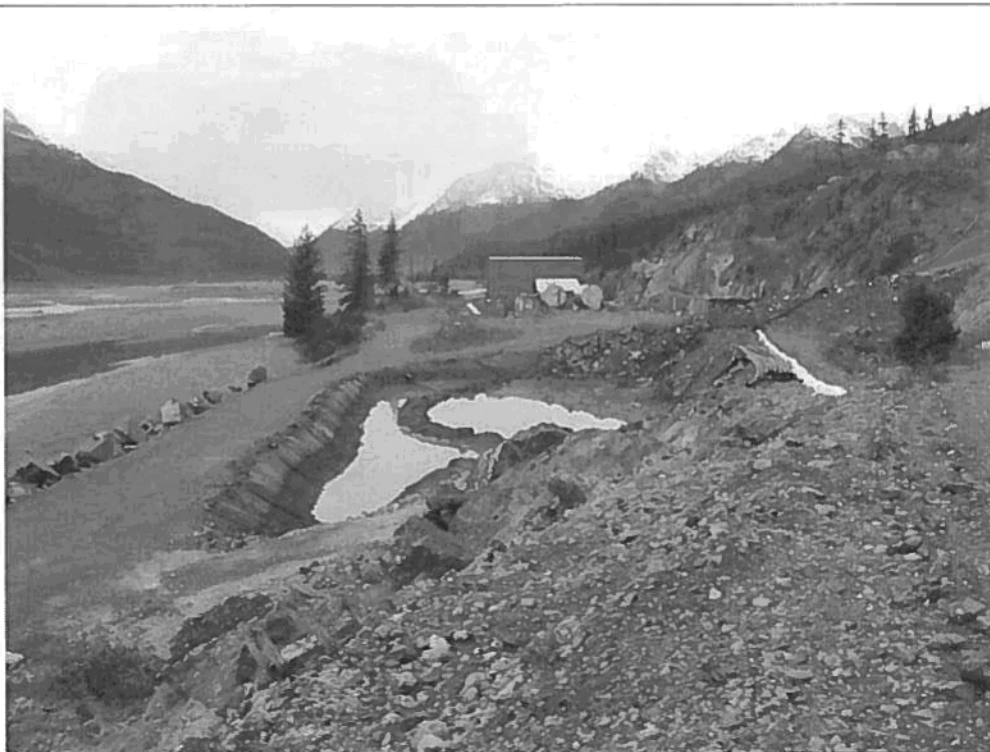
Photo 8

5200 portal.
Large rock on
neutral mine
water bypass
pipe.

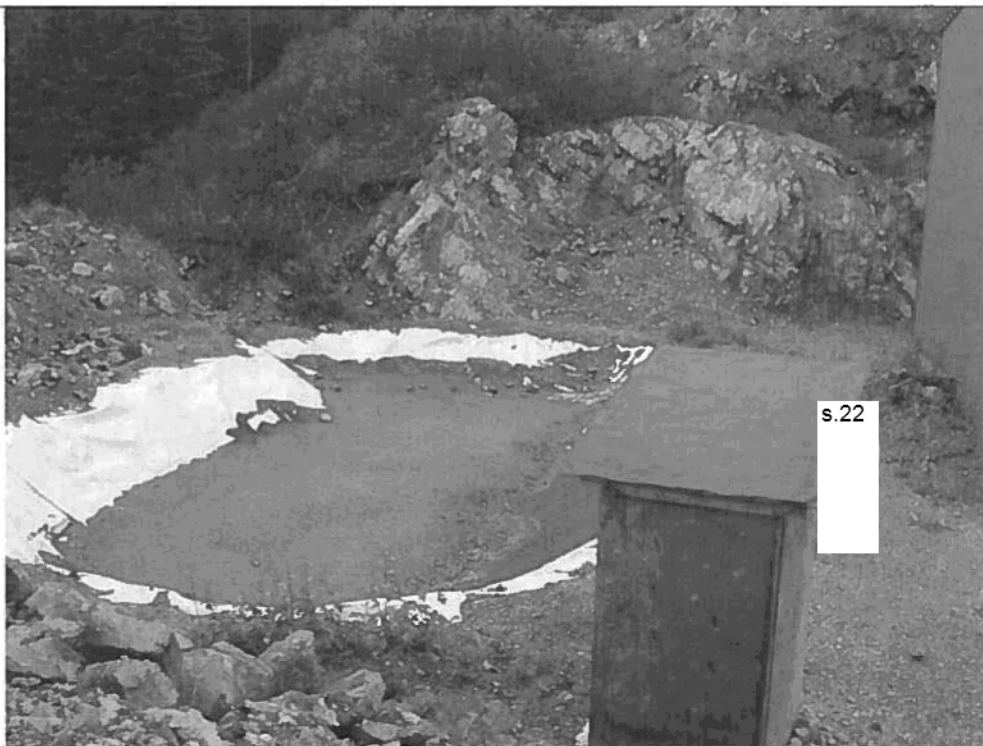
Photo 12

Water
treatment
plant holding
tanks.

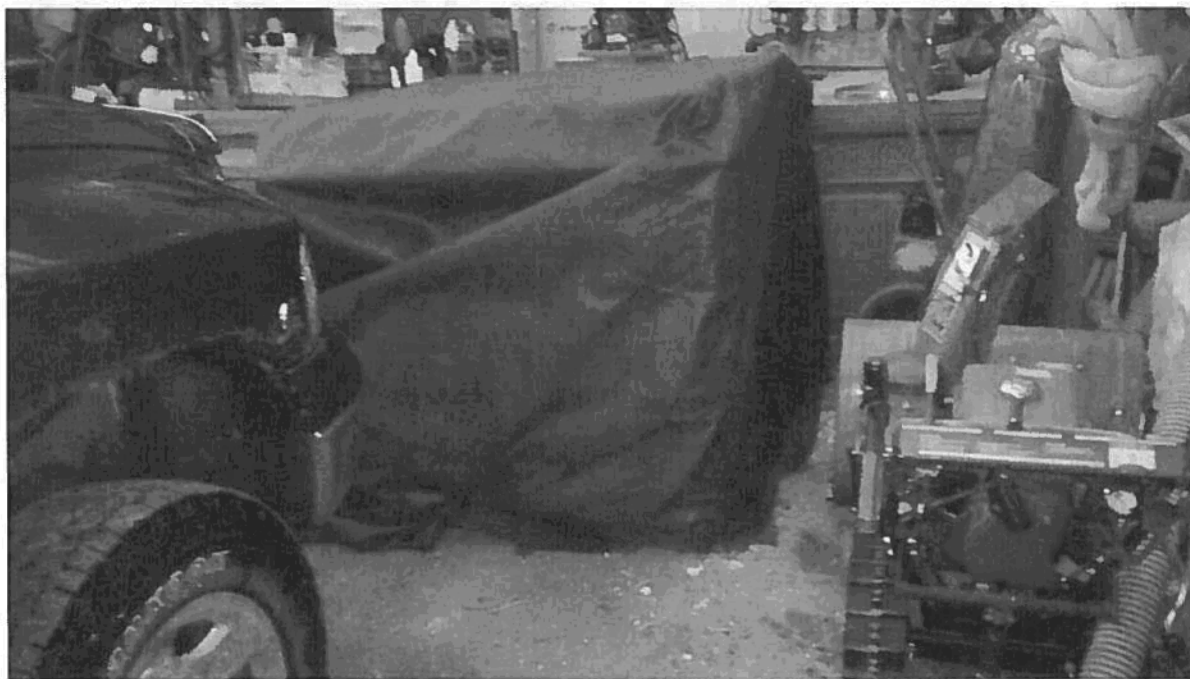
There were 22 pails of unused drilling products, including 2 partial (20 litre) pails of rod grease. The leaking white bucket contained AMC Pure Vis, a non-hydrocarbon drilling polymer. Bucket likely burst due to freezing conditions. Wildlife may have disturbed grease buckets but unlikely to have consumed any. Green buckets contain AMC K-Ion. Initial clean-up completed July 14. Pallets moved in to storage Oct 16, 2015 (photo below).

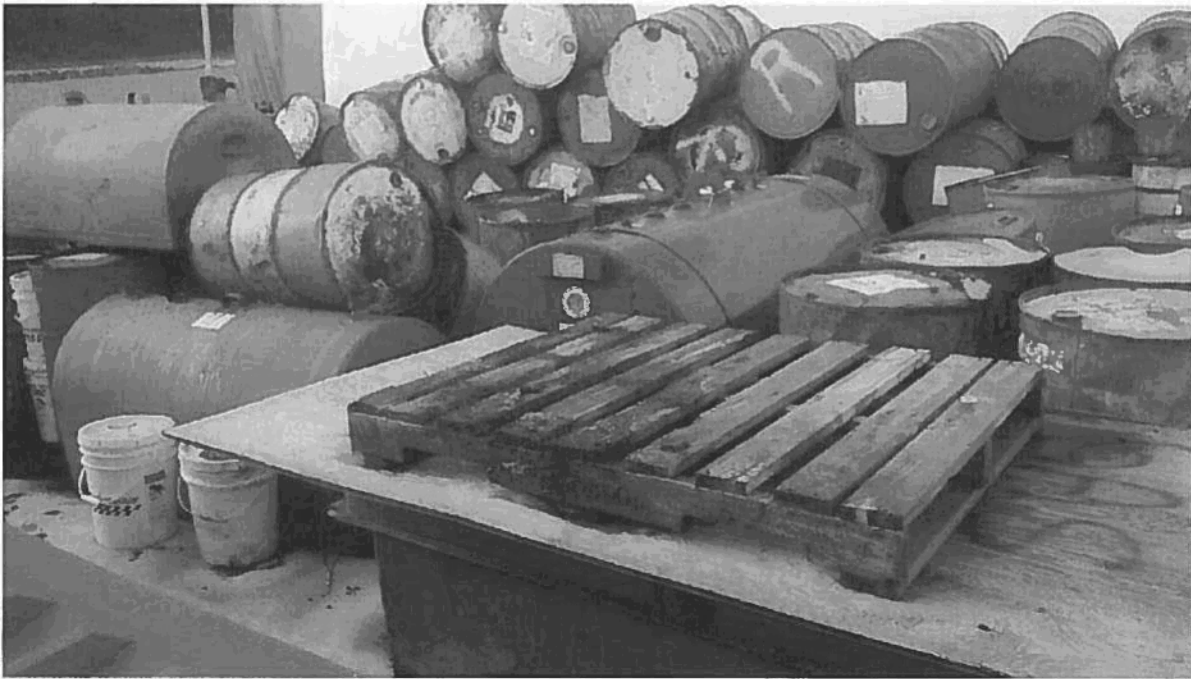
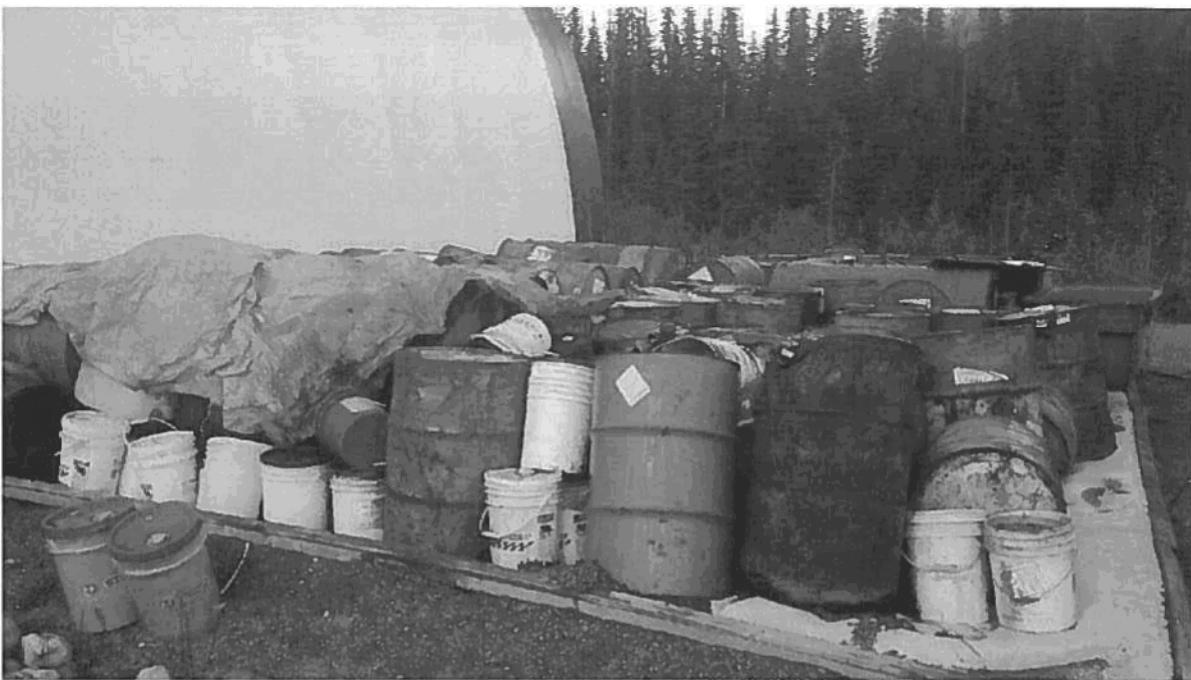
2-Secondary containment storage pad. Most of these drums are empty and have been on pad since Redfern operated site in 2008.

On Oct 17, some of the full 20 litre used oil pails were removed and flown out to Atlin.

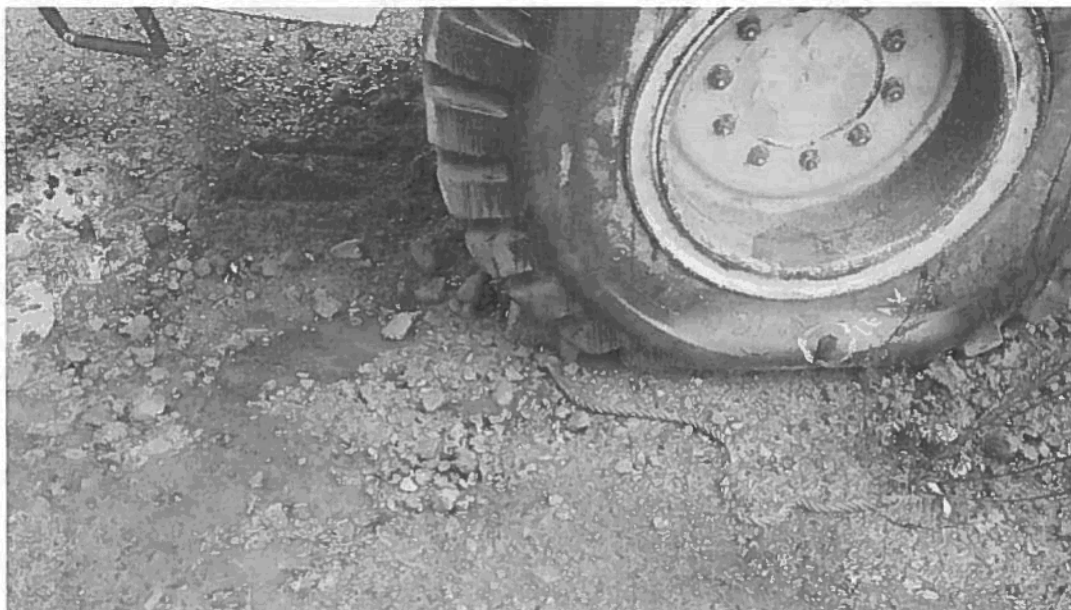
3-Moxi Dump Truck - site re-treated with oil sponge. White dump truck appears to have leaked diesel from underbody fuel filter due to ice. Fuel tank now empty – but readily available fuel had been previously scavenged from unused vehicles and tanks for camp heat, so only a relatively small volume remained in the lines and bottom of tank. Incinerator return fuel line was repaired Oct 16. The incinerator has not been used since last winter due to fire bans and camp being idled.

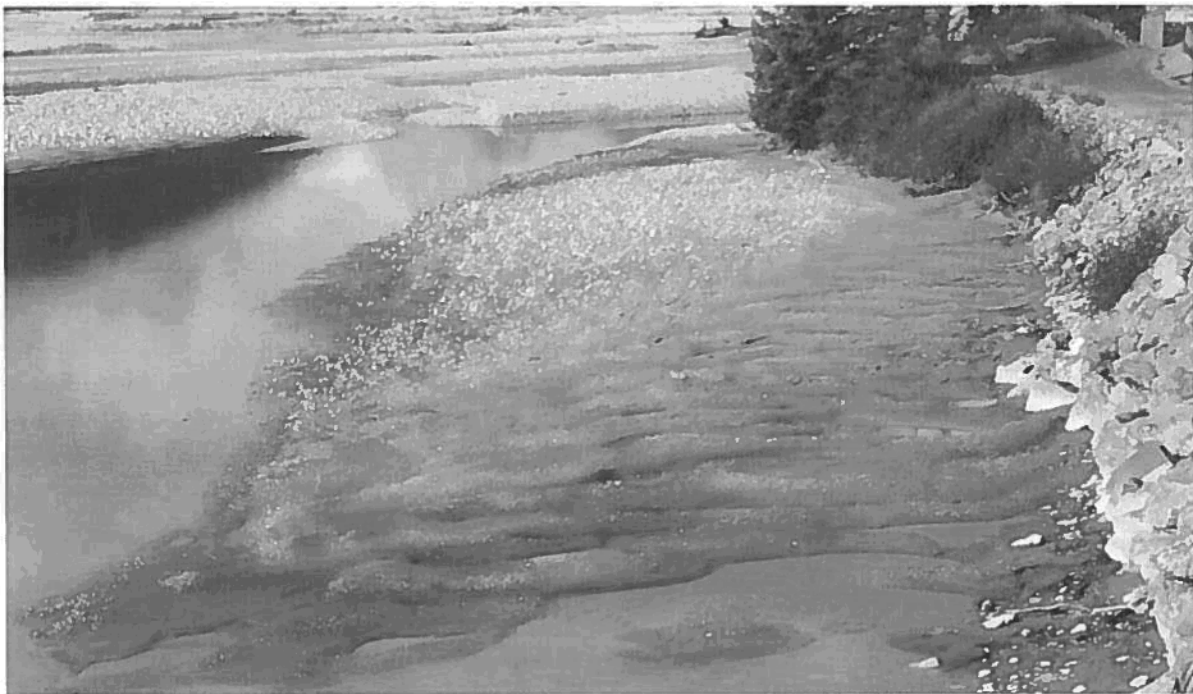
Picture 13 – Seepage from Exfiltration Pond filtering in to floodplain adjacent to berm (Oct 14, 2015)

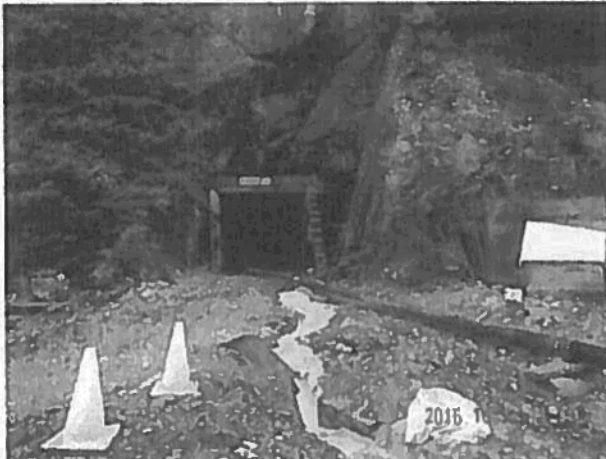
Photo 3: The black pipe is diverting neutral drainage captured underground; The Fe stained drainage (acidic) is flowing freely from the portal and is captured in a pipe in the foreground.

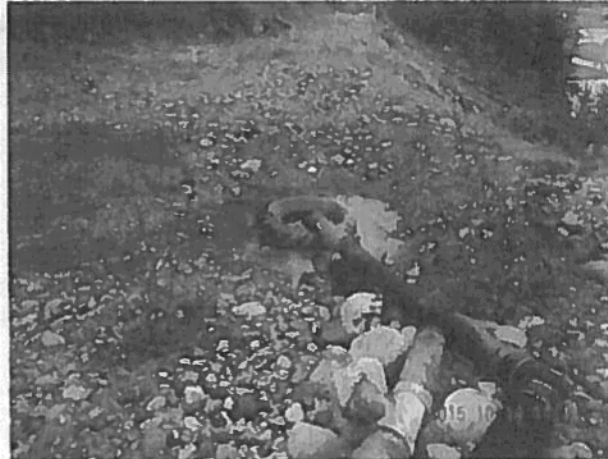
Photo 4: The neutral drainage is combined with the Portal Creek drainage into a HDPE pipe and diverted away from historical waste rock to the Tulsequah River

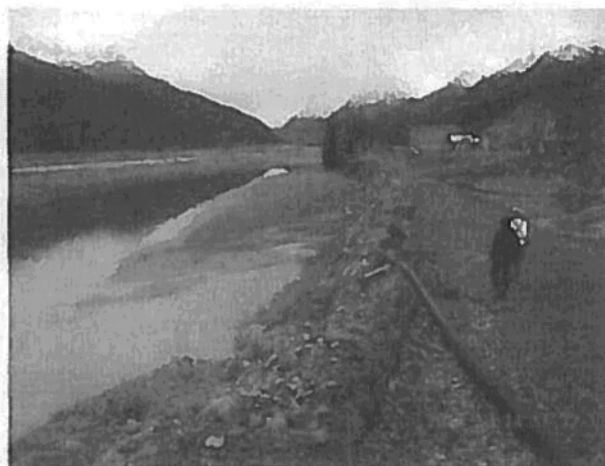
Photo 8: 5200 acidic portal discharge to Tulsequah River

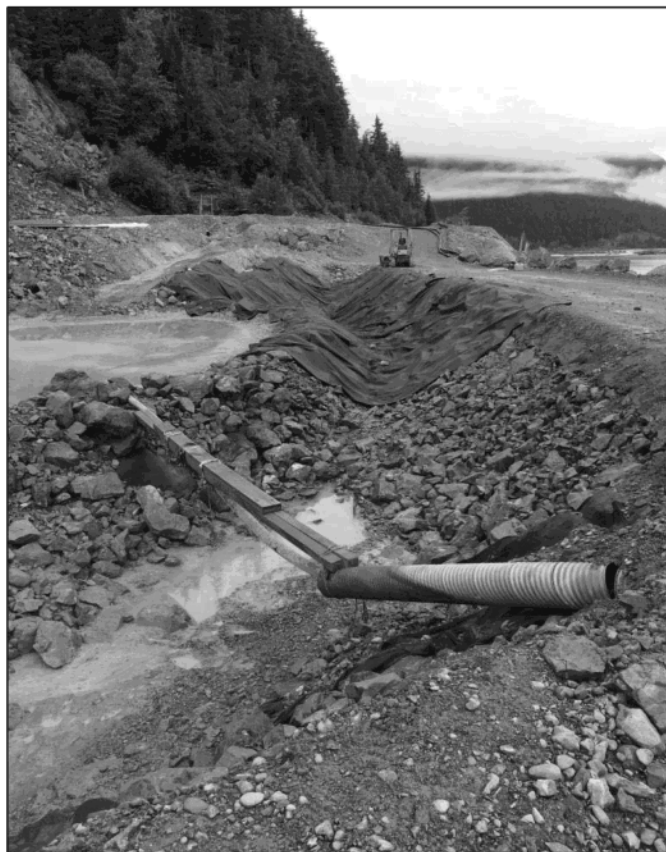
18 - July 2014

Upstream face. Sludge dug out and filter cloth replaced.

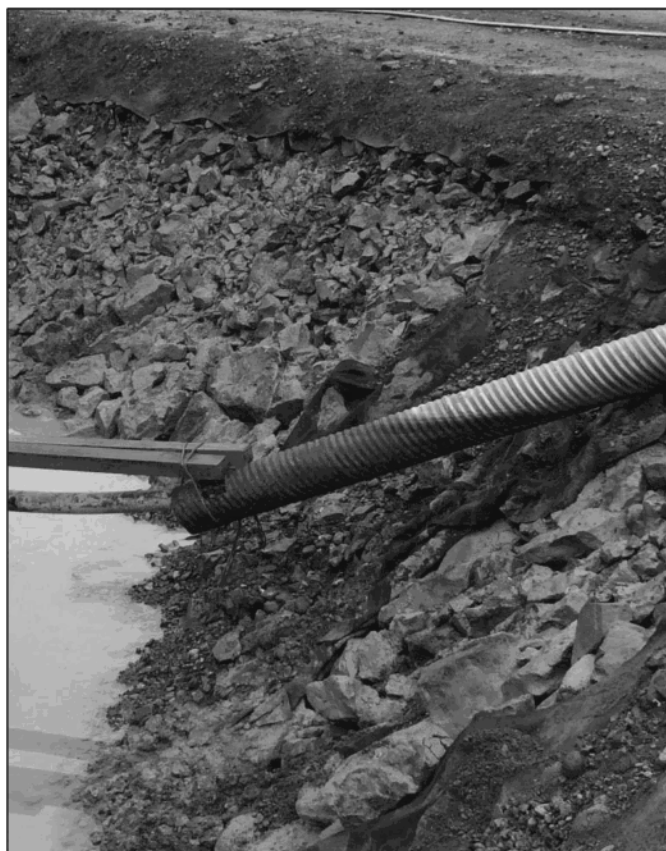
19 - July 2014

Upstream face. Sludge dug out and filtration cloth replaced

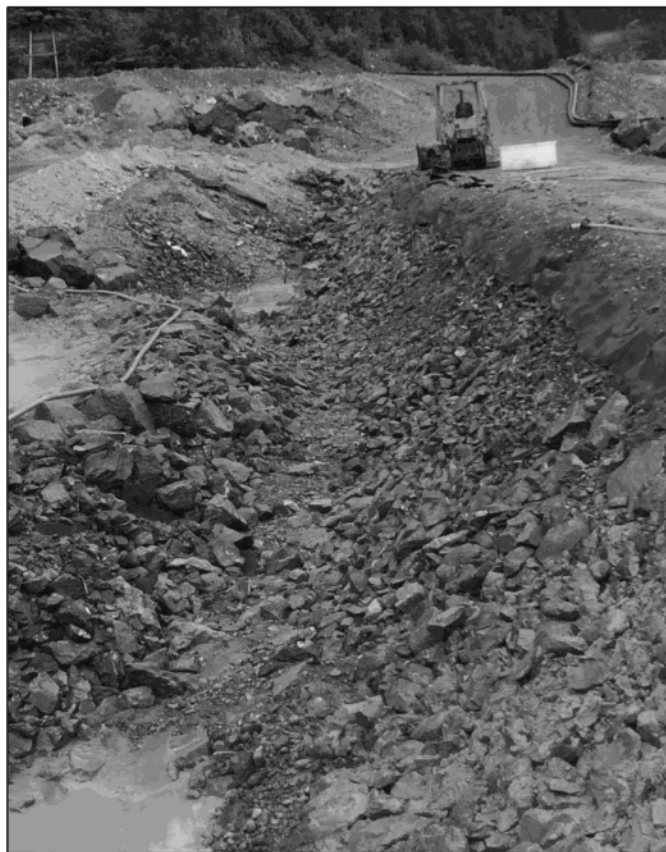
20 - July 2014

Upstream face. Sludge dug out and filter cloth replaced.

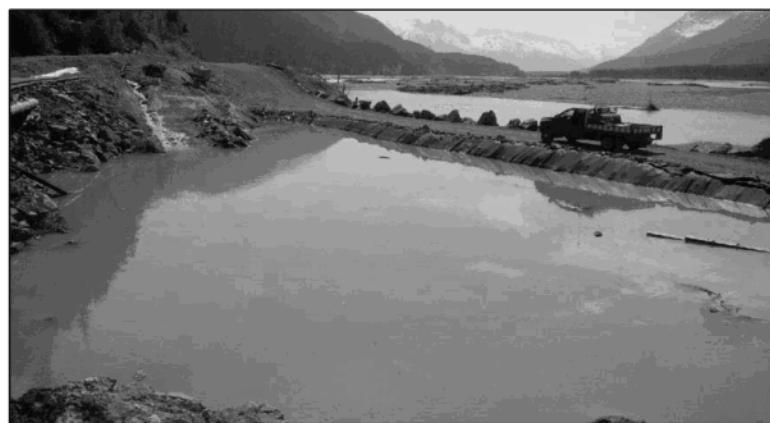
21 - May 19, 2015

View downstream of full pond.
