**From:** Green, Jack E ENV:EX  
**Sent:** Wednesday, September 16, 2015 4:33 PM  
**To:** Demchuk, Tania MEM:EX; McConnachie, Jennifer MEM:EX  
**Subject:** Mount Polley Inspection Reports  
**Attachments:** 2015-08-19 PE11678 Inspection Report.pdf; 2015-08-19 PE11678 Inspection Photos.pdf; 2015-08-19 PA15087 Inspection Report.pdf; 2015-08-19 PA15087 Inspection Photos.pdf

## Ministry of Environment - Photo Record Sheet

PA15087	Mount Polley Mining Corporation
August 19, 2015	Mount Polley Mine

# Ministry of Environment Inspection Record

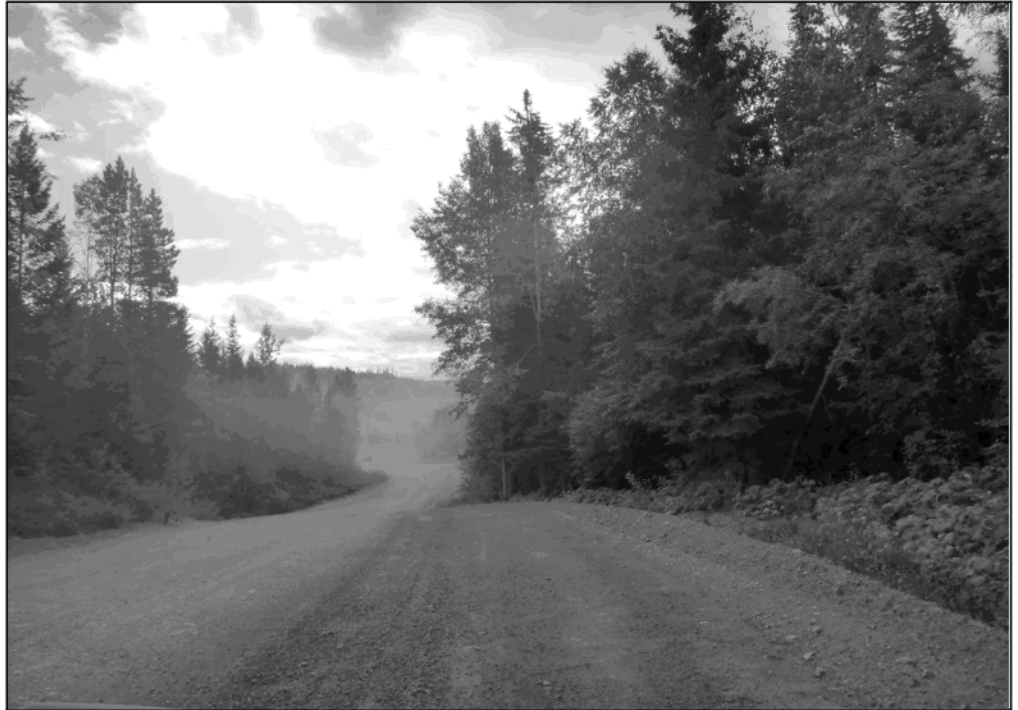
Road leading to Mount Polley Mine. The mine site starts approximately where the vehicle can be seen.

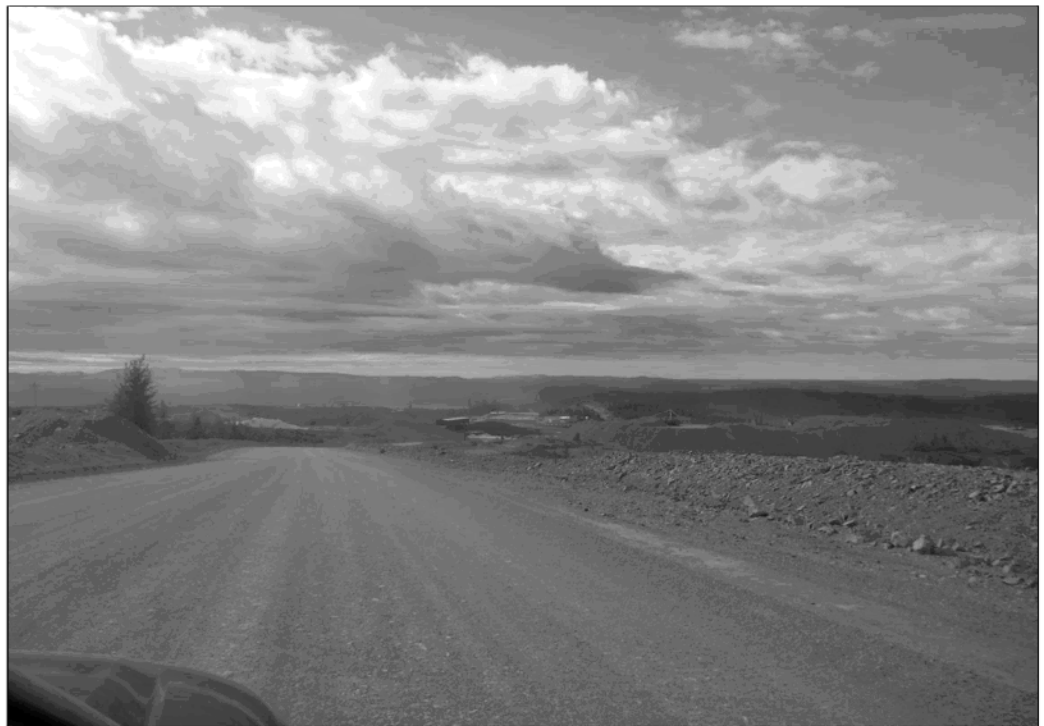
From the top of the mine site, near Mount Polley, you could see where the vehicle activity was on site from the dust plumes.

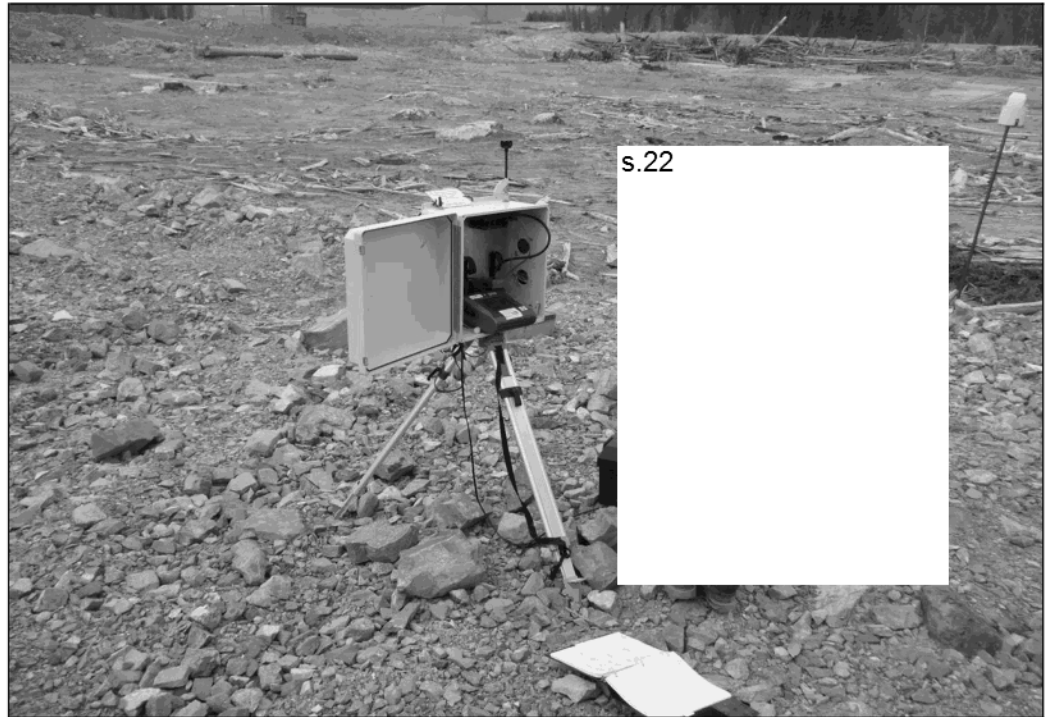
On of the four new dust monitors which are positioned around the tailings impoundment.

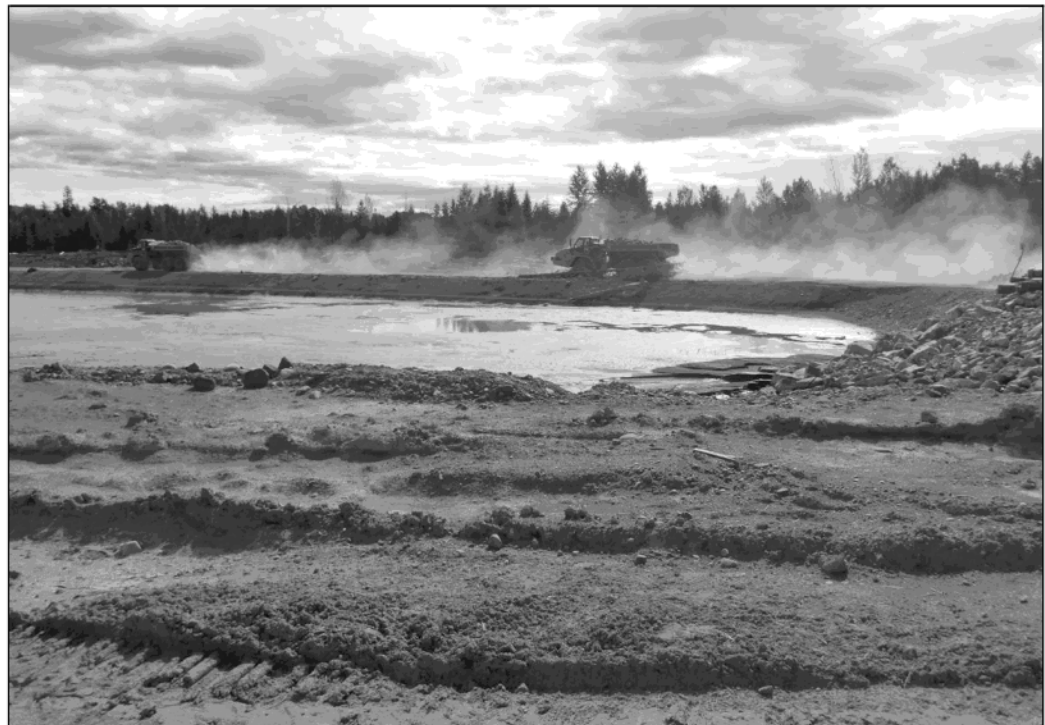
Dust generated by vehicles carrying fill down to the mouth of Edney Creek. While this is not considered operational area, MPMC has a responsibility to prevent pollution, that may be caused by fugitive dust.

Failure to suppress fugitive dust within the operational area. There is only one water truck on site and this was down for repairs. There didn't appear to be a contingency plan in place for when the water truck was unavailable.

ACTIONS REQUIRED BY REGULATED PARTY:		
<p>When the water truck was out of service, there appeared to be no plan for suppressing fugitive dust, mainly generated by vehicular movement on site. This is not acceptable. Please provide a brief contingency plan detailing what actions will be taken to suppress fugitive dust in the operational area, during periods when the water truck is unavailable.</p> <p>The main haul road to the site, from the point where the road becomes mine property, is regarded as the "operational area", as it is part of the mine site that experiences mine traffic. MPMC is therefore expected to suppress fugitive dust in this area. Please provide a brief report detailing what actions will</p>

be taken to fulfill this requirement.

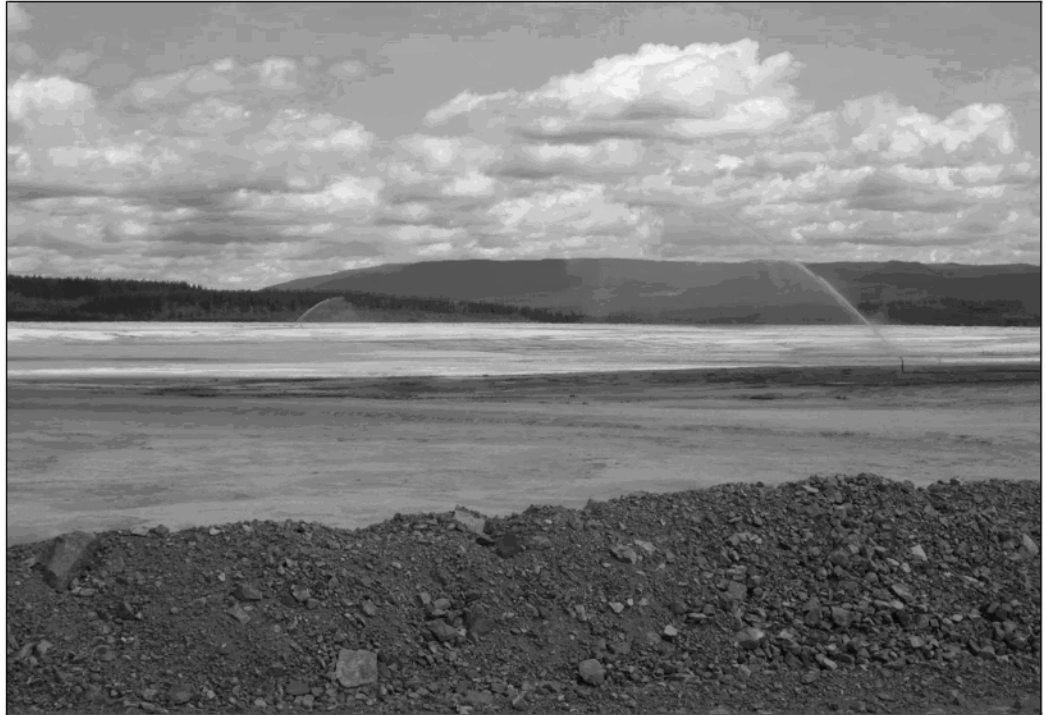
Six sprinklers have been set up on the tailings impoundment. These operate two at a time, as needed, and are fed from the main embankment seepage ponds.

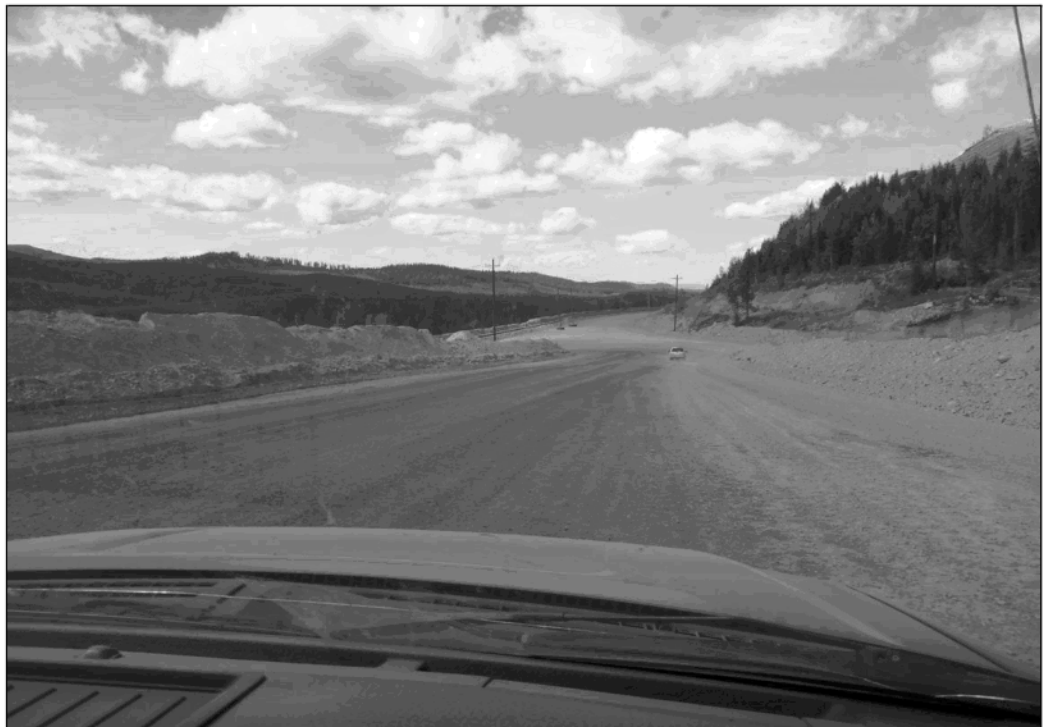
The water truck was eventually fixed and back online. This section of the haul road had been recently soaked.

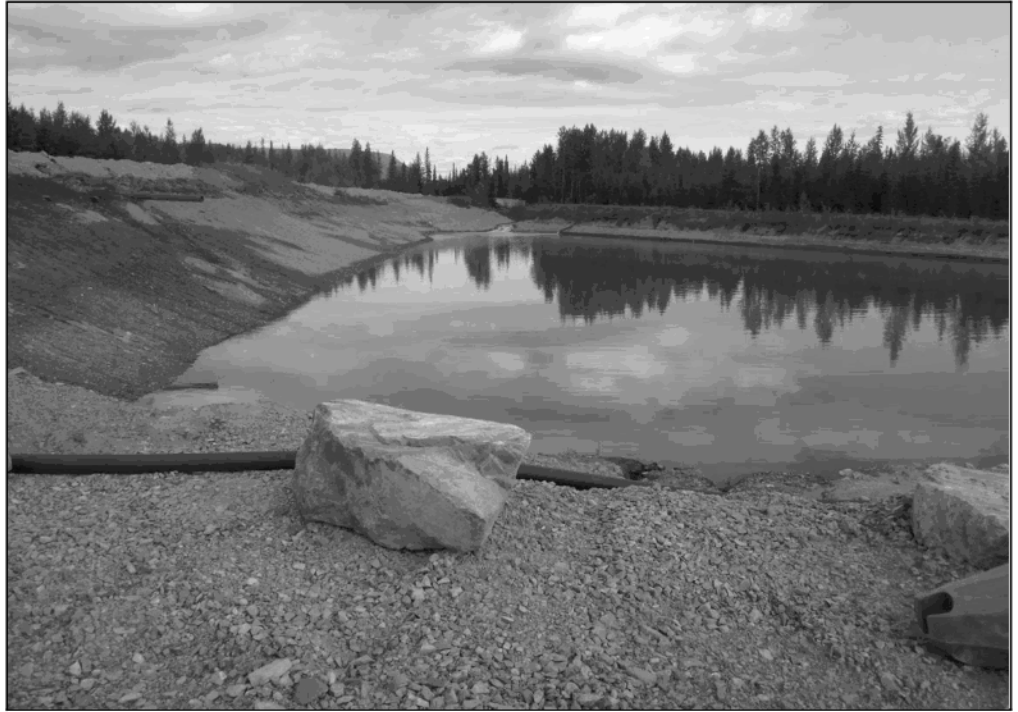
Central Collection Sump. Inflow from the Long Ditch and West Ditch is at the far end.

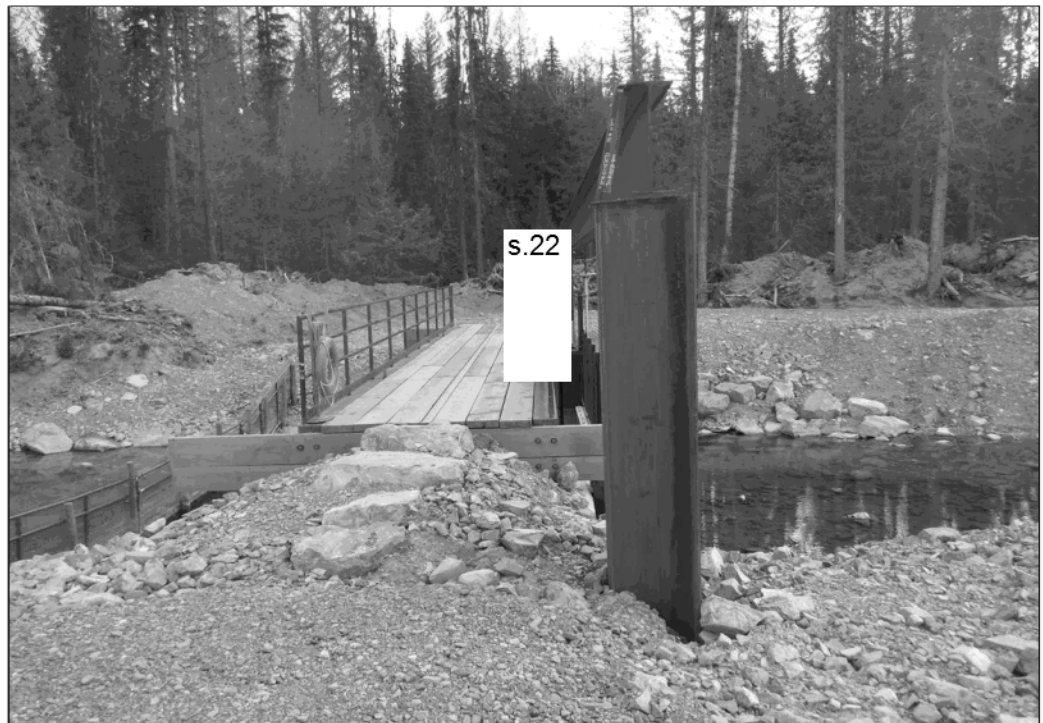
Weir at head of Hazeltine Creek. Note the fish barrier upstream (left) of the weir.

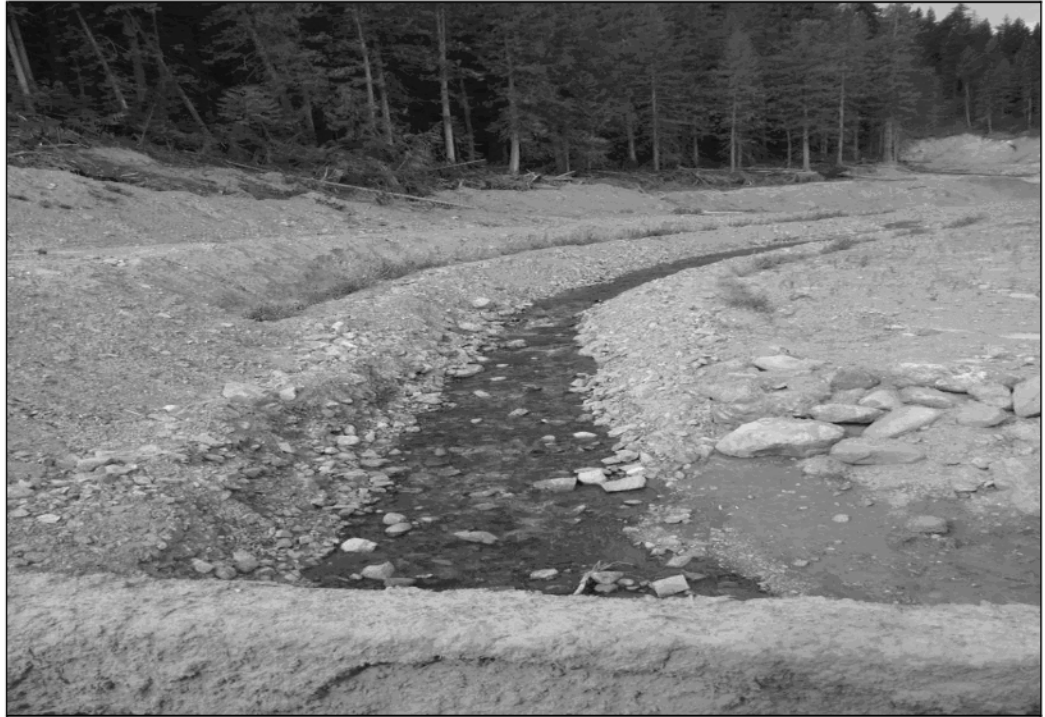
Hazeltine Creek has been lined with rock the whole way down. The banks have been graded, seeded and planted with native shrubs and bushes.

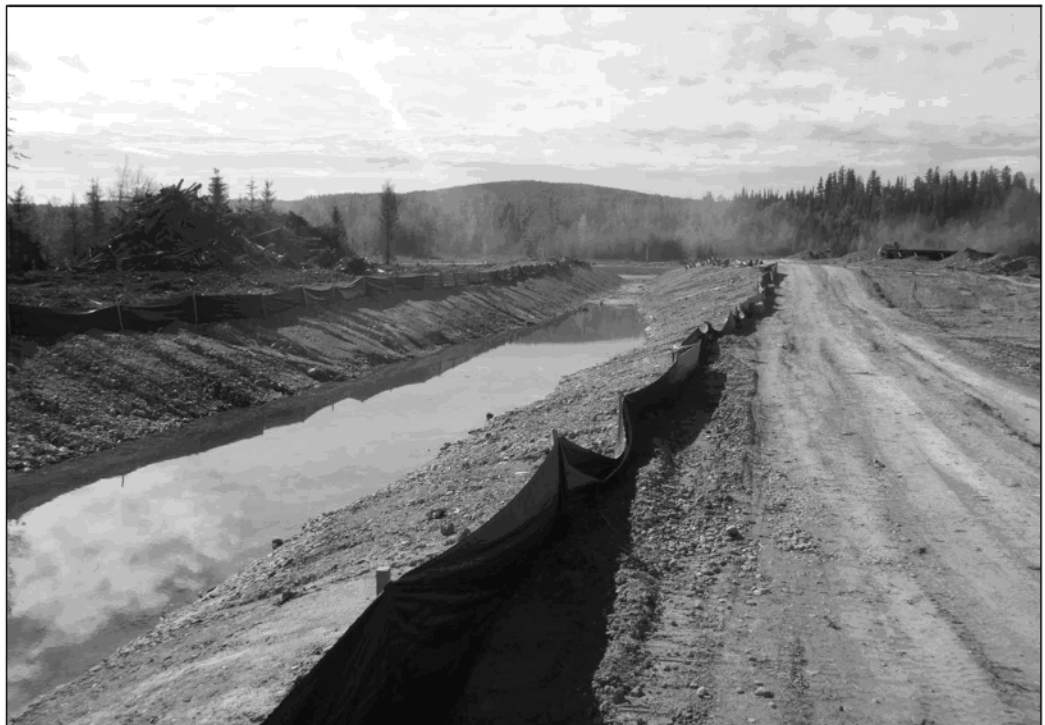
Discharge channel leading from the sediment control ponds at the end of Hazeltine Creek, leading to Quesnel Lake. Edney Creek was being diverted through the ponds and this channel at the time of the inspection, while the new creek channel was under construction.

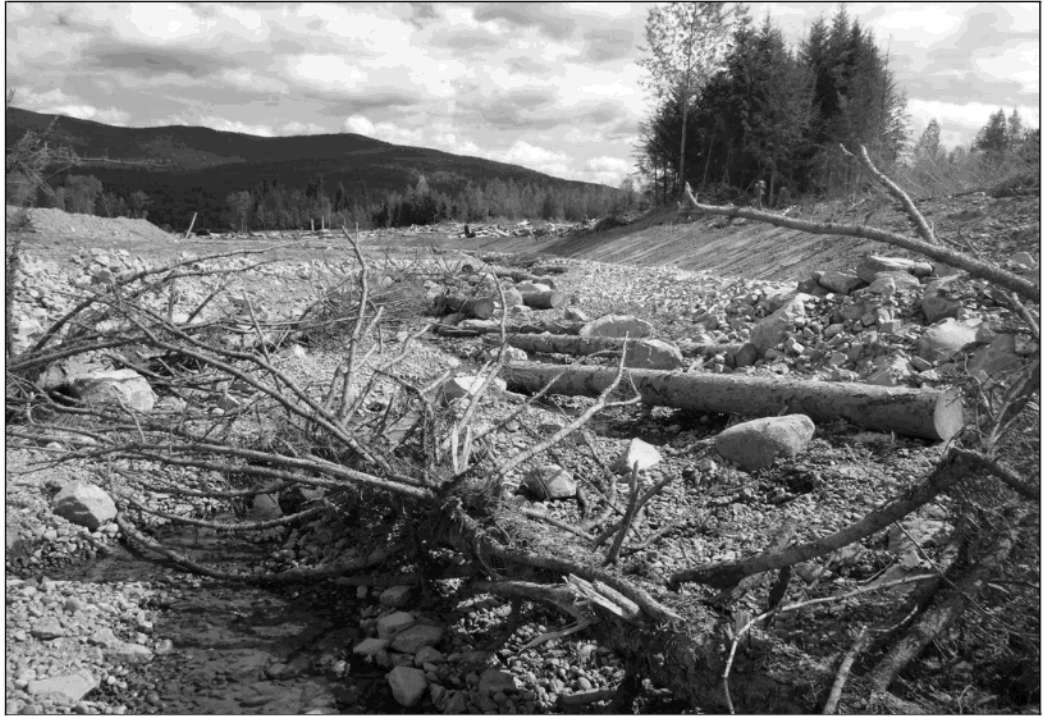
Edney Creek channel has been lined with rock material and logs have been anchored along the creek bed to create fish habitat.

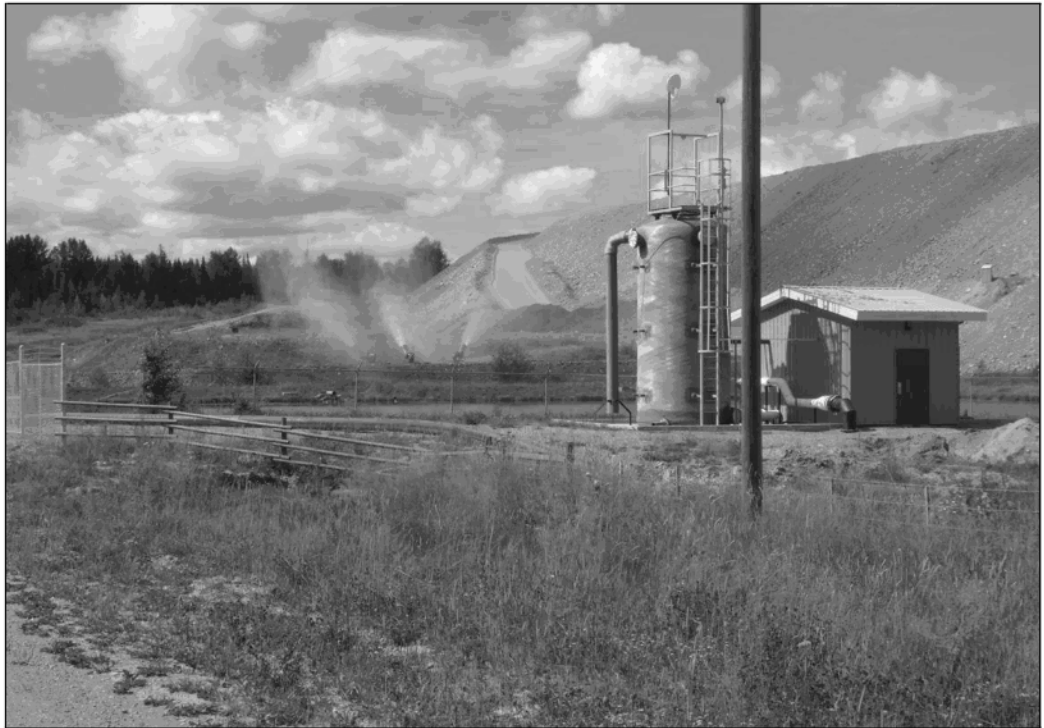
Snow blowers/misters at the Main Embankment Seepage Pond to increase evaporation.

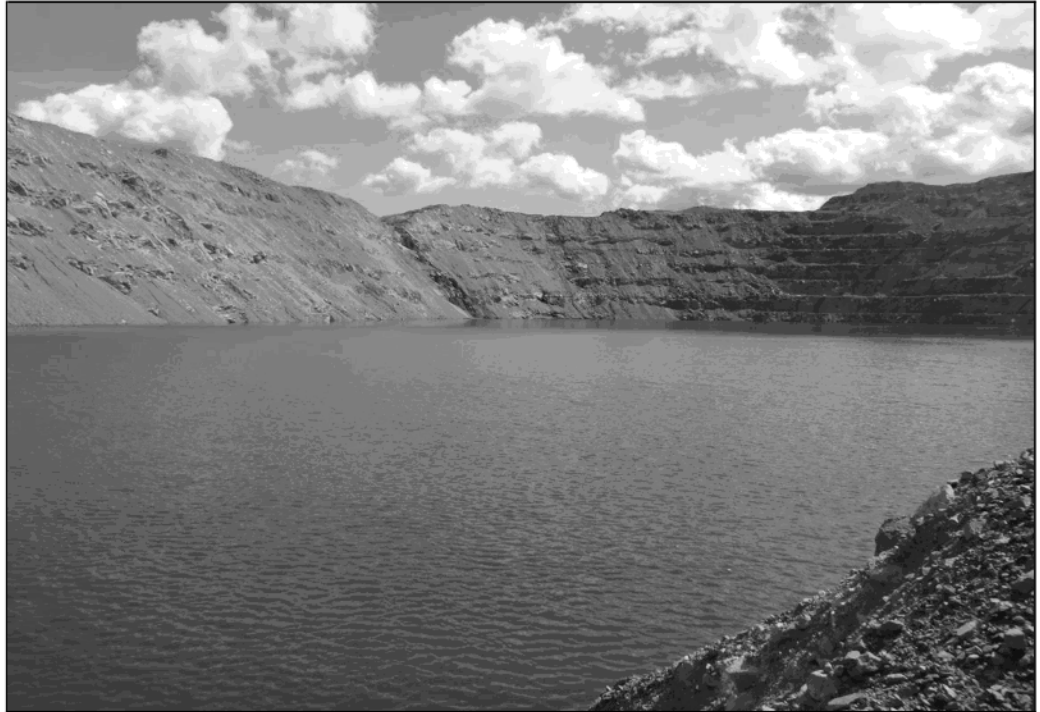
Springer Pit. The discharge from the mill is in the centre of the picture.

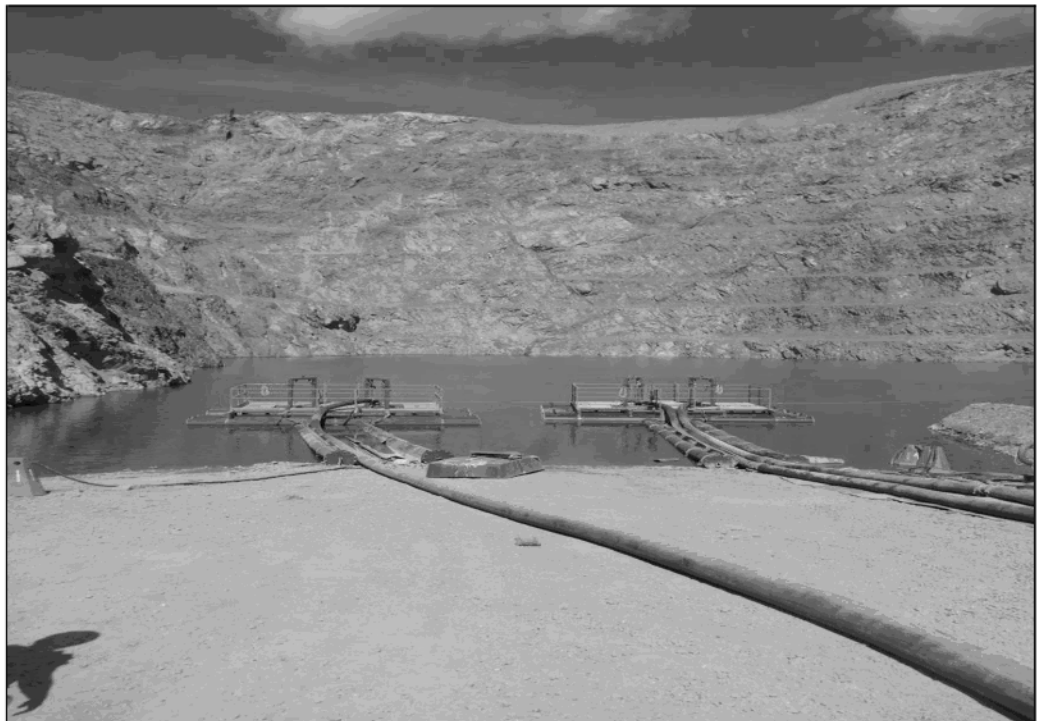
3 pumps in Springer Pit pumping water to the CCS for use as mill process water.
