**Site C Technical Review Panel**  
**John W. France, P.E., D.GE, D.WRE and Kaare Hoeg, PhD**  
**REPORT NO. 1**  
**January 22, 2021**

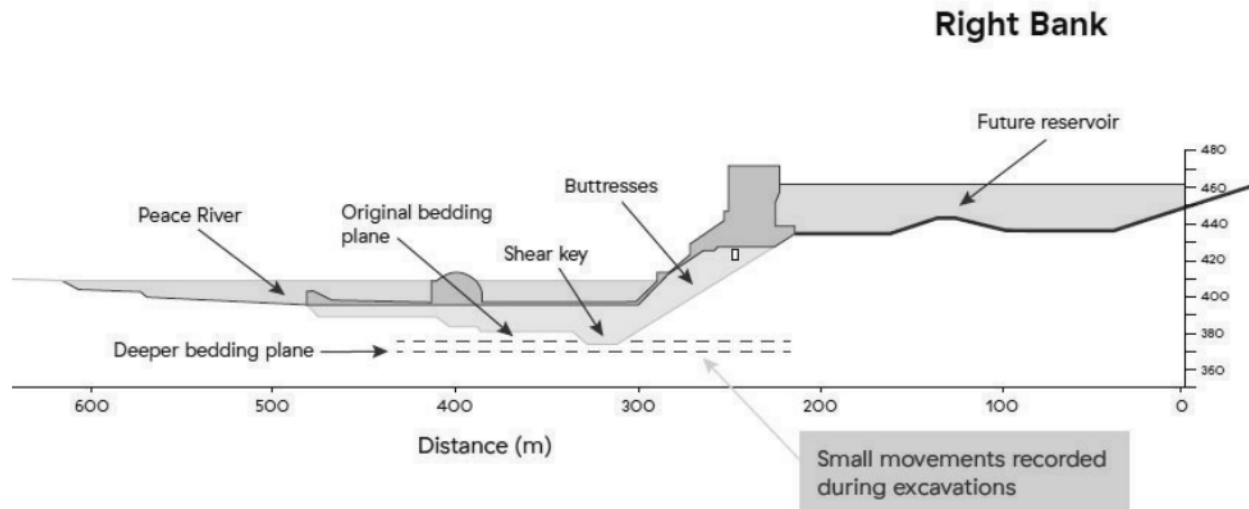
In 2018, during the excavation for the spillway buttress, small movements (millimetres) began to occur on a bedding plane below the bedding plane through which the shear key intersects. These small displacements indicated that the shear strength along bedding planes deeper than

the shear key bedding plane may be lower than what was initially assumed in the design basis. These small displacements, other instrument data, and the results of geological mapping led to a re-assessment of the expected strength of the bedrock at this depth.
