Re: Mine Inspection April 30, 2009
Property: Pumptown Quarry

Province of British Columbia
MINISTRY OF ENERGY, MINES AND
PETROLEUM RESOURCES

Mining & Mineral Division
Report of Inspector of Mines
(Issued pursuant to Section 15 of the *Mines Act*)

NAME OF MINE	Pumptown Quarry	LOCALITY	49.117, -122.113 ABBOTSFORD
OWNER/OPERATOR	Pumptown Quarry Inc.	ADDRESS	31992 South Fraser Way Abbotsford BC V2T 1V6
MANAGER	Scott Campbell	AREAS INSPECTED

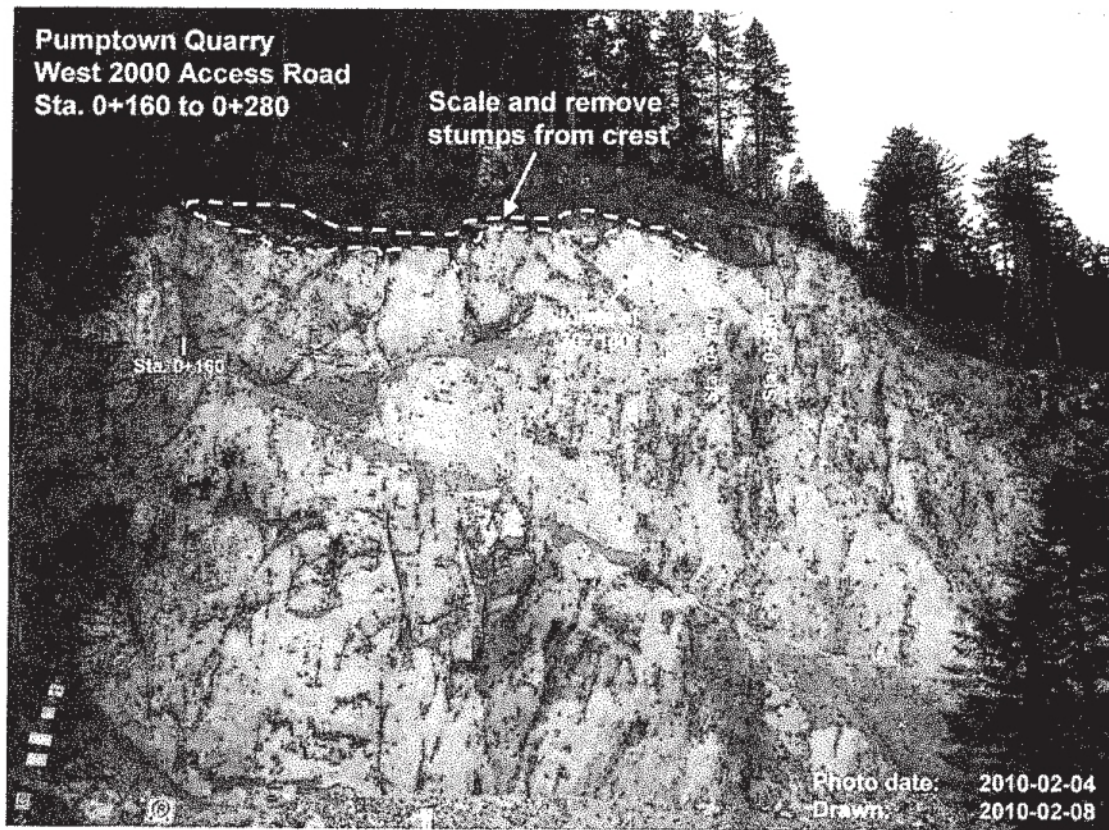
Photo 1 shows the access ramp from the switchback to the area where the heading direction changes at Sta. 0+280. Scaling of the overburden and crest of the cut are recommended in the indicated area. As shown in the photo, dominant jointing in the rock is approximately 70°/140° which roughly parallels the orientation of the road cut. A secondary joint set, which is more prominent in the bottom areas of the ramp, is perpendicular to the cut. This has resulted in rock slopes that have exposed relatively few adverse joints.

Photo 1 View of slope showing the West 2000 access road. In the upper portion of the ramp, the main slope stability hazards are the overburden and crest areas of the cut, where scaling is recommended.

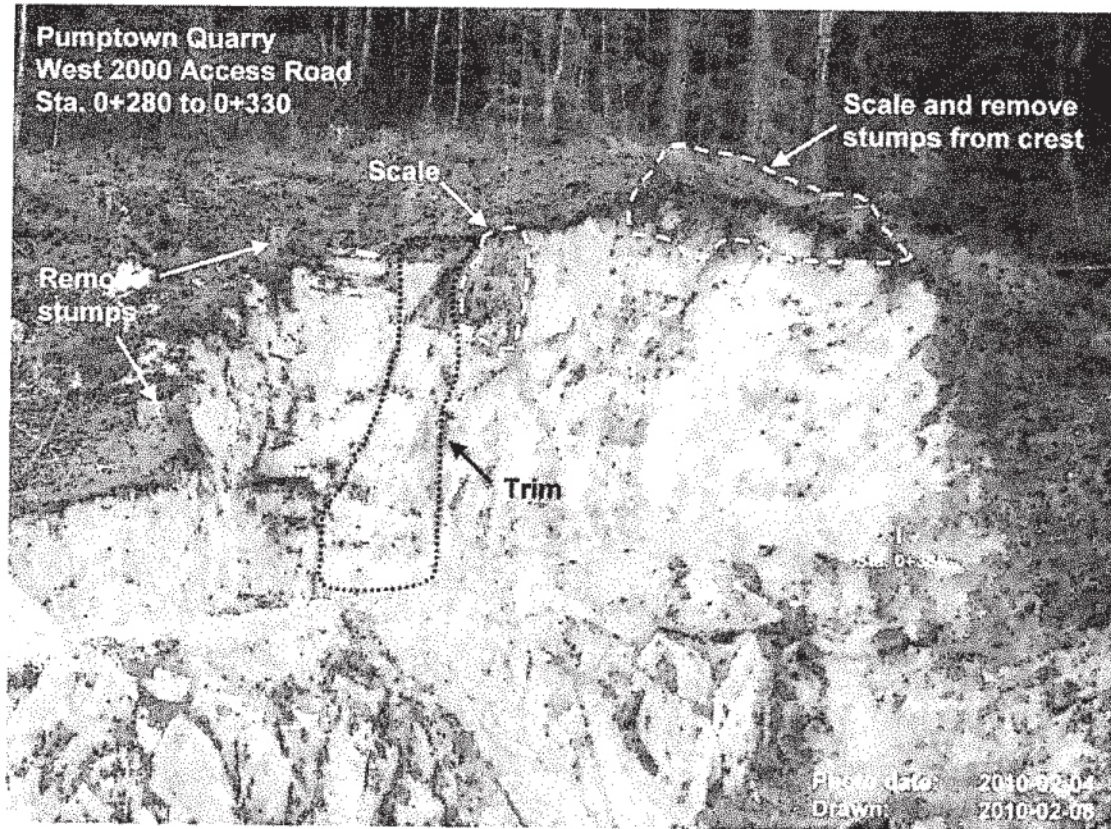
Since turning the access upslope at Sta. 0+280 however, some instability has been encountered as the cut is at an angle to the dominant jointing and therefore trimming and scaling of the rock face is recommended, as shown in Photo 2.

Photo 2 View of the upper portion of the access ramp at the current heading. The road cut changes direction at around Sta. 0+280 (photo left), resulting in some undercutting of the major structure and increasing the potential for blasting backbreak.

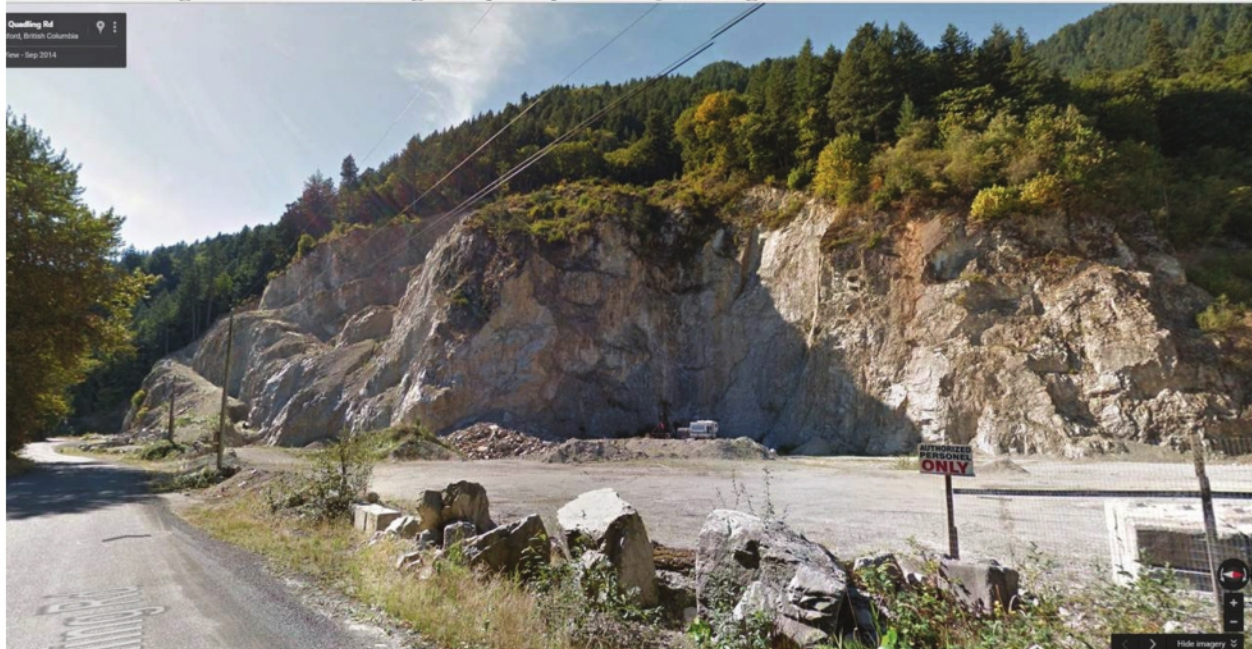
Photo 1: Google street view image of quarry from Quadling Rd

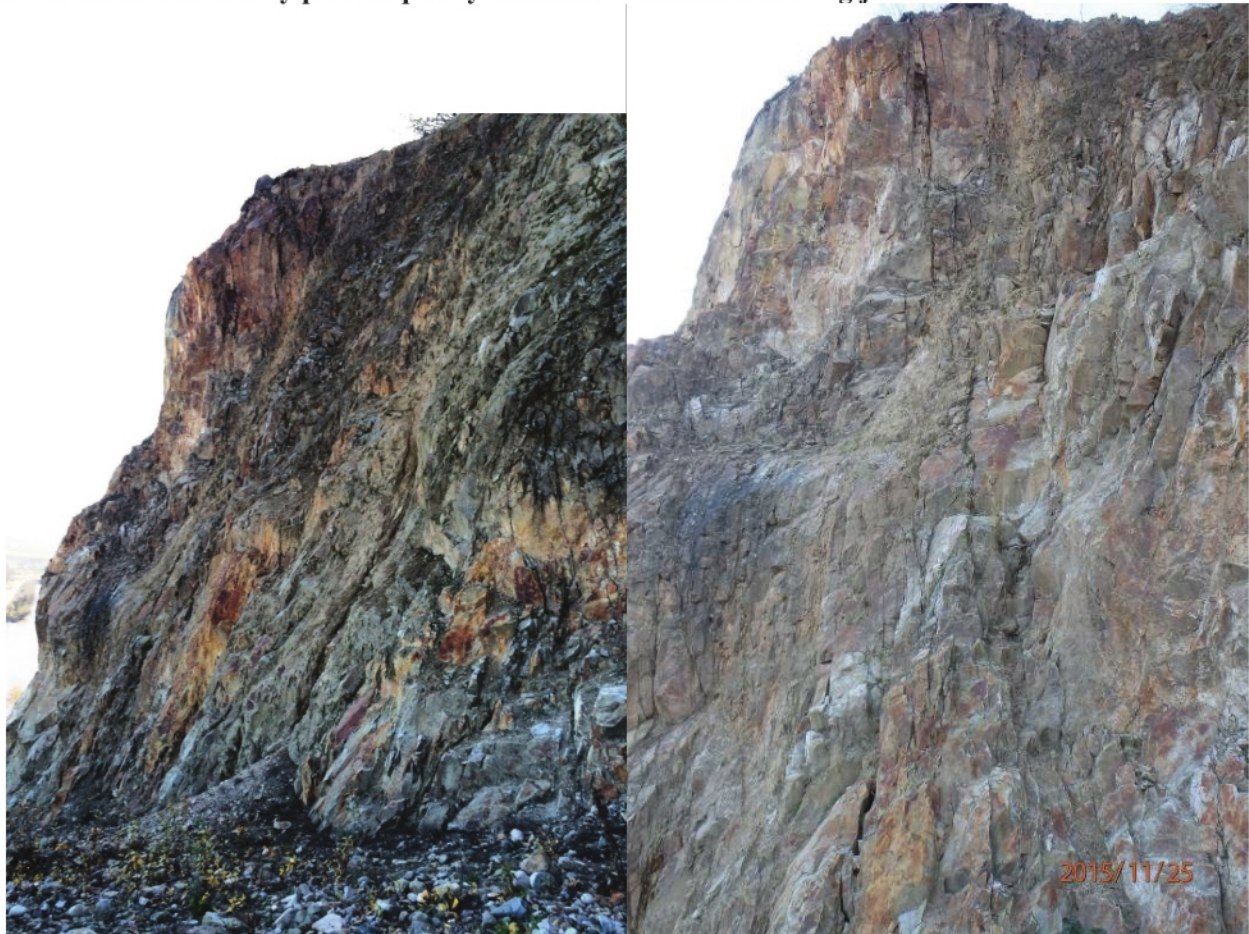
Photos 2 and 3: Visibly poorer quality rock mass with some dilating joints

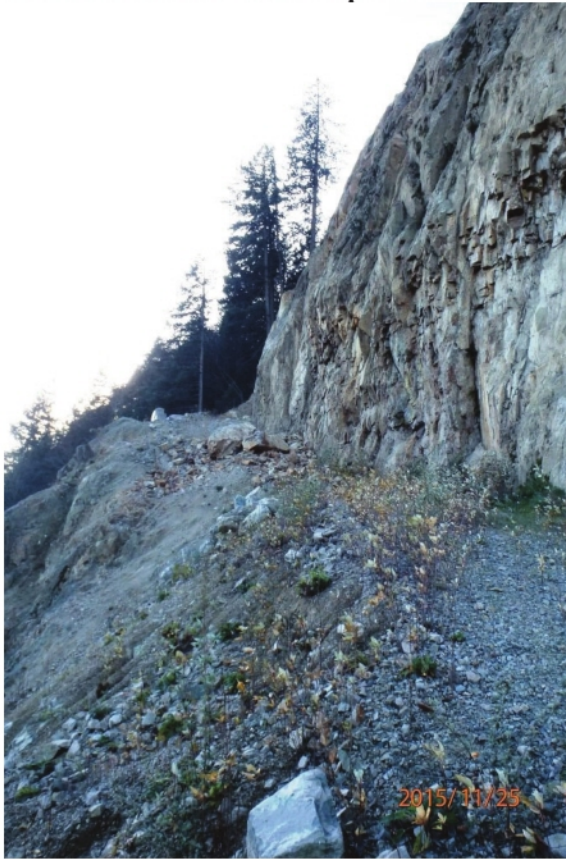
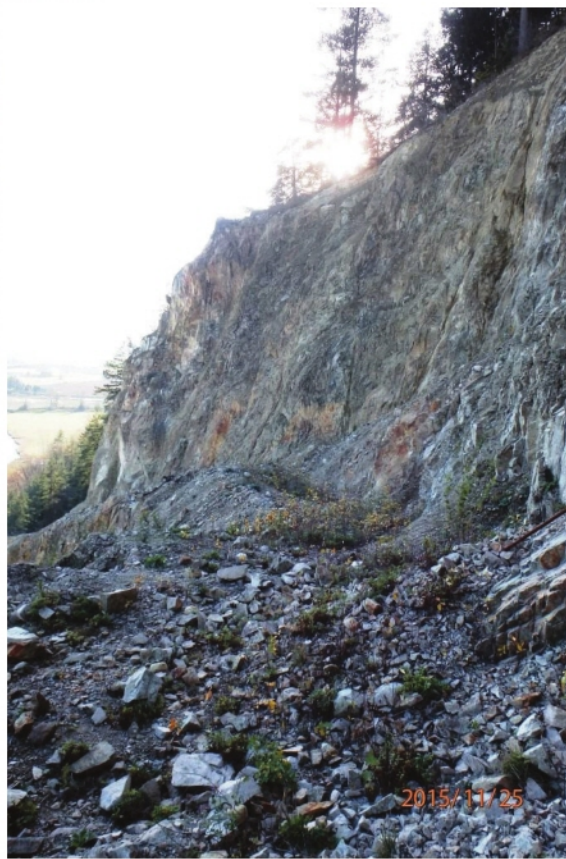
Photos 4 and 5: Access ramp with evidence of failures

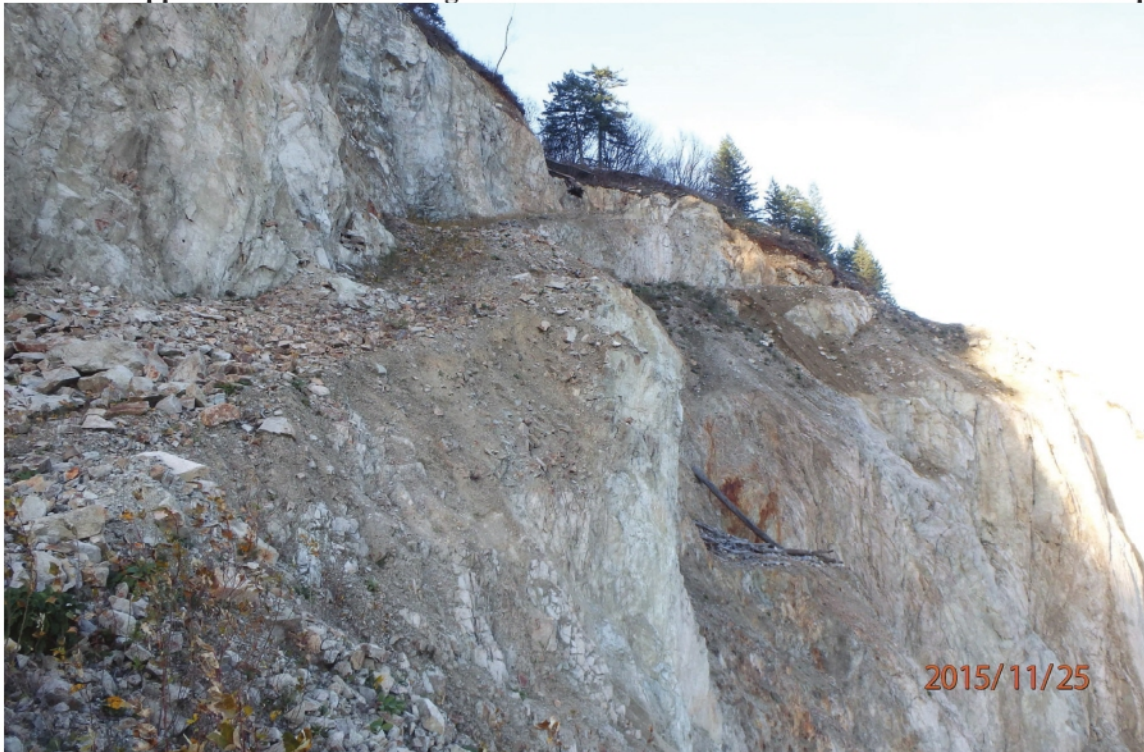
Photo 6: Upper access trail showing recent rockfall accumulation and area of failed fill slope

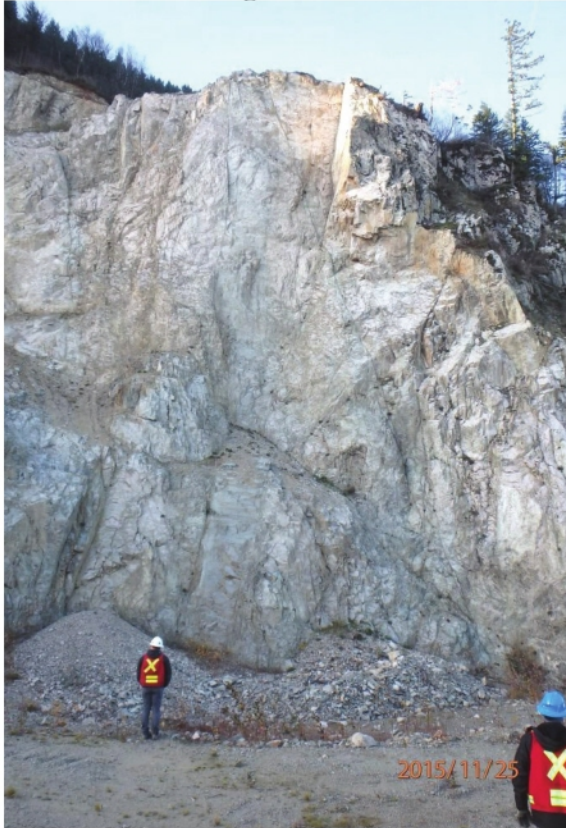
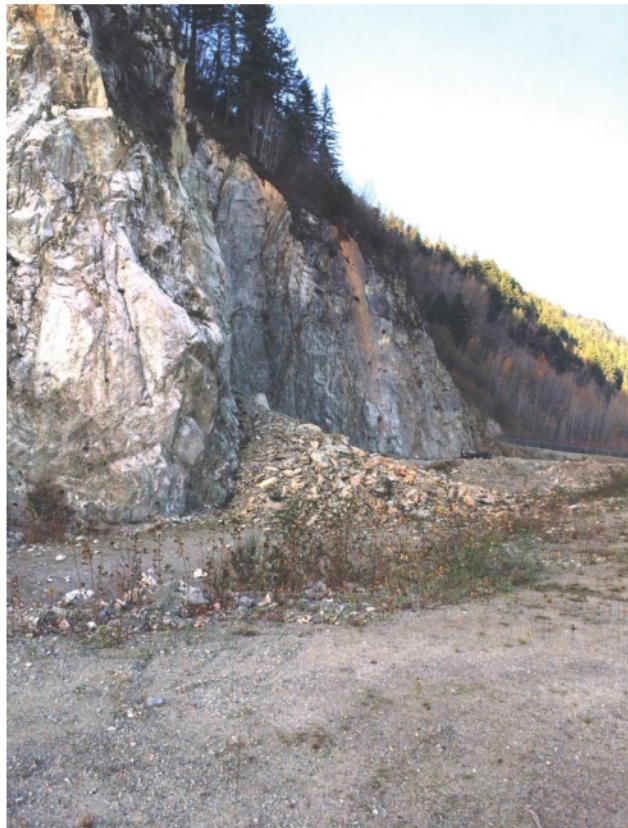
Photos 7 and 8: High vertical faces at north end of site

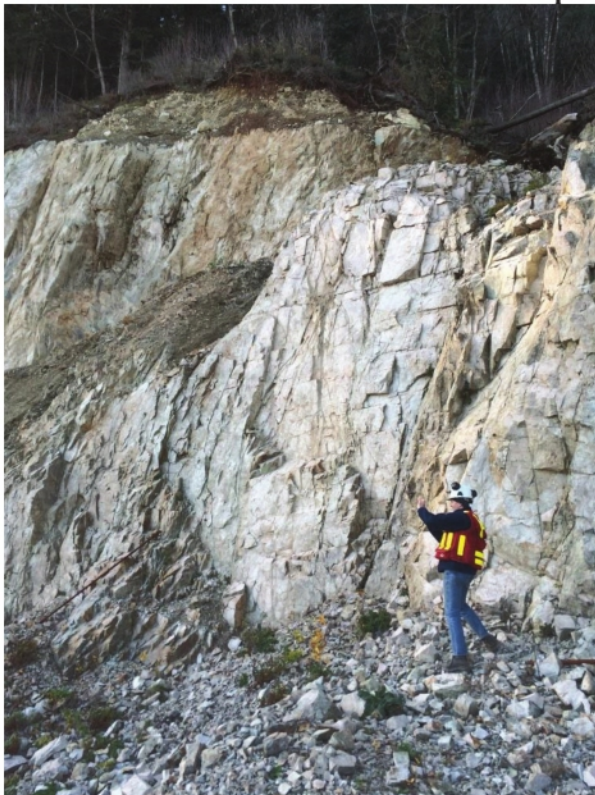
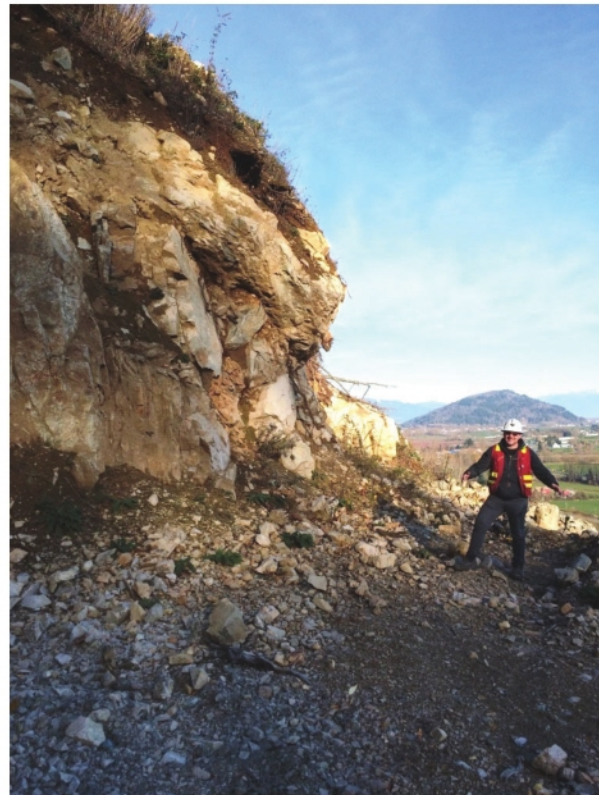
Photos 9 and 10: Overburden at crest of slope

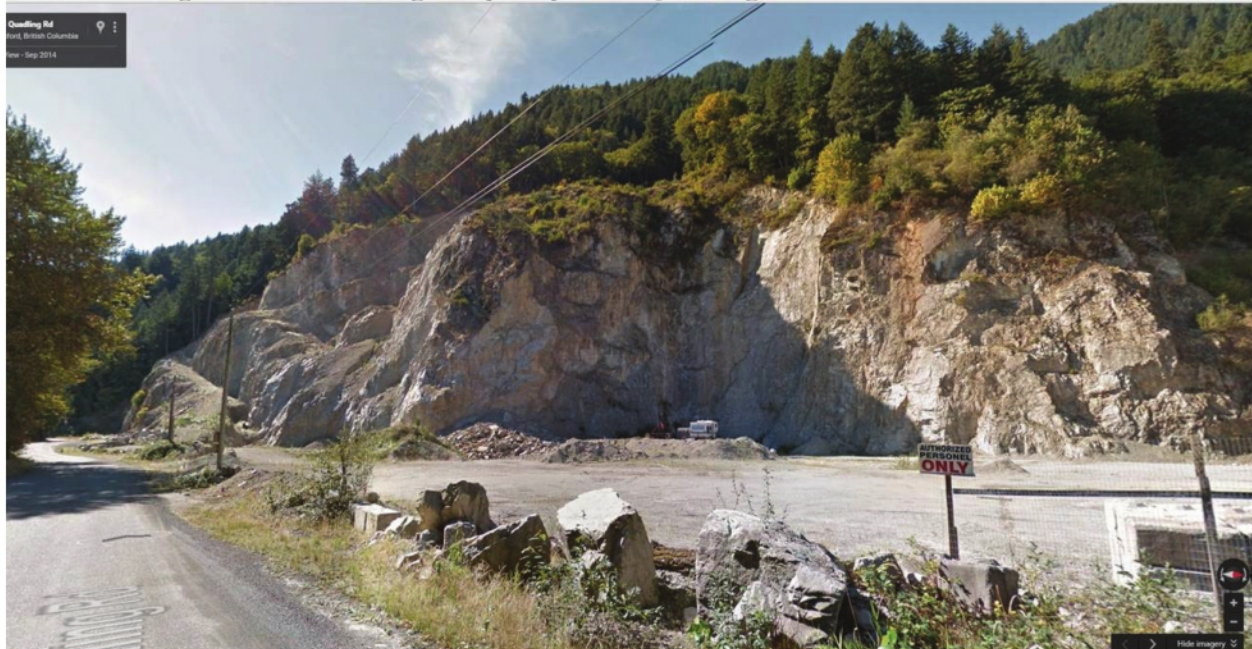
Photo 1: Google street view image of quarry from Quadling Rd

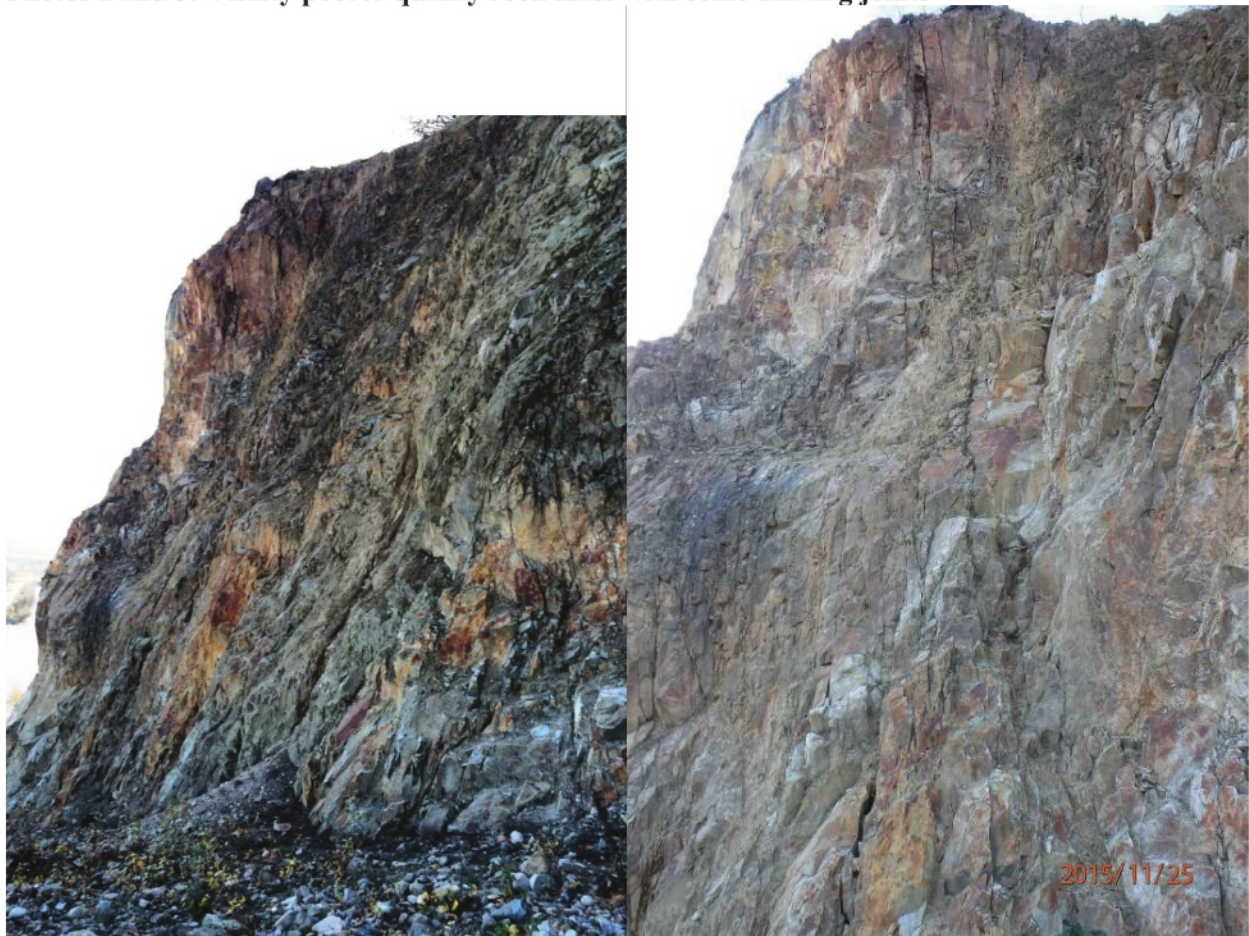
Photos 2 and 3: Visibly poorer quality rock mass with some dilating joints

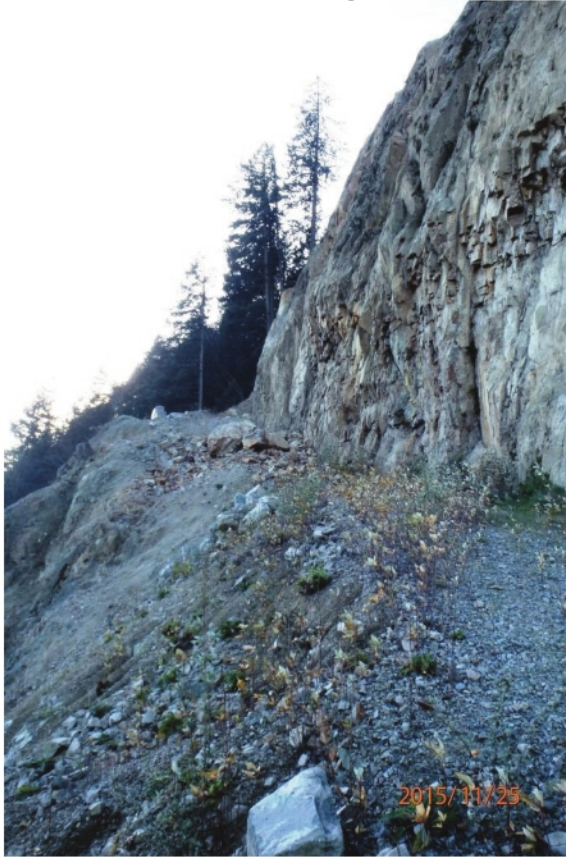
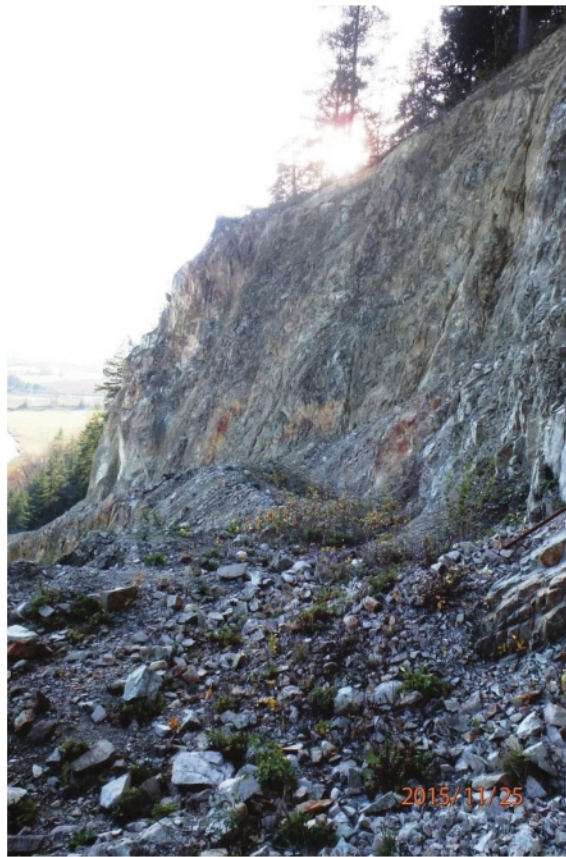
Photos 4 and 5: Access ramp with evidence of failures

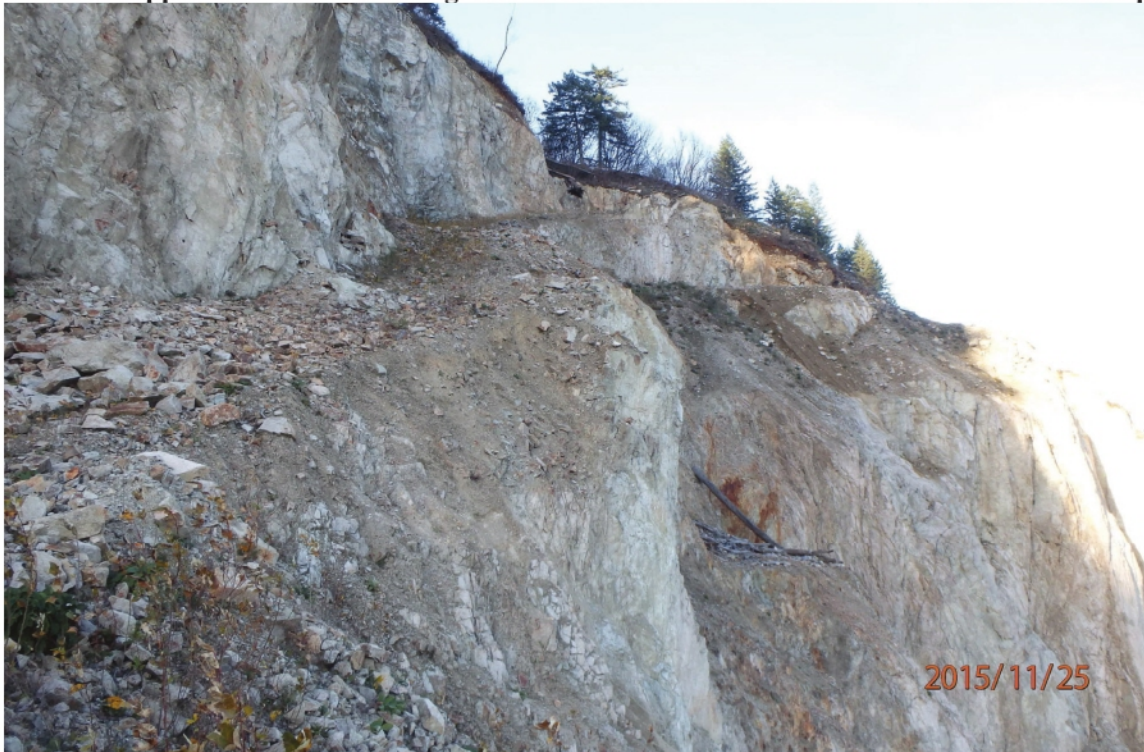
Photo 6: Upper access trail showing recent rockfall accumulation and area of failed fill slope

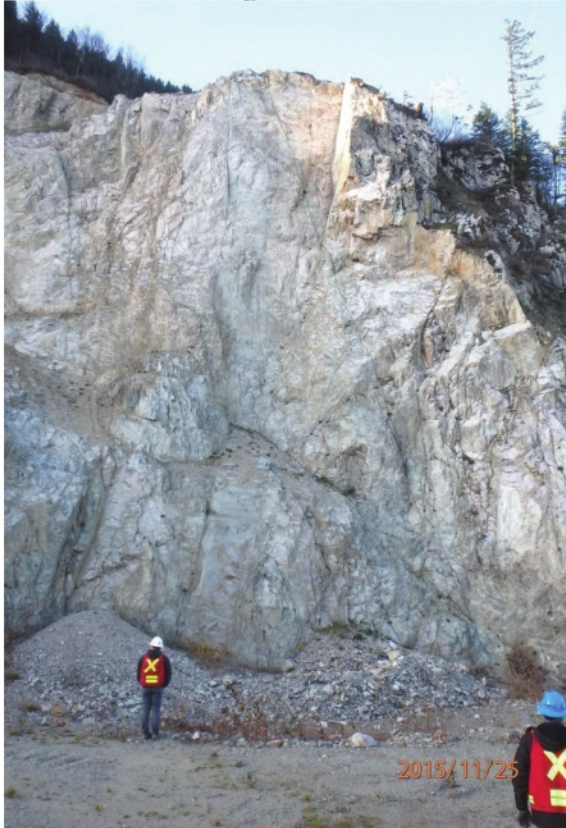
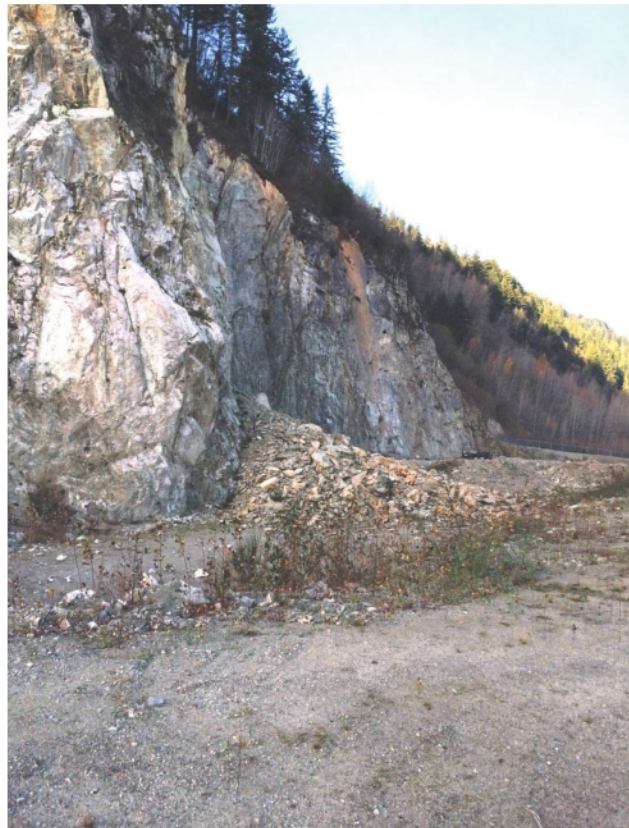
Photos 7 and 8: High vertical faces at north end of site

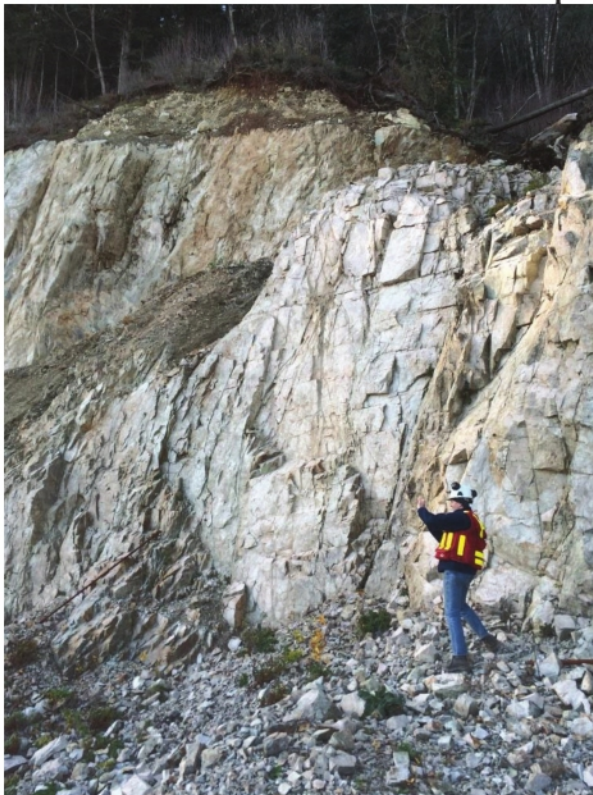
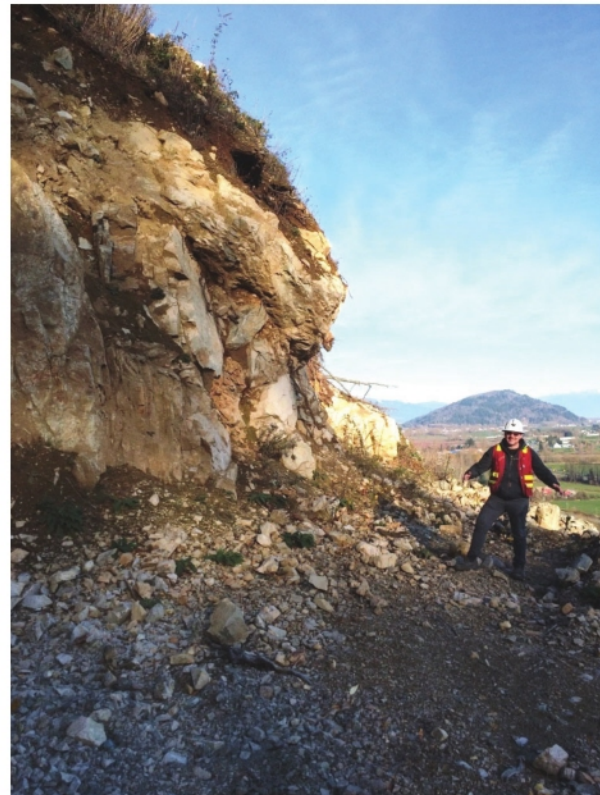
Photos 9 and 10: Overburden at crest of slope

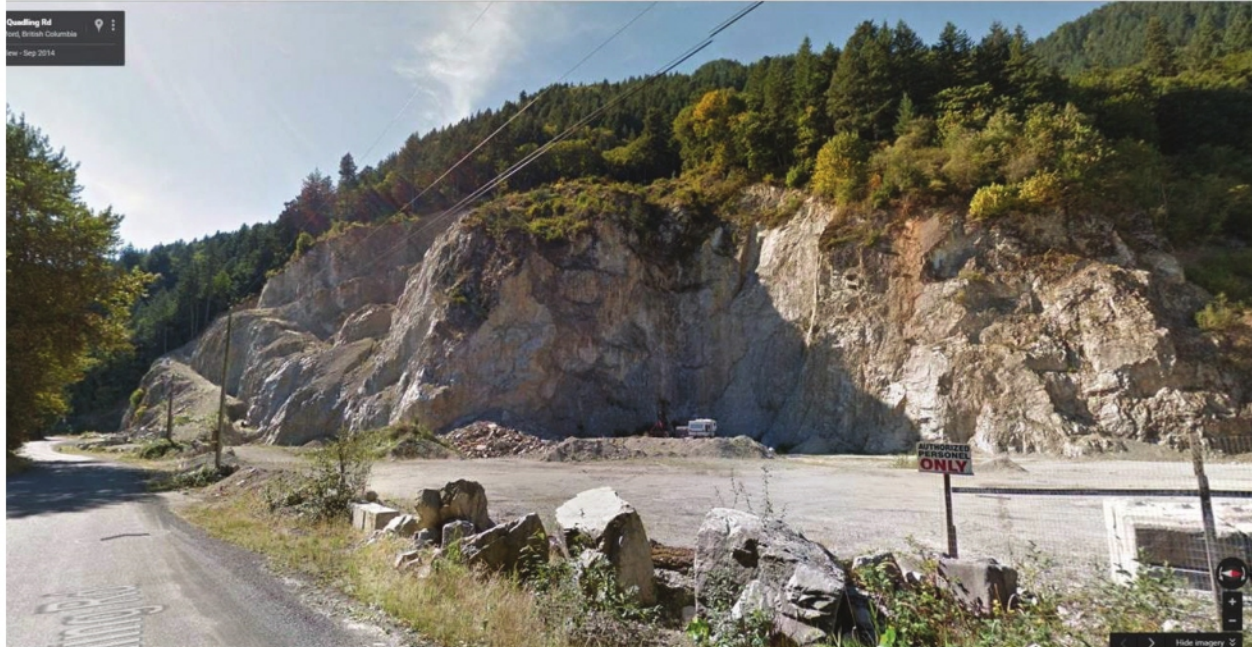
Photo 1: Google street view image of quarry from Quadling Rd

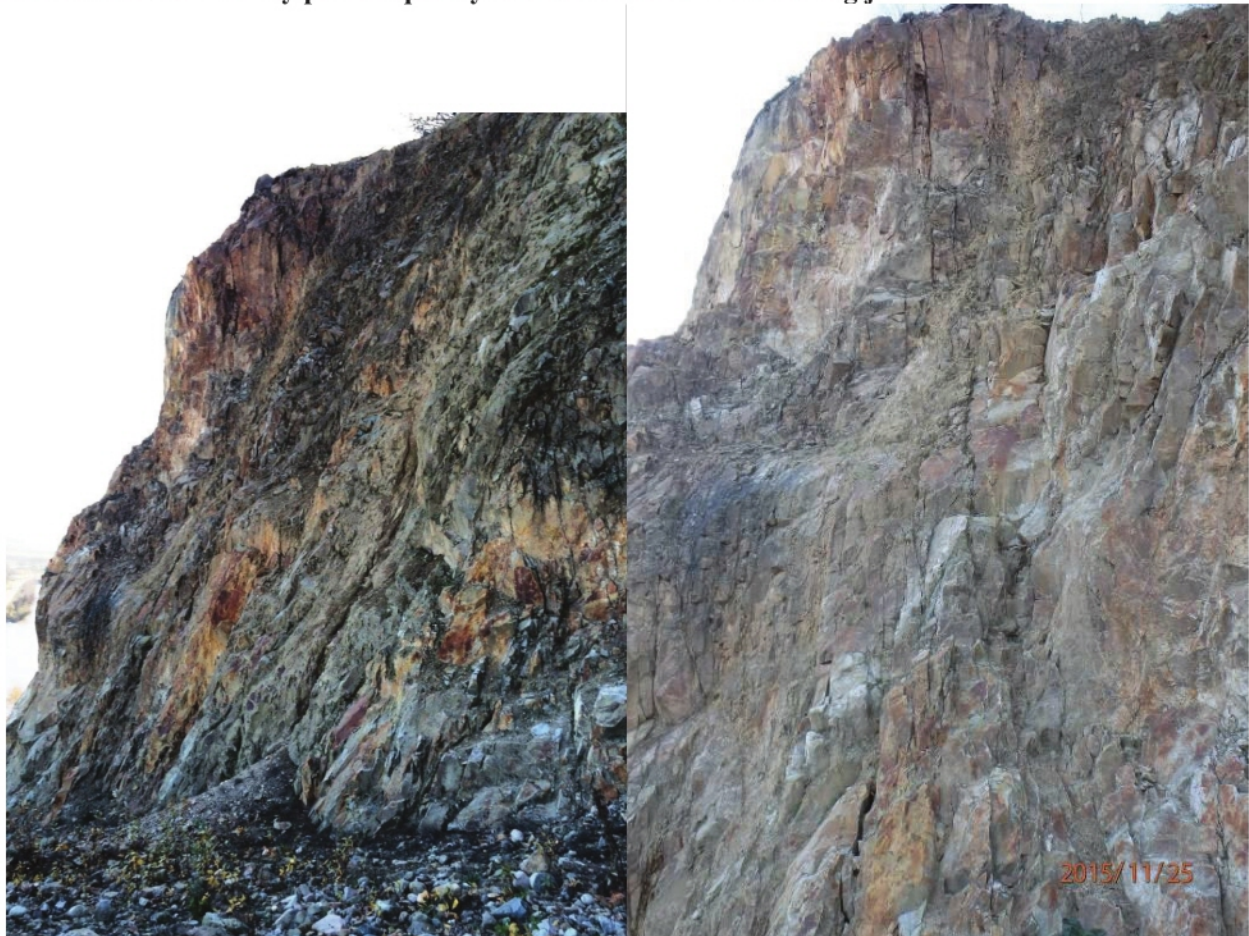
Photos 2 and 3: Visibly poorer quality rock mass with some dilating joints

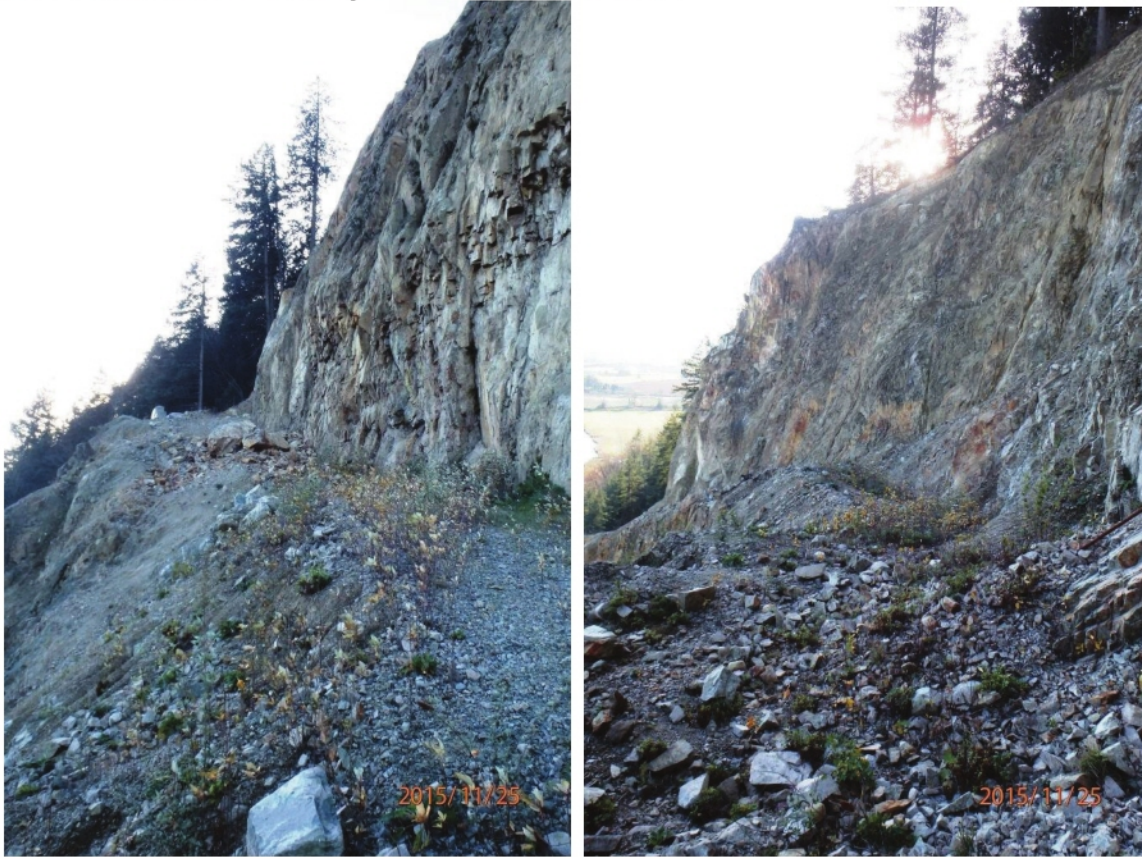
Photos 4 and 5: Access ramp with evidence of failures

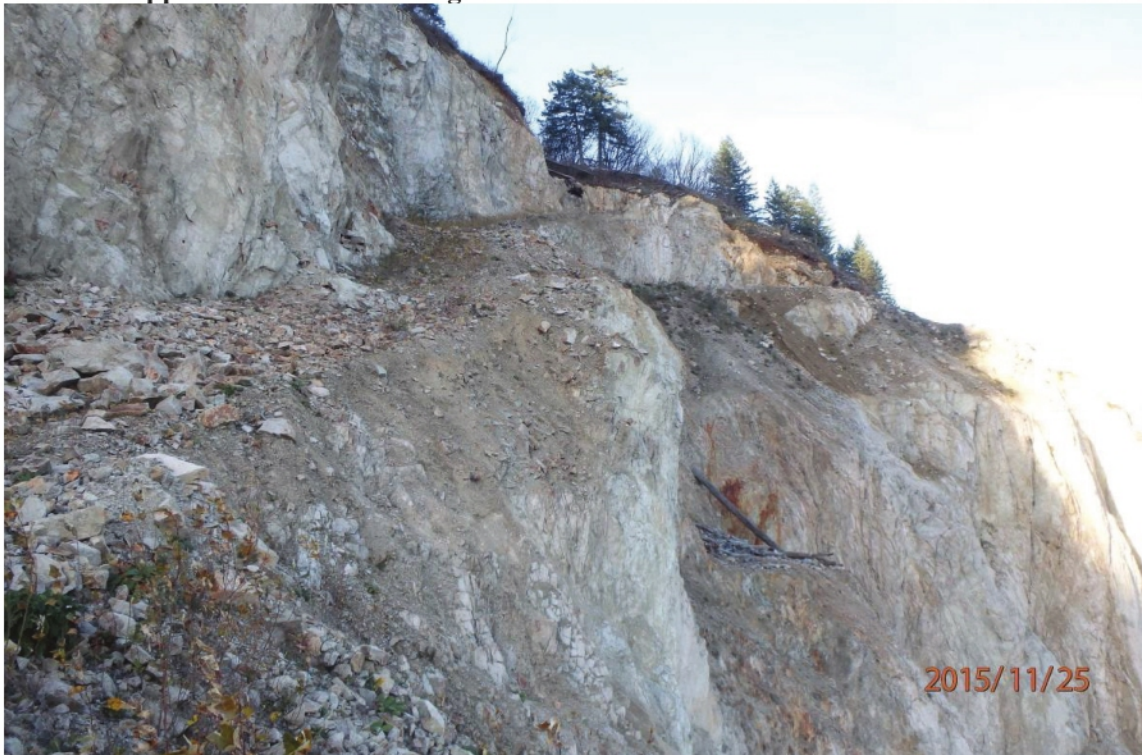
Photo 6: Upper access trail showing recent rockfall accumulation and area of failed fill slope

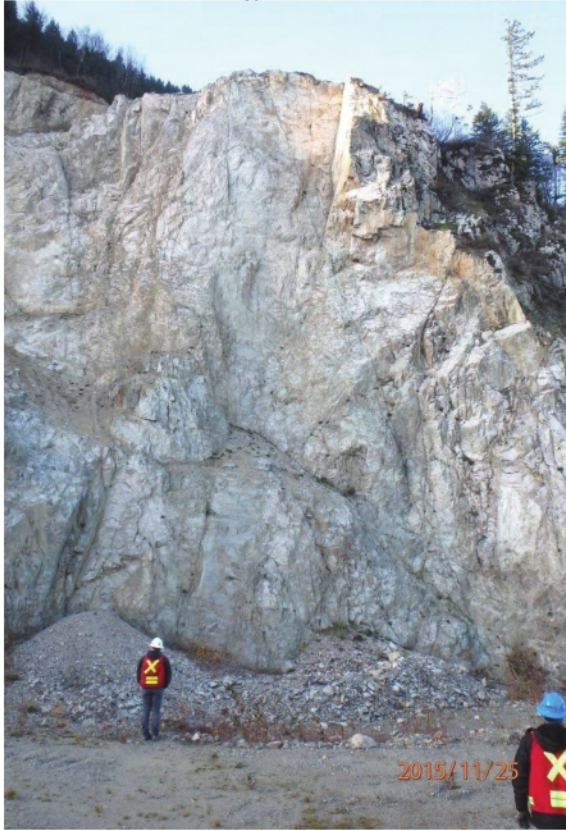
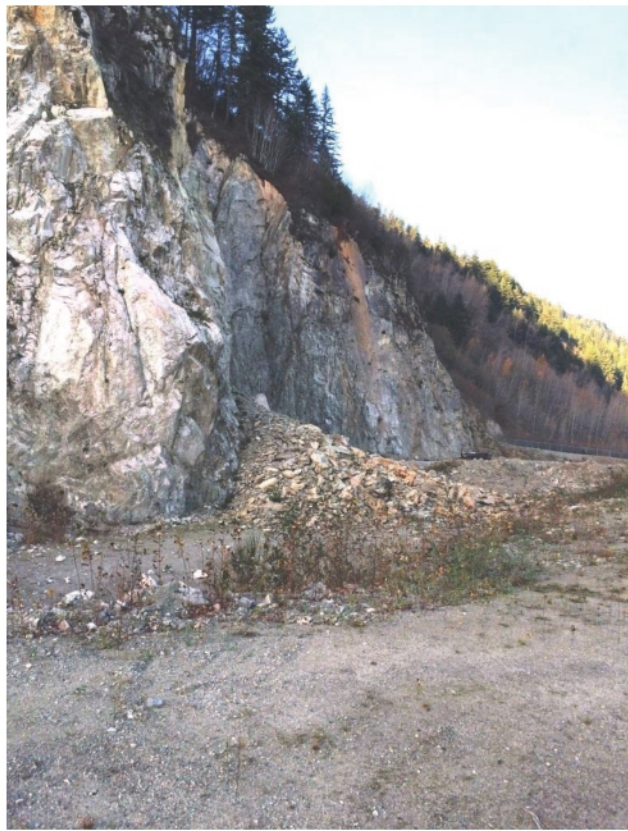
Photos 7 and 8: High vertical faces at north end of site

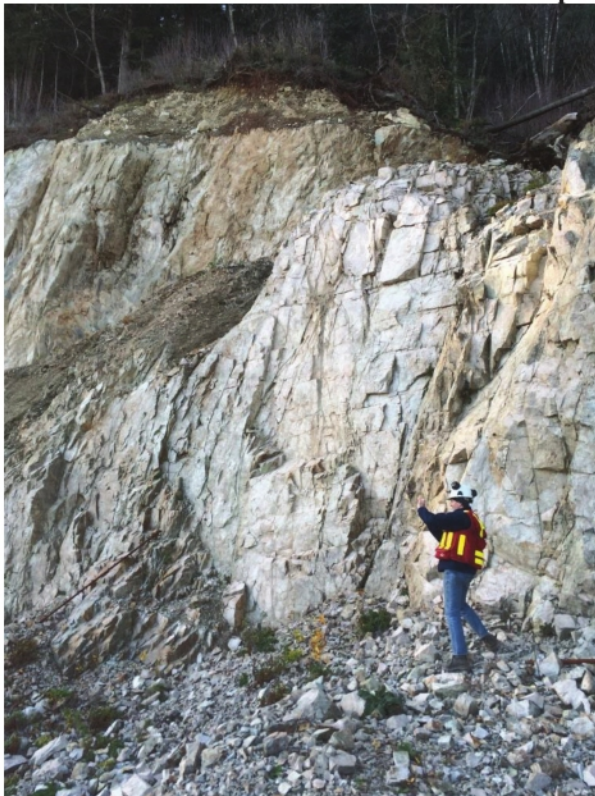
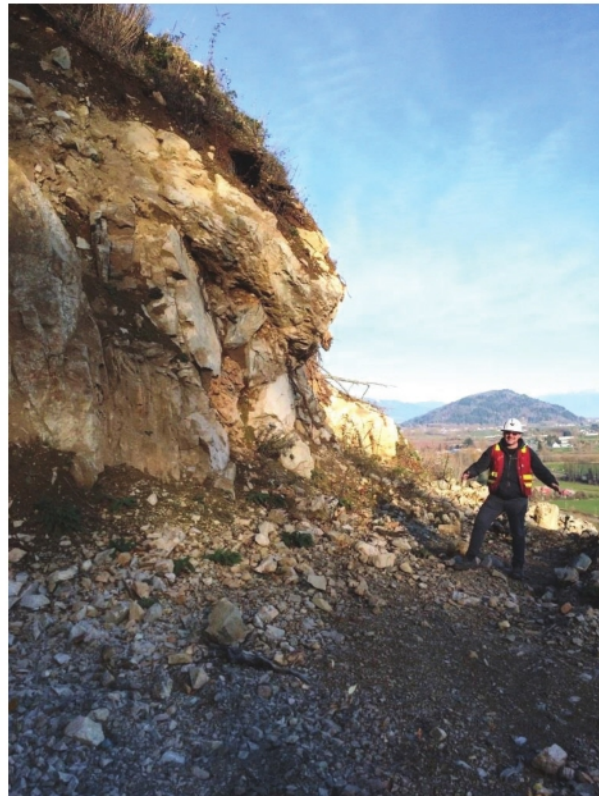
Photos 9 and 10: Overburden at crest of slope

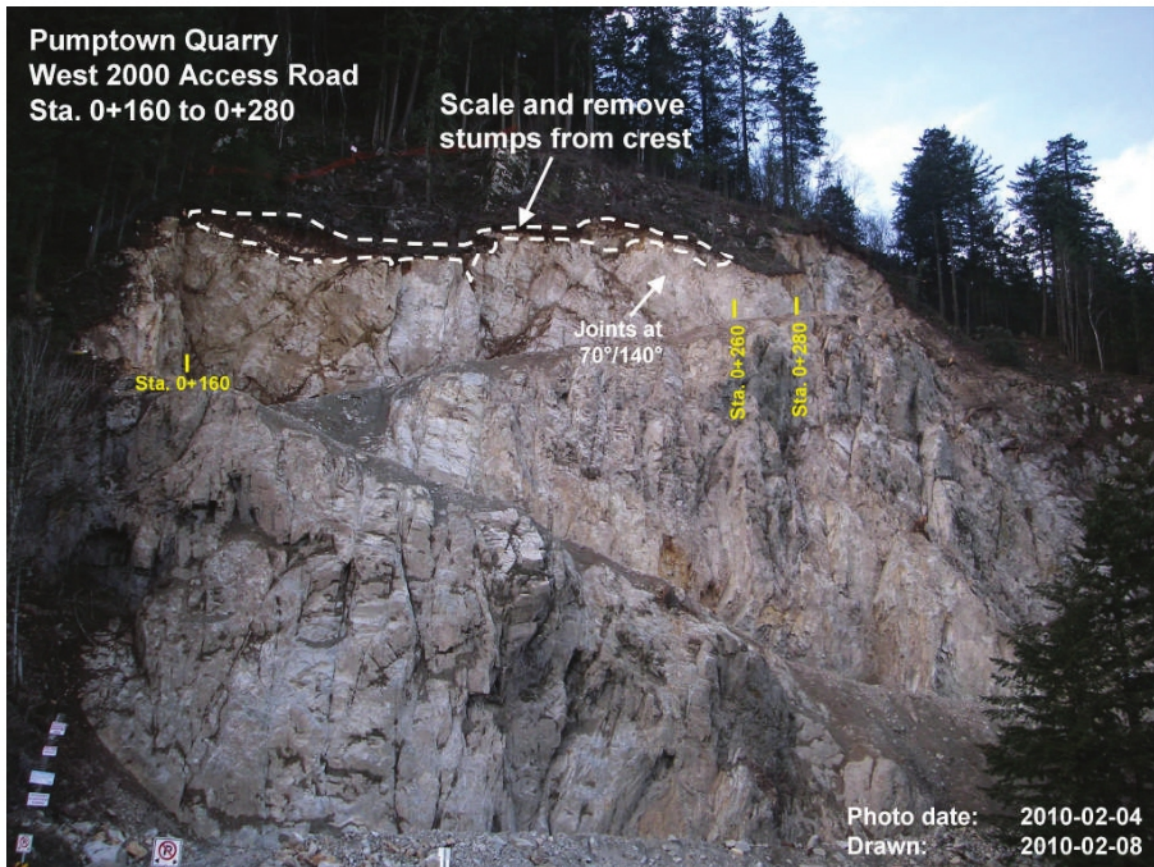
Photo 1 View of slope showing the West 2000 access road. In the upper portion of the ramp, the main slope stability hazards are the overburden and crest areas of the cut, where scaling is recommended.

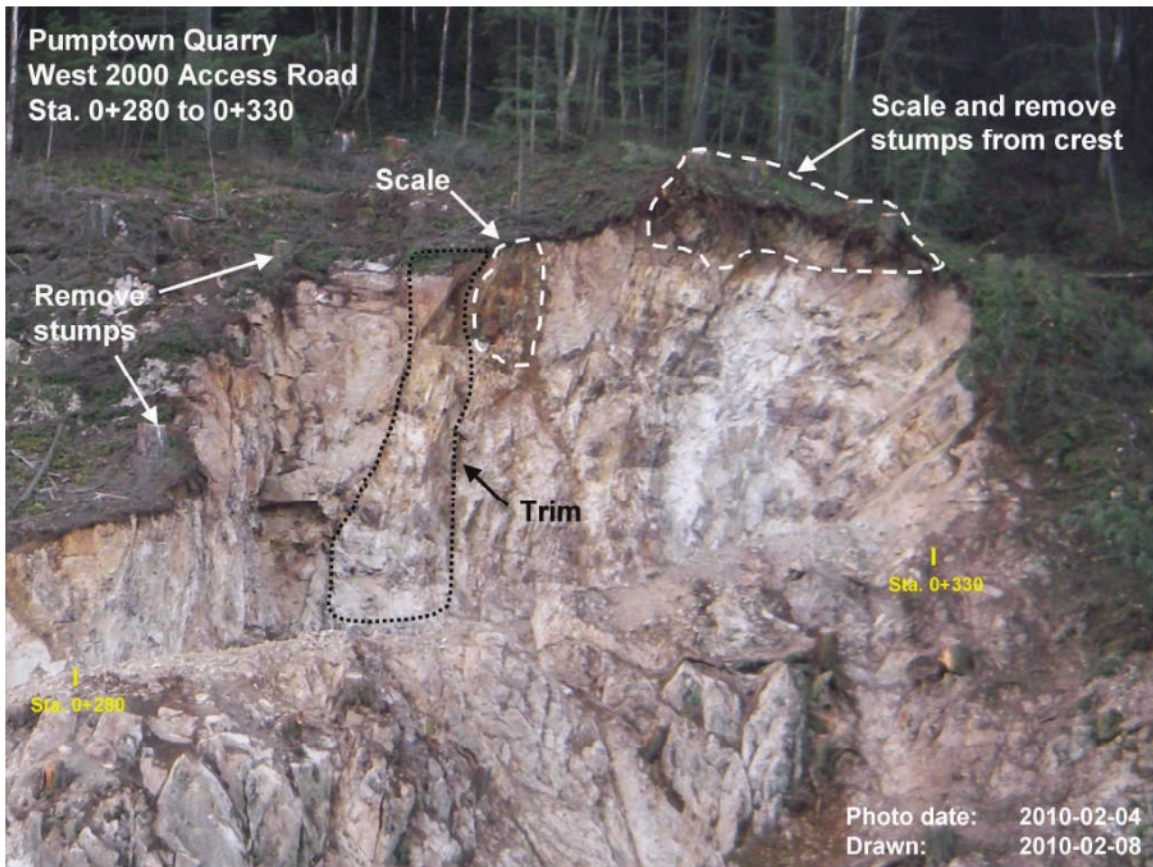
Photo 2 View of the upper portion of the access ramp at the current heading. The road cut changes direction at around Sta. 0+280 (photo left), resulting in some undercutting of the major structure and increasing the potential for blasting backbreak.
