Report of Inspector of Mines - Health and Safety

Mine Name/Number	Mt. Milligan 1300188	Visit Date	2020-07-15
Type of Mining	MS. METAL MINE - SURFACE	Location	
Latitude/Longitude	55.08241, -124.0273	Northing/Easting/Zone	434421, 6104444, 10U
		Permittee	Thompson Creek Metals Company Inc.
Inspector	Kristopher Bailey, INSPECTOR	Accompanying Inspector	
Address	350-1011 4th Avenue Prince George, B.C. V2L 3H9		
In Attendance	Ed P, Operator, Centerra Gold; Mike D, Safety Superintendent, Centerra Gold		
Copies to

Managers Response to Inspection 153862

Re: Managers response to inspection 153862 conducted July 15th, 2020. Inspection report received Friday July 17th @ 11:49.
Response due by end of day Saturday August 1st, 2020. Pictures only.

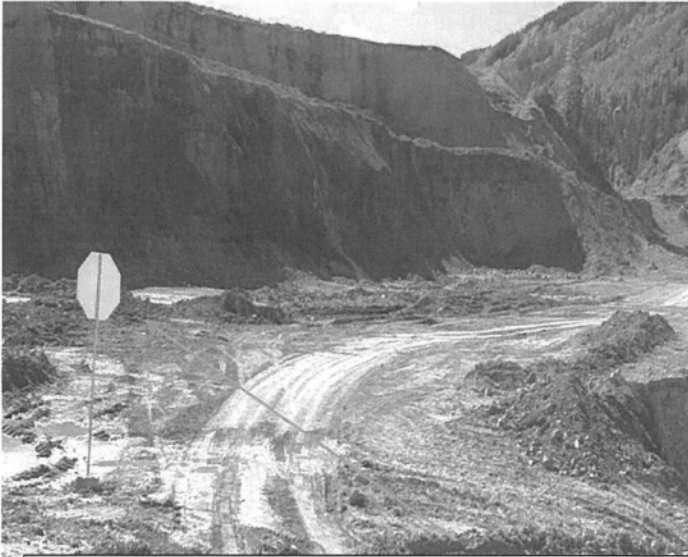
1055 bench meets PH3 haul road. **Stop** sign in place.

Order #153862-S1-02 – Signage - A road and intersection audit was assigned by Kent Hurley and completed within the Pit at key areas for safe traffic control to avoid confusion. As a result of this audit, three signs were erected. See attached pictures.

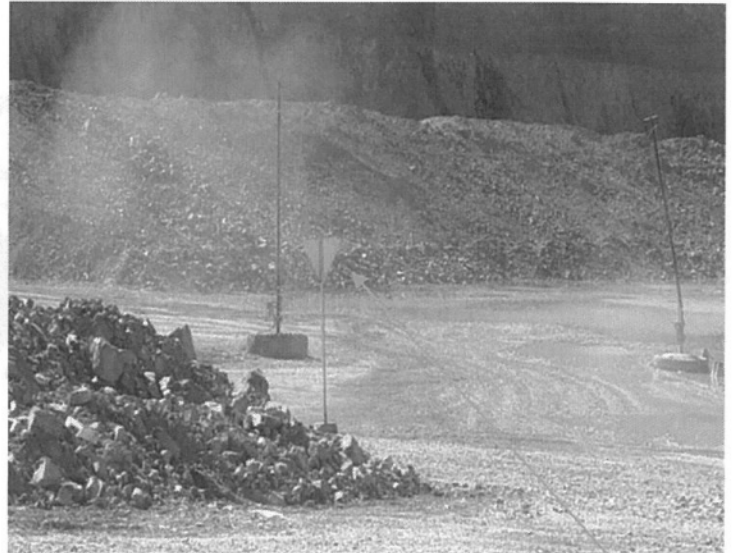
Yield sign - 1025 bench meets the PH3 haul road

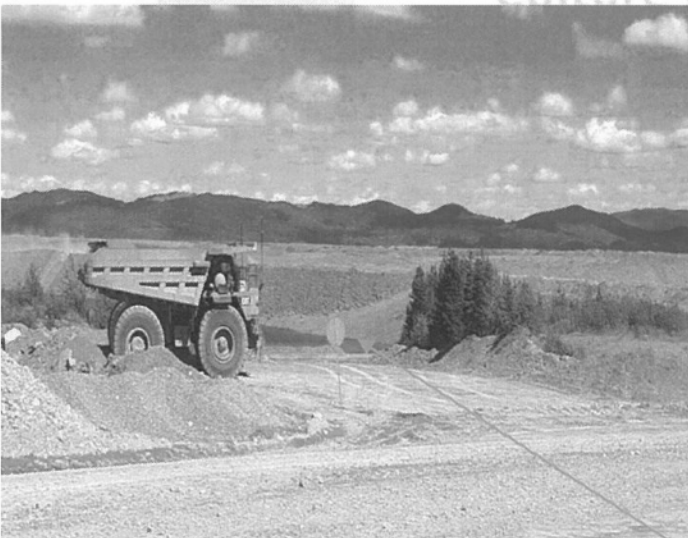
Laydown for rarely used equipment just off to the side on the north hammer road. This is a short cut road to the access road between the PCC and JAR roads. New **Stop** sign put up.

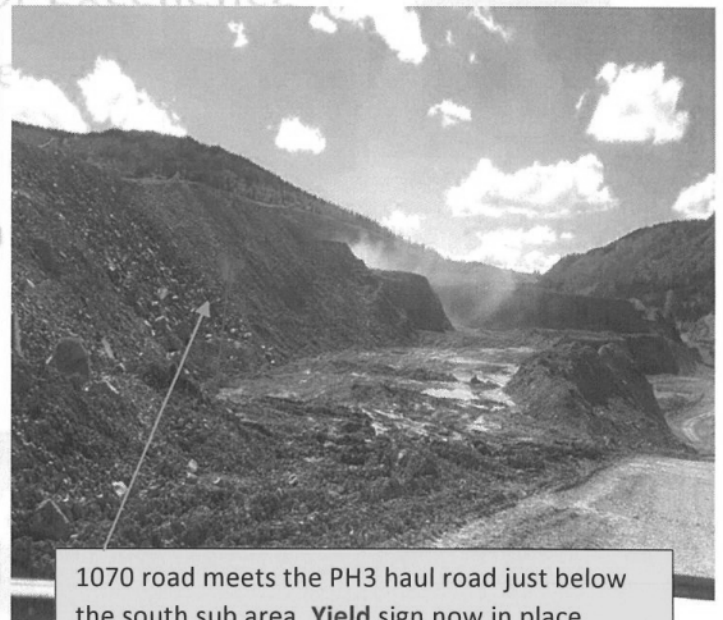
1070 road meets the PH3 haul road just below the south sub area. **Yield** sign now in place.

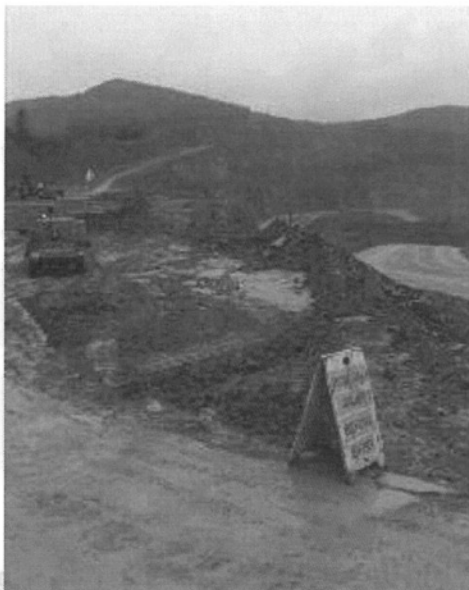
The berm on the 1040 bench along the access road to the explosive magazines and exploration drilling requires an extension of the berm pursuant to part 6.9.1(2)(b) of the HSRC. The road is set back from the crest of the bench and a tracked dozer has recently profiled the area in preparation for blast/drilling. Once the blast is complete, this will bring the drop of closer to the access road. It is understood that the berm will be extended within 2 days of this report. Please provide confirmation that this has been complete.

Advisory # 1: The berm along the 1040 bench access road was completed the day of the inspection

Advisory 153862-S1-A1 – The berm along the 1040 bench access road was completed the day of the inspection. See attached picture.
