Report of Inspector of Mines - Health and Safety

Mine Name/Number	Westside Pit 1620313	Visit Date	2021-05-12
Type of Mining	BCL	Location	
Latitude/Longitude	51.02194, -118.2227	Northing/Easting/Zone	414245, 5652976, 11U
		Permittee	Terus Construction Ltd.
Inspector	Jerrold Jewsbury, INSPECTOR	Accompanying Inspector	Haley Kuppers, Inspector;
Address	202-100 Cranbrook Street North Cranbrook, B.C. V1C 3P9		
In Attendance	Corey Rokosh, Site manager, TERUS; Jordan Leroy, New Site Manager, TERUS		
Copies to

Inspection Number: 178143
File Number:
Permit Number: G-4-188
Total Orders: 0
Mine Number: 1620313

Inspection Number: 188318
File Number:
Permit Number: G-4-188
Total Orders: 0
Mine Number: 1620313

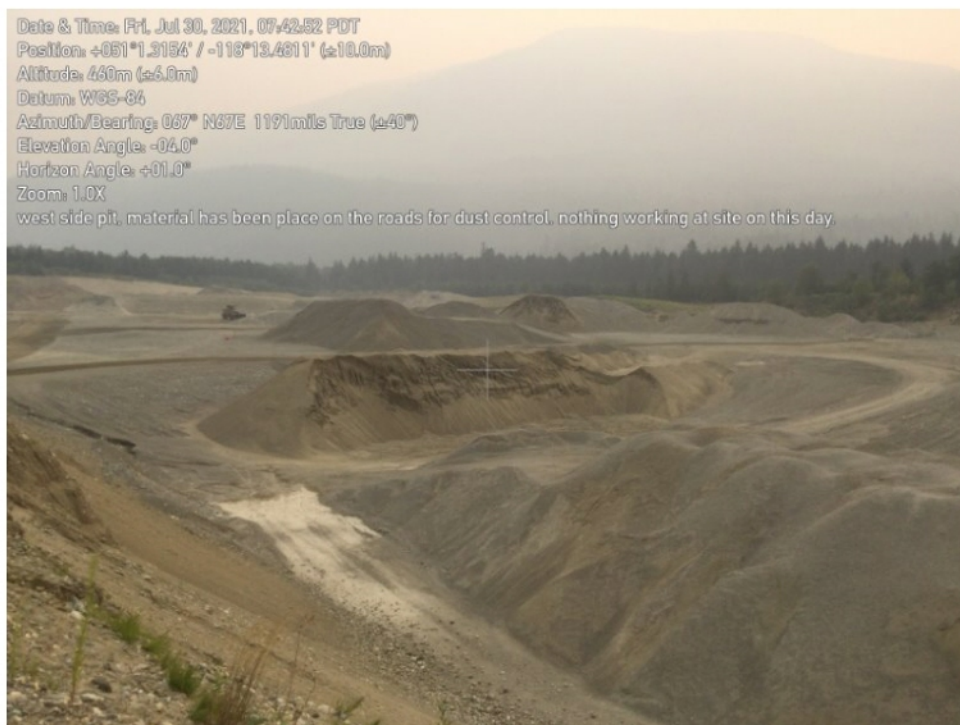
Image #1 - overview of pit and stock piles.

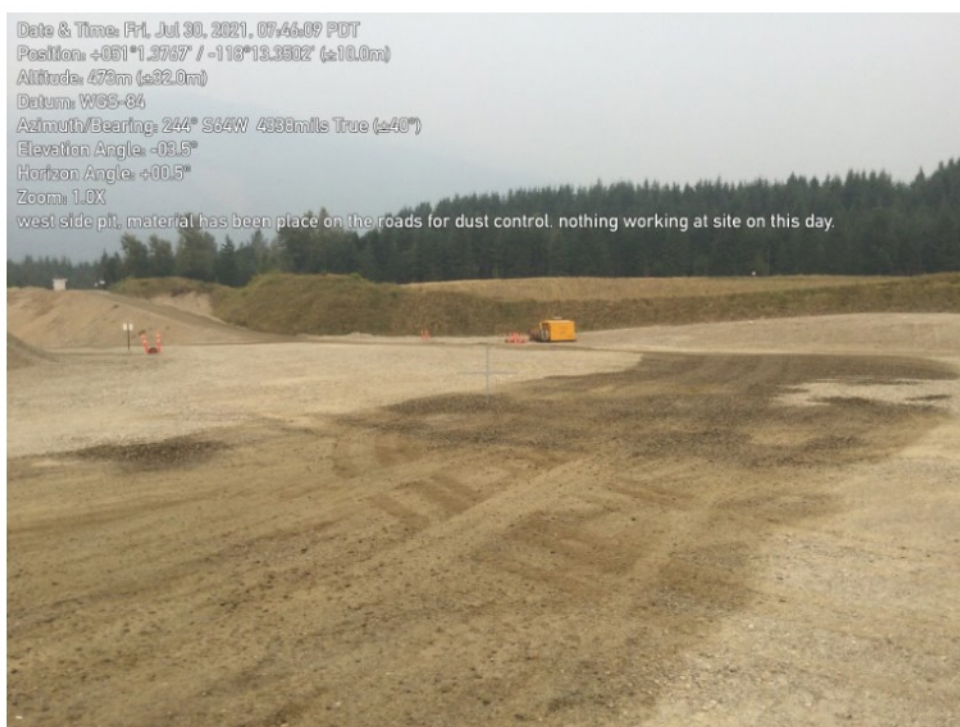
Current operations will see the stockpiles sprayed with an organic compound to mitigate dust from migrating off the piles as well the roads that are required will be sprayed with Mag-chloride to help suppress the dust off the roads that will be travelled by haul trucks as they are loaded and leaving site. Delineation barriers will be placed in locations to minimize wide use of the site and minimize dust.

Image #2 - showing dust suppression material on the roads.

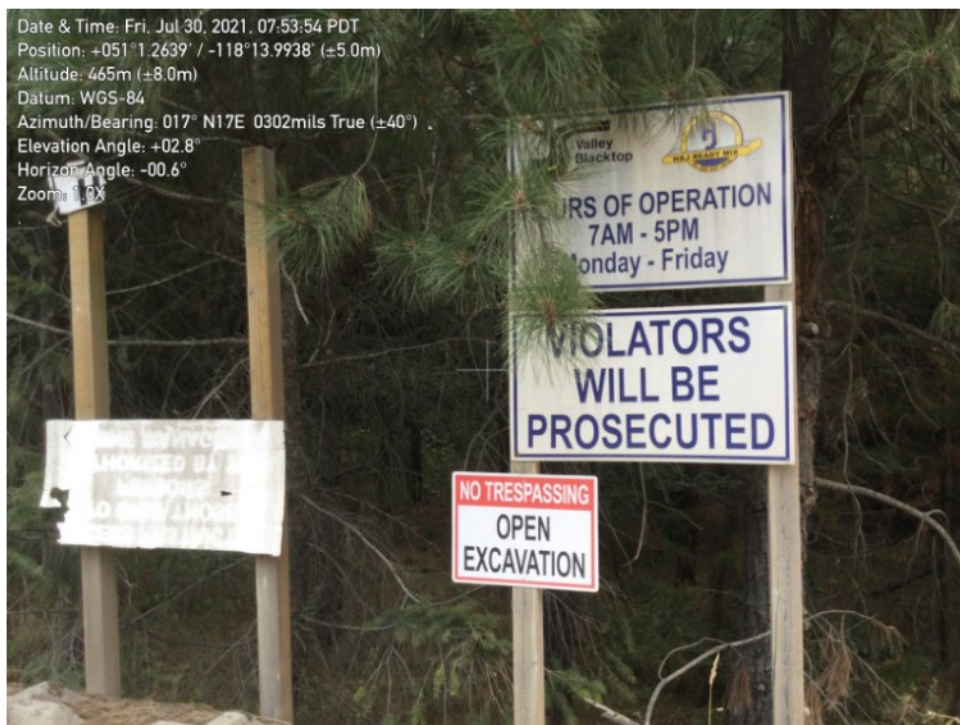
Image #5 - Signage in place as per code.

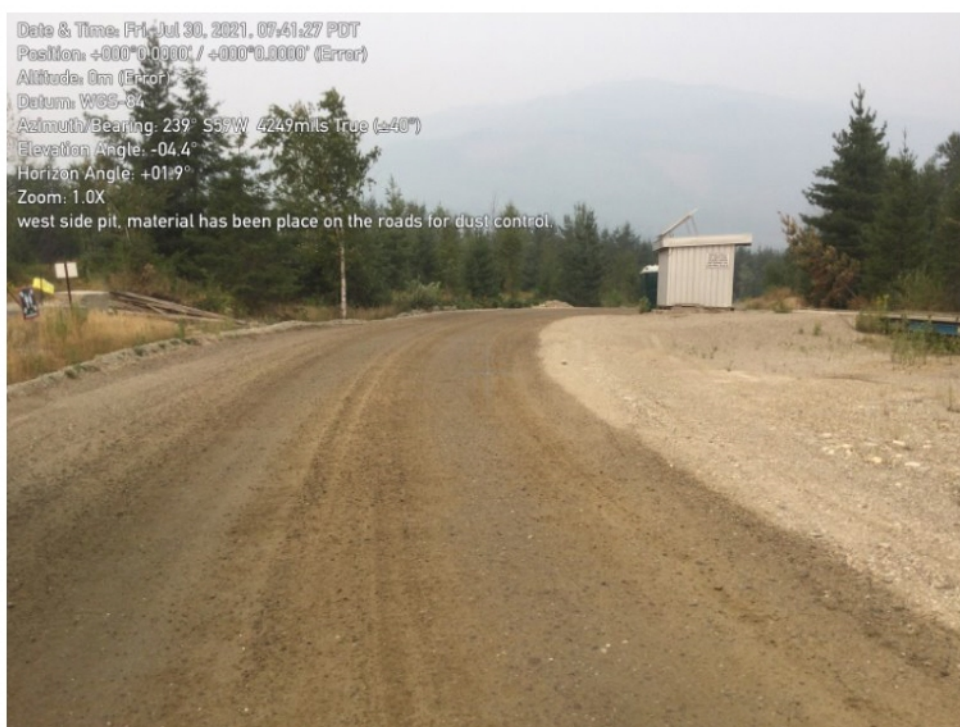
Image #6 - more dust suppression

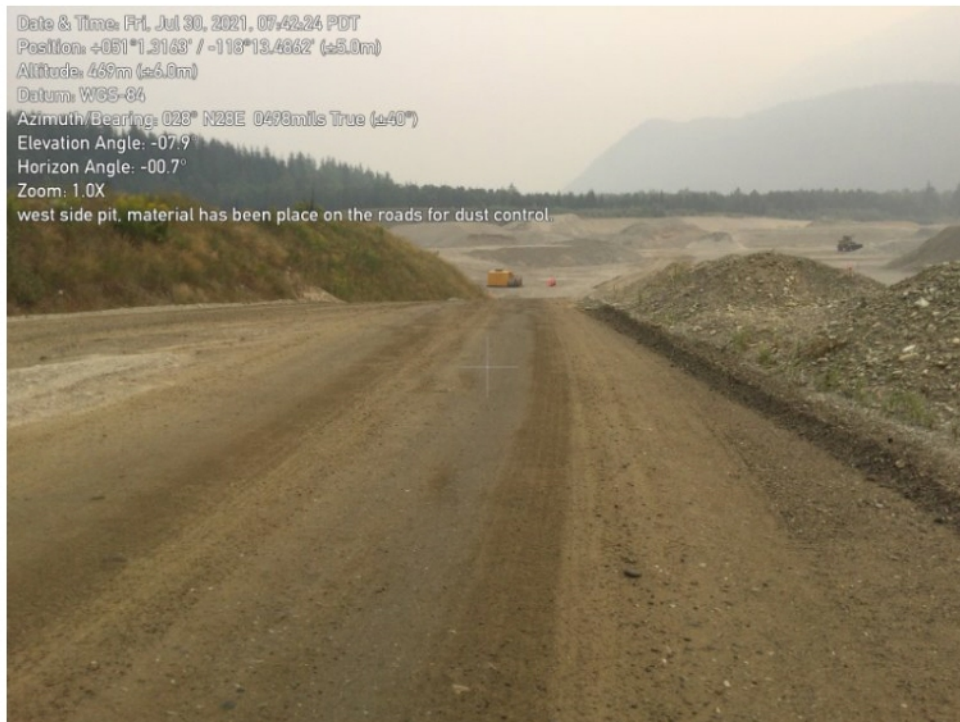
Image #7 - Dust suppression continued.
