# 2017 Dam Safety Inspection, Placid Tailings Storage Facility

Bull River Mine, Bull River, BC

December 22, 2017

Project No.:643035

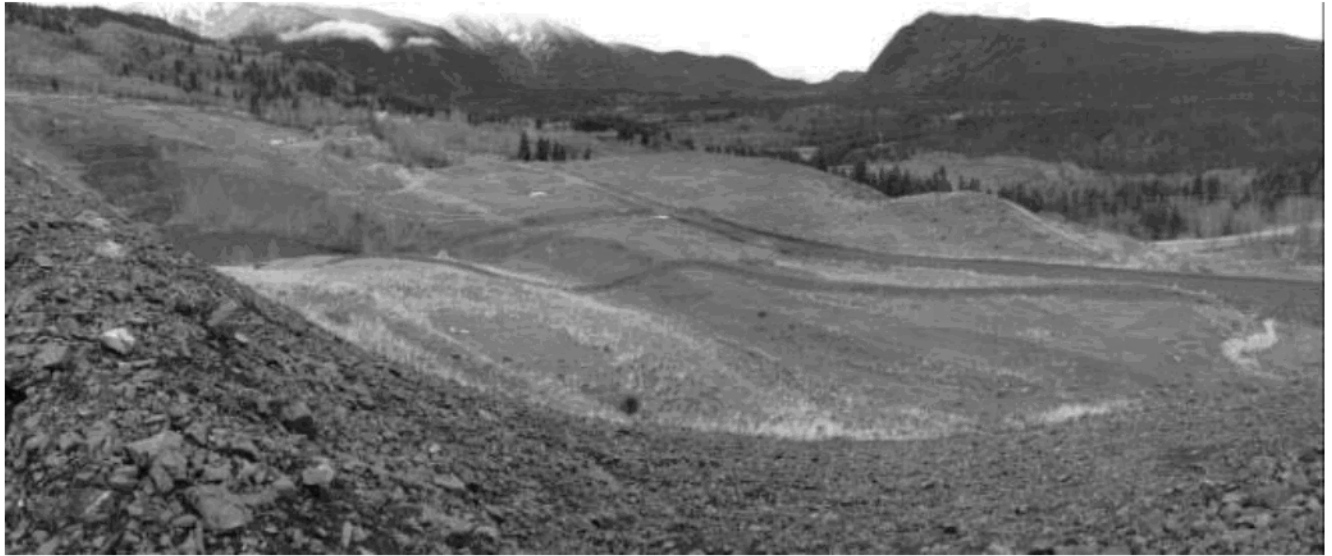
**Photograph 1: View to east from the waste dump in fall 2016. The primary settling pond / open pit is visible at the left edge. A haul road transects the TSF near the center of the photograph. The south (right) edge of the TSF crest has a depression hosting the old washout gully. The TSF surface slopes north (left) to the settling pond, with ditches and a culvert under the haul road.**

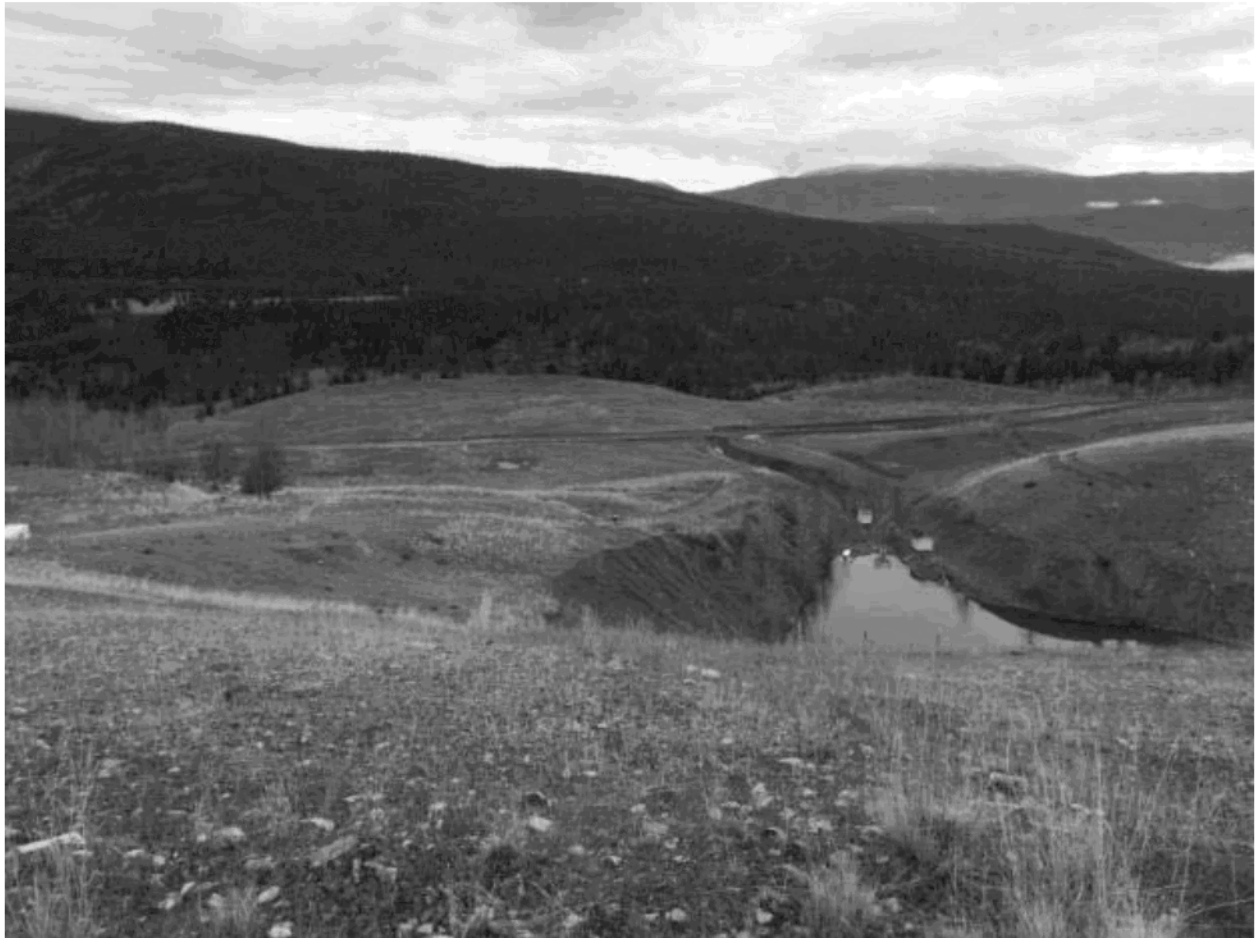
**Photograph 2: View to the south from a road above the open pit / settling pond in fall 2016. The TSF is in the center background, and the Bull River canyon is located in the background beyond the TSF. Ditches draining to the settling pond are visible, and the pond is pumped daily to the southwest in pipes to old Burntbridge Creek. The old washout gully is visible just above (south) the settling pond in the photograph, beyond the haul road.**

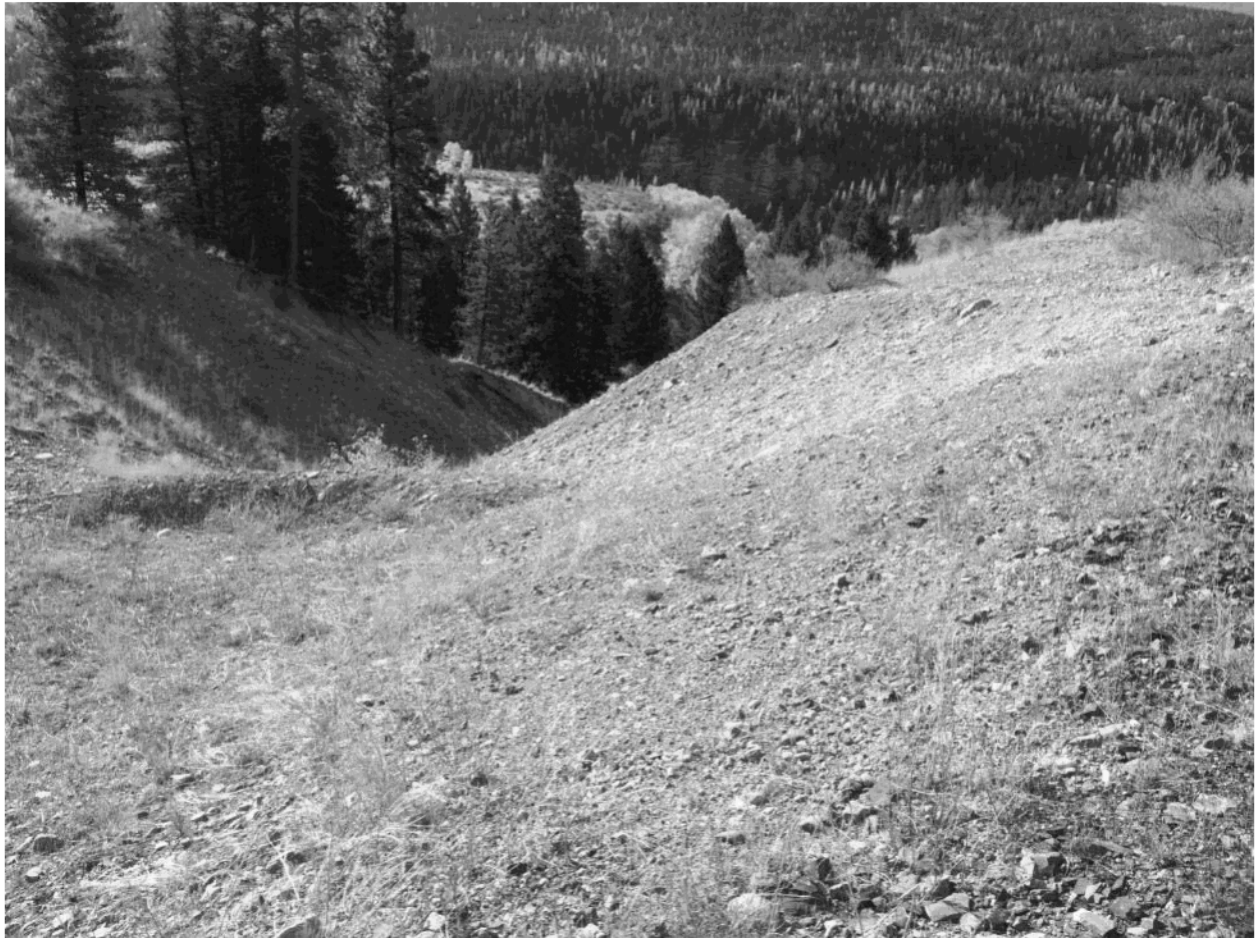
**Photograph 3: View south down the old washout gully to the Bull River Road from the TSF crest. Dam soils consist of silty sands with gravels and cobbles. The side slopes were repaired and recontoured in 2015. Cross berms were installed. The TSF surface, behind the photographer, was shaped and ditched to shed water in the opposite direction from this gully, north toward the settling pond. No changes were observed compared to 2016.**

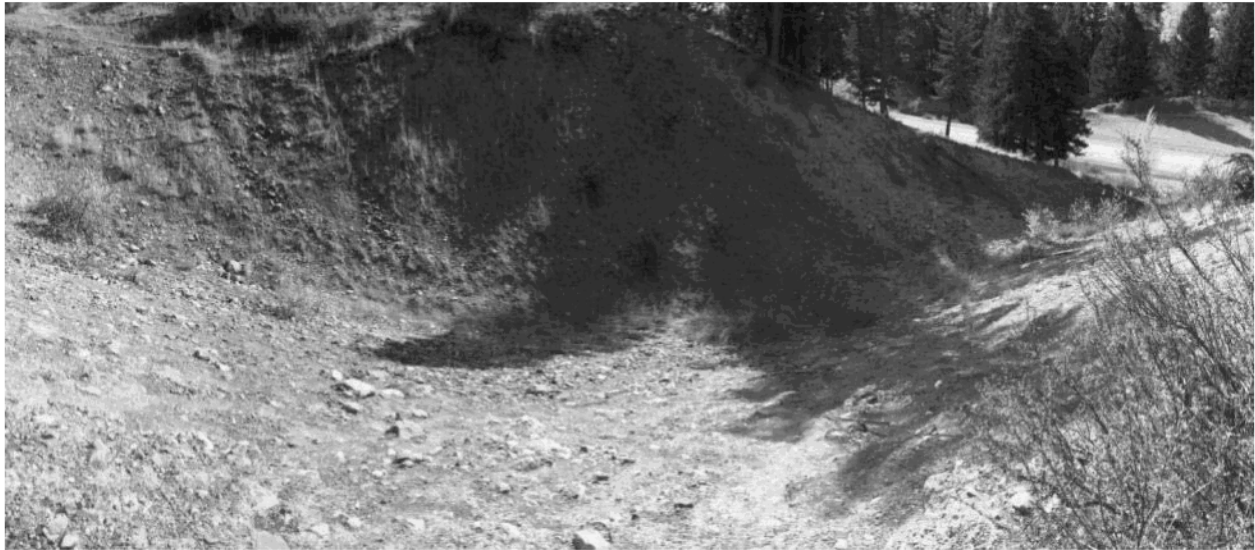
**Photograph 4: View to the south to the Bull River Road, showing the lower end and deposition zone from the old washout gully. The gully was stabilized in 2015 and TSF surfaces were modified to ensure surface water, if any, would flow north away from the crest of this gully.**

The old washout gully in the south TSF face, shown in various figures and photographs above, was repaired in 2014 to 2015, and the TSF surface shaped so that only direct precipitation on the gully footprint could form any source of surface water inflow.

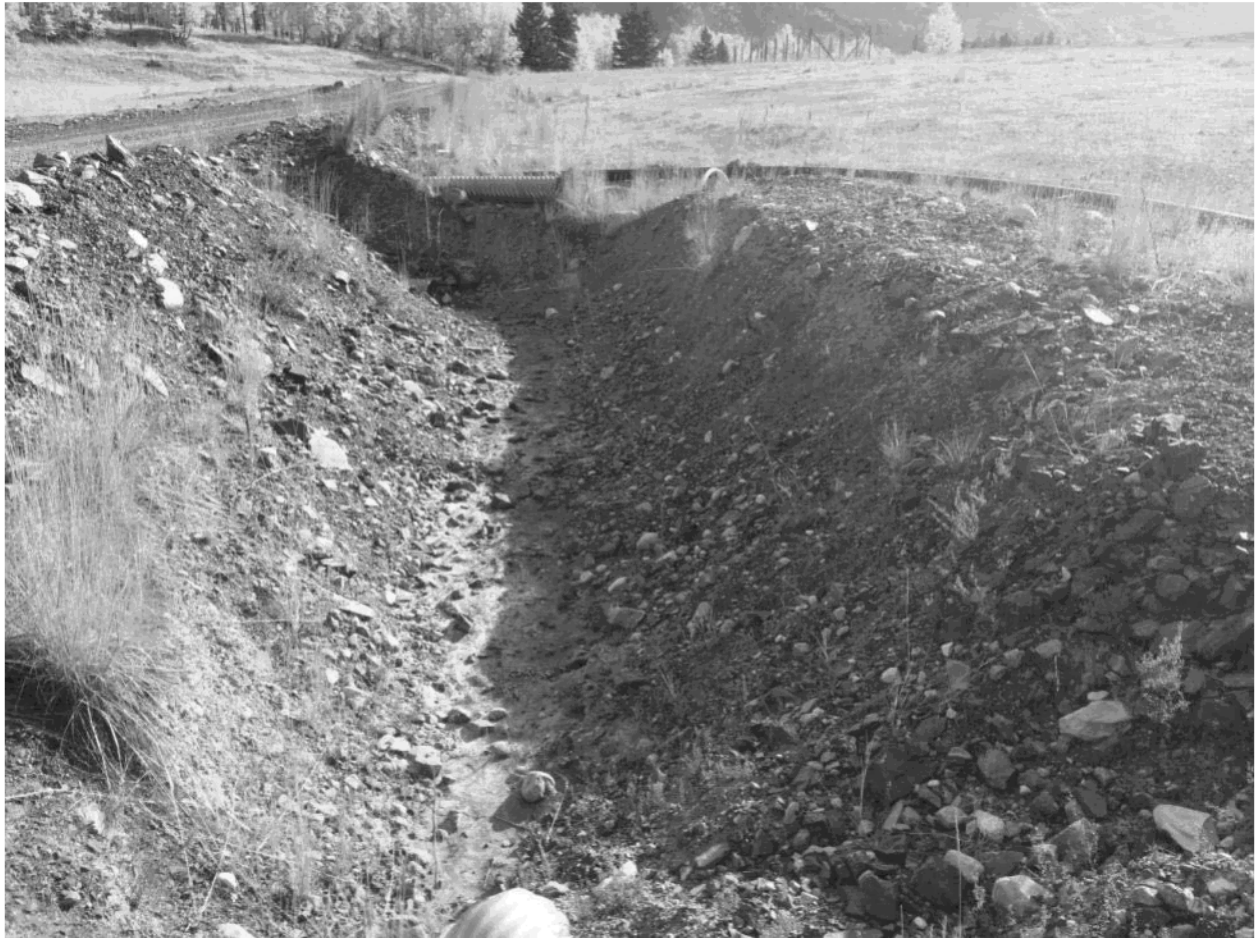
**Photograph 5: View to east at the haul road through the TSF. The foreground ditch and culverts were constructed in 2015 to ensure any surface water would flow north to the primary settling pond in the old open pit, situated left of this photograph.**

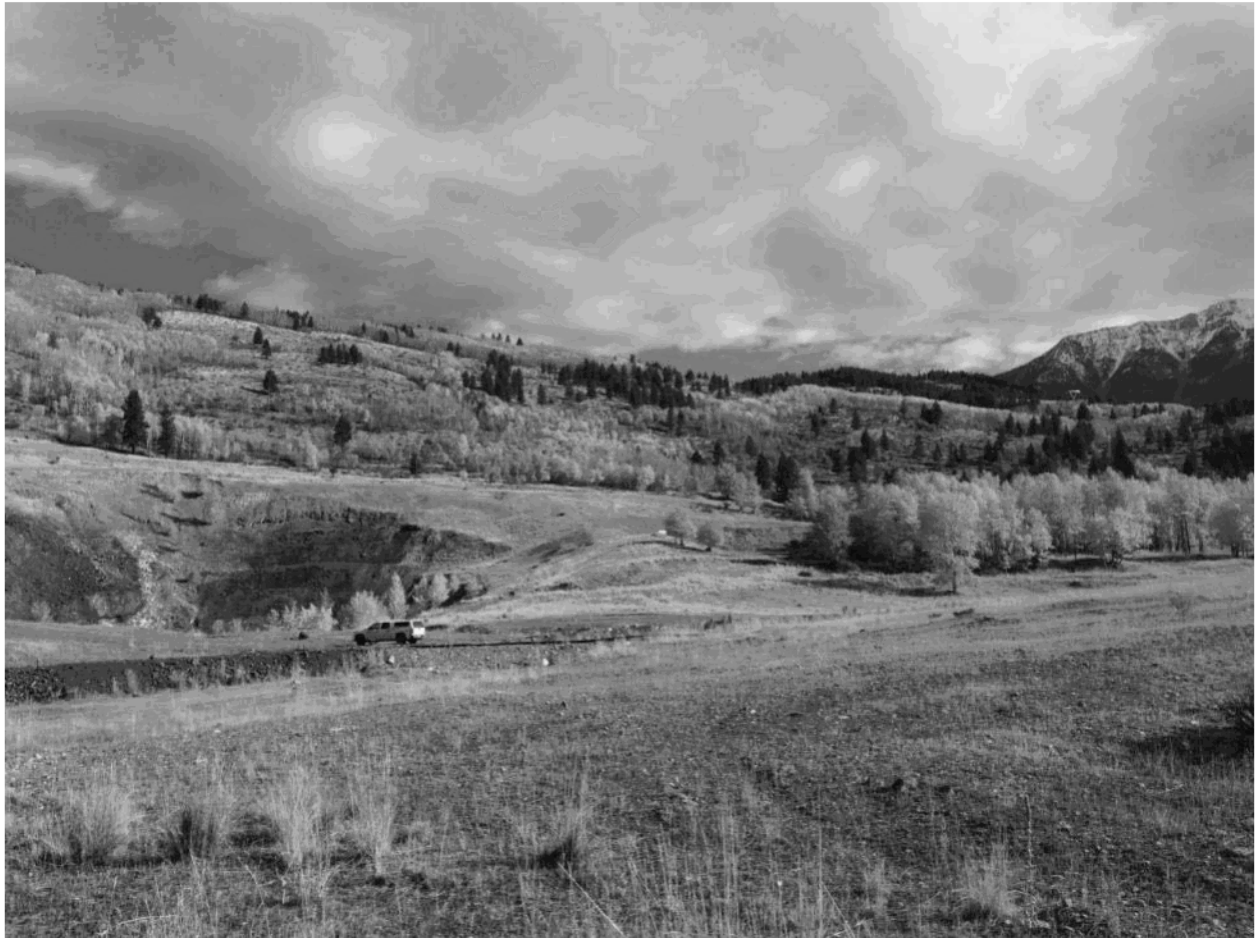
**Photograph 6: View to northeast to terrain on the north fringe of the TSF, with the old open pit at the left edge of the photograph. The soils are relatively porous, and terrain graded toward the pit or to ditches flowing to the open pit situated just beyond the white pickup truck.**

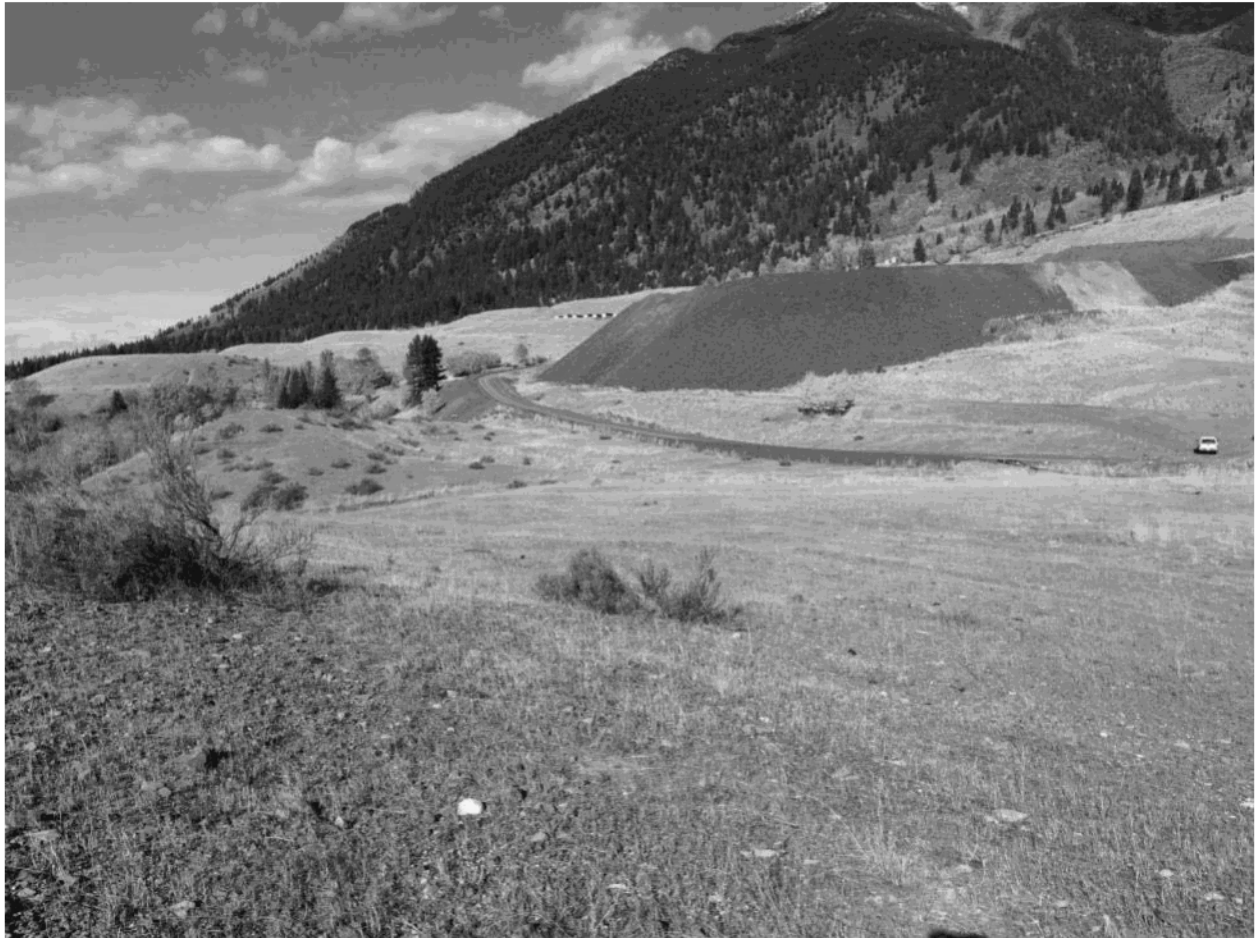
**Photograph 7: View to the northwest from the TSF south crest toward the haul road to the ore stockpile. Burntbridge Creek flows from the mountain basin in the upper right background.**

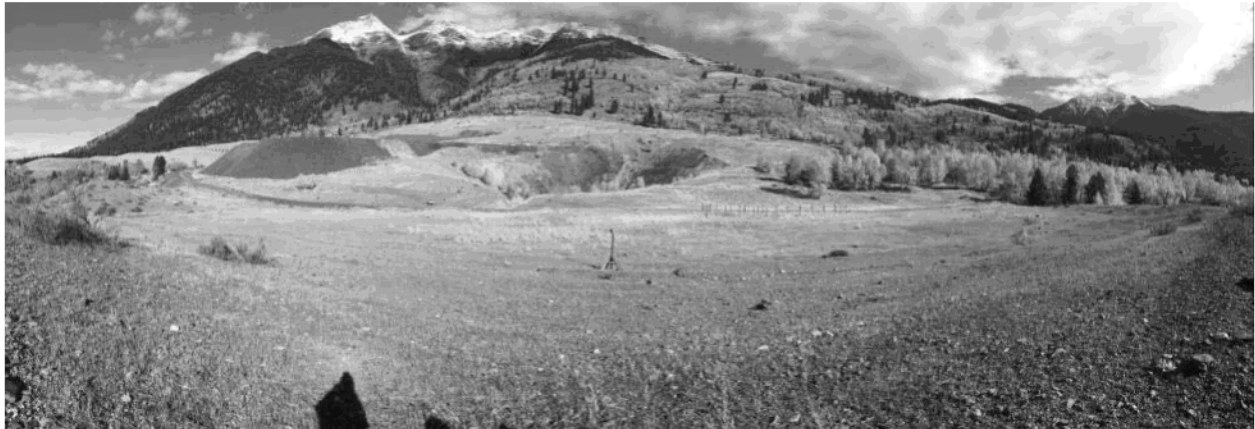
**Photograph 8: Panoramic view to the north across the TSF from its south crest, showing the old open pit in the center, and the haul road aligned east-west across the Placid TSF.**

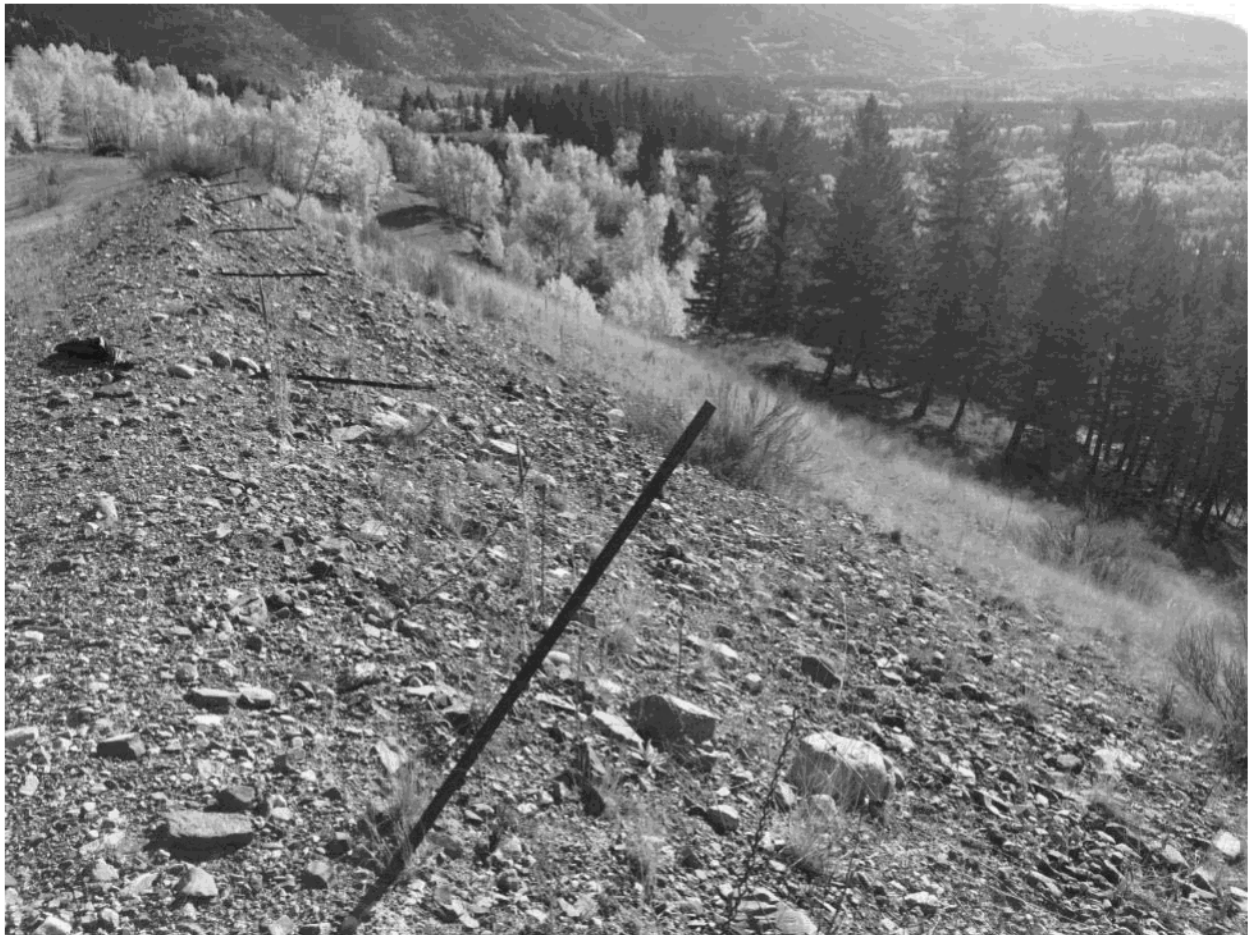
**Photograph 9: View to the east along the south TSF crest, with the Bull River Road in the lower right background. The embankment's downstream face appeared to be free from signs of instability and erosion along its perimeter.**

The dam crest was recontoured so its undulating surface would obscure visually detectable evidence of settlement or slumping. The downstream dam face did not exhibit signs of bulging, slumping or cracking, nor cracking on or near the slope crest.
