## Report of Inspector of Mines - Permitting

<b>Mine Name/Number</b>	Porter-Idaho 0101399	<b>Visit Date</b>	2018-08-15
<b>Type of Mining</b>	ES. EXPLORATION - SURFACE	<b>Location</b>	
<b>Latitude/Longitude</b>	55.90611, -129.92611	<b>Northing/Easting/Zone</b>	442102, 6196017, 9U
<b>Manager</b>	Ron Nichols	<b>Permittee</b>	Mt Rainey Silver Inc
<b>Phone Numbers</b>	(604) 684 8725	<b>Address</b>	650 - 1021 West Hastings Street Vancouver BC V6E 0C3
<b>Email</b>	mcathro@skeenaresources.com		
<b>Inspector</b>	Andrea Ross, INSPECTOR	<b>Accompanying Inspector</b>	Megan Frederick, Inspector;
<b>Address</b>	2nd Floor, 3726 Alfred Avenue Smithers, B.C. V0J 2N0		
<b>In Attendance</b>	George Alexcee, Skeena; Brett Godwin, Skeena		
<b>Copies to</b>

On August 15, 2018 Andrea Ross, Senior Inspector of Mines, Permitting and Megan Frederick Inspector of Mines, Permitting conducted an onsite inspection of the Porter Idaho Property to verify compliance with the *Mines Act*, the *Health Safety and Reclamation Code for Mines in British Columbia* and Permit MX-1-985. The following orders are a result of this inspection.

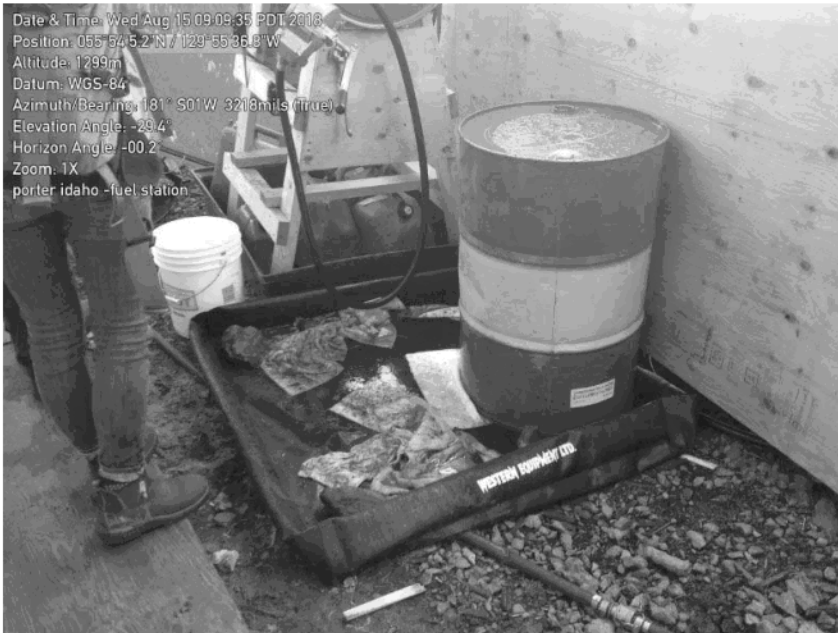
It was observed that the secondary containment tray at the fuel station contained debris and fluid.

Photo is of the secondary containment at the fueling station.

The manager shall ensure that all secondary containment remains free of debris and water.

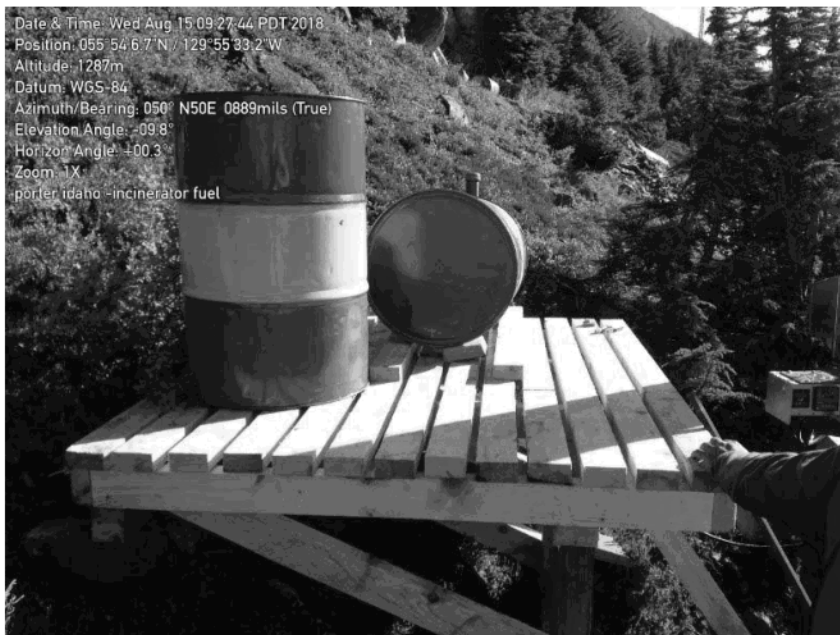
It was observed that fuel drums at the incinerator did not contain secondary containment and should be better secured to the platform.

The photo illustrates the fuel drums without secondary containment at the incinerator.

The manager shall obtain a secondary containment unit under the incinerator fuel drums, in addition to a spill kit and fire extinguisher.

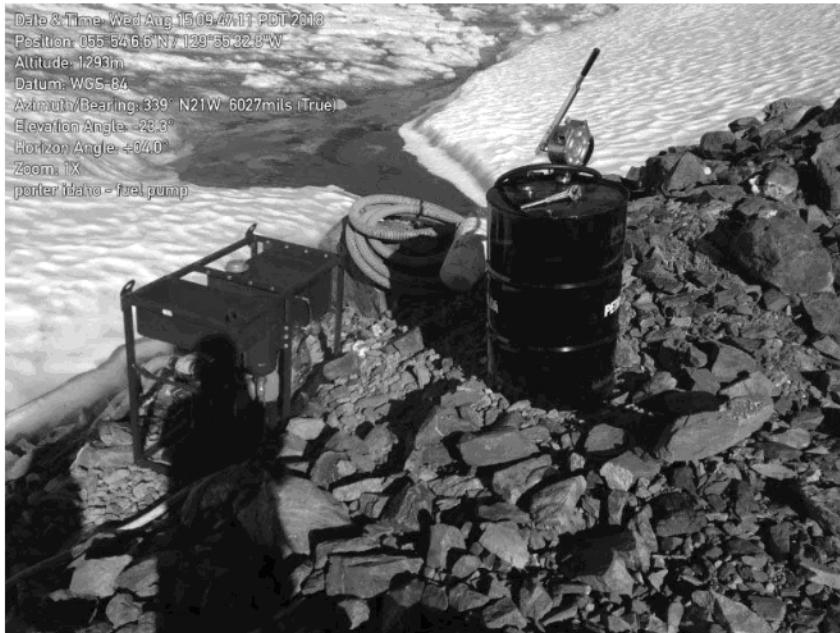
It was observed that the fuel drum near the water pump supplying the drill did not have secondary containment, a spill kit or fire extinguisher and the fuel drum did not have a self-sealing break-away fitting on the fuel delivery hoses. Please refer to the BC Fire Code in Div. B, Part 4, Section 4.6.5.2(4).

The photo illustrates a fuel drum near the drill pad and the water pump. It is missing a spill kit and secondary containment.

The manager shall install self-sealing breakaway fitting on all fuel delivery hoses.

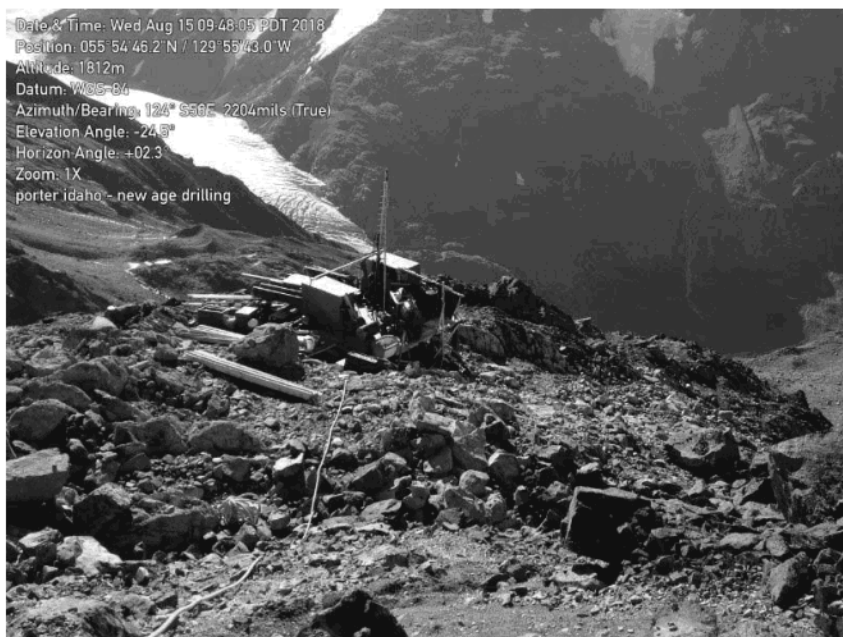
It was observed that auxiliary fuel containers, aka Jerry Cans, at the drill did not have secondary containment.

The photo illustrates the drill during the move. In the photo the Jerry Can did not contain secondary containment. Two fuel barrels (empty) were waiting to be removed.

The manager shall ensure all fuel containers have adequate secondary containment as per the Code.

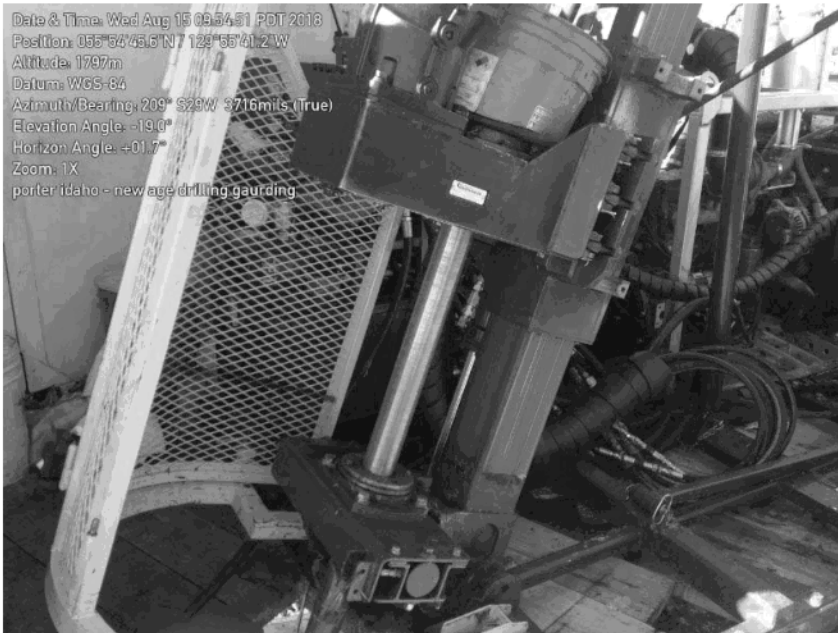
It was observed that guarding was not in place on the drill (both on the rods and over the wireline drum).

Guarding was missing from drill. We talked with the driller about this where he said he would have the cage on when drilling.

The manager shall ensure all pieces of rotating equipment are effectively guarded.

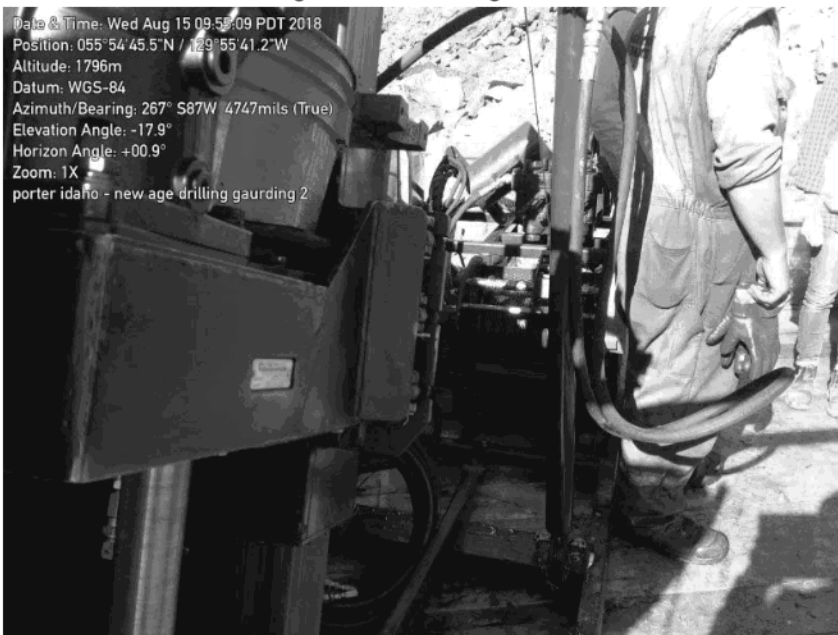
Guarding over wireline drum is missing.
