Report of Inspector of Mines

Geotechnical

Inspection No.: 099689
Mine No.: 0500770
Permit No.: M-226
Total Orders: 9

Mine Name: Max Molybdenum Mine
Location: Trout Lake, B.C.
Owner, Manager: Dan Omeniuk
Company: MX Gold Corp.
Address: 1300 Redonda Street,
Winnipeg, MB R2C 3T7
Workers Contacted: None
Type of Mining: Metal – Underground (MU)
Date of Inspection: 2018-08-29
Inspector: Jennifer Brash, M.Eng., P.Eng., Senior Geotechnical Inspector
Accompanying Inspectors: Paul Hughes, Andrew Craig
In Attendance: None
Copies to: Al Hoffman, Diane Howe, Lowell Constable, Jennifer McConnachie, Tania Demchuk, Alan Day, Kathie Wagar; Heather Narynski

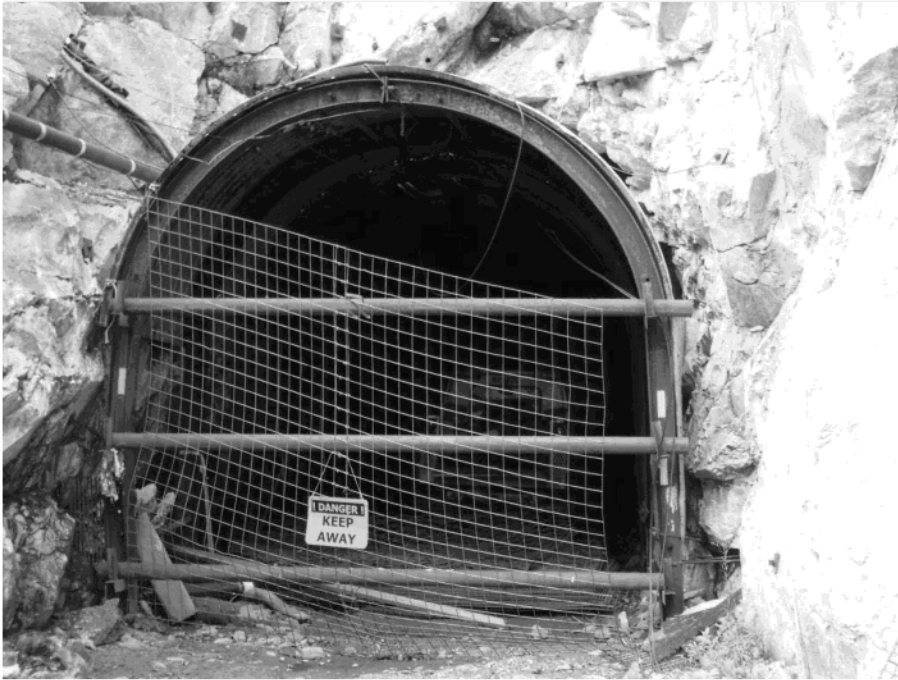
Photo 1: West Portal, note loose mesh

- Prior inspection by a Professional Engineer;*
- Written authorization for entry provided by a Professional Engineer; and,*
- Completion of any and all ground control measures recommended by the Professional Engineer.*

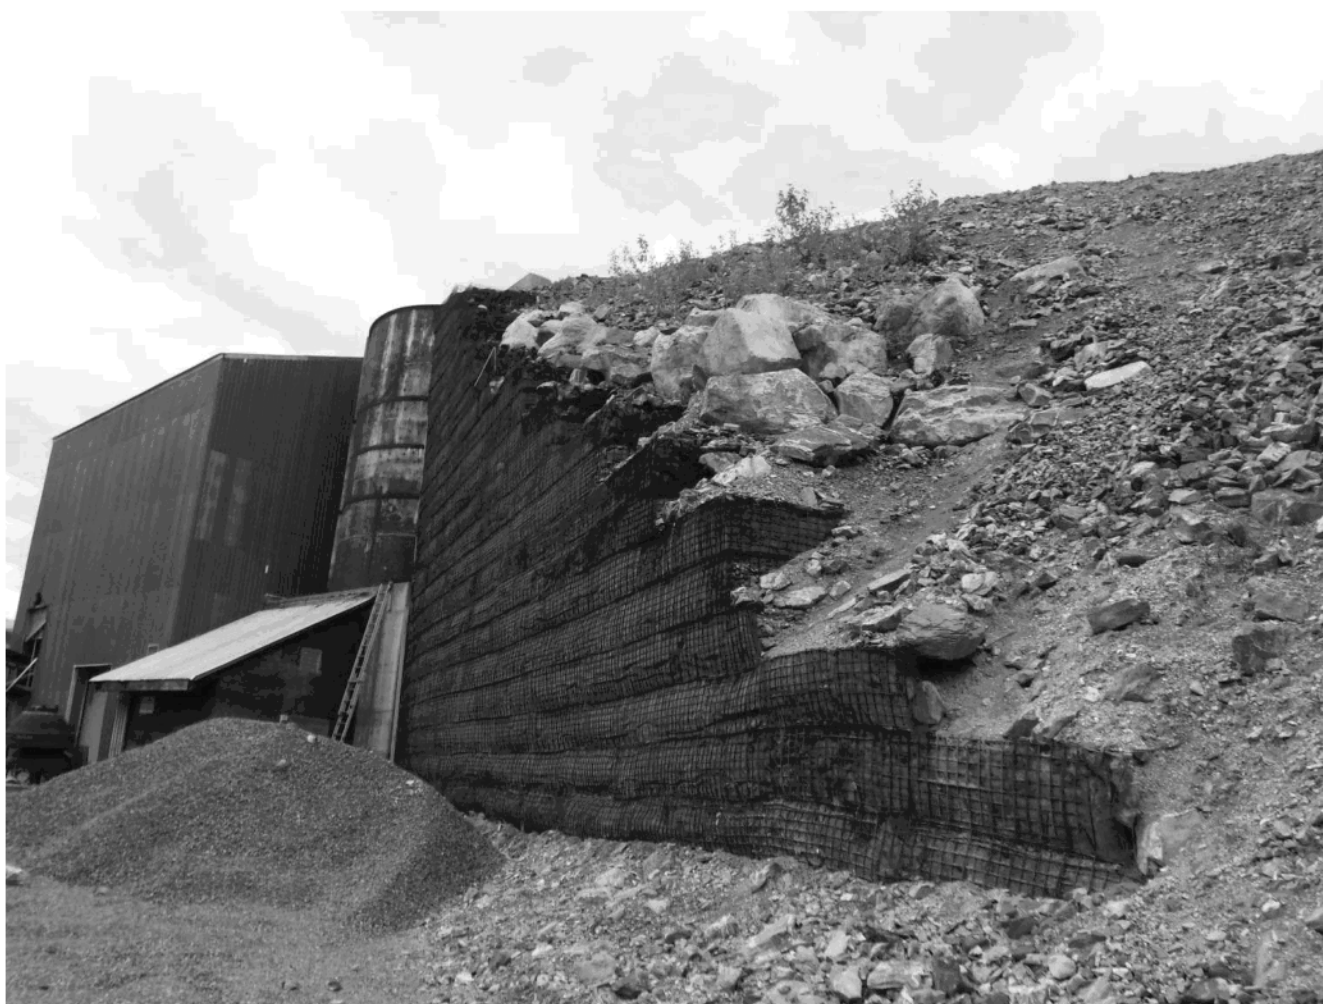
The waste rock dump is located upslope of the mill site and is partially retained by MSE walls. The MSE wall segment to the west of the ore bin appeared to have experienced visual bulging/deformation and rock was observed to be sliding down off the wall crest area and accumulating at the wall toe (Photo 3).

Photo 3: MSE wall retaining waste rock dump

Should usage of the ore bin, waste rock dump, or areas beneath the MSE walls be required, an assessment of the MSE wall stability, signed and sealed by a Professional Engineer and including recommendations for a monitoring program, will be required.

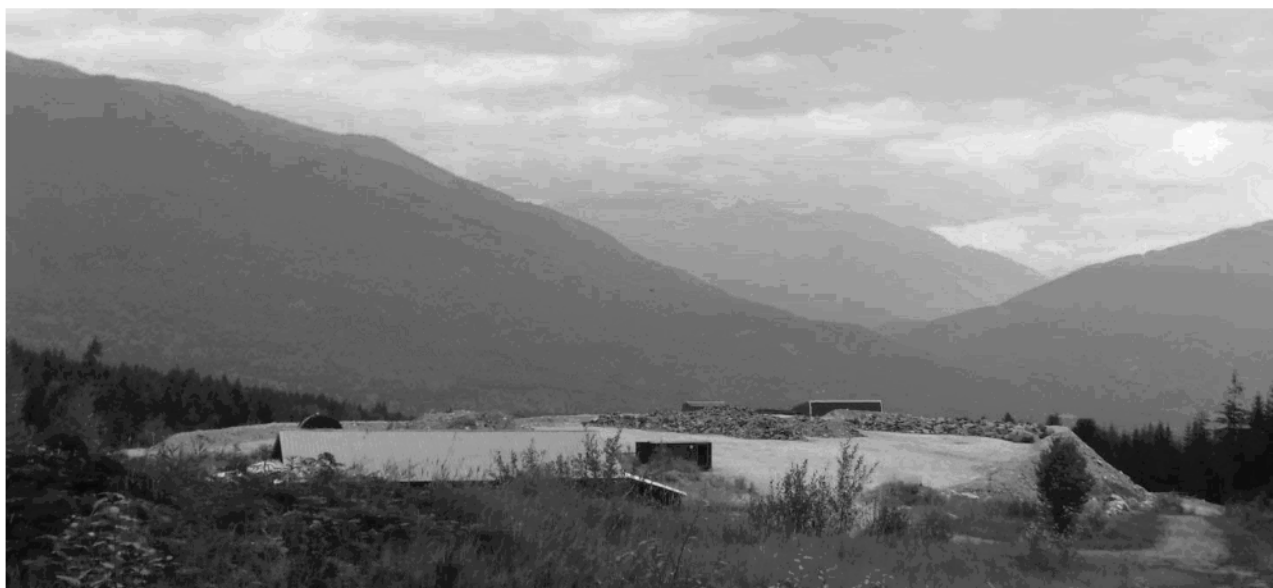
The crest of the dump was largely free of water and had berms present (Photo 4). Access roads are present at the toe of the dump in some areas; no rockfall catch ditches or berms were observed (Photo 5). A surficial failure was observed on a steep bank of waste rock, resting at angle-of-repose, adjacent to the surface repair shop (Photo 6). Berms are not present in this area.

Photo 4: Waste Rock Dump Crest

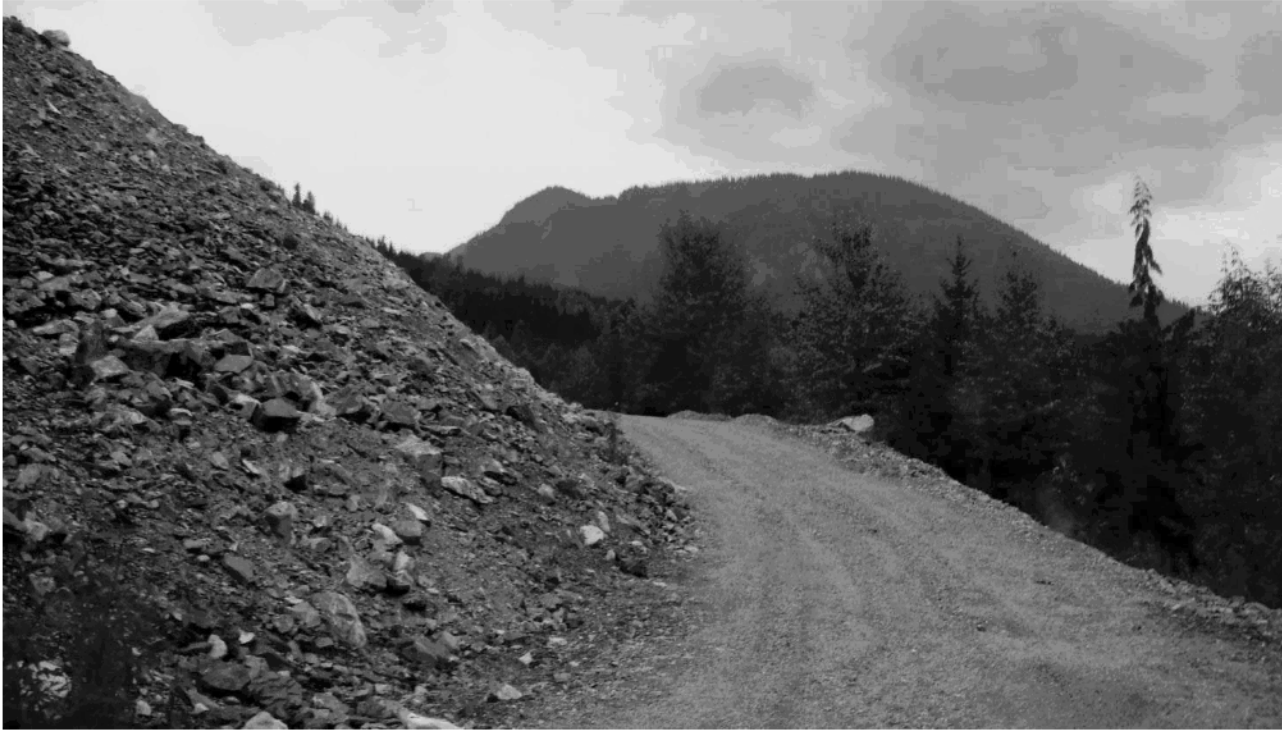
Photo 5: Access road at toe of dump

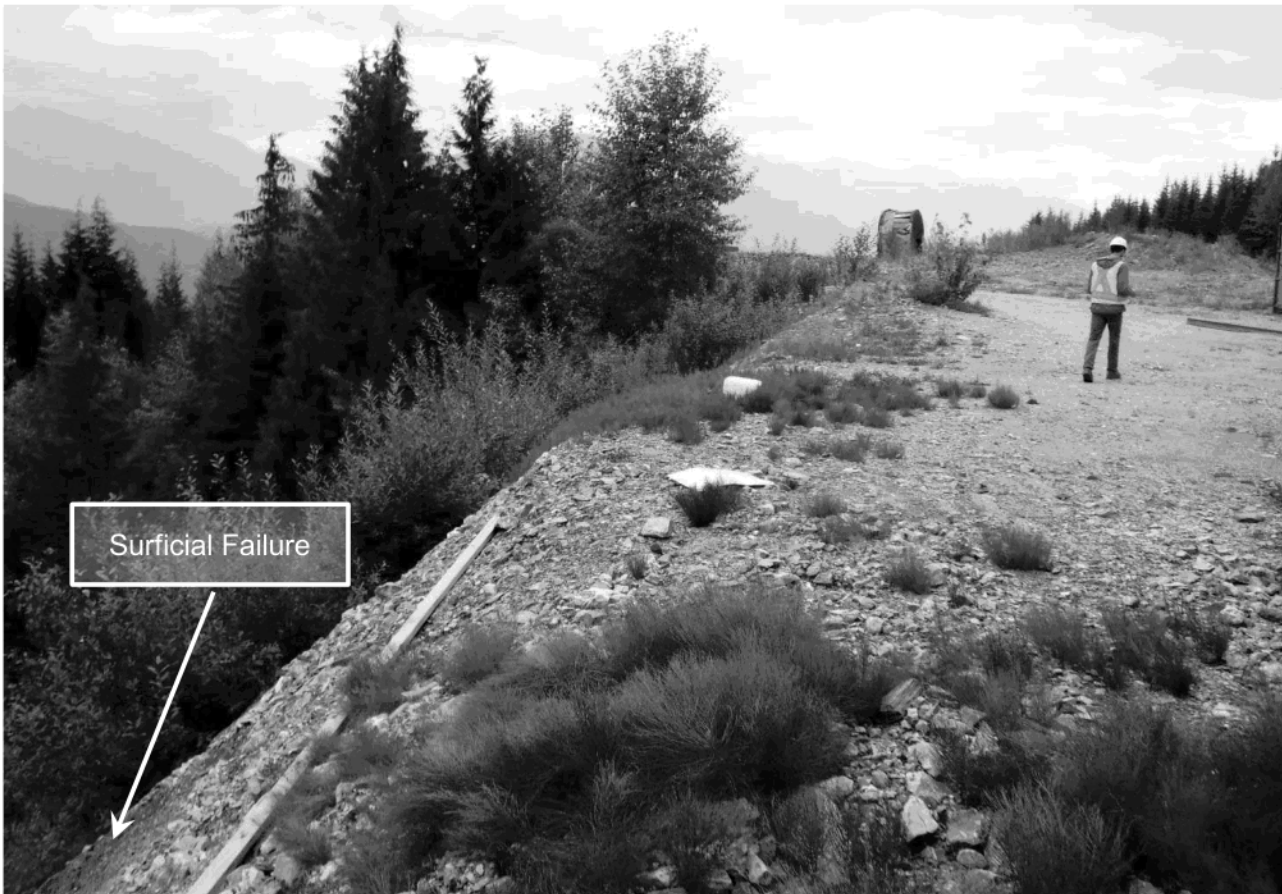
Photo 6: Steep slope adjacent to surface repair shop

Advisory 4: *Access to the steep bank near the surface repair shop should be restricted.*

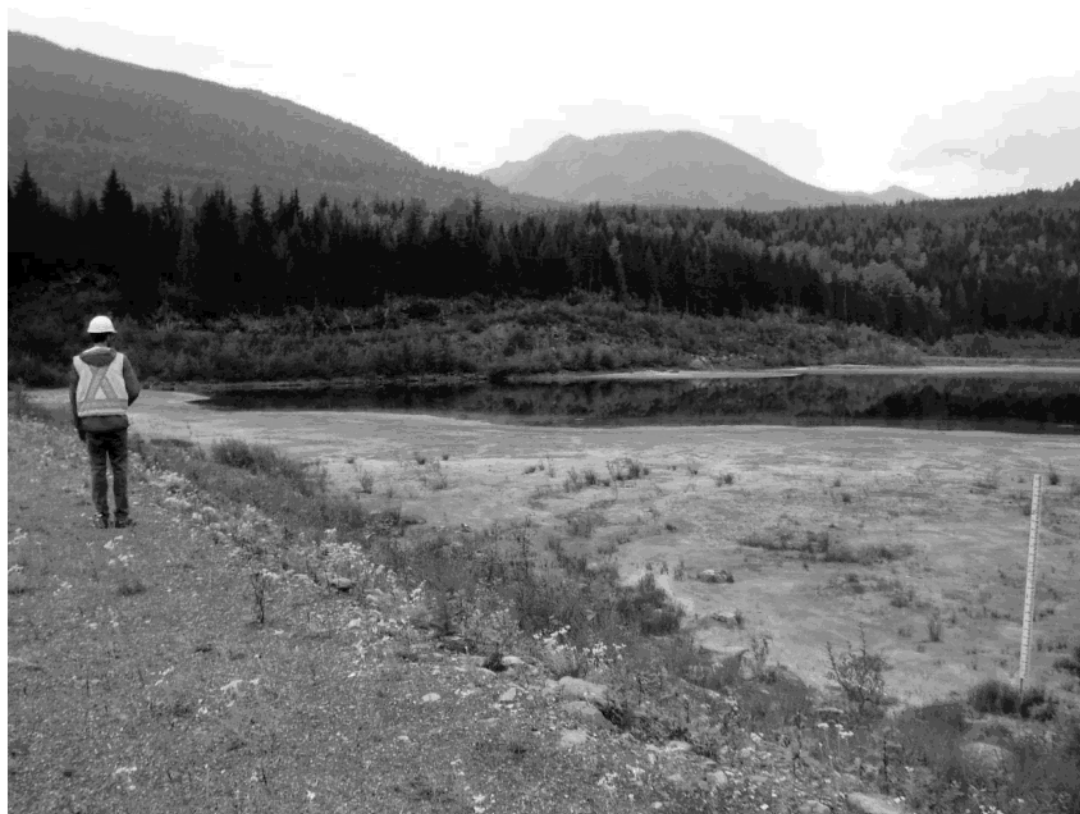
At the time of inspection, the TSF pond level was below the level of the tailings and staff gauge, resulting in exposed tailings beaches (Photo 8). However, water marks located near the right abutment of the Northwest Dam indicated that water had recently been approximately 1.5 m to 2 m higher. The impounded water was generally still (i.e. no surficial inflows were evident), with the exception of local areas of upward bubbling. One such area was observed within the pond to the upstream of the spillway area; here, bubbling was observed continuously for upwards of 5 minutes (Photo 9). Less consistently, bubbling was also observed along/near pipes from the Southeast Dam into the impoundment on the left side, near the roadway.

Photo 8: TSF, beaches upstream of Southeast Dam

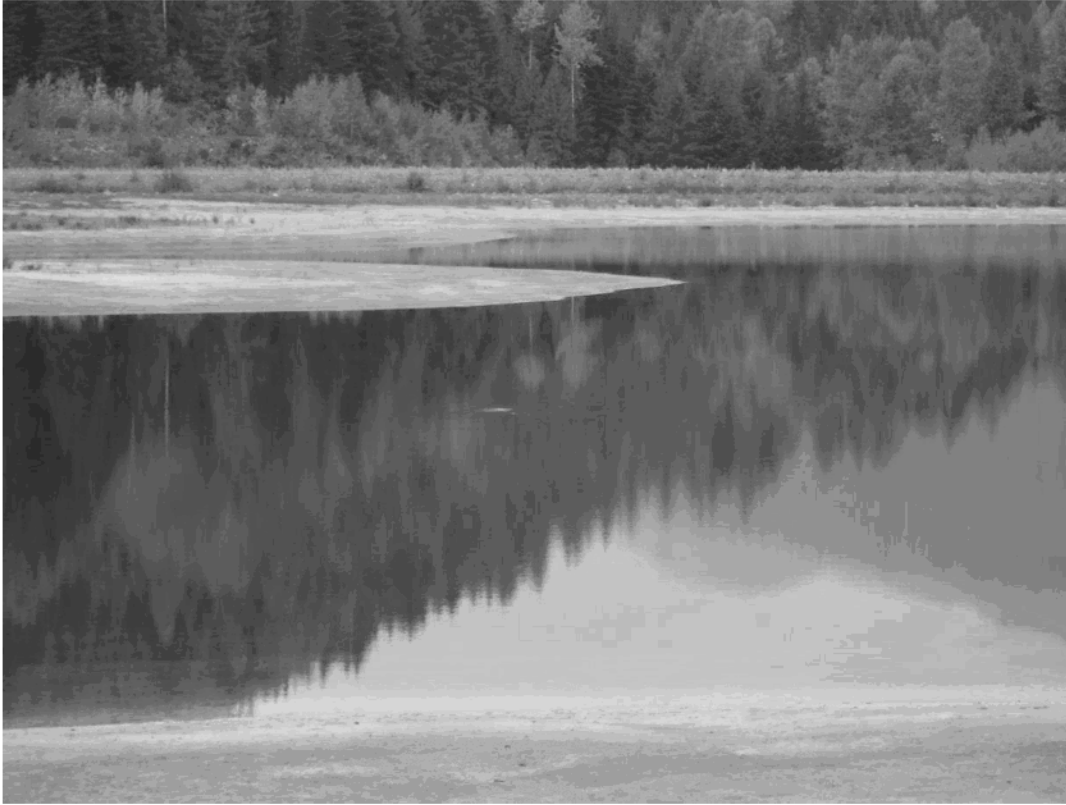
EMPR observed bubbling within the TSF pond and cracking along the upstream side of the Southeast Dam.

Photo 9: TSF, bubbling in pond, view from Southeast Dam towards Northwest Dam

Pursuant to Code clause 1.1.2, the Mine shall immediately implement a program of monitoring that includes the bubbling within the TSF pond, observation of the upstream tailings beaches and cracking along the upstream side of the Southeast Dam.

Pursuant to Code clause 1.1.2, the Mine shall submit to the Chief Inspector commentary from the TSF Engineer-of-Record assessing the causation of TSF pond bubbling and upstream cracking at the Southeast Dam. This can be submitted as part of the 2018 DSI, if desired.

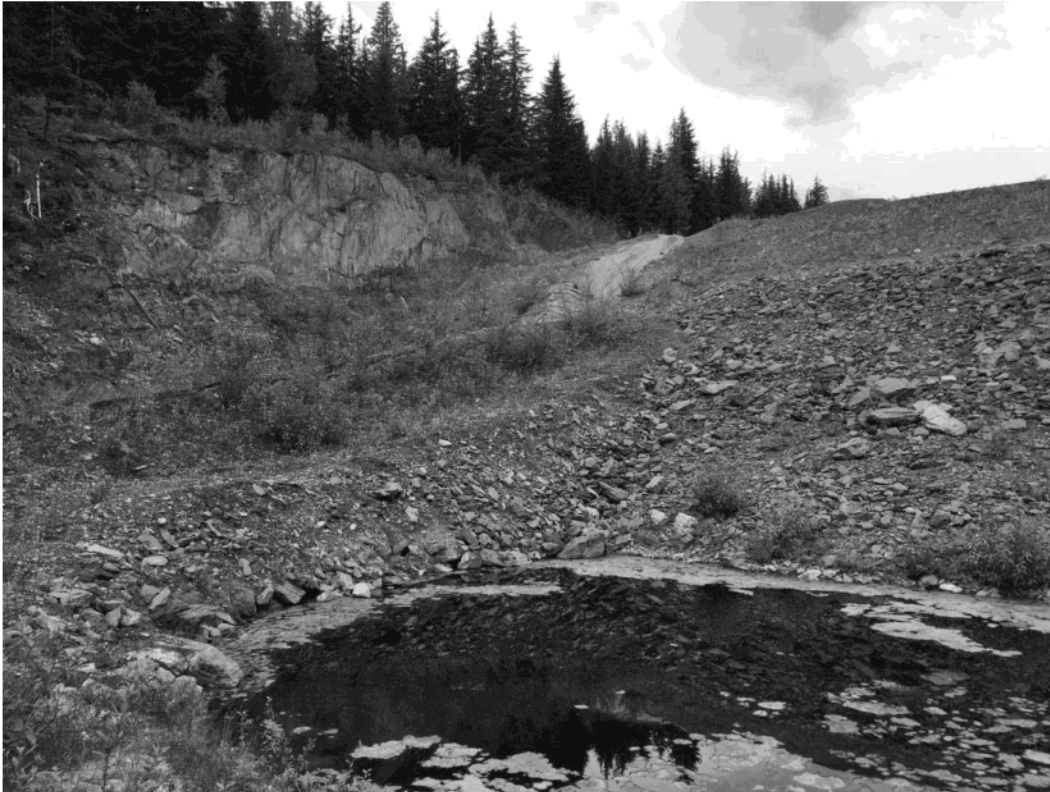
Preparation for a future lift at the Southeast Dam was evident; dental concrete and rock foundation preparation is evident on each abutment. The downstream dam slope has rockfill on the lower portion and finer-grained fill exposed on the upper portion and crest (Photo 10). Local ditching was present at each abutment to direct surface water flows off the dam. The dam crest was free of ponded water and appeared to grade into the pond. The upstream slope of the dam did not have erosion protection present. A small crack (approximately 2 m long and 0.5 cm wide) was observed on the upstream side of the dam; its location was marked with a small rock pile to facilitate monitoring by site personnel. Ponded water was observed downstream of the left side of the dam.

Photo 10: TSF, Southeast Dam downstream slope, note spillway towards left

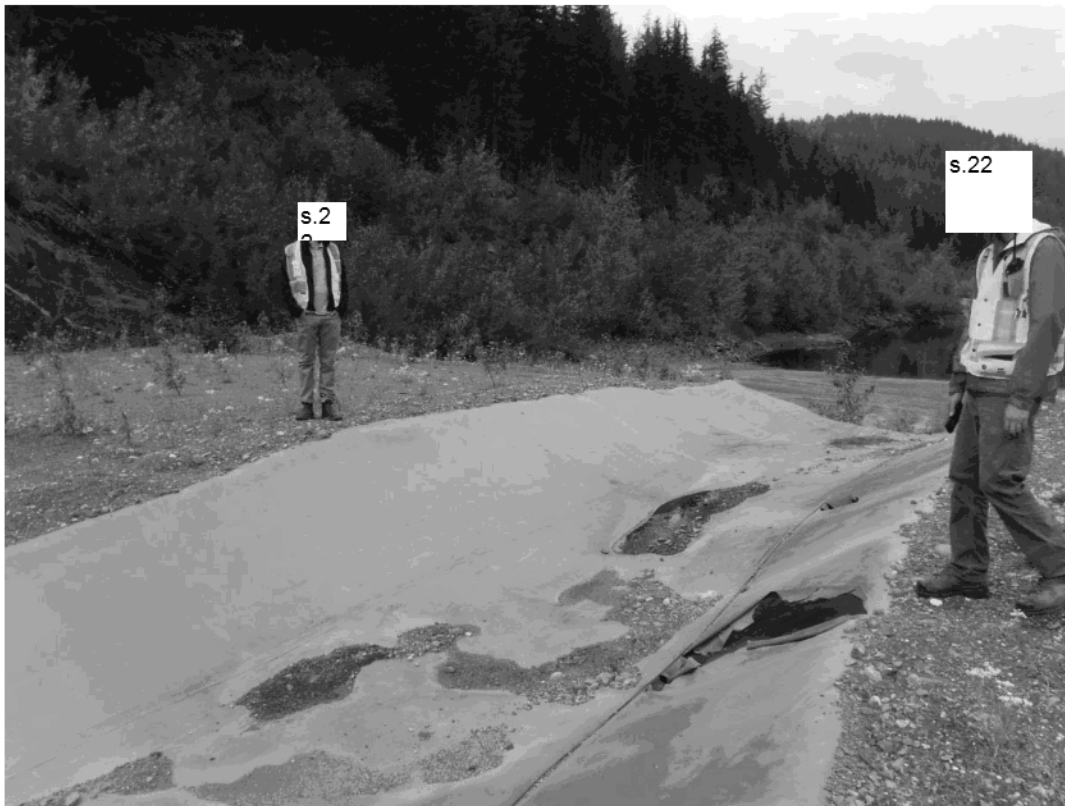
High-water marks were observed significantly above the pond level at the time of EMPR inspection. The temporary spillway in place is damaged.

Photo 11: TSF, Southeast Dam spillway

- Provide pond level records for 2018;*
- Confirm if the temporary spillway discharged at any time in 2018; and,*
- Submit a statement from the TSF EOR confirming the adequacy of the temporary spillway or recommending remedial works/an updated spillway design (as appropriate).*

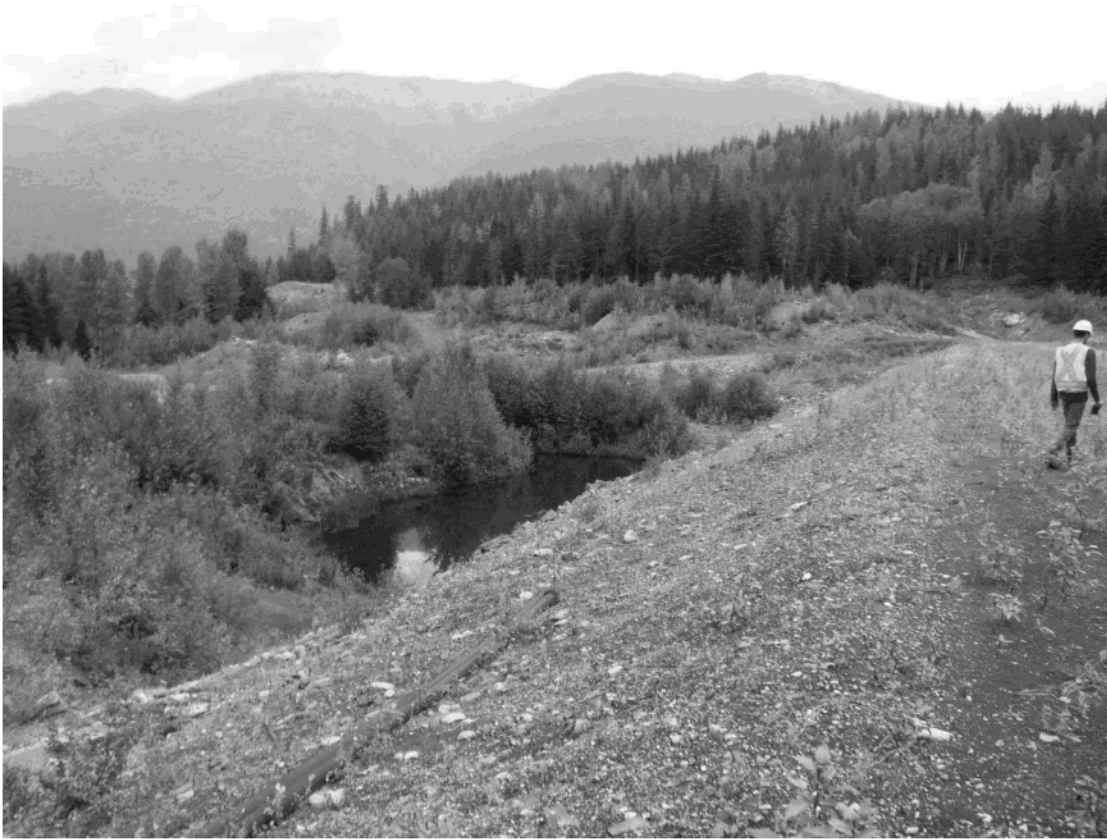
The Northwest Dam conditions are similar to those at the Southeast Dam – the crest is generally well drained, local ditching diverts upslope water off the dam crest, tailings are exposed adjacent to the dam face, finer fills are exposed on the downstream slope and crest, and no erosion protection was present on the upstream dam face (Photo 12, 13). Some local evidence of ponded water was observed on the dam crest, particularly along the core-downstream shell interface. Minor erosion gullies were observed on the downstream face. Ponded water was present adjacent to the downstream toe of the Northwest Dam, and an outlet for this water was not readily observable (Photo 13).

Photo 13: TSF, Northwest Dam downstream slope and ponded water at toe

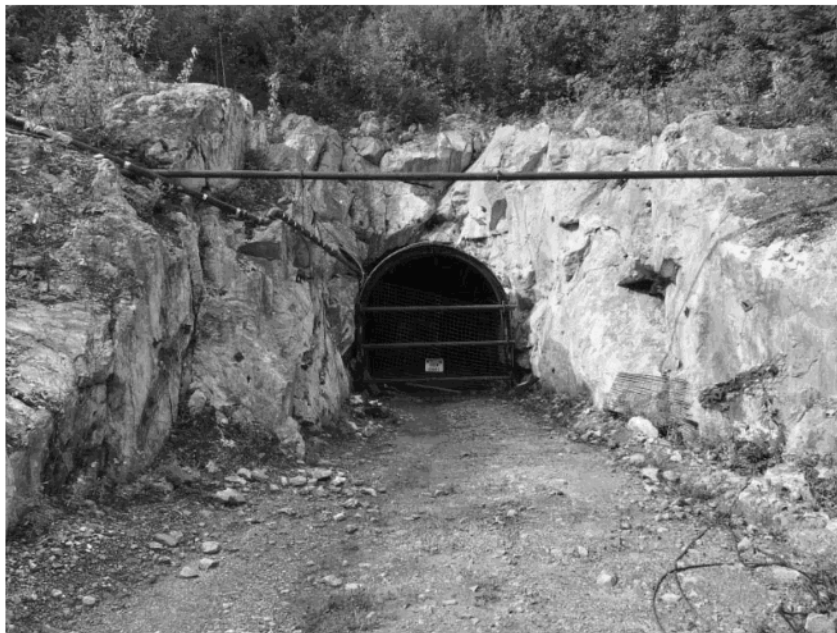
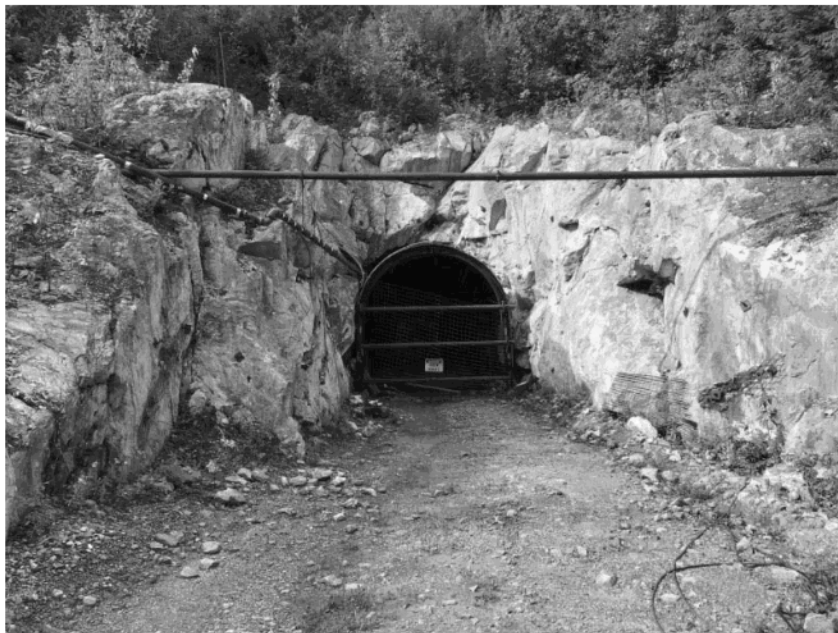
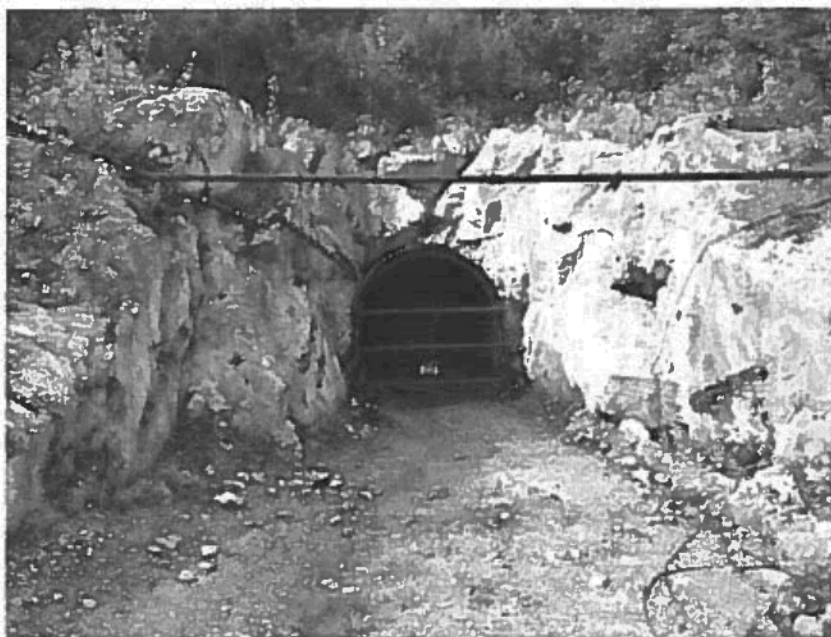
The East and West Portals are located southwest of the Mill and were gated and fenced to prevent access, but were not adequately secured (Photo 1 and Photo 2). At the time of the inspection, water was actively flowing from the East Portal via a drainage channel and from the West Portal via a pipe into a settling pond. Iron staining was observed in the drainage channel and settling pond (Photo 2 and Photo 3). Subsequent drainage from the settling pond was piped approximately 1 km to a series of secondary settling ponds.

Photo 1. West Portal.

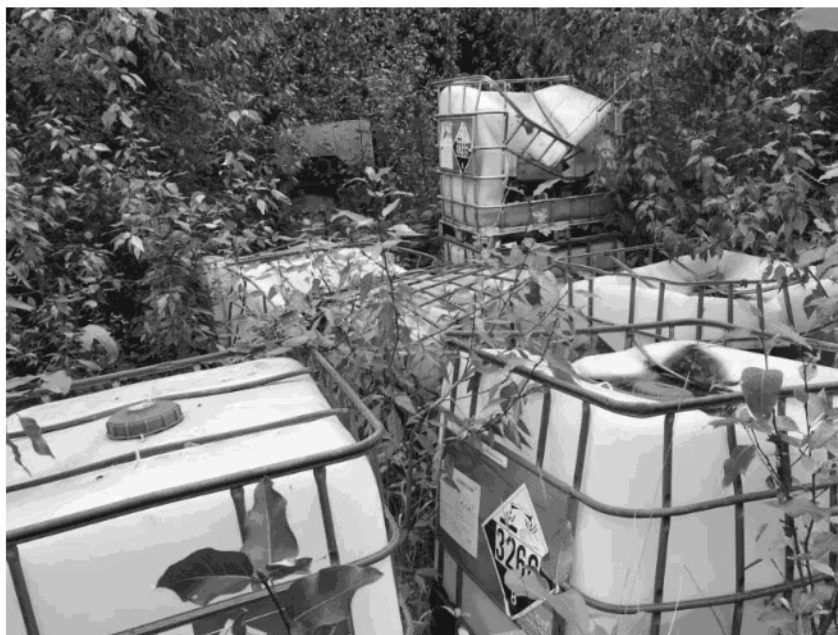
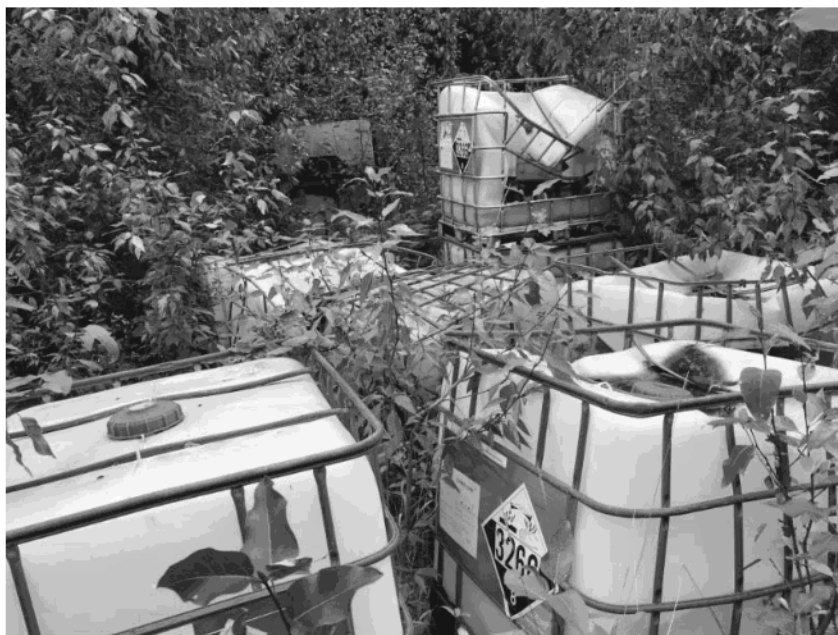
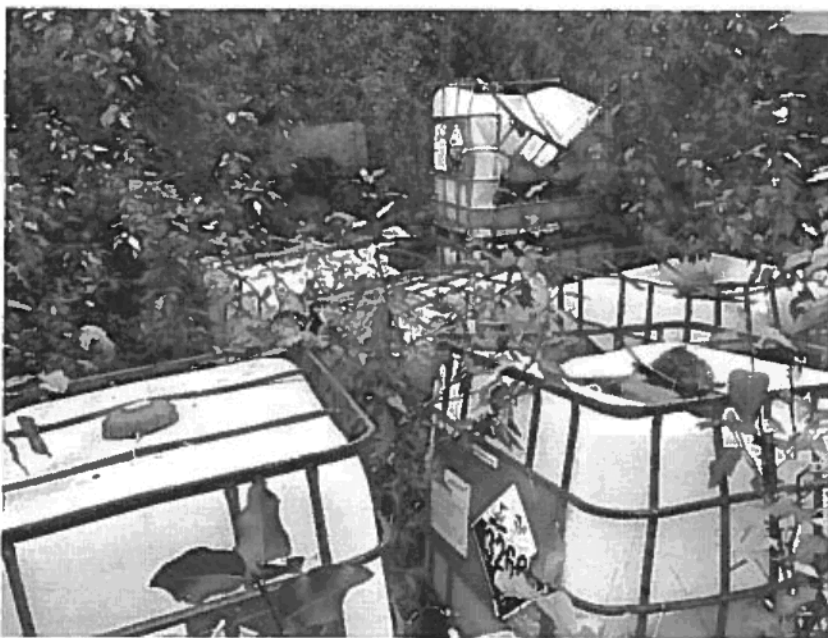
Numerous waste storage containers and scrap materials were observed in an unmarked lay down area during the August 2018 site inspection (Photo 4 and Photo 5). Many of the reagent storage containers appeared to be damaged and holding unknown materials/fluids (Photo 4). Similar observations were documented in the 2015 Reclamation Inspection Report #54096.

Photo 4. Damaged reagent storage containers holding unknown materials/liquids.

Pursuant to Sections 2.3.4, 2.3.6 and 10.7.19 of the Health, Safety and Reclamation Code for Mines in BC, the Mine Manager must ensure hazardous waste materials are handled appropriately by trained persons with spills or releases cleaned up as soon as possible by trained persons. Contaminated and hazardous materials shall be disposed of appropriately off-site if they cannot be returned to the manufacturer.

In addition, the Permittee shall submit a Spill Prevention and Response Plan to the Chief Inspector by October 15, 2018, that specifies procedures for disposal and removal of all hazardous materials not in use on-site, training of site personnel to handle hazardous materials and respond to spills, and investigate contaminated ground and water caused by spills and releases of hazardous materials. All stored hazardous materials must be appropriately labeled with MSDS posted in storage locations for reference. Note, this is a repeat order from the 2015 Reclamation Inspection Report #54096.

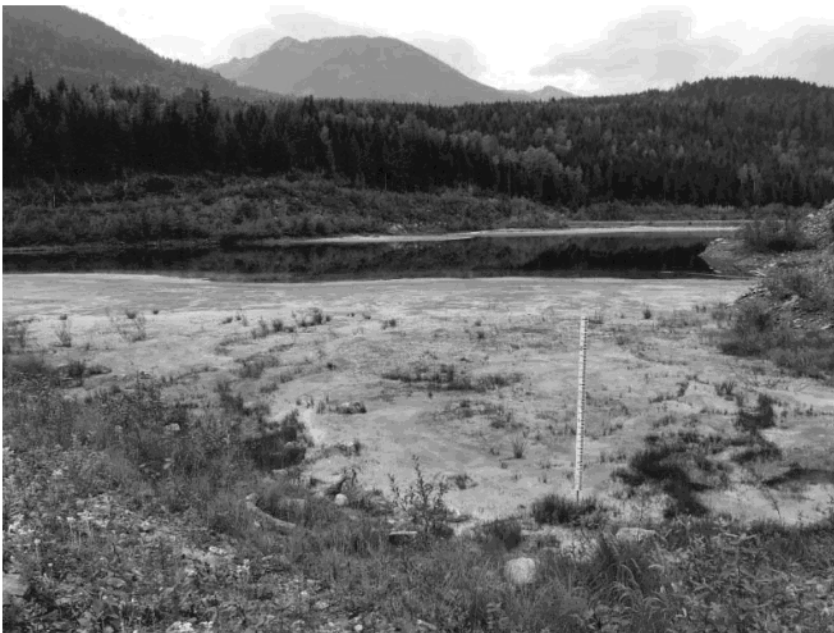
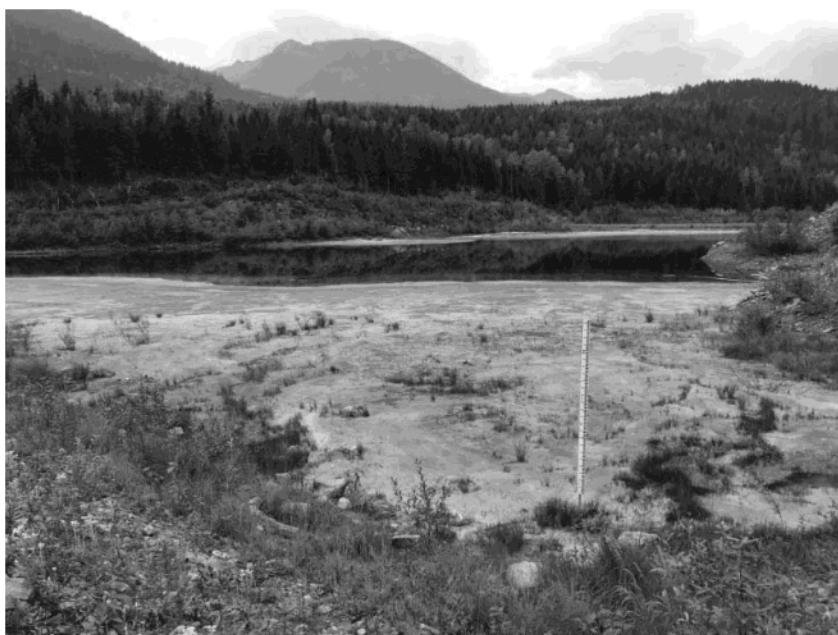
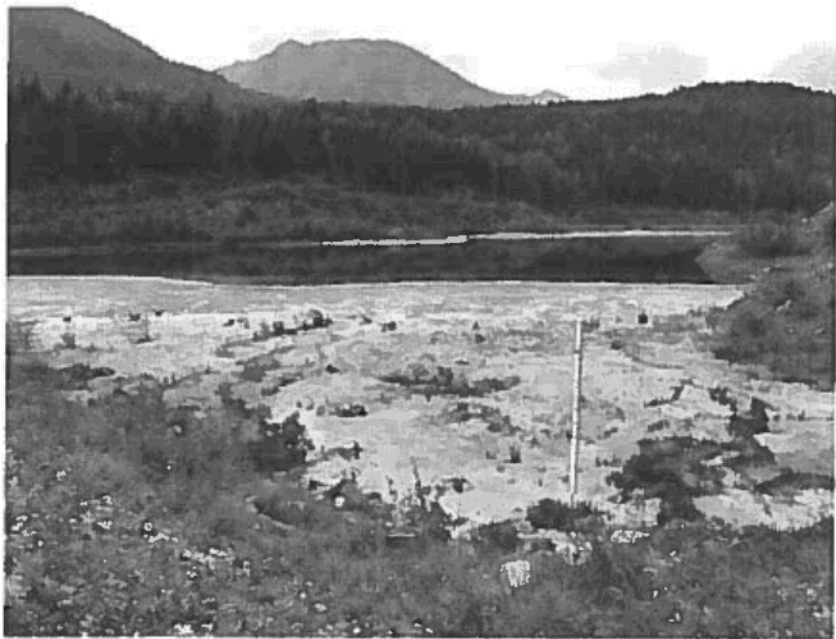
Deposited tailings above the water level were observed at the North Dam beach, the Southeast Dam beach and at several locations along the perimeter of the TSF (Photo 10 and Photo 11). According to the 2017 OMS Manual, tailings were last sampled in September 2008 and oxidation of tailings is to be mitigated by keeping a significant percentage of the tailings flooded.

Photo 9. Exposed tailings above the water level along the southeast dam.

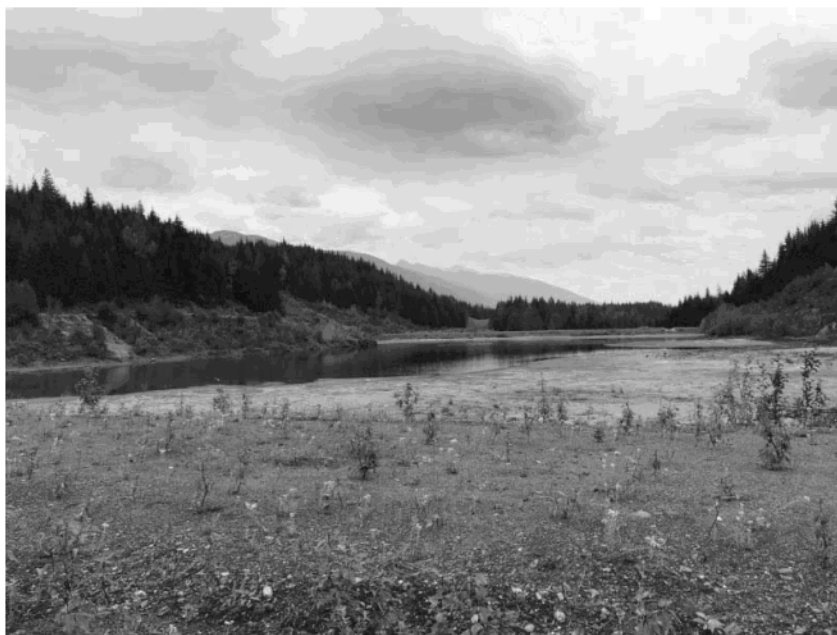
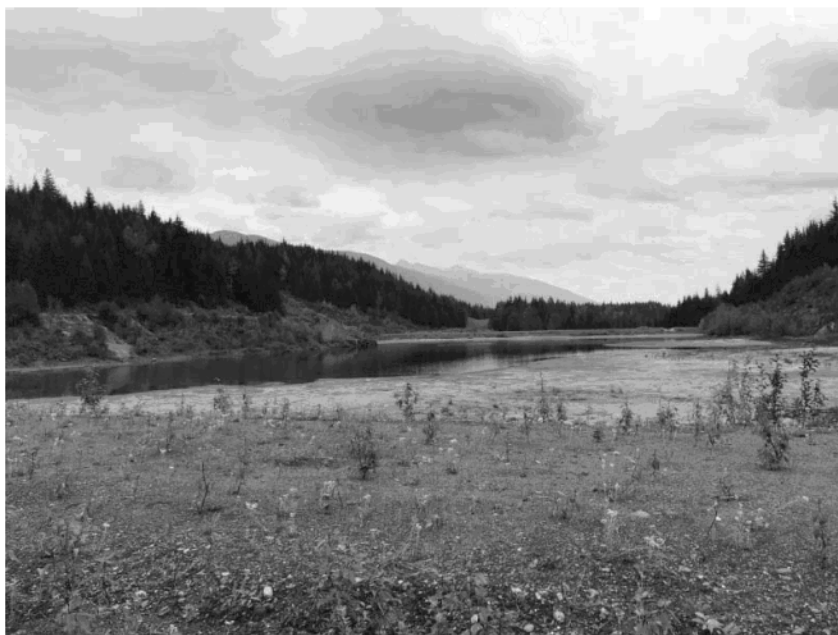
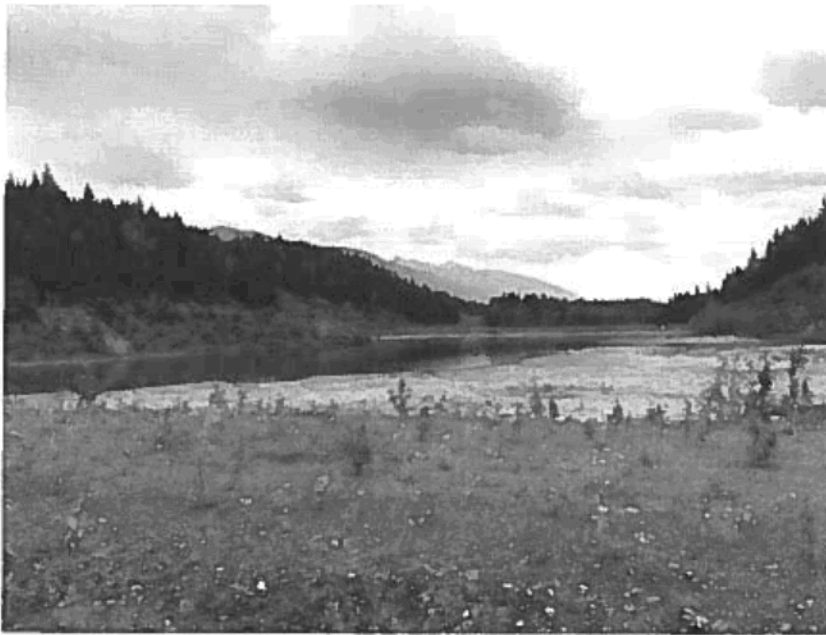
Photo 10. Exposed tailings above the water level along the north dam.

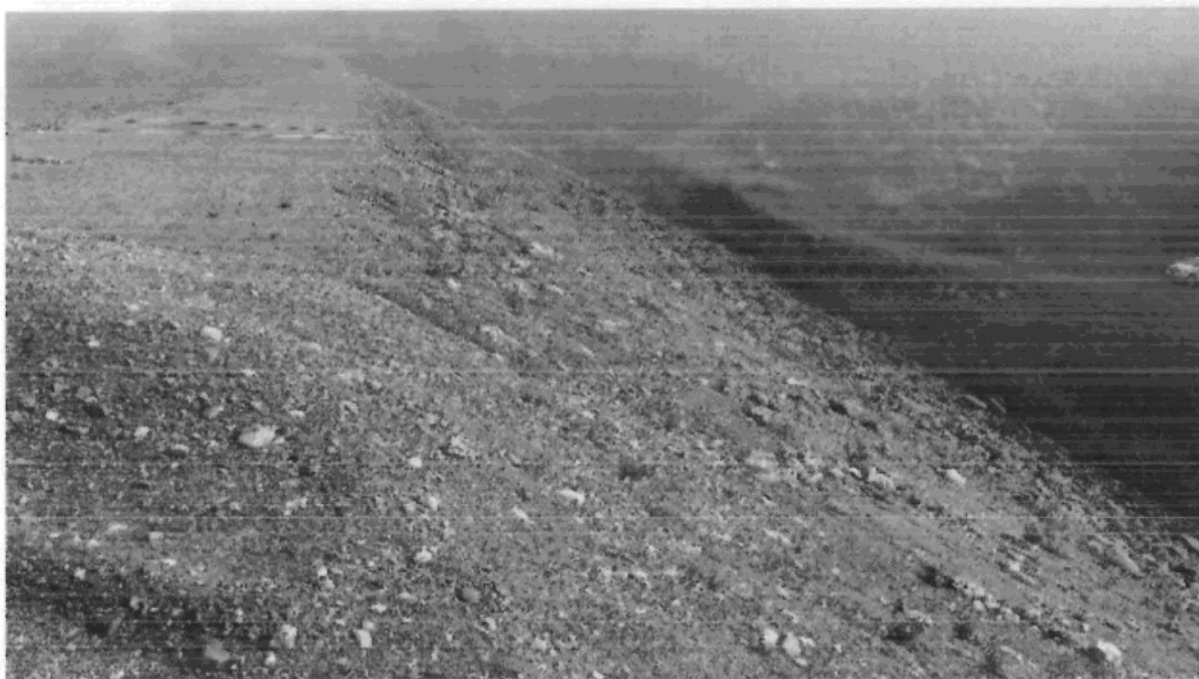
Picture 2: Note riling and minor erosion along crest of dam face. Also, note limited vegetation cover established on the upper section of the dam.

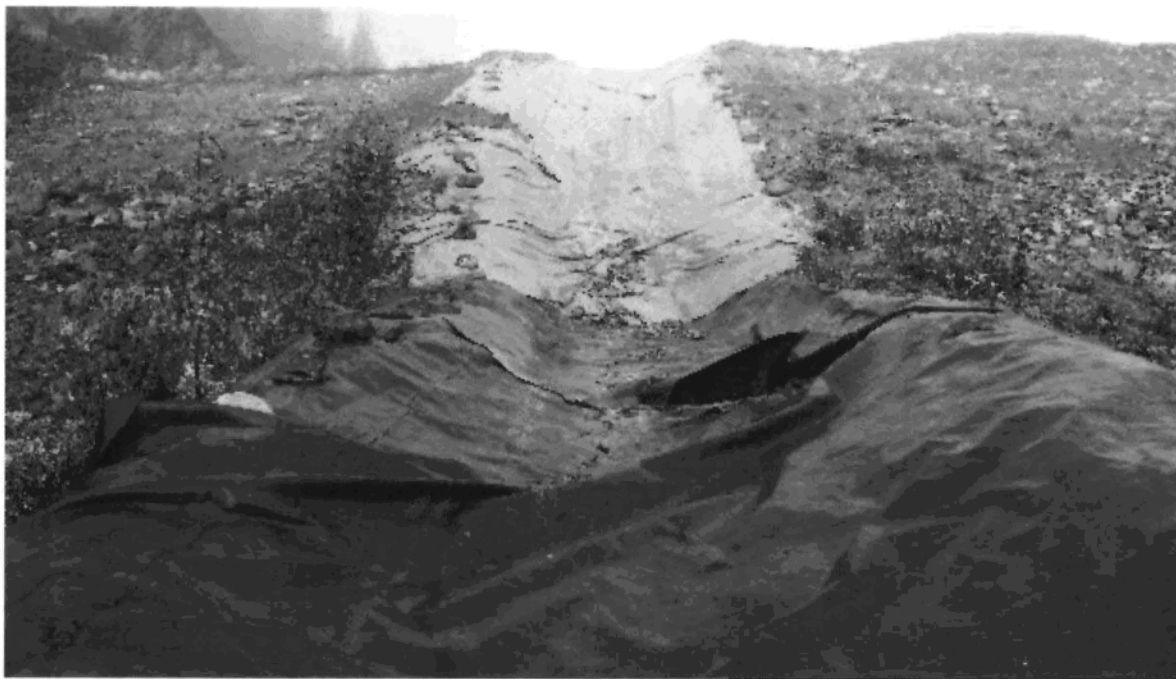
Picture 3: Spill way geo-membrane liner for spill way from Dam. Membrane is poorly installed and anchored.

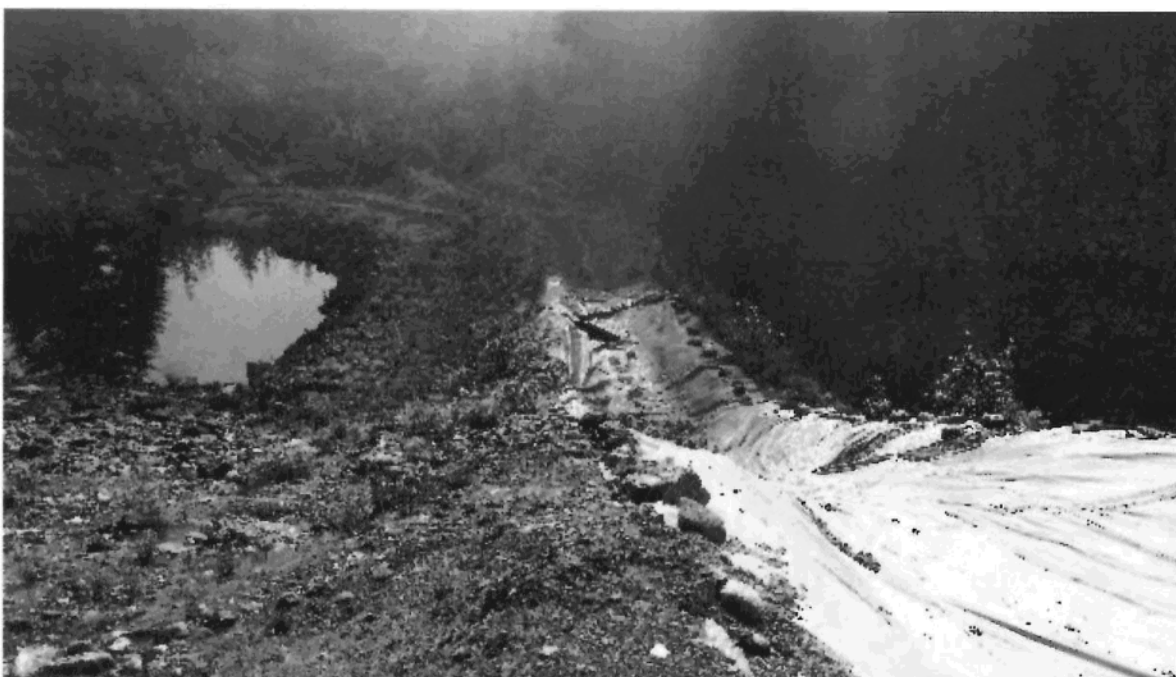
Picture 4: Note over all condition of the liner on the spillway (rips and improperly anchored). Liner does not extend to bottom of spill way.

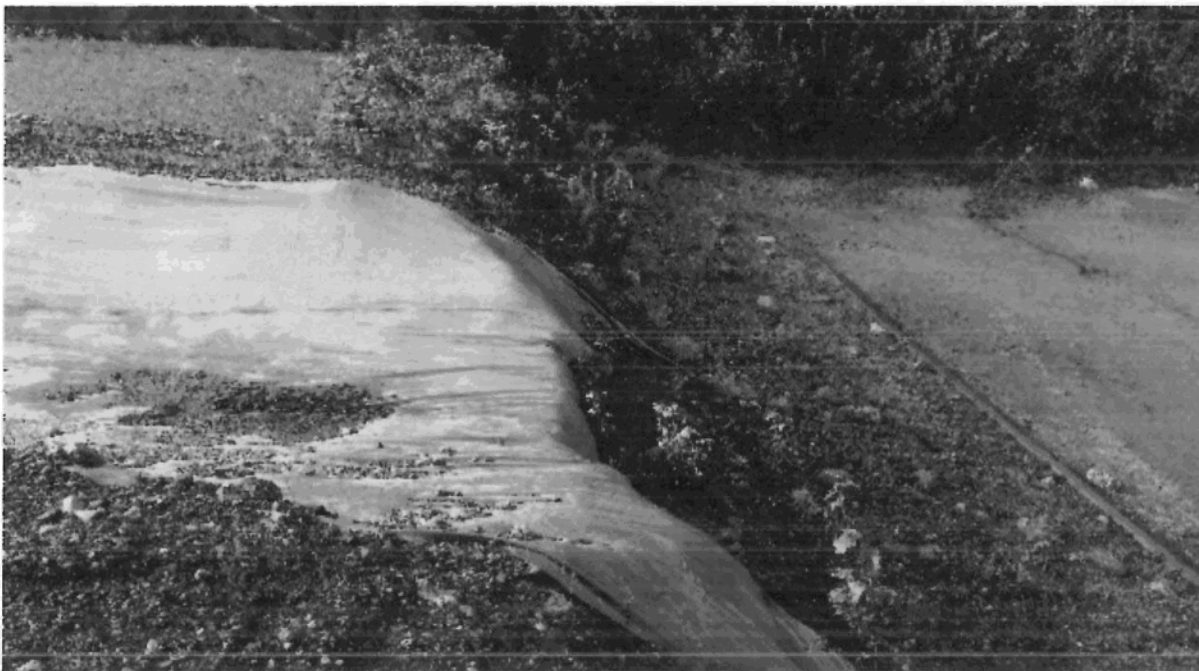
Picture 5: Outlet from tailings pond to the emergency spillway. Note that the edges of the liner are exposed/unanchored.

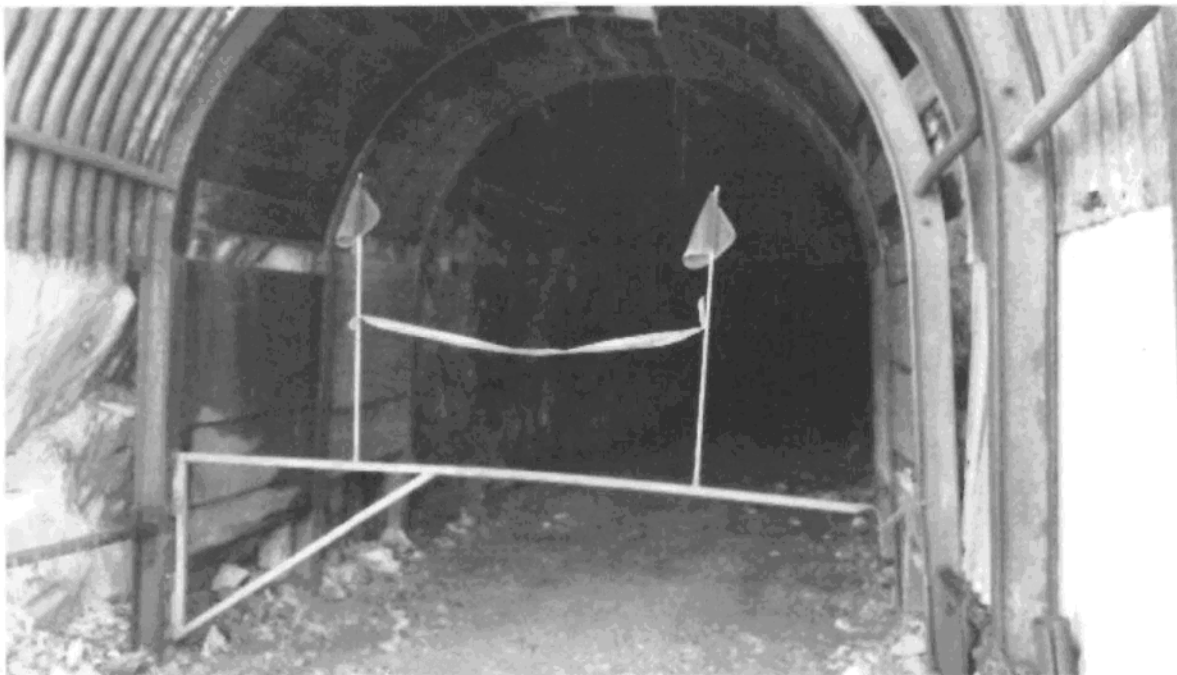
The two main underground entrances (picture 7, 8) were inspected. It is apparent that no effective barrier to access is installed or maintained. Direct access to the underground workings exists and poses a significant safety hazard. As discussed with the site representative, public do still access the site via trails and ATV, thus the safety risk is high with respect to the closure of the workings. Priority must be given to install effective barriers to the underground at both of these entrances.

Picture 7: Mine entrance. Note, no gate or barrier to access has been established. The mine vehicle is the only control from accessing the underground.

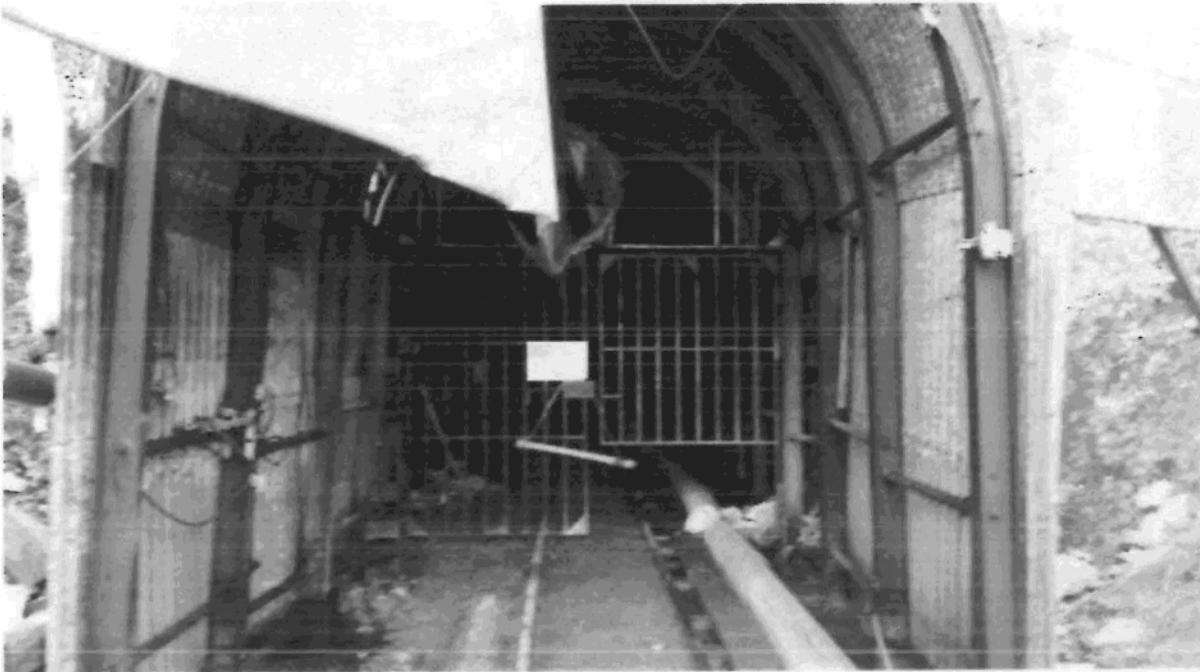
Picture 8: Second mine entrance remained open and unlocked. No effective barrier to access was in place as gate was unlocked. Note water along sides of this entrance.
