Report of Inspector of Mines

Geotechnical

Inspection No.: 099689
Mine No.: 0500770
Permit No.: M-226
Total Orders: 9

Mine Name: Max Molybdenum Mine
Location: Trout Lake, B.C.
Owner, Manager: Dan Omeniuk
Company: MX Gold Corp.
Address: 1300 Redonda Street,
Winnipeg, MB R2C 3T7
Workers Contacted: None
Type of Mining: Metal – Underground (MU)
Date of Inspection: 2018-08-29
Inspector: Jennifer Brash, M.Eng., P.Eng., Senior Geotechnical Inspector
Accompanying Inspectors: Paul Hughes, Andrew Craig
In Attendance: None
Copies to: Al Hoffman, Diane Howe, Lowell Constable, Jennifer McConnachie, Tania Demchuk, Alan Day, Kathie Wagar; Heather Narynski

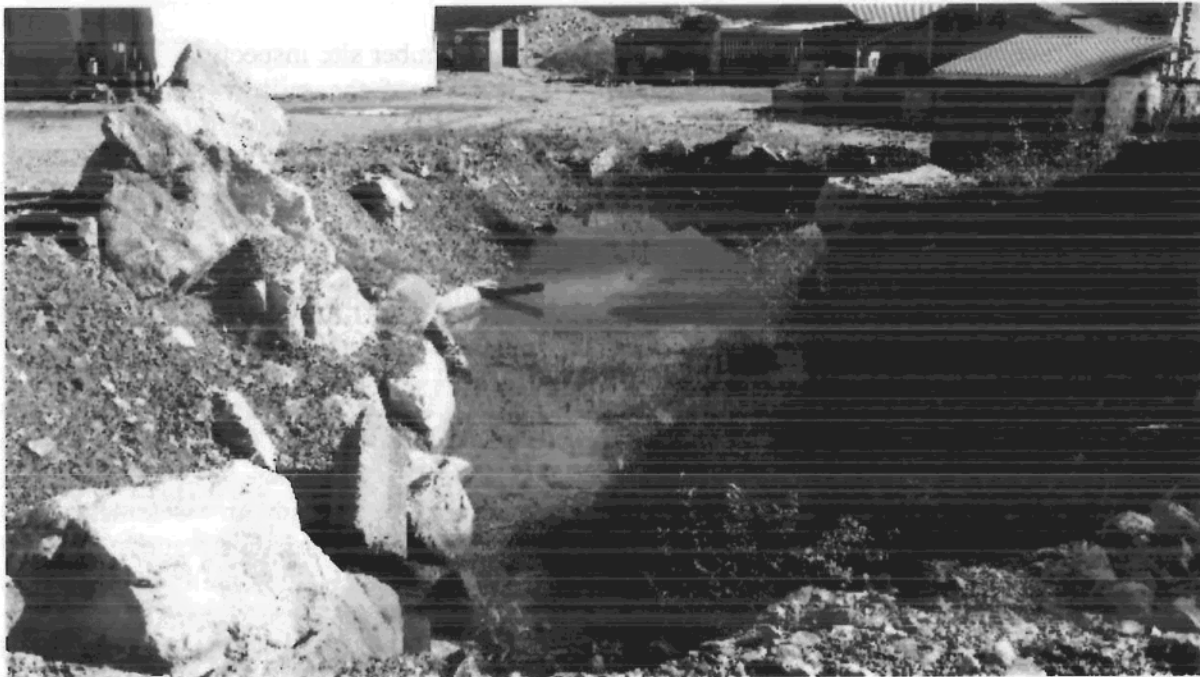
In addition to the open and unsecure mine workings, water was actively draining from both entrances and collecting in a small pond/sump near the mine entrance (picture 8, 9). The pump shack (picture 10), where additives (flocculent) would be mixed in to the flow, was open and not secure. The pump shack may be considered a confined space. Until determined otherwise through the process of conducting a risk assessment, a confined space procedure must be developed and implemented immediately, in accordance with the Mines Act and Healthy, Safety and Reclamation Code of Mines in British Columbia.

Picture 9: Sump/pond where mine water is collecting. At the time of the inspection, the site representative did not know where the water reported to.

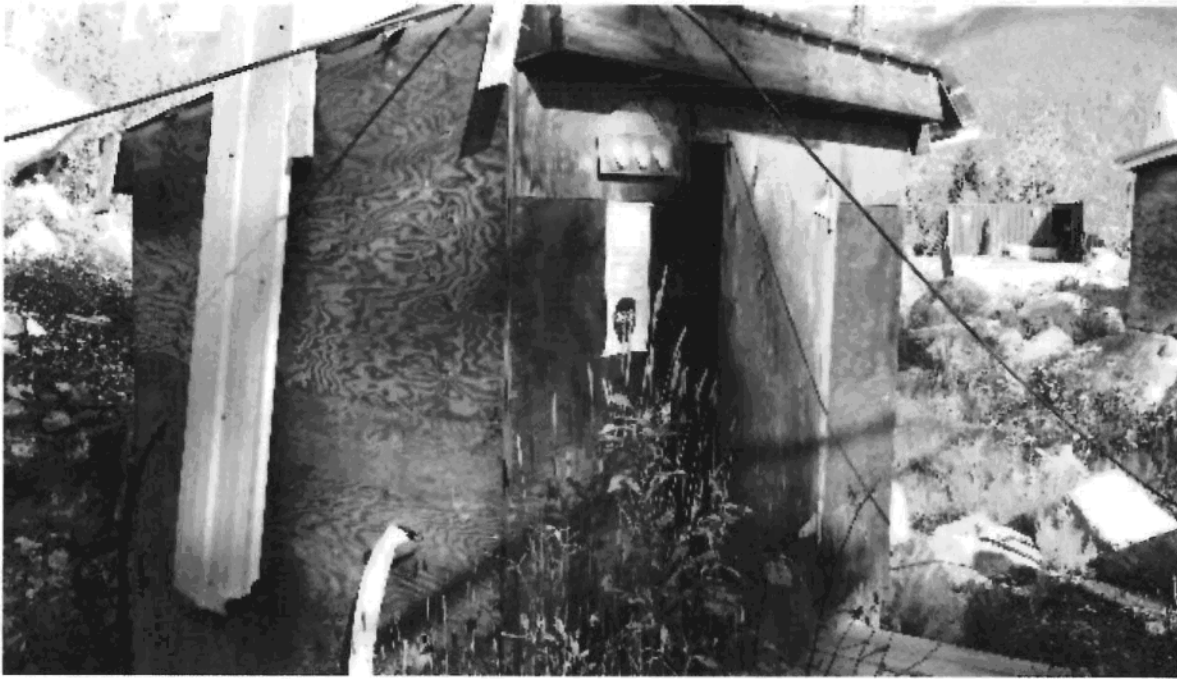
Picture 10: Pump shack and sump near mine entrance. Not appropriately signed and structure was not secured.

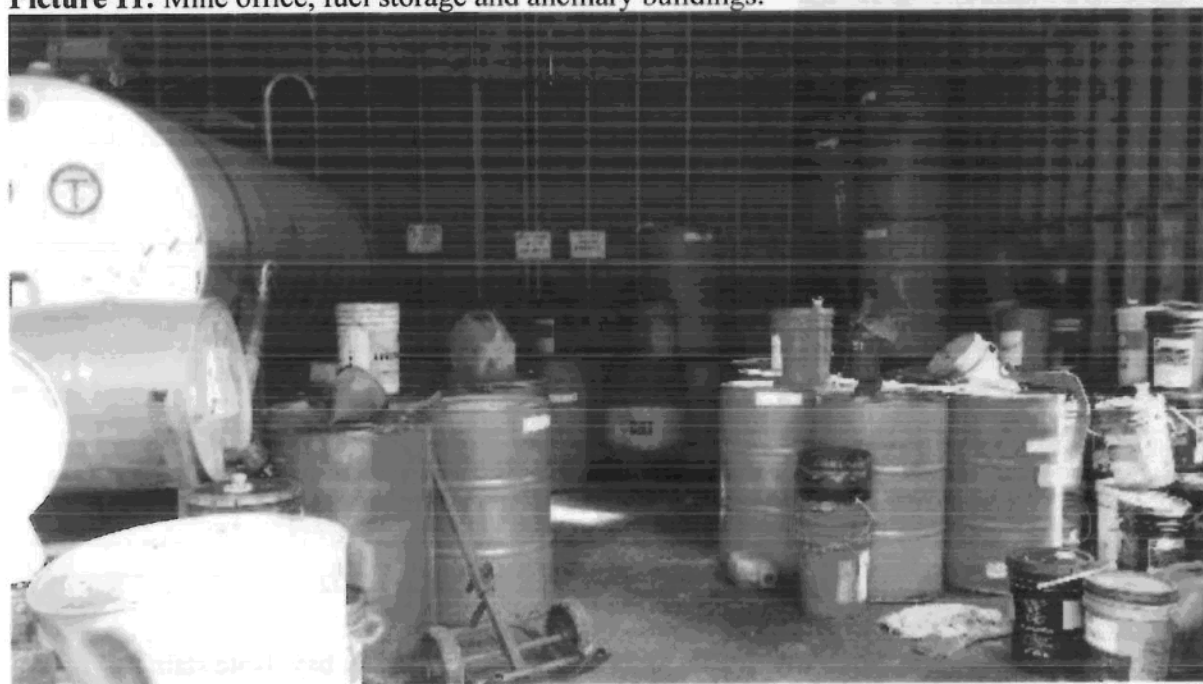
Picture 12: Fuel Storage area. Numerous barrels with no labels, some with lids or left open. No MSDS available or catalogue of chemicals retained on site.

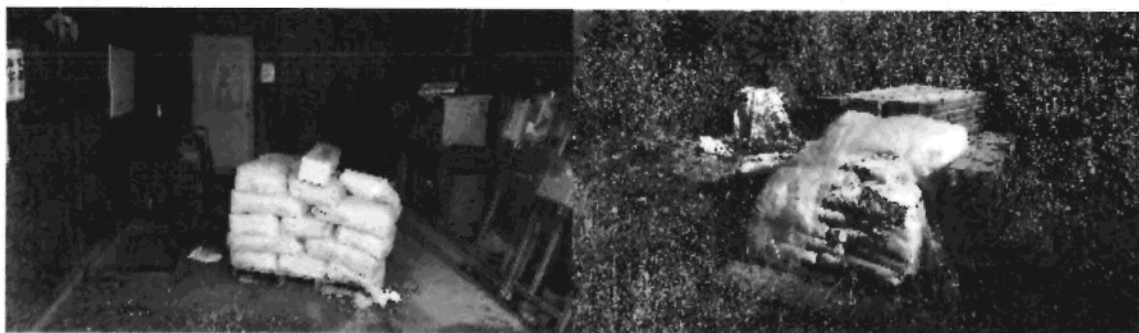
Picture 13: Two examples of process chemicals in various storage areas and in a range of conditions or with/without containment. Note bags are open and material has been deposited on the ground.

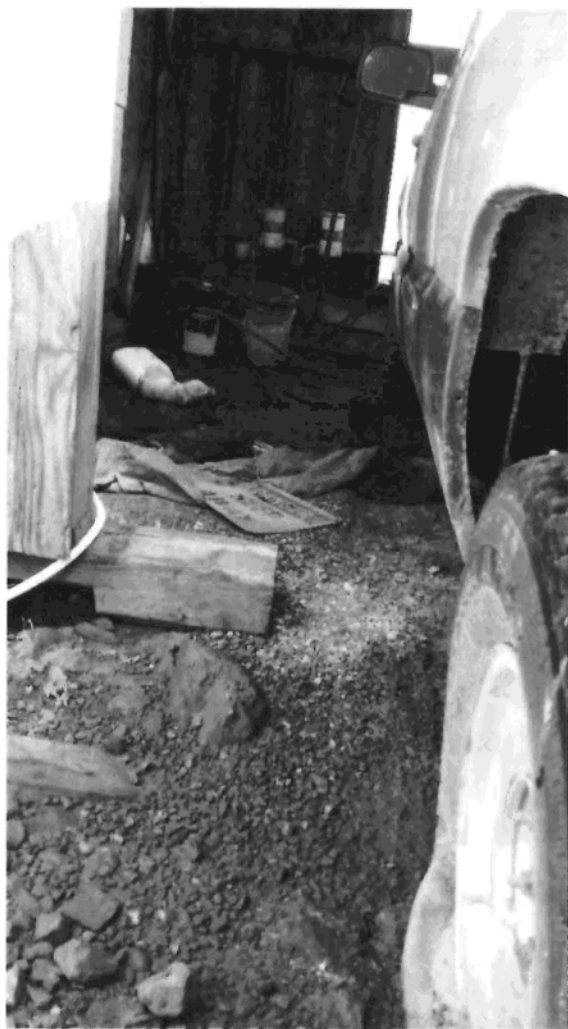
the fuel storage facility (picture 14) and near the old ore bins (pictures 15, 16). A spill prevention and response plan must be developed and implemented, and an investigation of contaminated ground must be conducted to inform a remedial action plan.

Picture 14: Numerous buckets, filters and empty vessels were observed in the truck bay. Note staining.

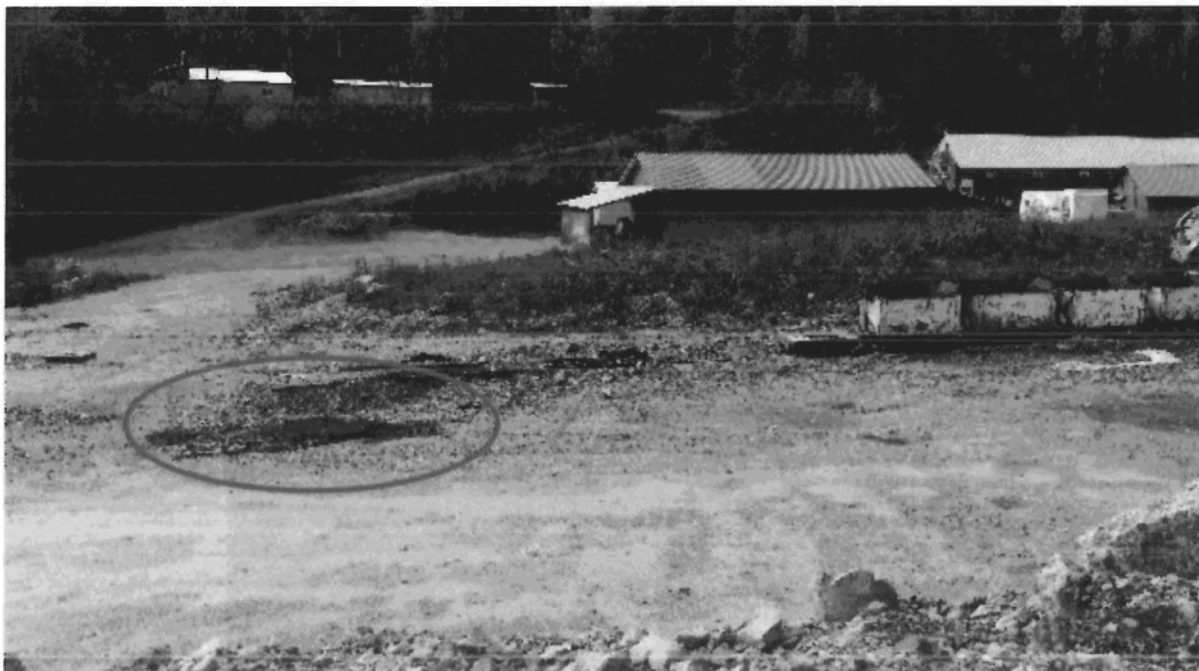
Picture 15: Note area of staining in left center of picture in red circle.

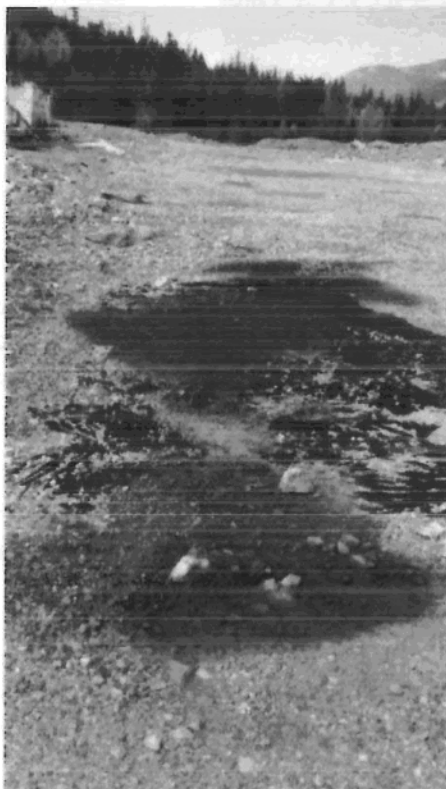
Picture 16: Close up of ground staining identified in picture 15.

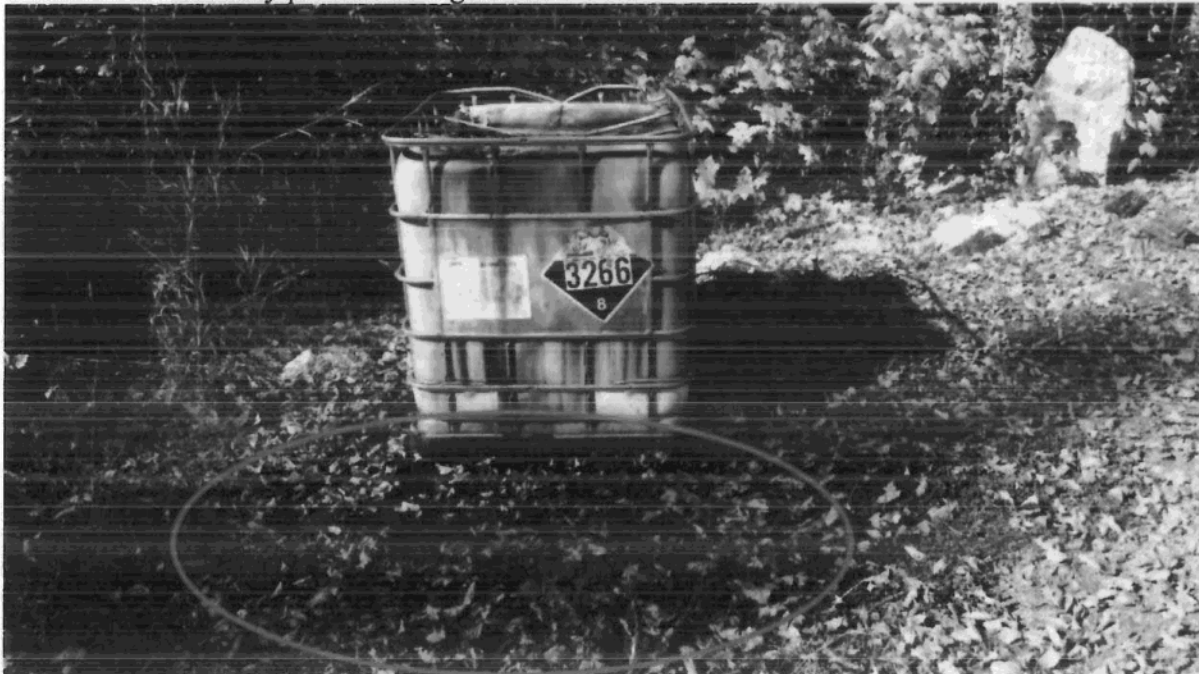
have no lid or cap and was left vented to the atmosphere. No secondary containment was observed around this tank. Further, the tank appeared to be full of hydrocarbon and potentially water due to the tank being left open to the environment.

Picture 19: Open topped hydrocarbon vessel at core storage area. Note black staining on ground. Significant staining on the ground within the red circle.

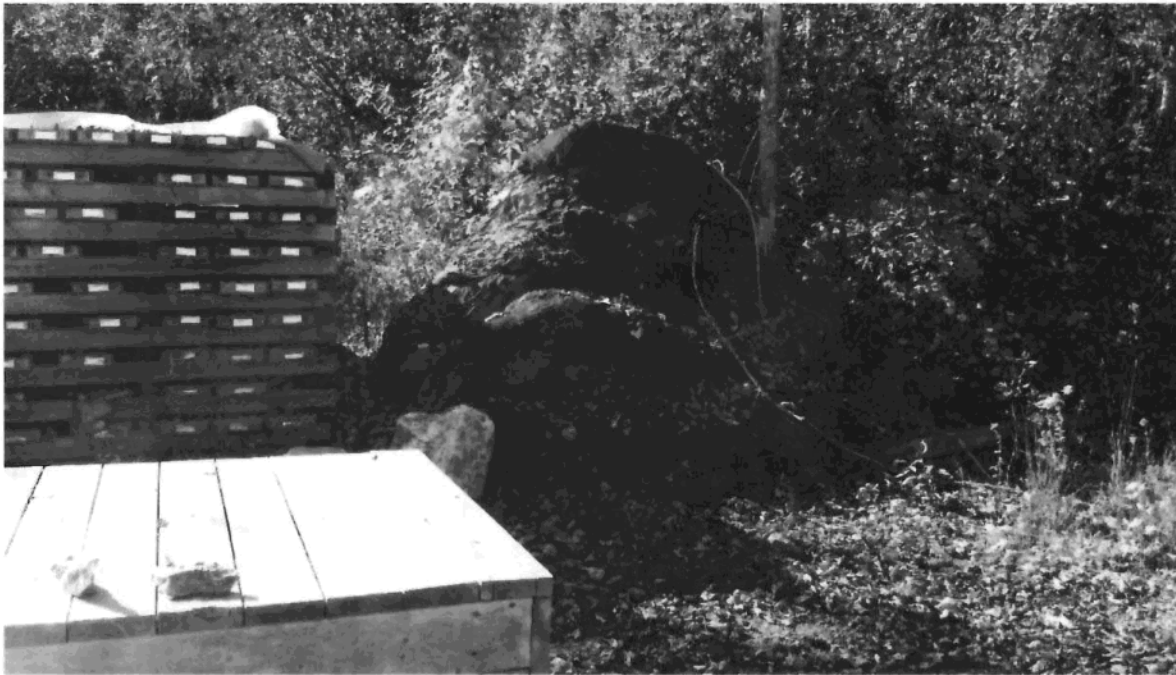
Picture 20: Oil contaminated geotextile wraps at core storage area.

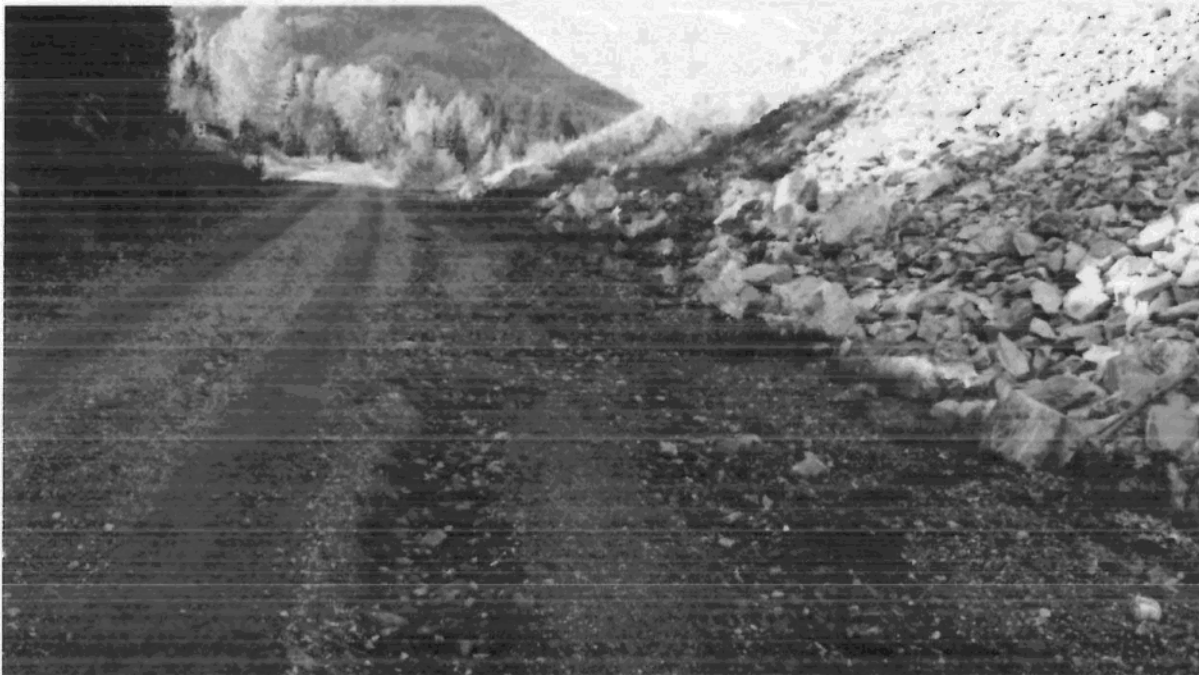
Picture 22: Mine and Forestry road. Canada thistle observed at numerous locations along the road.

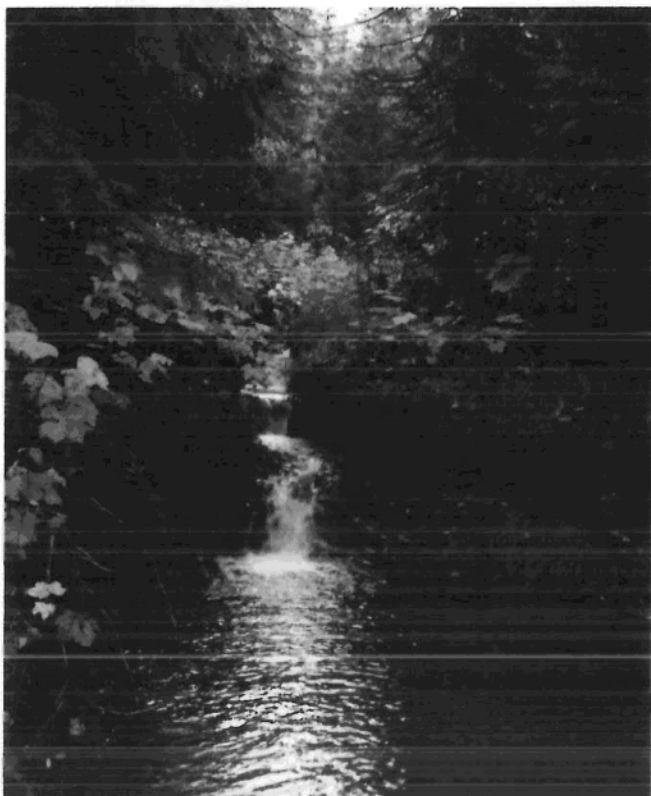
Some channel incising was observed at various channel inlets to the ponds. Minor bank erosion and undercutting was observed (picture 24), with no one location appearing to be of significant concern currently. Rip rap should be placed at select outlets/inlets to ponds to reduce erosion and improve bank stability. Monitoring of channels throughout the settling pond area is required to ensure banks and channel remain stable or if modifications are required that they are carried out in a timely manner.

Picture 24: Cascade into settling pond. Note some erosion and undercutting along channel.

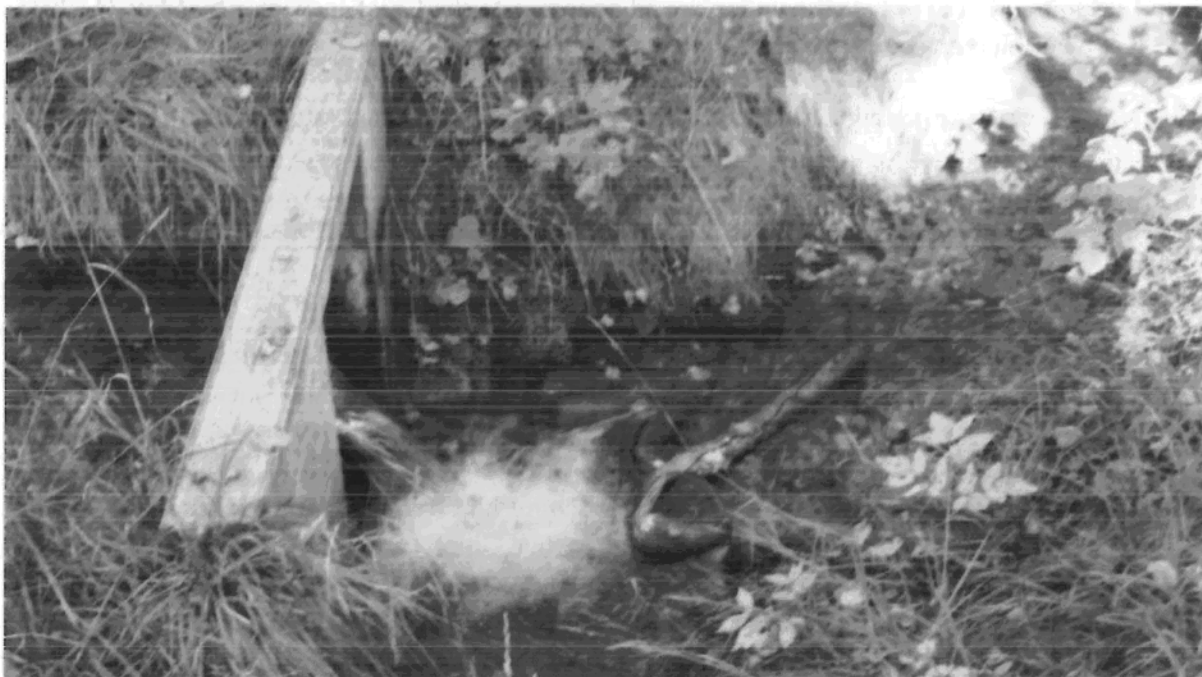
Picture 25: Note soaker boom in stream below the settling pond outlet weir.

A soaker boom was installed downstream of the outlet weir (picture 25) and should be removed and disposed of properly. No explanation as to the purpose of the boom was available. It was likely installed to skim hydrocarbons present in the ponds at the outlet which does provide evidence that there may have been previous hydrocarbon releases or contamination present in surface waters draining through the settling ponds. The surrounding banks and openings associated with the various settling ponds appear to be well vegetated and stabilized. No erosion or slumping within the ponds was identified.
