REPORT NO. 212003/1

**MYRA FALLS OLD TAILINGS DISPOSAL FACILITY
2013 DAM SAFETY REVIEW**

MYRA FALLS OLD TAILINGS DISPOSAL FACILITY 2013 DAM SAFETY REVIEW

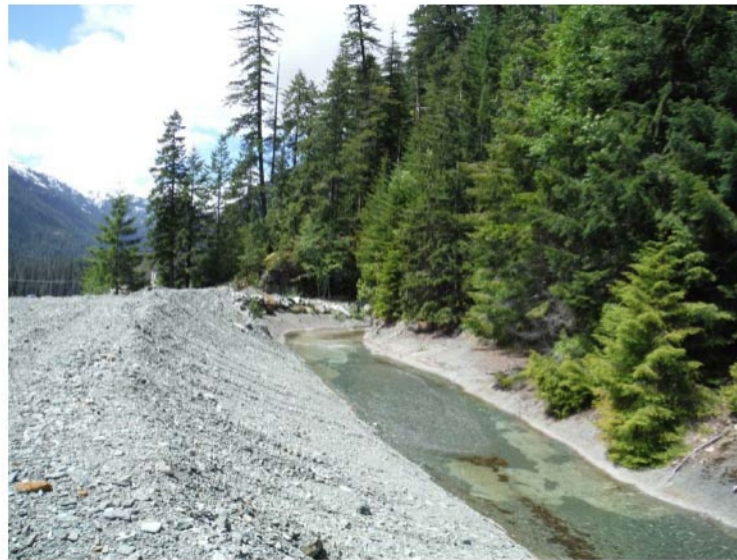
In places the concrete lining is affected. The channel is subject to debris inflow and sedimentation accumulation. This channel is the subject of ongoing design evaluations and will likely be removed and replaced as part of closure construction.

In the opinion of the writers of this document, the channel as it is currently is not suitable as a permanent structure or as part of an overall closed facility. We believe the permit conditions and the decision by Nyrstar to replace this channel are correct decisions and courses of action.

Figure 1. The Upgradient Drainage Channel on the north side of the TDF. Note the shotcrete lining on the upgradient side. The light-colored material on the downstream side is gravel that accumulated in the channel and was subsequently removed from the channel.

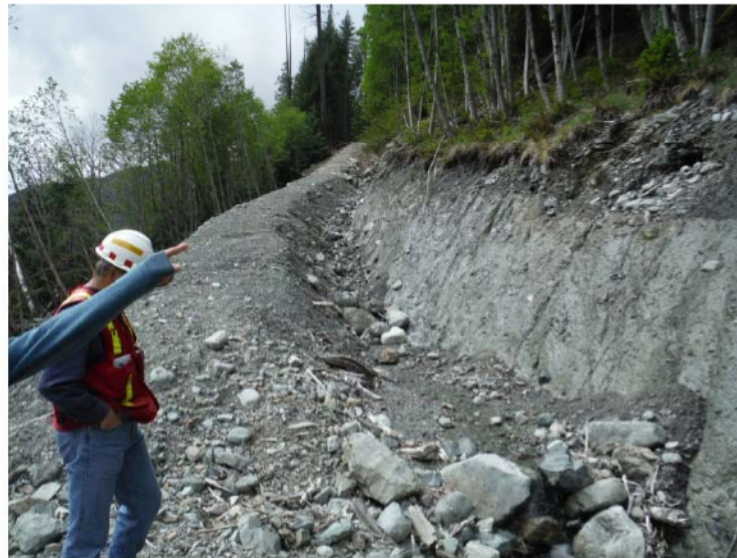
To the east of the TDF is a steep channel also used to divert upgradient runoff water; this channel is known as the “Alder Reach”. This channel was installed pursuant to recommendations in AMEC (2008) that a secondary ditch able to accommodate the 1 in 200 year 24-hour storm event be constructed.

Figure 2. The Secondary Upgradient Channel. Note the steep cut into consolidated clay on the upgradient side. Note also the accumulation of gravels and boulders in the channel.

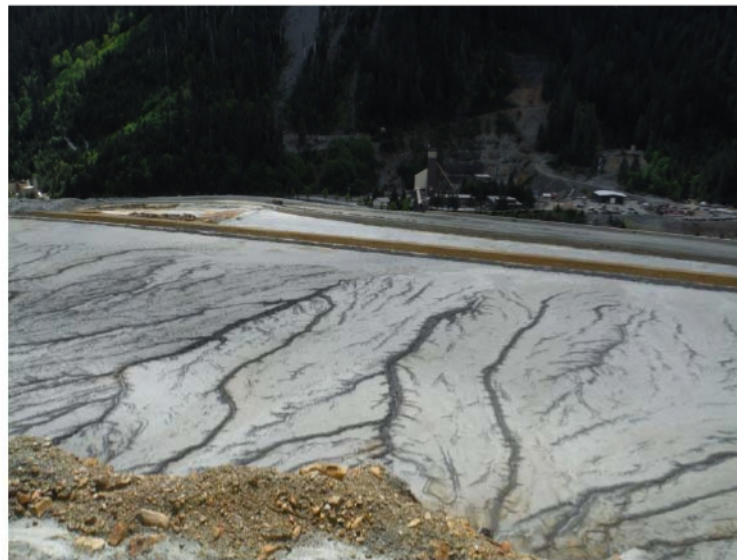
Figure 6. Erosion of the upper surface of the paste tailings, looking from north to south.

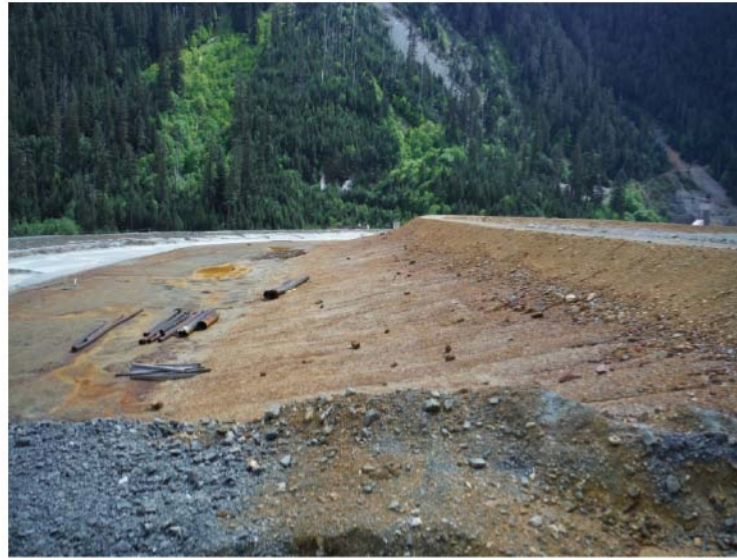
There is no observed significant erosion or deformation of the berm. This berm will be regraded and covered as part of closure construction. The writers of this report concur that this is necessary and appropriate for closure.

Figure 8. The downgradient side of the paste berm. Note the variable slope inclination leading to the tailings surface on the left side of the photo.

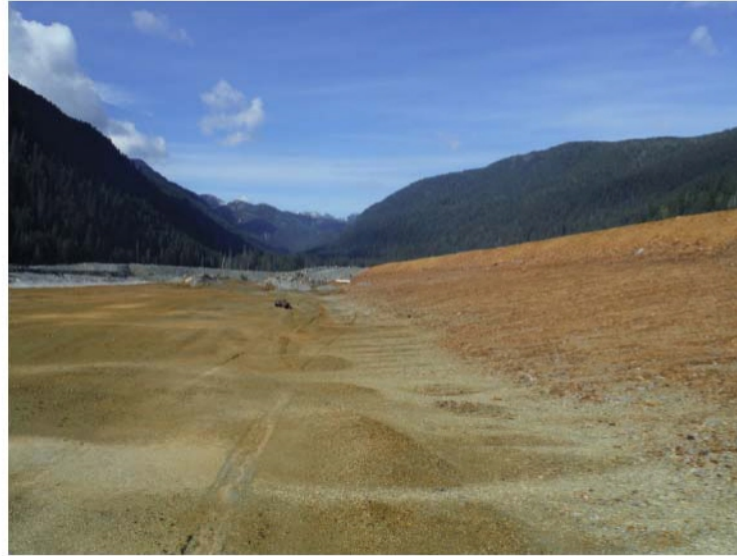
Parts of the surface of this area just downgradient of the paste berm were observed to be wet and soggy. No rain had fallen in the period immediately preceding observations. It is not known if the wet areas are the result of seepage from the paste area, or represent upward seepage associated with possible tailings drainage. The authors of this report are informed that this condition is being evaluated by others as part of the compilation of a new slope stability analysis. We concur that this is necessary and appropriate.

Figure 10-A. The toe of the paste berm looking west. This is the general area where wet and soggy conditions were observed on the flat surface at the toe of the berm.

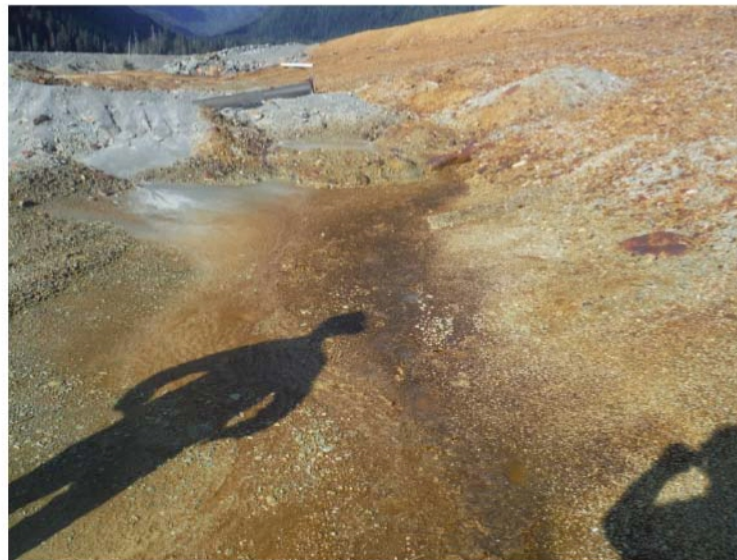
Figure 10-B A close-up view of the affected surface. Note there was no standing water, simply wet and soggy tailings.

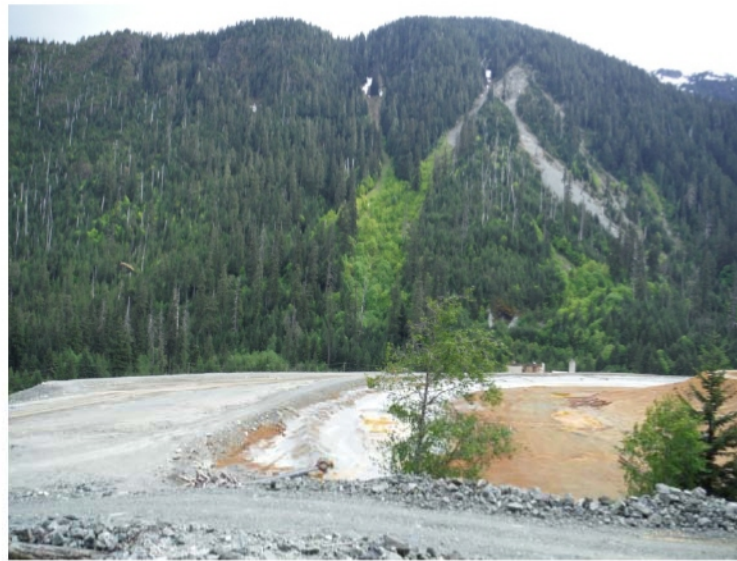
When observed, construction work was in progress to regrade the surface of this area and the top of the recently completed seismic buttress. The area was variously undulating and rough. Incident precipitation would pool in low points or flow to the edge of the seismic berm and hence down the outer face of the berm.

Because of the active regrading of the area, no erosion or cracking (if any) was observed.

Figure 11. The top surface of the old tailings and seismic buttress. The surface was being regraded to comply with closure requirements.

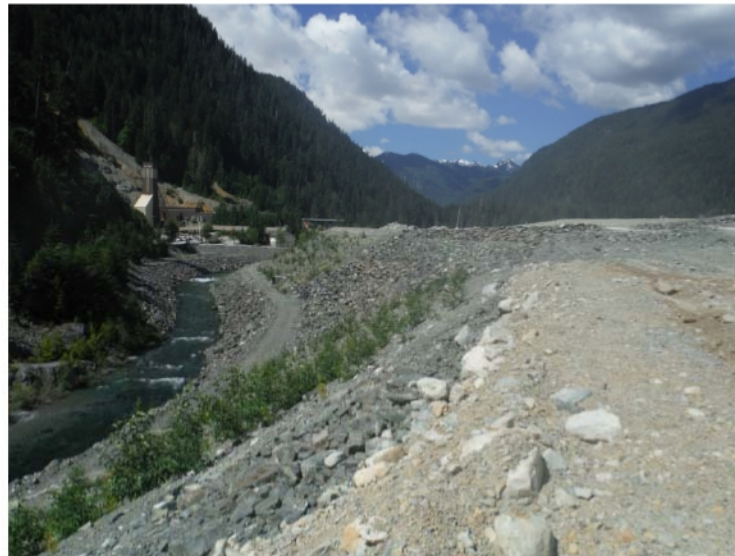
The downstream face of the recently constructed seismic berm is subtended by an access path and Myra Creek. New vegetation has been established on the face of the berm. Minor erosion was observed near the upper crest of the berm.

Figure 14. The outer face of the seismic berm, looking north. Note from left to right: Myra Creek; the toe access road; and the sloping face of the berm with new vegetation.

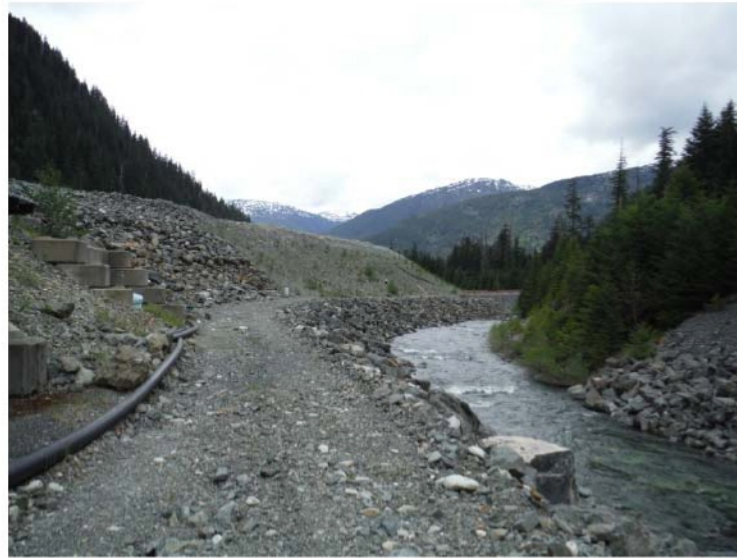
There is a rock spillway on the south face of the seismic berm. It was constructed to be part of the surface water management system and to serve as an operational spillway. We were informed that adequate filters were not placed between the erosion control rock and the underlying materials at the north end of the spillway; and that accordingly the upper portion of the spillway is to be removed and replaced as part of closure construction.

Figure 15. South face of seismic berm. Note the large boulders that constitute the spillway just to the left of the photo.

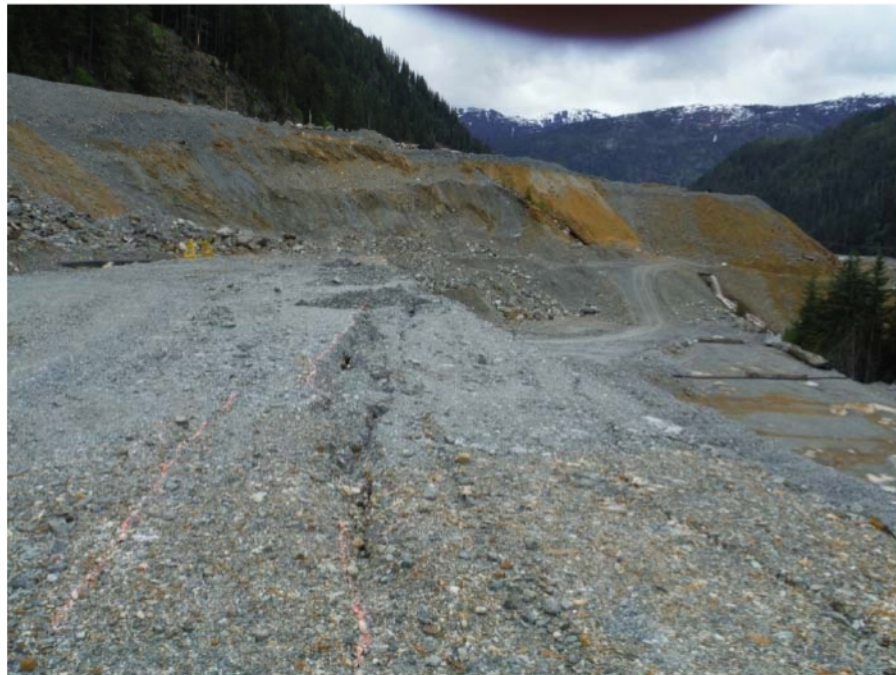
The zone of cracked embankment as described in AMEC (2013b) was remediated. The report on 2013 construction is being prepared by AMEC.

When observed in June 2013, there was extensive cracking along the downstream crest (Figure 3).

Figure 3. Cracking along the downstream crest of the embankment as observed in June 2013. The cracked zone was, reportedly, removed and replaced as part of 2013 embankment raising.

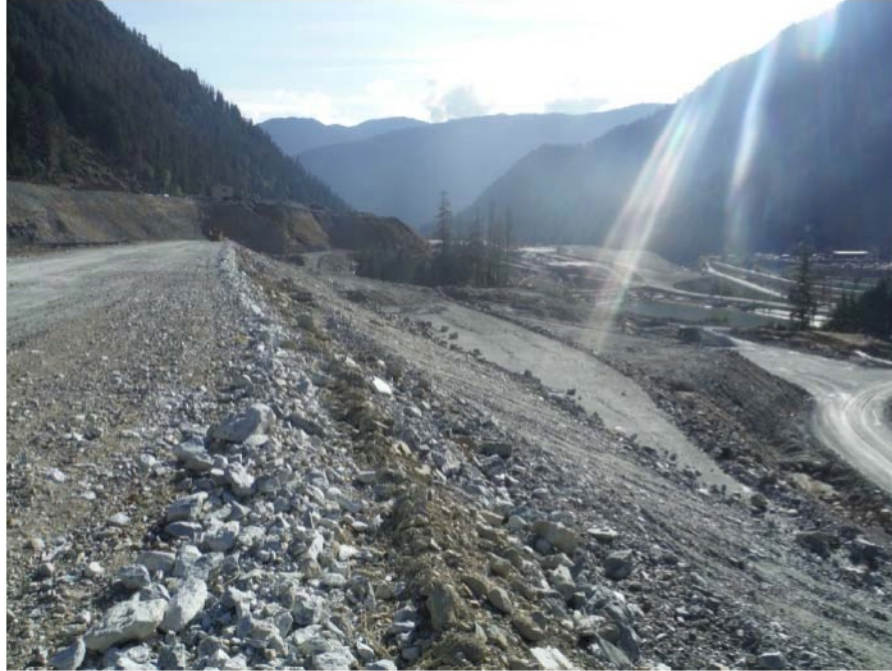
When observed in September 2013, raising of the embankment dam had just been completed. The authors of this report were informed that the zone of cracking was removed and replaced as part of the embankment raising. No cracking of the embankment was observed (Figures 4 and 5).

Figure 4. Looking west to east along the downstream crest of the embankment dam in September 2013. To the left of the crest line is the top of the embankment, which is a compacted surface of waste rock. To the right of the crest line is the downstream face of the embankment which is also compacted waste rock.

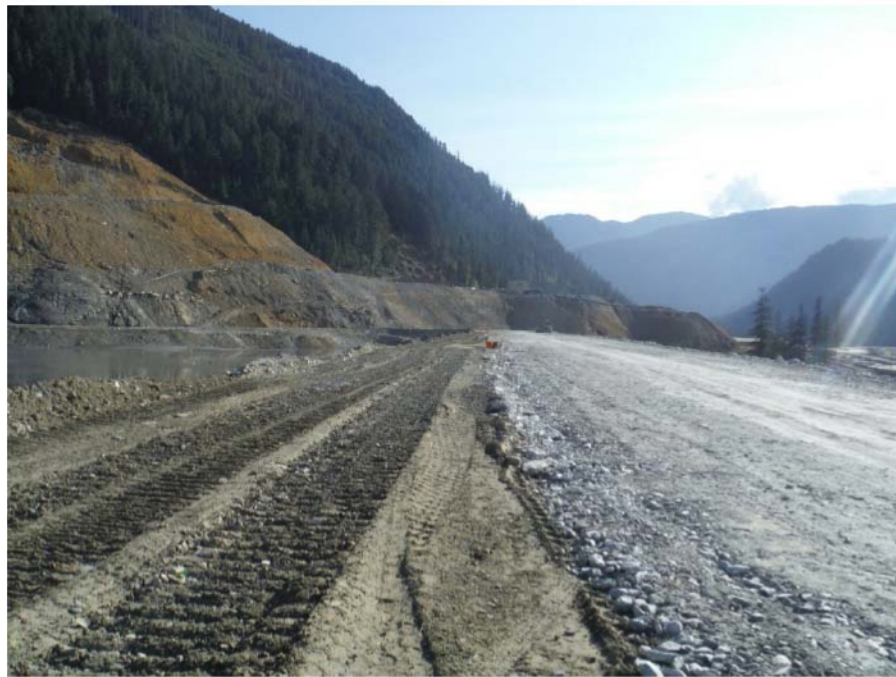
The top surface of the upstream filter zone was observed (Figure 6). The material is finer than the rockfill and in appearance suitable for its design purpose—controlling migration of tailings into the voids of the embankment rockfill. On the upstream side of the filter zone is either paste tailings or sand (Figures 7 and 8).

Figure 6. Looking west to east along the upstream crest of the embankment. To the left is the compacted finer-grained material of the filter zone; to the right is the top surface of the compacted waste rock.

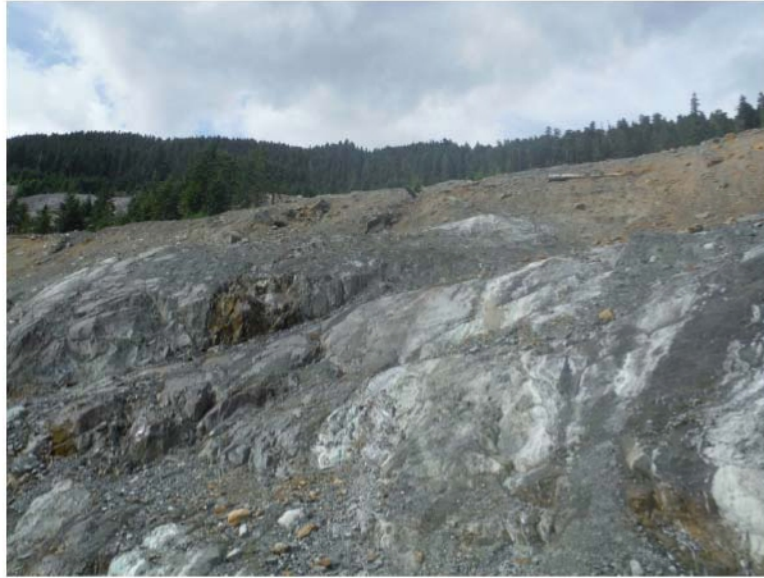
Figure 12. Seepage from joints in the bedrock on the north side of the Lynx TDF. Flow quantities vary in response to precipitation. The zone of bedrock seepage is relatively large and extends some meters up the slope.

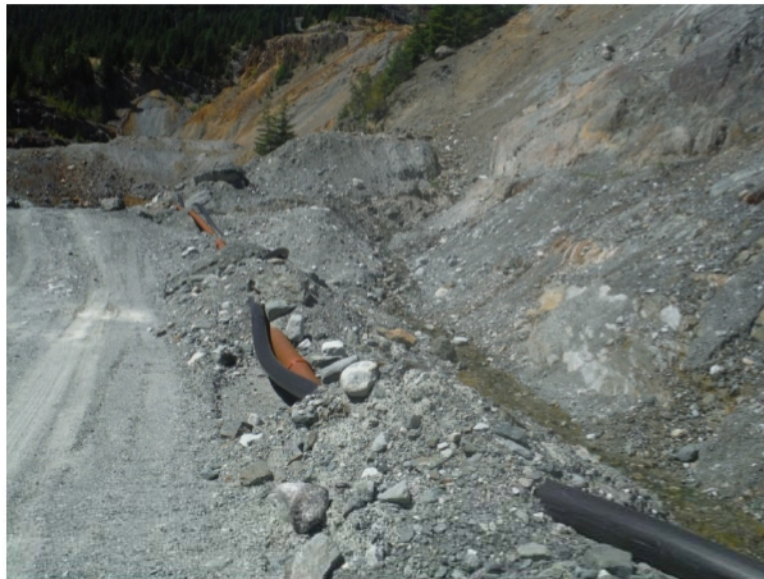
Figure 13. The channel to the east end of the north side of the Lynx TDF. The channel is formed of the bedrock and piled-up waste rock, Seepage is collected in the channel and flows east.

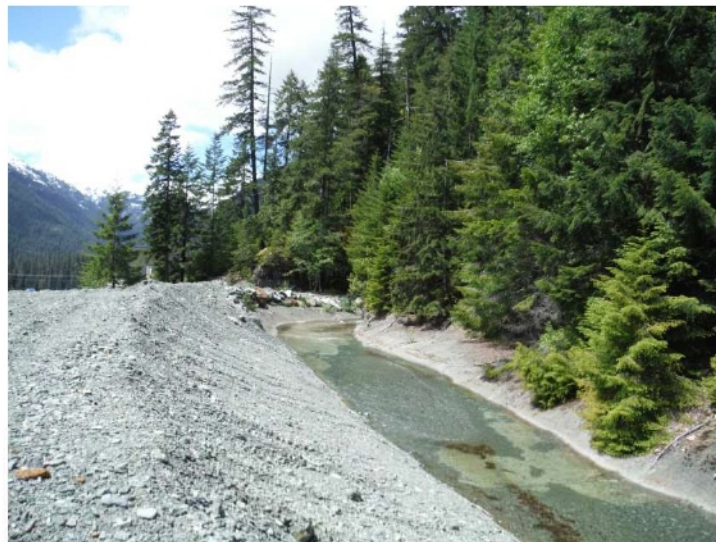
Figure 1. The Upgradient Drainage Channel on the north side of the TDF. Note the shotcrete lining on the upgradient side. The light-colored material on the downstream side is gravel that accumulated in the channel and was subsequently removed from the channel.

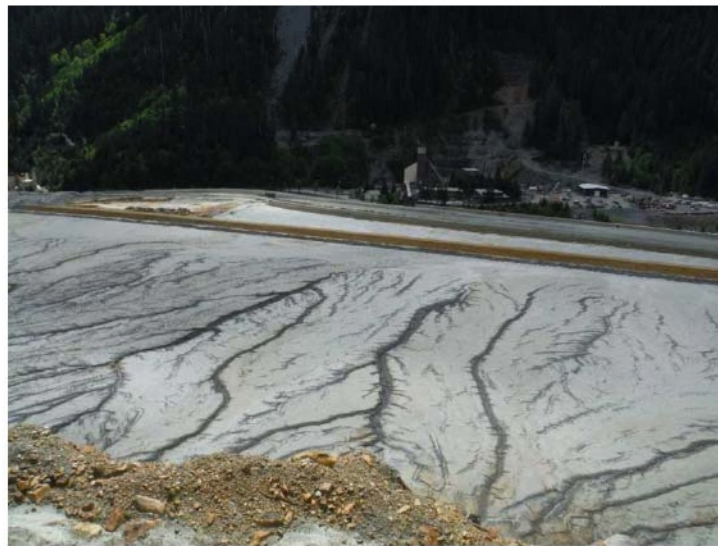
Figure 6. Erosion of the upper surface of the paste tailings, looking from north to south.

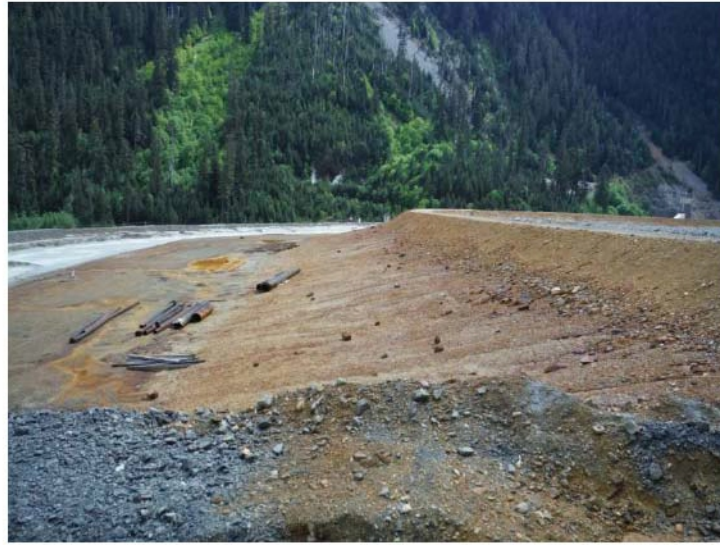
Figure 8. Looking southwest along the paste berm from the east end of the paste berm area. The downgradient side of the paste berm. Note the variable slope inclination leading to the tailings surface on the left side of the photo.

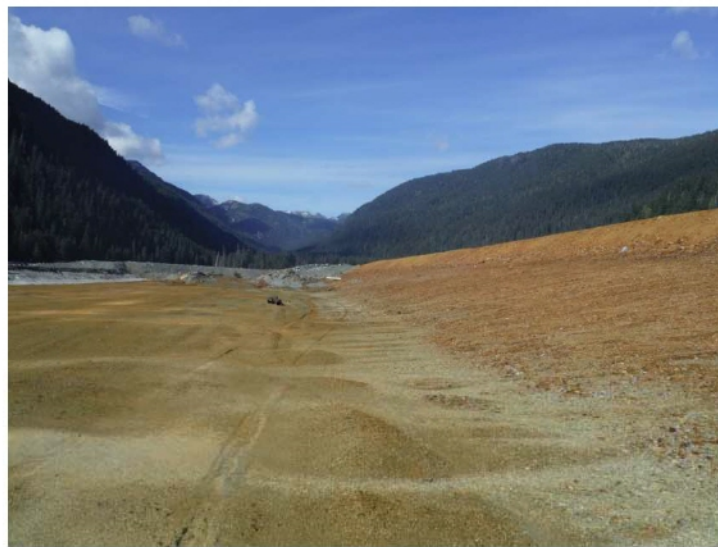
Figure 10-A. The toe of the paste berm looking west. This is the general area where wet and soggy conditions were observed on the flat surface at the toe of the berm.

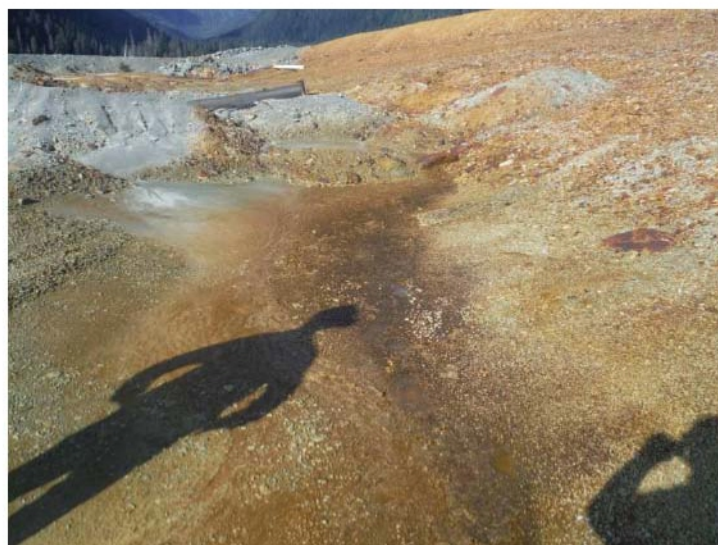
Figure 10-B A close-up view of the affected surface. Note there was no standing water, simply wet and soggy tailings.

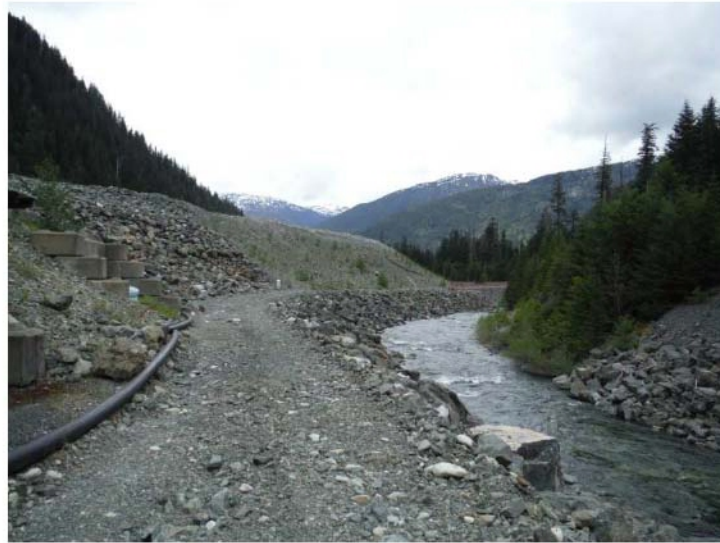
Figure 15. Looking east along the south face of the seismic berm. Note the large boulders (just beyond the concrete blocks) that constitute the spillway just to the left of the photo.

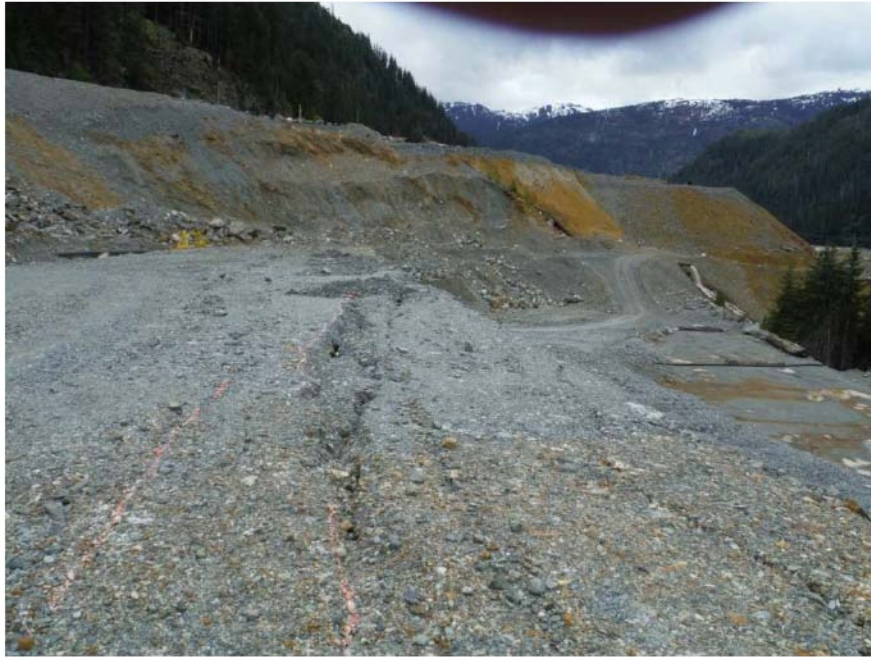
Figure 3. Cracking along the downstream crest of the embankment as observed in June 2013. The cracked zone was, reportedly, removed and replaced as part of 2013 embankment raising.

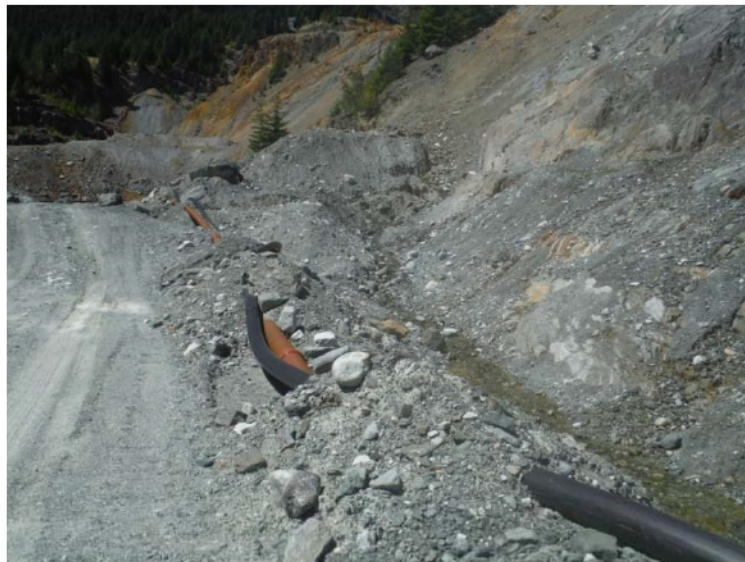
Figure 13. The channel to the east end of the north side of the Lynx TDF. The channel is formed of the bedrock and piled-up waste rock, Seepage is collected in the channel and flows east.
