**KGHM AJAX MINE INC.**

## **DAM SAFETY REVIEW AFTON TAILINGS STORAGE FACILITY**

VA101-246/16-2  
Rev 0  
March 28, 2014

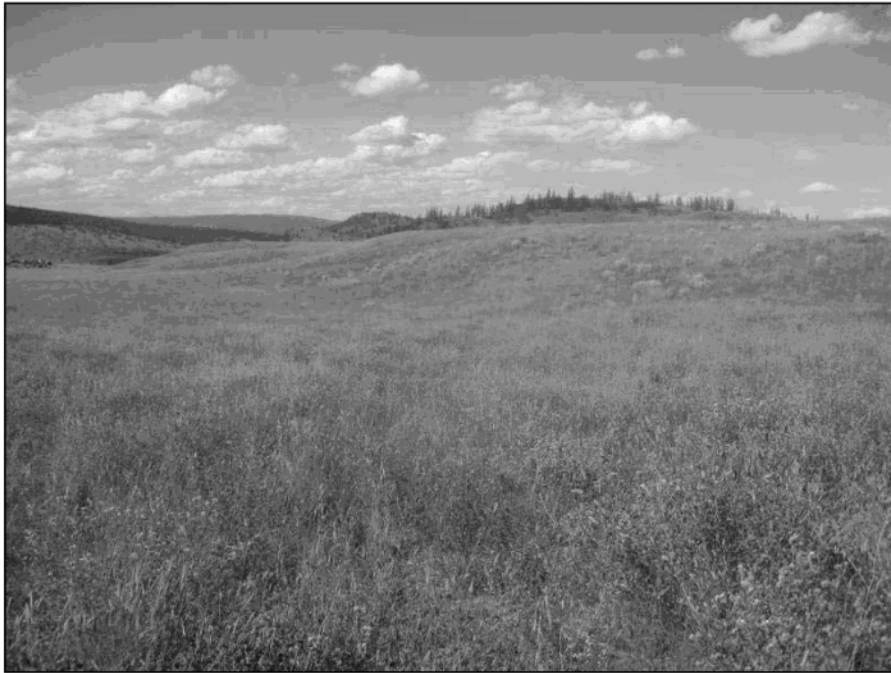
**PHOTO 1** – Re-vegetated downstream slope near crest of West Dam.

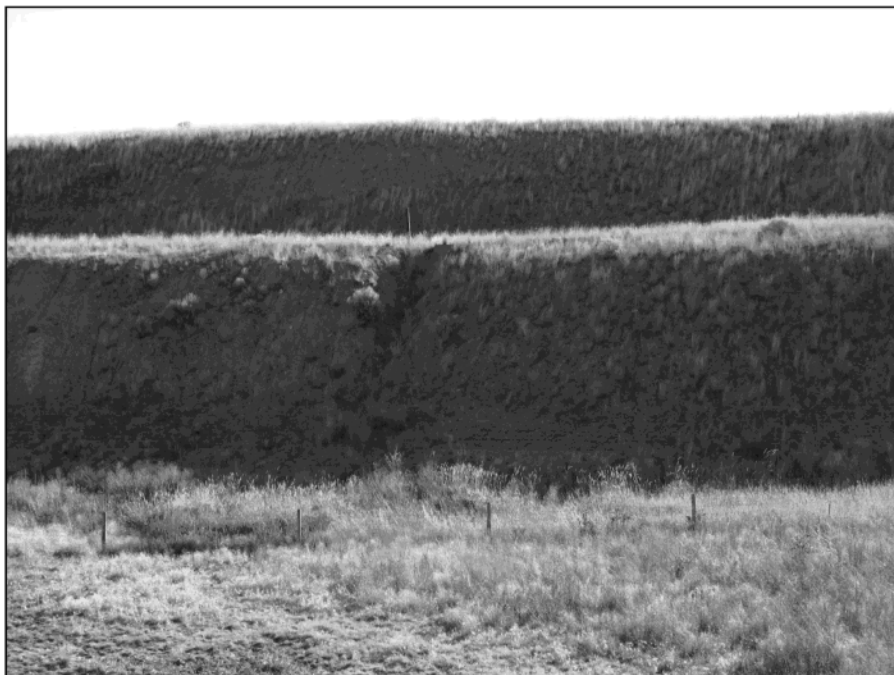
A visual inspection of the dams was made by walking along the crest, downstream slopes and abutments during the site visit of July 9, 2013. No signs of distress were identified on the dams. The dam slopes were approximately planar and there was no evidence of cracking, bulging or slumping in the fill materials. The dam crests appeared to be relatively level with no signs of differential settlement or distress. There was no evidence of animal burrowing. No evidence of seepage through the dams was observed during the site inspection. The downstream slope of the West Dam has been re-vegetated (Photo 1). There are a few small erosion gullies on the downstream slope of the West Dam (Photo 2). The West Dam is very wide as previously discussed and the erosion gullies are not a dam safety concern.

**PHOTO 2** – Downstream toe of West Dam showing small erosion gullies.

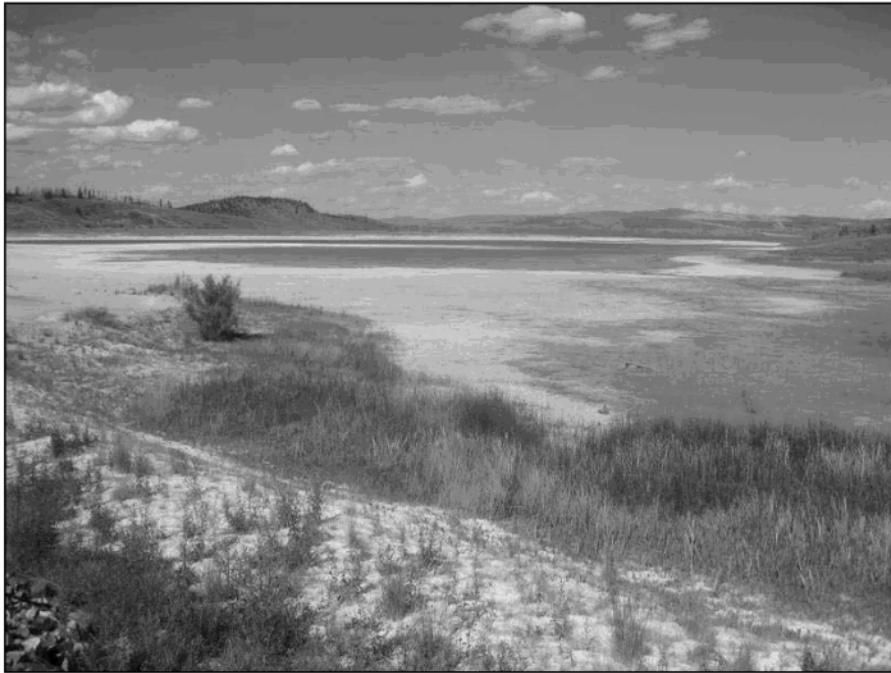
**PHOTO 3** – TSF pond and beach.

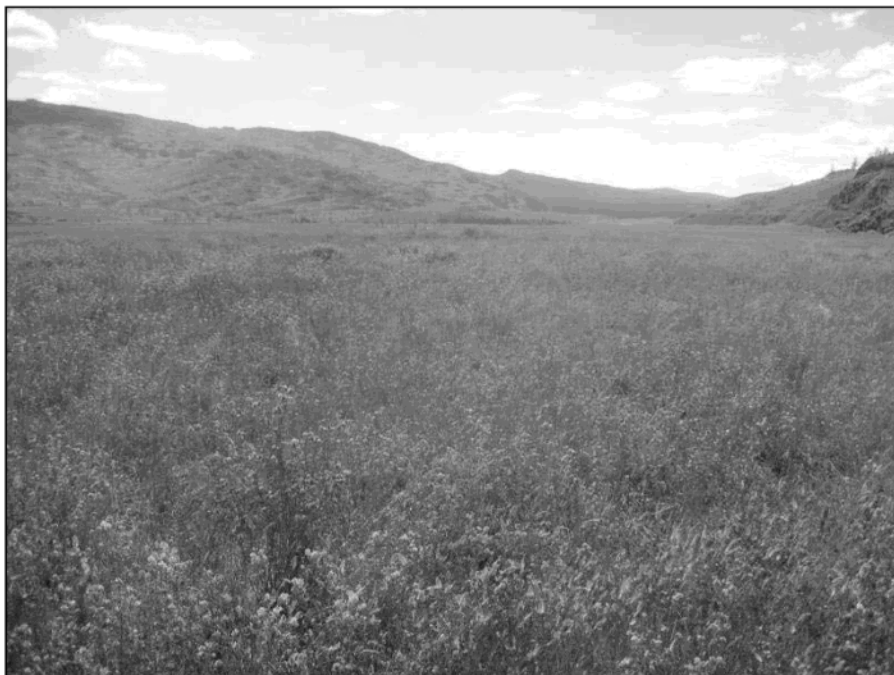
**PHOTO 4** – Re-vegetated tailings beach near East Dam.

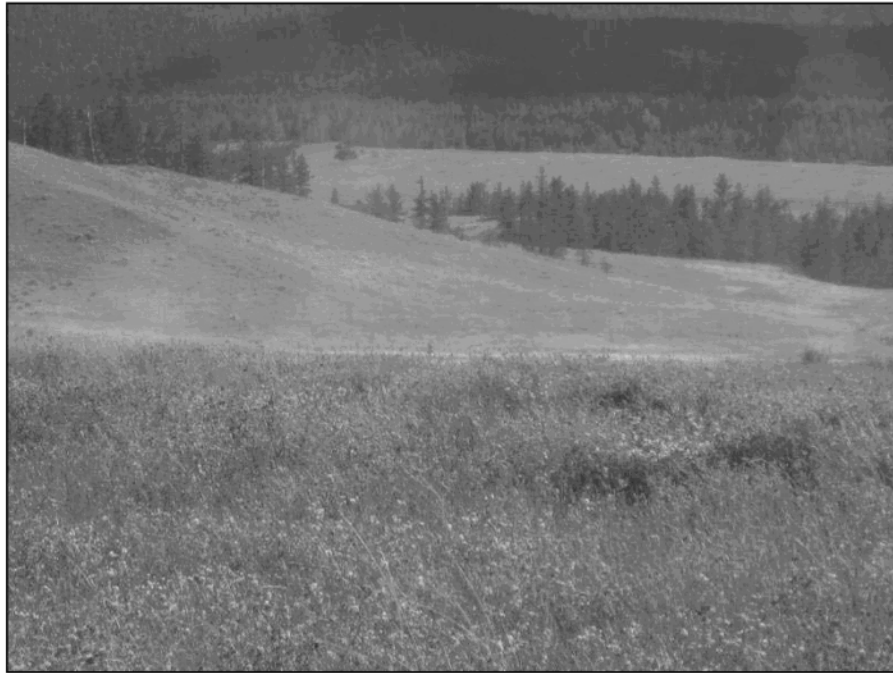
Windblown dust was observed from the tailings beach during the inspection (Photo 5). Potential environmental impacts from fugitive dust are beyond the scope of this DSR.

**PHOTO 5** – Wind blown dust from tailings beach.

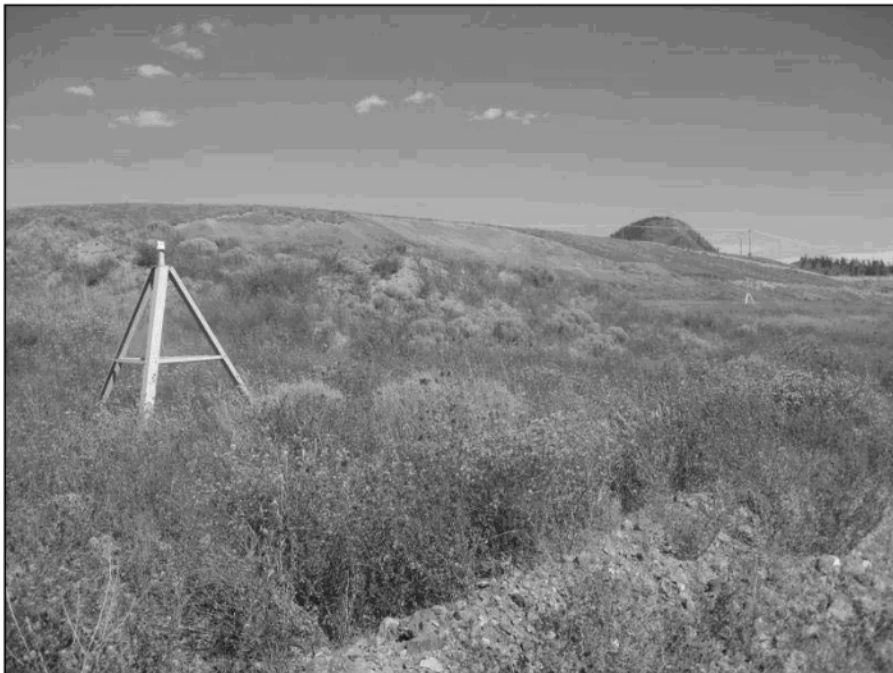
**PHOTO 6** – Surface monitors at East Dam.

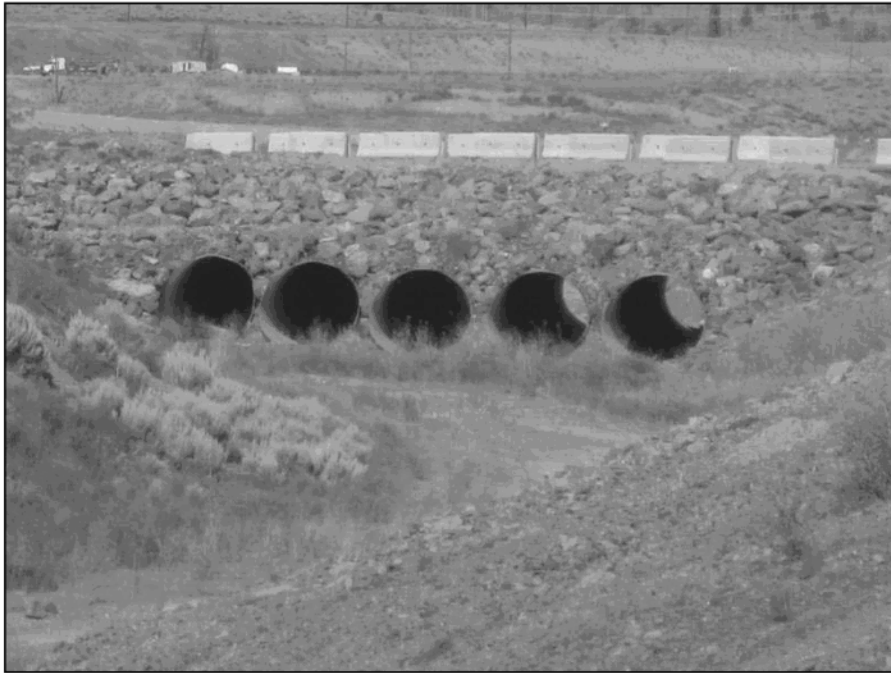
**PHOTO 7** – Culverts installed in spillway channel. Culverts installed in 2011 by New Gold.

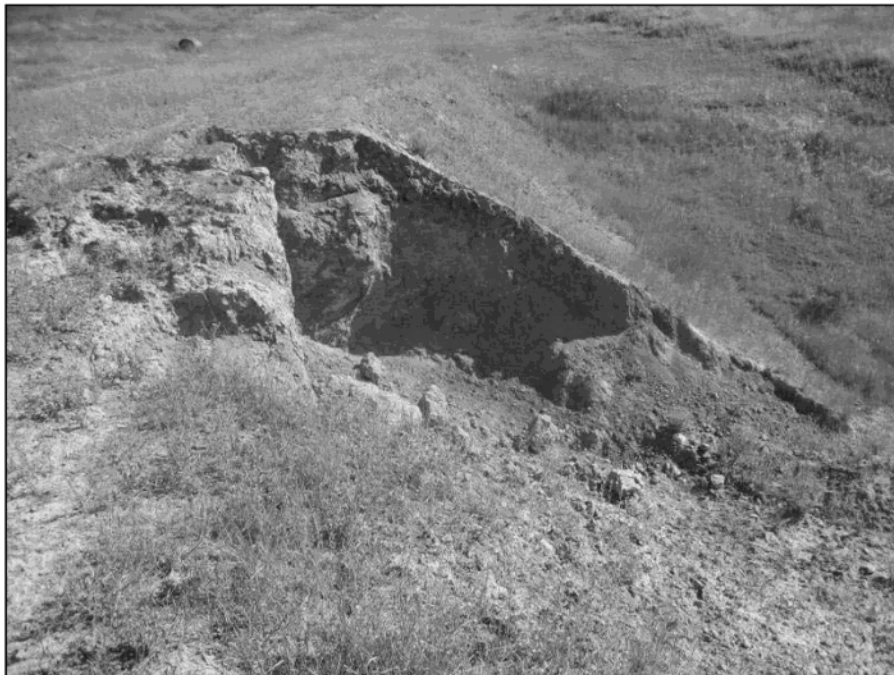
The southwest seepage dam is a small dam located downstream of the southern end of the TSF West Dam. The southwest seepage dam has a very small upstream catchment and primarily collects surface runoff from the downstream face of the Afton TSF West Dam; the ponded area upstream of the dam is typically dry. The dam overtopped in May, 2011 following a storm event and subsequent failure of the upslope Alkali diversion channel which diverts surface flows from an upstream catchment area of approximately 53 km<sup>2</sup>. This resulted in the erosion of a portion of the dam downstream slope (photo 8).

**PHOTO 8** – Eroded section of the southwest seepage dam.

KGHM contracted Dawson Construction, a local contractor, to complete the repair work in October 2013. KGHM also contracted KP to provide construction Quality Assurance and to document the work. The dam was repaired (photo 9) and a construction quality assurance report was issued to KGHM (Knight Piésold 2013b).

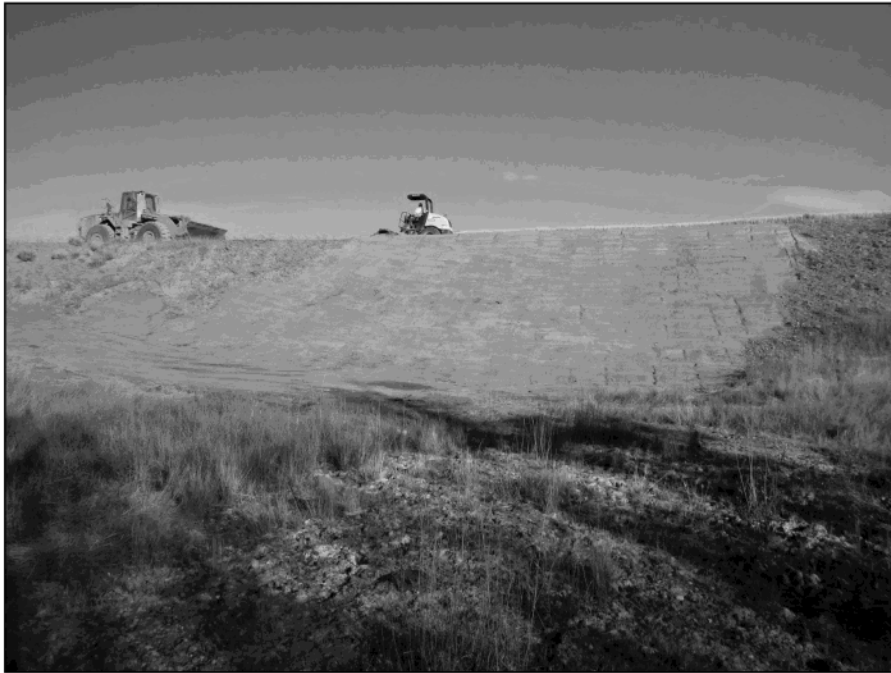
**PHOTO 9** – Eroded section of the southwest seepage dam repaired in October 2013.

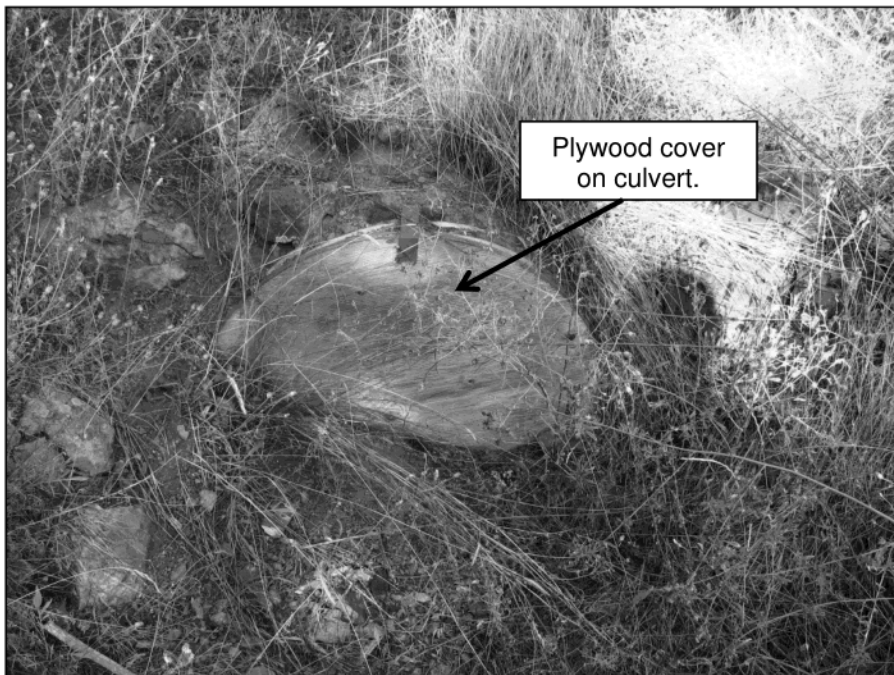
**PHOTO 10** – Plywood gate and debris blocking outlet at northwest seepage dam.

A recommendation from the 2009 DSR was to clean up the inlet such that the plywood barrier could be removed during a flood event. Removing the plywood barrier during a flood event may be difficult

(it is bolted on) and it is recommended KGHM explore alternative plans to safely pass flood events from the northwest seepage pond during storm events.

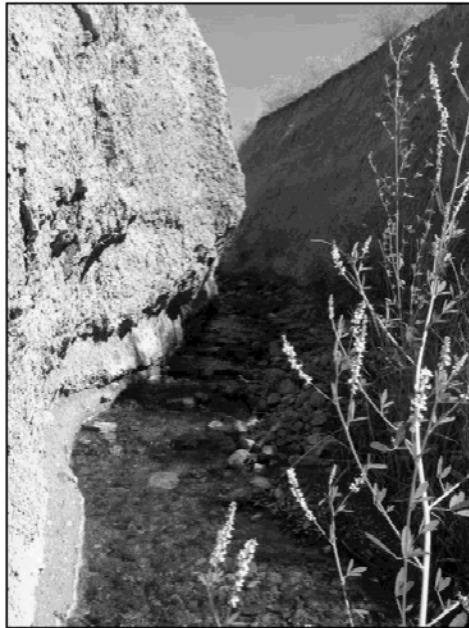
The Alkali diversion channel is located on the south side of the TSF and diverts flows from Alkali Creek downstream of the southeast seepage dam into Cherry Creek. The diversion channel is undercut in places (photo 11) and there is a risk the side slopes will slough into the channel during a high flow event in the channel as occurred in 2011. It is recommended the Alkali diversion channel be refurbished to safely pass the design flow. KGHM has plans to upgrade the Alkali diversion channel in spring of 2014. A hydrologic study and channel design have been completed for this work by Knight Piésold.

6. The section of the Alkali diversion channel to the west of the TSF is in need of repair as it has eroded down to bedrock in places and has over steepened side slopes. There is a risk the side slopes will slough into the ditch during a high flow event. This occurred in 2011 and the resultant discharge overtopped and eroded a section of the southeast seepage pond.

**PHOTO 11** – Alkali diversion channel, undercut section. Diversion channel modifications/repair planned for 2014.
