December 9, 2011
File: 285-042.03

Re: Report on Hazardous Materials Assessment – 504 Clarke Road, Coquitlam, BC

**Ref: CONTRACTOR VERSION - PRE-DEMOLITION HAZARDOUS BUILDING MATERIALS SURVEY OF THE
MULTI-TENANT COMMERCIAL BUILDING LOCATED AT 504A AND 504B CLARKE ROAD,
COQUITLAM, BC**

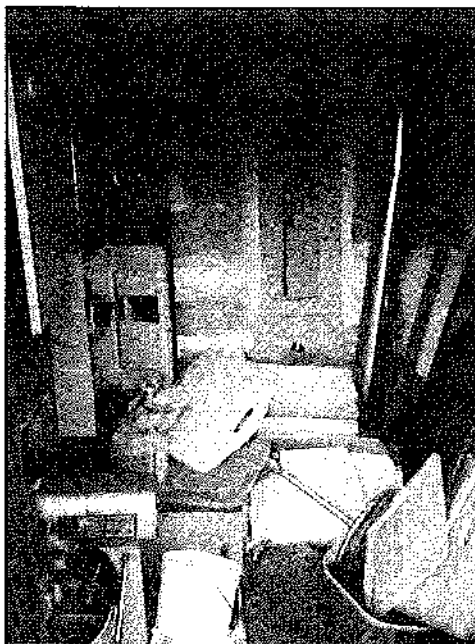
Photo 3: View inside the electrical room of the commercial building at 504 Clarke Road (October 28, 2011)

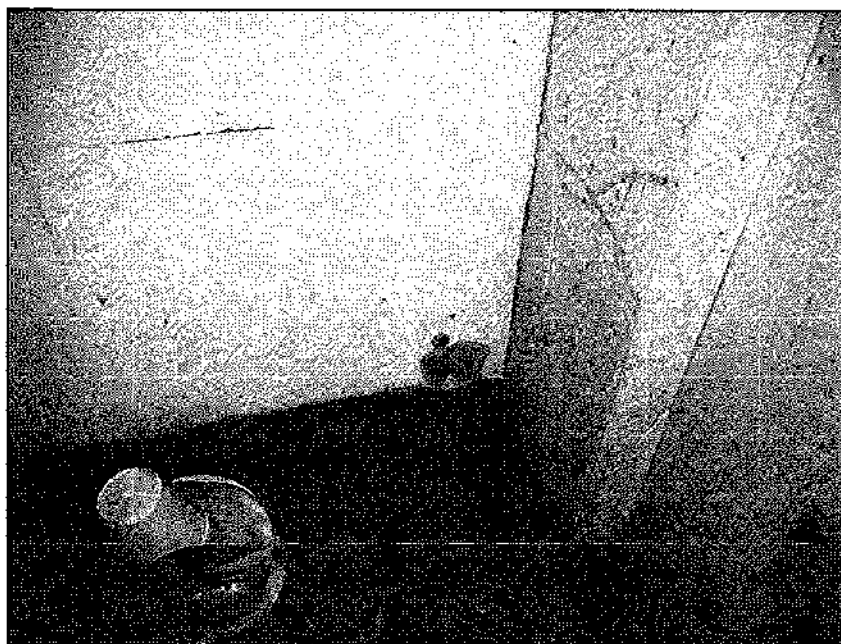
Photo 4: View of some of the mould inside unit 504A of the commercial building at 504 Clarke Road (October 28, 2011)

The differing types of moulds and/or fungi which can cause infectious disease and/or respiratory disease in humans should be removed as biohazardous waste by a qualified abatement contractor in accordance with the Workers' Compensation Board of British Columbia Occupational Health and Safety Regulation, prior to unprotected trades performing work in the building. In lieu of removing moulds and fungi, workers shall wear respirators and protective clothing while in contaminated areas of the building.

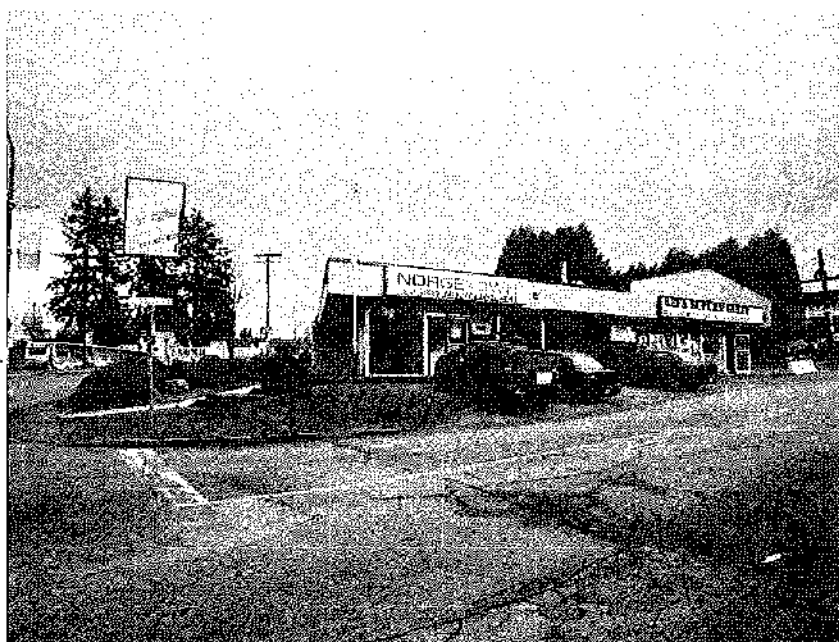
Photograph 8: Neighbouring Property to the South (Dry Cleaner).
