Province of
British Columbia
MINISTRY OF ENVIRONMENT
LANDS AND PARKS

Re: Landslide on Brooklyn Creek

CPR Landslide Brooklyn Creek

BROOKLYN CREEK - CPR FAILURE

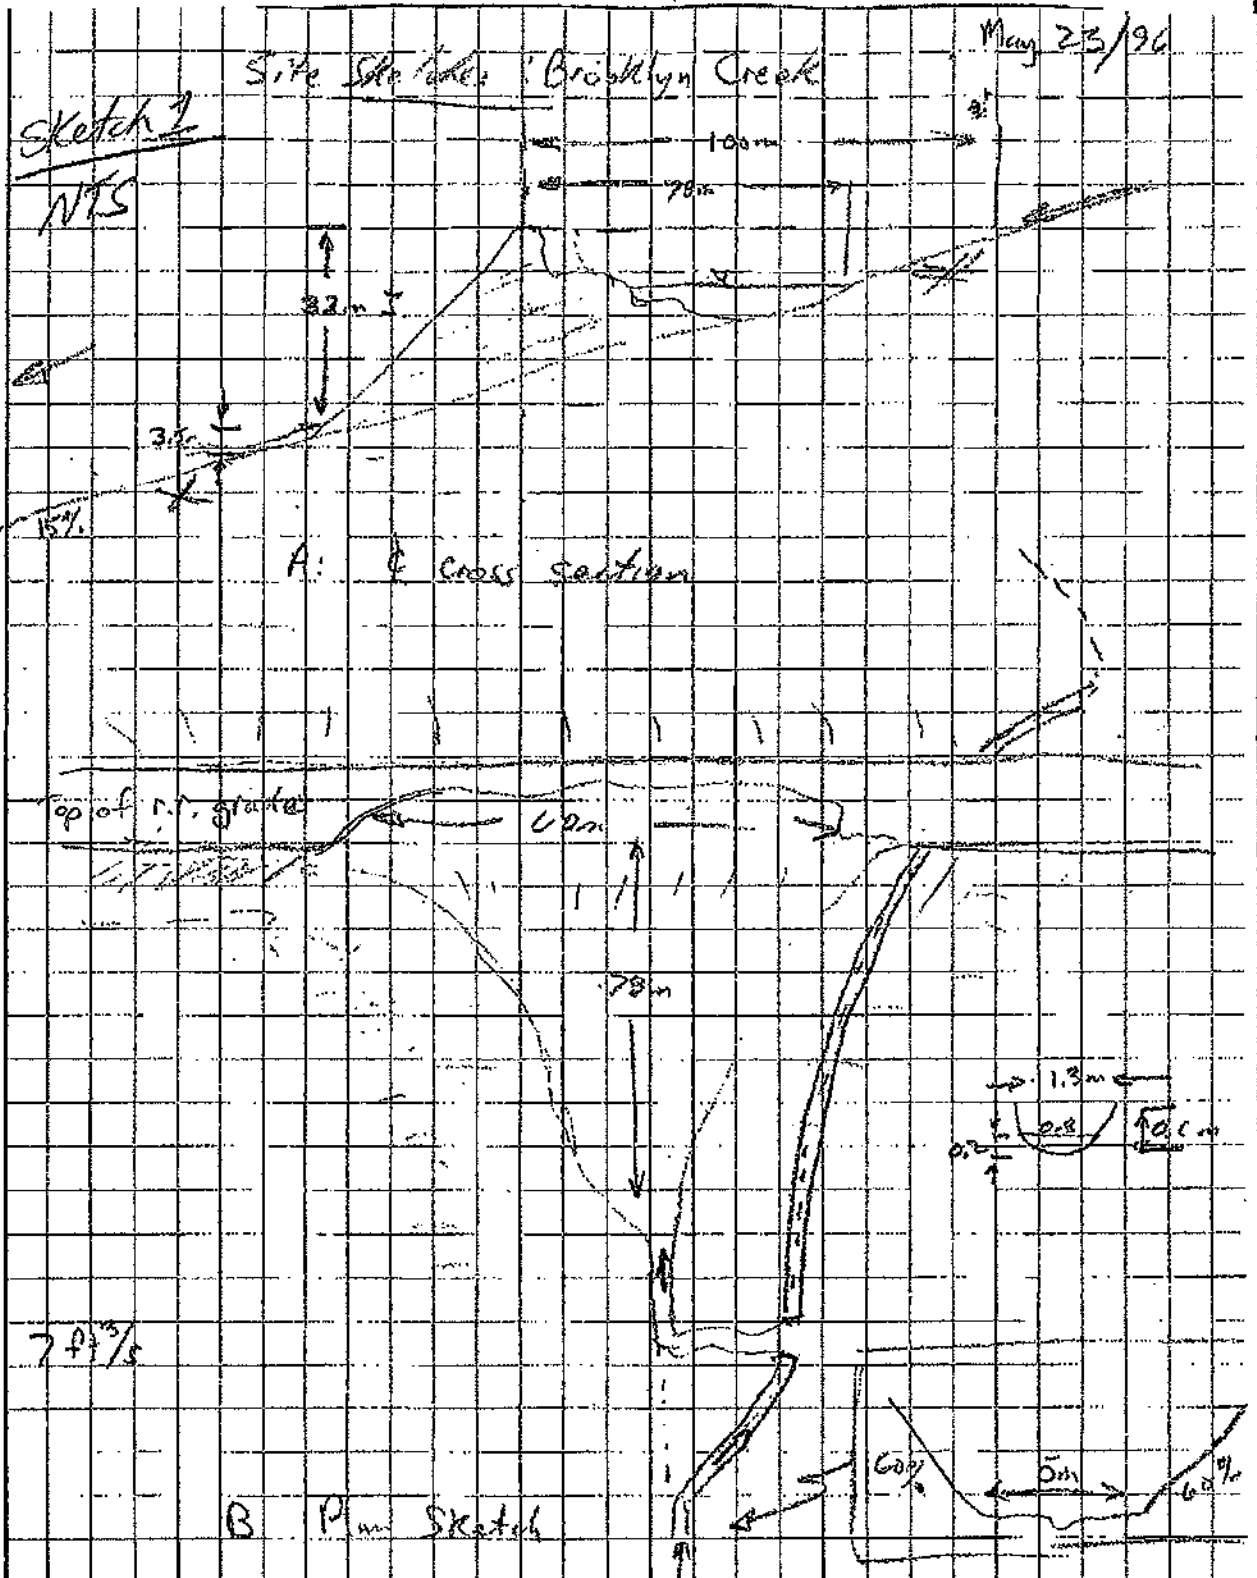
Sketch 2

Rough dimensions of the fill failed material and pondage are shown on the attached sketches. The slump was on the upstream side of the crossing. (photos 1 - 61) There was no evidence of any culvert through the base of the structure at the time. The upstream side of the railway grade was covered in debris (photos 3, 5 & 6). There was no evidence of a culvert at the downstream side of the railway grade (photos 11 & 12). Approximately 100 m upstream from the crossing, in a 1.3 m wide and 0.6 m deep half culvert (see photos 7, 8 & 9) was used to convey the water by the structure and discharge it on the slope as shown in the sketch and photos 9 & 10. The flow in the creek above the structure was estimated at $7 \text{ ft}^3/\text{s}$

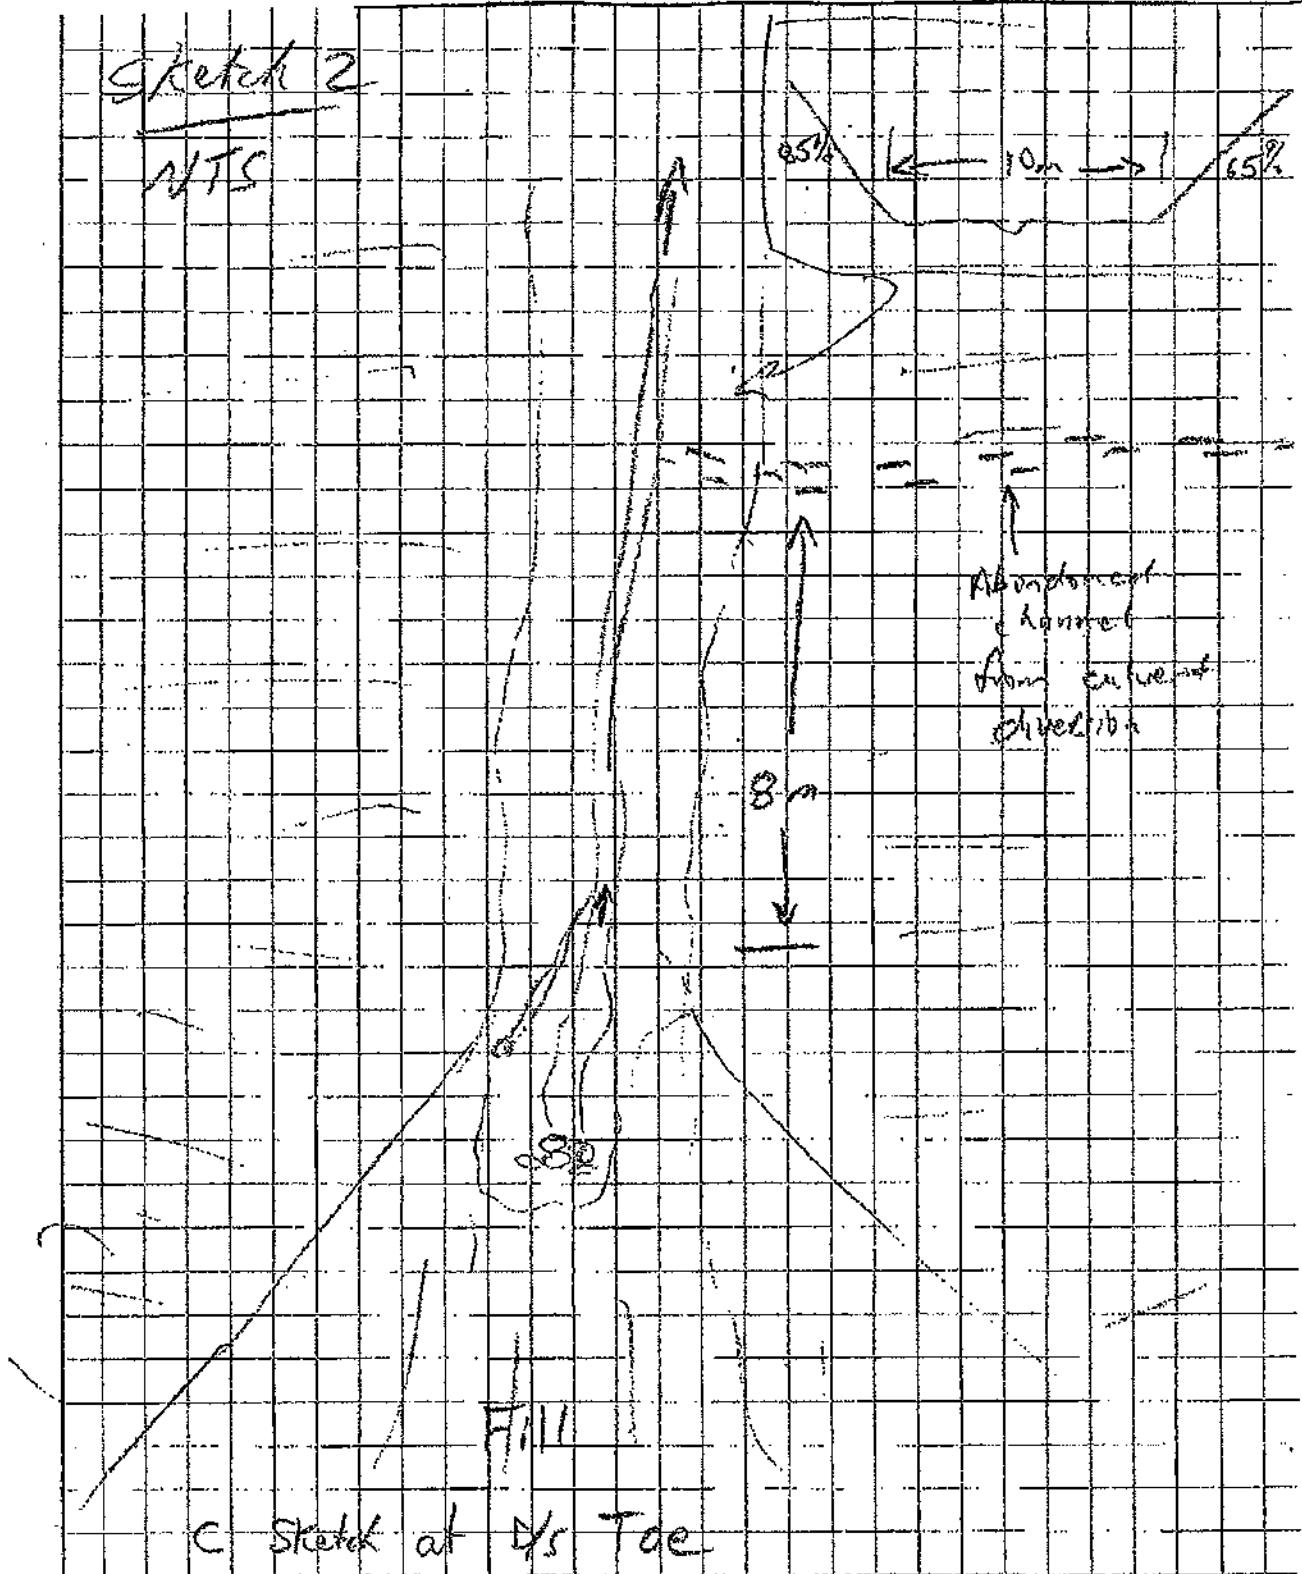
C Sketch at 1/2 Toe

Approximately $7 \text{ ft}^3/\text{s}$ was exiting the ^{toe} toe of the fill as shown in photo 8 and sketch # 1. There was no evidence of distress or weakening of the remaining railway grade. There was no seepage or slumping on the down slope face of the fill and there was only minor evidence of fines emerging at the toe. The base of the fill seems to have a large percentage of large rock.

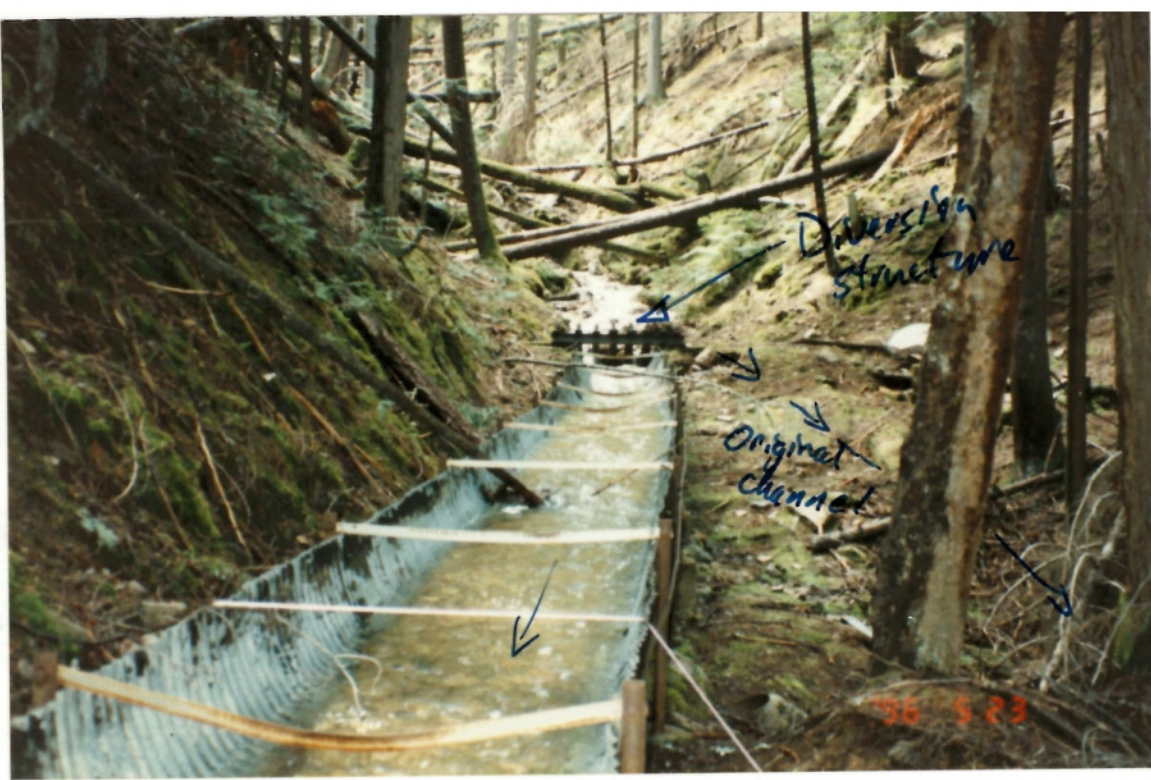
7

Unfortunately, a section of the conveyance channel failed (see photos and sketch) resulting in all the water flowing to the railway crossing embankment. The failure was caused when foundation pedestals were displaced by a minor hill slope failure. The water flowing into and ponding against the fill may have caused the failure of the railway fill.

1. View of fill failure looking east
2. Closer view of fill failure looking east
3. Closer view of fill failure looking east - diversion channel
4. View of remaining fill
5. View of gully upstream from vantage point on top of railway fill
6. View of failure looking west
7. View of half culvert side hill diversion channel. Arrow points to diversion structure
8. View of failed section of channel
9. End of diversion channel
10. Dry channel down slope where water was previously diverted
11. Flow emerging from downstream toe of fill. Arrows show two spots where flow emerges
12. Closer view of main flow from toe of fill.

At 2:30 p.m. I called Ed Palsz; CP Rail. He advised that they had not flown the line yet, but had plans to do so in 2 weeks. They had not received any notification of a landslide. When asked what should be done I advised him to inspect the site. At a minimum they could fix the bypass channel to get through high water. There is still plenty of snow in the mountains and we can expect higher runoff when we get a warm spell.
