Investigation of the 2012 Woodlot 1572 Landslide

Investigation of the 2014 Woodlot 1572 Landslide

RE: Woodlot 1572 landslide field review (April 2012)

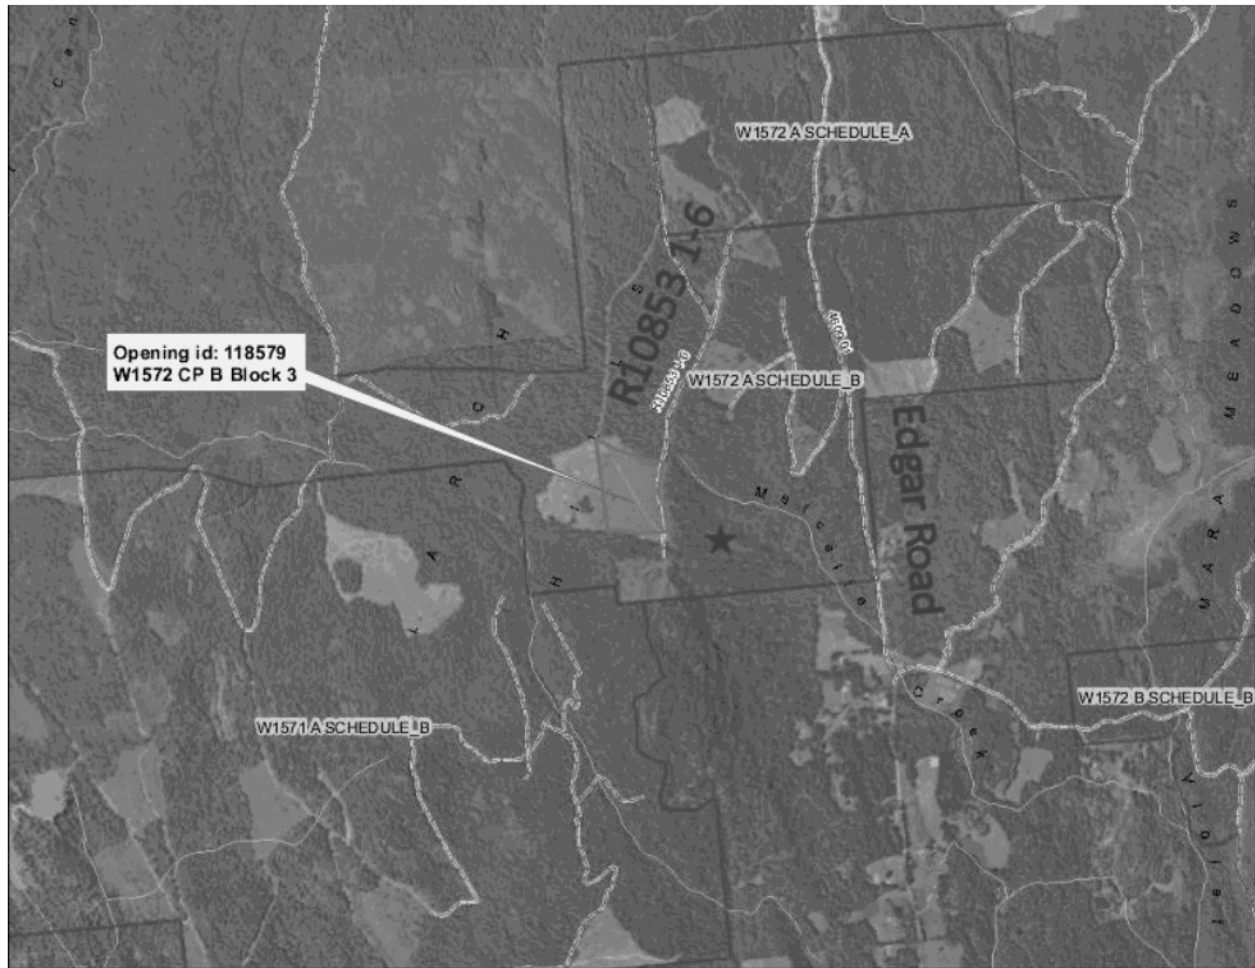
The cause of the landslide appears to be an excess of water in a shallow draw reaching a steep slope below Block B-3 (Figures 1 and 2). As the draw left the Block B-3 it was a small swale, 2-3 m deep, 5-10 m wide and definable as linear watercourse. Downslope, we were able to follow the draw continuously until it reached a steep rock-cored face where it flattened and became more unconfined. The landslide initiated within the shallow

Figure 1: Location map of the Woodlot 1572 showing road access across the woodlot on R10853 1-6 into block B-3. The spur road is visible crossing block B-3 from southeast to northwest. The landslide initiation location is marked with a star.

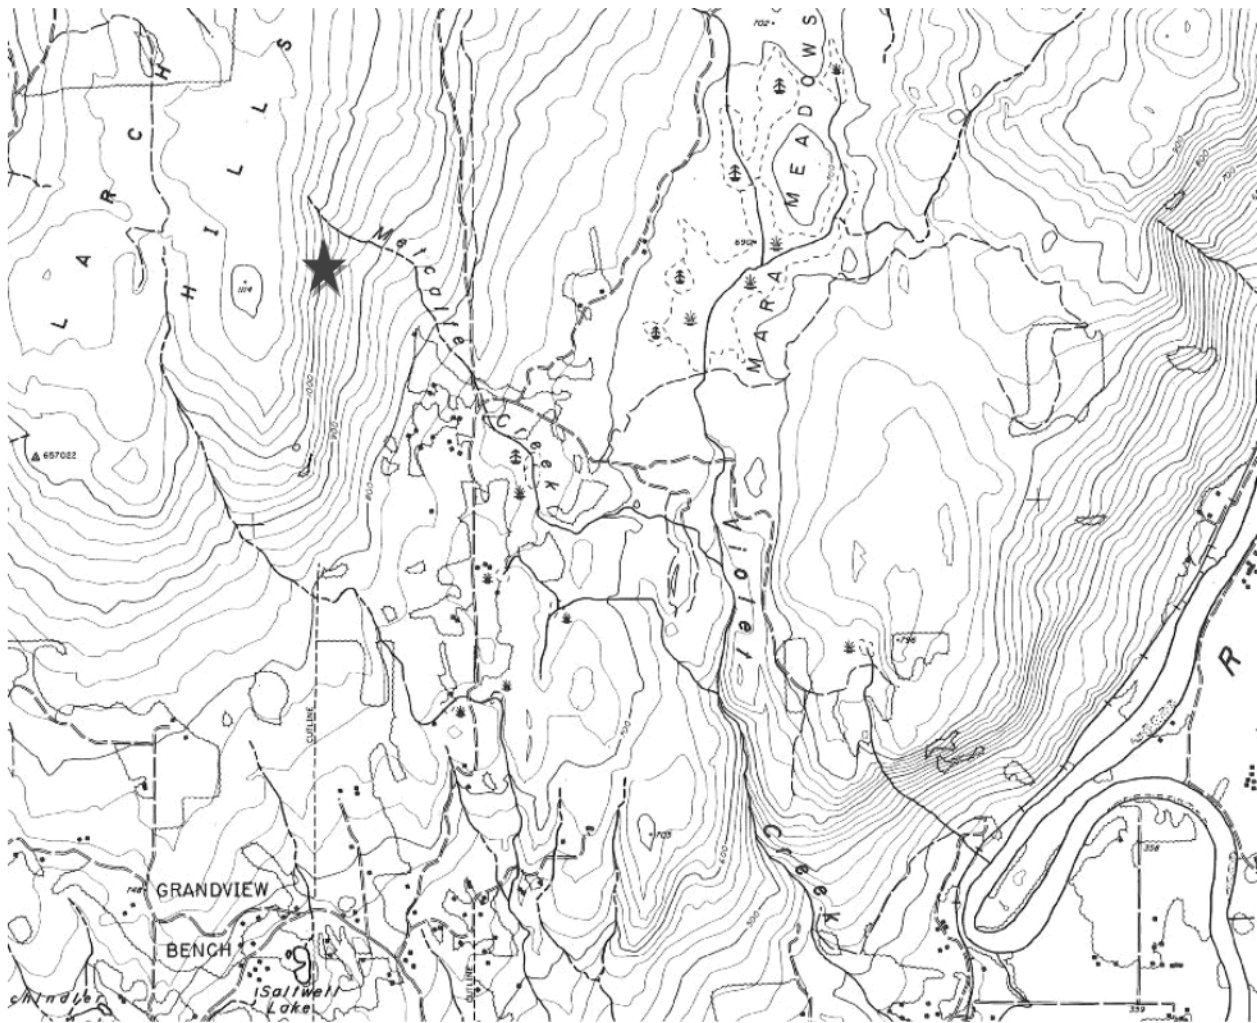
Figure 2: Approximate location of initiation point of landslide. Block B-3 located upslope to the west on the top of the upland plateau (see Figure 1).

It is recommended that rehabilitation of the spur road across Block B-3 be completed to disperse the ditchline flow. The existing waterbars serve only to disperse road surface water flow, but not to intercept and disperse the ditchline flows. This will require several cross-ditches be constructed to move water across the road and into existing shallow draws. Location of the cross-ditches should be checked to ensure a continuous drainage path into an established draw on the steeper slopes below. The ditchline should be blocked on the downhill side of the cross-ditches to prevent future flow. There will still be some flow in the lower segment of the ditchline which will continue to flow into the existing shallow draw, but this flow should be much reduced and the draw should be capable of handling the flow.

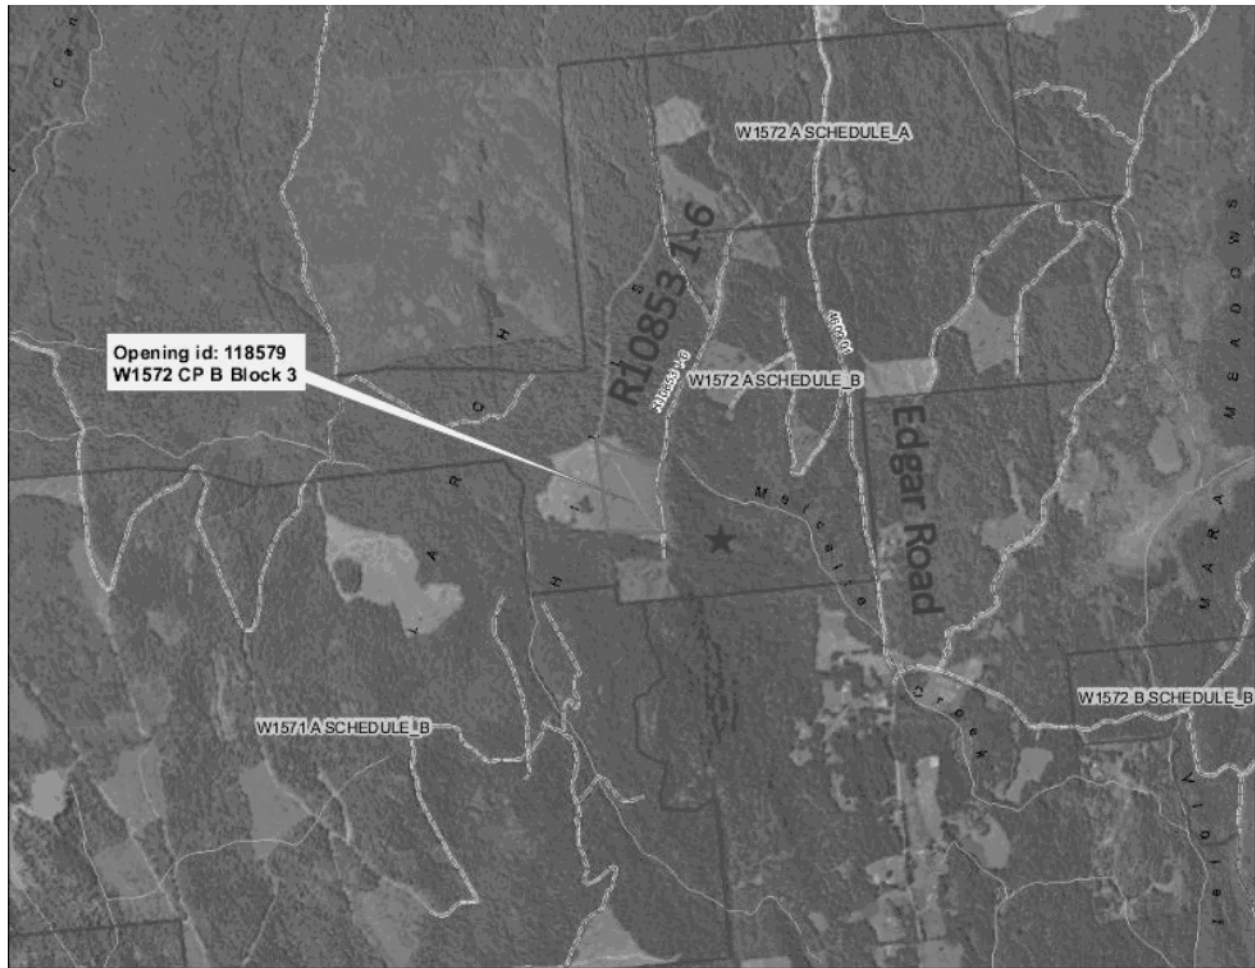
The cause of the landslide appears to be saturation of the slope due to an excess of water reaching the steep slope below Block B-3 (Figures 1 and 2). Removal of forest cover in Block B-3 changed the accumulation of snow and timing of snowmelt; increasing the amount of snow accumulated and increasing the rapidity of snowmelt. Typically this results in a larger volume of water flowing downslope over a shorter period of time as snowmelt occurs. Rainfall at the time of snowmelt would also increase the flow volumes. From a spur road cross-ditch, water could be traced to the main access road, into a ditch-line and then through either a culvert or cross-ditch onto the moderate 20-30% slopes immediately below the road. The road drainage structures (culverts or cross-ditches) have taken the widespread flow of groundwater (sub-surface flow) on the plateau and concentrated it on the downslope side of the road. Despite this, there was no clearly traceable watercourse on the slope between the culvert or cross-ditch and the headwall of the landslide. The water running through the culvert or through the cross-ditch disappears into the ground below the main access road but a steady flow reappears in the headwall of the failure approximately 75 m downslope. Likely the concentrated flow is beginning to disperse across the slope, but the plume of this sub-surface flow is still more concentrated than natural groundwater flow. Also, due to the increased volume the water is likely moving faster and saturating areas much more rapidly.

Figure 1: Location map of the Woodlot 1572 showing the main road (R10853 1-6) access across the woodlot to the plateau and block B-3. The spur road is visible crossing block B-3 from southeast to northwest. The approximate location of the 2014 landslide initiation point is marked with a star.

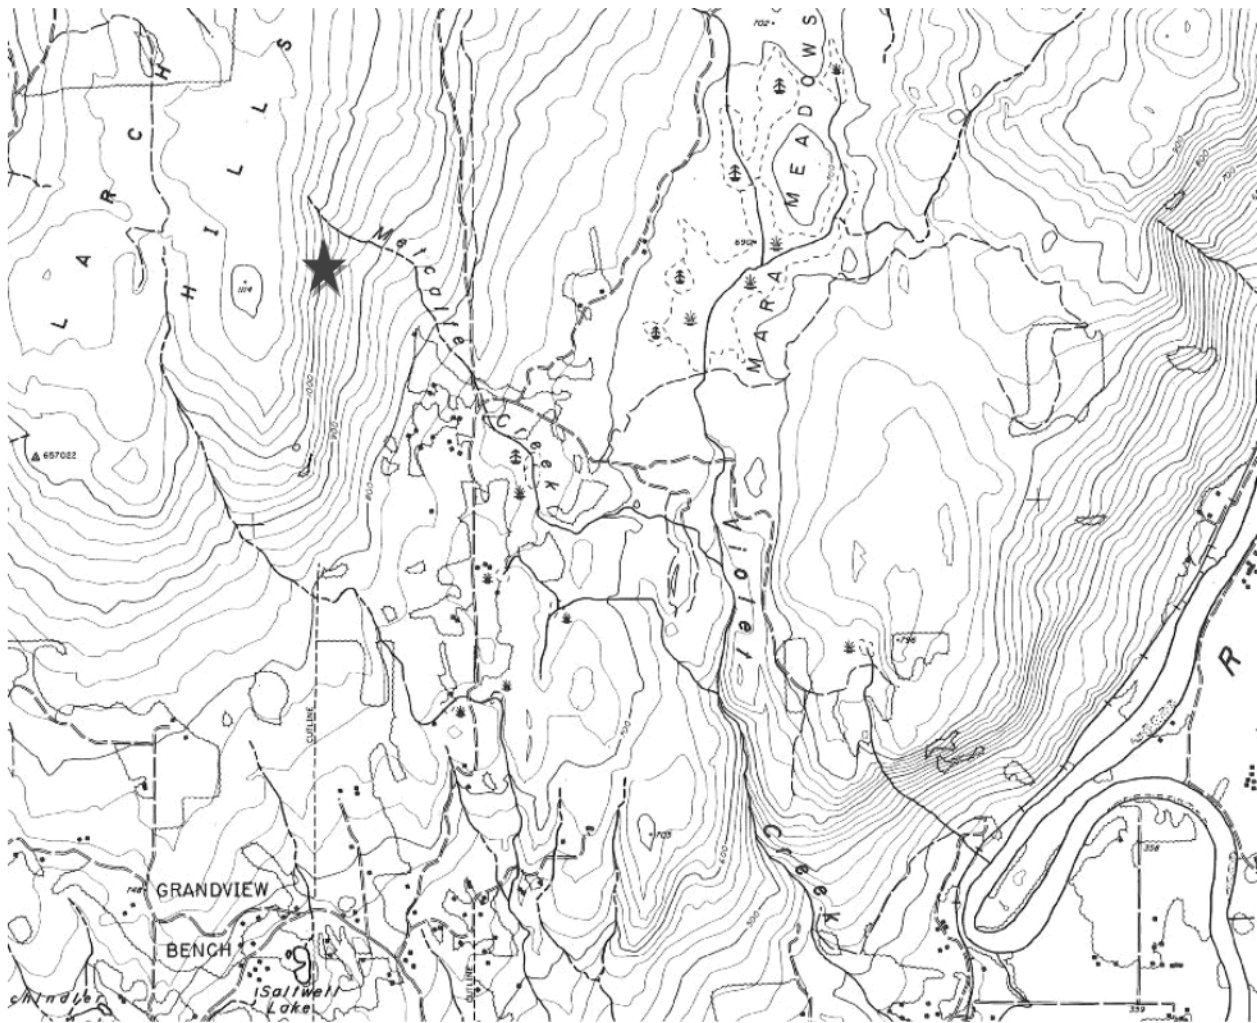
The initial failure was a shallow plane of weakness in the till or colluvial material which overlies bedrock. The slope at the headwall of the landslide is up to 70%. Downslope of the initiation point the slope is continuously over 60% for 100 metres and starts to form a draw into which the landslide entered and followed downslope. The plume of water from the culvert and cross-ditch saturated this slope and failure occurred as a shallow translational slide. This moved downslope en masse with trees, sediment and water essentially sliding as one. The sliding mass entered the draw and once it became more confined it transitioned into a debris flow. This debris flow was much more mobile and followed the confined draw downslope through a series of turns until it reached the alluvial fan approximately 800 m distance below. At this point the flow was substantial in size but the channel was infilled with standing timber which slowed and deflected the flow. Some of the debris continued moving through the channel, some deflected onto the Kunzler's access road, and some of it spread out and deposited amongst the standing timber.

Figure 2: Approximate location of initiation point of the 2014 landslide. Block B-3 located upslope to the west on the top of the upland plateau (see Figure 1).

Future efforts to control the drainage off the plateau might review this and attempt to further disperse these flows with more cross-ditches and culverts. At present water still appears to be being moved slightly southwards by the ditch-lines, it would be preferable to move it directly downslope (easterly) or even slightly northwards as the slopes get gentler to the north. Another course of action might be to completely rehabilitate the main access and spur roads in an attempt to return the drainage to a more natural condition. Any changes in drainage patterns should be reviewed in the field to ensure that proper drainage courses are used to drain the water downslope and eventually into the main stem of Metcalfe Creek.

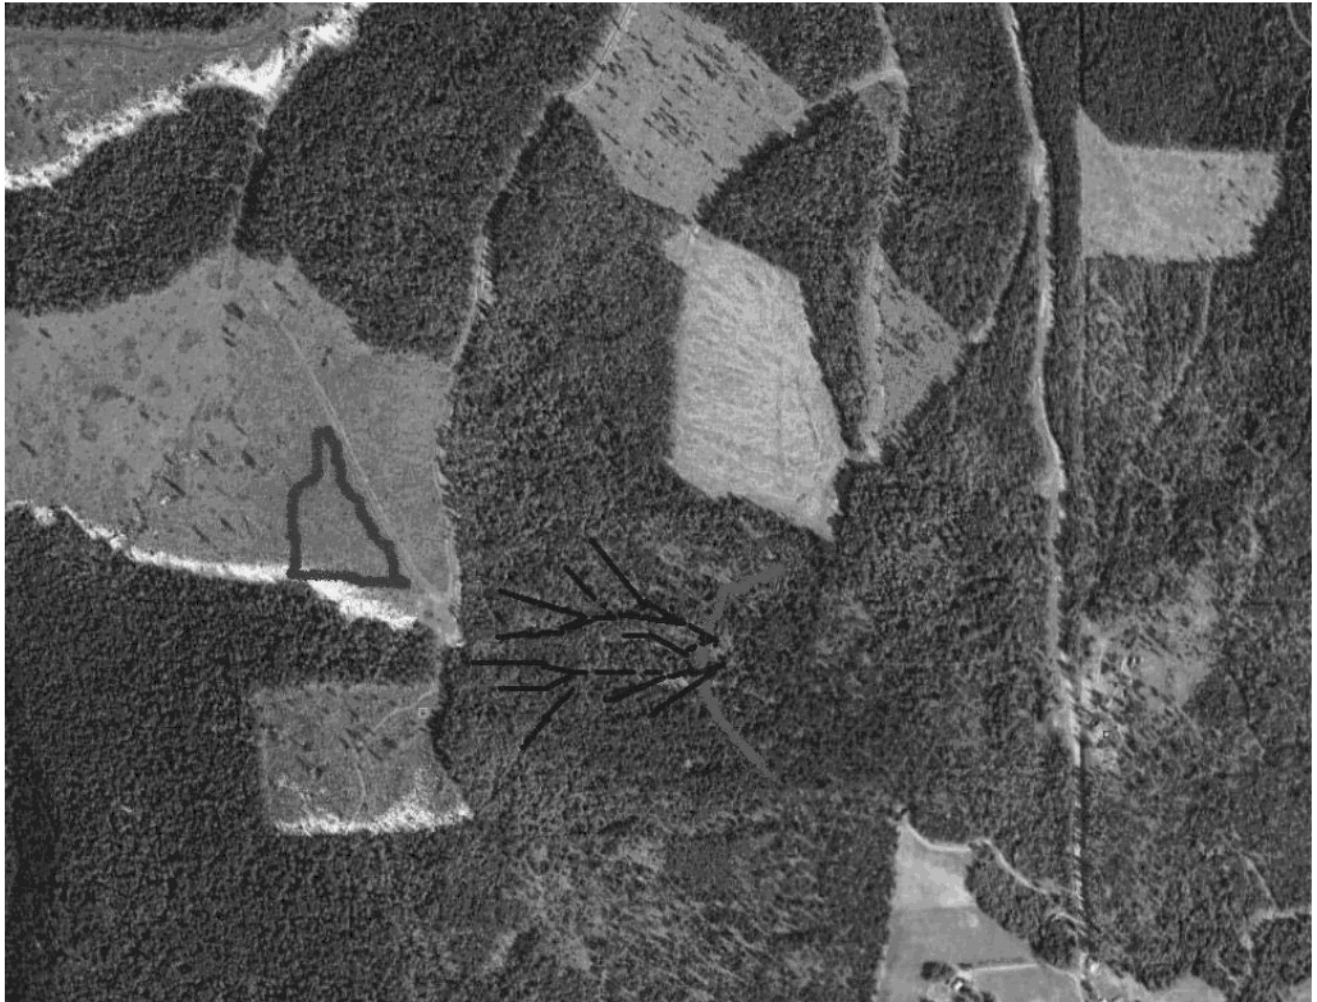
Figure 2 – Location of features observed in the field.

Red outline = area of influence by road in B-3 with no cross drains installed (max. 2ha).

Blue lines = complex of existing, well defined, incised gullies converging downslope

Magenta thick line = existing boundary of mixed deciduous trees with historical high frequency of disturbance

- 2) Multiple landslide events occurred in the Salmon Arm area during the April 26 rain on snow event.
- 3) The physical area (shown above in red) influenced by the spur road in relation to collecting and re-directing surface water flow is very small in relation to the watershed area or area of surface water collection above the land slide head scarp. The area in the cutblock to the west or left of the red polygon in Figure 2 drains to the west, away from the area being investigated. Based on the pre-existing complex of well defined gullies (shown above in blue) that all converge down slope and lead to the initiation point of the landslide, the water would likely have ended up in the same draw if the road was not present. Although the road changed the surface drainage on a micro site scale, the water that ultimately resulted in the landslide was being introduced on a macro scale to the entire surrounding area. The relatively small flat 2 ha collection area above the spur road may not have influenced the initiation of the landslide.

- 4) There was an abundance of indicators found in the field that show the immediate area where the landslide initiated and ran out had very high levels of historical disturbance (area shown in magenta in Figure 2 above). In the area immediately surrounding the initiation point of the landslide, there are several other smaller slumps and small landslide disturbances from previous years.

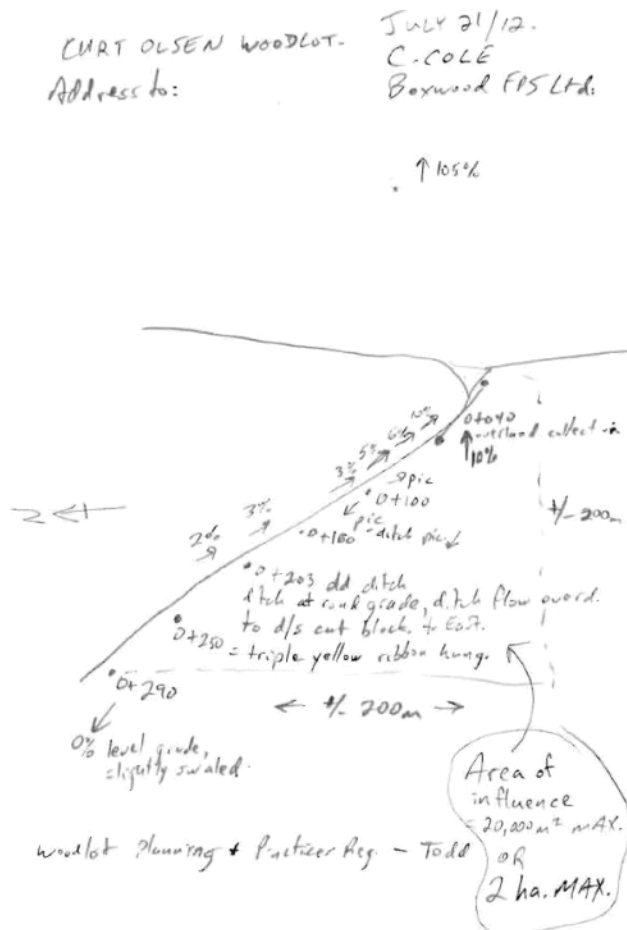
Figure 4 – Field notes indicating terrain slopes and area influenced by the spur road in B-3. Spur road length from height of land back down to switchback = 290m.
