# BC Ministry of Forests, Lands and Natural Resource Operations Thompson Okanagan Region

## Investigation of the 2014 Cooke Creek Debris Flood

## INVESTIGATION REPORT INTO THE COOKE CREEK/DALE LAKE LANDSLIDE OF MAY 2, 2014

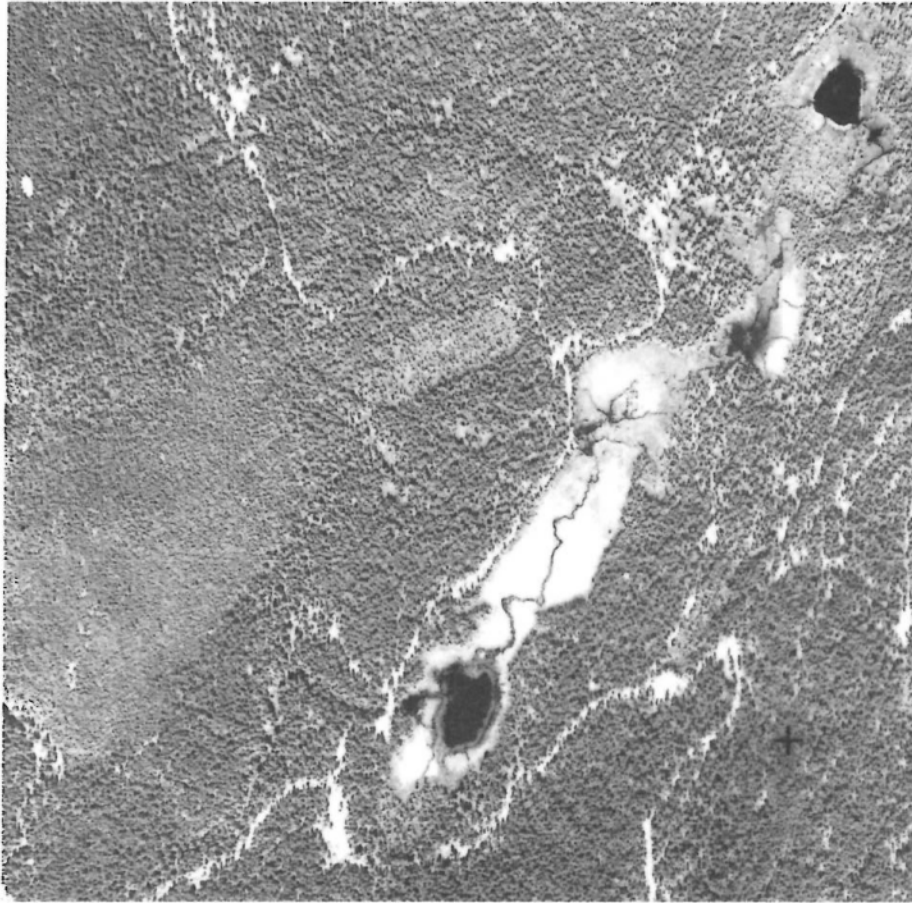
Lake levels change through the years of photography, but the basic form of the lake remains similar between 1959 and 2004 (Plate 1). The lake has three basins: south, central and north. The south basin has always had an open pond of water, approximately a hectare in size, through all years of imagery prior to 2007. The central basin is elongate, up to 600 m long over 100 m wide with marsh grasses and a defined stream channel running through the centre of it. In a few images the north end of the central basin has open ponds, likely associated with beaver dams. The north basin is small, 100 m by 80 m wide and originally had a small open pond which over the years has ingrown with marsh grasses. The stability of the lake levels implies that the drainage systems into and out of Dale Lake were sufficient to manage the streamflow.

Plate 1: Aerial photograph BC2640-67, date of exposure is July 22, 1959. The open water in the south, central and north basins can be clearly seen on this black and white image. The pale coloured areas around the open water are marsh grasses. Spruce Lake, with a pond of open water, can be seen to the upper right. The breach site is on the west side of the south basin where the road is closest to the water.

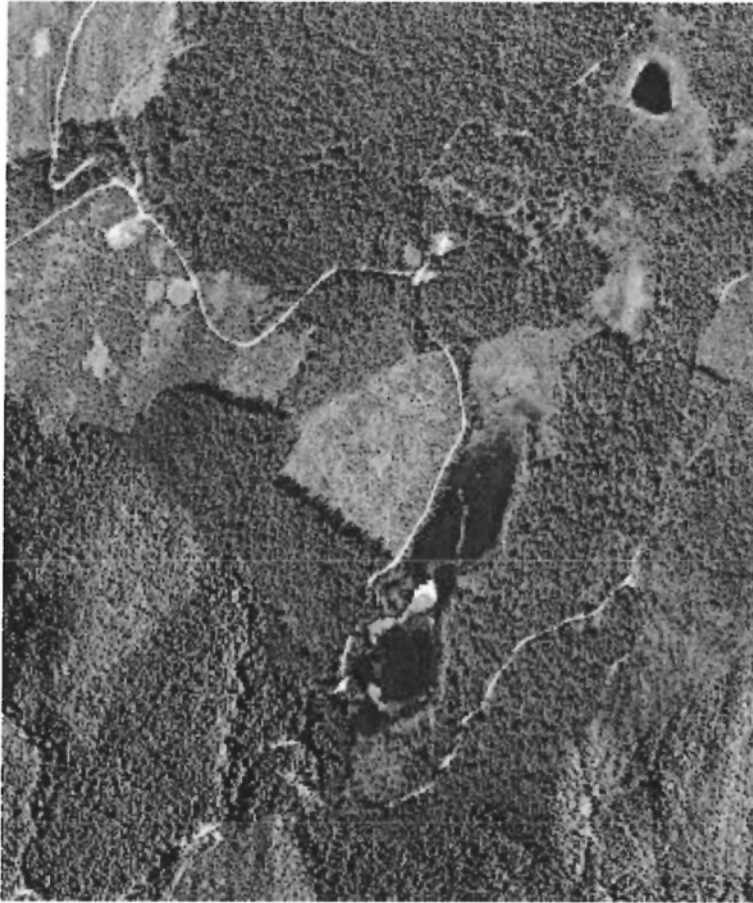
In the 2007 imagery a major change in the water level of the lake can be observed and indicates that something has changed at the outlet. The lake expands from a small pond in the south to a large lake which covers the south and central basin. The south basin can still be seen, outlined by a ring of marsh grass, and the central section of the lake is inundated with water, covering as far north as the first beaver dam. Change at the outlet may signify an increase in the flow coming into the lake, but with no change in the outlet level only excess inflow to outflow beyond the capacity of the lower culvert would cause the lake level to rise. This, however, is unlikely as this image is from July 5, 2007 and the peak inflows from freshet have passed allowing the culvert time to pass the water and lower the lake level. For the lake to cover this aerial extent the water level must rise significantly, and impoundment must be maintained. I believe this indicates that the old culvert was non-functional in 2007 and that the new upper culvert now controlled the lake level. The elevation difference between the base of the old and new culverts is approximately 1 m which due to the shallow sloping nature of the shorelines probably means a large increase in the surface area of the lake.

Plate 2: Aerial photograph BCC07008-197, date of exposure is July 5, 2007, illustrating the elevated lake levels. The marsh grasses are a lighter shade than the trees or water.

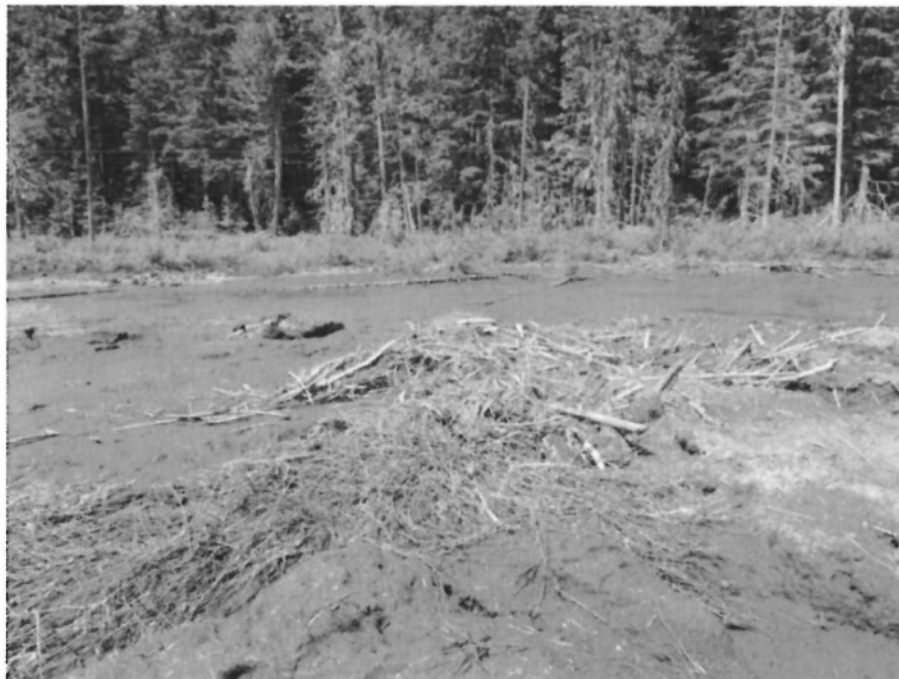
Review of aerial photographs shows a beaver lodge on the margin of the south basin, immediately north of the breach site, prior to 1984. This lodge was viewed in the field as it had been exposed by the lowered lake level, it was flattened, broken and inactive (Plate 3). The exit runs from the lodge were still visible but have become infilled with shrubbery. Remnants of an old beaver dam were observed on the upstream side of the breach (Plate 4) and this suggests that at some time beavers may have controlled the elevation of outflow of the lake. No sign of this dam can be seen on the 1959 aerial photographs.

Plate 3: Old beaver lodge in the embayment 100 m north of the breach. The main lodge, with the lighter coloured sticks, has collapsed in on itself. One exit run can be seen on the lower left and is ingrown with grey coloured branches.

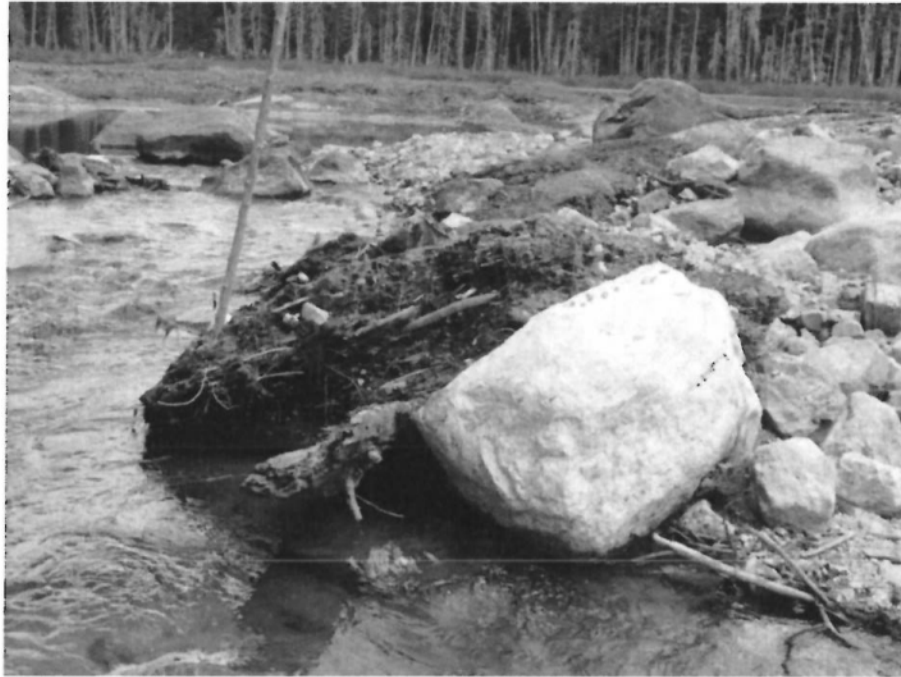
Plate 4: Remnants of a beaver dam near the breach. The dam is composed of beaver-cut sticks, stones and organic detritus. The dam is elongate across the breach suggesting it was originally across the lake outlet into Dale Creek.

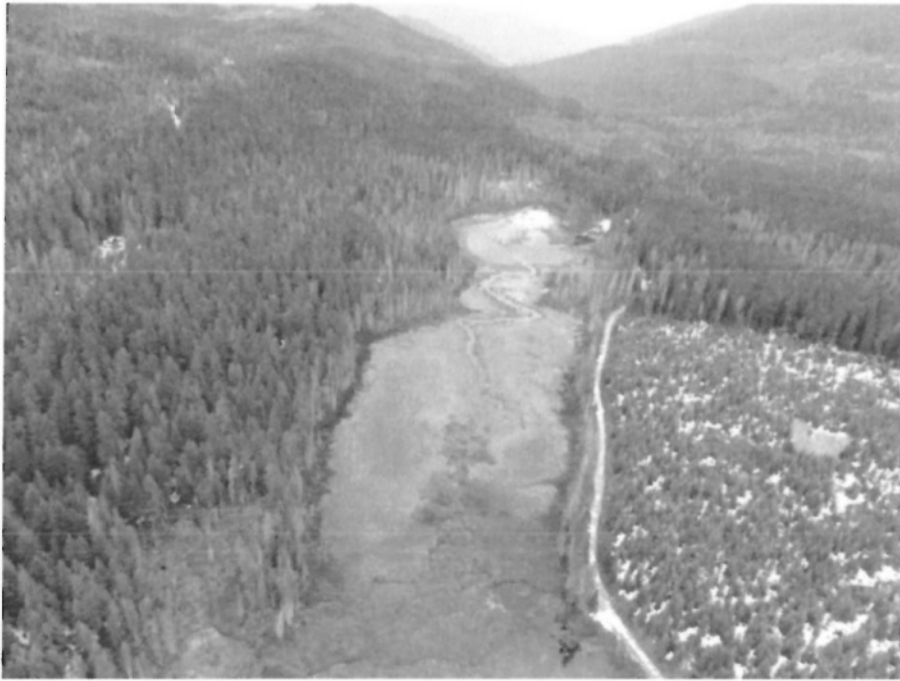
Scarring of the bark on trees at the margin of the breach was initially thought to be the result of passage of ice downstream. However, when we flew over the area on the afternoon of the day the event occurred, no ice was observed in or around the south basin of the lake. There was also no ice visible downstream of the breach along Dale Creek. The northern portions of the lake, including isolated ponds behind the beaver dams, also had no sign of ice (Plate 5).

Plate 5: Photograph of Dale Lake looking south on the afternoon of May 2, 2014. Breach site is towards the upper right corner of the lake as viewed. No floating ice can be seen on lake or in the stream, nor is there any ice along the margins of the lake in the marsh grass.

Ice is discounted as a factor in the failure of the culverts to convey the water out of the lake and into Dale Creek. No ice was seen on the lake, in the vegetation along the margins of the lake or along Dale Creek.

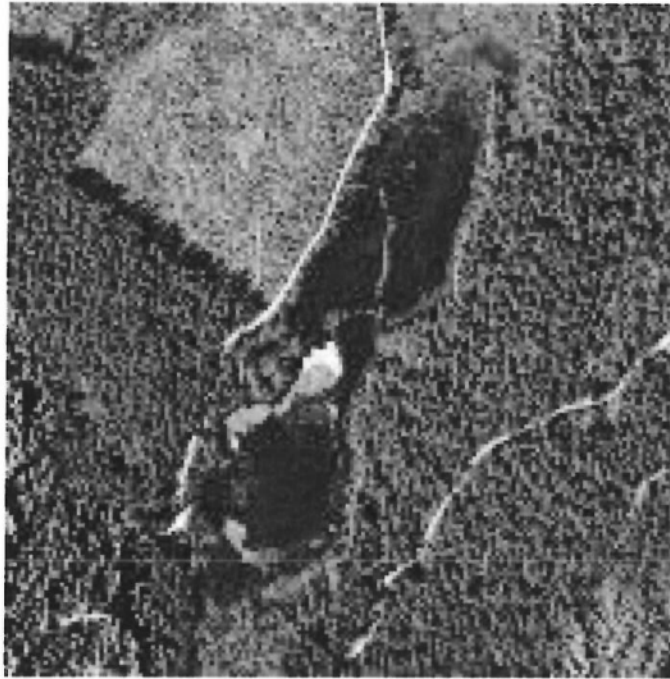
In the 2007 image (Plate 6), despite the presence of the new culvert in the roadfill, shows the lake with elevated water levels and two sections of marsh grass appear to be floating. This implies that the lower culvert was non-functional in 2007 and the new upper culvert maintained the lake level at a slightly higher elevation. One grass mat is located in the bay 100 m to the north of the breach and the second at the north edge of the south basin.

Plate 6: Close up view of Dale Lake from 2007; only the south and central basins are visible. The breach site is towards the bottom left of the image (southwest corner of the lake). Two large sections of floating marsh grasses are visible.

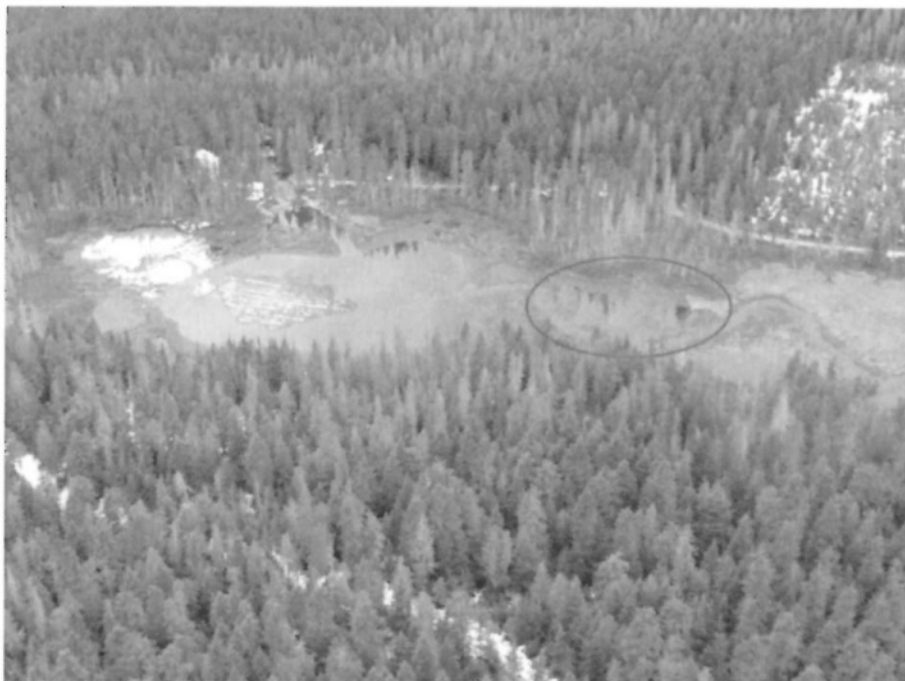
Plate 7: Floating grass mat on Dale Lake, May 2, 2014. This mat of marsh grass can be moved to the right and fits the area inside the stream channel at right centre (circled). Breach is at left centre of photograph.

In the summer of 2014, both large sections of the marsh grasses have moved. The grasses that were once in the bay immediately north of the breach have completely disappeared. The large floating grass mat now present in the middle of the south basin matches the shape and size of marsh grasses visible immediately north of the south basin on the 2007 aerial photograph (Plates 6 and 7).

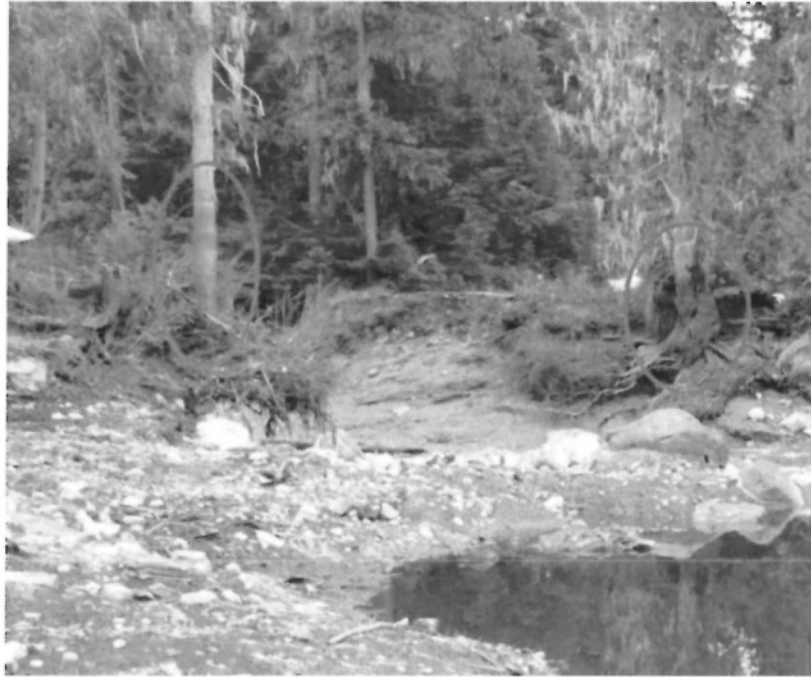
The scarring on the trees at the margins of the breach is a result of passage of one of the large marsh grass mats that used to exist in the lake. A piece of grass mat can be seen surrounding the trunk of the tree on the north side of the breach (Plate 8). Large accumulations of marsh grasses were observed in the first 300 m of the Dale Creek channel (Plate 9). These mats were readily entangled by standing trees along the margins of the flow, by large woody debris in and across the creek, and in overbank areas.

Plate 8: View from the lake bed of two scarred trees located on the upstream side of the breach. The tree on the right has a section of marsh grass wrapped around it.

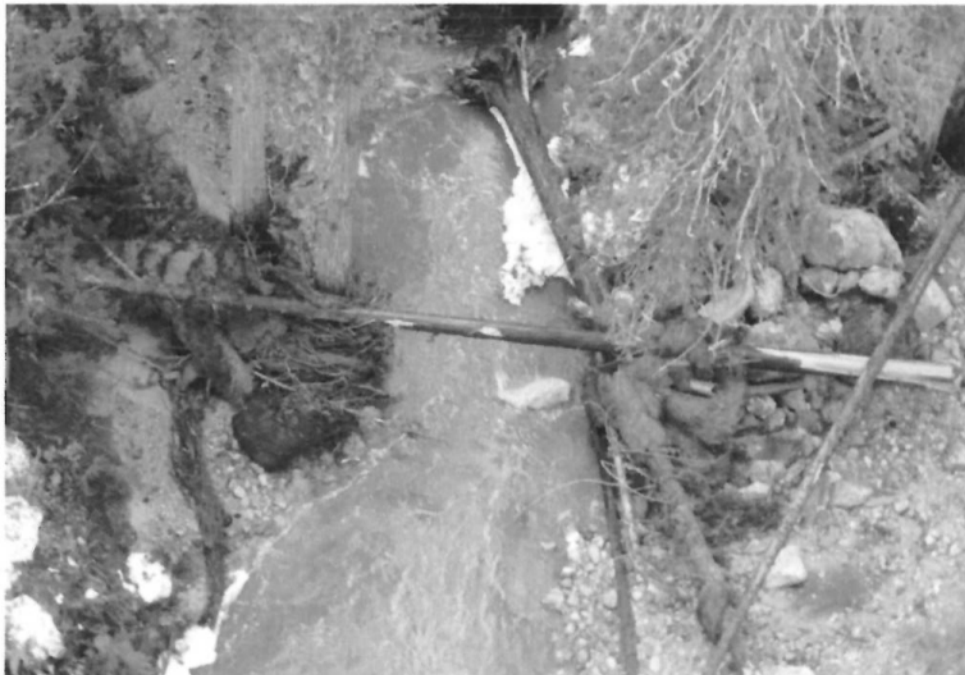
Plate 9: Aerial view of marsh grasses mats entangled with culverts and trees about 200 m downstream from the breach location on Dale Creek.

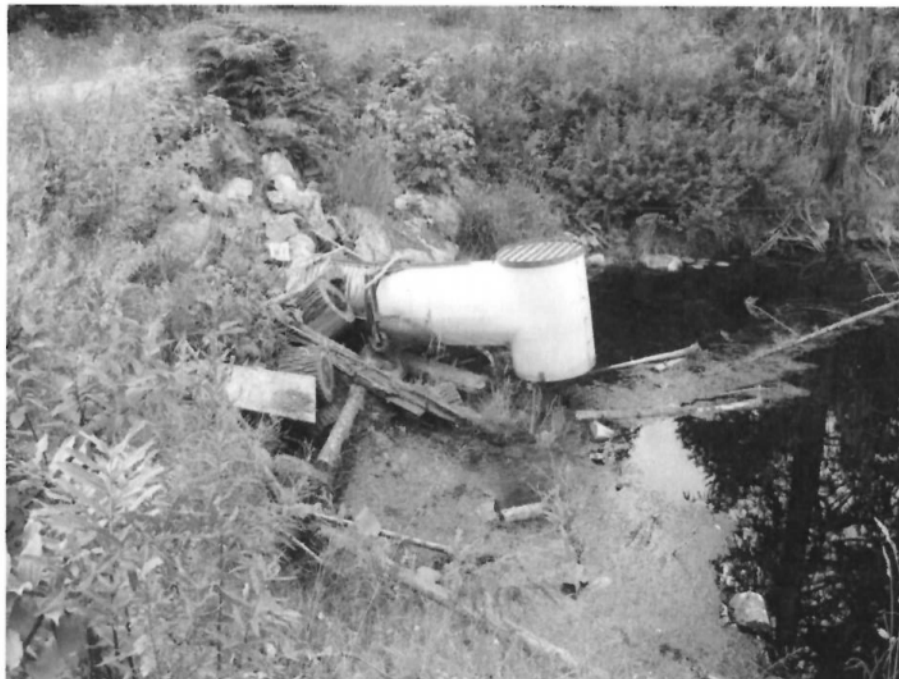
Several photographs from Dale Fennell show the condition of the culvert inlets in the summers of 2012 and 2013. In a photograph dated August 21, 2012, only the upper culvert with the beaver-stop attachment is visible (Plate 10). There is no sign of the lower culvert, but the water level is below the upper culvert suggesting that there is flow out of the lake and that the lower culvert is passing water. All of the wood pieces are of human origin, either logs cut for firewood or stump seats, or plywood sheets. The beaver-stop attachment is jammed open with pieces of wood placed between the metal culvert and the plastic. This does not occur without human intervention as the attachment is heavy and does not float, thus someone must have pulled the attachment up to insert the wood.

Plate 10: Dale Fennell photograph from August 21, 2012, showing the inlet of the upper culvert on the road crossing. The lower culvert is not visible but the lake is below the base elevation of upper culvert suggesting the lower culvert is allowing some flow and controlling lake level.

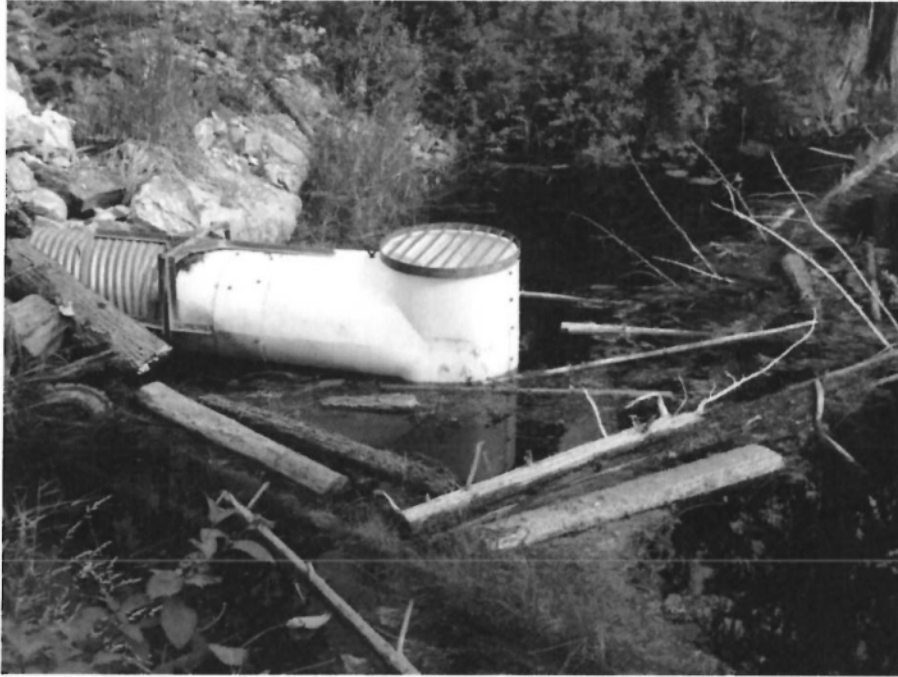
In two photographs from July 12, 2013, the beaver-stop attachment is correctly aligned on the end of the upper culvert (Plate 11). In one photo the lower culvert can be seen (Plate 12) and the water level is at the base of the upper culvert indicating that even though the lower culvert is visible, it is partially blocked by debris.

Plate 11: Dale Fennell photograph from July 12, 2013, showing the inlet of the upper culvert on the road crossing. Woody debris around the inlet is cut by humans. The base of the upper culvert is at lake level, suggesting that this culvert may be controlling lake level and that the lower culvert is partially blocked.

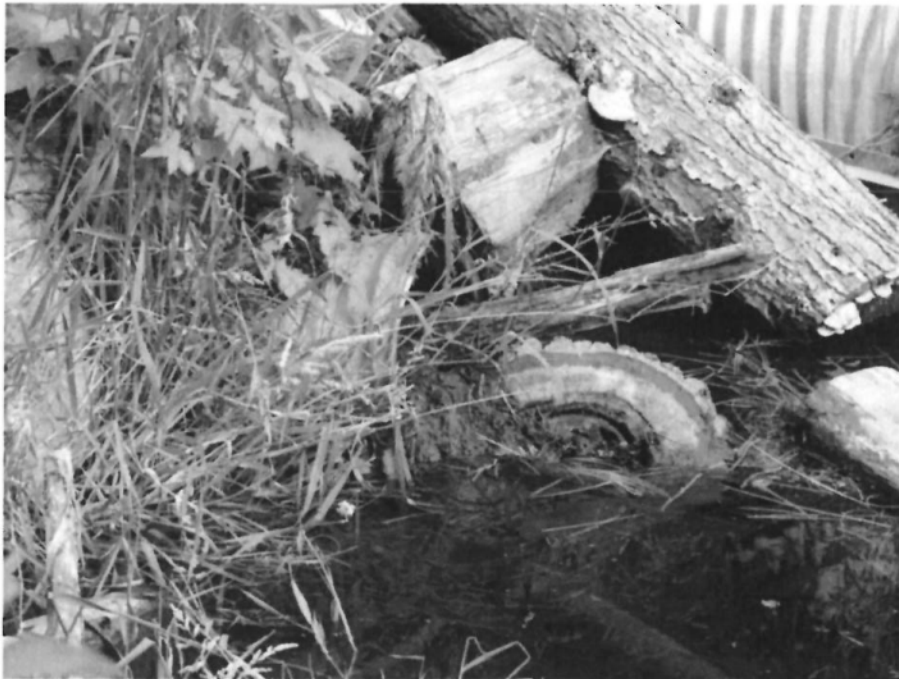
Plate 12: Dale Fennell photograph from July 12, 2013, showing the inlet of the lower culvert on the road crossing. The culvert appears to be partially jammed with debris as water is halfway up the culvert but it may still be active and controlling the lake level.

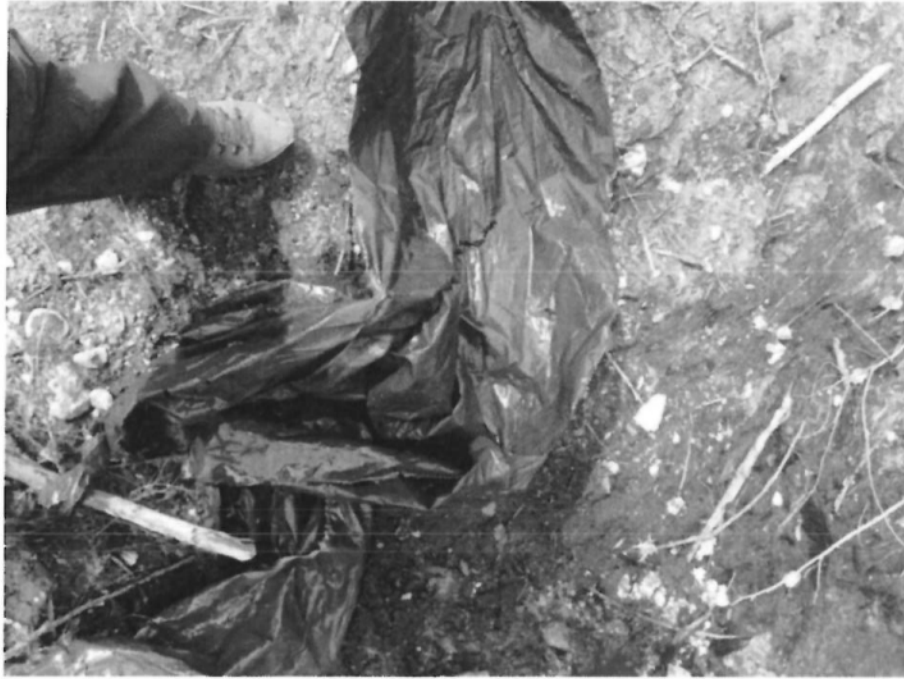
Several pieces of plastic were found near the breach site and along Dale Creek. These occurred as fairly large sheets, 1 to 2 mm thick and were a dark blue-black color. These were definitely large enough to have covered 800 mm culvert inlet, but might not have been strong enough to hold back the lake water to allow over-topping of the road. Folding the plastic over or using multiple layers may have been sufficient to prevent flow through the culvert.

Plate 13: One of the pieces of heavy-duty plastic that was found near the breach site.

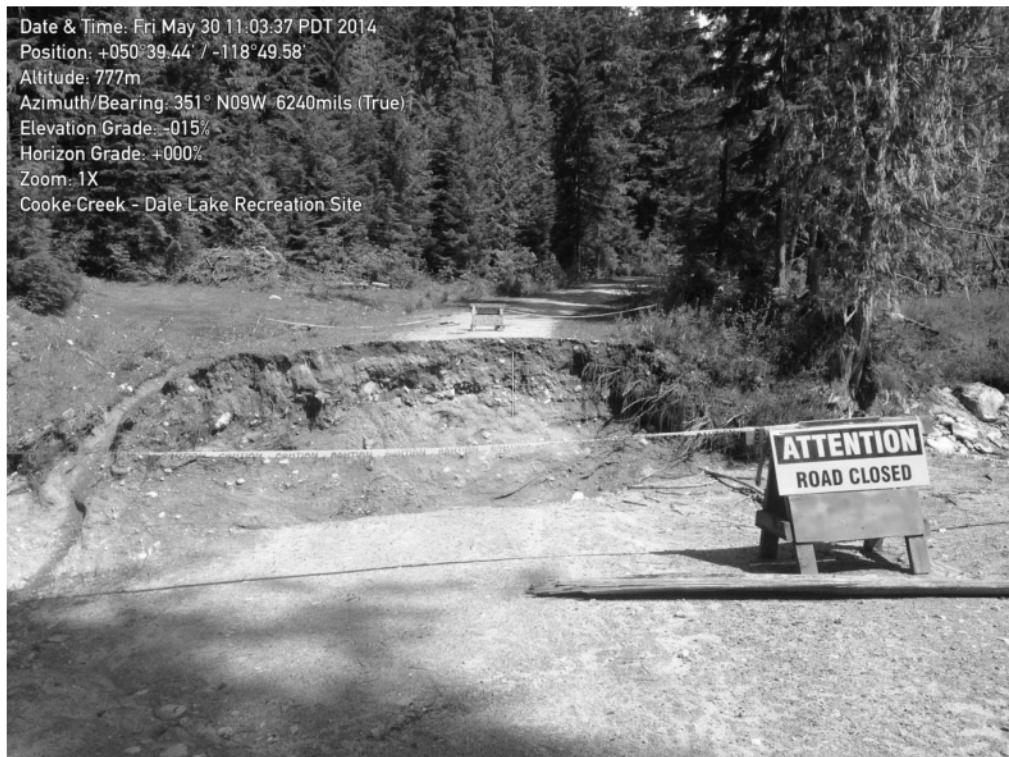
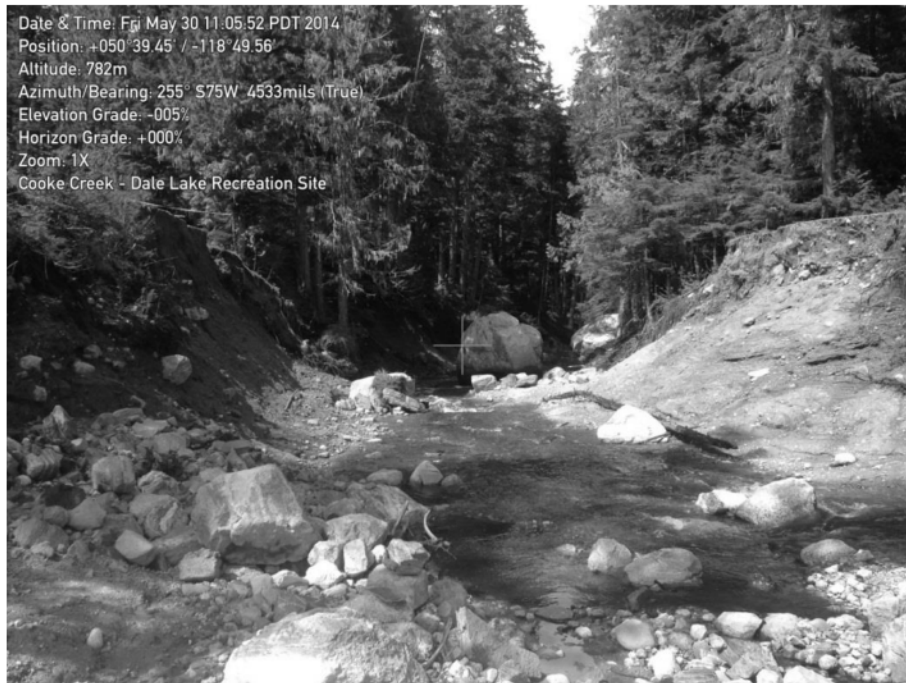
## Photographs of Breach

The Investigators observed aquatic vegetation in the trees above the road surface at the breach location, which indicated that the lake water had overtopped the road. View from the lake bed of two scarred trees located on the upstream side of the breach. The tree on the right has a section of marsh grass (grassy mats) wrapped around it.

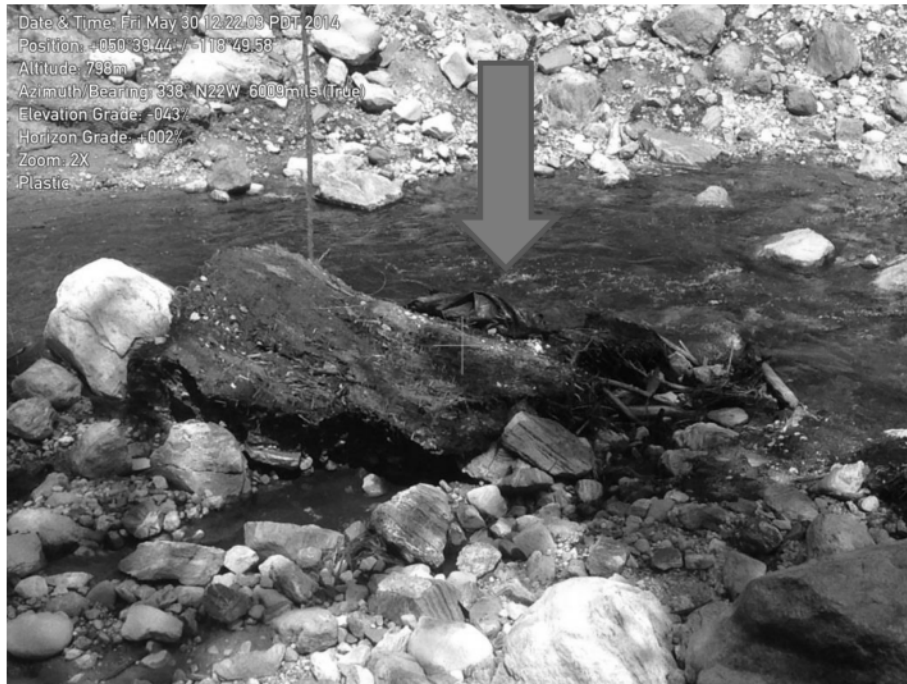
## Plastic Found at Breech

The Investigators also observed heavy duty black plastic which appeared to be a recent arrival, therefore not in a discoloured or deteriorated condition.

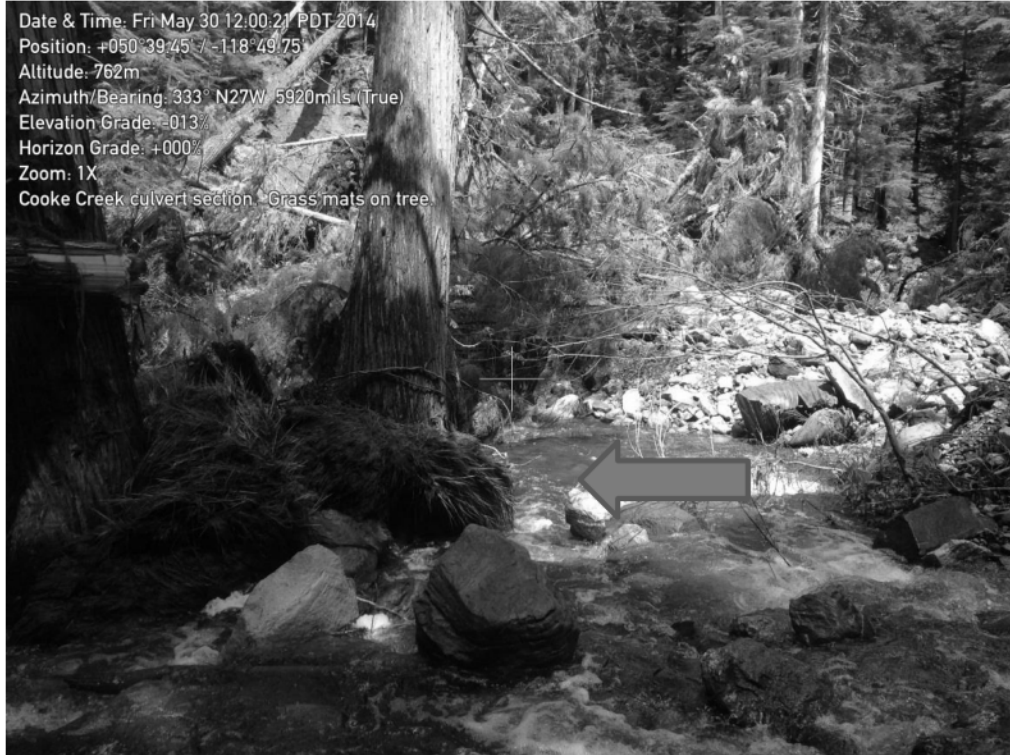
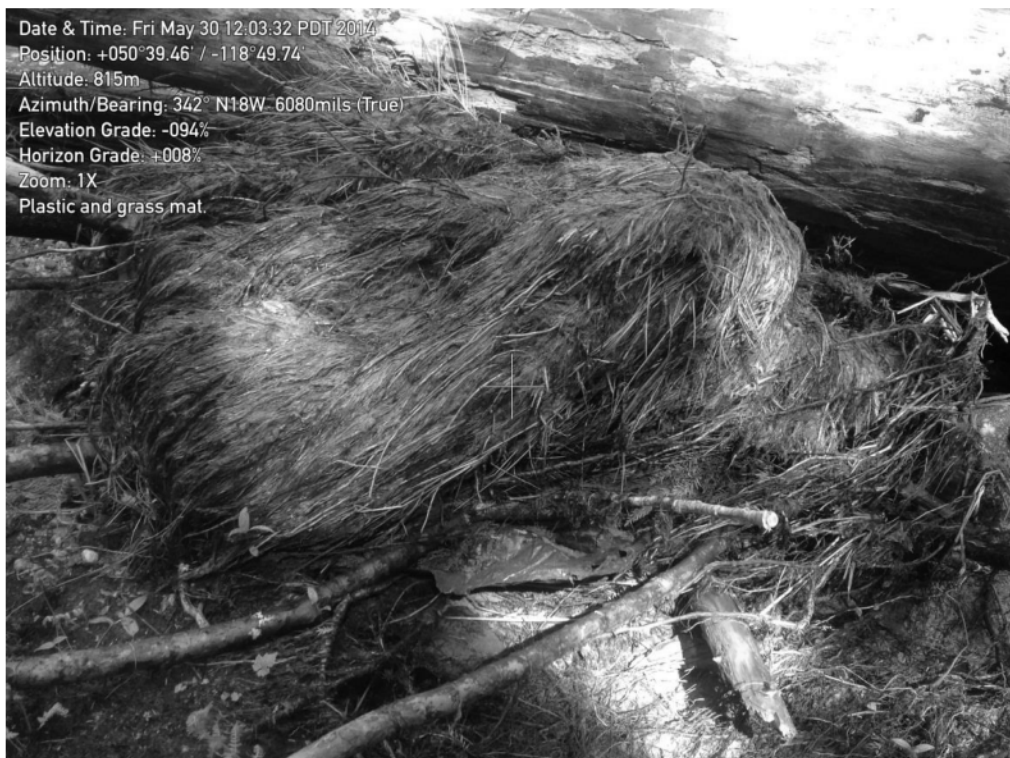
## Grass Mats located downstream

The Investigators walked downstream to where the culverts were deposited. While walking downstream the Investigators observed aquatic vegetation (grass mats) in the trees adjacent the creek.

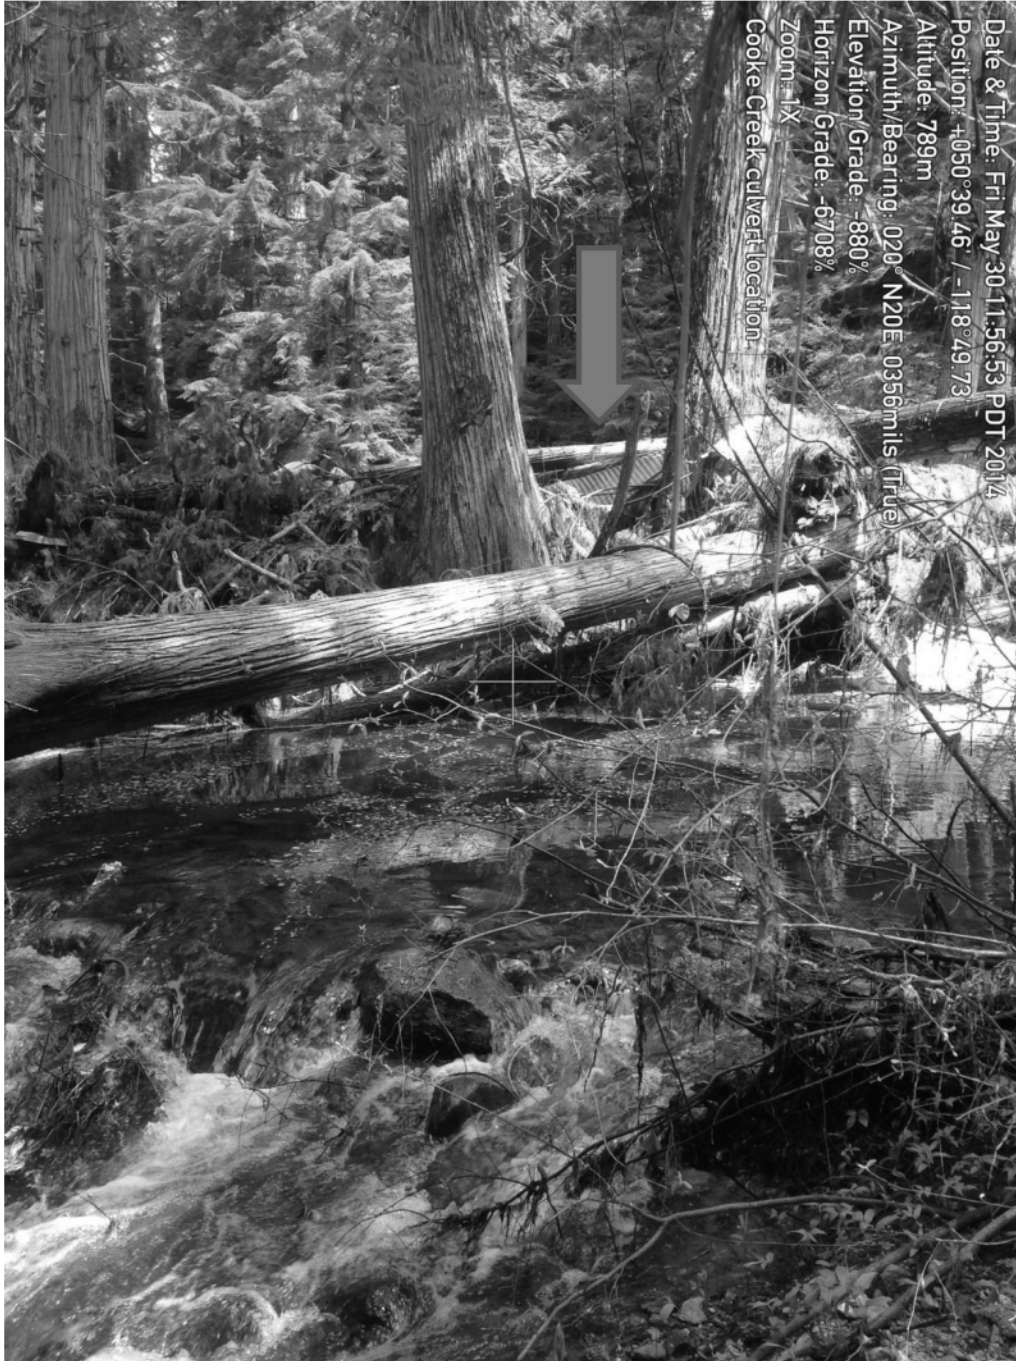
## Main Culvert found downstream

The Investigators found the culverts in relatively close proximity of each other, and found that the “Beaver Proof Add On” (BPAO) was still attached to the overflow culvert.

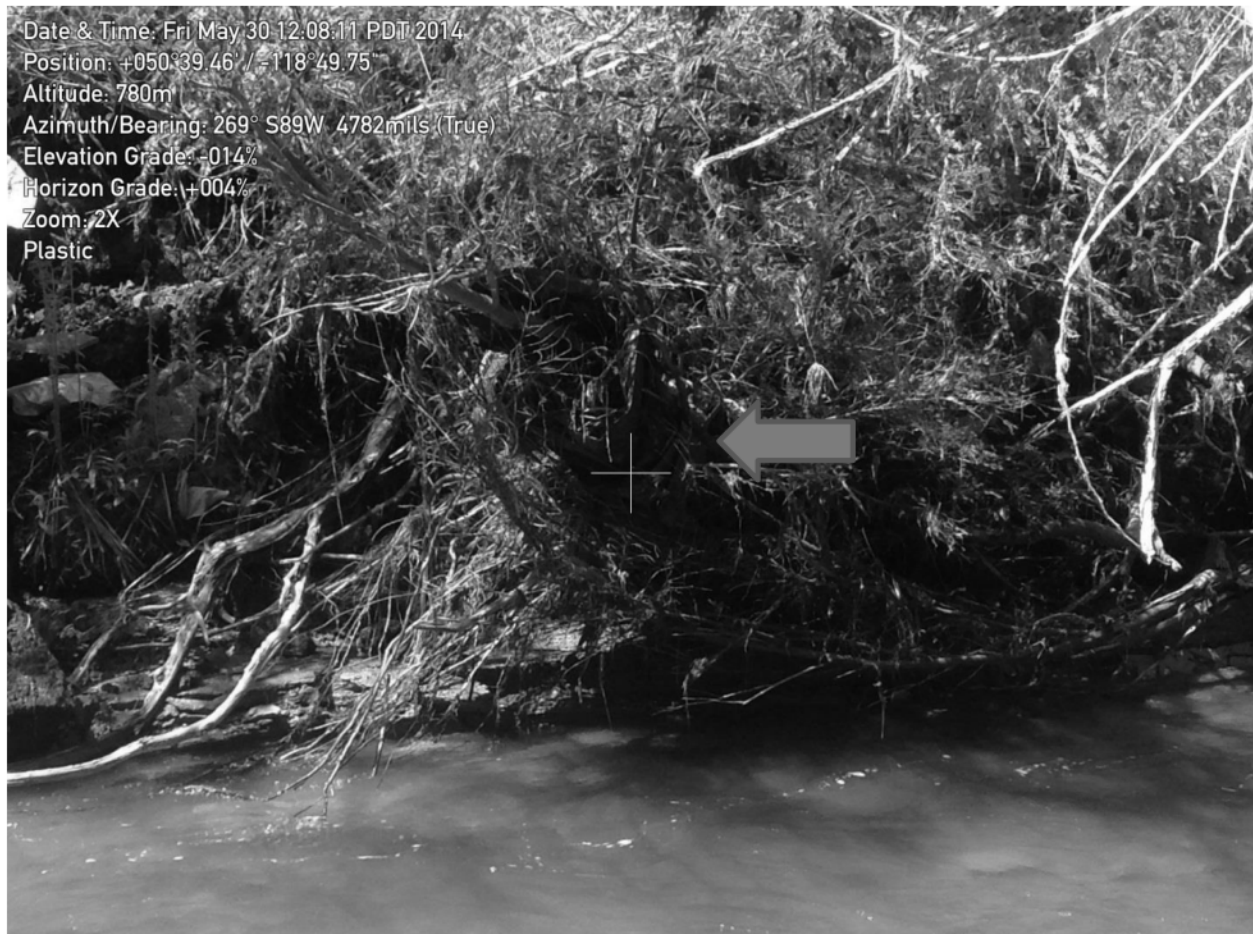
## Black Plastic

The Investigators observed heavy duty black plastic adjacent the culverts. The black plastic also appeared to be a recent arrival, therefore not in a discoloured or deteriorated condition.

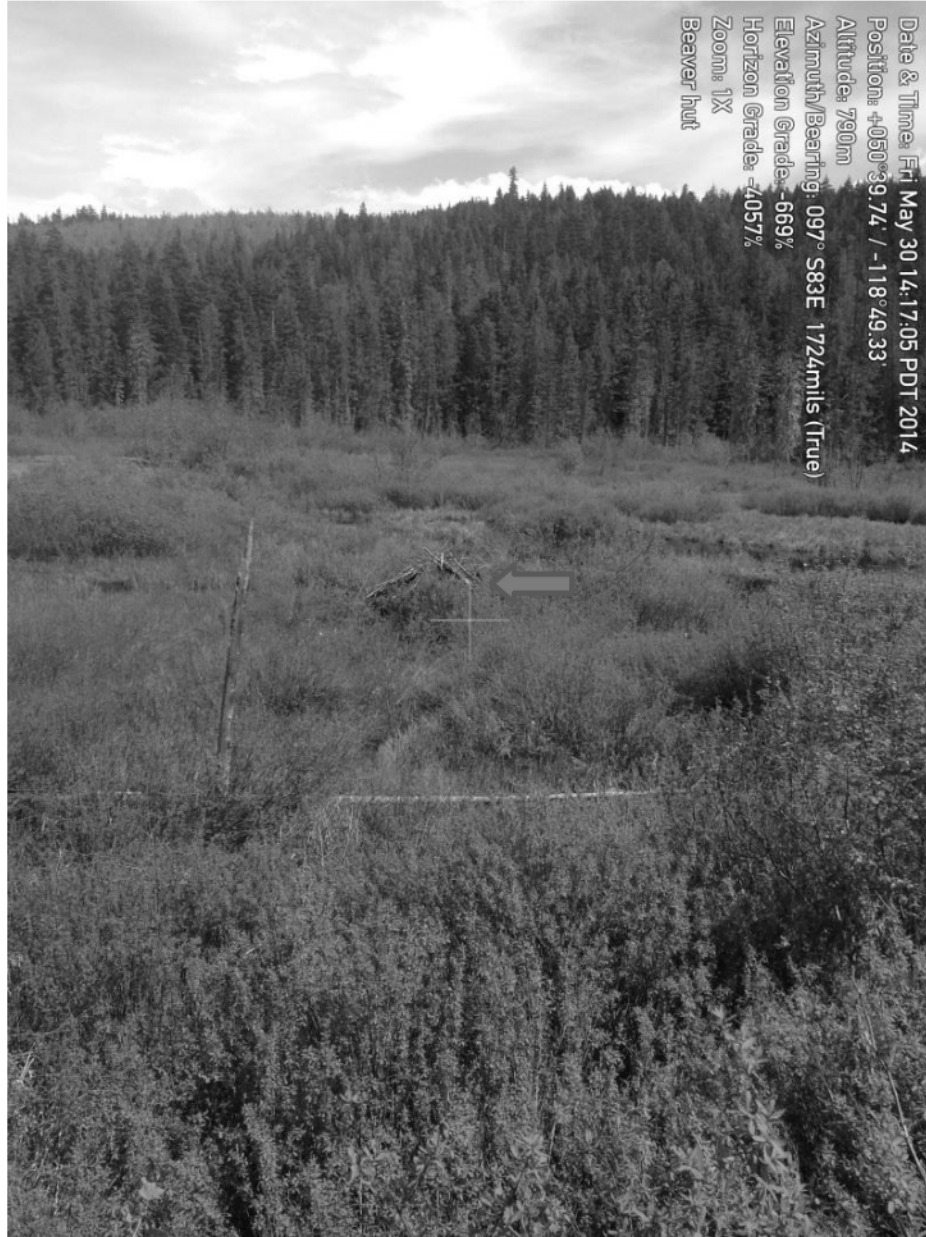
## Beaver Lodge

The Investigators observed what appeared to be an active beaver hut and a beaver dam on the north end of Dale Lake on route to Spruce Lake, however there was no evidence found of recent beaver activity at the outlet of Dale Lake.
