Kent

**CONFIRMATION OF ANNUAL DIKE INSPECTION 2011**

**RE: District of Kent – 2011 Dike Inspection Report**

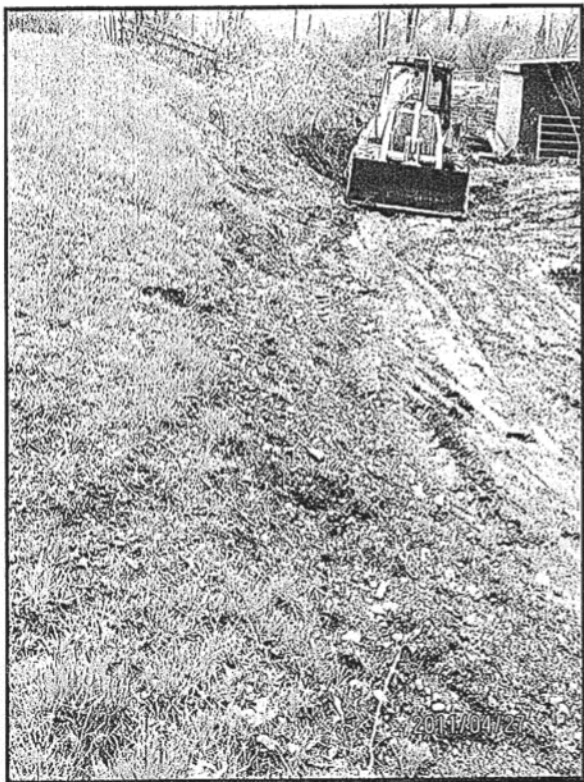
- minor damage to a gate post at the access to Appel Road (Dike Section A);
- unauthorized excavation and minor plantings along the toe of the dike at the west end of Cutler Road (Dike Section B) (Photographs 1, 2 and 3);
- gravel stockpiling and heavy machine damage at the south end of Hamilton Road (Dike Section C) (Photographs 4, 5 and 6); and
- downed trees are lying against the side slopes of the dike (Dike Section D).

Photograph 1. Looking east at excavation along the toe-of-slope of dike section B (April 27, 2011)

The District requests that the toe-of-slope adjacent to your property be reinstated to its previous, unaltered state and any trees planted be removed by **May 31, 2011**. When the dike slope has been reinstated please contact the District to perform a follow-up inspection. Failure to correct this issue may result in fines, incarceration or both. Penalties for contravention of the Dike Maintenance Act are as follows:

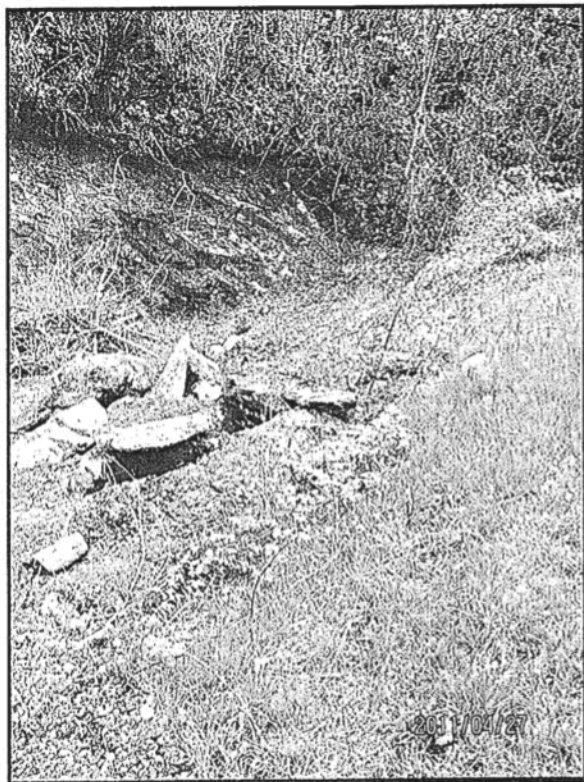
Photograph 2. Looking west towards the dike's termination at Hopyard Mountain (April 27, 2011).

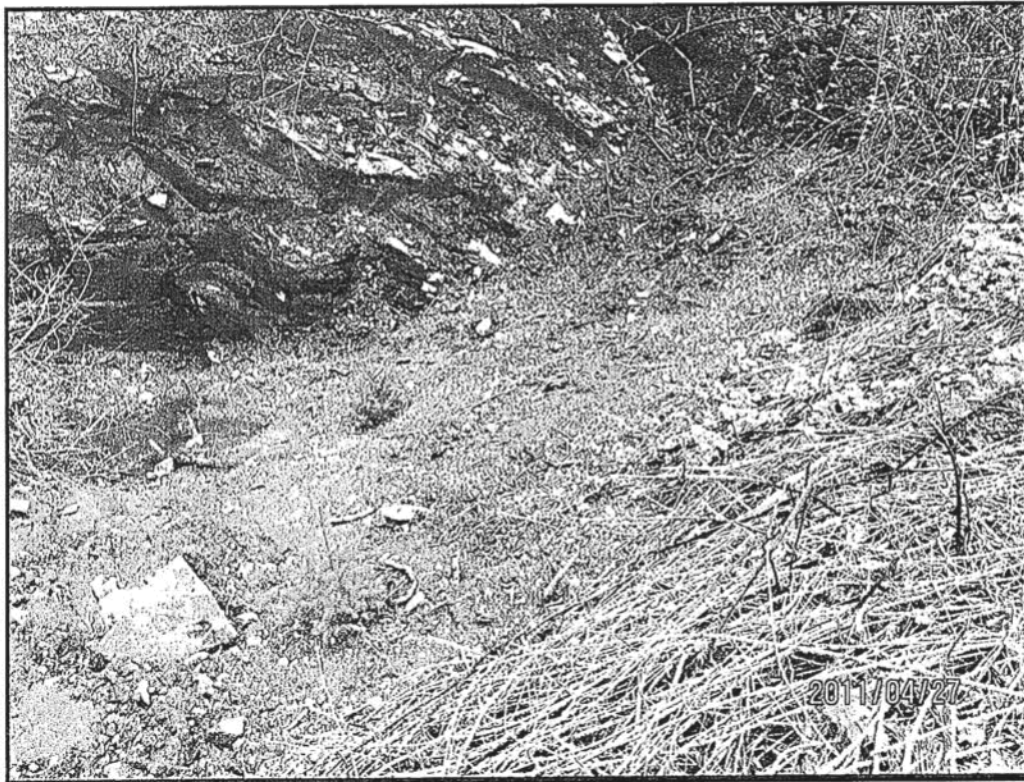
Photograph 3. Looking west at recent excavation along the toe of the dike and at recently planted conifers (April 27, 2011)

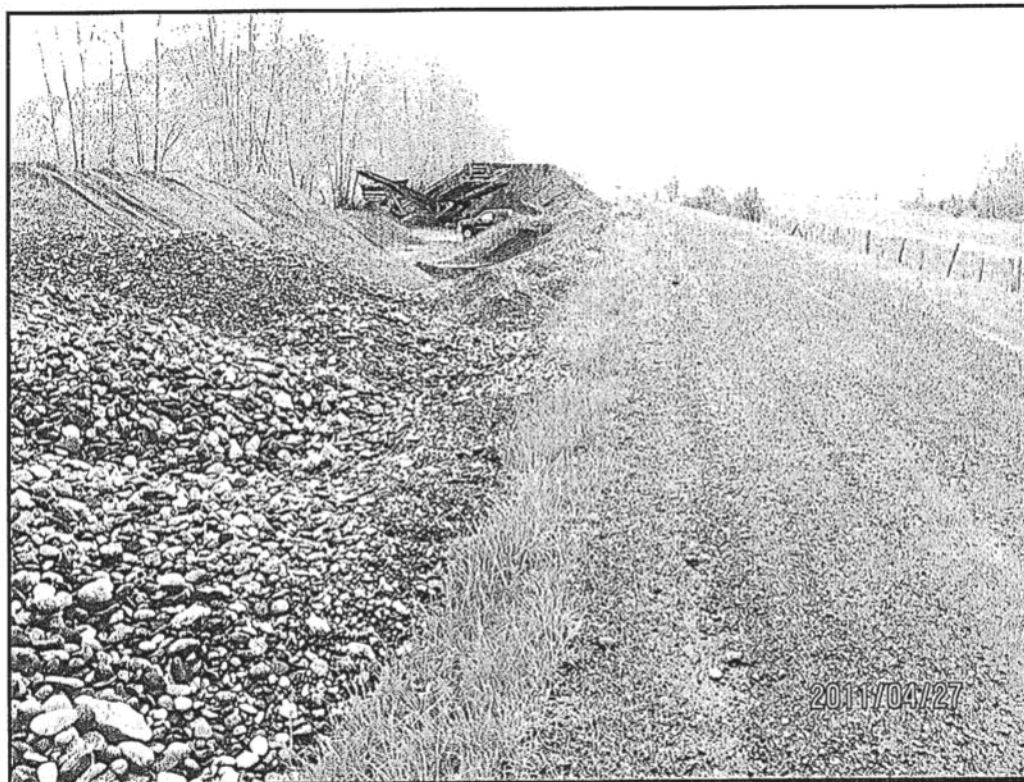
Photograph 4. West view of gravel stockpiled against the dike (April 27, 2011)

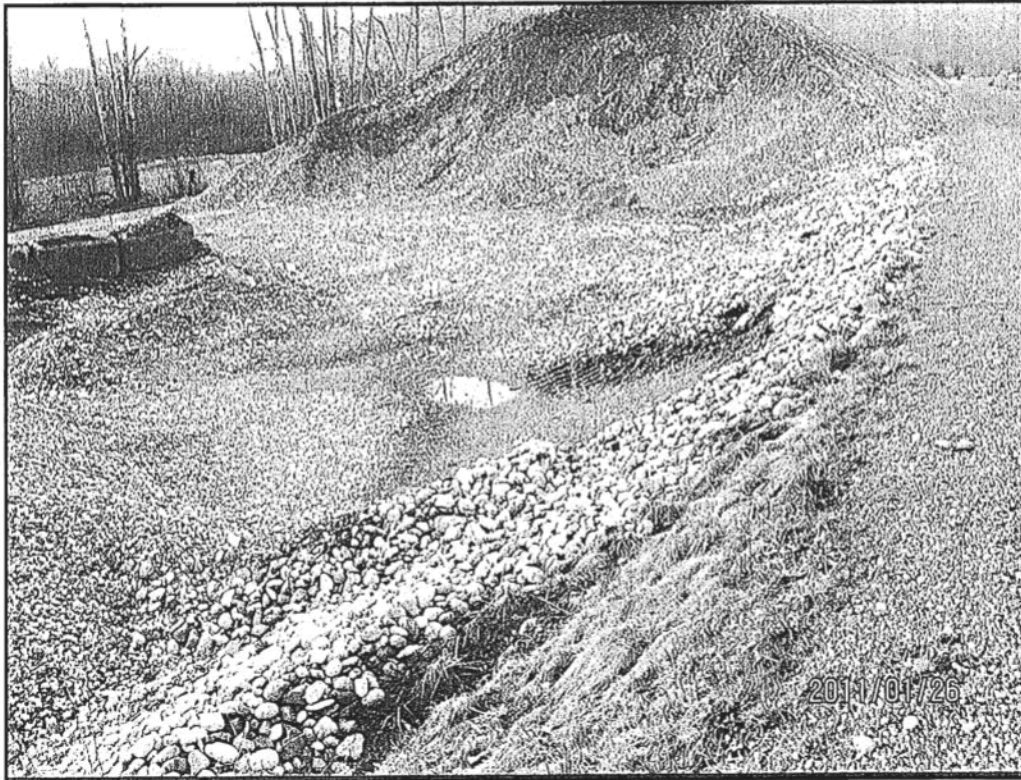
Photograph 5. Looking west at gravel pile adjacent to dike (January 26, 2011)

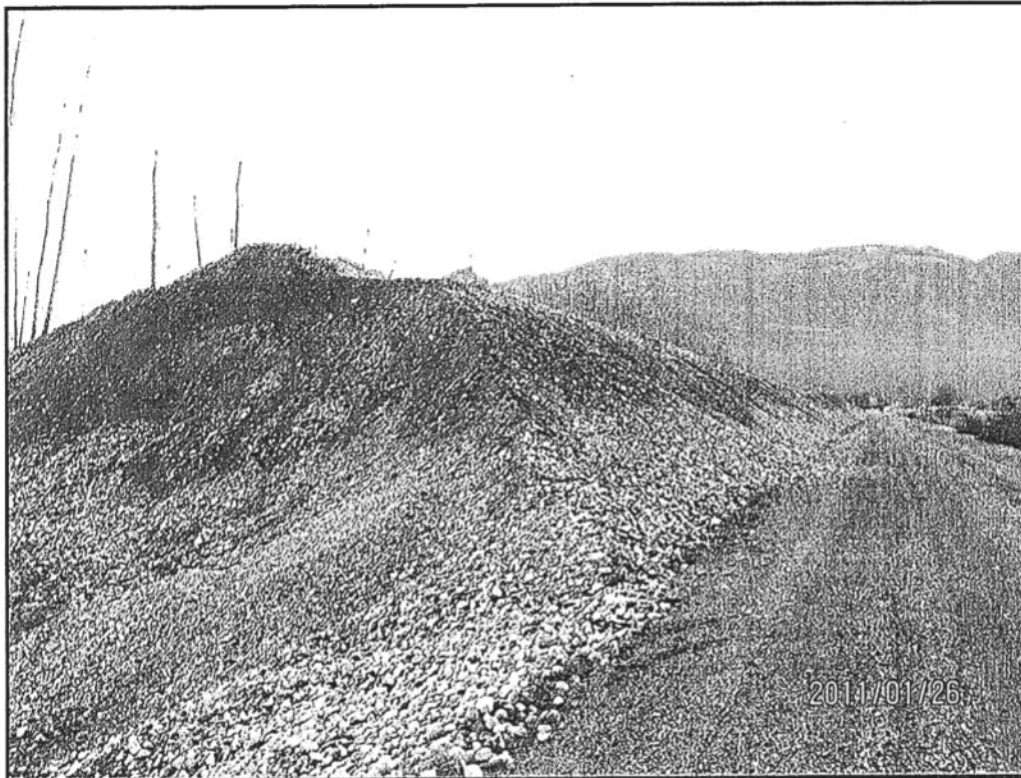
Photograph 6. West view of main gravel pile against dike (January 26, 2011)

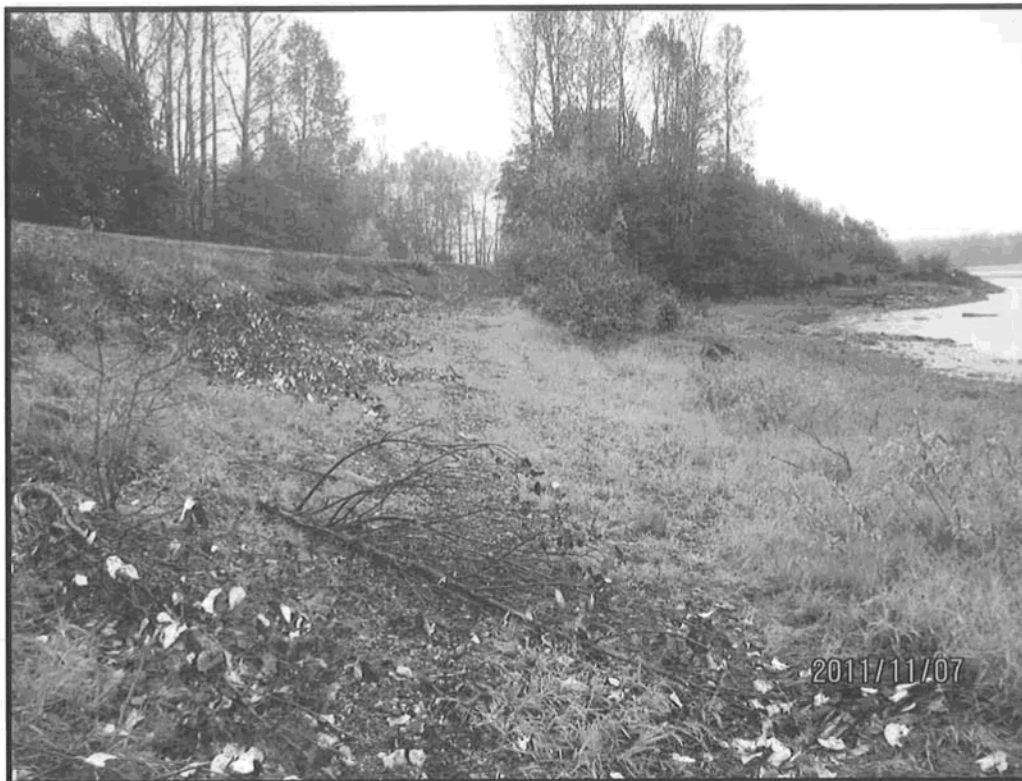
**Photograph 1. Looking south at Dike D in the area of heavy erosion (November 7, 2011)**

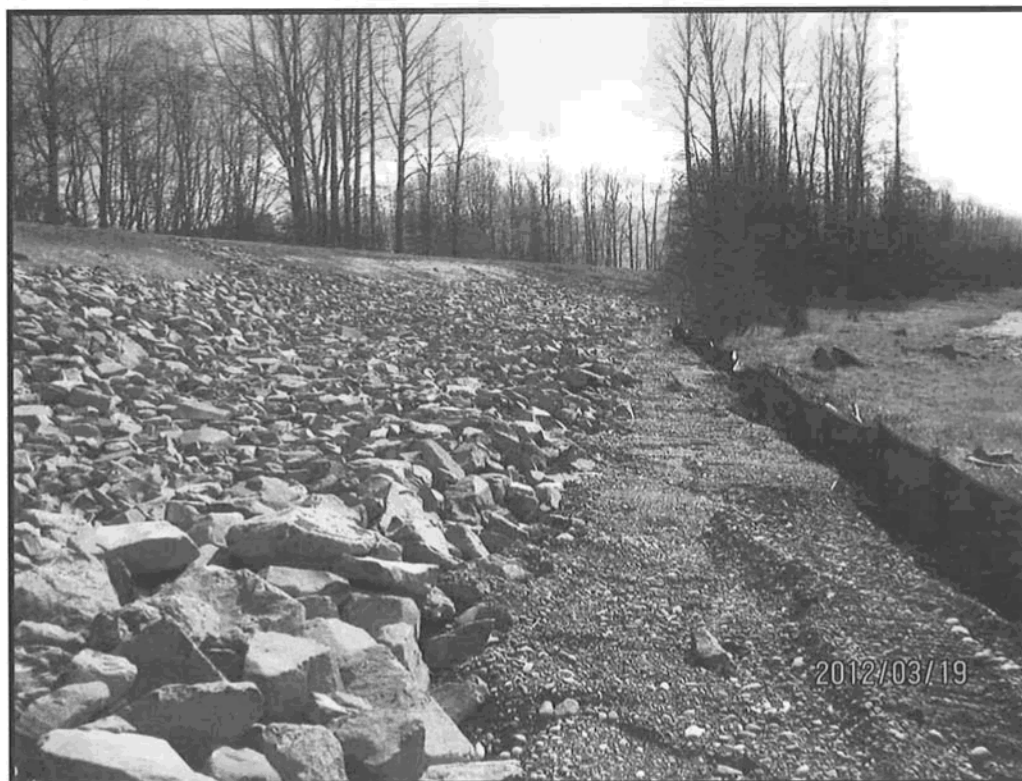
**Photograph 2. South view of rip rap work performed on Dike D to combat erosion (March 19, 2012)**

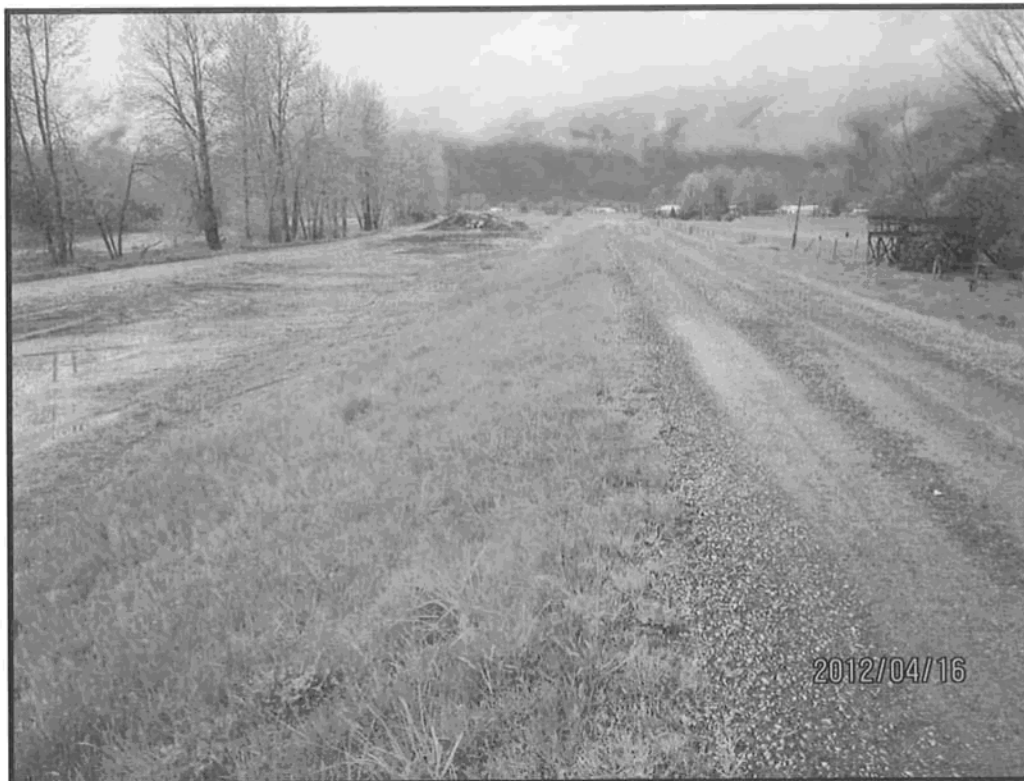
**Photograph 3. Looking west at Dike A at the end of Hamilton Road after bank stabilization was undertaken (April 16, 2012)**

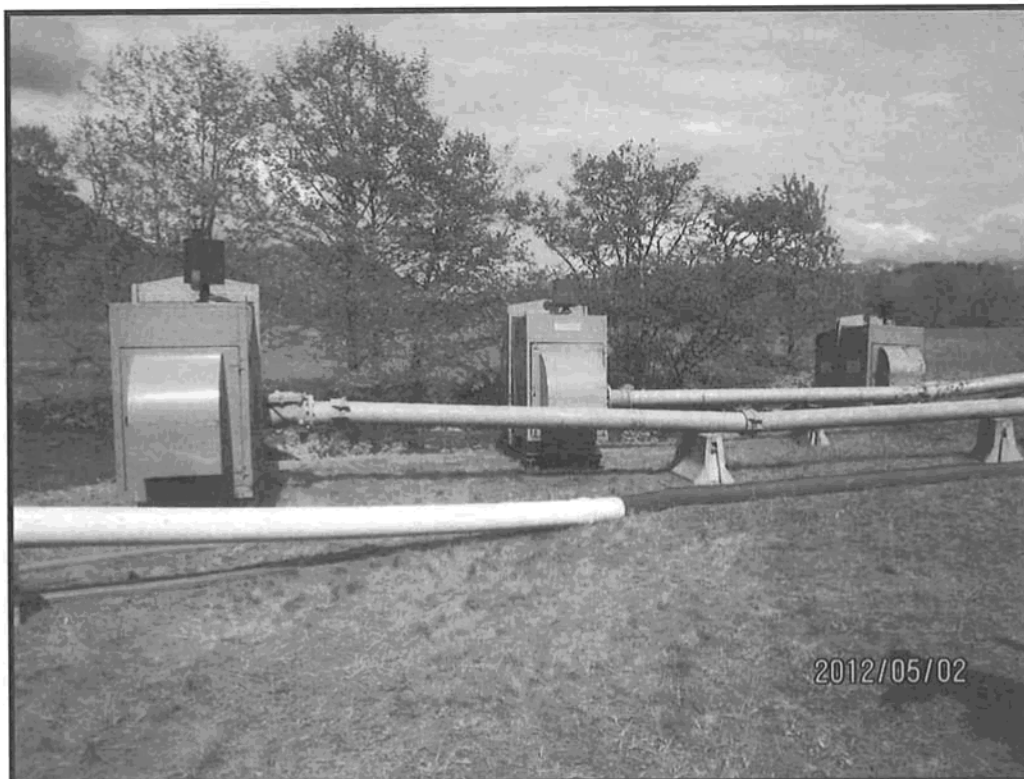
On April 29, 2012 District staff were notified of unusually high water levels in drainages that flow into the Mountain Slough. It was determined that the 125 HP pump at the Hammersley Pump Station had malfunctioned as the Fraser River was rising. Emergency pumps (Photographs 4 and 5) were brought in while the existing pump was removed and sent to be repaired (Photograph 6). Localized high water levels occurred (Photograph 7) but no infrastructure or homes were impacted. The pump has been repaired and re-installed. An alarm is being installed on the pump that will alert the District of unusually high water levels and of any future pump malfunctions.

**Photograph 4. Emergency pumps used during Hammersley Pump Failure (May 2, 2012)**

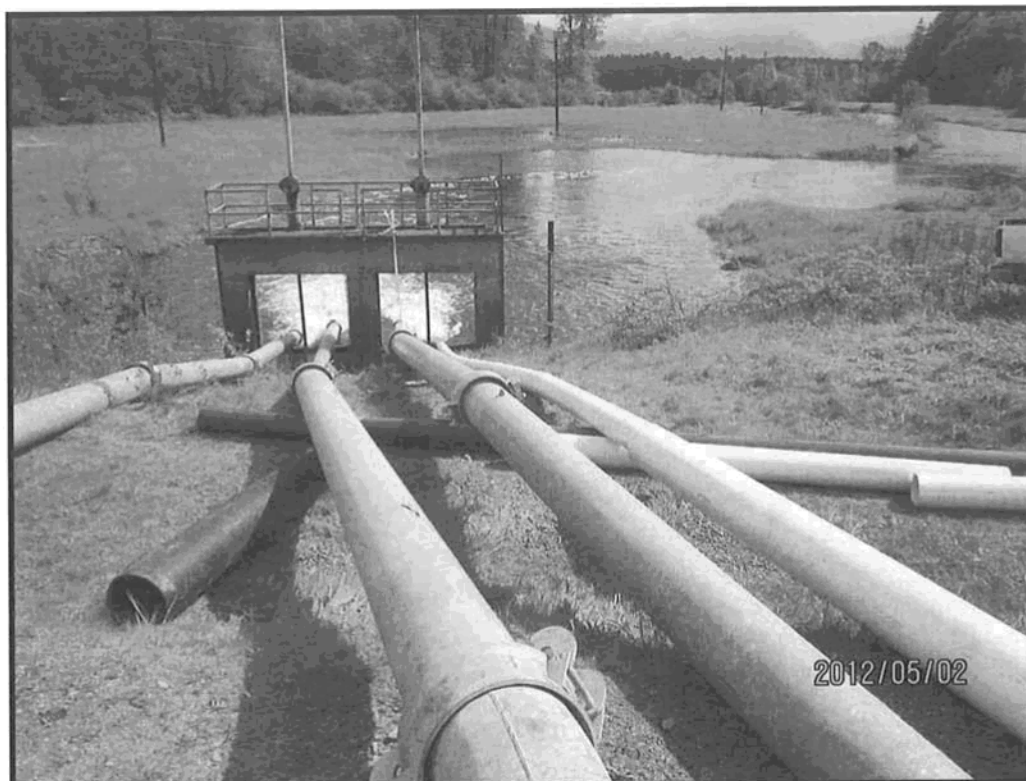
**Photograph 5. Emergency Pumps Discharging downstream of the Hammersley Pump Station (May 2, 2012)**

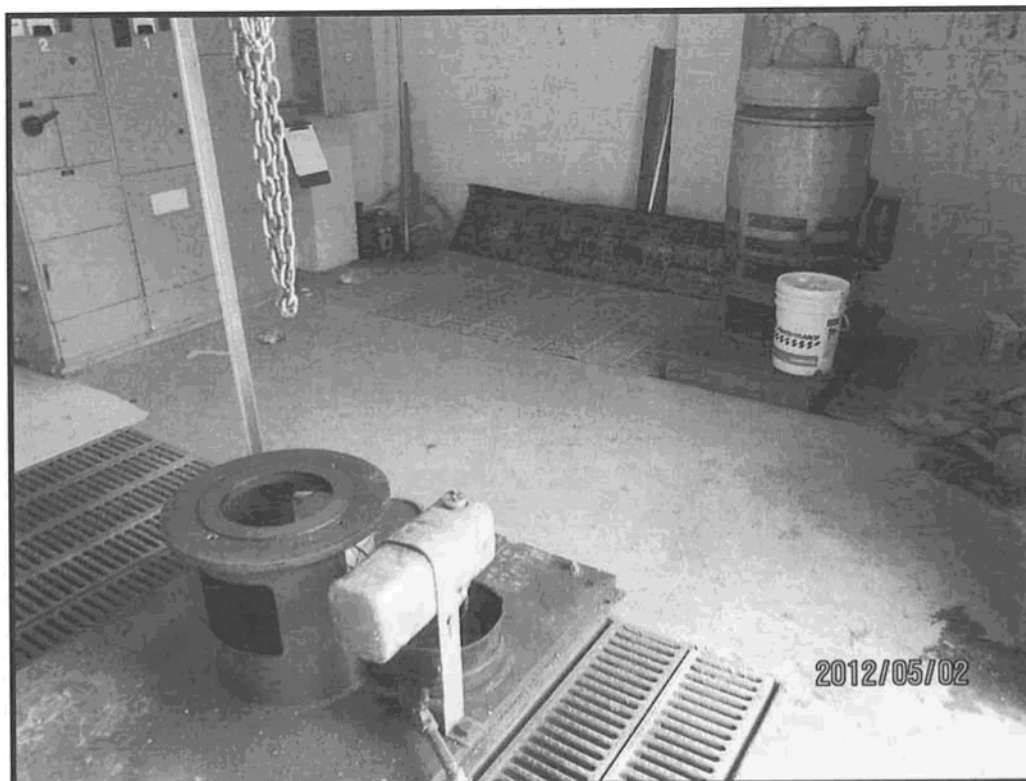
**Photograph 6. Looking inside Hammersley Pump Station with 125 hp pump removed; 50 hp pump is still in operation (May 2, 2012)a**

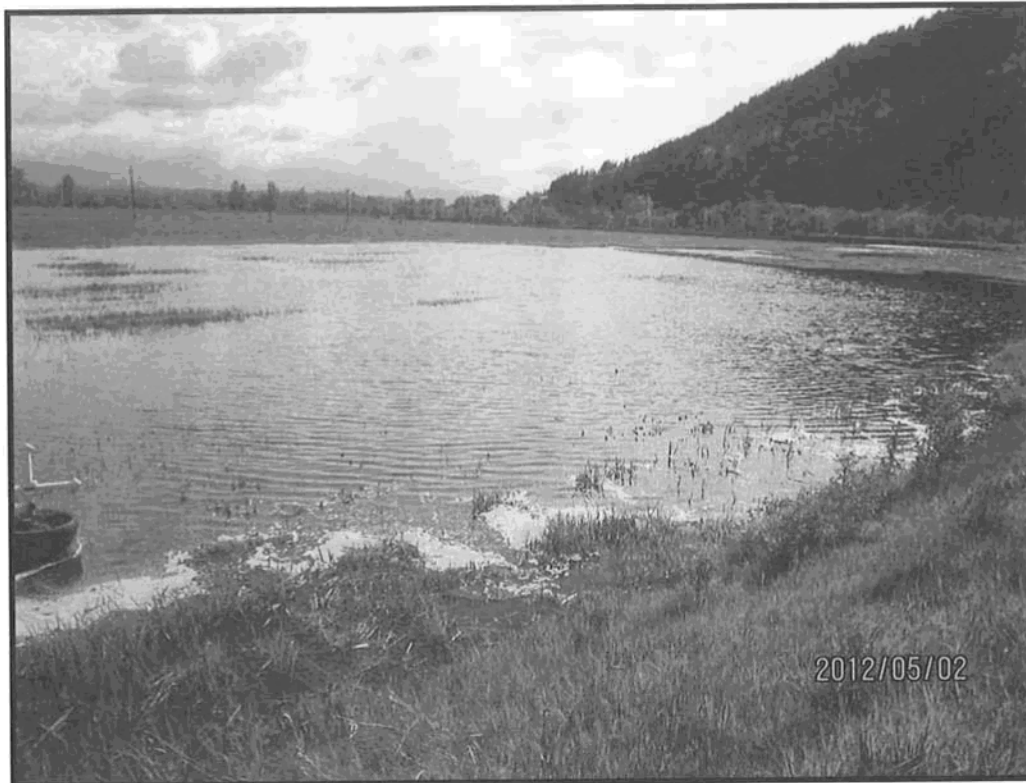
**Photograph 7. Looking southwest at localized high water in a farmers field (May 2, 2012)**

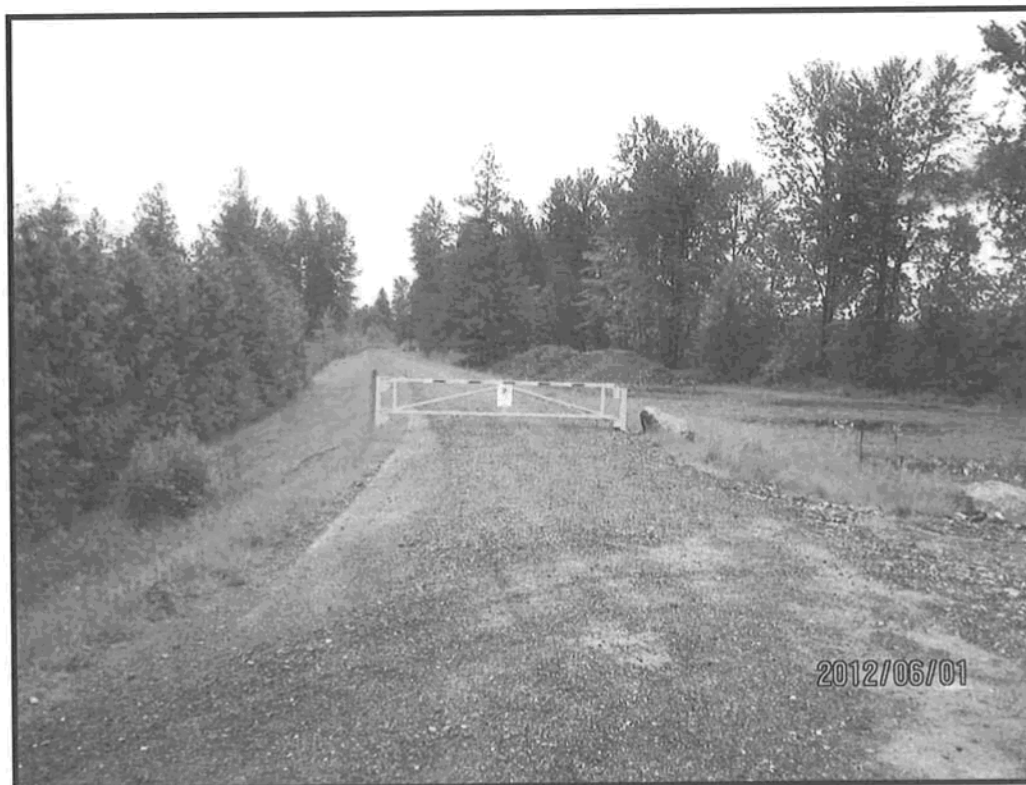
**Photograph 8. Looking east at Dike recently installed by a local land owner (June 6, 2012)**

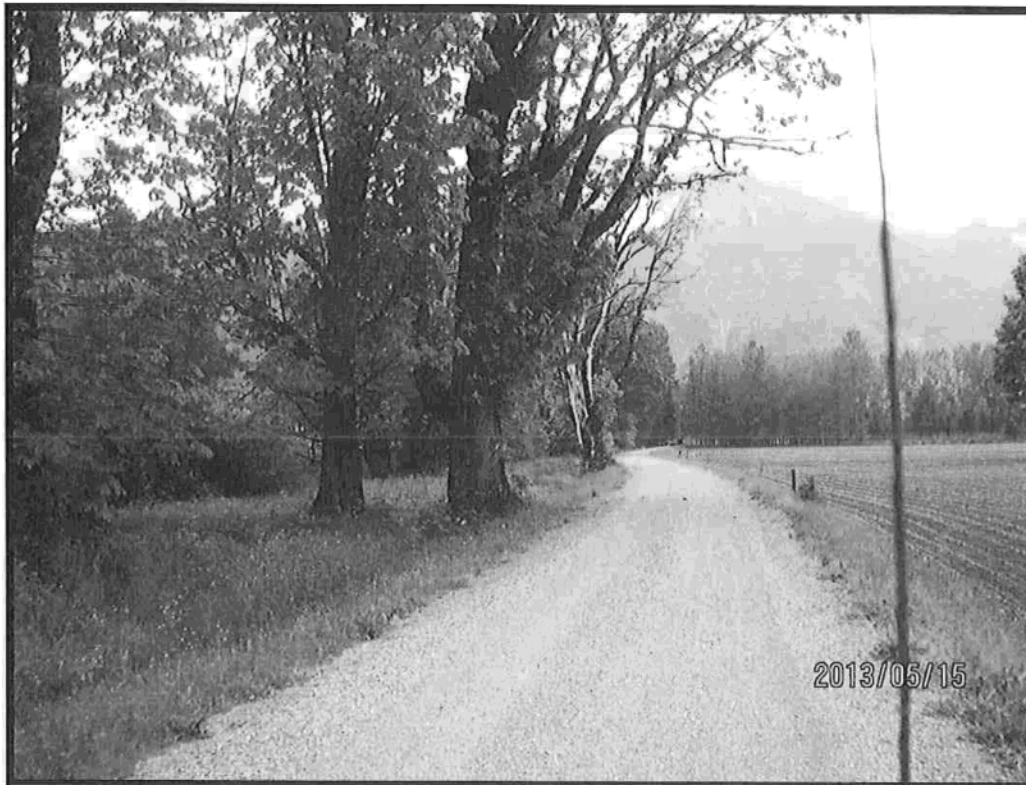
YES	NO	N/A
• Trees in or near dike (within 2m from toe) with potential for uprooting?	X		
<p>Location(s):</p> <p>3 large trees near north end just outside dike bank between Cuthbert and McDonald Roads (Photograph 2)</p> <p>Maintenance Recommendations: Tree and root removal; dike rehabilitation necessary due to large root systems</p> <p>When will Recommendations be Completed: When additional funding is in place</p>			
• Multi-year vegetation management plan in place?	X		
<p>If not, please discuss how one will be put into place:</p>

Photograph 2. South view of Dike A where three large trees are growing in the dike between Stations 20+00 and 73+20. (May 15, 2013)
