2015 MATSQUI DYKE INSPECTION

Prepared By: James Hill

October 2015

CITY OF ABBOTSFORD

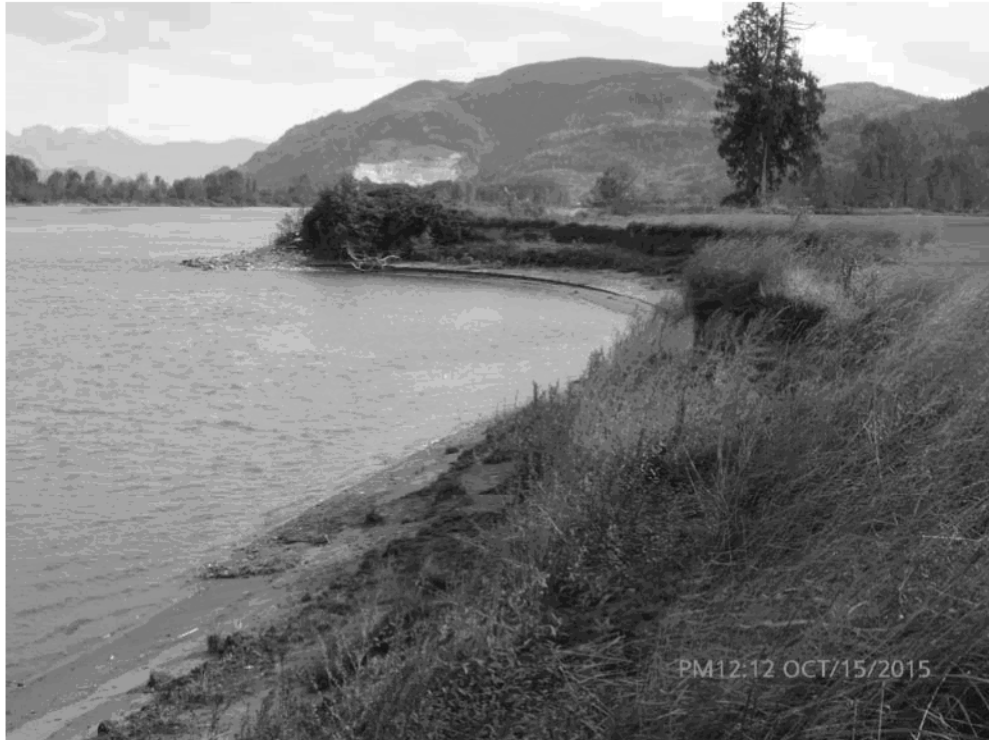
Figure 18: Dyke - Station 95+00 – One of the Erosion Arcs

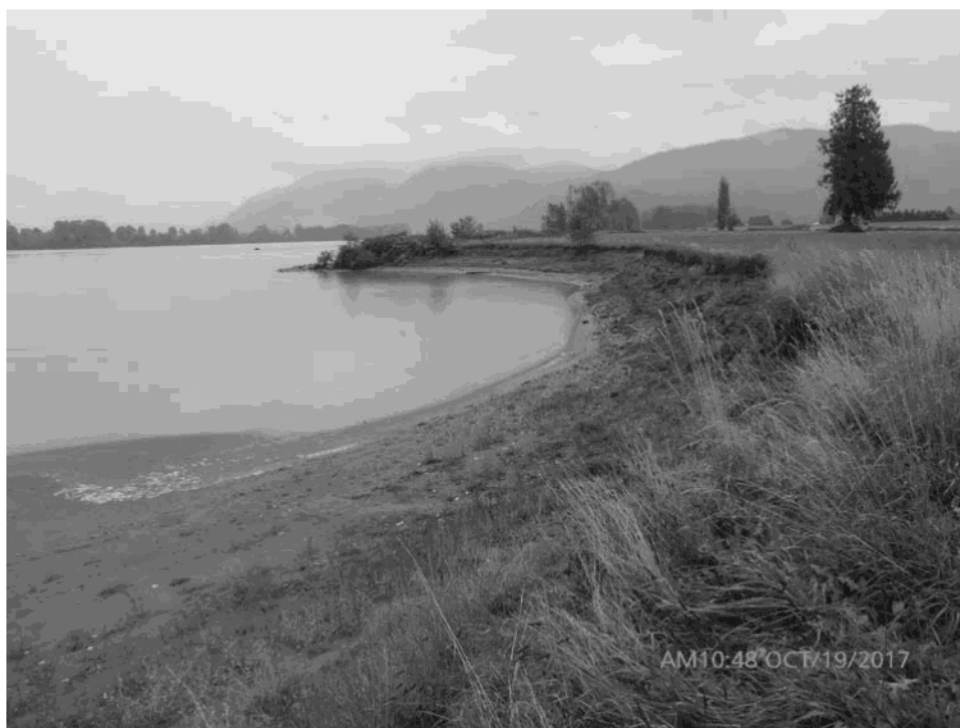
Figure 18: Dyke - Station 95+00 – One of the Erosion Arcs

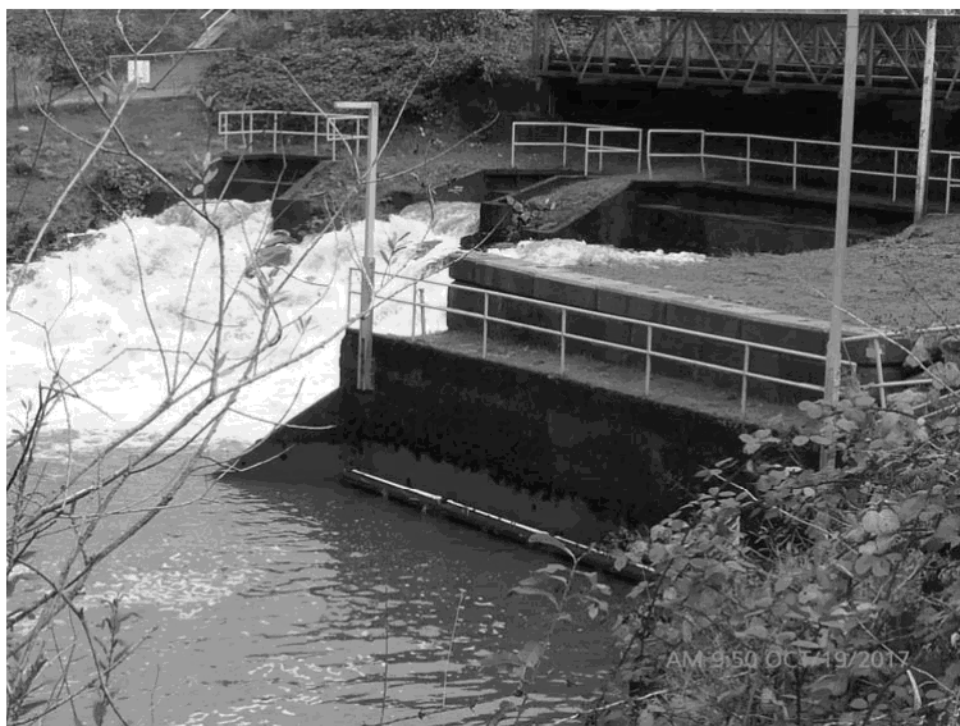
Flood boxes, pump discharge gates and tidal gates were inspected in May and Oct 2017. The gates were greased and exercised prior to and after the freshet season. All gates were found to be in good condition. Tidal Gates at Matsqui Pump Station had new seals installed. Also Gate #1 was replaced so repair on a gate valve could be done. This gate will be sandblasted, inspected then galvanized before going back into service. There are no other items that require immediate attention.

Figure 268: Matsqui Station Tidal Gates (new seals) - Station 34+50

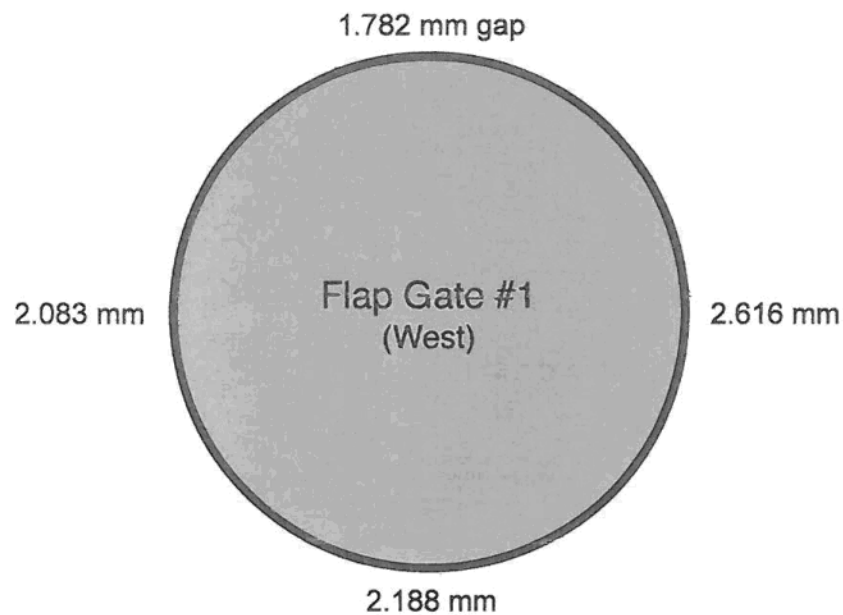
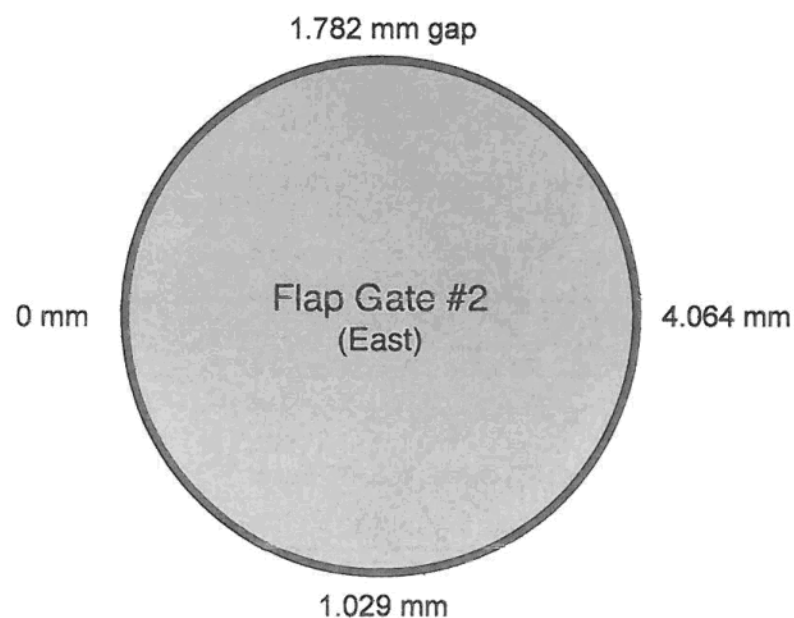
1.0 Flap Gate Inspection (see ref.1-4)

In general, all areas of the water discharge structure appear to be in good condition. Visibility was fair at this location, limited to 6-8 inches. The concrete apron and wing walls were found to be in good condition and free of debris or obstructions. Gap measurements along the sealing face of Flap Gate #4 and #3 were taken at the 12-3-6-9 O'clock positions with the biggest gap found being the one reported. The following diagrams illustrate our findings.

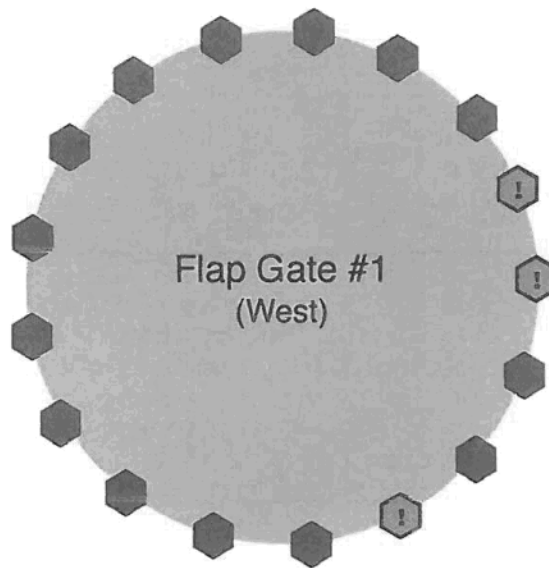
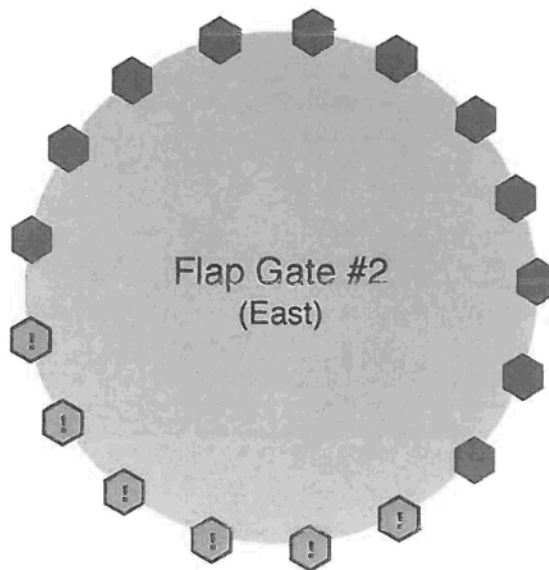
1.1 Flap Gate Nut Tightening (see ref.1-4)

Some of the nuts securing the gate were found finger-loose prior to torquing with our hydraulic impact gun. A total of 17 bolts/nuts secure each gate thimble to the wall (see ref.9). The following diagrams illustrates the location and number of loose nuts on the two Flap Gates.

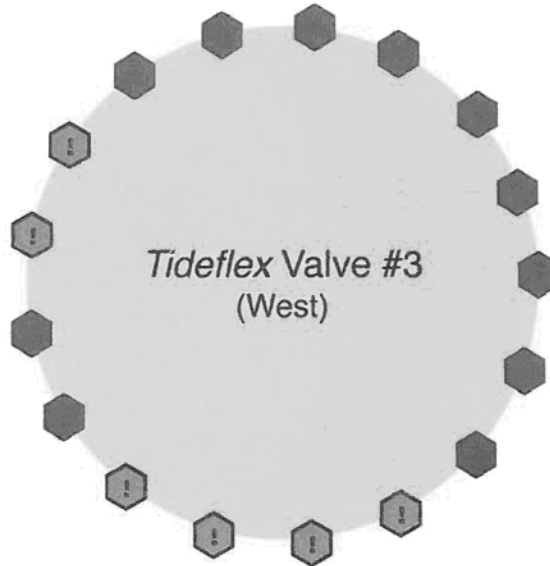
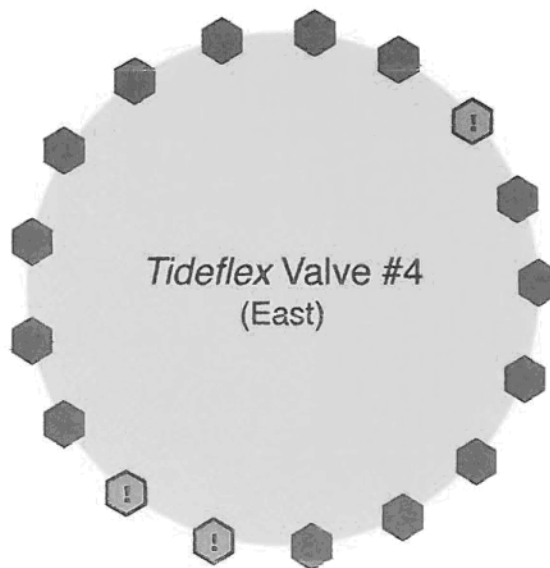
1.2 *Tideflex* Valve Inspection/Tightening (see ref.9)

Some of the nuts securing the *Tideflex* Valves were found finger-loose prior to torquing with our hydraulic impact gun (see ref.9). Some of the nuts were torqued by hand using a one inch drive ratchet. A total of 17 bolts/nuts secure each *Tideflex* Valve to the wall. The following diagrams illustrates the location and number of loose nuts on the two *Tideflex* Valves.
