**Date:** April 8, 2018  
**File:** 76915-06, 76915-20/

## **DAM INCIDENT REPORT - Unauthorized Dam (Cotter)**

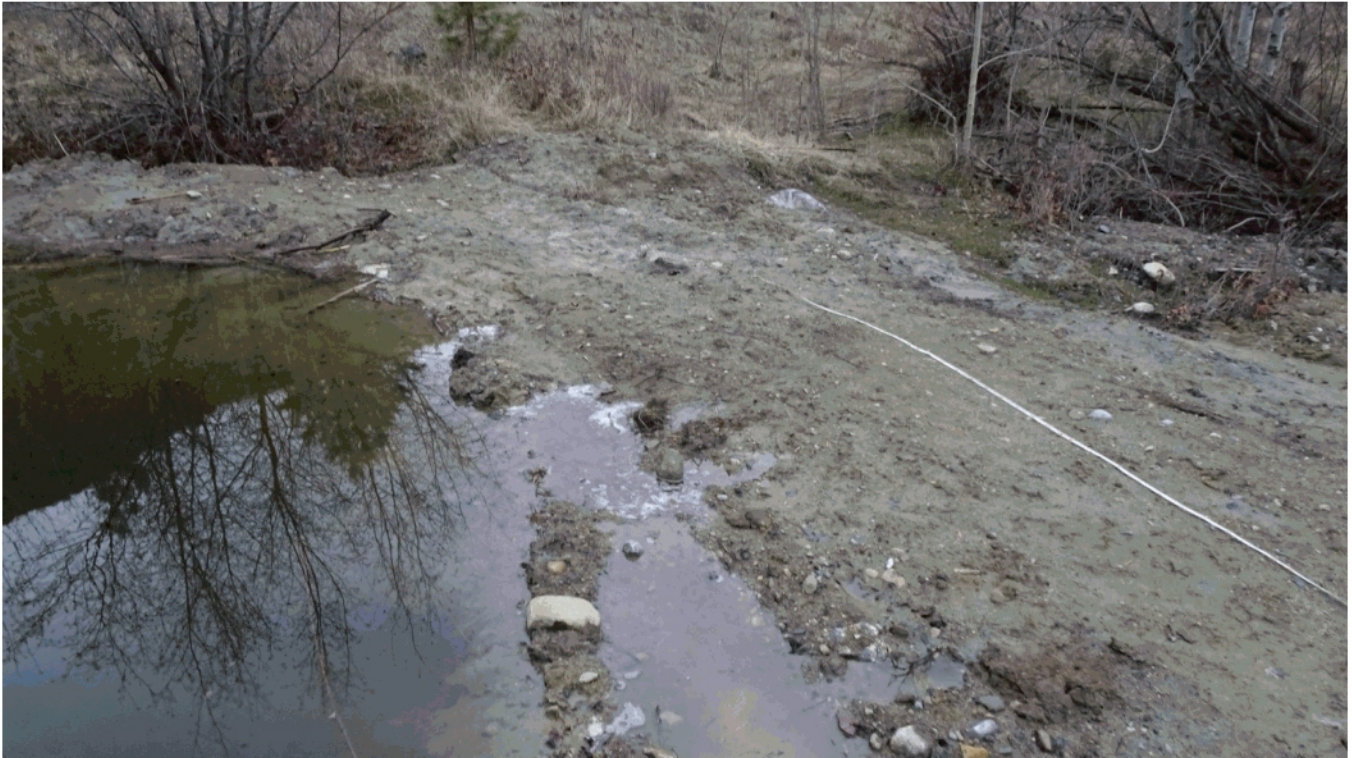
**Background Info of Site:** Based on historic orthophotos, the site appears to have contained a natural wetland feature. What appears to be the recent construction of a dam, has impounded approx. 32,700m<sup>3</sup> of storage. A review of the water licences layer in iMap did not find a current or past licence, therefore the works are unauthorized. The dam at the time of the site audit found the dam nearing overtopping (1" of freeboard).

Photo 1. Reservoir near to cresting.

**Communication and Response - by FLNRO:** Dam owner (Doug Cotter – s.22 cell or 250.493.6308 work) was on site during my visit on April 7<sup>th</sup> and was provided a verbal Order to immediately lower the reservoir.

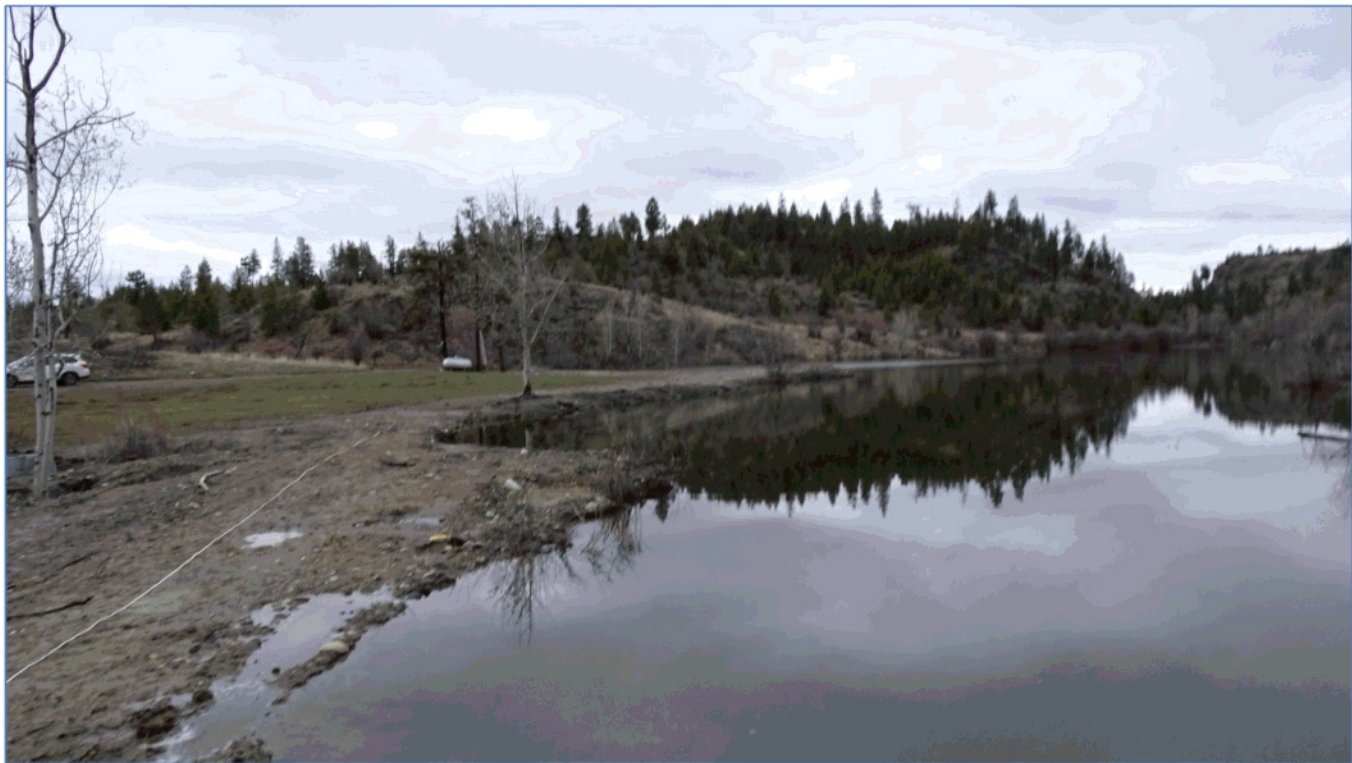
Photo 2. Reservoir near to cresting.

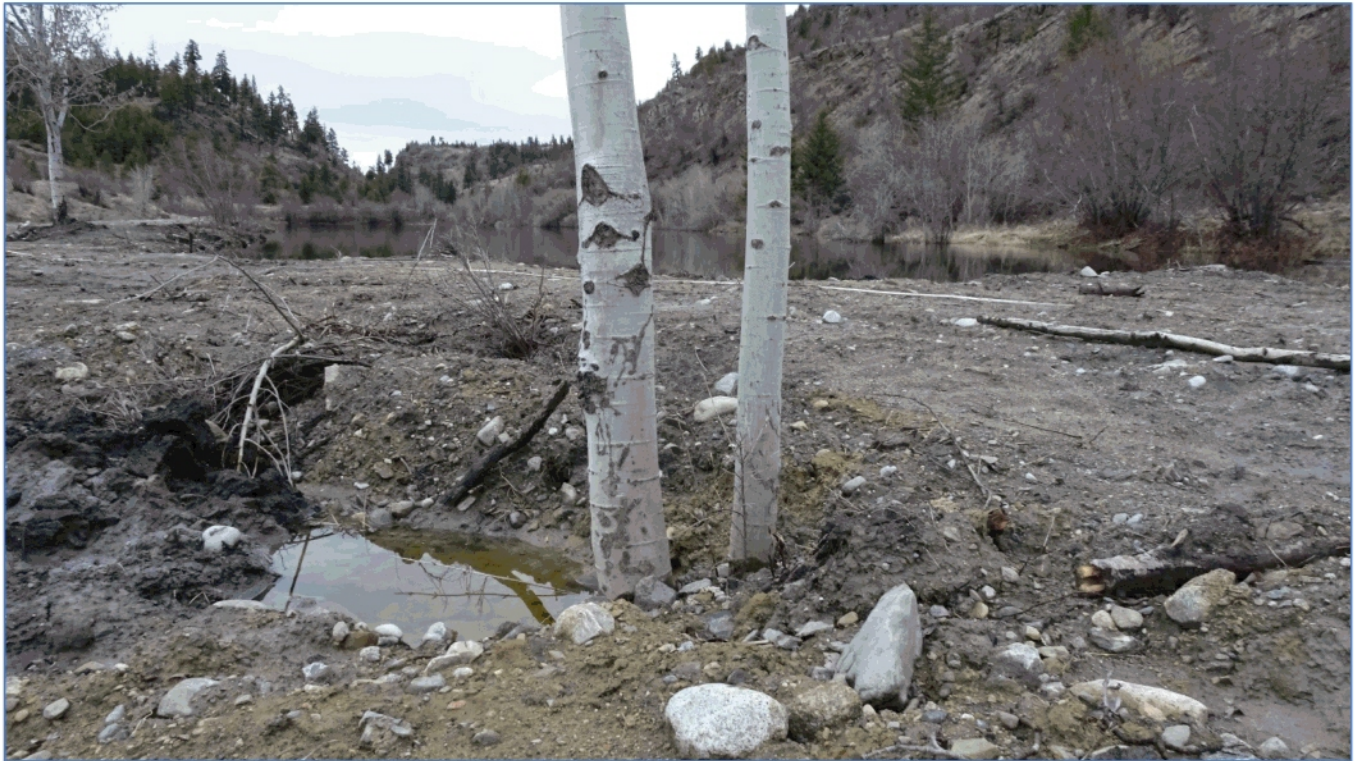
- The dam has no spillway;
- There is no LLO;
- The dam was not constructed to provincial standards.

Photo 3. Dam appears to be 1-2m in height. Note partially buried trees.

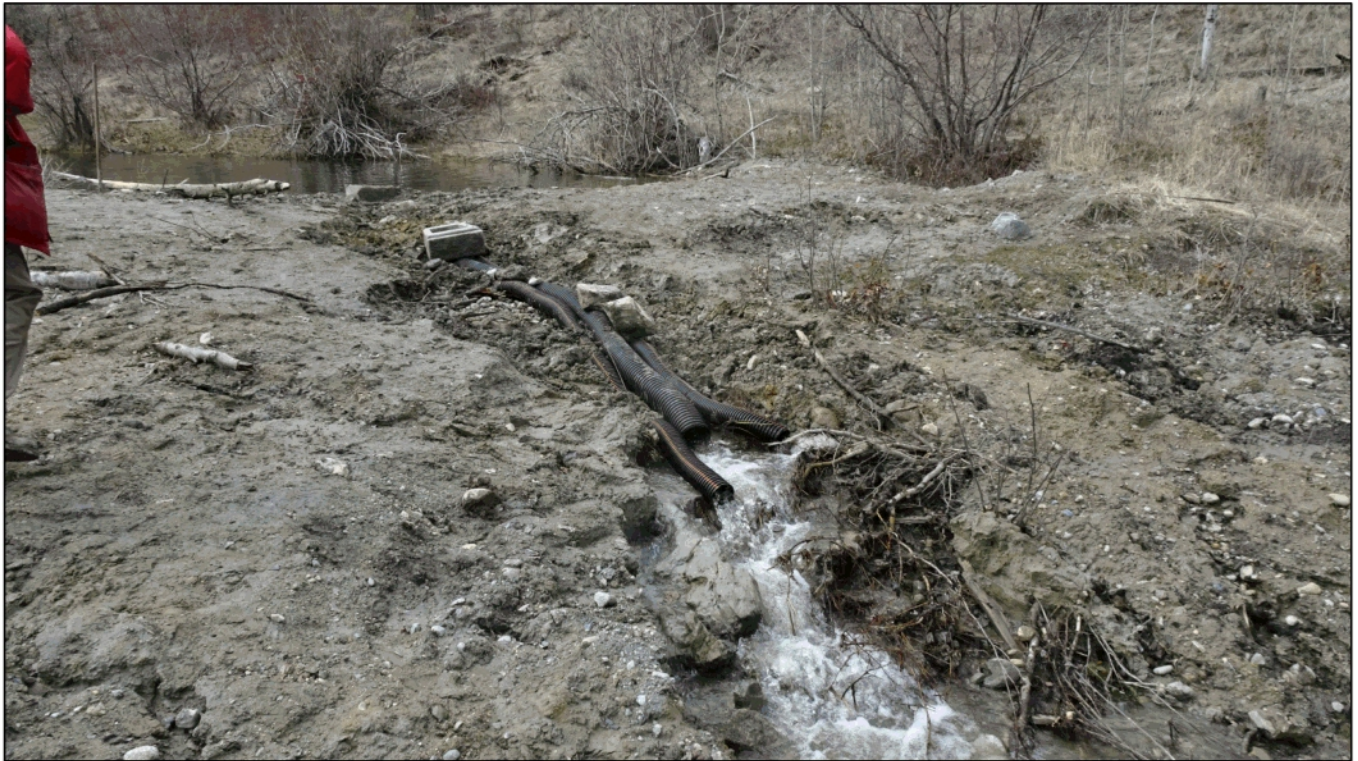
Photo 5. Erosion from discharge.

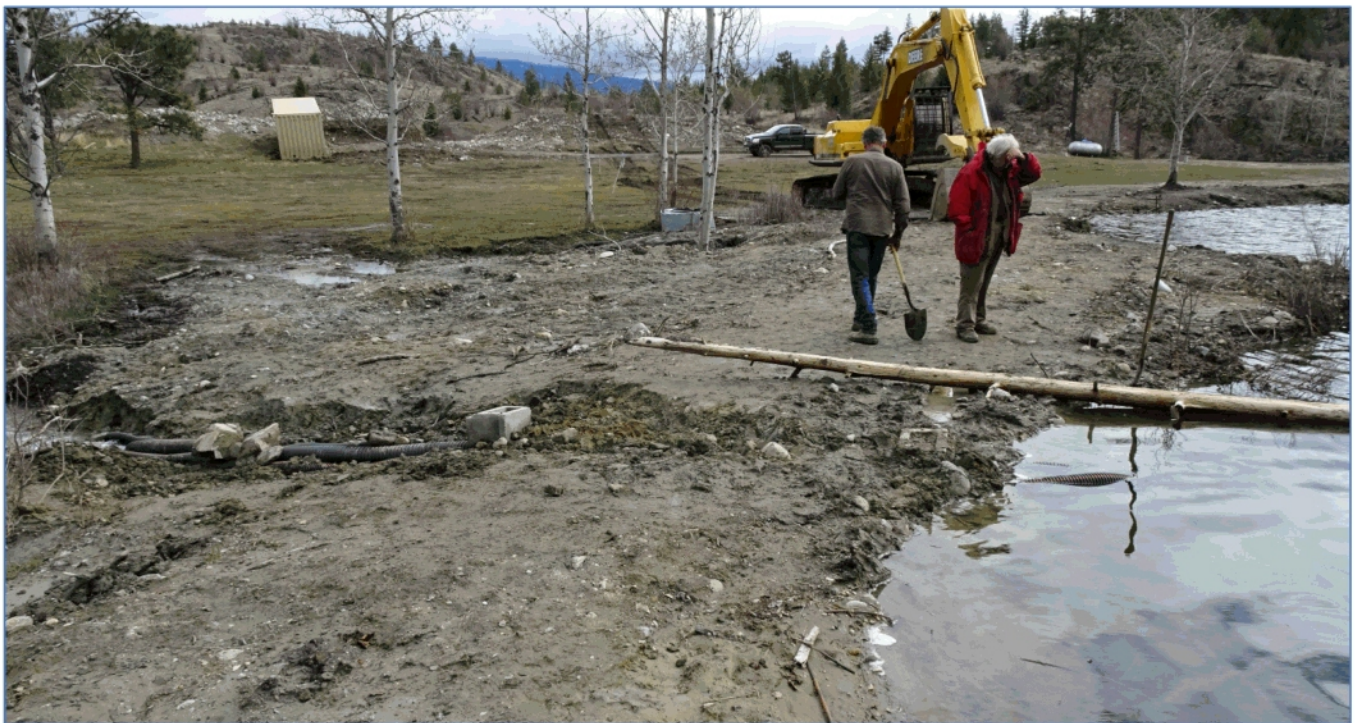
**Follow Up Actions:** A follow-up later that evening found that Mr. Cotter did not return with a pump s.22 ) and instead installed a small diameter culvert in a shallow hand-excavated trench. He said that he would be returning in 2-3 hours with additional pipe for siphoning.

Photo 6. Hand excavated trench with plastic pipe.

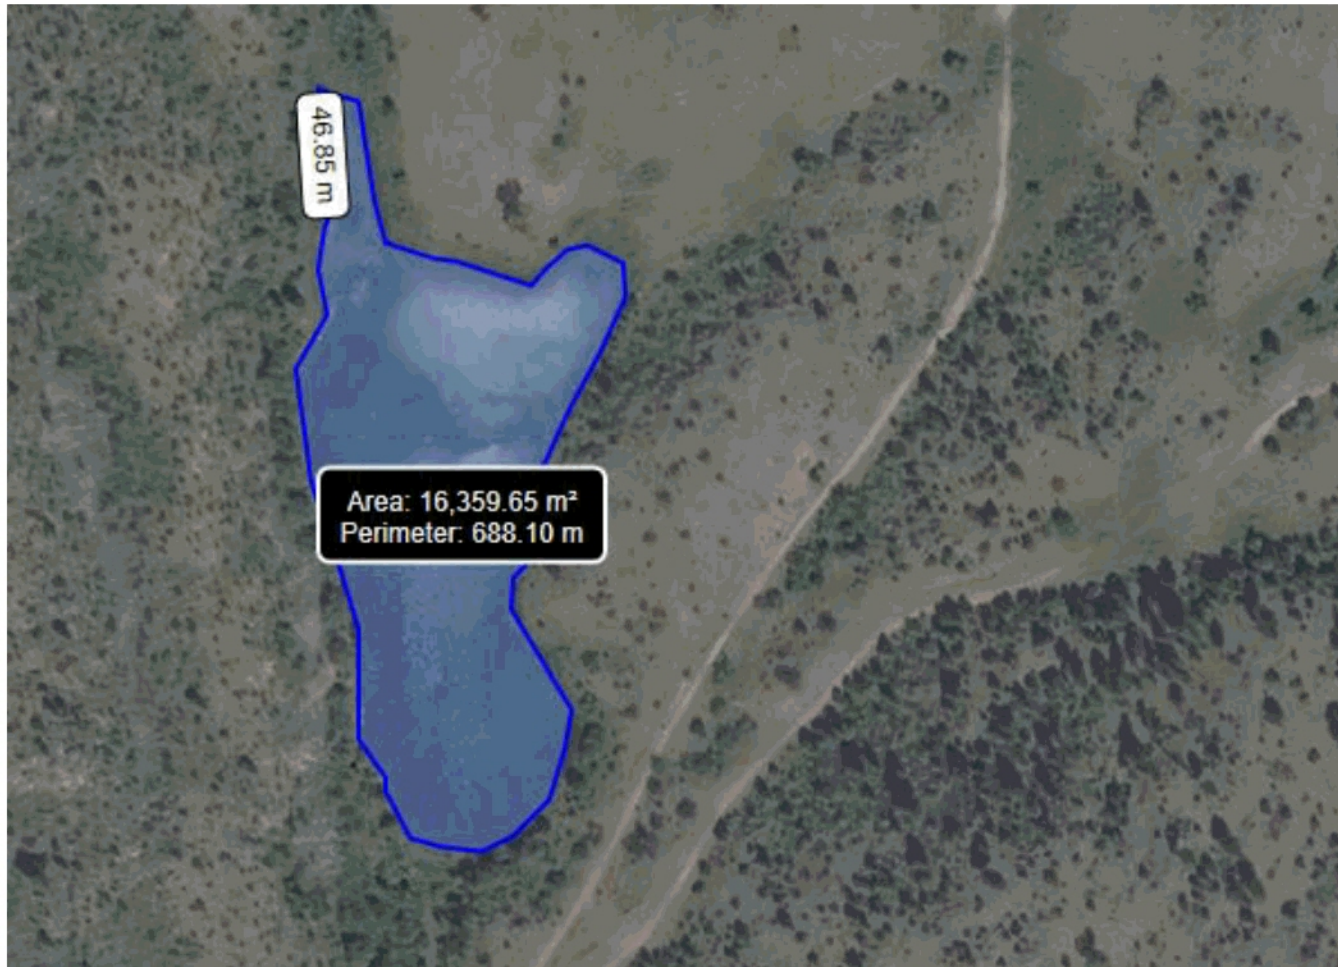
Orthophoto of reservoir. Estimated volume =  $16,360\text{m}^2 \times 2\text{m} = 32,720\text{m}^3$ .
