## **Mount Ida - Haines Creek South FSR (0825.05) Drainage Review**

Ministry of Forests, Lands and Natural Resource Operations  
Okanagan Shuswap Natural Resource District  
2501 – 14<sup>th</sup> Avenue,  
Vernon, BC V1T 8Z1  
Attention: Paul Blomberg RFT

**Westrek Geotechnical Services Ltd.**  
101 – 1285 Dalhousie Drive  
Kamloops, BC V2C 5Z5  
[www.westrekgeotech.com](http://www.westrekgeotech.com)

September 11, 2017  
File No. 017-049

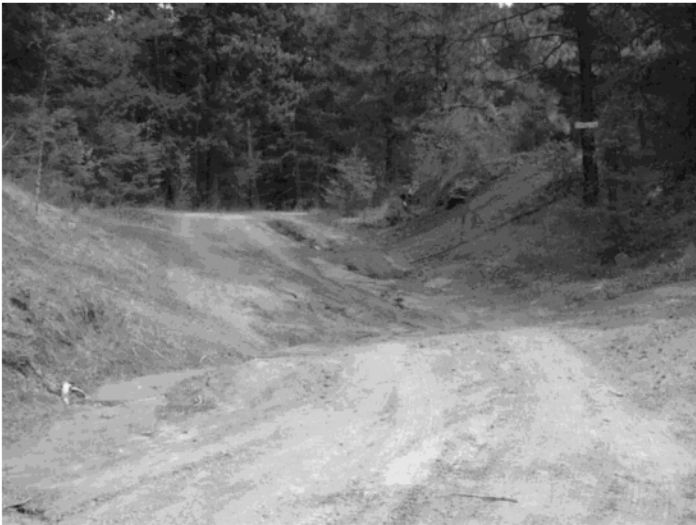
*Photo 2 – Surface erosion at Wpt 629.*

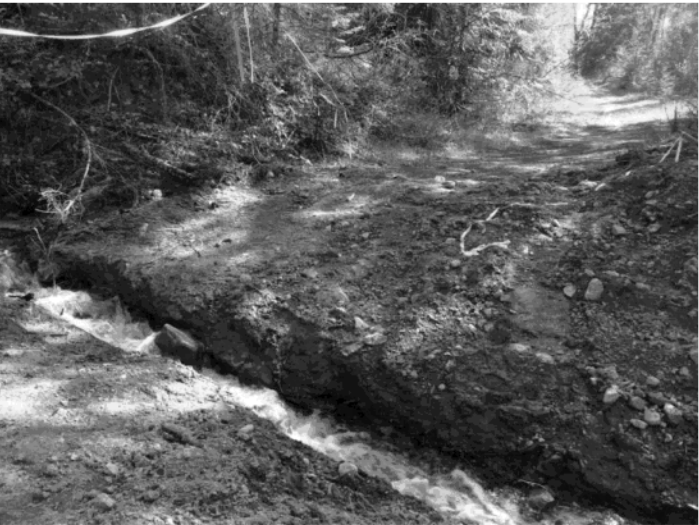
*Photo 3 – Cross-drain culvert removed at Wpt 201.*

Given the amount of off-road vehicle traffic on the road and presence of water licenses on Andrew Brook, install an adequately sized culvert at Wpt 201 to replace the stream culvert cross-ditch that was removed and replaced with a cross-ditch during the emergency response. A minimum culvert size of 500 mm is recommended.

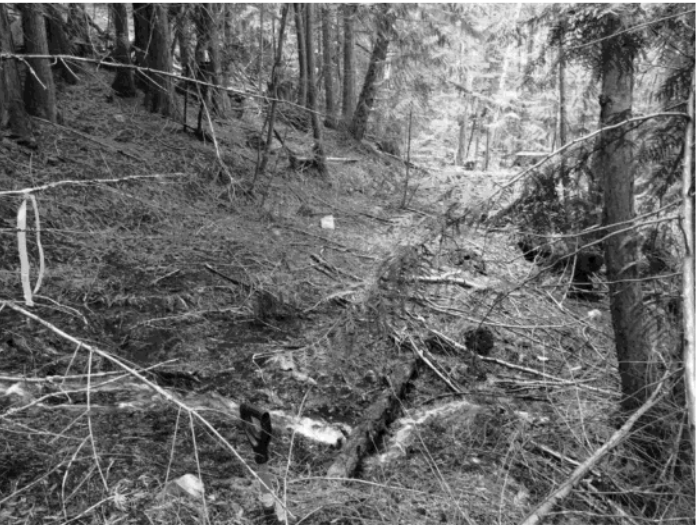
*Photo 4 – Exfiltration zone is approximately 10 m upslope of Wpt 307 and is the source of Andrew Brook.*

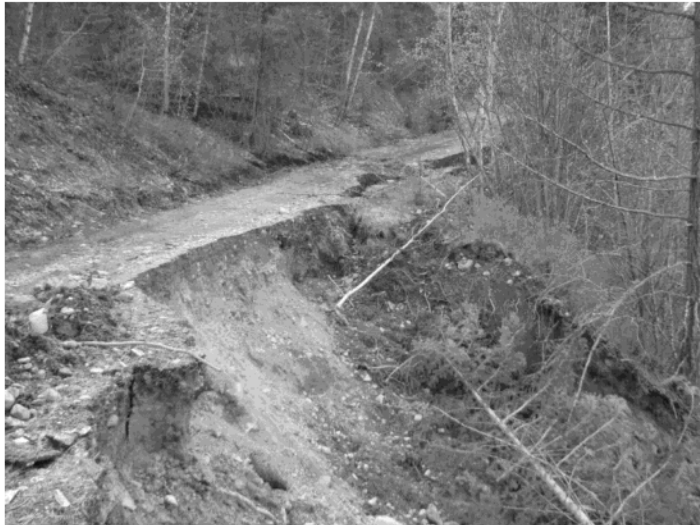
Landslide 1 (Wpt 197) initiated from a fill slope failure at km 2.8 on the FSR (Photo 5). The scarp was about 12 m along the shoulder, but tension cracks and slumped ground extended an additional 18 m and 27 m to the north and south, respectively. Most notably, the crack to the south (uphill) of the scarp opened and dropped about 0.3 m, and about half of the road was lost.

The scarp was 2.0 to 3.5 m high and nearly vertical. Surface water was observed to be flowing into and along tension crack and then into the landslide scarp. A significant portion of this water likely came from the spring at Wpt 172 (Photo 6). In addition, a major spring was observed emerging from the coarse sediments in the base of the scarp which added to the runoff flowing down the landslide.

*Photo 5 – Slide 1 (Wpt 197). Photo faces towards the bush.*

A 60 m long section of slumped fill remains at Wpt 197 to 197a, which has the potential to initiate another landslide should it become saturated. To reduce this hazard, pull back the slumped fill to the tension crack and flatten the fill slope to no more than 1.5H:1V (67%). The pulled-back material should be end-hauled to an approved spoil location, such as the bowl-shaped area at Wpt 204.

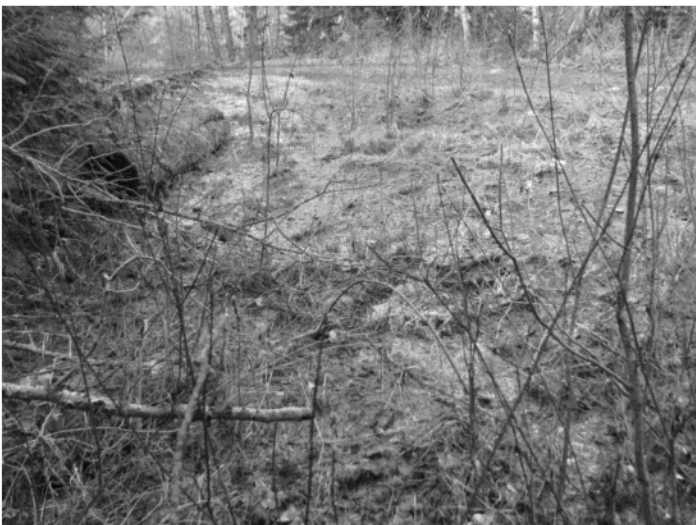
*Photo 6 – Large spring at Wpt 172. Photo faces downslope towards town.*

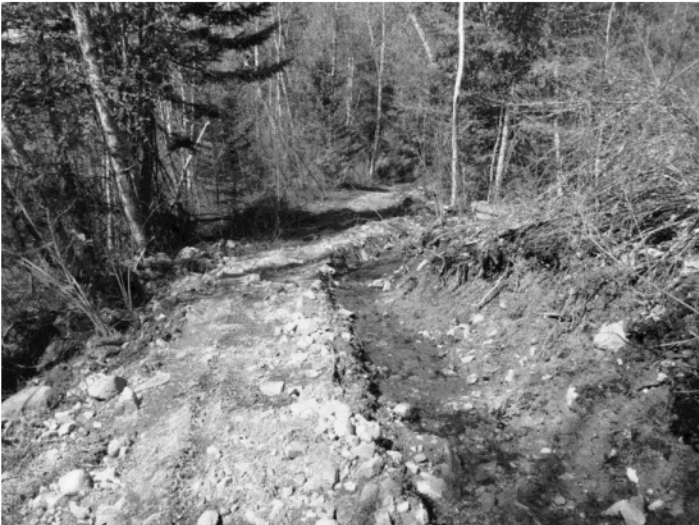
Westrek recommended the construction of a ditch between Wpt 188 and Wpt 190 to intercept the flow from the spring (Photo 7) and direct it towards the crossing at Wpt 201 in Andrew Brook. The ditch was constructed later that day. By May 1, surface water was no longer flowing in the tension crack, but moderate seepage was noted to be flowing from the base of the scarp.

*Photo 7 – Interception ditch between Wpt 188 and 190. Photo faces towards town.*

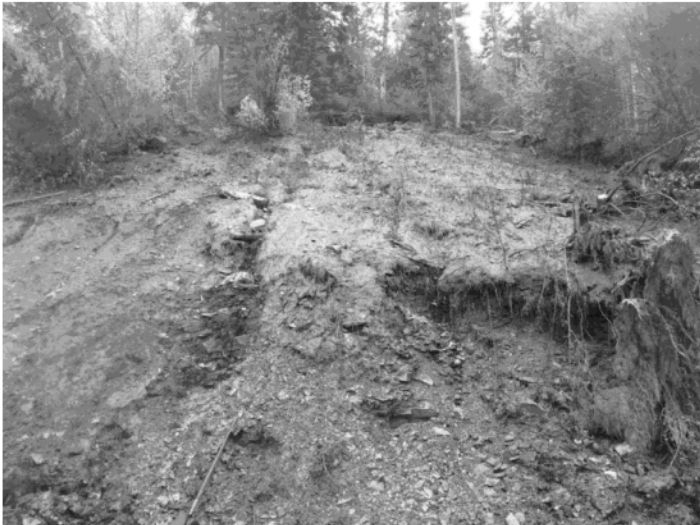
Landslide 2 (Wpt 176b) occurred at km 4.0 km on the FSR ( $\pm 745$  m elevation) at some time between May 3 and May 6 (Photo 8). The scarp was approximately 11 m wide and 1.5 m high, and was located immediately beneath a slope break that steepened from 25% to 60%. The failure surface was along the interface between sandy colluvium and till, which consisted of silty sand with some gravel and occasional cobbles. The total initiation zone was approximately 250 m<sup>3</sup>. Bedrock was present in the landslide track near Wpt 176b.

*Photo 8 – Slide 2. Photo taken May 16<sup>th</sup> and faces upslope from Wpt 176b towards the headscarp.*

The landslide debris cleared from the road at Wpt 176a and Wpt 185 and temporarily placed on the fill slope should be removed and hauled to a suitable spoil site. This will reduce the likelihood of a subsequent fill slope failure from the additional loading generated by the stockpiled debris.

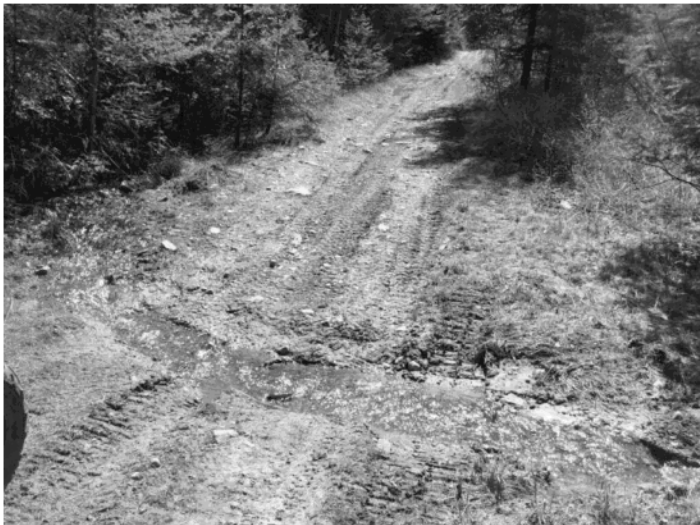
*Photo 9 – Cross-ditch at Wpt 169 drains to Slide 2 headscarp. Photo taken May 1 and faces towards town.*

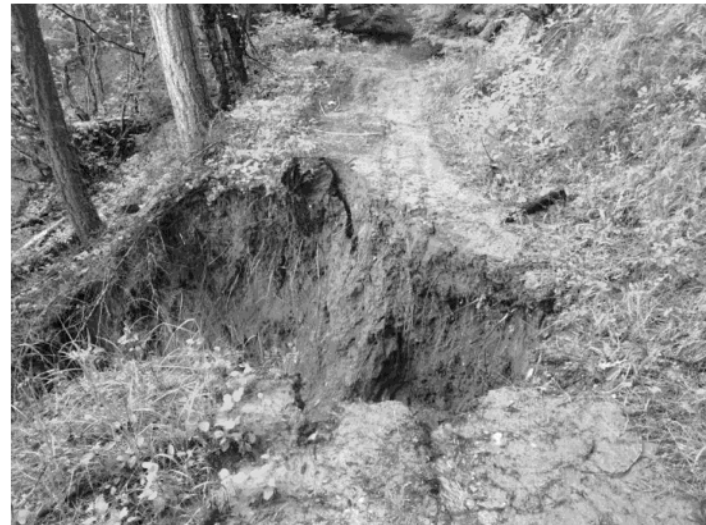
Landslide 3 initiated as a 3 m wide by 3 m deep road fill failure at Wpt 2201 sometime between May 3 and 10, 2017. The failure initiated on a non-status road that leads down from the FSR to the water intakes on Andrew Brook (Photo 10). The road is no longer usable as its entire width has been lost at the scarp. The fill slope was approximately 70% and surface flow from the road was flowing into the scarp. The flow appeared to originate at a two seepage zones (Wpt 2200 & 2200a) approximately 85 m up the road from the slide. The road surface was U-shaped in this section and no drainage structures were present (Photo 11).

*Photo 10 – Slide 3 (Wpt 2201). Photo faces towards the bush direction.*

This landslide likely initiated as a result of fill slope saturation that was caused by the diversion of drainage along the access road leading down to the intake. Westrek understands this is a non-status road and the person responsible for this road may have to implement the repair. To minimize additional failures from the road, the road fill at the head scarp that is reachable with an excavator should be pulled back to 1.5H:1V (67%) and a cross ditch should be installed in the draw located at Wpt 2200a. A berm should be constructed on both sides of the landslide to prevent access and signs should be posted warning road users of the hazard. Due to the cost of the repair, the person needing the road should consider other access options once the slope above the creek has been stabilized.

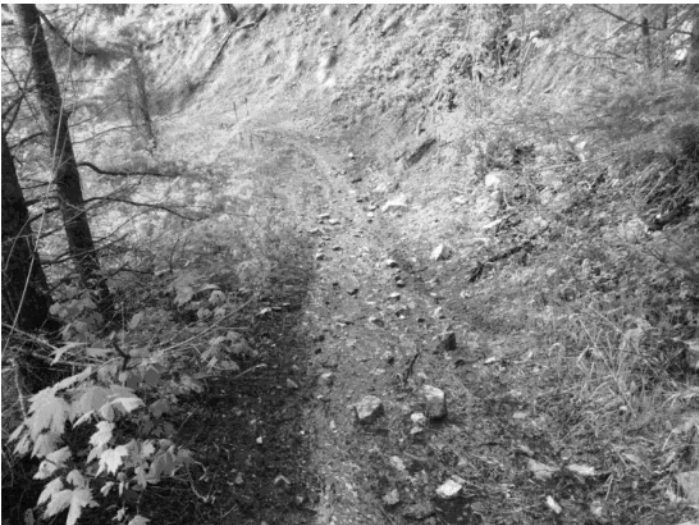
*Photo 11 – Seepage flow diverted by trail from Wpt 2200 to Slide 3.*

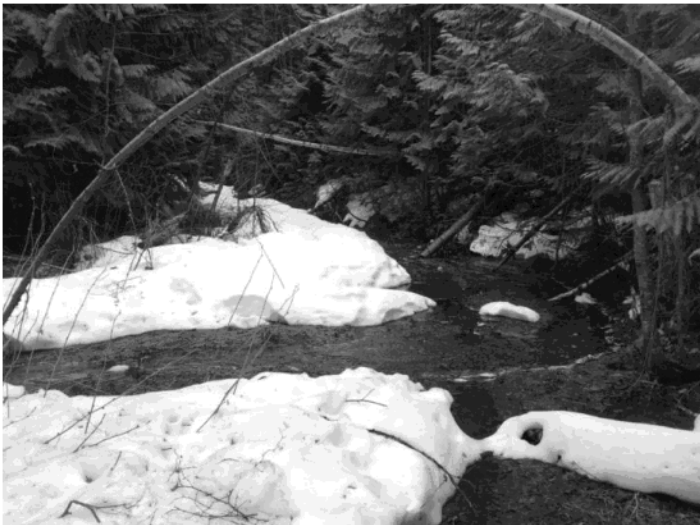
Stream A was tracked by GPS and is shown on Figure 1. The channel is poorly confined in several locations in the higher elevations and ponding was common. No obvious diversions were observed until it intersects the FSR near Wpt 800. At this location, the entire stream flow is diverted west by about 90 m to a dip in the FSR at Wpt 810 (Photo 12), at elevation +/- 1190 m.

*Photo 12 – Large diversion from Wpt 800 flowing off road at FSR. Photograph faces towards the bush.*

Stream A can be restored to its natural drainage path below the FSR by constructing a ditch and small berm at Wpt 800. The following is recommended:

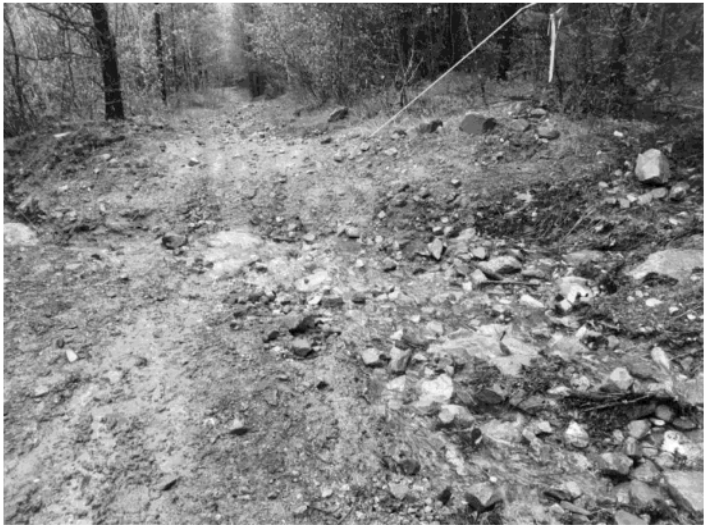
*Photo 13 – Culvert recently removed at Wpt 137. Significant road surface erosion noted towards town.*

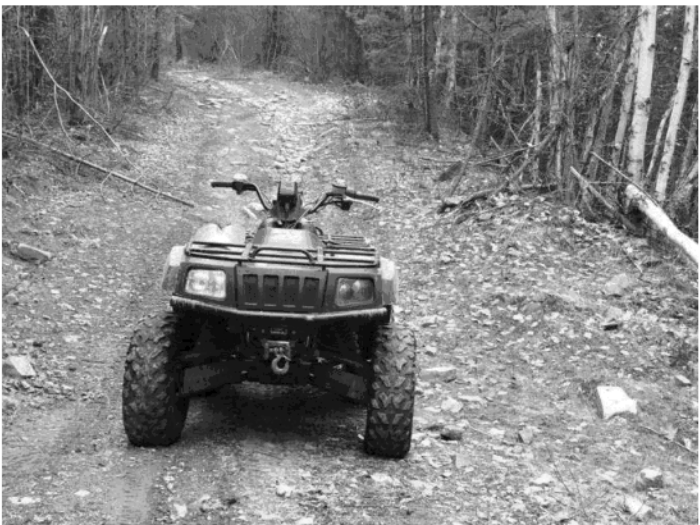
*Photo 14 – Road surface erosion between Wpt 137 and 139 suggests drainage was likely diverted along the FSR prior to removal of the culvert at Wpt 137. Photo is located at Wpt 139 and faces towards the bush.*

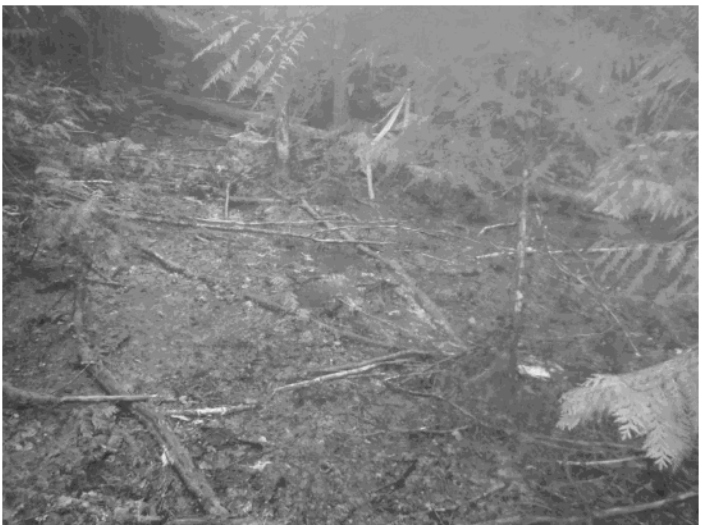
*Photo 15 – Diversion along old logging trail at Wpt 1108.*

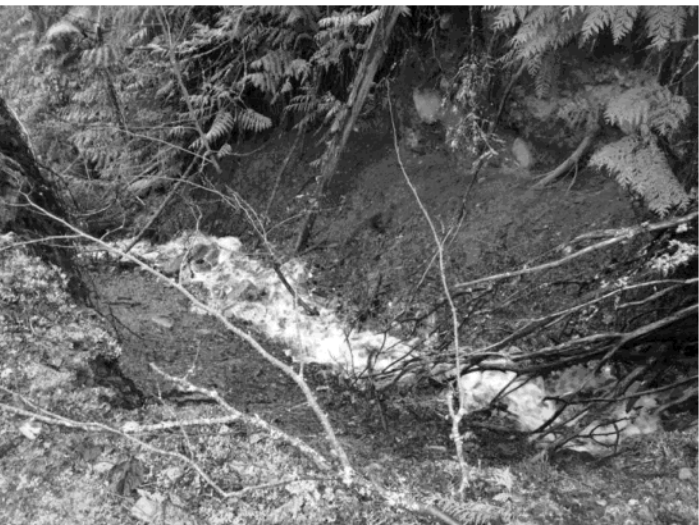
*Photo 16 – Eroded take-off ditch at Wpt 149 drains into Gully A.*

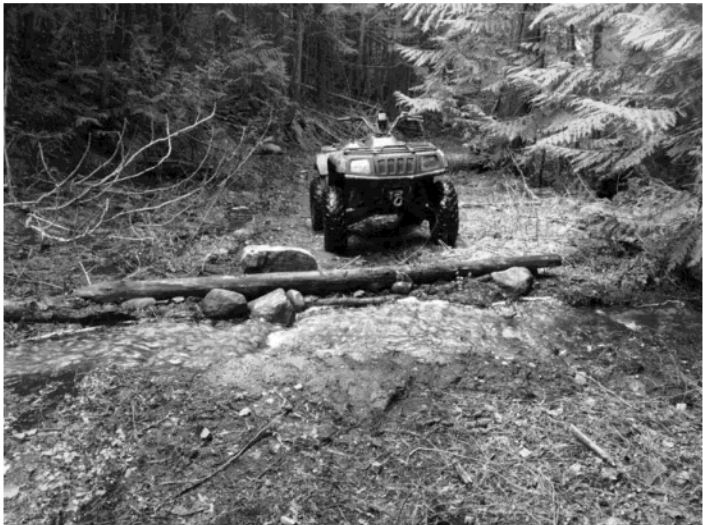
*Photo 17 – Partial diversion of Stream B at Wpt 1000. Photo faces towards town.*

To remove the diversion of Steam B and restore the natural drainage path, Westrek recommends constructing a 0.5 m cross-ditch at Wpt 1000. This should be armoured with available rock to minimize erosion.

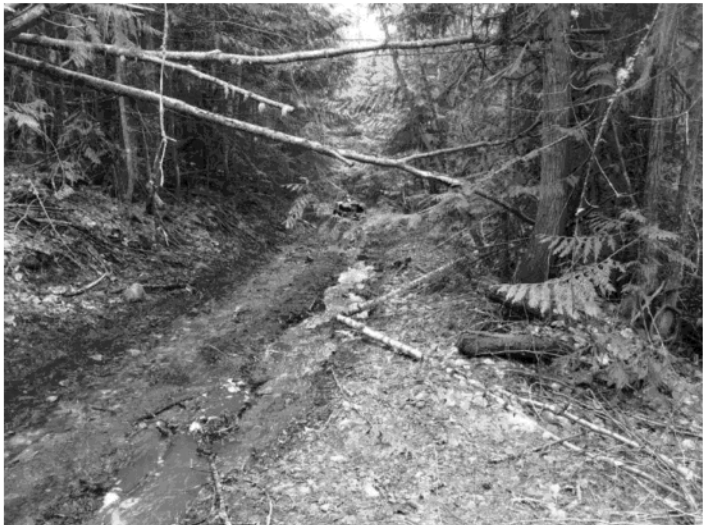
*Photo 18 – Road surface erosion between Wpt 1000 and 1005.*

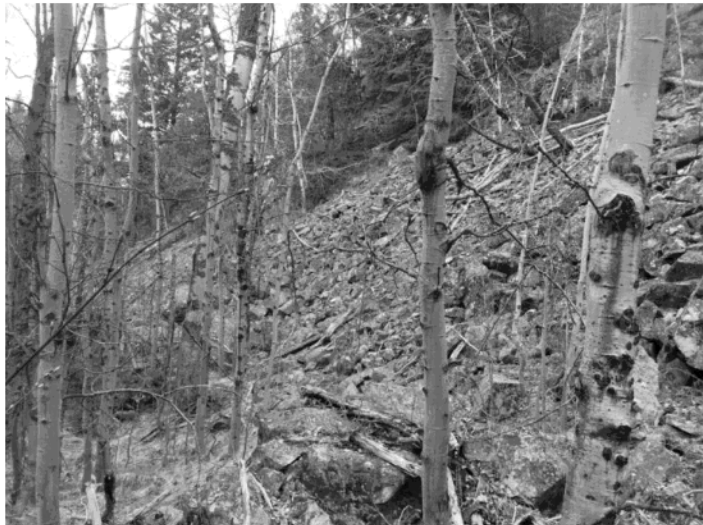
*Photo 19 – Source of rock for armoring near Wpt 126.*
