Ripple Rock Recreation Trail (REC0472) Incident on July 17, 2018.

The below information was obtained through an informal inspection of the Ripple Rock Trail following the death of a hiker that occurred on the trail on July 17, 2018. The trail is located approximately 16km North of Campbell River, BC. I have recorded as close to chronologically as I can throughout the day on July 18, 2018 from the time I was notified of the fatality until I returned to the office.

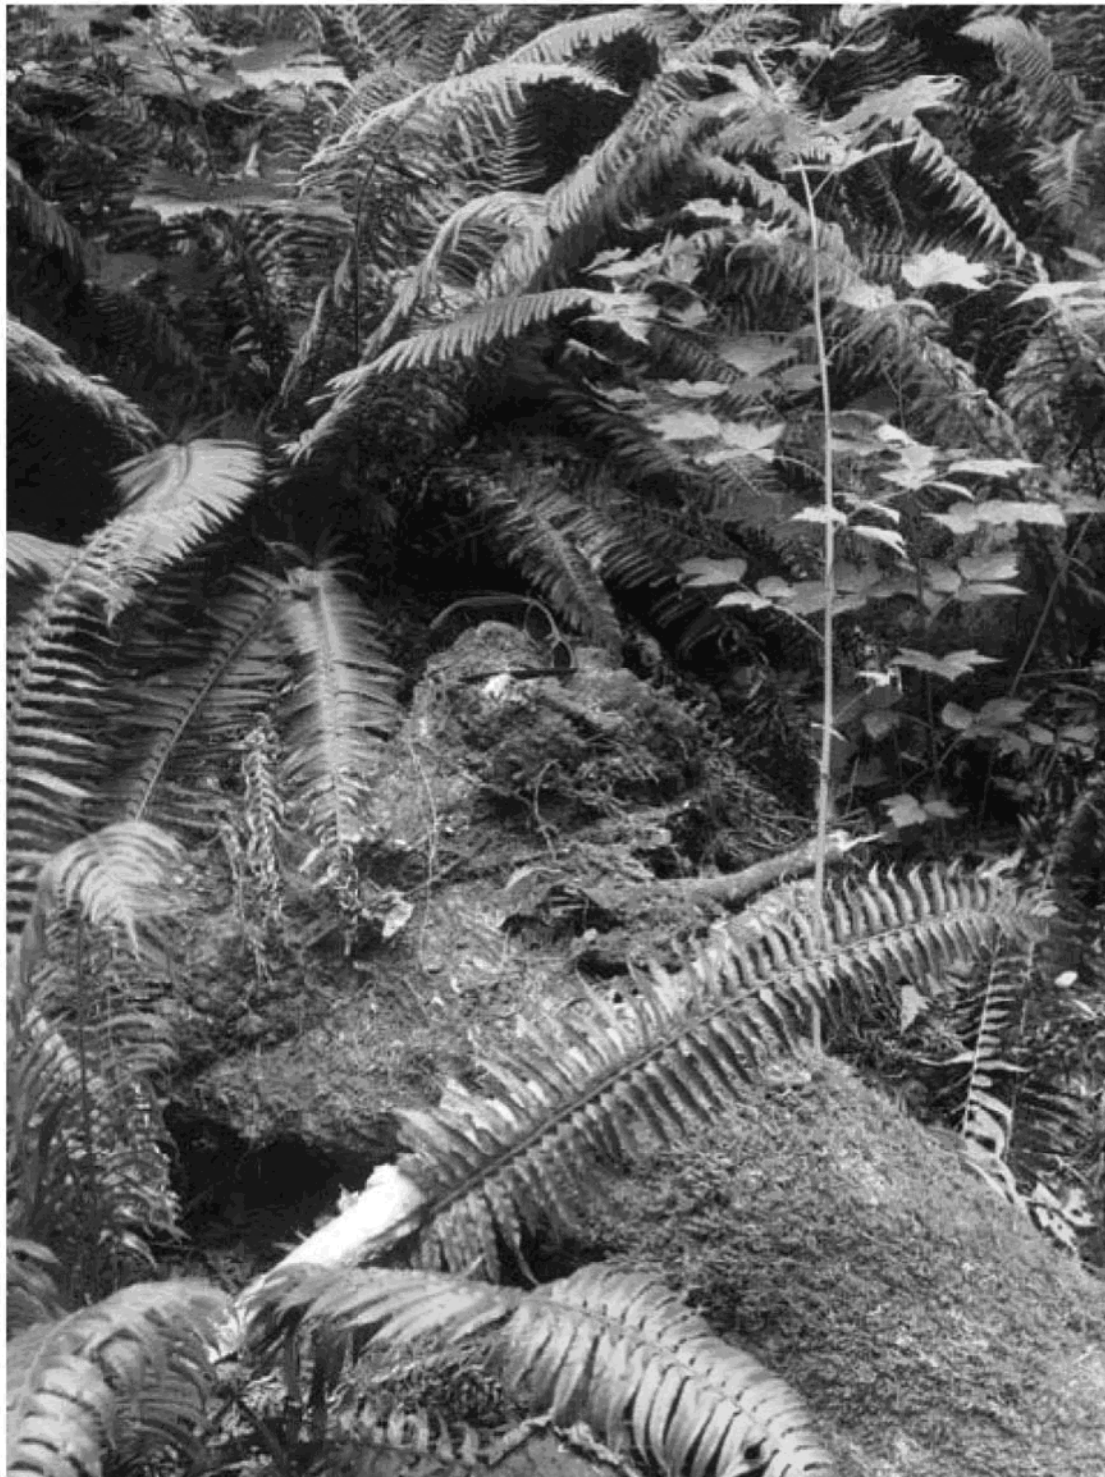
Root ball with sun glasses for scale. Some broken roots and lifted material. Ground felt extremely dry

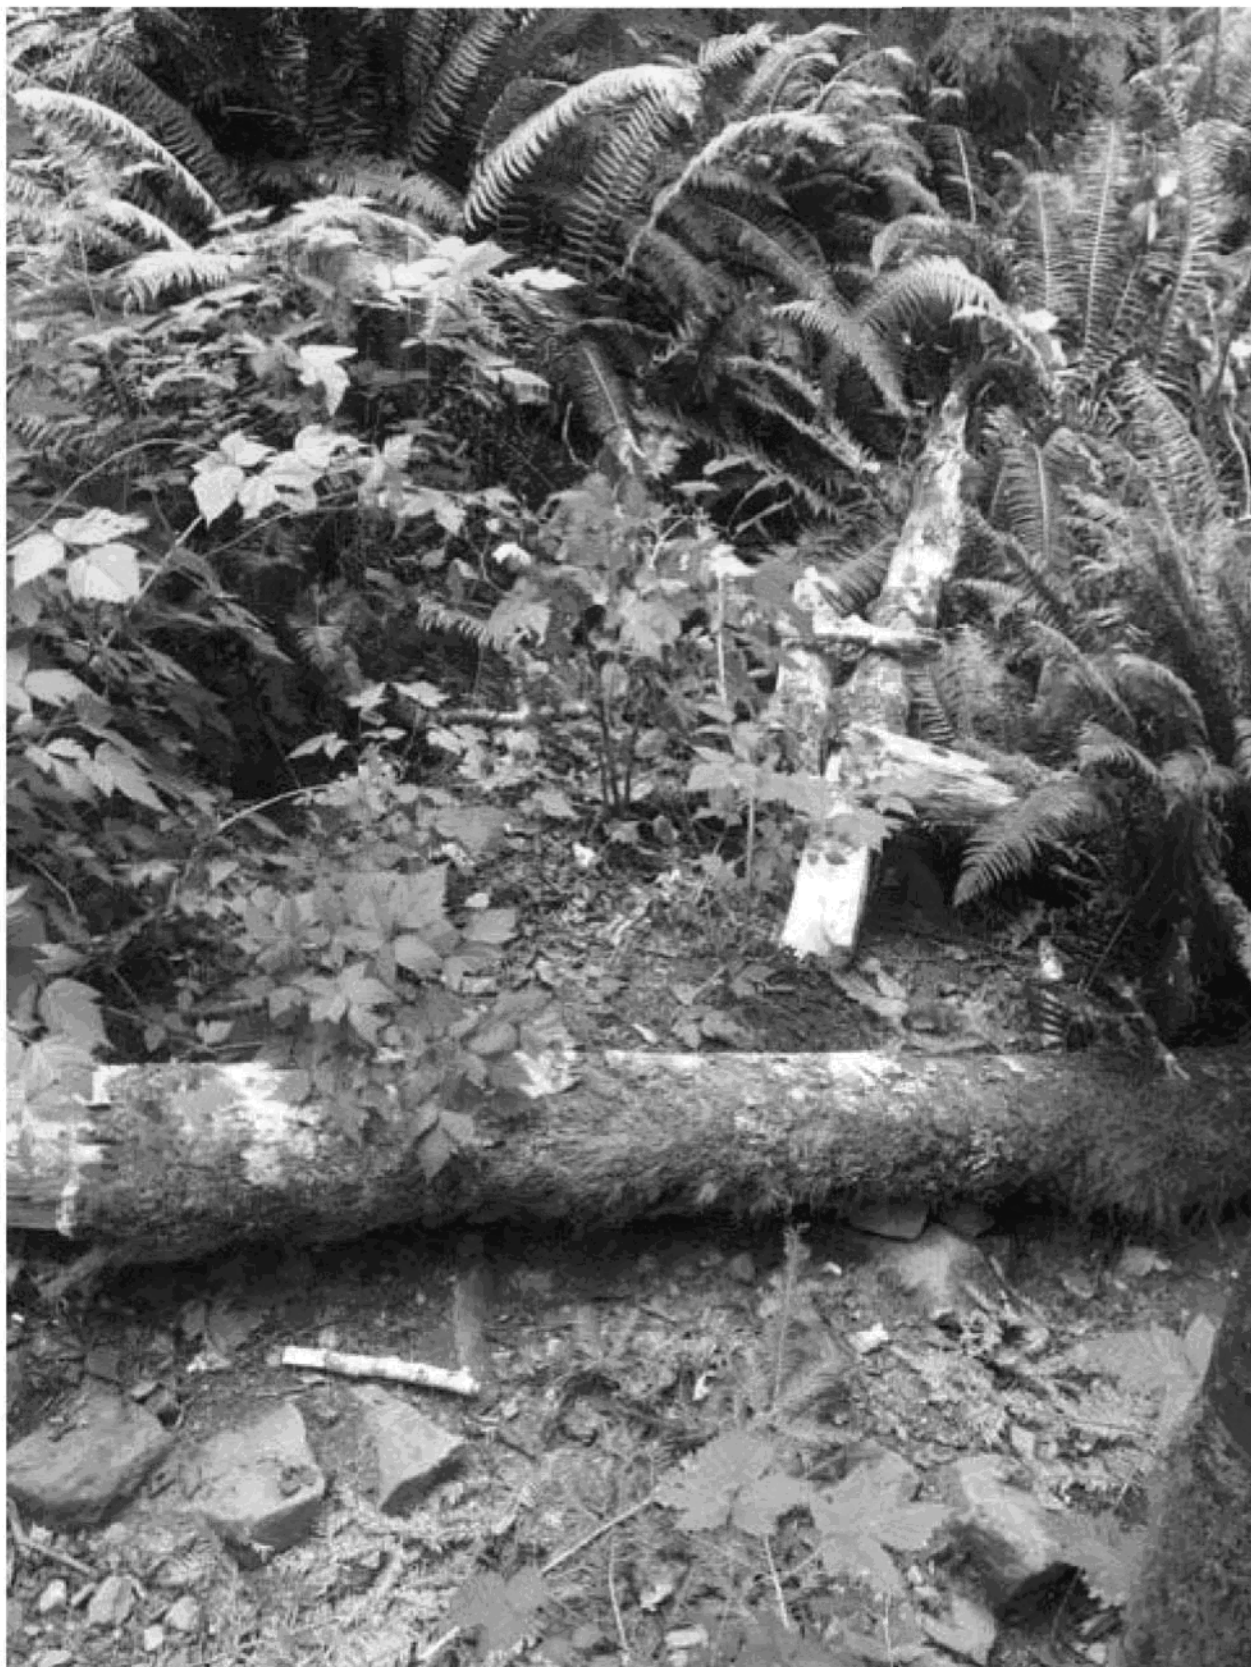
Middle of stem adjacent to trail and a piece of the top

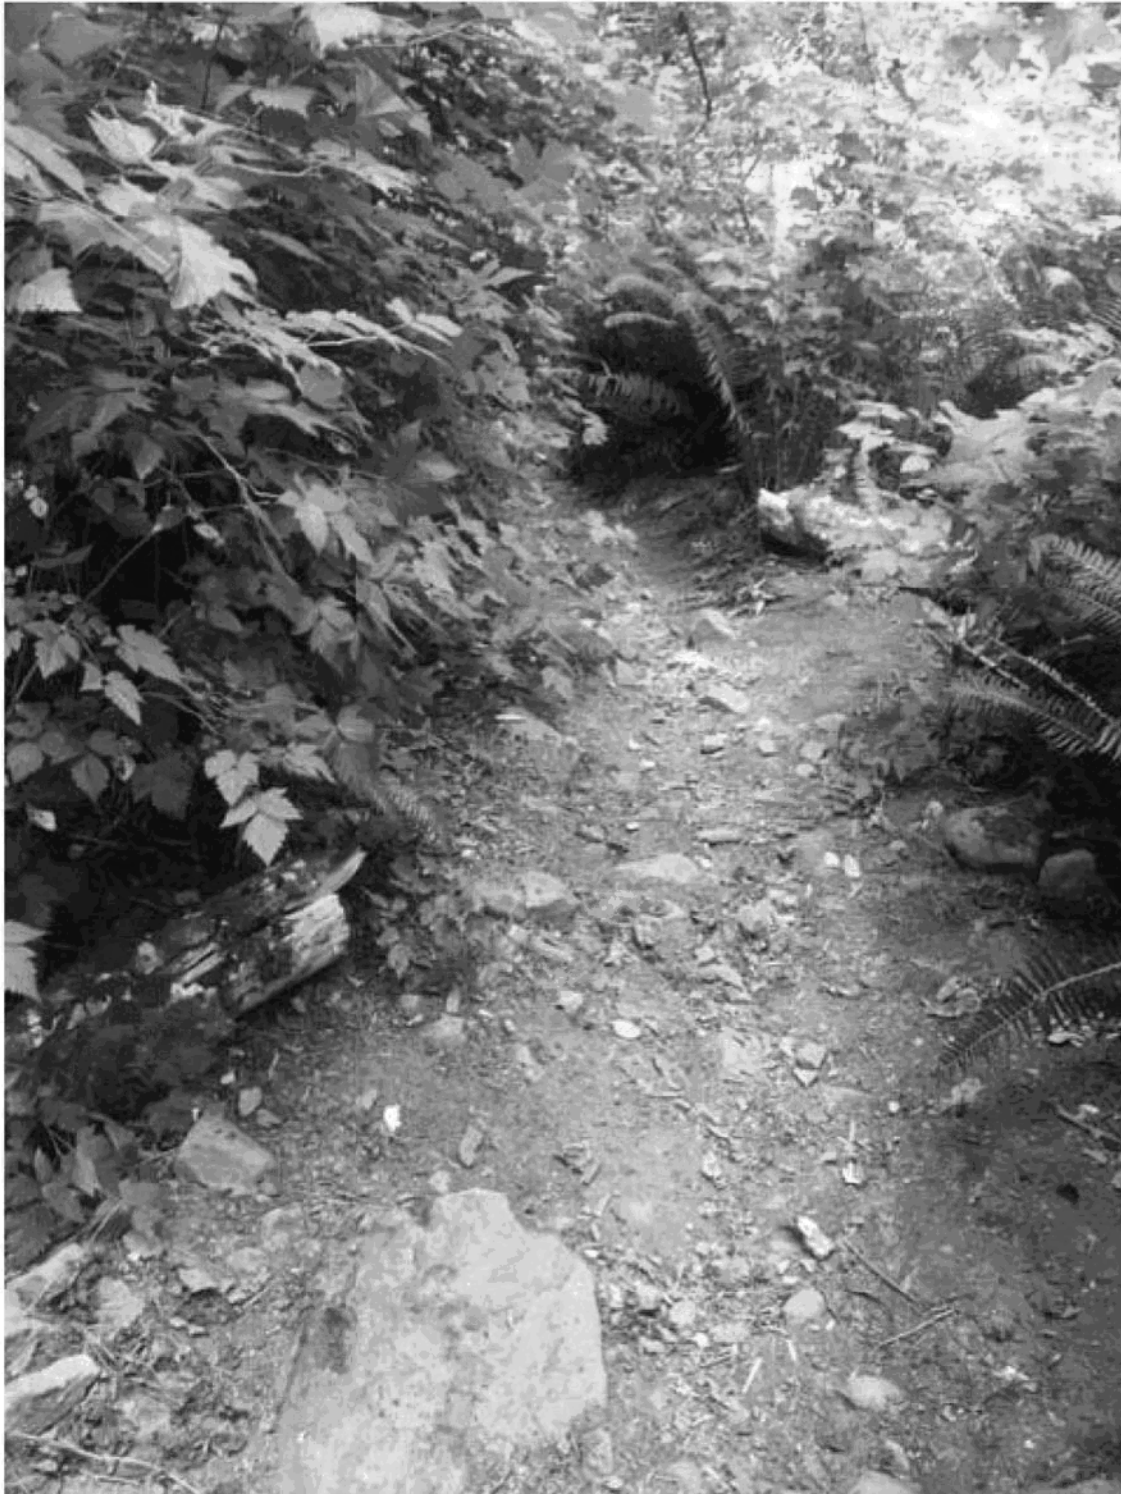
Upper middle portion of stem on left, top of stem on the right of trail which had been moved by hikers

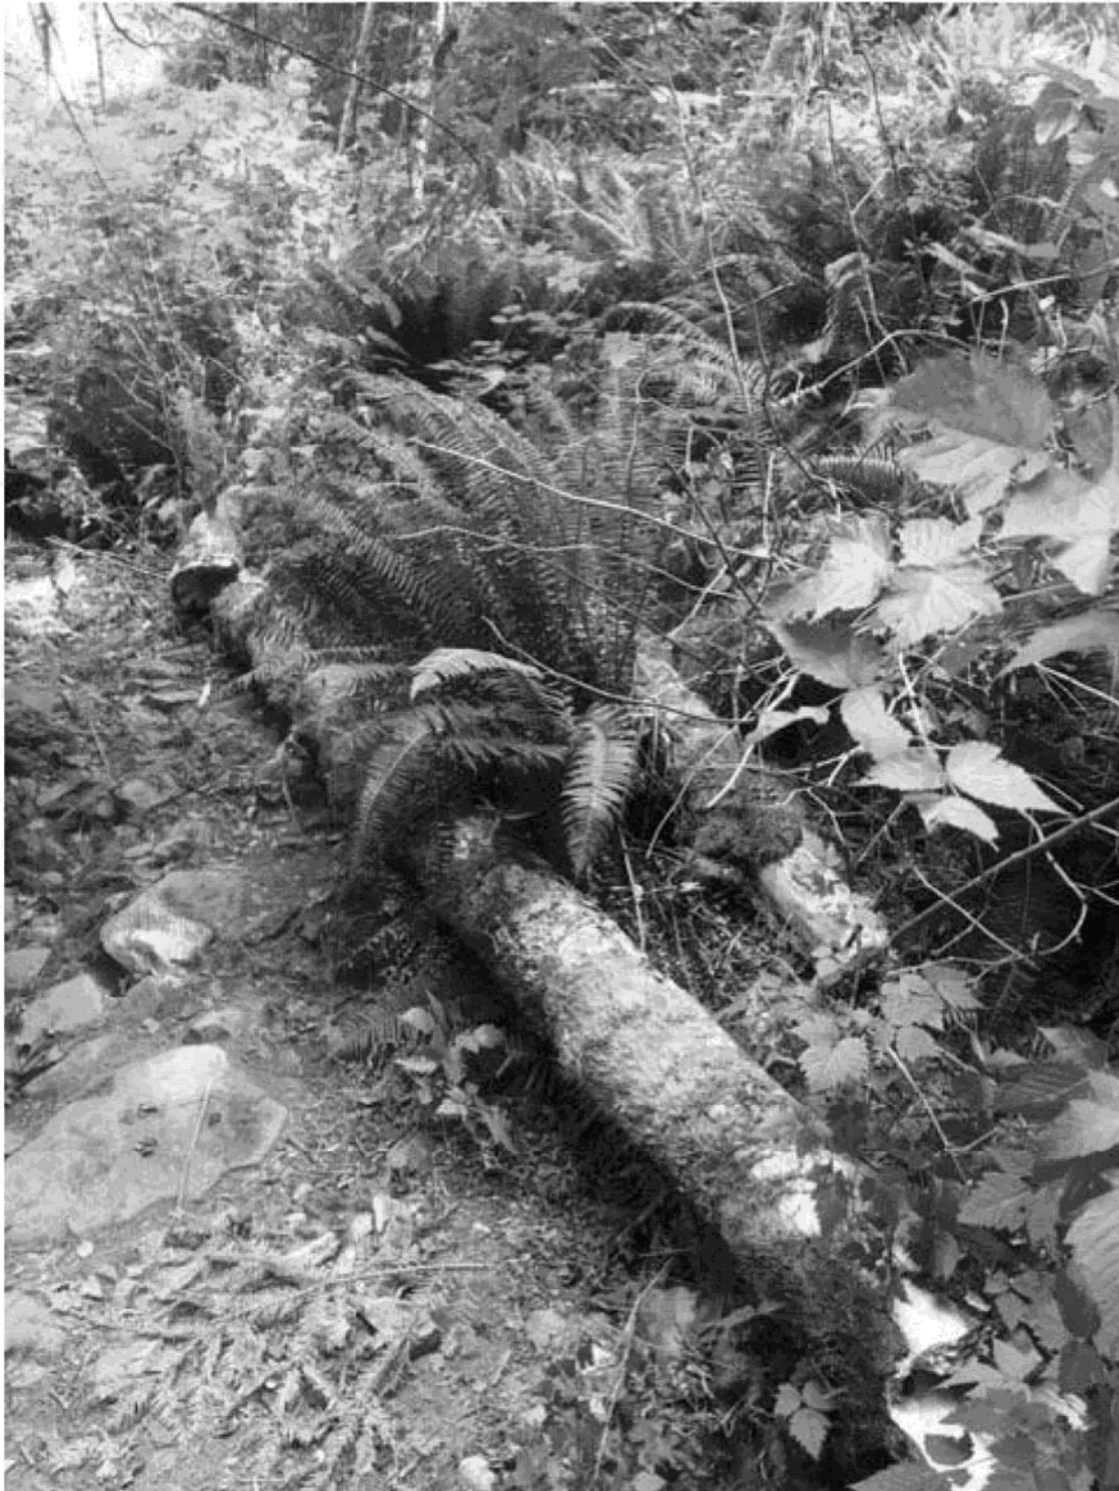
Looking across slope from the location the tree crossed the trail. A portion of this stem appears to have been moved to the side from the middle of the trail

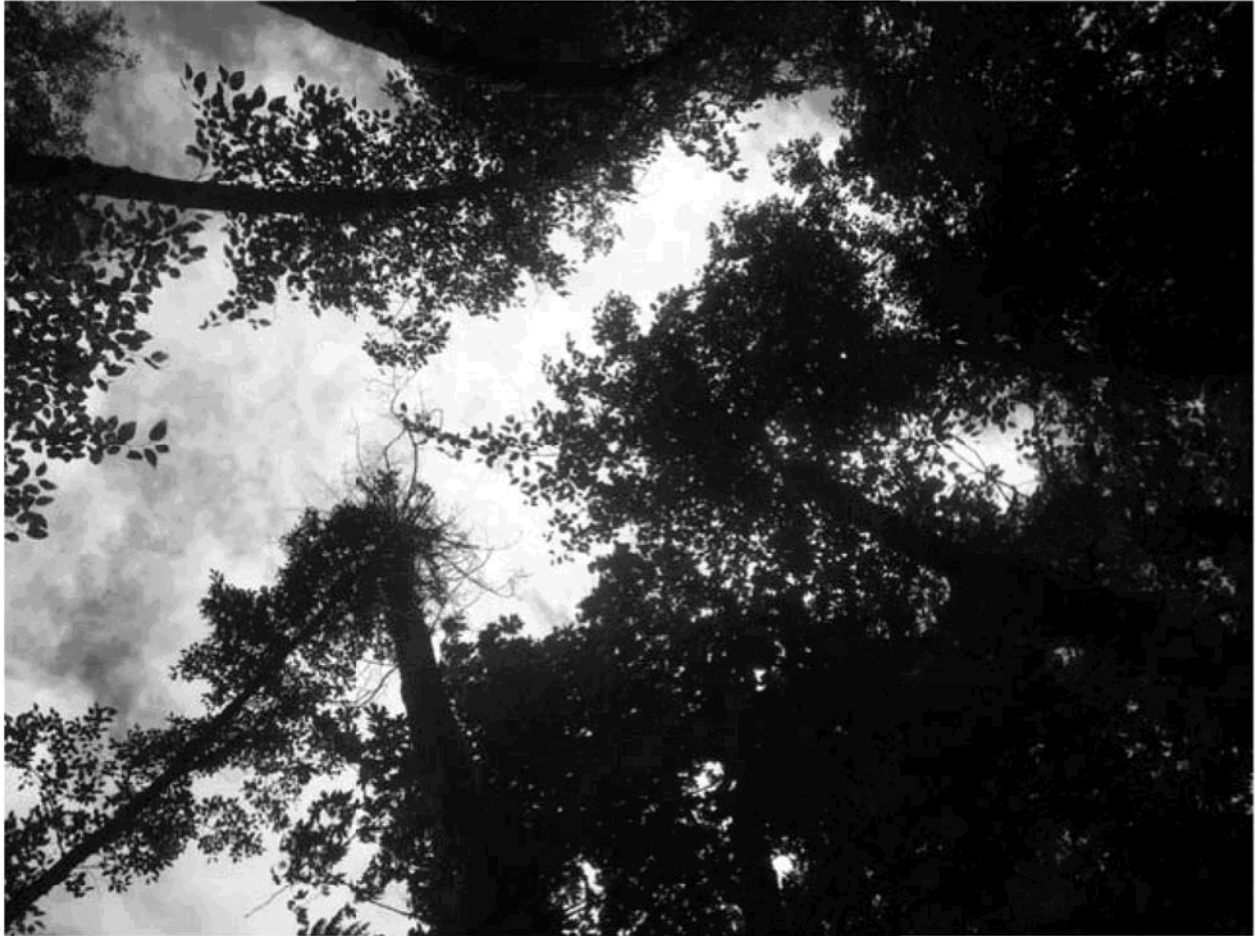
View from the root ball showing canopy closure and over-story stems

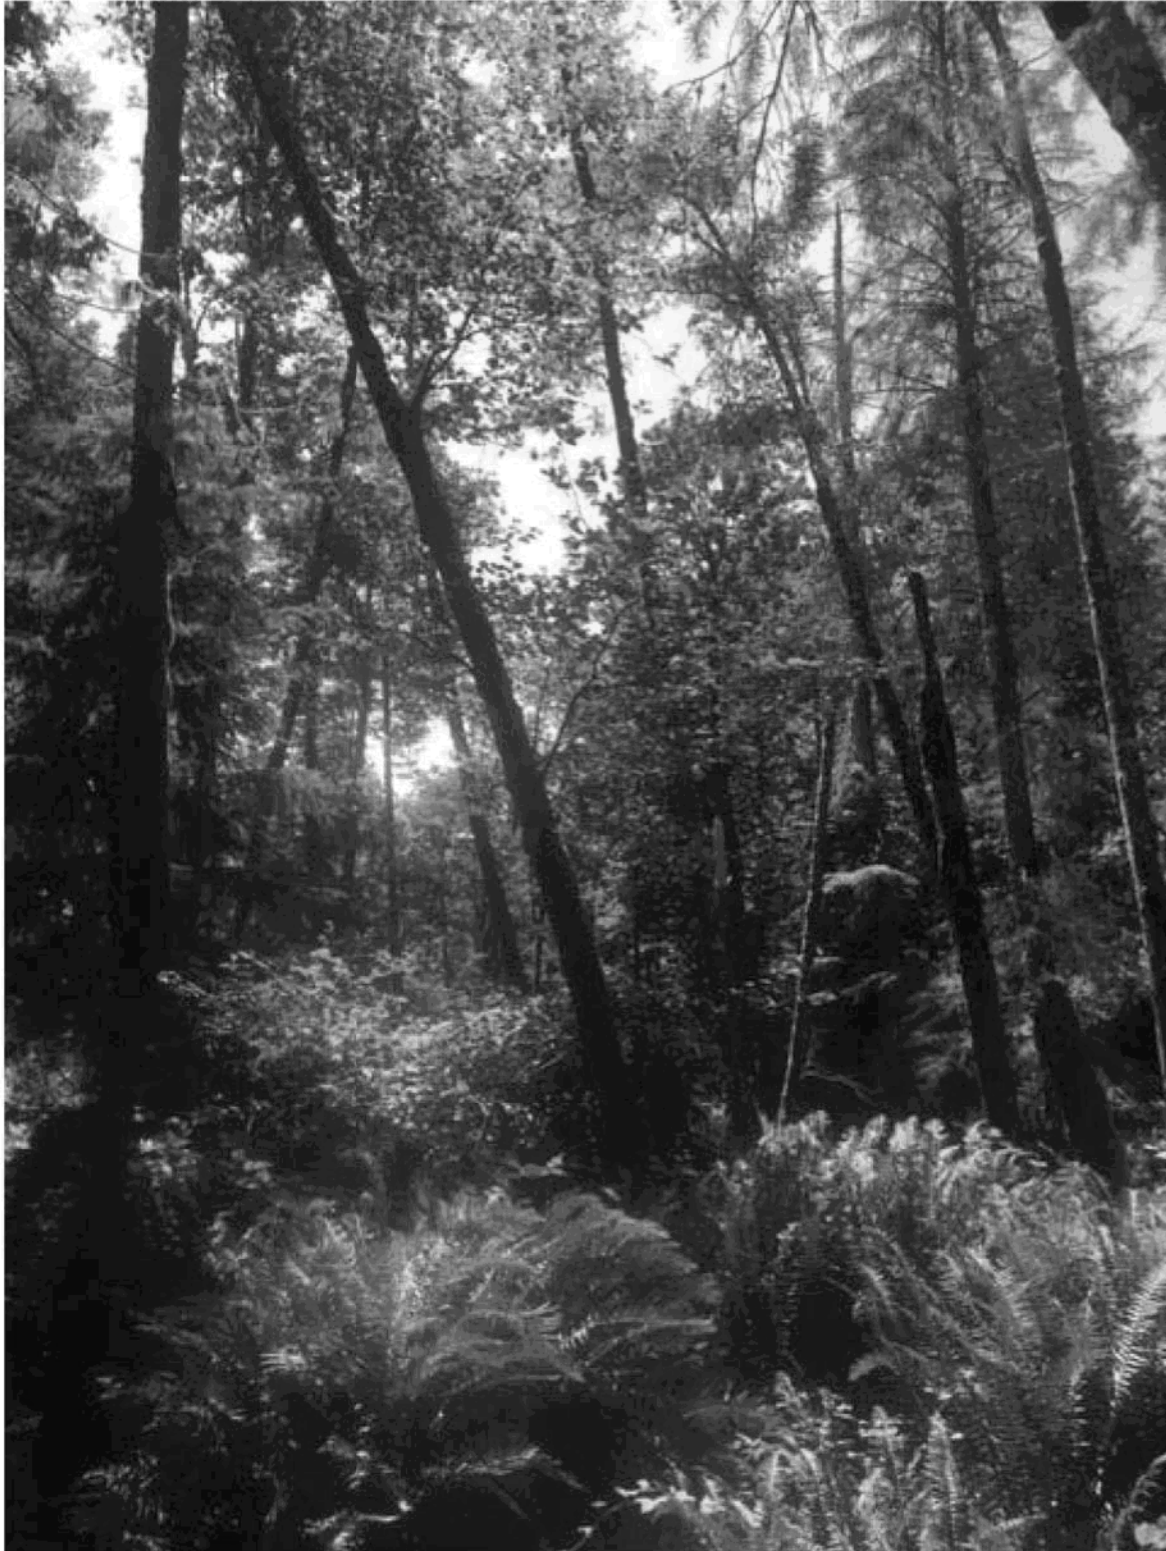
View looking down the trail towards the location of the incident to capture forest type and adjacent sound, standing snags
