# MINISTRY OF FORESTS, LANDS, NATURAL RESOURCE OPERATIONS AND RURAL DEVELOPMENT

### INSPECTION REPORT

<b>NRIS COMPLAINT ID #:</b> 87767		<b>ERA REPORT #:</b> DCK-37271
<b>OTHER AGENCY FILE #:</b> NA	<b>CLIENT #:</b> 00025869	<b>CLIENT NAME:</b> William Miles DICKEY
<b>REGION:</b> South Coast		<b>FIELD UNIT:</b> Chilliwack
<b>GEOGRAPHIC LOCATION:</b> s.22		<b>ACT/SECTIONS INVOLVED:</b> Water Sustainability Act
<b>INSPECTION DATE:</b> 2018-08-20		<b>IN ATTENDANCE:</b> None

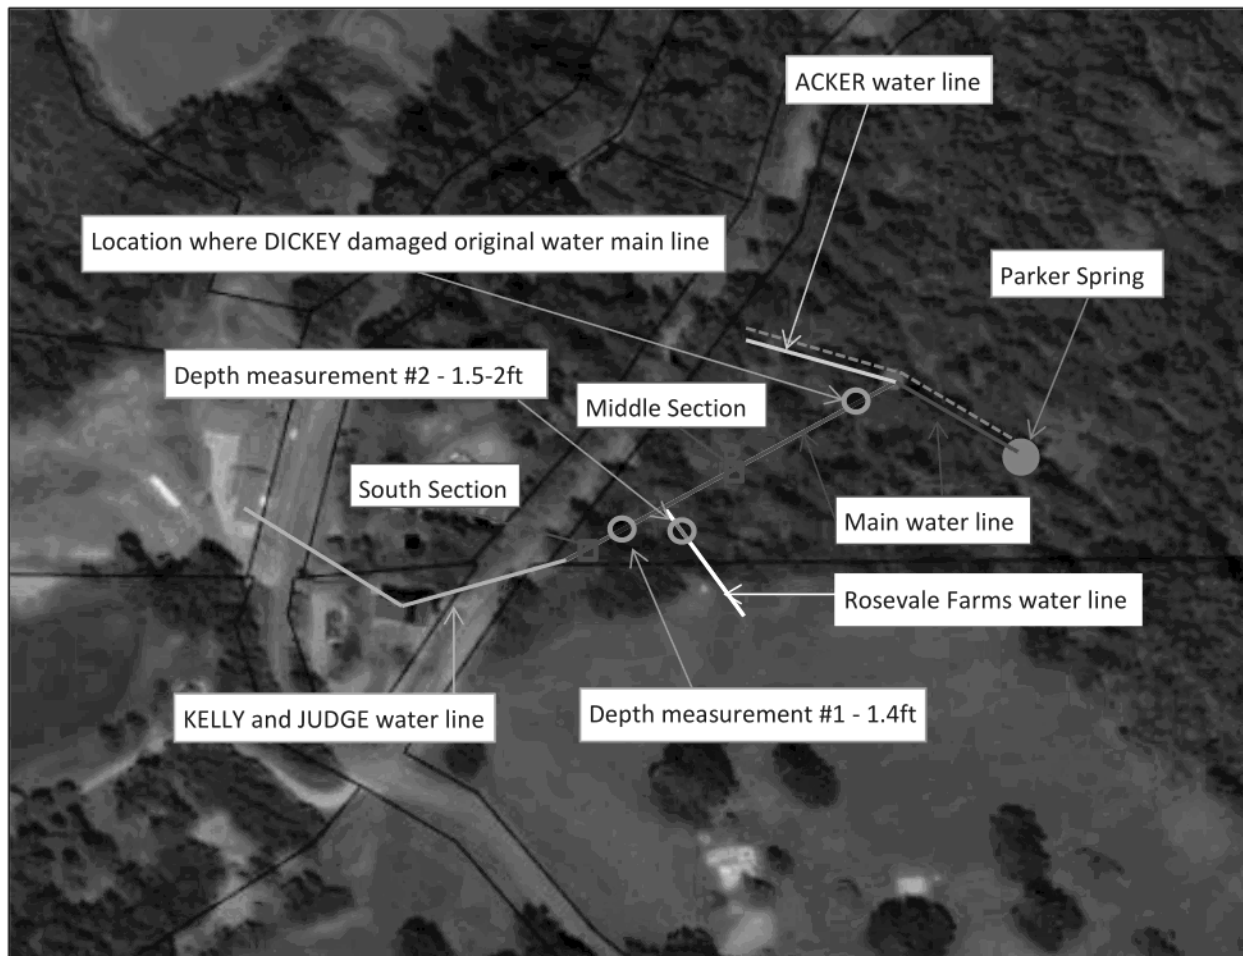
**FIGURE 1**

NRO SIDOW observed that the southern section of the original water main line was only partially buried, with intermittent sections of exposed water line. There had been no excavation by DICKY in this area.

NRO SIDOW also inspected the location where property owner DICKY connected the new water main line to the original water mainline. At this location, the original water main line had been partially excavated and exposed, but appeared to be undisturbed in its original location and at its original depth. NRO SIDOW took a measurement at this location and estimated that the original water main line was at a depth of about 1.4ft.

Following the original water main line, NRO SIDOW discovered another exposed segment which appeared to him to be in its original location. NRO SIDOW measured the depth of this section and estimated that it was located somewhere between 1.5ft and 2ft below the surface of the ground.

**MAP: Approximate location of water lines, Parker Spring and depth measurements.**

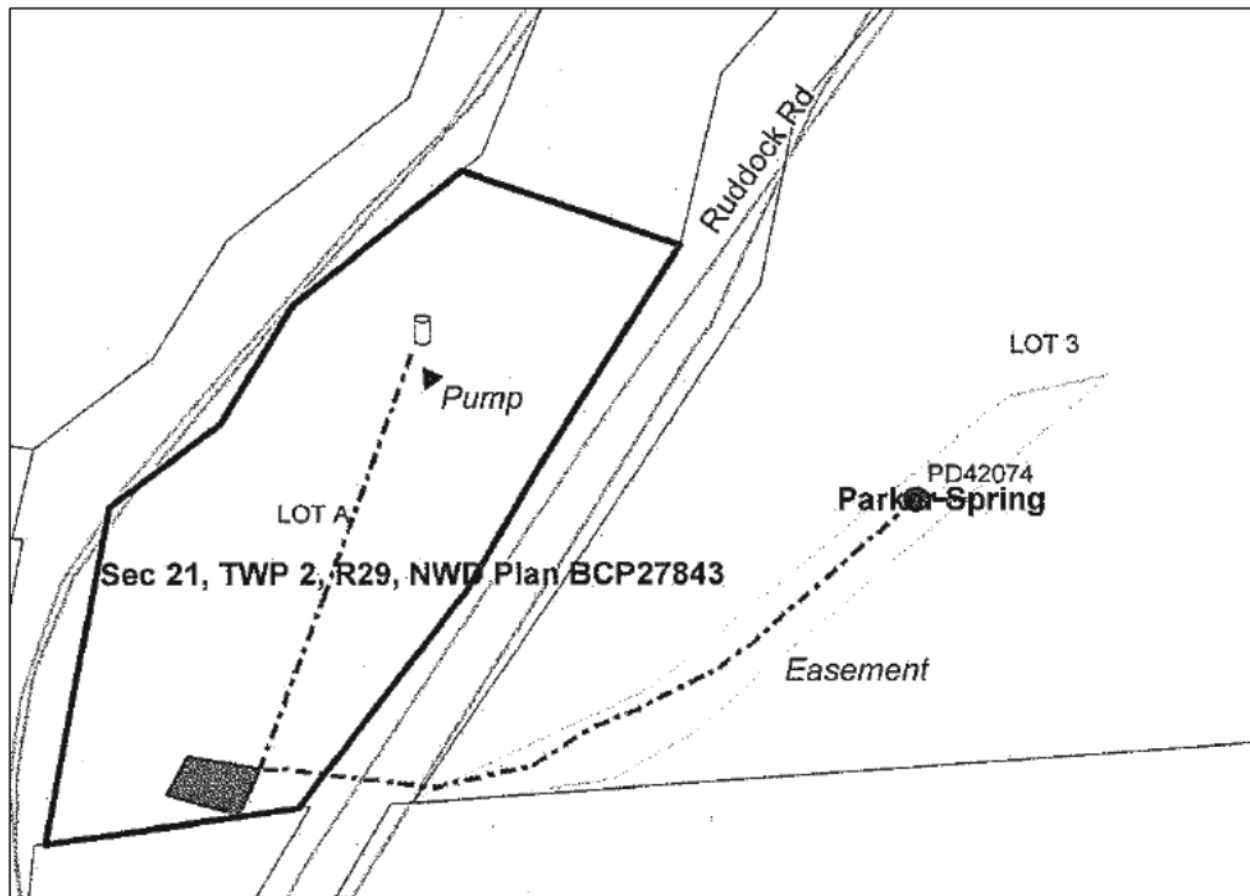
FIGURE 2

NRO SIDOW and GPO ELSLIGER reviewed the license documents for Parker Spring and discovered an easement map and a Memorandum of Agreement from 1967 for DICKEY's property. The Memorandum of Agreement specified that the water main line must be buried no less than 3ft below the surface of the ground.

Easement Map

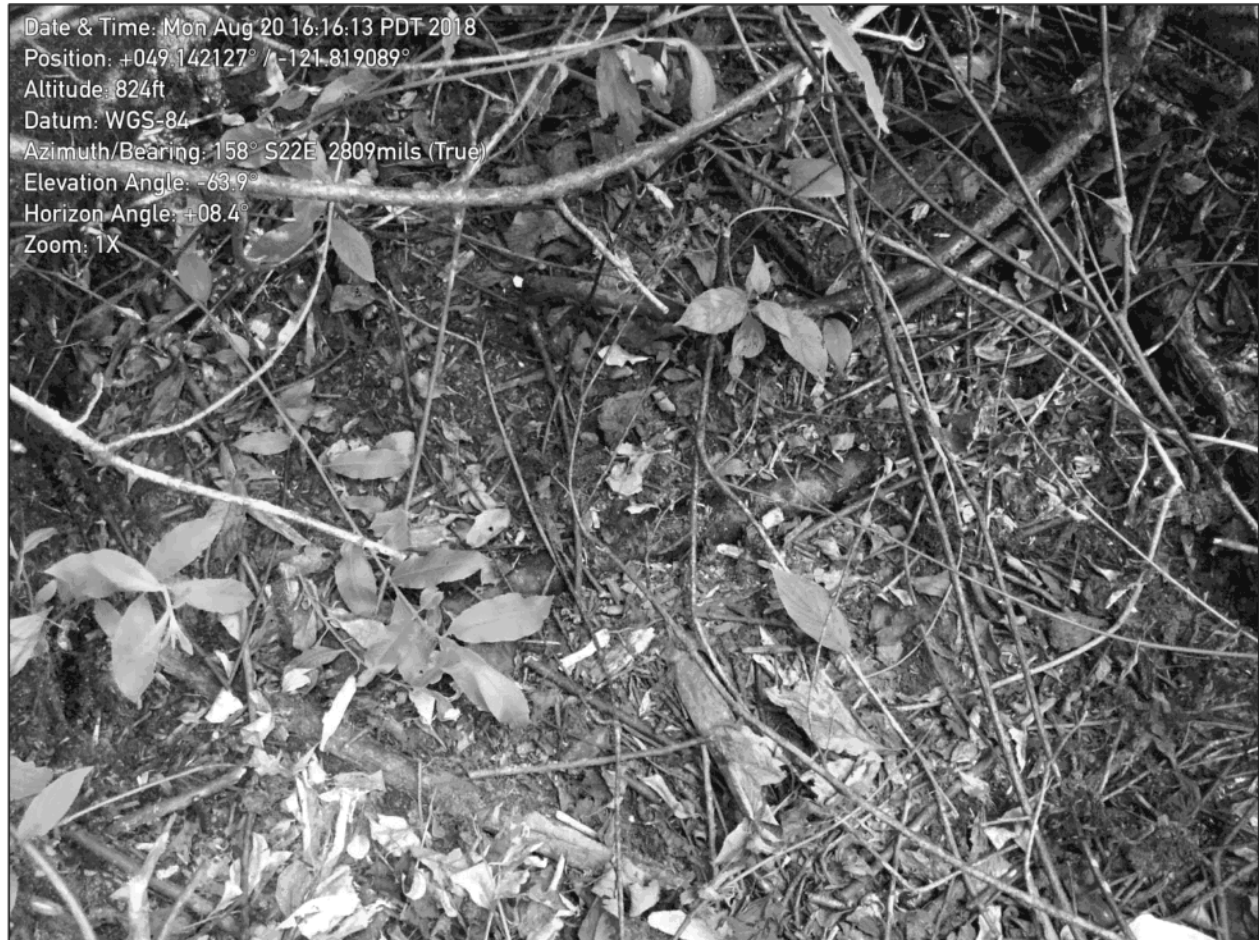
**FIGURE 4**

**IMG\_0278: Southern section of original water main line partially exposed to the surface.**

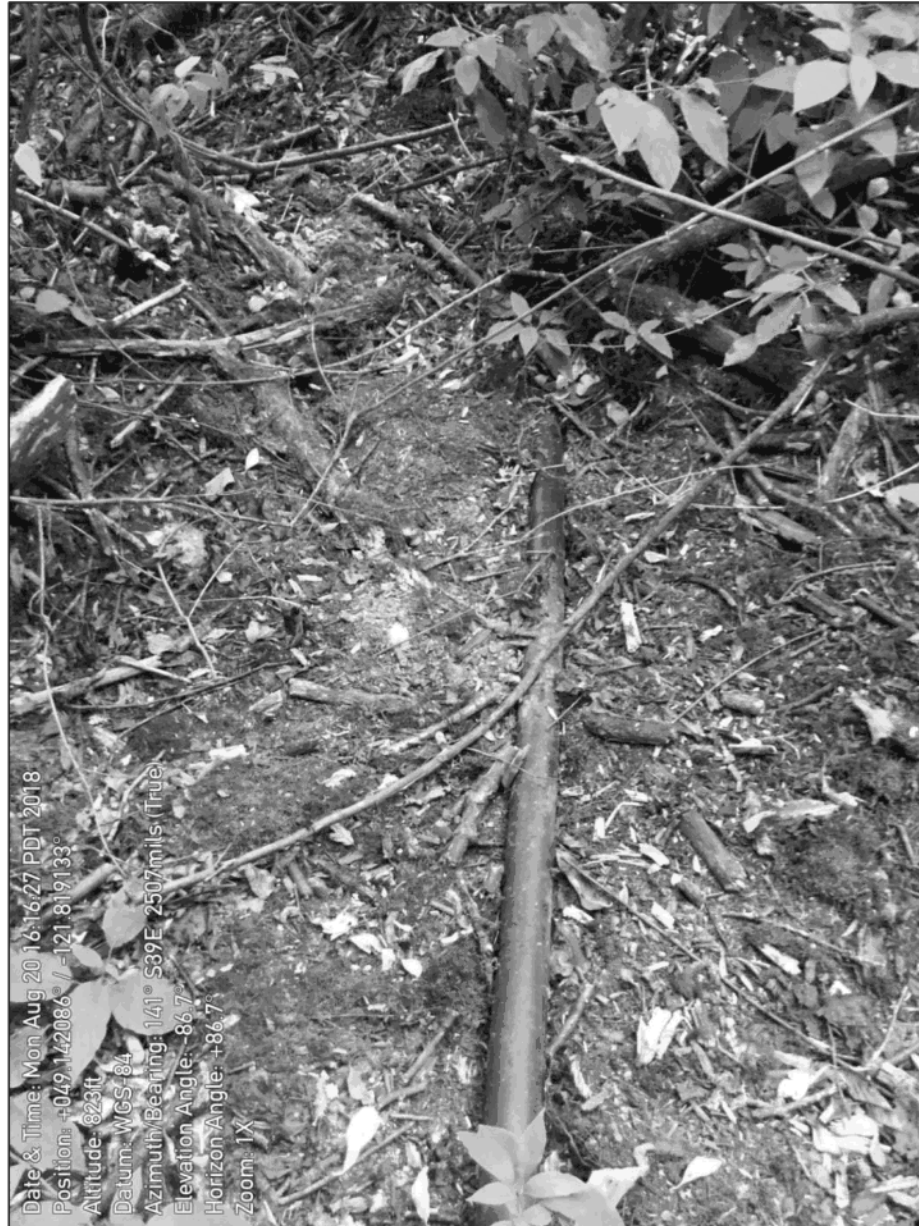
FIGURE 5

IMG\_0280: Southern section of original water main line partially exposed to the surface

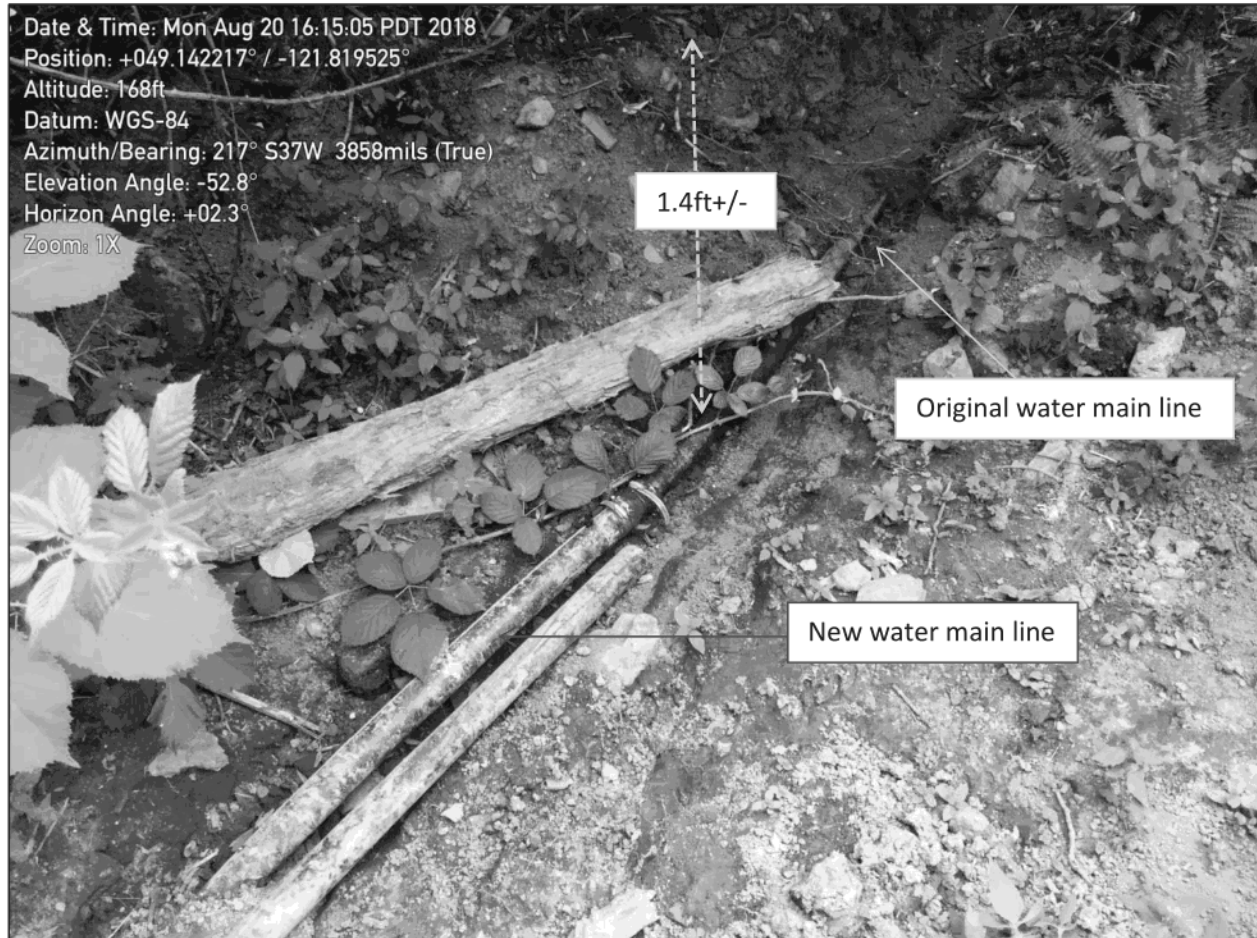
FIGURE 6

IMG\_0274: Depth measurement #1 - New water main line connects to original water main line. Original water main line depth measured at about 1.4ft. Original water main line does not appear to have been moved from its original location or depth.

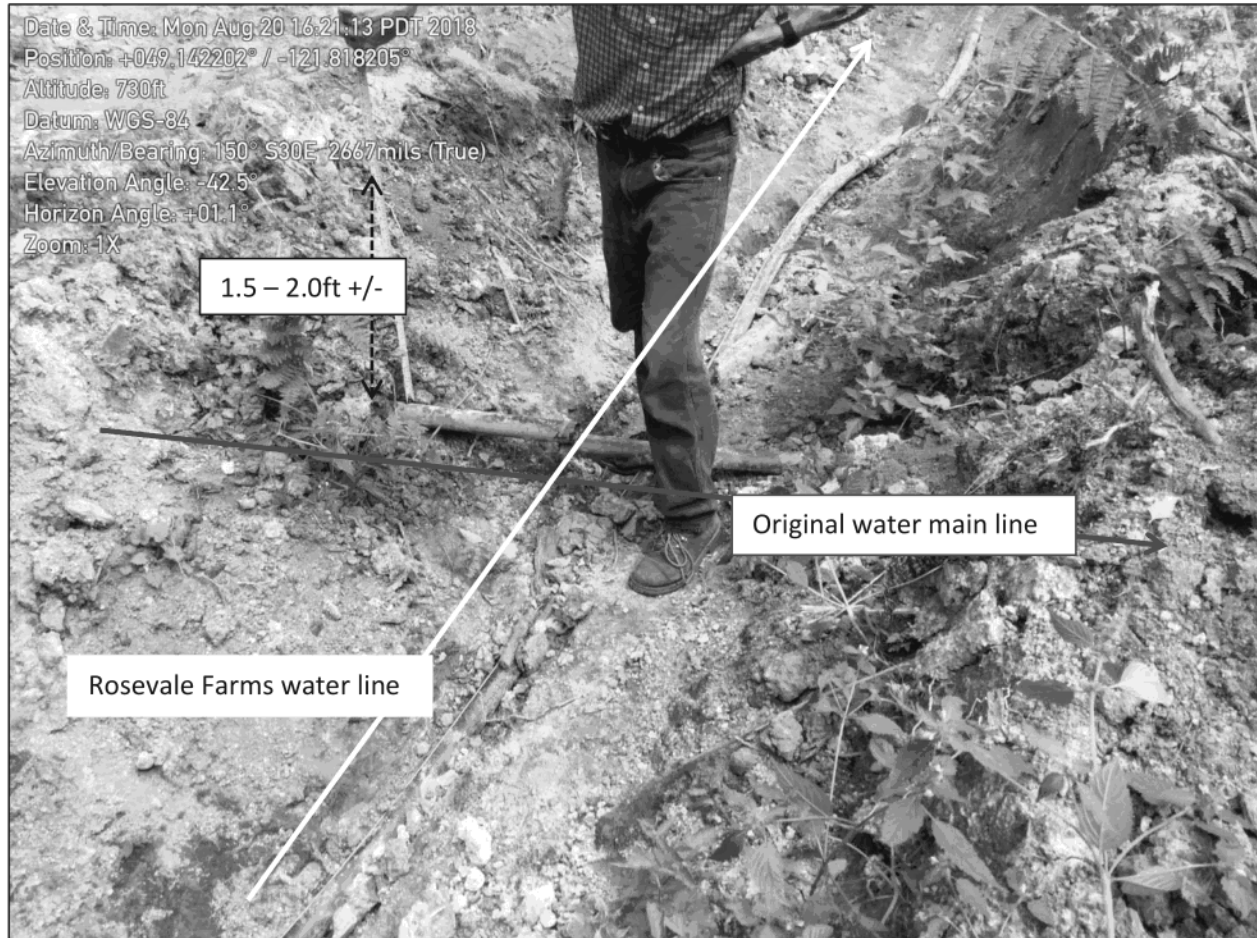
FIGURE 7

IMG\_0282: Depth measurement #2 – Measurement taken at location of original water main line was 1.5 - 2ft.

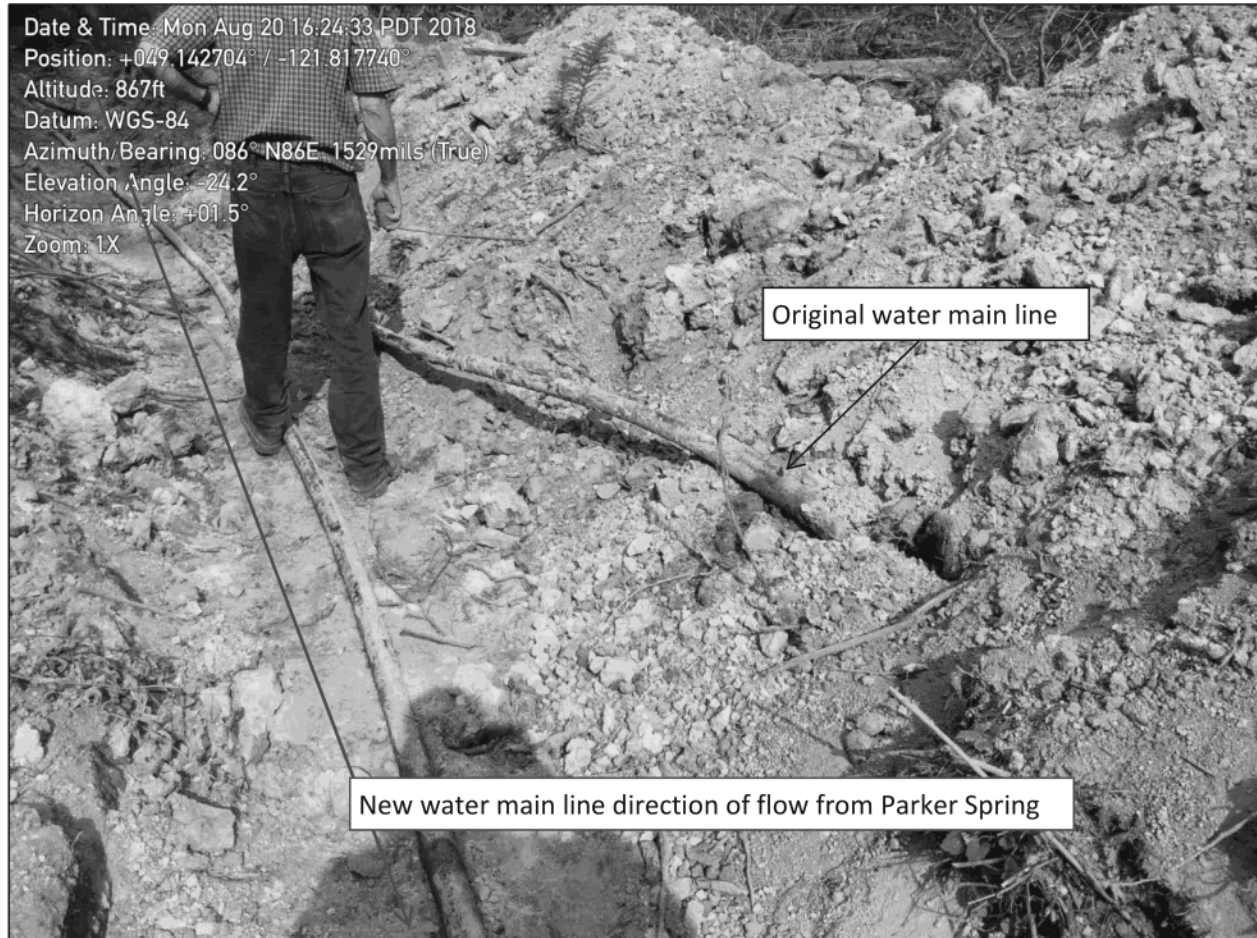
**FIGURE 8**

The middle section of the original water main line had been excavated, moved and replaced by the new water main line. As a result, NRO SIDOW was unable to make an estimate of the burial depth in this section. Though NRO SIDOW was unable to make an estimate of burial depth, it did appear that the water main line was buried through the middle section prior to the incident.

**IMG\_0284: Original water main line adjacent to the new water main line replaced by DICKEY.**

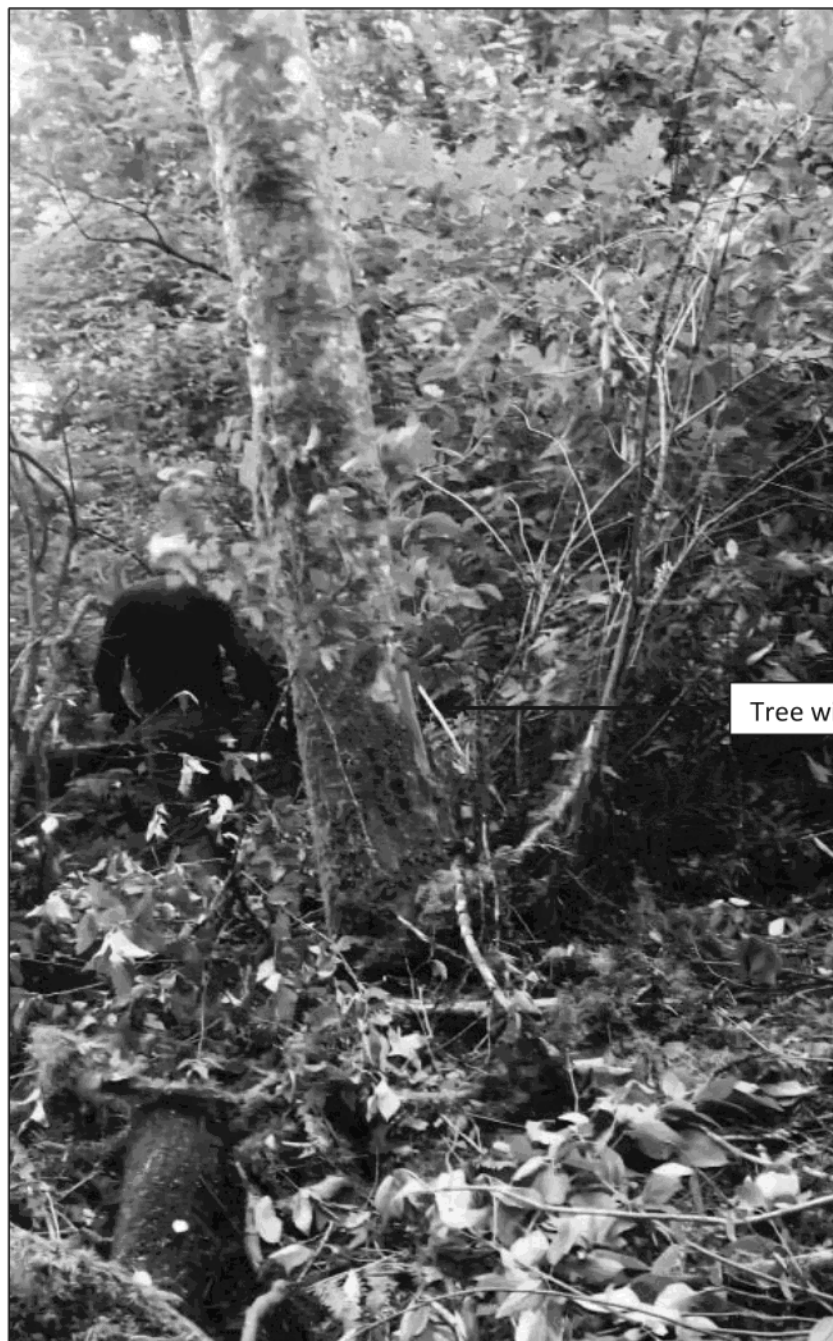
**FIGURE 9**

NRO SIDOW continued following the original water main line and property owner DICKY identified the location where he snagged and damaged the original water mainline. NRO SIDOW recognized a scar on a nearby tree, which appeared to have been caused by heavy equipment use, from the video provided by complainant s.22. This corroborated DICKY's claim that this was the location of the incident.

**Video Snapshot: Approximate location where DICKEY snagged and damaged the original water main line.**

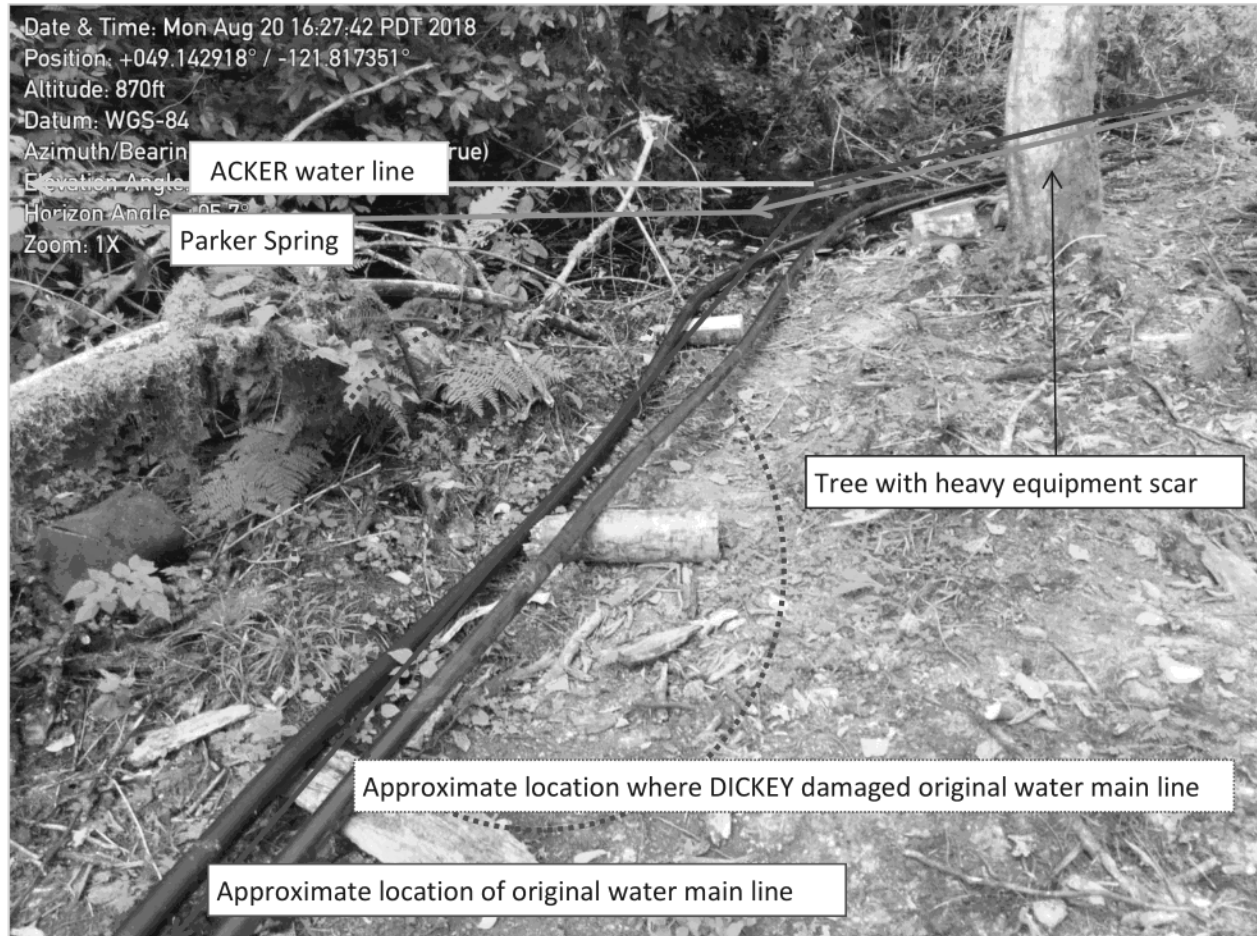
FIGURE 10

NRO SIDOW didn't observe any excavation at the location where DICKY snagged and damaged the original water main line. The new water main line was resting on the ground in what appeared to be the approximate location of the original water main line. Based on this observation, NRO SIDOW inferred that the original water main line had not been buried to 3 feet, and was on the surface as DICKY had claimed when he snagged and damaged it.

**IMG\_0290:** Approximate location where DICKEY snagged and damaged original water main line with excavator. It does not appear that any excavation was conducted by DICKEY at this location to replace the original water main line.

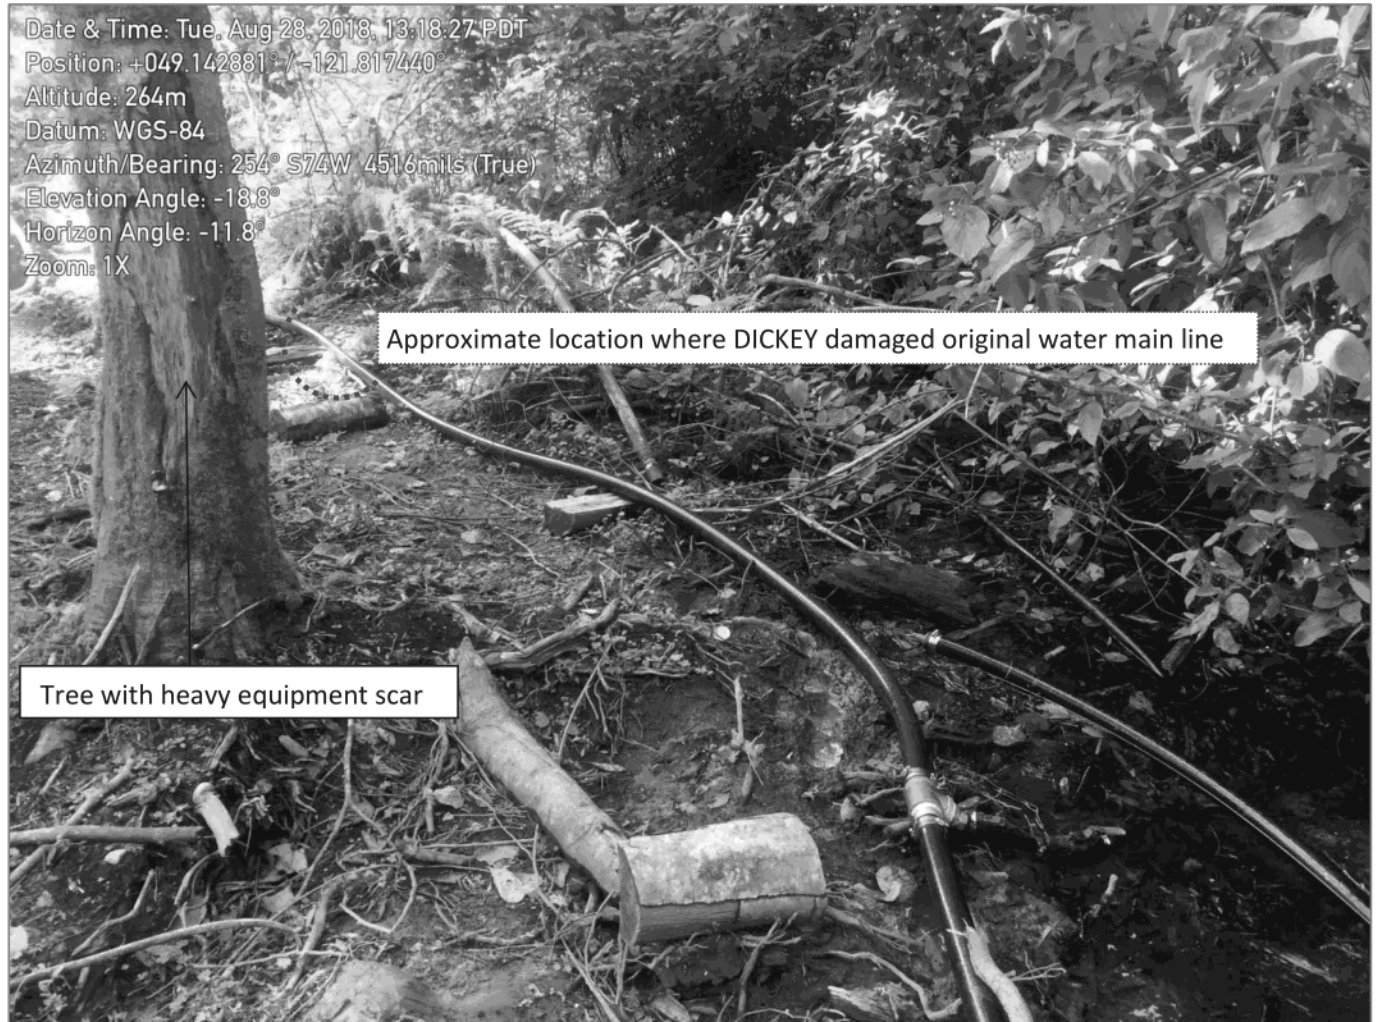
FIGURE 11

**TABQ1398:** Approximate location where DICKY snagged and damaged original water main line with excavator. It does not appear that any excavation was conducted by DICKY at this location to replace the original water main line.

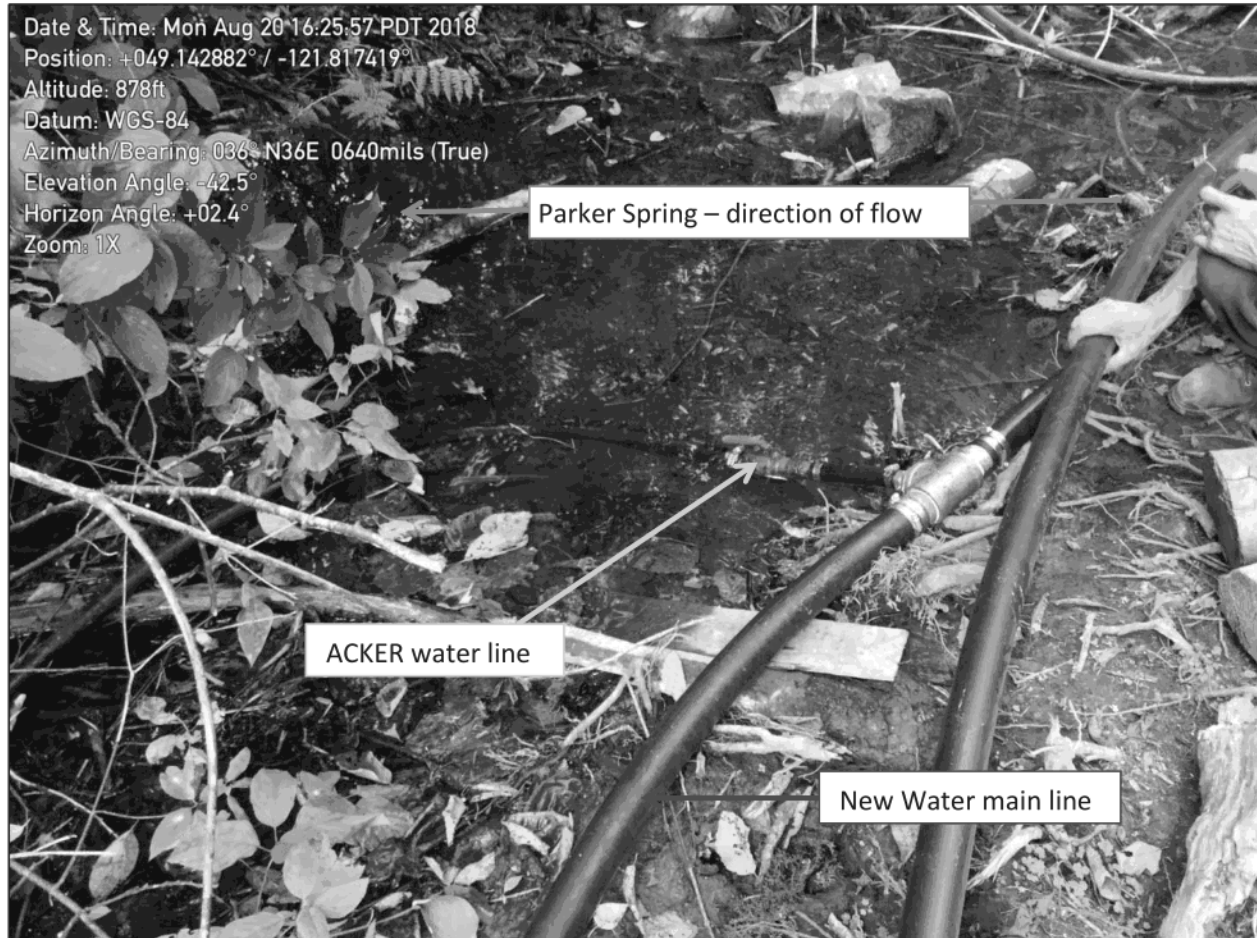
**FIGURE 12**

NRO SIDOW also observed and followed another water line at the intersection of the original water main line and Parker Spring. This water line was identified as belonging to Dave ACKER, and it followed Parker Spring west towards the road where the creek and the water line disappeared into the ground.

**IMG\_0287: Intersection of water main line, ACKER water line, and Parker Spring.**

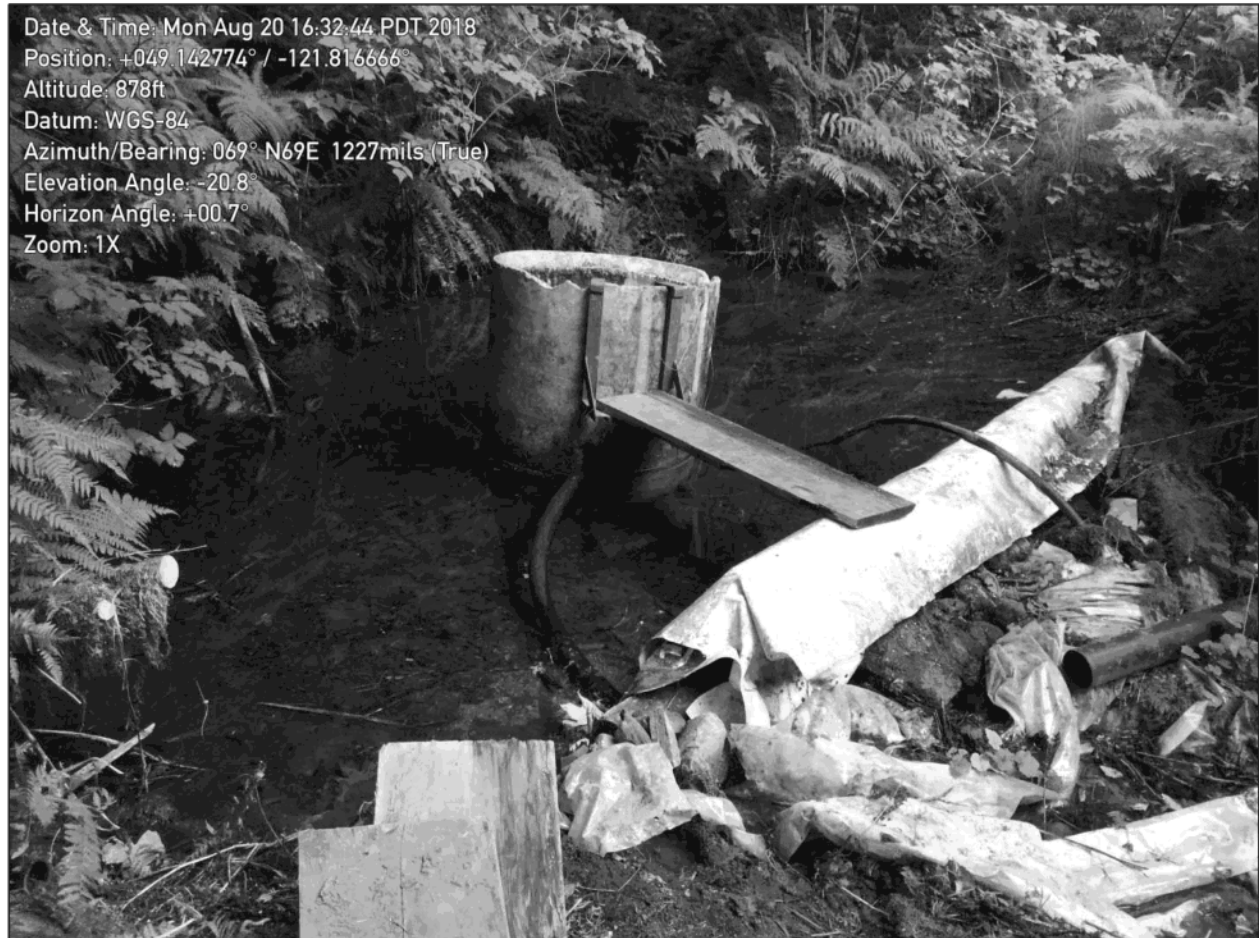
**FIGURE 13**

NRO SIDOW continued following the original water mainline, which began to follow Parker Spring to the east. The original water mainline followed Parker Spring until the headwaters, where there was a concrete well, intake and pump.

**IMG\_0296: Parker Spring headwaters**

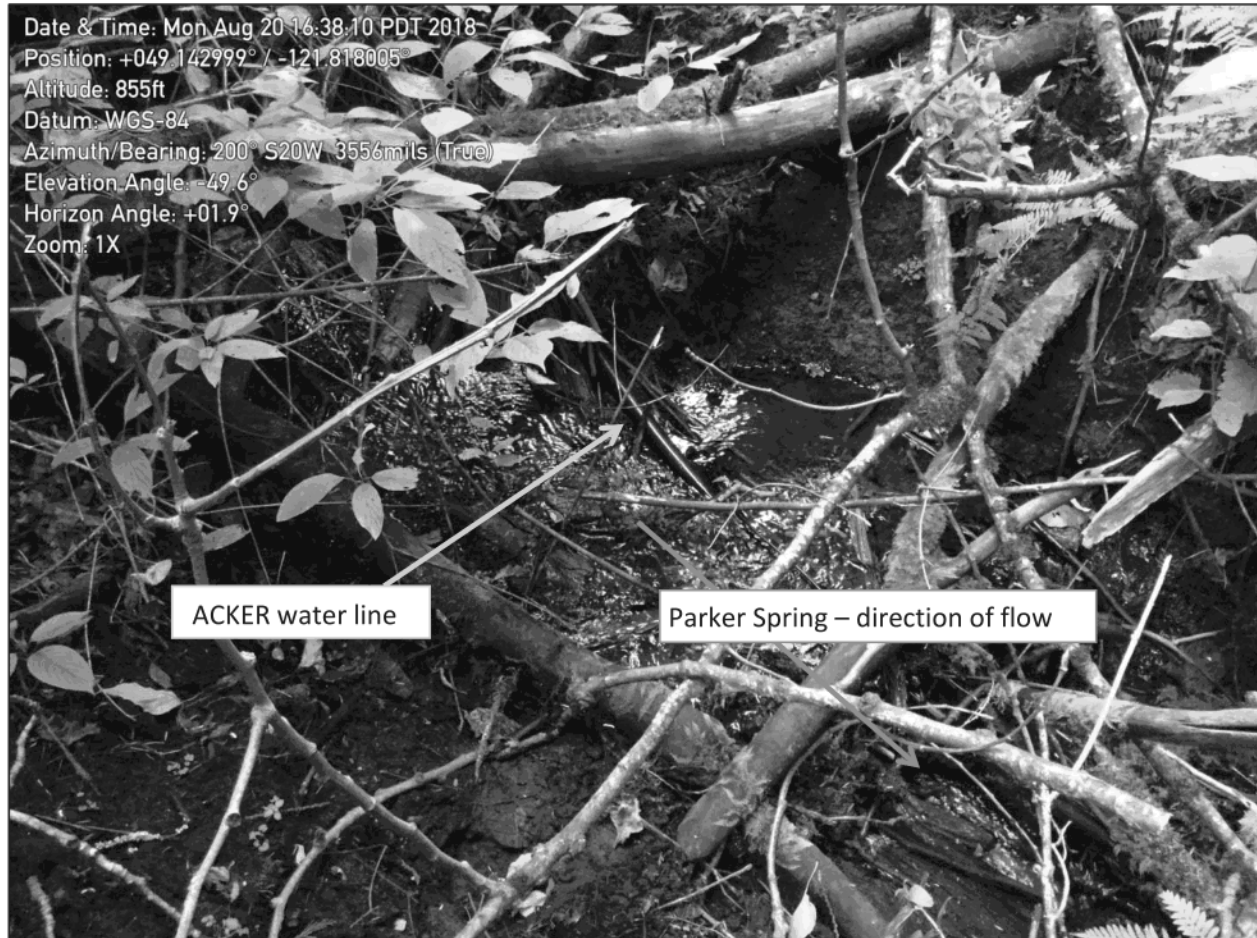
FIGURE 14

IMG\_0301: ACKER water line running west through Parker Spring.
