**Watershed Assessment of Proposed Forest Development  
within the  
Peachland Creek Community Watershed**

**Prepared for  
Tolko Industries Ltd.  
BC Timber Sales (Okanagan-Columbia Business Area)  
Ntityix Resources LP**

**Revised Final Report**

**November 5, 2018**

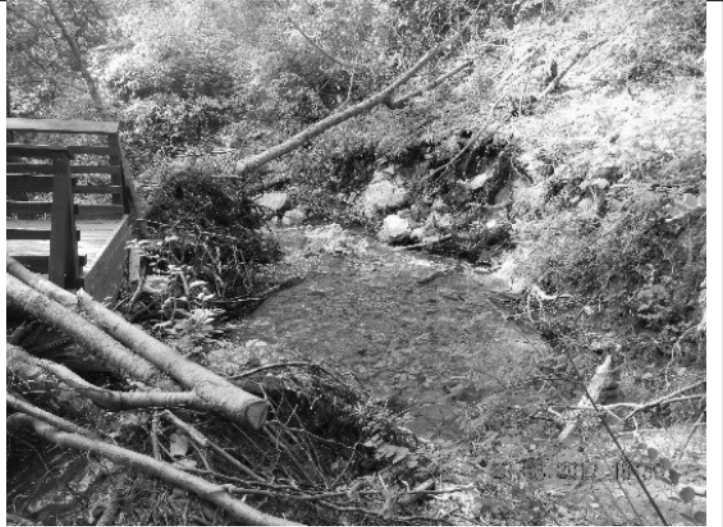
Lower reach of Peachland Creek below Hardy Falls was actively eroded in the 2017 spring freshet. The abutment/streambank of approximately two of the foot bridges were washed out within Hardy Falls Regional Park.

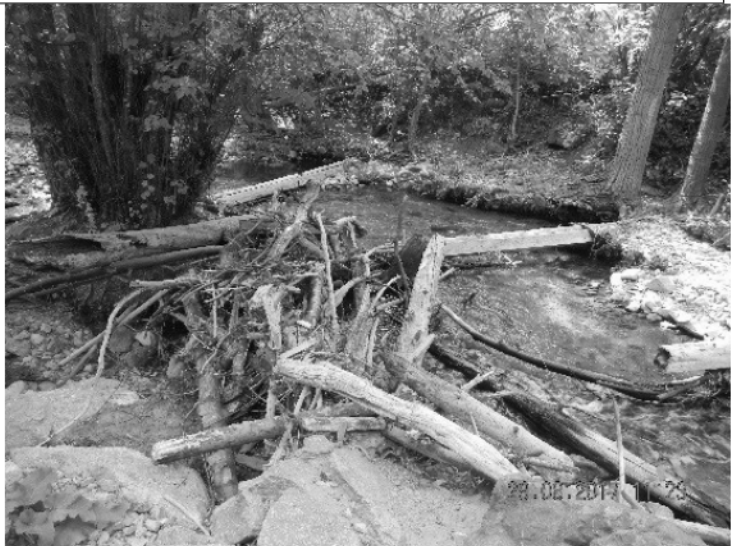
**Photo #2 (Field Stop 1):**

Lower reach of Peachland Creek below Hardy Falls was actively eroded in the 2017 spring freshet. Forced riffles placed to create fish habitat were undermined.

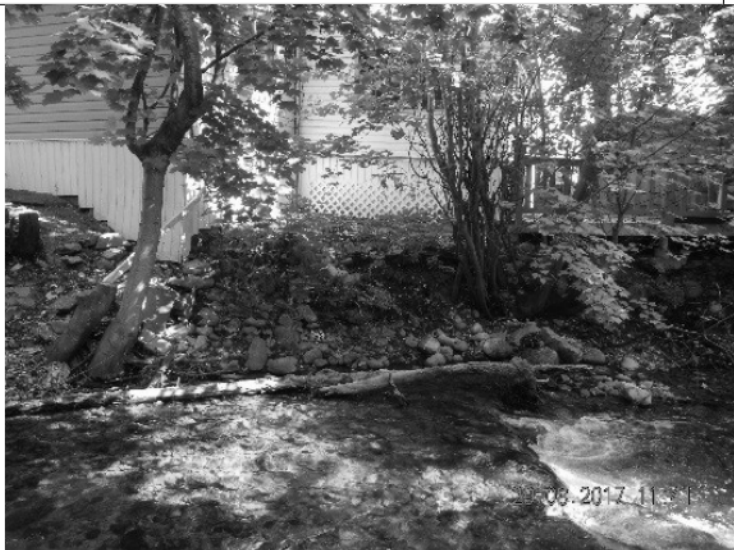
**Photo #3 (Field Stop 1):**

Peachland Creek is directly adjacent to homes situated below Renfrew Road. Channel bank below homes is highly erodible.

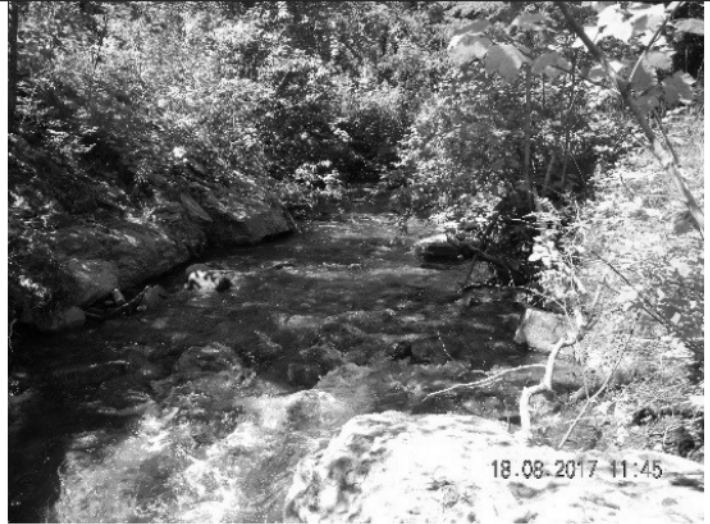
**Photo #4 (Field Stop 2):**

Munro FSR is a significant contributor of fine sediment into Peachland Creek. The District of Peachland water intake is only located ~ 250 m downstream.

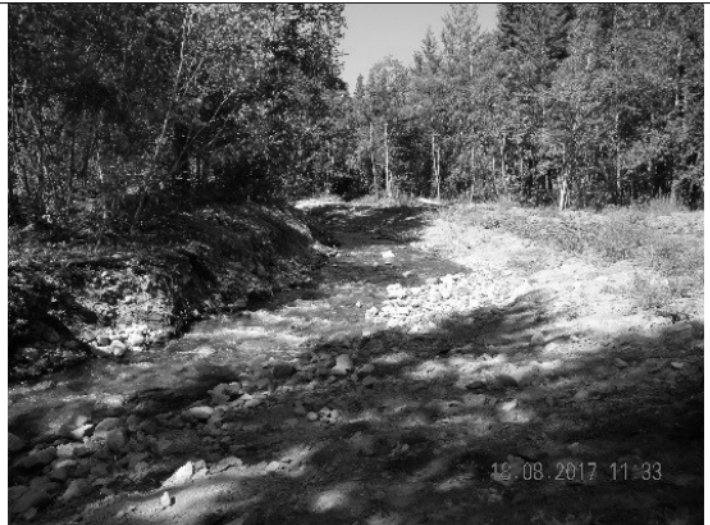
**Photo #5 (Field Stop #3):**

In 2017 channel was relocated approximately 30 metres to east of original location of channel as result of landslide below the Munro FSR that occurred on April 28, 2017. Channel banks are unvegetated and likely stabilize over next few spring freshets.

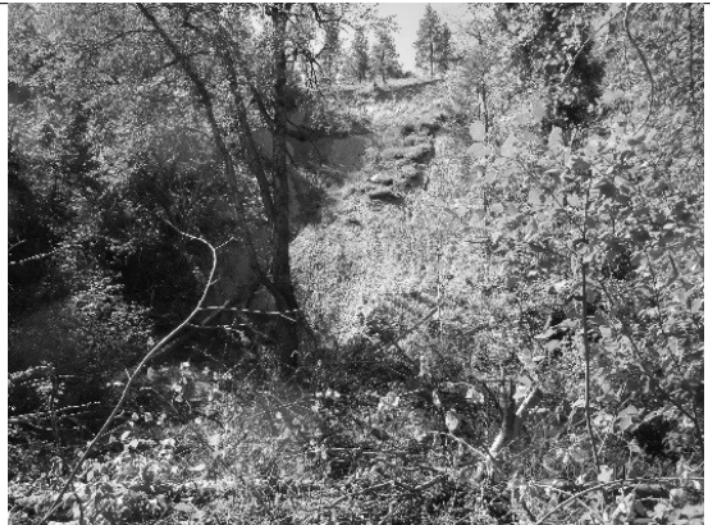
**Photo #6 (Field Stop #3):**

Landslide directly impacted Peachland Creek subsequent to this event ~120 m of Peachland Creek was relocated to the eastside of the partially confined channel valley.

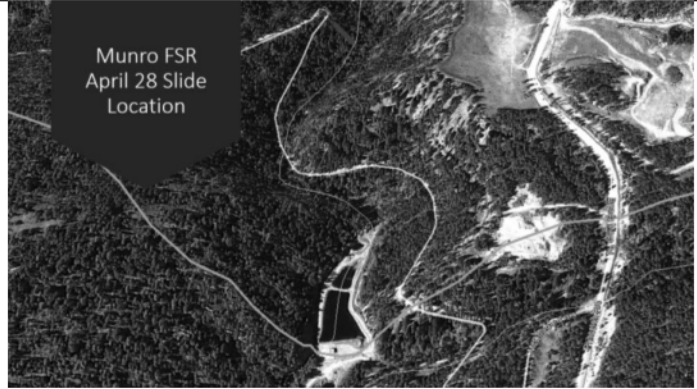
| <p><b>Photo #7 (Field Stop #3):</b></p> <p><b>Location:</b><br/>Landslide below Munro FSR on west side of Peachland Creek</p> <p><b>Notes:</b><br/>Overview of Munro FSR landslide (red arrow) situated above the District of Peachland water intake.</p> <p><b>Photo Source:</b> Gorman Bros. Lumber Ltd., Licensee presentation to the Peachland District Mayor and Council (June 13, 2017).</p> | |

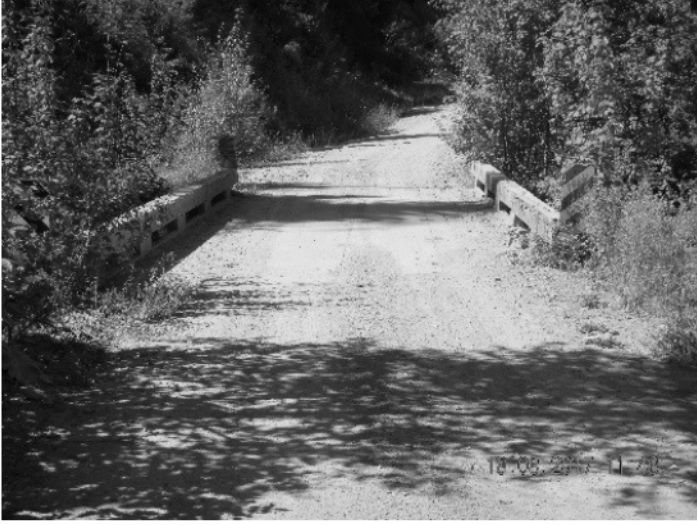
| <p><b>Photo #9 (Field Stop #2):</b></p> <p><b>Location:</b><br/>Munro FSR bridge over Peachland Creek</p> <p><b>Notes:</b><br/>Bridge deck and road approaches are major delivery points for sediment. District of Peachland intake is approximately 250 m downstream.</p> | |

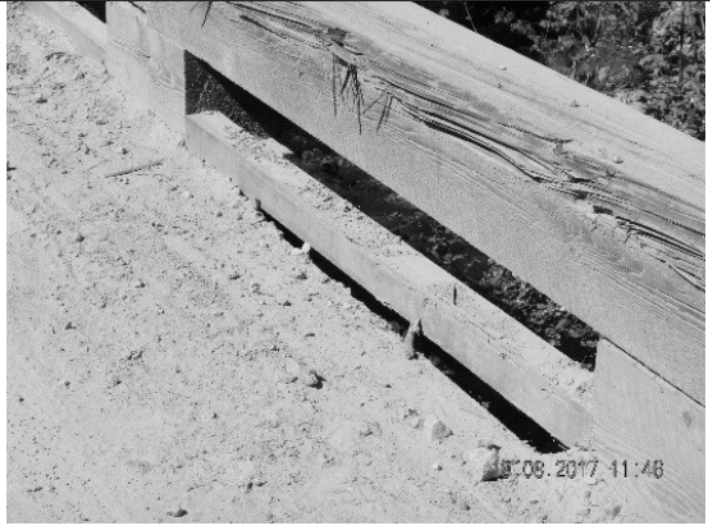
**Photo #10 (Field Stop #2):**

Barrier used to minimize delivery of sediment off of the bridge deck into Peachland Creek requires maintenance.

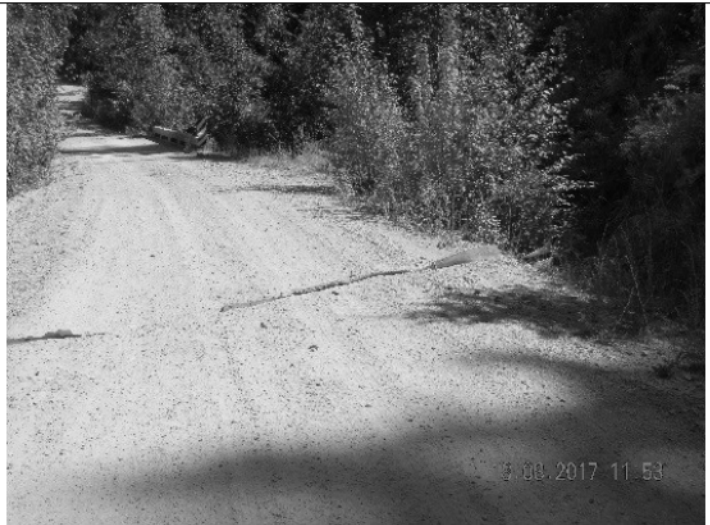
**Photo #11 (Field Stop #5):**

Rubber belting used to divert surface flow of water and sediment along surface of Munro FSR needs to be replaced.

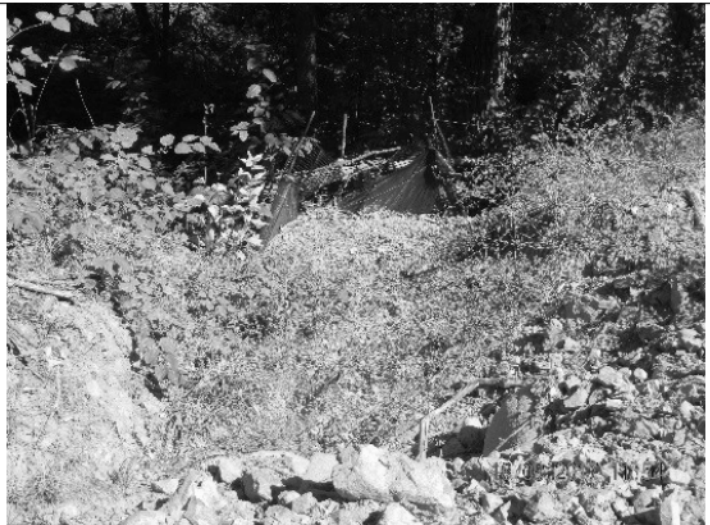
**Photo #12 (Field Stop #5):**

Sediment fence installed below cross-drain culvert require maintenance.

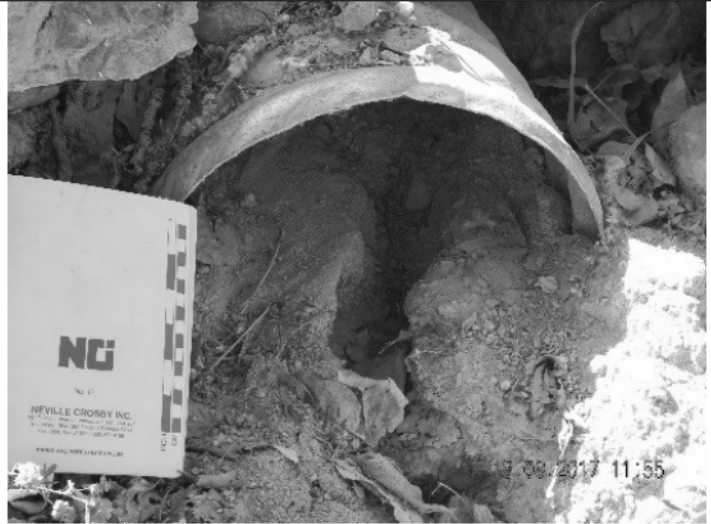
**Photo #13 (Field Stop #5):**

Cross-drain culvert has been filled by fine sediment. This photo highlights the mobility of fine sediments along this portion of the Munro FSR.

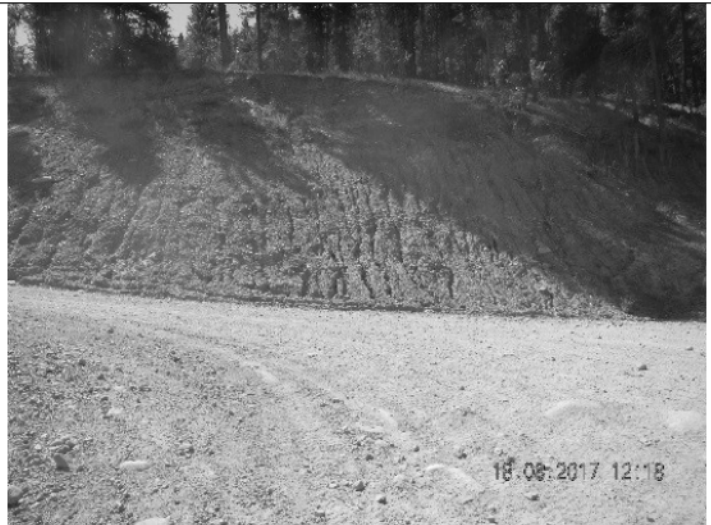
**Photo #14 (Field Stop #5):**

Mineral soil is exposed along cutbank. Extensive rill erosion was present along cutbanks.

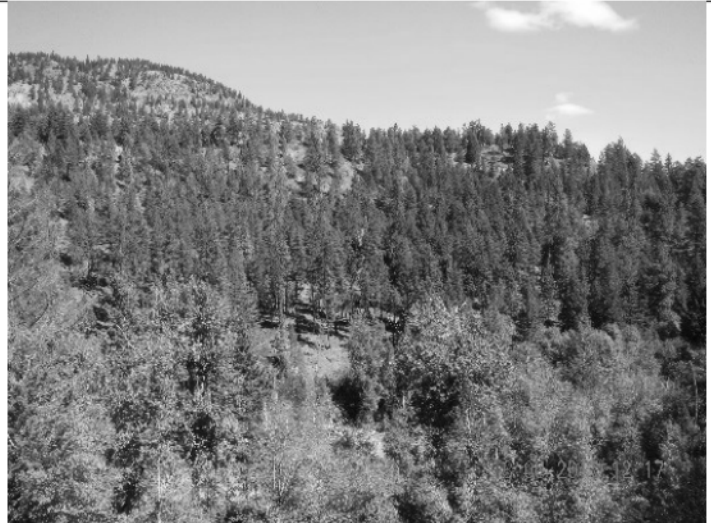
**Photo #15:**

No direct sediment erosion or delivery hazards were observed below lower end of fire however the lower end of an access trail/fire guard located along the south edge of fire should be deactivated.

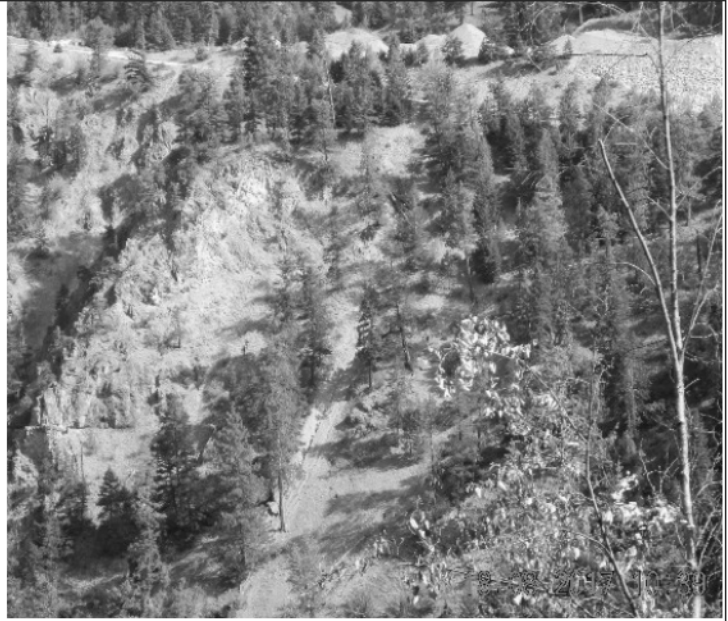
**Photo #16 (Field Stop #7):**

Overland flow along road surface and associated surface erosion from Brenda Mines Road directly connected to Peachland Creek as evidenced by rill erosion (Relatively large rill shown in centre of photo). Note: Rill erosion is also visible on Google Earth images.

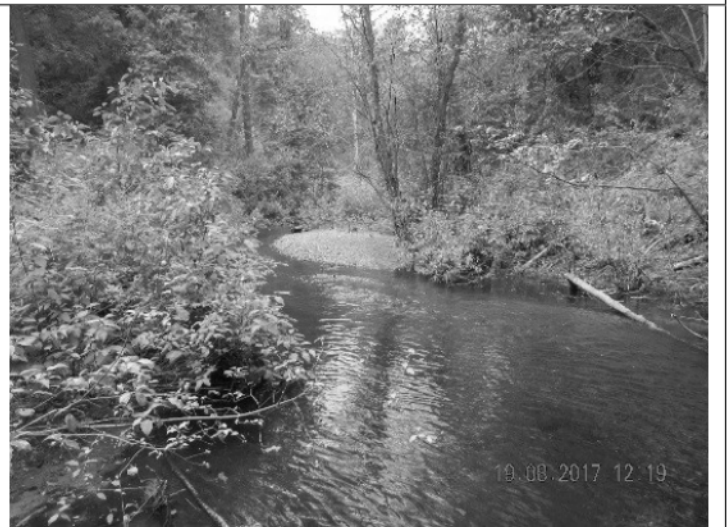
**Photo #18 (Field Stop #9):**

Partially Aggraded, Riffle-Pool (Cobble/Gravel)

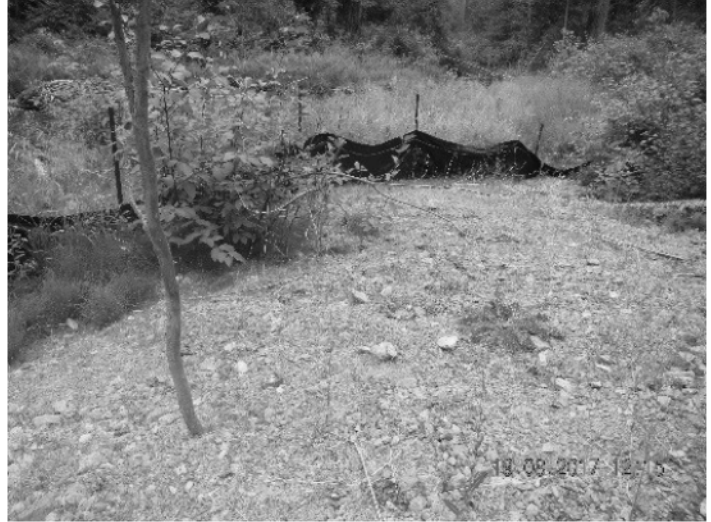
**Photo #19 (Field Stop #10):**

Sediment fence appears to require maintenance to ensure sediment is does not enter Peachland Creek.

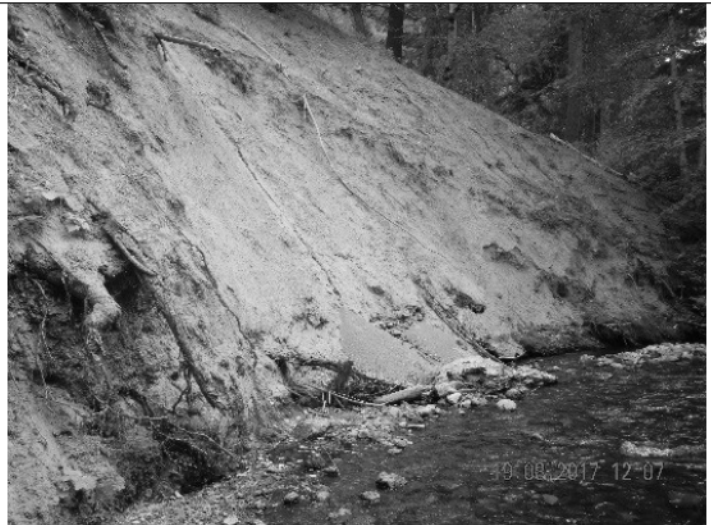
**Photo #20 (Field Stop #11):**

Bank failure appears to be natural as result of the slope being undercut by Peachland Creek

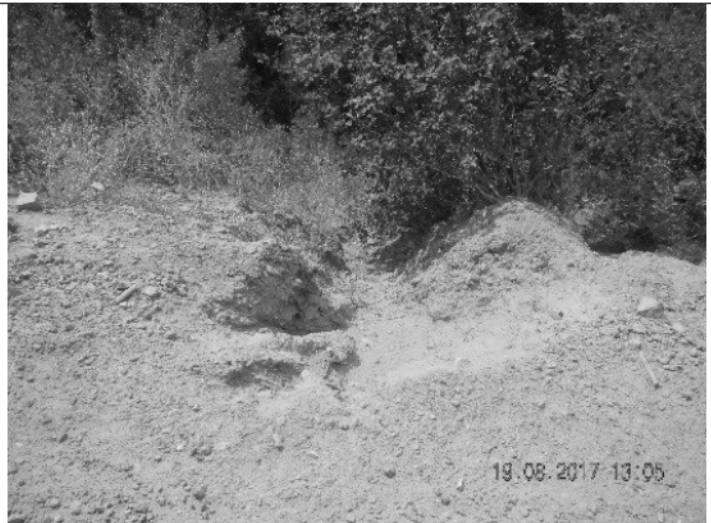
**Photo #21 (Field Stop #16-21):**

Overland flow along road surface and associated surface erosion along Peachland Main is directly connected to Peachland Creek as evidenced by rill erosion along the fill slope of the road

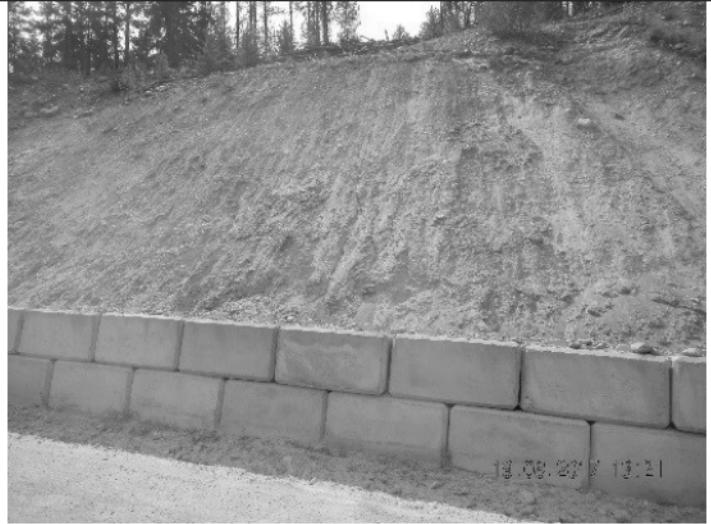
**Photo #22 (Field Stop #20-21):**

Cutbank along west of Peachland Creek is a chronic sediment source to Peachland Creek.

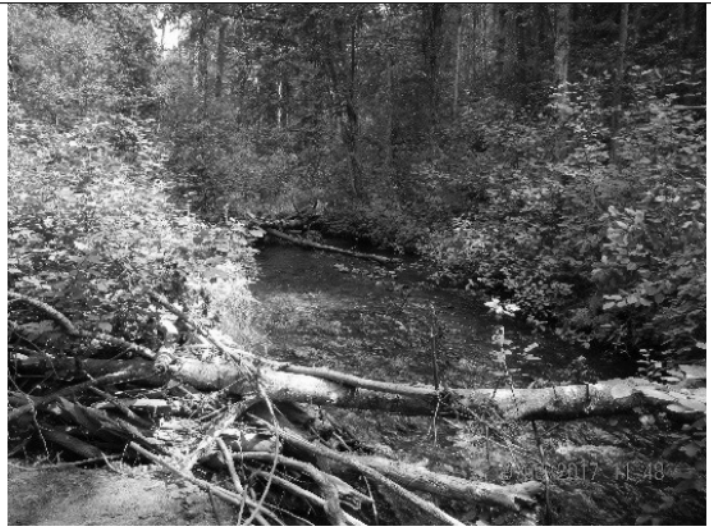
**Photo #23 (Field Stop #15):**

Stable, Cascade-Pool (Cobble) channel.  
No evidence of major bank erosion from the 2017 spring freshet however flows appear to have overtopped the channel banks in the Spring of 2017.

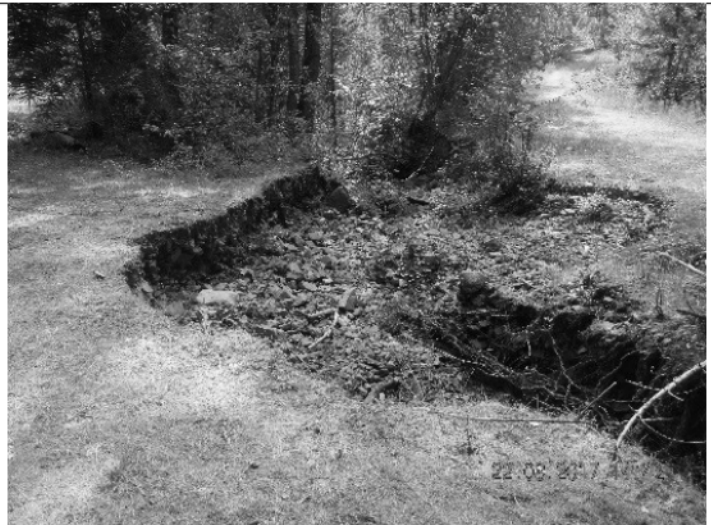
**Photo #24 (Field Stop #22):**

Partially Degraded, Step-Pool (Boulder/Cobble) channel. Old trail has been overtopped and Mile Creek has eroded the trail

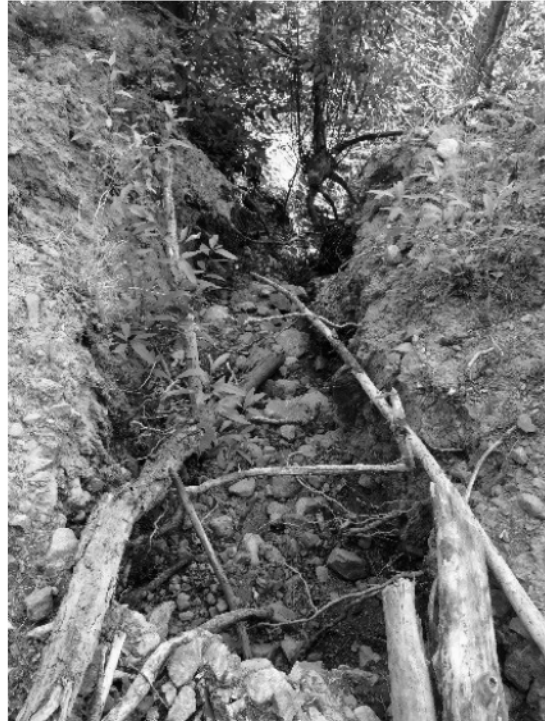
**Photo #25 (Field Stop #24):**

Old trail has been overtopped and gully has been created (1 m wide x 4 m long x 0.5 m deep)

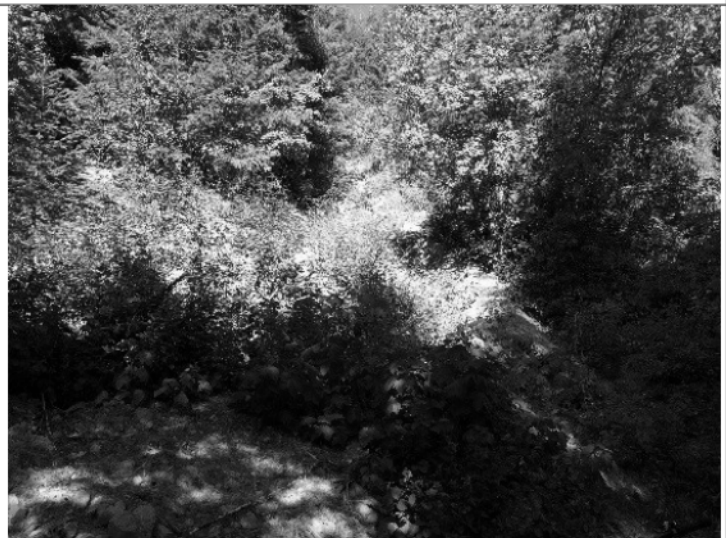
**Photo #26 (Field Stop #26):**

Debris flow track is partially vegetated and sediment fence has been used to contain sand/gravel.

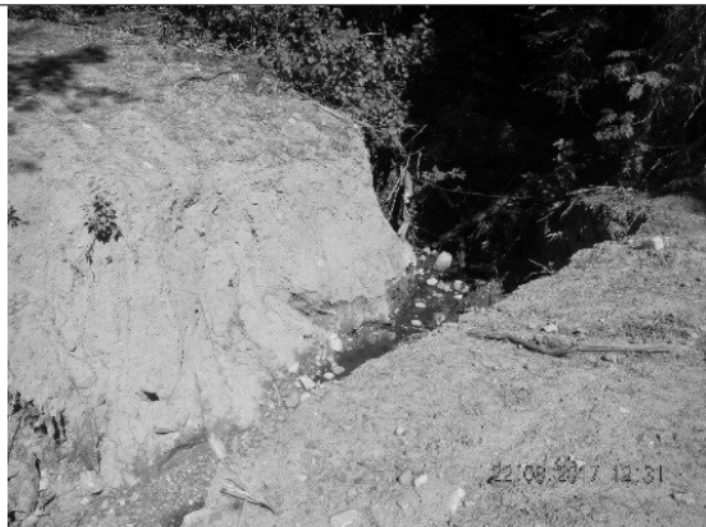
**Photo #28 (Field Stop #32):**

Two fill slope failures are located in this area. A small tributary has overtopped the old trail and has created a gully. Recent harvesting in 2015 (KP1032) is located directly upslope ~30 – 50 m. Water was diverted down a dichline off of a trail that connects with the lower trail. Slope failure is directly connected to Peachland Creek. Gully in photo is approximately 2 m deep.

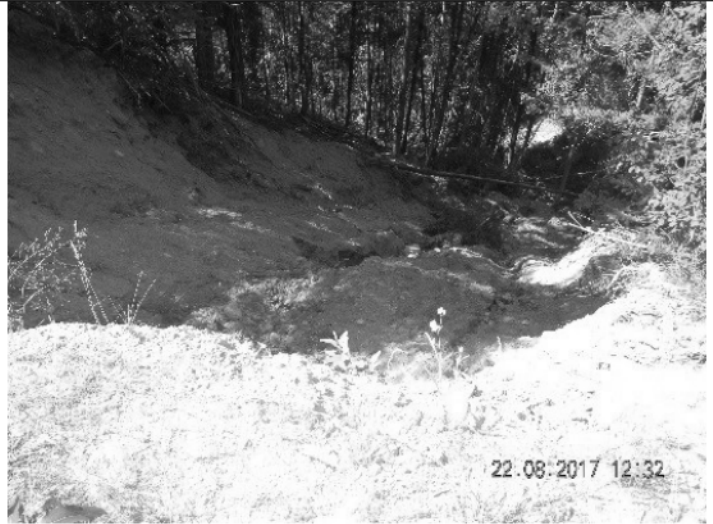
**Photo #29 (Field Stop #32):**

Two fill slope failures are located in this area. A small tributary has overtopped the old trail and has created a gully. Recent harvesting in 2015 (KP1032) is located directly upslope ~30 – 50 m. Water was diverted down a ditchline off of a trail that connects with the lower trail. Slope failure is directly connected to Peachland Creek

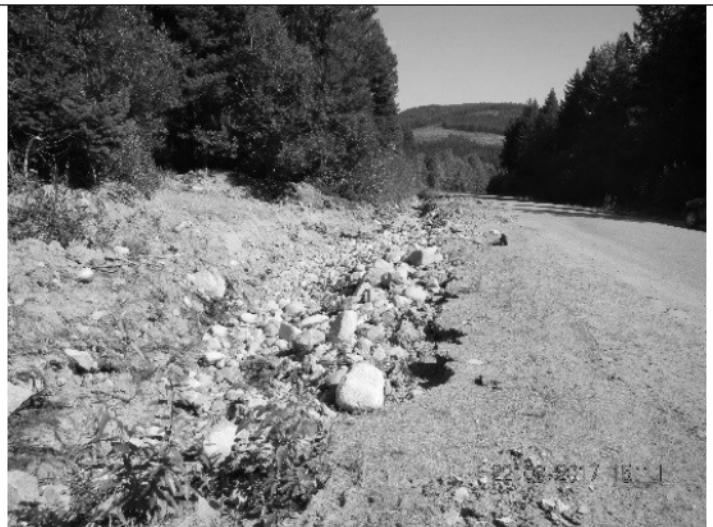
**Photo #30 (Field Stop #33 to 36):**

Culvert inlet is plugged at the Brenda Mines Road crossing over Mile Creek. A pond above the road overtopped and eroded the ditchline for >400 m down Brenda Mines Road. Road ditchline was repaired in the summer of 2017 after this photo was taken.

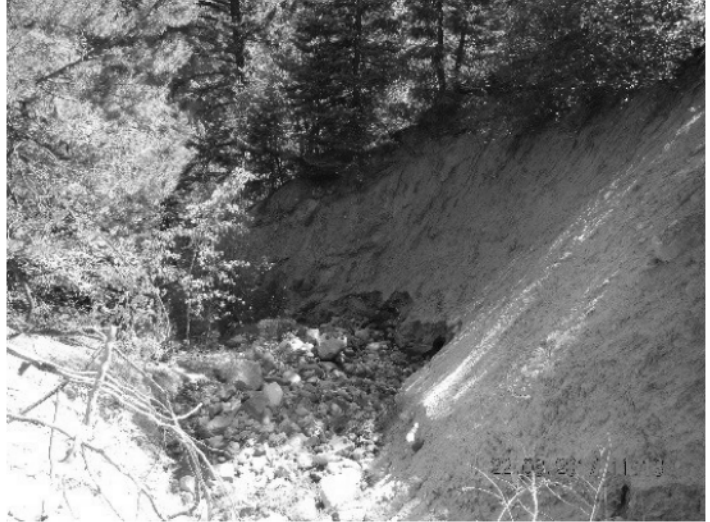
**Photo #38 (Field Stop #38):**

East end of diversion ditch from Peachland Lake drains onto steep valley slope. A large gully has been eroded in the steep valley slope as result of flow from diversion ditch.

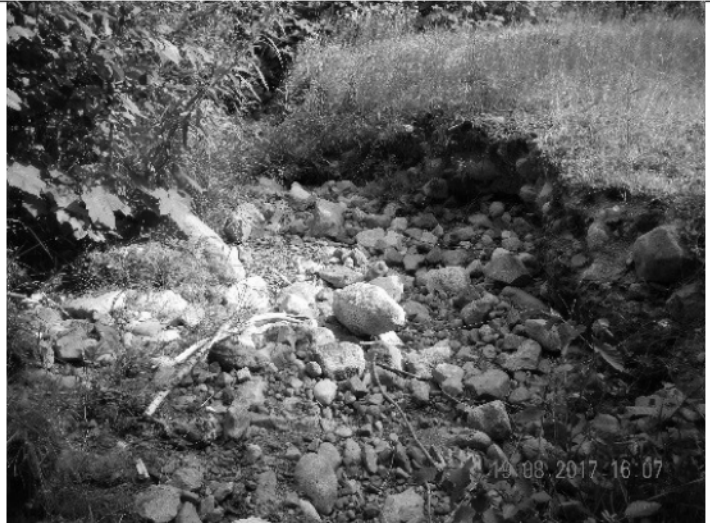
**Photo #40 (Field Stop #41-42):**

Partially Degraded, Cascade-Pool (Cobble) channel. 1990's logging. Wood culvert has failed.

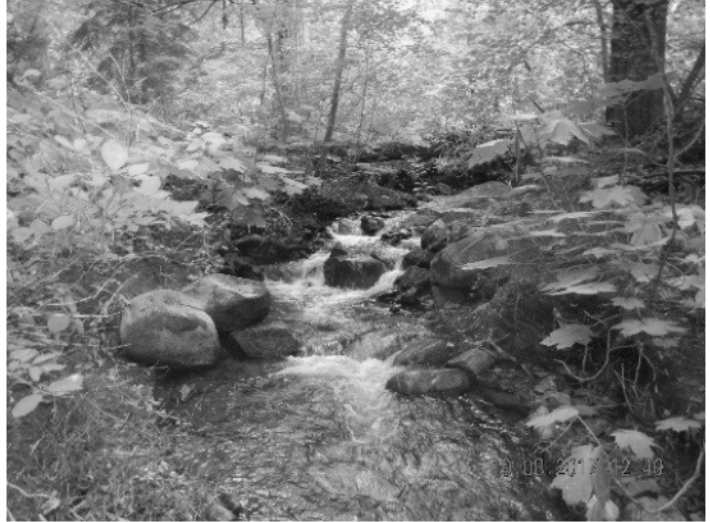
**Photo #41 (Field Stop #46):**

Partially Degraded, Step-Pool (Cobble) channel. Moderate to low bank erosion. Exposed fine roots along banks. Channel overtopped bankfull in the spring of 2017.

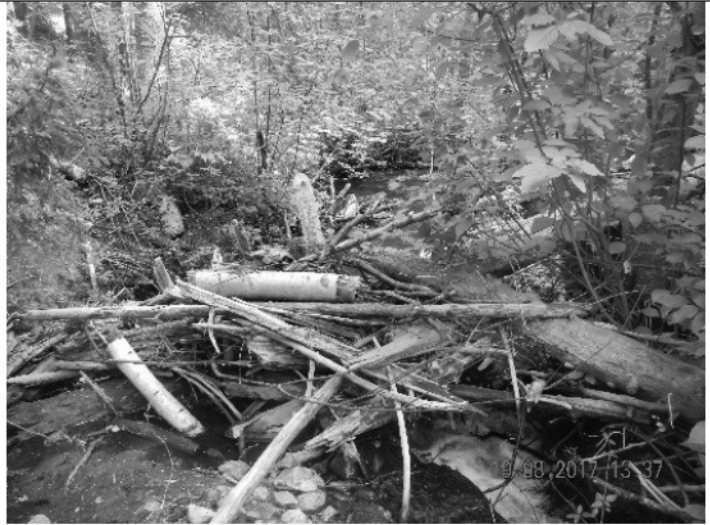
**Photo #42 (Field Stop #47):**

Stable, Cascade-Pool (Cobble) channel. Moderate to low bank erosion. Minor evidence of bank erosion.

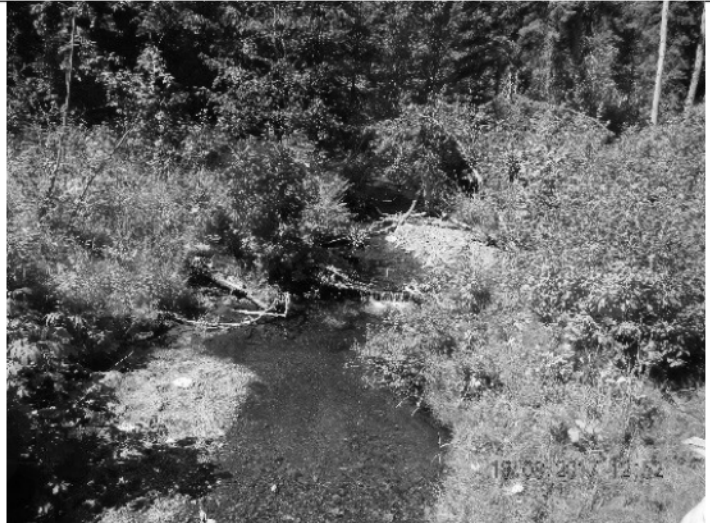
**Photo #43 (Field Stop #48):**

Partially aggraded, Cascade-Pool (Cobble) channel. Numerous elevated channel bars with sand and gravel along edges of channel. Minor bank erosion.

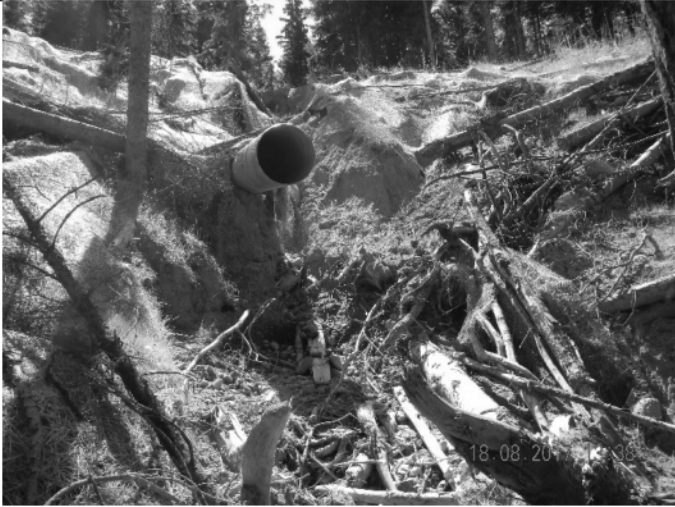
| <p><b>Photo #44 (Field Stop #50):</b></p> <p><b>Location:</b></p> <p>Small Tributary crossing Ester Road</p> <p><b>Notes:</b></p> <p>Small failure above and below crossing. Highly erodible sandy silts. Fine sediment delivery is directly connected to Greata Creek.</p> | |

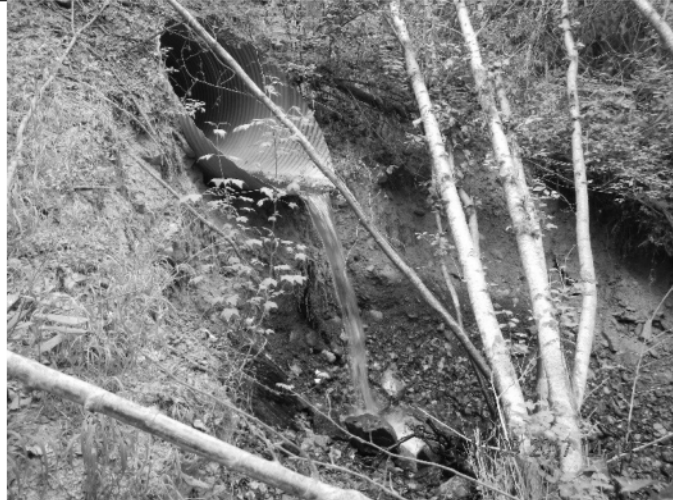
**Photo #47 (Field Stop #55):**

Excessive erosion of channel below culvert (gun barrel culvert protruding from road fill). Surface flow over Peachland Main is entering Bolivar Creek on the uphill side of the road. A relatively large wedge of fine sediment was observed above the culvert inlet.

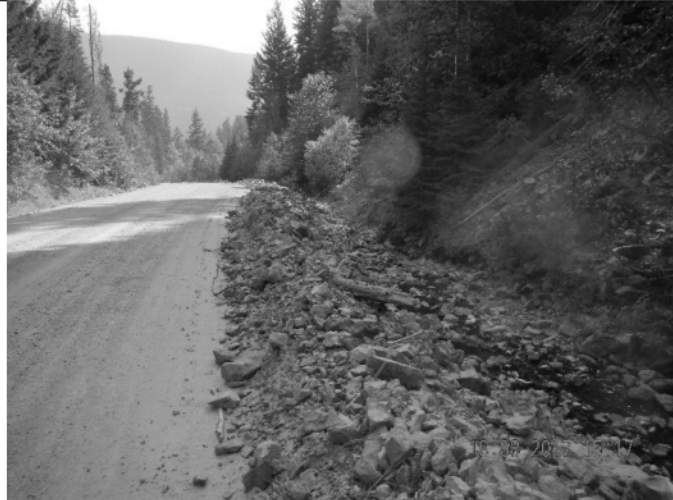
**Photo #50 (Field Stop #58):**

Moderately Degraded, Step-Pool (Boulder/Cobble) channel. Bolingbroke Creek eroded Peachland Main in the spring of 2017. The channel was subsequently excavated to maintain flow down ditchline.
