**MINISTRY OF FORESTS, LANDS AND NATURAL RESOURCE OPERATIONS
POST-WILDFIRE NATURAL HAZARD RISK ASSESSMENT**

RECONNAISSANCE REPORT

FIRE: K21644 Embleton Mountain Fire	FIRE YEAR: 2021	DATE OF REVIEW: September 1, 2021
AUTHOR: Tim Giles, P.Geo., Geoscientist, Westrek Geotechnical Services Ltd.		
REPORT PREPARED FOR: BC Wildfire Service – Kamloops Fire Centre, Kamloops Fire Zone Thompson Rivers Natural Resource District (FLNRORD)		
FIRE SIZE, LOCATION, AND LAND STATUS: <p>The Embleton Mountain Fire was approximately 992 hectares in size. The Natural Hazard Assessment Map of the fire is attached (Figure 1).</p> <p>The majority of the fire burned on Crown Land but there are portions of private land parcels close to or within the fire perimeter, including:</p> <ul style="list-style-type: none"> • several along the south side of fire above the Heffley-Louis Creek Road (HLC Road), • on the east side of the fire above Whitecroft, and • on the northeast side of the fire above the Louis Creek Road. <p>A preliminary vegetation burn severity map was provided by FLNRORD Thompson Okanagan Region (Figure 2).</p>

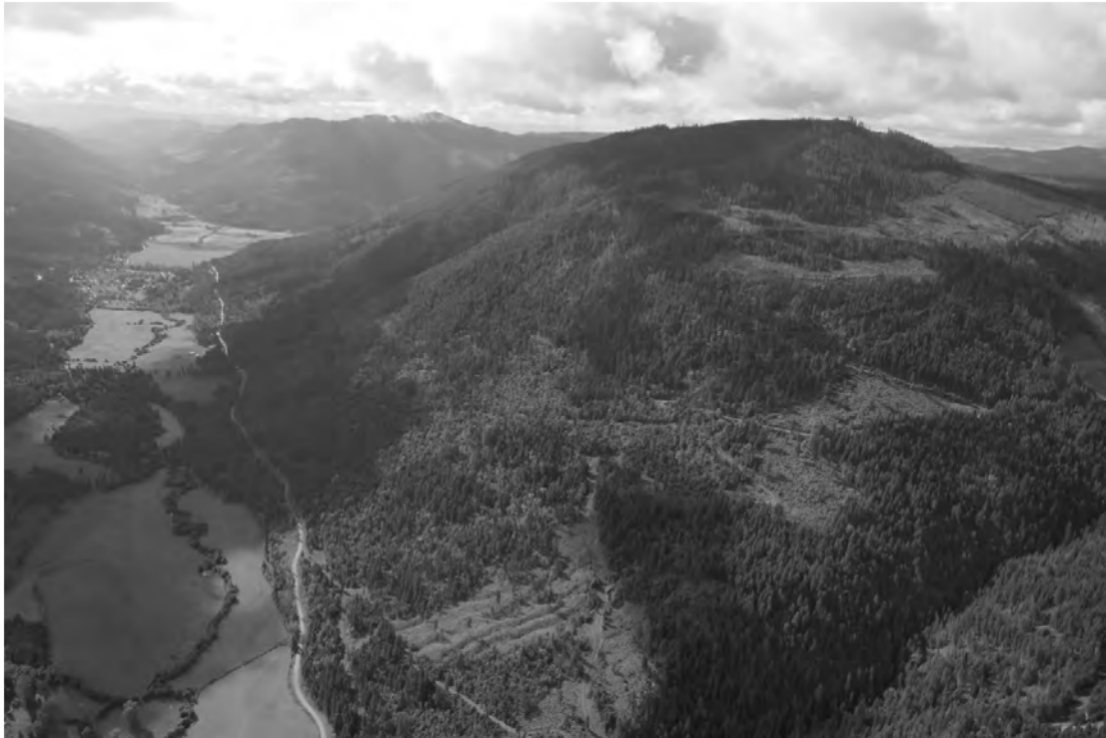
Plate 1: Looking south along the east facing slopes above the Louis Creek Road. The upper slopes are moderate to gently sloped and burned at a moderate or high vegetation burn severity.

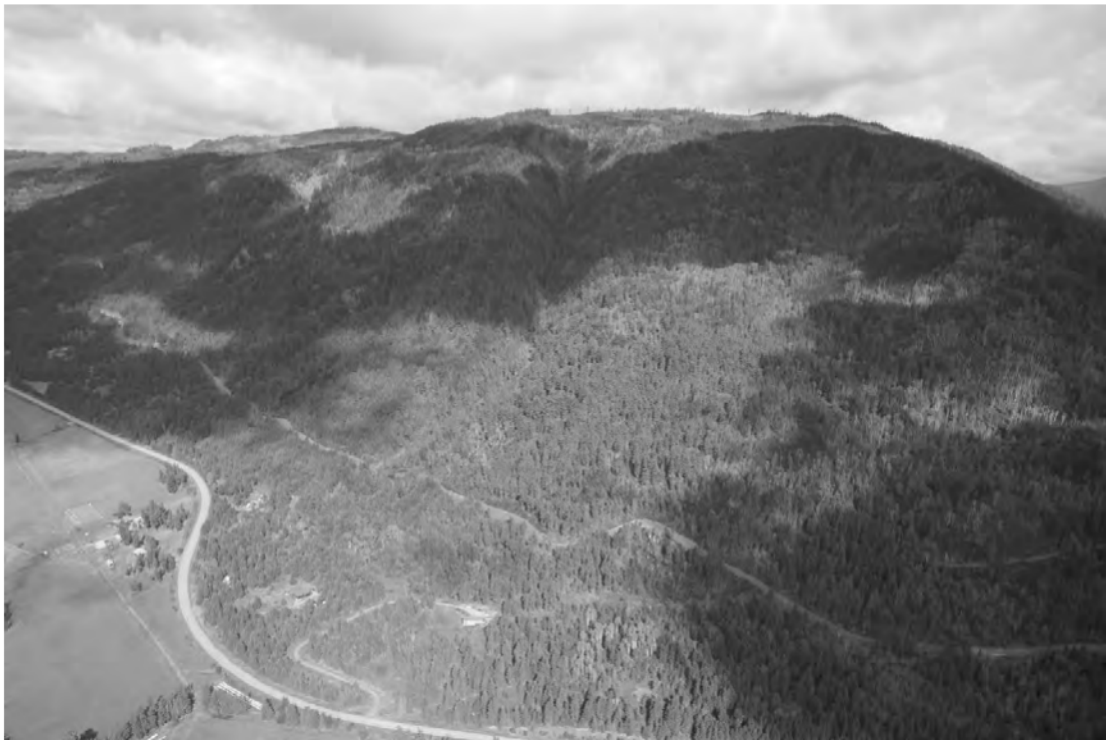
Plate 2: Looking northwest at the south facing slopes above the Heffley-Louis Creek Road. Watershed WS2 is the mostly clearly defined draw in the centre of the image.

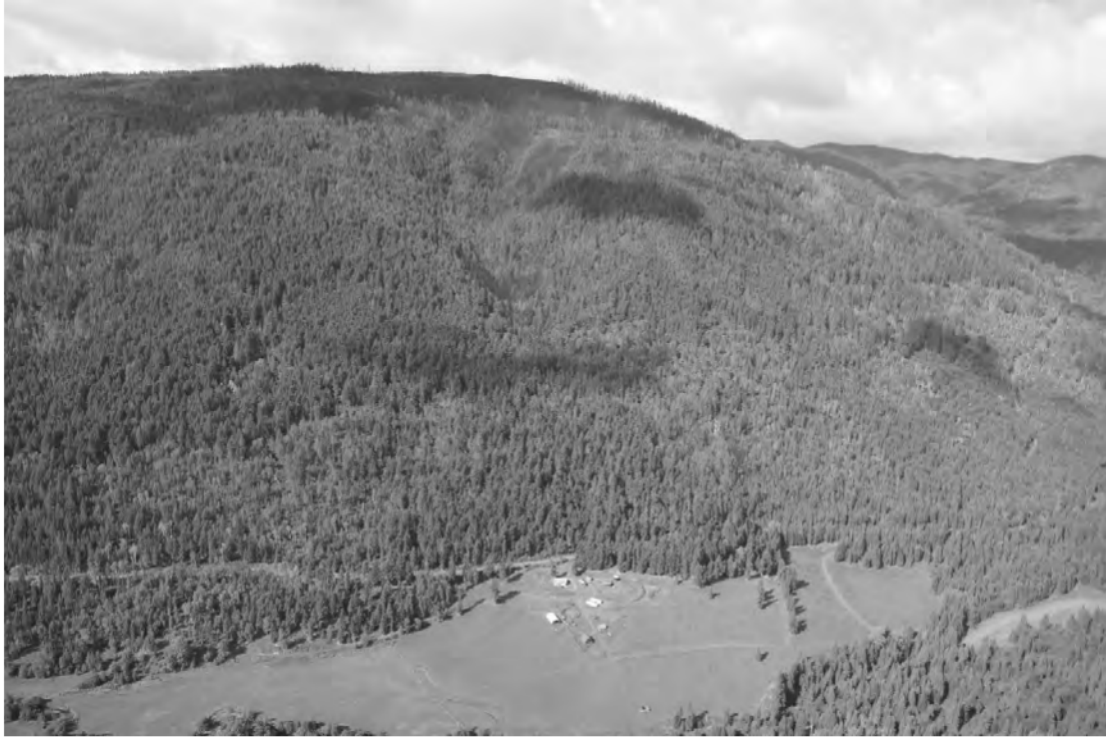
Plate 3: Watershed WE1 on the east facing slope of Embleton Mountain. The upper slopes have moderate to high vegetation burn severity. The creek runs out across Louis Creek Road and only the faintest trace of a watercourse was observed on the north side (right) of the fan

<p>FURTHER ACTIONS:</p> <p>A further review of watershed WE1 is recommended. The Embleton Mountain fire burned the majority of the WE1 watershed across the steep face and it is expected that an increase in the rapidity of snowmelt runoff in the spring in the next 3 years has the potential to initiate a landslide from the upper slopes in the watershed.</p> <p>A further review of watershed WS2 is recommended. A previous landslide (believed to be a debris flood) occurred in the spring of 2017, likely related to removal of the timber on the plateau surface between 2001 and 2017. The Embleton Mountain fire burned the majority of the WS2 watershed across the plateau surface and down the steep face and it is expected that an increase in the rapidity of snowmelt runoff in the spring in the next 3 years may initiate a similar landslide from the upper slopes in the watershed.</p>		
<p>POTENTIAL MITIGATION:</p>

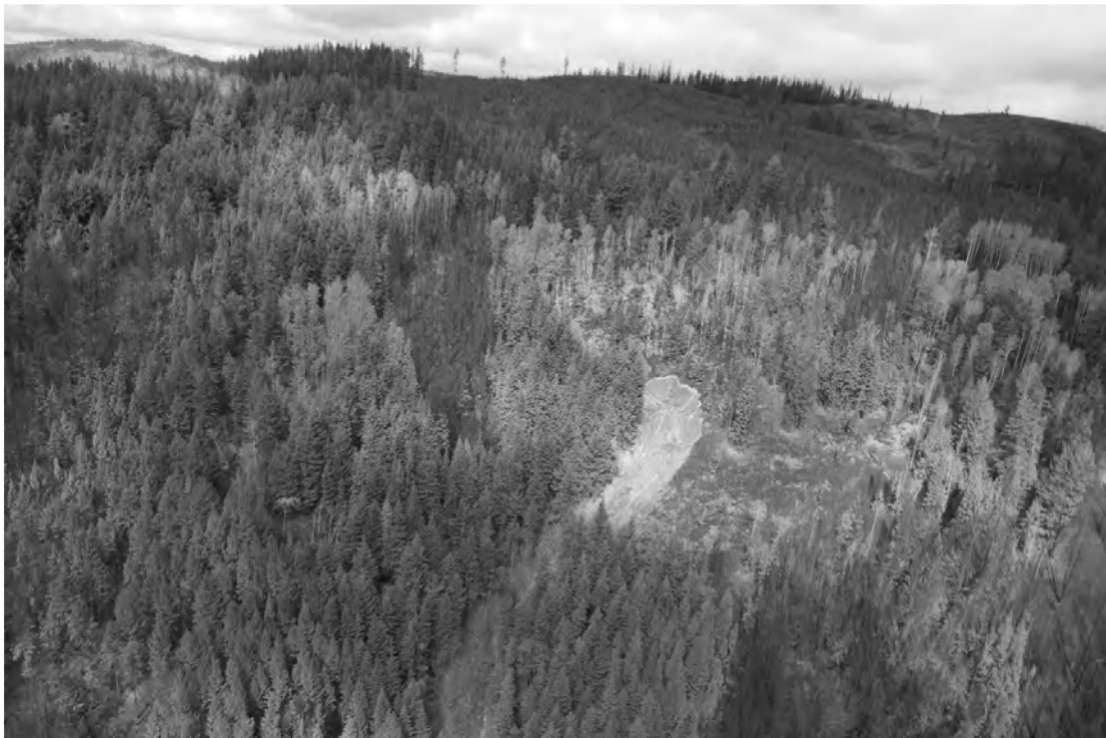
Plate 4: Headscarp of the 2017 landslide (debris flood) which ran out through watershed WS2. The upper plateau surface is quite gentle, moderately burned and was harvested between 2001 and 2017.

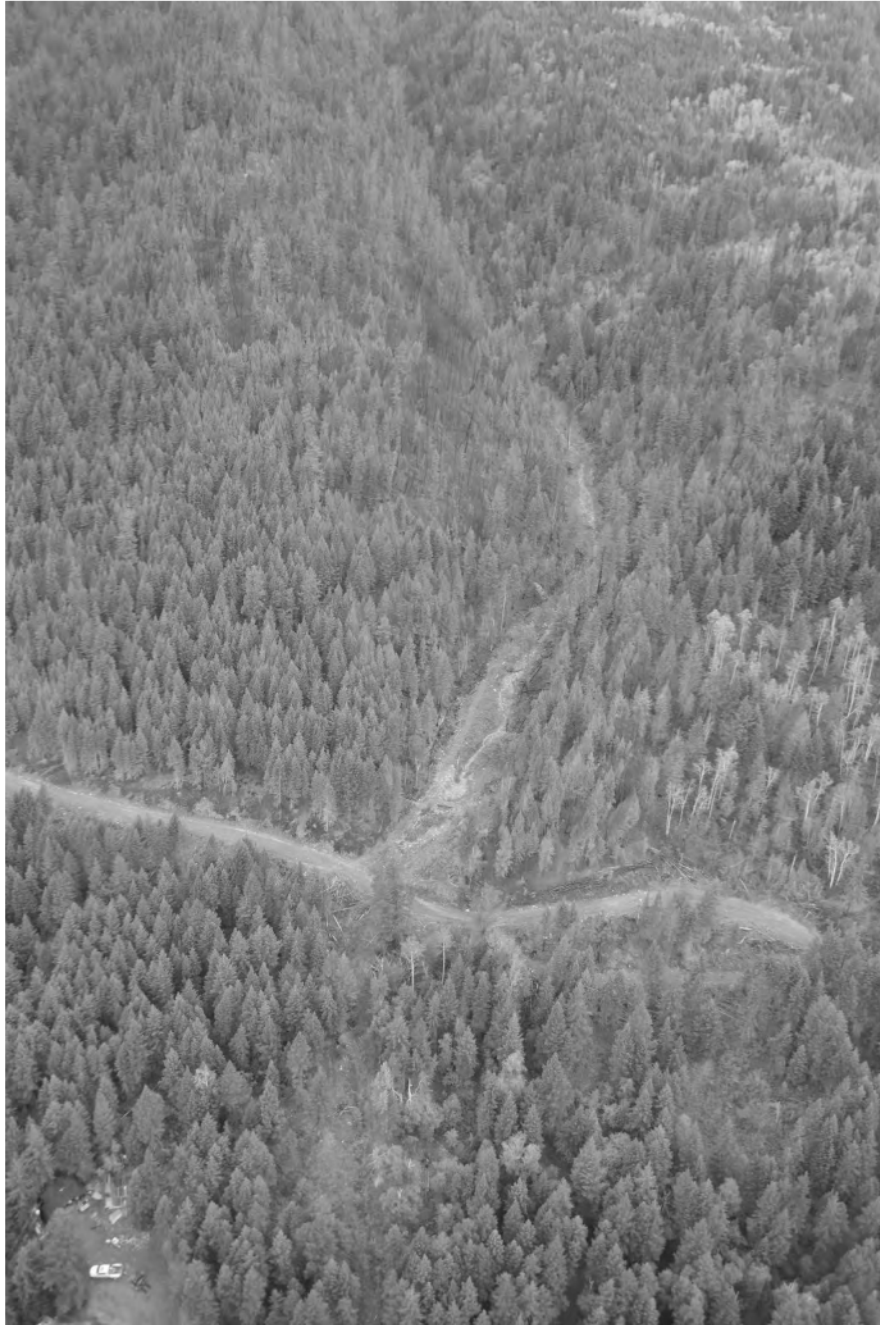
Plate 5: Looking upslope along watershed WS2. The debris flood from 2017 cleared trees along the margins of the draw making the channel wider. The trace of the creek can be seen at lower centre.

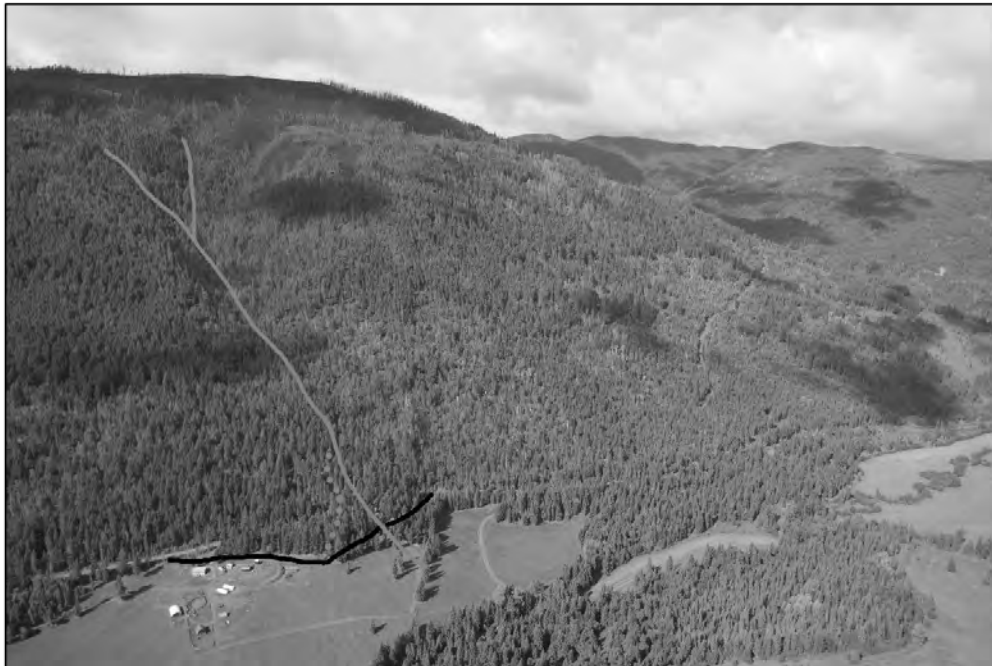
This watershed (Photo 1) drains east into the Louis Creek valley from the peak of Embleton Mountain, roughly elevation 1610 m (Figure 1). The Burn Severity Map (Figure 2) indicates that there is a mix of unburned, low, moderate and high burn severity. The creek extends upslope to 1440 m and joins the main channel of Louis Creek on the floodplain at 745 m. A longitudinal profile of the creek (Figure 3) indicates the upper channel has a 65% gradient above a

Photo 1: View of the WE1 watershed which drains from the peak of Embleton Mountain down to the Louis Creek Road (LCR) and Louis Creek. The solid blue line is the well-defined original channel, and the dotted blue line is the approximate location of the water diversion pipe and ditch. The old LCR alignment is shown in black.

For watershed WE1, it is recommended that the Ministry of Transportation and Infrastructure (MOTI) review the drainage where the creek intersects the LCR and, if appropriate, install a culvert. Further downslope, the draw crosses an old road alignment which should be culverted or cross-ditched as needed to provide appropriate drainage.

For watershed WE1, it is recommended that the Ministry of Forests, Lands, Natural Resource Operations and Rural Development determine the status of the water system and direct the owner to repair or remove it.

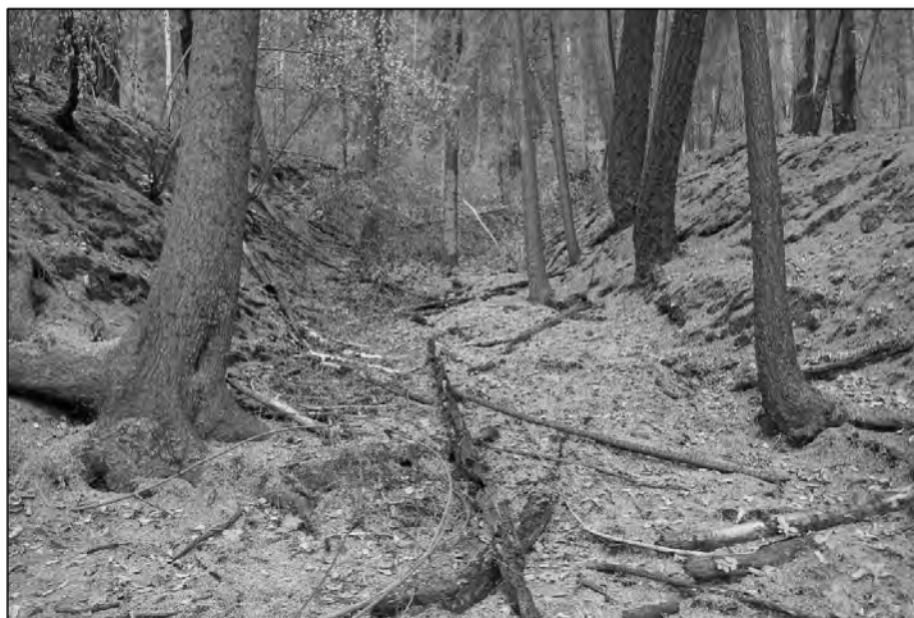
Despite the relative steepness of the watershed, no sign of debris flow levees were observed on the channel or alluvial fan (Photo 2). The lower channel was an incised draw, 8 to 10 m wide, 3 to 5 m deep, with a very small stream within it. Streamflow disappeared gradually downslope and had completely infiltrated about 50 m upslope from the LCR. At the LCR, the draw is still 5 to 10 m wide and 2 to 3 m deep, but no culvert is present. Further downslope, the draw crosses an old road alignment (Photo 1, likely the original LCR alignment) which also has no culvert. This watershed now has significant areas of moderate and high burn severity (Figure 2). It is expected that for the next 3 to 5 years there will be increased streamflow and associated sediments off the slopes above due to the effects of the fire and this may impact the LCR.

Partial diversion of water in the creek is presently occurring about 175 to 200 m upstream from the LCR. This diversion consists of a 1-inch plastic pipe embedded in the stream which runs southeast into a cistern located about 60 m upslope from the LCR. The plastic pipe has burned, or otherwise ruptured, in at least 3 places between the creek and the cistern. The cistern drains downslope through a small drainage ditch, passes under the LCR through a culvert about 50 m south of the actual creek draw. A shallow swale carries water down to an old road alignment, which it passes under in a second culvert before being discharged into the field below.

Photo 2: View up the channel on the alluvial fan of the WE1 watershed.

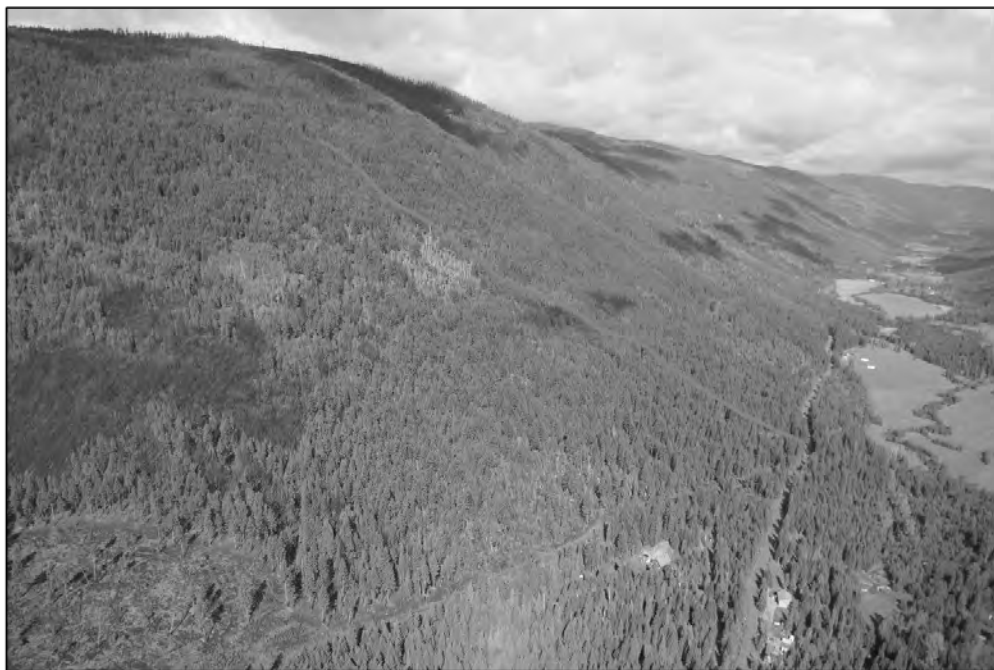
This watershed drains east into the Louis Creek valley from the slopes of Embleton Mountain (Figure 1). The Burn Severity Map (Figure 2) indicates that there is a mix of unburned, low and moderate burn severity. A view of the slope looking north along the LCR suggests it was mostly unburned and low burn severity (Photo 3). The creek draw has a well-defined V-shape, with a 1 to 2 m wide channel and 5 to 8 m deep sidewalls. No water was flowing in the channel, but some sediment accumulation was observed indicating ephemeral (freshet) flow likely occurs. It is expected that for at least the next 3 years there will be slightly increased streamflow off the slopes above due to the effects of the fire and this may impact the LCR.

Photo 3: View of the WE2 watershed on the east-facing slope of Embleton Mountain. The blue line is the approximate channel. The LCR is at lower right and Louis Creek can be seen at far right.

For watershed WE2, it is recommended that MOTI review the LCR drainage and, if appropriate, install a culvert.

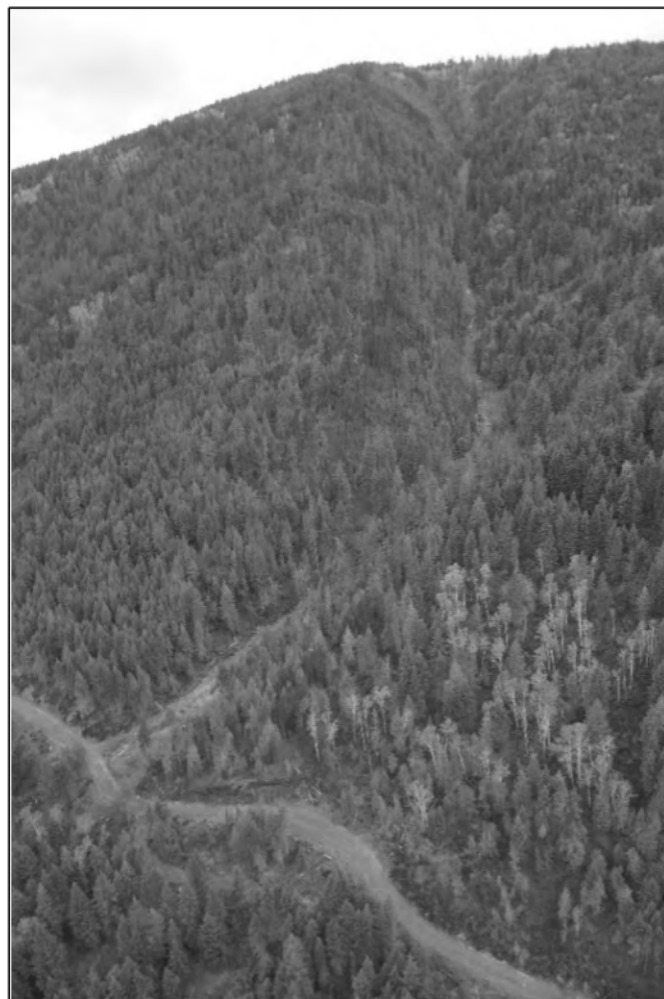
Photo 4: View of the lower half of the WS2 Creek on the south-facing slope of Embleton Mountain. A fireguard constructed during firefighting crosses the creek just below the apex of the alluvial fan.

For watershed WS2, it is recommended that, prior to the 2022 spring freshet, MOTI review the drainage where the creek intersects the HLCR and, if appropriate, install a culvert. Existing culverts and ditch-lines along the HLCR should also be cleaned and properly maintained.

For watershed WS2, it is recommended that the Ministry of Forests, Lands, Natural Resource Operations and Rural Development, rehabilitate the fireguard (visible in Photos 4 and 5) through the creek draw. Removal of all the sediment and woody debris used to construct the fireguard through the channel is required. The natural channel at the crossing should be re-established to be of similar width and depth as it is upslope. The base of the channel should be lined with a layer of larger rocks (>25 cm diameter) to armour the channel base and reduce erosion from the area of the fireguard crossing.

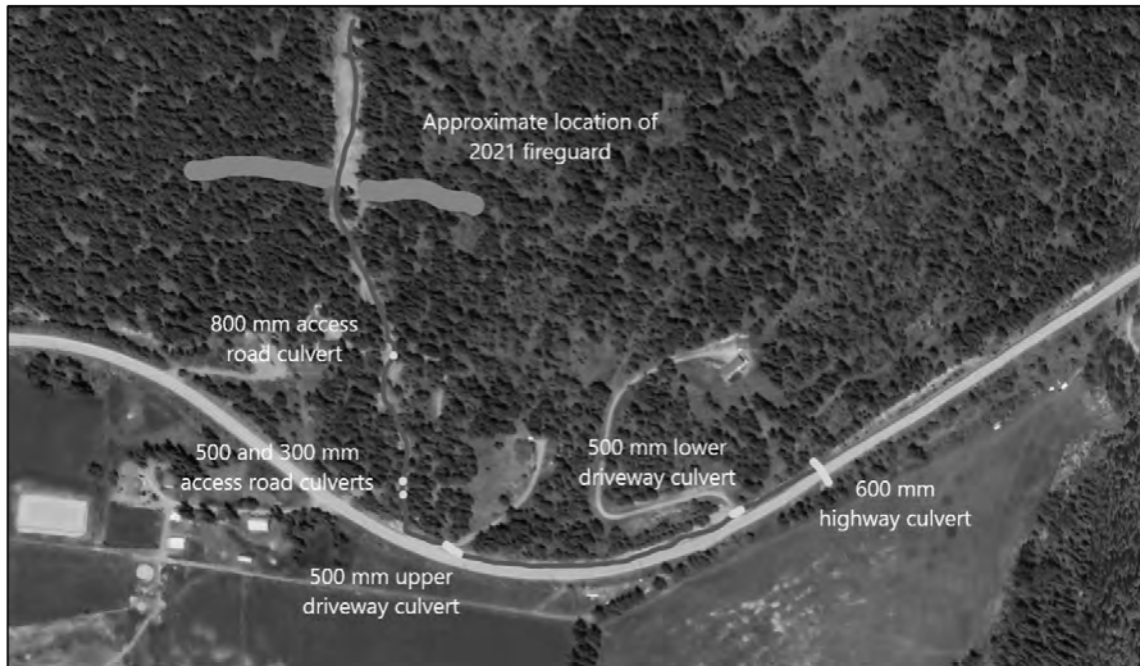
In May 2017, a landslide initiated at the top of the south-facing slope and deposited debris through the private land, down to the HLCR. A review of landslide by Westrek in 2017 (unpublished field investigation) concluded that the event was a debris flow. Debris fanned out on the alluvial fan surface and lobes of sedimentary debris were deposited amongst the trees. Further downslope, culverts in the residential access road, two driveway accesses and under the HLCR, were impacted by sediment-laden streamflow (Figure 5 and Photo 6).

Figure 5: Google Earth view of the WS2 Creek alluvial fan from 2017. The track of the debris flow can be clearly seen coming off the upper slopes, running through the residential area, before reaching the HLCR. The creek currently follows the highway ditch-line east for 400 m to a 600 mm culvert, which passes it into the field below and then into Christian Creek.

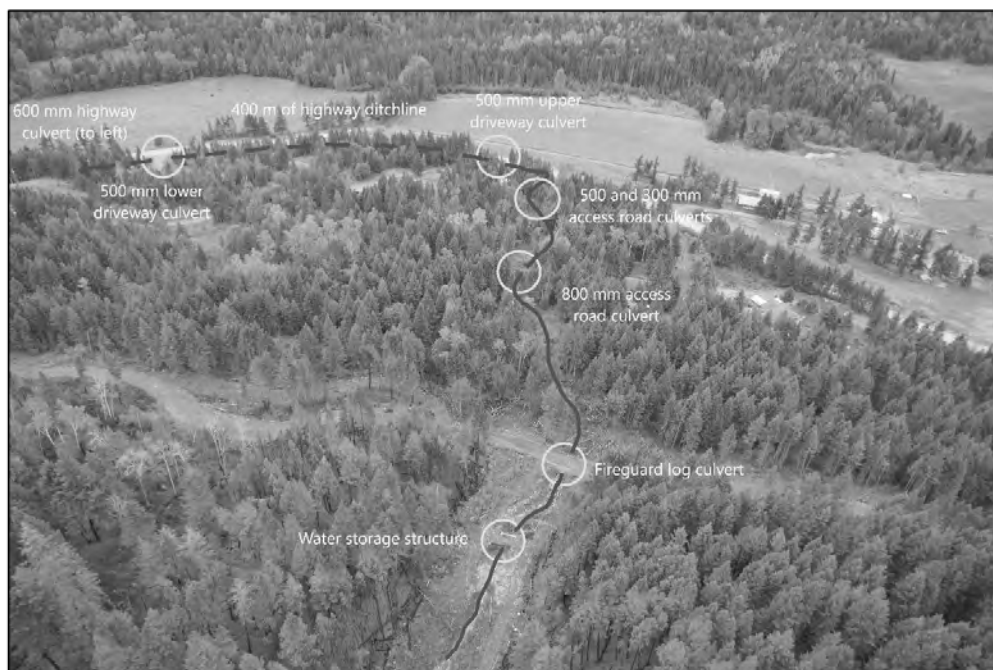
Photo 5: View looking south of the WS2 Creek alluvial fan above the HLCR. The creek passes through a number of culverts and then follows the highway ditch-line to the east before draining south into Christian Creek.

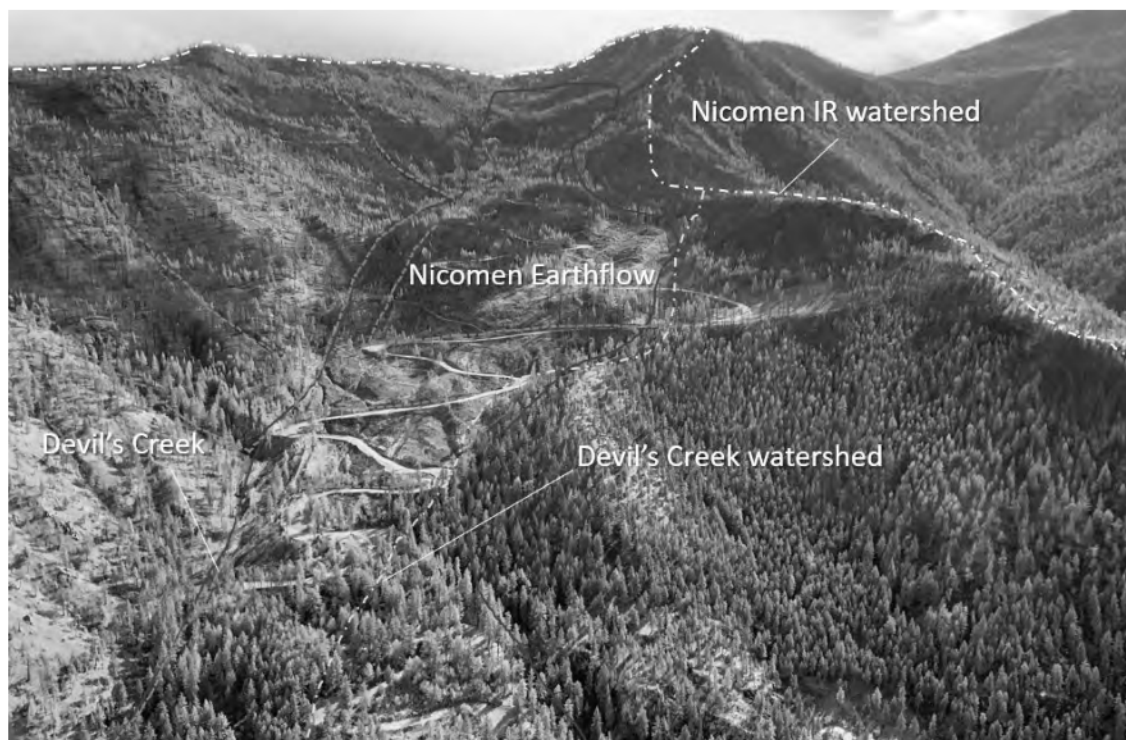
Figure 2-1 is an aerial image showing the burn severity in the upper Devil's Creek watershed showing the Nicomen Earthflow¹, the forest service road (FSR), the outline of the Devil's Creek watershed and Devil's Creek with some of its main tributaries. The side slopes and tributaries, especially in the eastern and eastern and southern portions of the Devil's Creek watershed, were burned at moderate and high severities (Figure 2-1). Post-wildfire debris flows on August 16 and September 17, 2021 have emanated from moderate to highly burned tributaries.

Figure 2-1. Upper Devil's Creek watershed on September 30, 2021 showing the different burn severities. The earthflow is located in the centre of the photo delineated in red and partially logged. Photo by BGC looking towards the South.

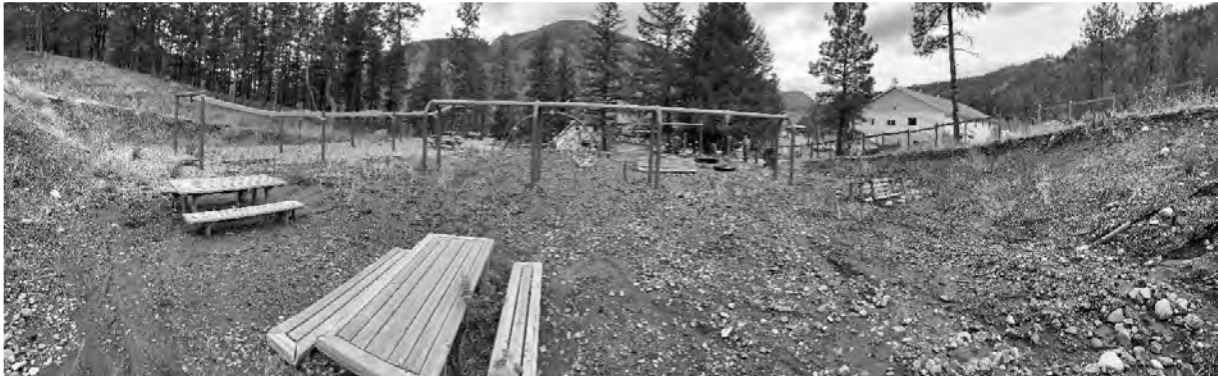
Post-wildfire debris flows and debris floods on August 16 and September 17, 2021 in Devil's Creek avulsed approximately 250 m upstream of Nicomen River Road. The resultant flows entered the playground adjacent to the Nicomen Band Office and deposited 0.1 to 0.2 m of sediment into the playground area (Figure 2-2). The unnumbered building directly downstream of the playground had water and sediment less 0.1 m deep deposit into the yard surrounding the building during the September 17, 2021 event.

Figure 2-2. Panoramic view towards the north from upstream of the Nicomen 1 I.R. playground looking downstream. The foreground shows debris coverage of approximately 20 cm height thinning towards the distal portions of the playground. The Nicomen Band office is the white building on the right side of the image. Photograph: BGC, September 29, 2021.

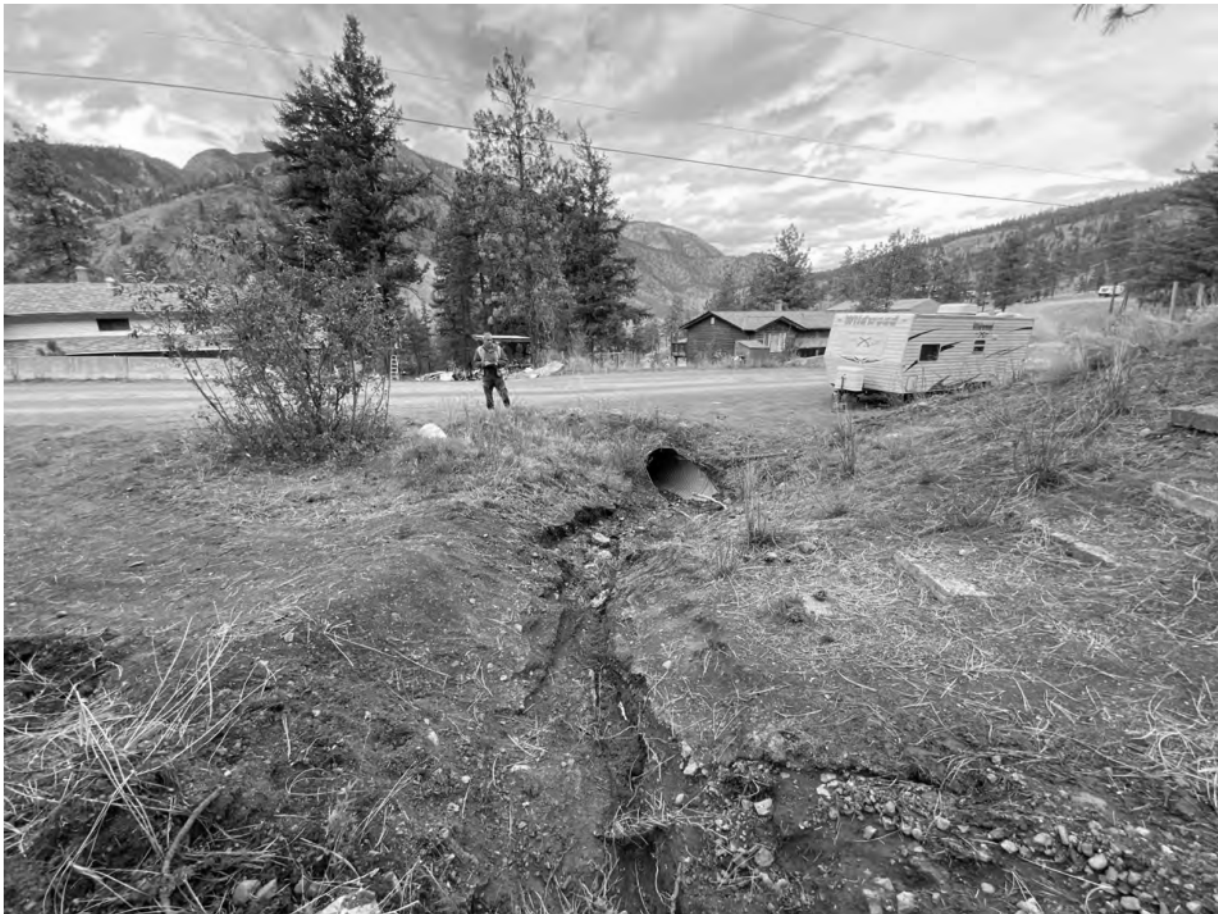
At Nicomen River Road, Devil's Creek is conveyed through a 1 m diameter corrugated steel pipe culvert (Figure 2-3). BGC observed a travel trailer parked on the road directly beside the culvert intake. The stream flows out of the culvert and into an incised drainage ("North Gully") on the east side of the property at 1027 Nicomen River Road.

Figure 2-3. Culvert intake for Devil's Creek at Nicomen River Road. Note the travel trailer parked in the foreground and two houses downstream of the culvert in the background of the photo. Photo: BGC looking downstream (north). September 29, 2021.

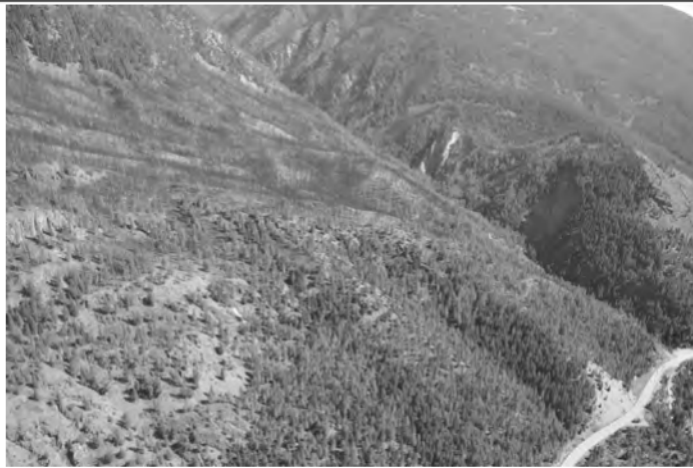
Photo 1 – View looking south of moderate to high vegetation burn severity along the lower Siska Creek watershed just above the Trans Canada Highway. Note the sidewall failures on the south side of the creek valley.

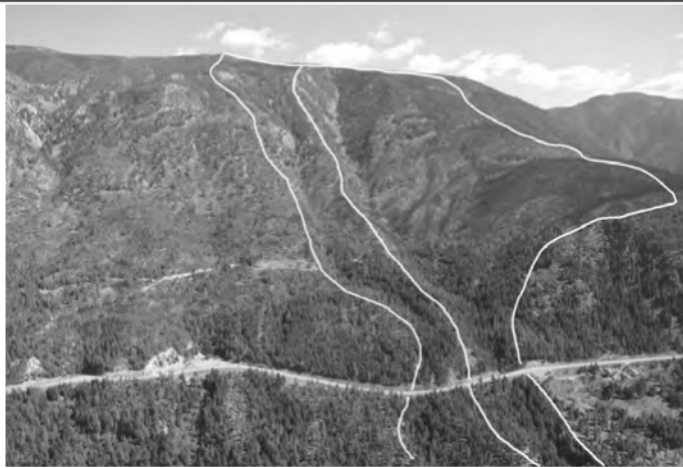
Photo 2 – View of North and South Skuppa Creeks, outlined left and right respectively. The upper watershed areas have moderate to high vegetation burn severities; the lower watershed is mostly unburned.

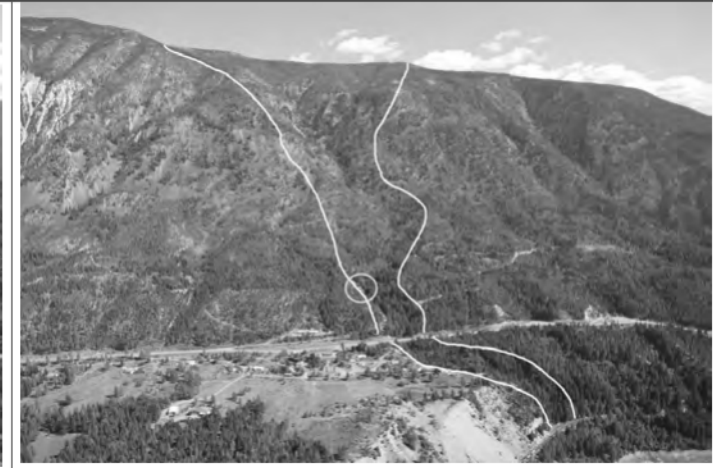
Photo 3 – View of George Creek watershed (outlined). The watershed has mostly low to moderate vegetation burn severities. The water system intake is close to the blue roofed building (circled) in the centre of the image.

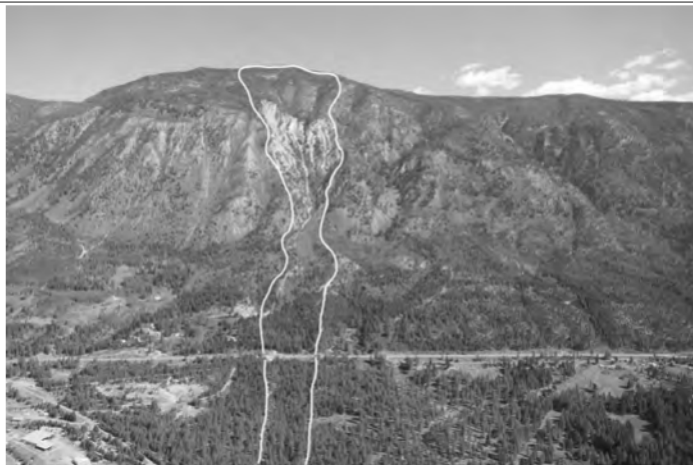
Photo 4 – View of the Saw Creek watershed (outlined). The upper watershed above the steep chutes has moderate to high vegetation burn severity; the remainder of the watershed is a mix of unburned and low vegetation burn severity. The broad active debris flow draw can be seen leading down towards the Trans Canada Highway.

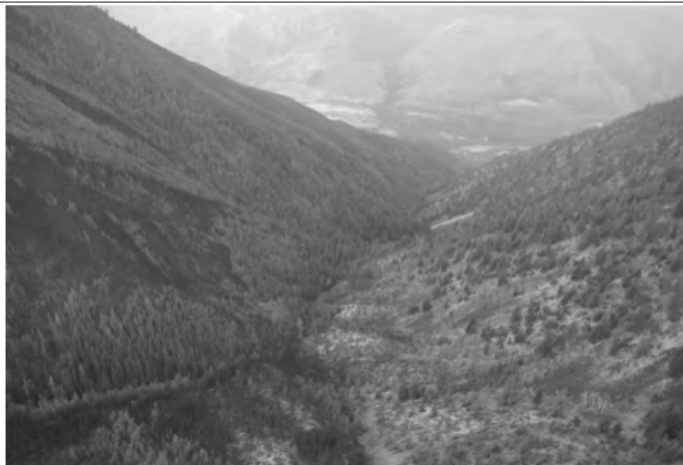
Photo 5 – View looking down mid-Lytton Creek towards the Fraser River. Coarse talus deposits on the south-facing slopes (right) reach the valley floodplain.

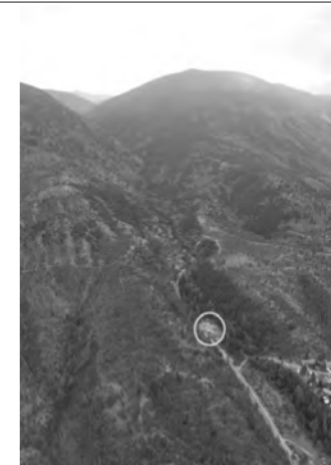
Photo 6 – View looking up Lytton Creek. The Village of Lytton water system buildings (circled) are at the end of the road on the north (left) side of the creek. Loring Way crosses the creek at lower right.

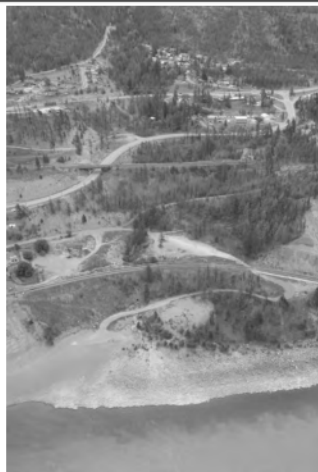
Photo 7 – View of the lower end of Lytton Creek. Image includes the Fraser River at the bottom, the six road crossings and two rail crossings.

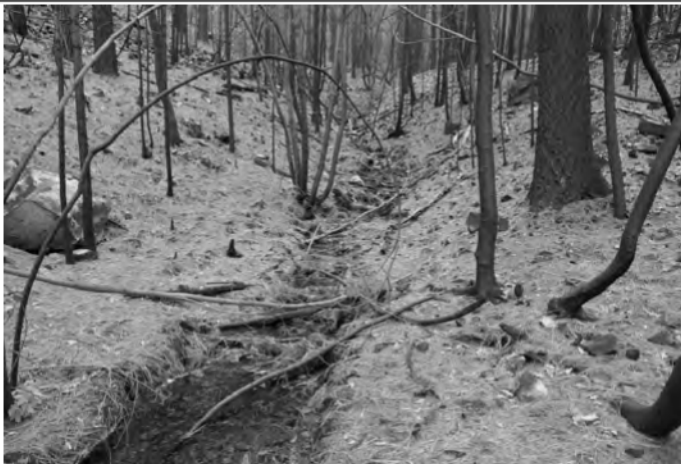
Photo 8 – View of South Skuppa Creek around 475 m elevation. Note the coarse rubbly nature of the ground, predominantly glaciofluvial gravels at this location but transitioning into colluvial deposits upslope.

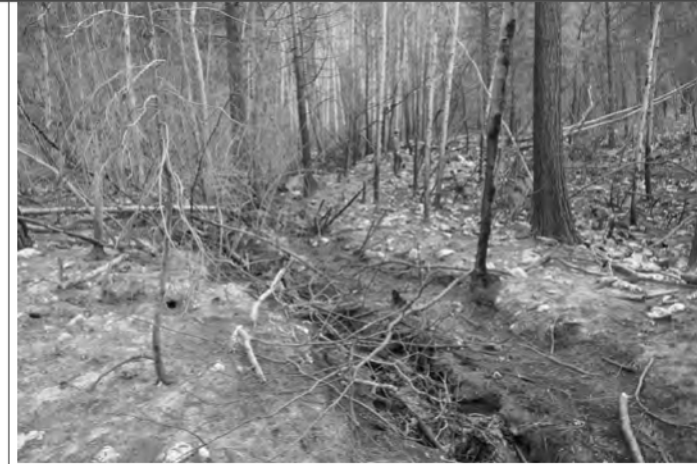
Photo 9 – View of North Skuppa Creek around 525 m elevation. The creek has incised into the coarse angular rubbly talus deposits which fill the broad valley of North Skuppa Creek.

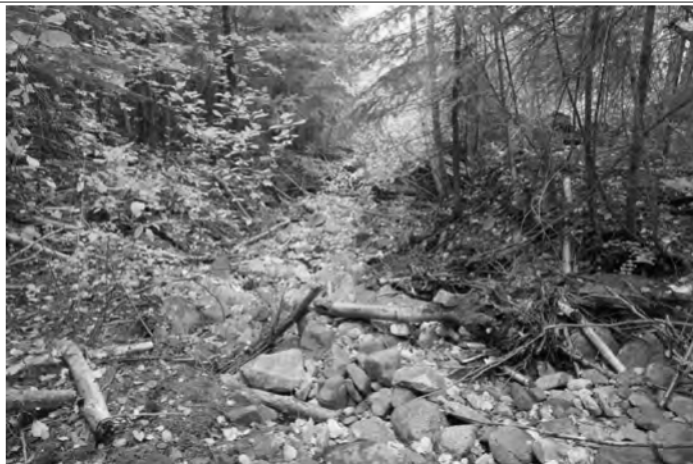
Photo 10 – Looking downstream on George Creek at around 375 m elevation. The water system buildings are located approximately 50 m to the north (to the right of image). The creek is an open boulder-step pool with limited wood framework.

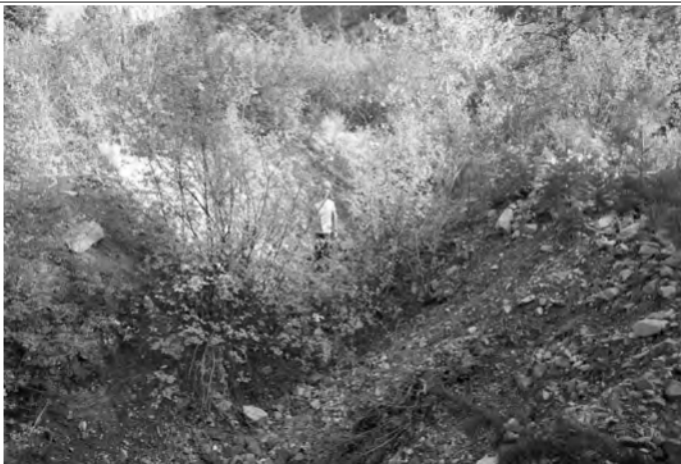
Photo 11 – View of debris flow track with 2-3 m high levees on the margins in the broad draw that defines mid-Saw Creek around 350 m elevation. Trees growing on the levee tops are even aged and approximately 10-12 years old. No streamflow was observed at the time of inspection.

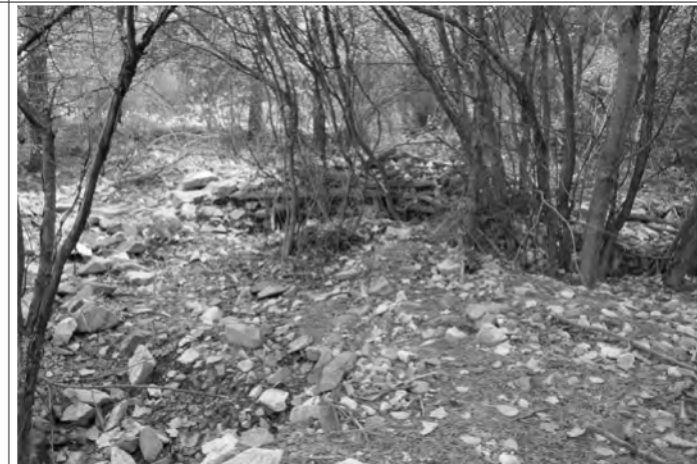
Photo 12 – Log jam, sediment lobes and distributary splays of sediment in the broad draw of Saw Creek, approximately 325 m elevation. Small creek channels develop downstream of where the sediment lobes and splays deposit.

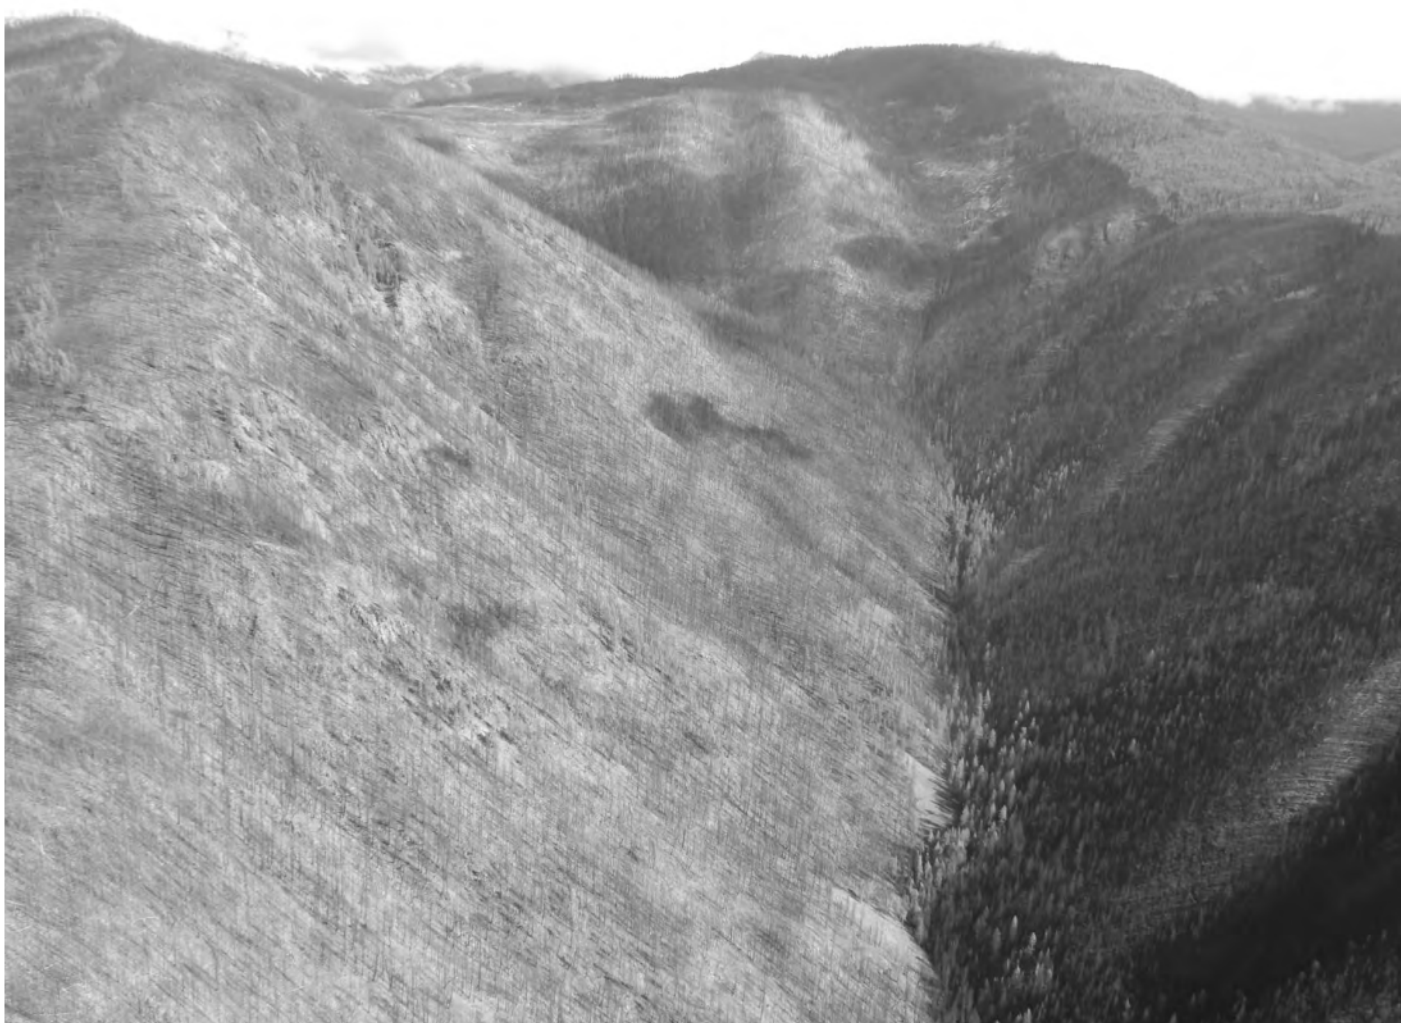
Photo 1. High burn severity in Van Houten Creek watershed.

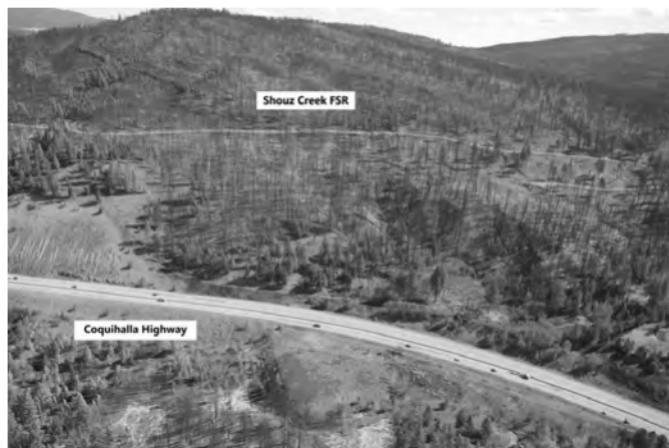
Photo 1 – View looking east at the steep slope between the Coquihalla and the Shouz Creek FSR. Centre of image is approximately 1 km north of the Brookmere interchange.

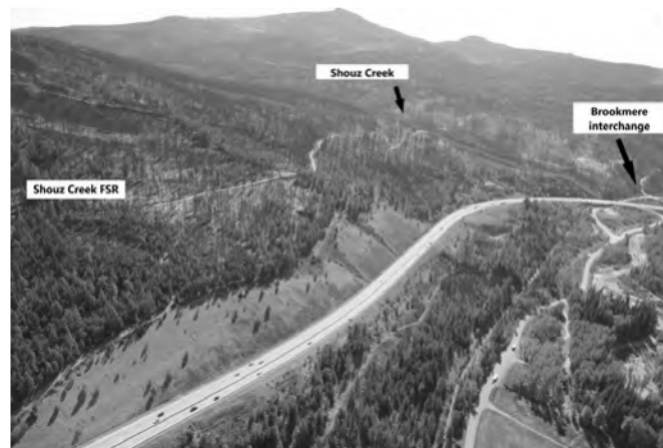
Photo 2 – View looking south at the steep slope between the Coquihalla and the Shouz Creek FSR. Shouz Creek is shown as a blue line leading down to the Brookmere interchange. Shovelnose Mountain is the peak at centre of image.

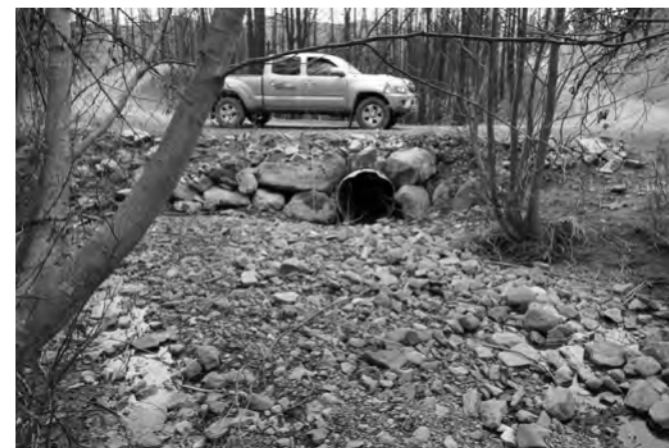
Photo 3 – Looking downstream along Shouz Creek towards the 900 mm diameter culvert under the Shouz Creek FSR. The culvert constricts the creek as it passes under the road and at high flows will back up flow. This may cause sediment deposition above the inlet which may further restrict flow.

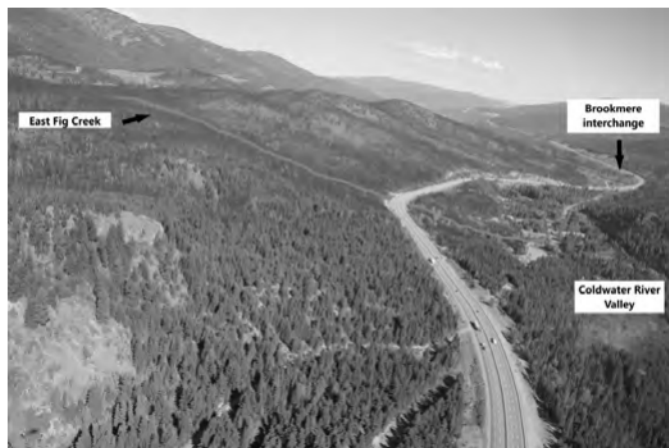
Photo 4 – View looking north along the Coquihalla north of Larson Hill. The trace of East Fig Creek is shown as a blue line leading down to the Coquihalla and further to join the Coldwater River.

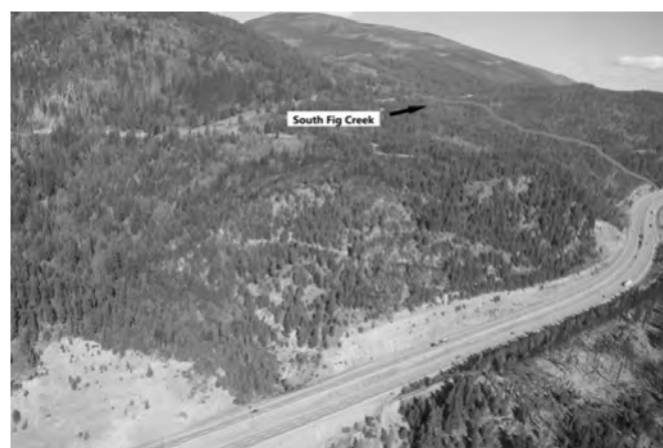
Photo 5 – View looking north along the Coquihalla at Larson Hill. The trace of South Fig Creek is shown as a blue line leading down to the Coquihalla. Fig Peak is located at top centre of image.

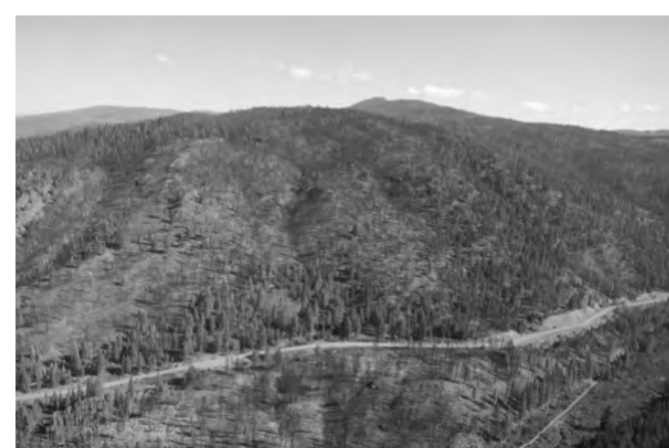
Photo 6 – View looking north at a moderate to high vegetation burn severity patch on the south-facing slopes above Brookmere Road. Community of Brookmere is to the east (right) of image.
