Inspection Date	2021-11-17 12:35:12 PM	Latitude	Longitude
User Name	Samuel Lyster	49.336651	-117.798922
Structure ID #	CW-003	49°20'11.94"	-117°47'56.12"
ORCS File #	CW-003		Accuracy (m) 5
Road Resp.	DSE	Design Info Available	No
FSR Project		Construction Info Available	No
File ID / Branch		Estimated Year Installed	
Road Name	Columbia Western Railway	ORG Responsible for Design	
User km	10		
Design Function	Wall to retain road fill or bridge approach fill		
Wall Type	Gravity		
Facing Type	Cast in place concrete		
Inspection Comments

Inspection Date	2021-11-17 12:56:17 PM	Latitude	Longitude
User Name	Samuel Lyster	49.336364	-117.796188
Structure ID #	CW-002	49°20'10.91"	-117°47'46.28"
ORCS File #	CW-002		Accuracy (m) 7
Road Resp.	DSE	Design Info Available	
FSR Project		Construction Info Available	
File ID / Branch		Estimated Year Installed	
Road Name	Columbia Western Railway	ORG Responsible for Design	
User km	9.8		
Design Function	Wall to retain road fill or bridge approach fill		
Wall Type	Gravity		
Facing Type	Cast in-place Mass Concrete		
Inspection Comments

Inspection Date	2021-11-17 1:15:56 PM	Latitude	Longitude
User Name	Samuel Lyster	49.335554	-117.792881
Structure ID #	CW-0

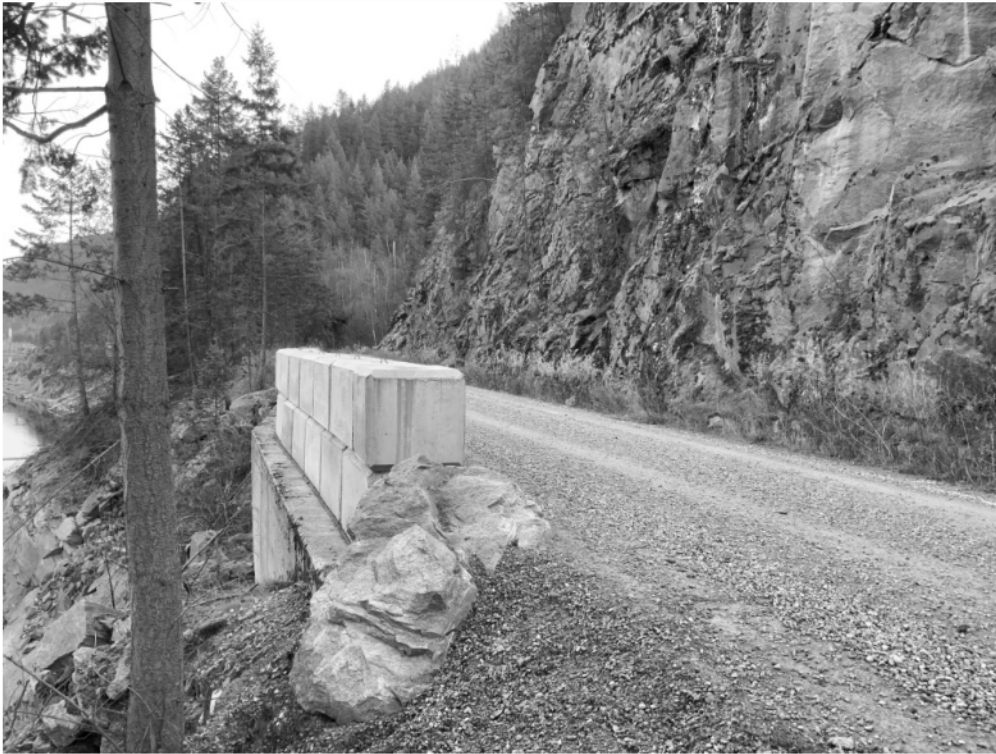
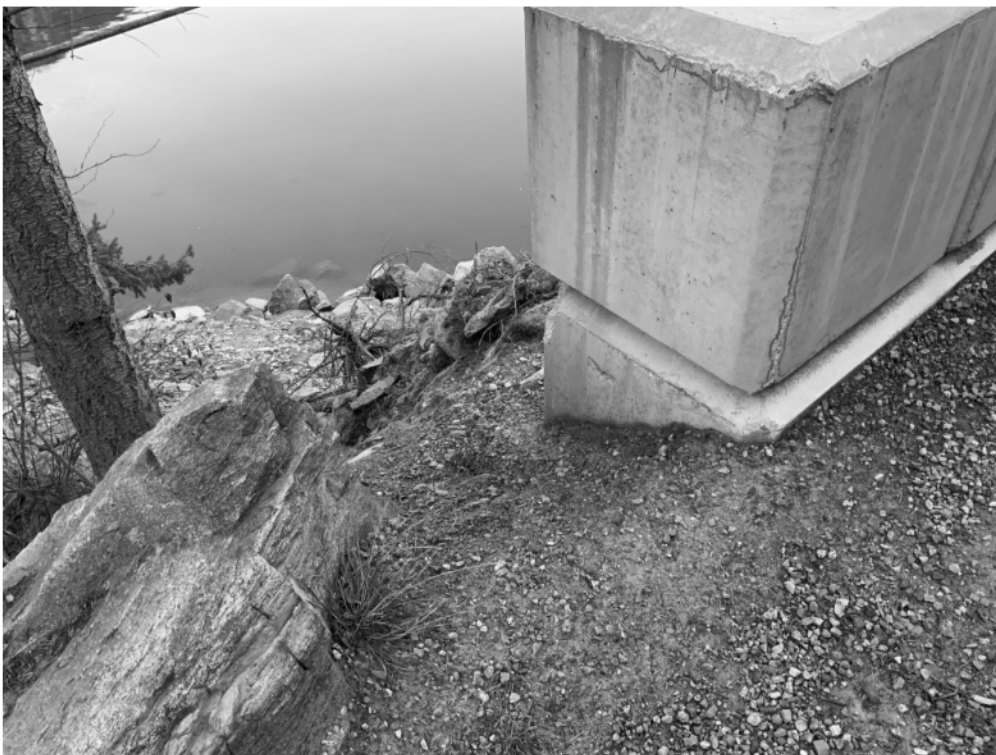
Drainage System	Good	One drain noted near bottom centre of wall.
Traffic Barrier/ Fence	Good	Interlocking concrete blocks
Road	Good	
Upslope	Good	Rock cut
Downslope	Good	Rock and boulders.
Lateral Slope	Fair	Potential for surface drainage induce erosion of left (upchain) lateral slope.
Detrimental Vegetation		
Culvert		
Curb/Berm/ Ditch	Good	Large ditch on upslope side of road
Other Secondary Element

Left (up chain) side potential for surface erosion issues on lateral slope.

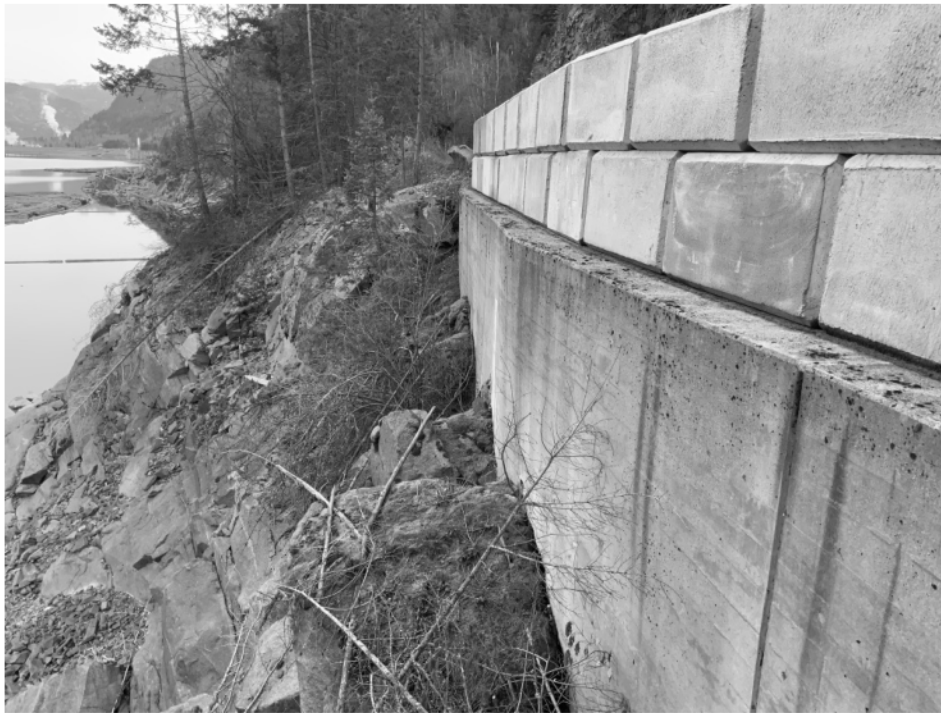
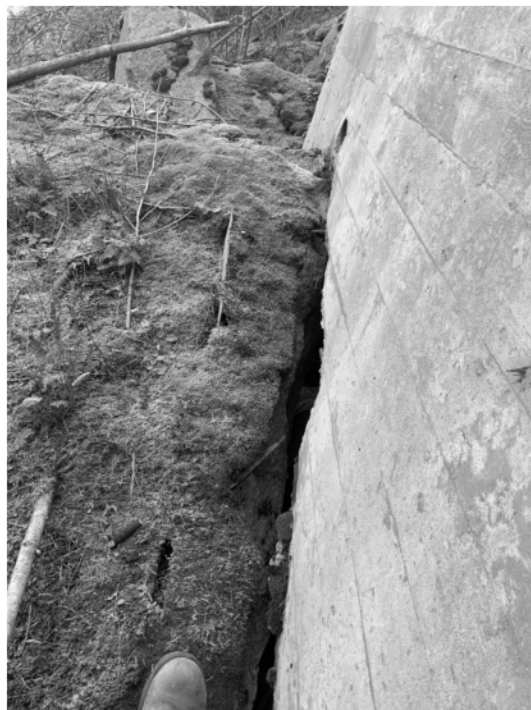
Large boulder in wall foundation has displaced 180 mm
away from wall

Concrete interface on large Boulder. Boulder has moved 7 inches away from wall

Recommend hiring a geotechnical engineering to inspect the wall and prescribe a repair to stabilize the left section of wall that has displaced due to foundation boulder movement.

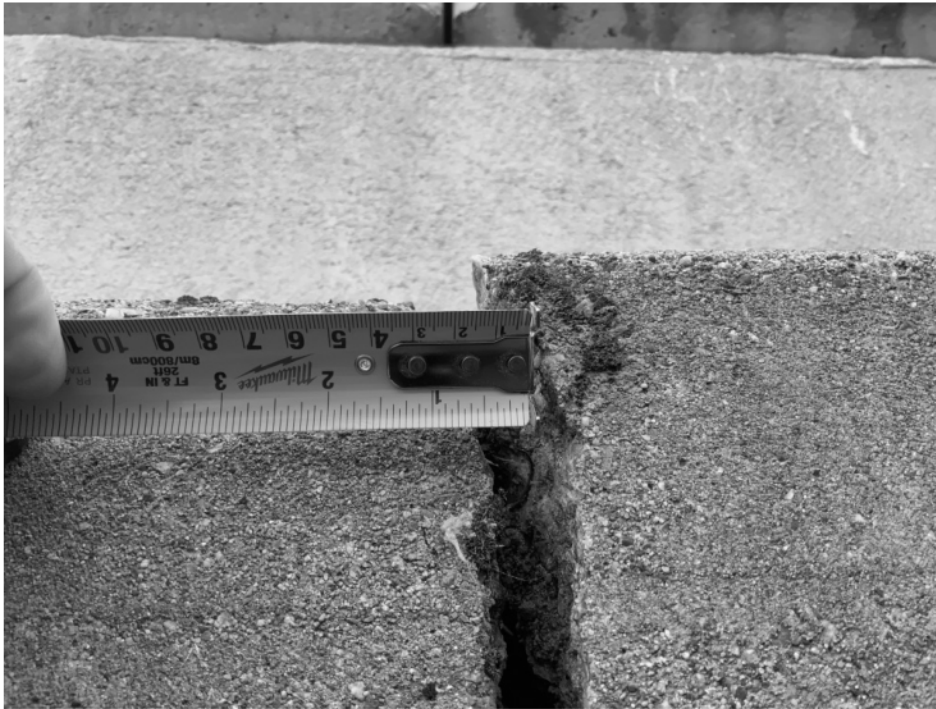
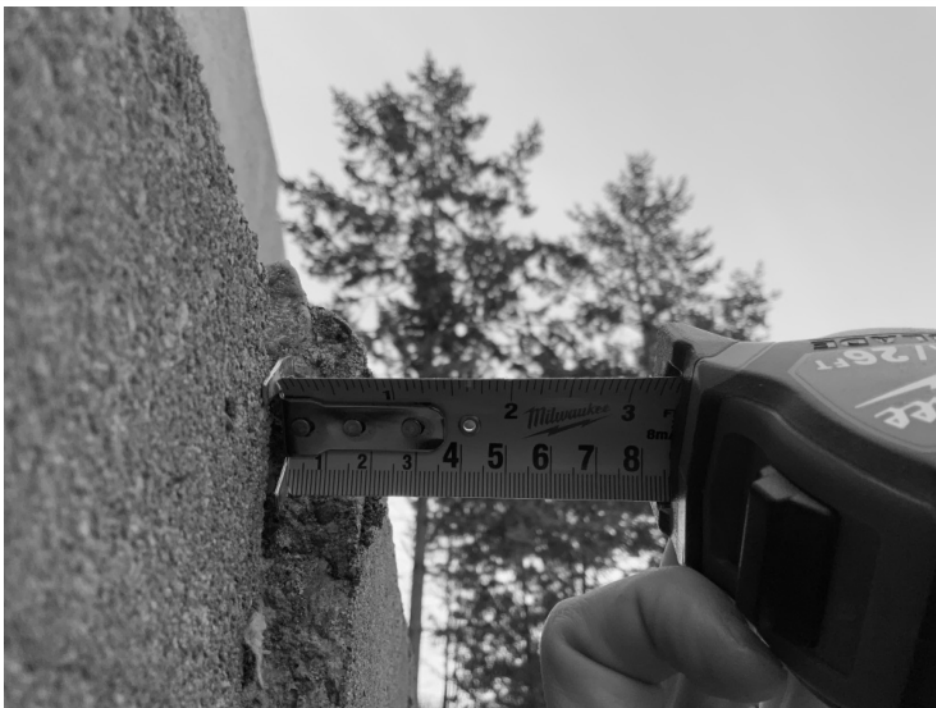
Crack near center of wall. Hairline at base, and expands to ~20mm width at top of wall.
Wall section on left side of crack tilts out ~20mm. Crack likely caused by wall
movement from the foundation boulder moving.Shortcrete or
GroutManufactured
Block/Panel/
Brick

Wall tilt 2cm

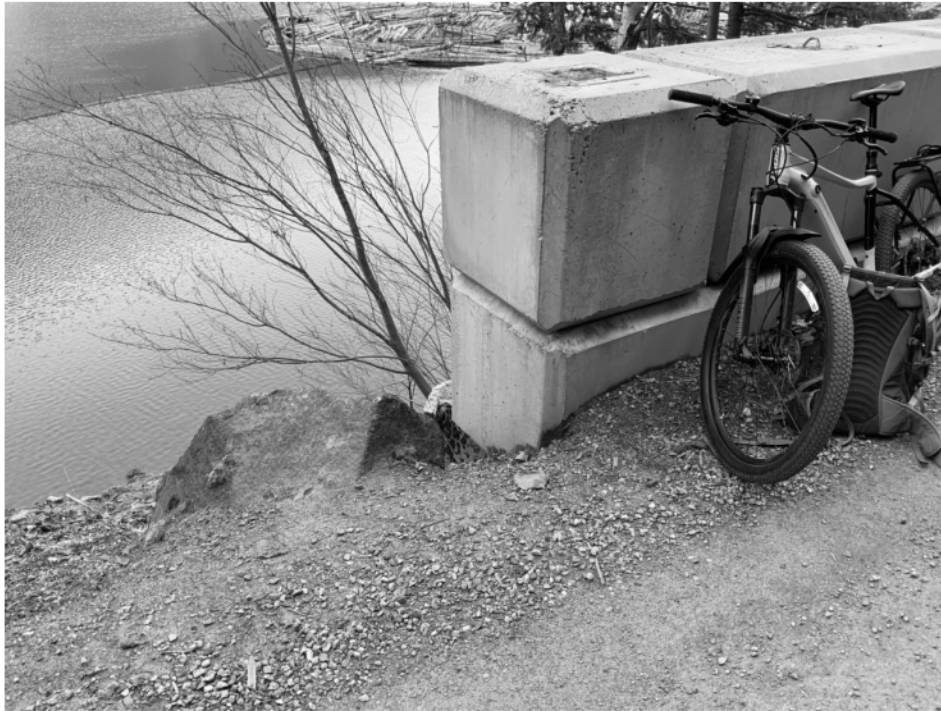
Potential surface flow erosion location

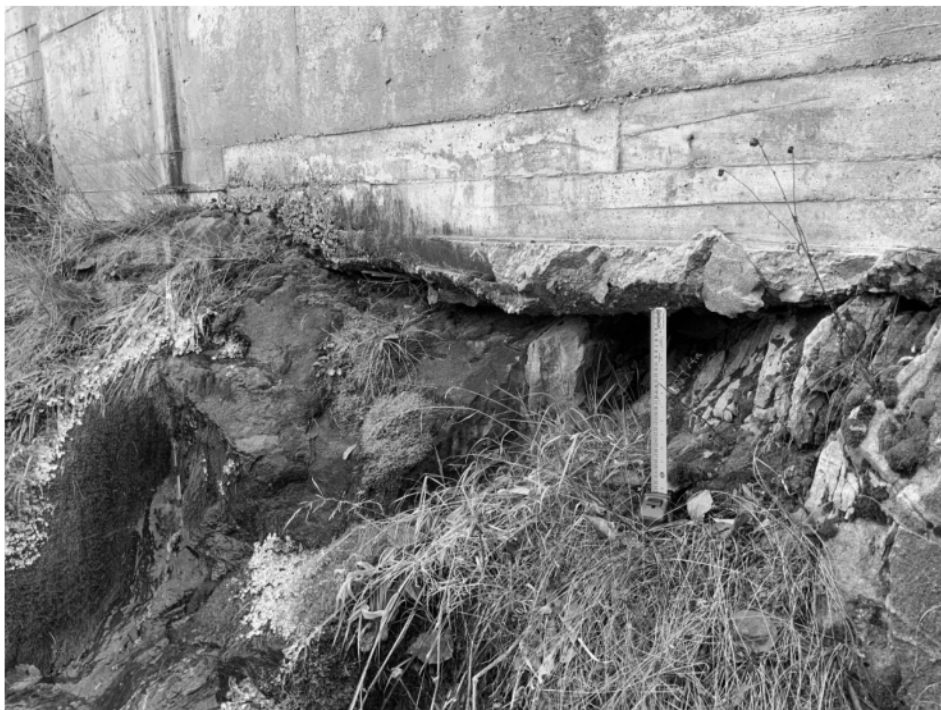
Foundation erosion located 1.5m left and 2m right of culvert plunge location. See

Drainage System	Poor	5 drain pipes observed with evidence of drainage. Evidence of subsurface flow and erosion of wall foundation 1.5m left of where culvert flow hits rock. Erosion 50cm into wall, 1.2m wide. Additional erosion unlikely as it's on bedrock.
Traffic Barrier/ Fence	Good	
Road	Good	4.4m wide
Upslope	Good	
Downslope	Good	Bedrock
Lateral Slope	Good	Potential for erosion from surface flow at left end
Detrimental Vegetation		
Culvert	Poor	Inlet blocked 75%
Curb/Berm/ Ditch	Good	1.5 to 3m wide ditch
Other Secondary Element

Inspector's Wall Performance Condition Rating	Fair
Condition Narrative	Functional. Monitor location of foundation erosion. Likely driven by downslope failure from reservoir levels, or possibly from subsurface flow through wall.
Date of Last Inspection	
Previous Inspection Record(s) Considered?	
Available Design Information / Construction Documentation Considered?	
FSR Road Status (at time of inspection)	
Capitalized FSR	
Is there any movement or settlement instrumentation data to record?	
FRPA forest values at risk of damage or loss given a catastrophic wall failure	None
Estimate of failure consequence <u>given</u> a catastrophic wall failure	High: Seasonal to long term loss of road access; loss of life or injury; no alternate routes available
Inspector's <u>opinion</u> if additional investigation and/or more thorough inspection or risk assessment required?

Erosion of foundation 1.5m left (upchain) of culvert.

Clean culvert inlet and excavate a sump.

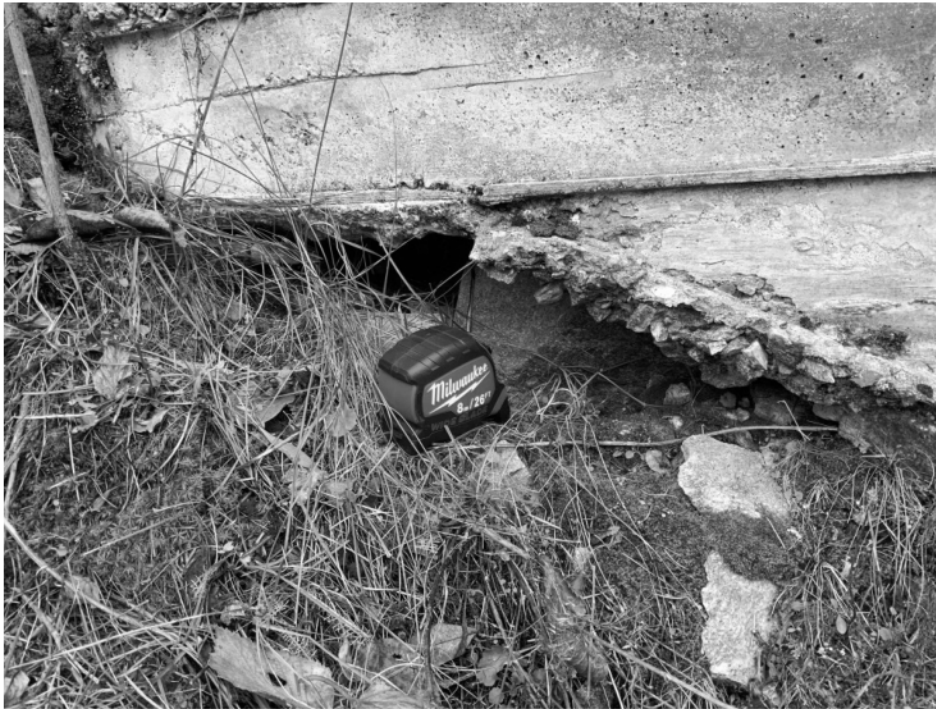
2m right of culvert plunge location, 20cm into wall, 40cm wide, 14cm high

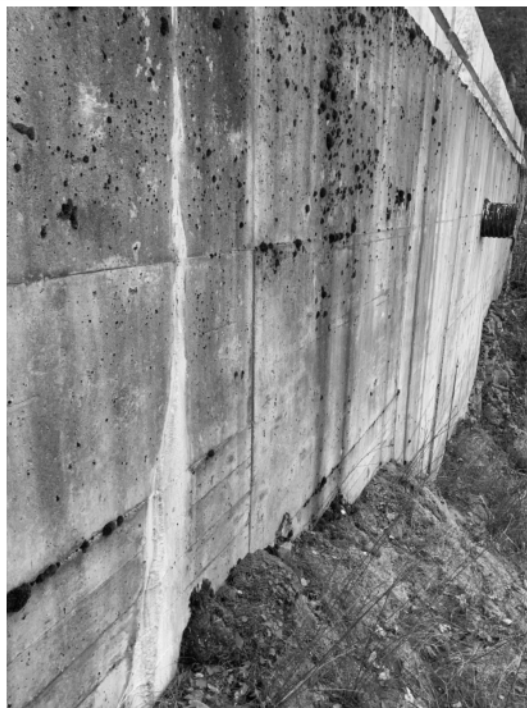
Hairline crack at top of white deposits

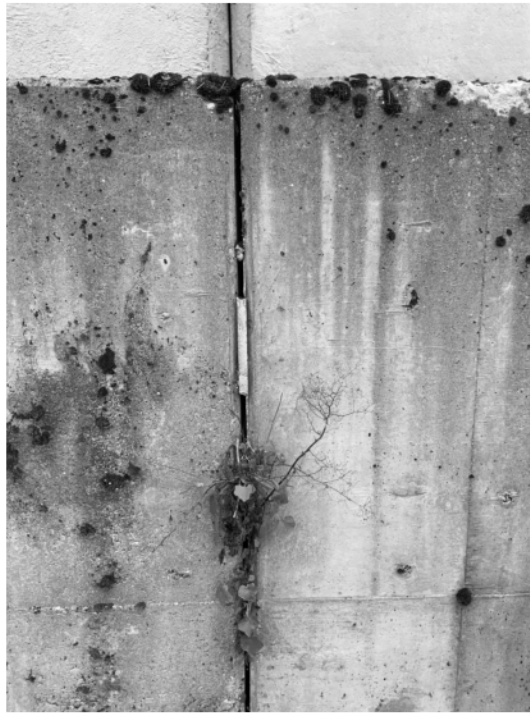
Joint. Sealant mostly gone.
