August 24, 2020

**RE: Hydrological investigation and Professional Consultation for 4716 Cowichan Lake Road, Duncan, BC**

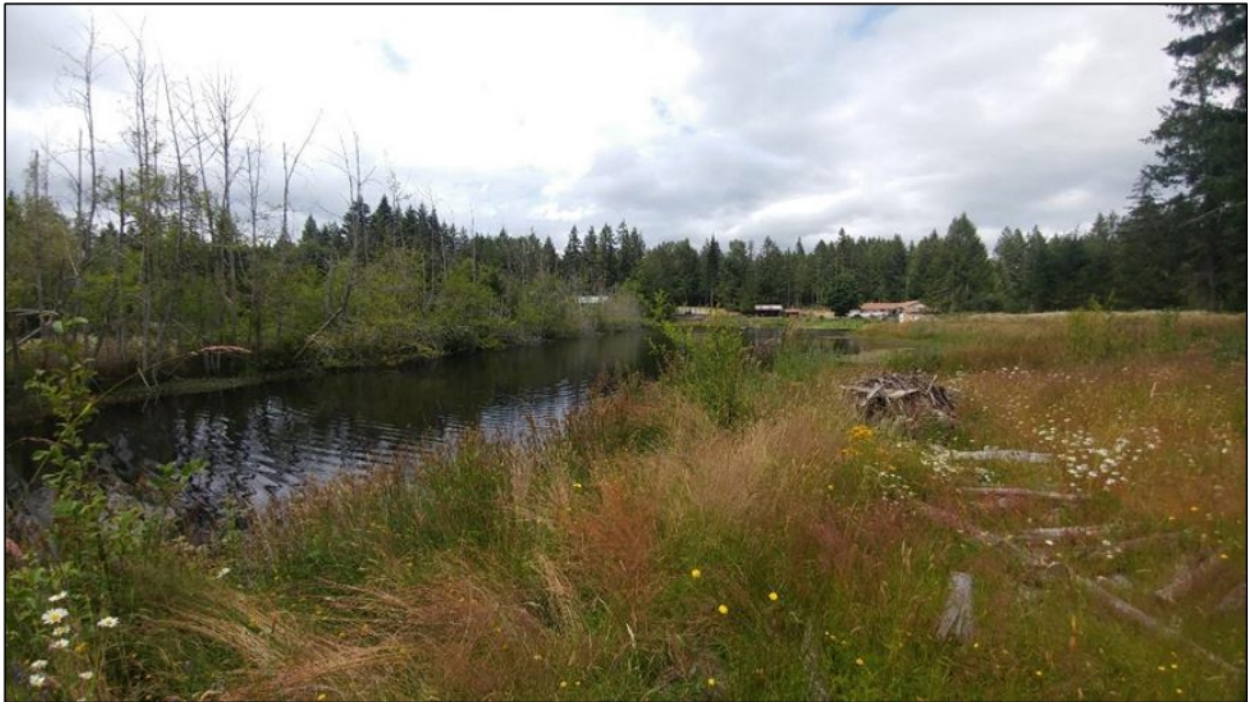
Arriving at the field site, drainage was observed running from west to east across the Site (also identified remotely via Google Earth). Moreover, A north to south trending berm separates two bodies of water, and

**PHOTO 1. RETENTION POND AND NORTH TO WEST TRENDING BERM THAT SEPERATED THE CLIENTS PROPERTY (4716 COWICHAN LAKE ROAD, DUNCAN, BRITISH COLUMBIA) FROM THE ADJACENT PROPERTY. PHOTO WAS TAKEN BY MADRONE ENVIRONMENTAL SERVICES. DATE OF PHOTO: JULY 02, 2020.**

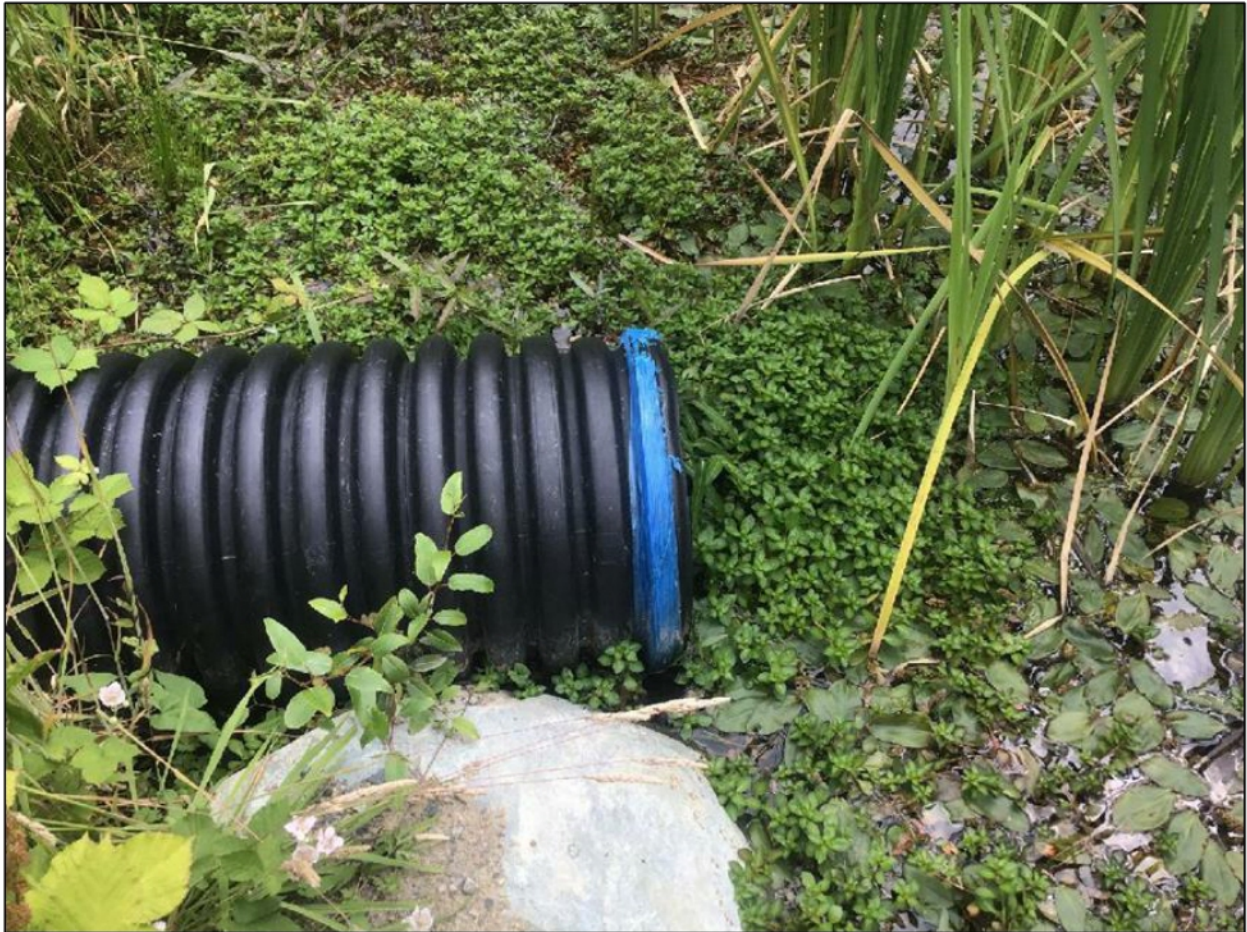
- The culvert appears to be free of debris or materials that could inhibit flow;
- The intake of the culvert appears to be at a minor incline (i.e., lower than the remaining pipe). The entire culvert appears to be slightly bowed and inclined though its course;
- Thick vegetation and woody debris were also noted to occur downstream of the culvert but are not interpreted to impede flow or have been the cause of upstream flooding;
- The client's culvert was also noted to be at a higher elevation than the adjacent upstream culvert.

Given the recommendations from FLNRORD and evidence I gathered from my inspection, it is my opinion that an undersized, improperly installed 500 mm culvert has resulted in increased retention of water in the Client's pond which inundates the adjacent property beyond pre-existing conditions.

**PHOTO 2. VIEW LOOKING DOWNSTREAM (TO THE LEFT) CULVERT INTAKE PIPE TRENDING IN AN EAST-NORTHEAST DIRECTION. PHOTO WAS TAKEN BY MADRONE ENVIRONMENTAL SERVICES. DATE OF PHOTO: JULY 02, 2020.**

It is my suggestion that the client follows FLNRORD's advice to install an 800 mm culvert that is at level with neighboring culverts (upstream and downstream), which is approximately 10 cm lower than the existing culvert in place. I will furtherly suggest that ancillary works be conducted that includes culvert inlet armoring to protect from further erosion and entrainment of sediment to off-site sensitive receptors. Armouring can be accomplished through complete coverage with geotextile (on bottom, against native sediment) and riprap (on top) within 1m of the culvert inlet and outlet. The riprap should consist of coarse angular stones of no less than 20cm in minimum diameter.

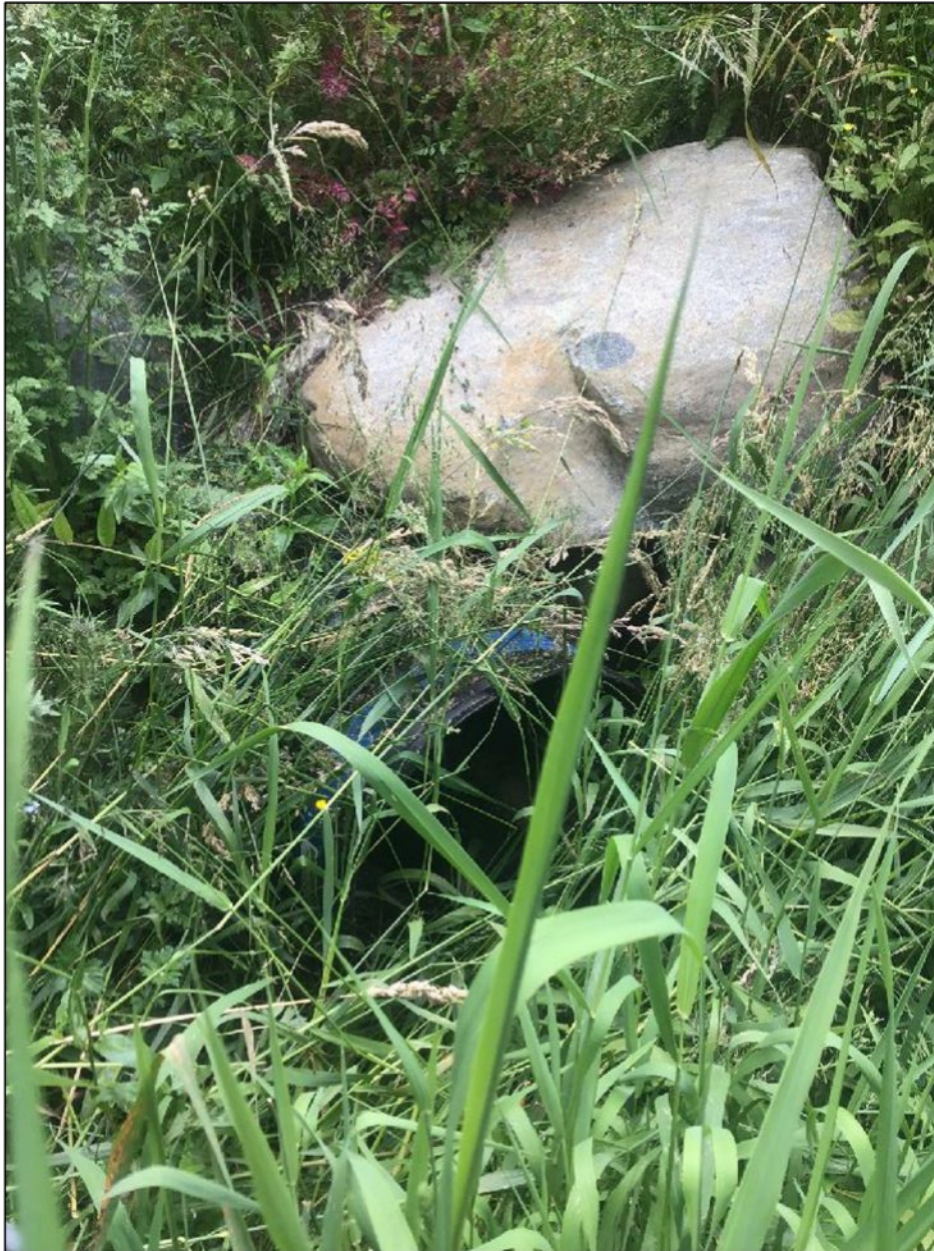
**PHOTO 3. VIEW LOOKING UPSTREAM FROM OUTFLOW OF THE CULVERT. PHOTO WAS TAKEN BY MADRONE ENVIRONMENTAL SERVICES. DATE OF PHOTO: JULY 02, 2020.**
